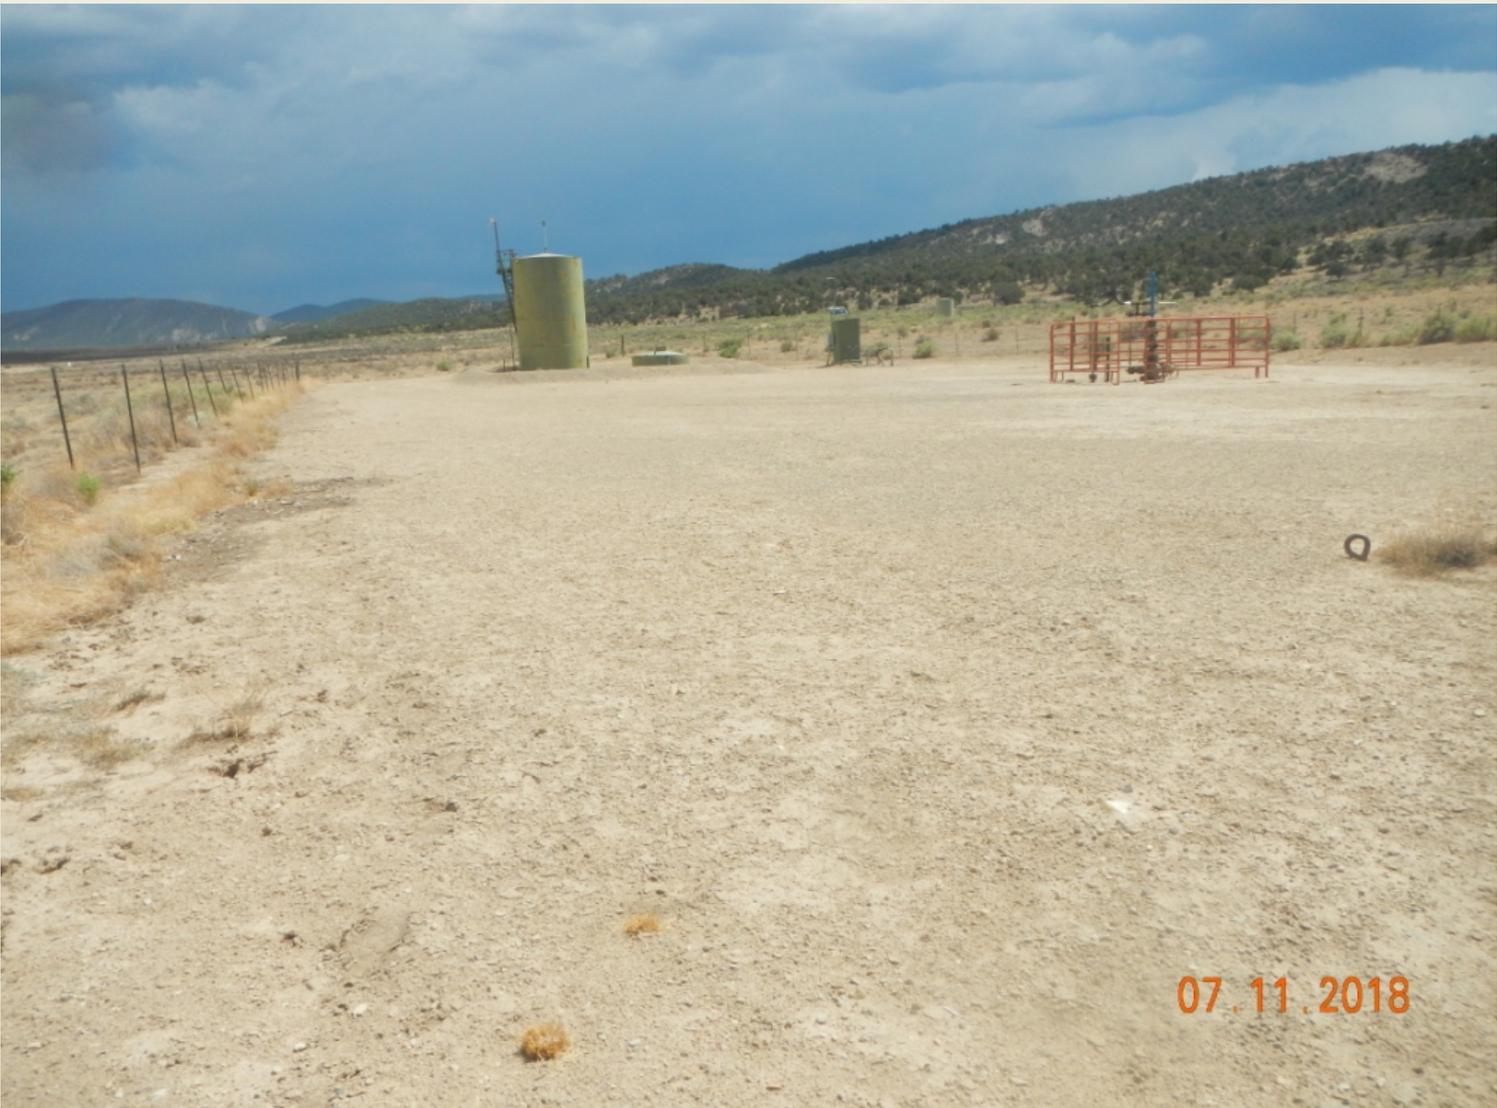
Photo 1. View of the project area from the northwestern corner facing center.

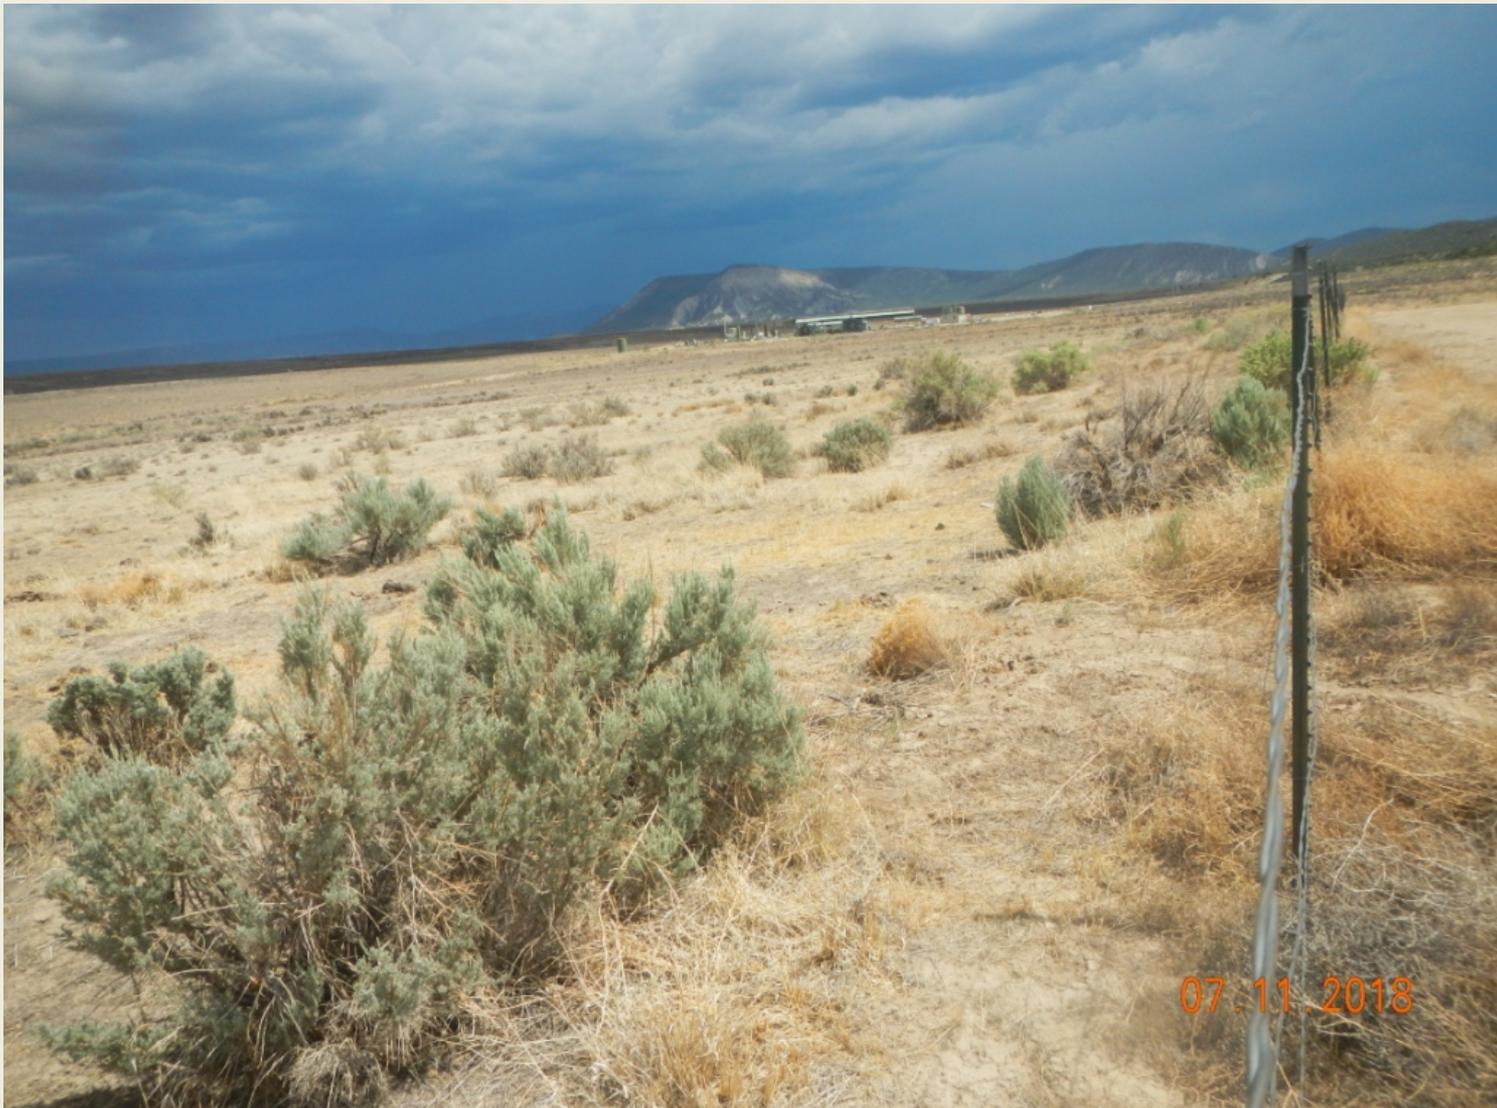
Photo 2. View of the northern interim reclamation area from the northwestern corner facing eastward. Vegetation is dry, but appears to be progressing.

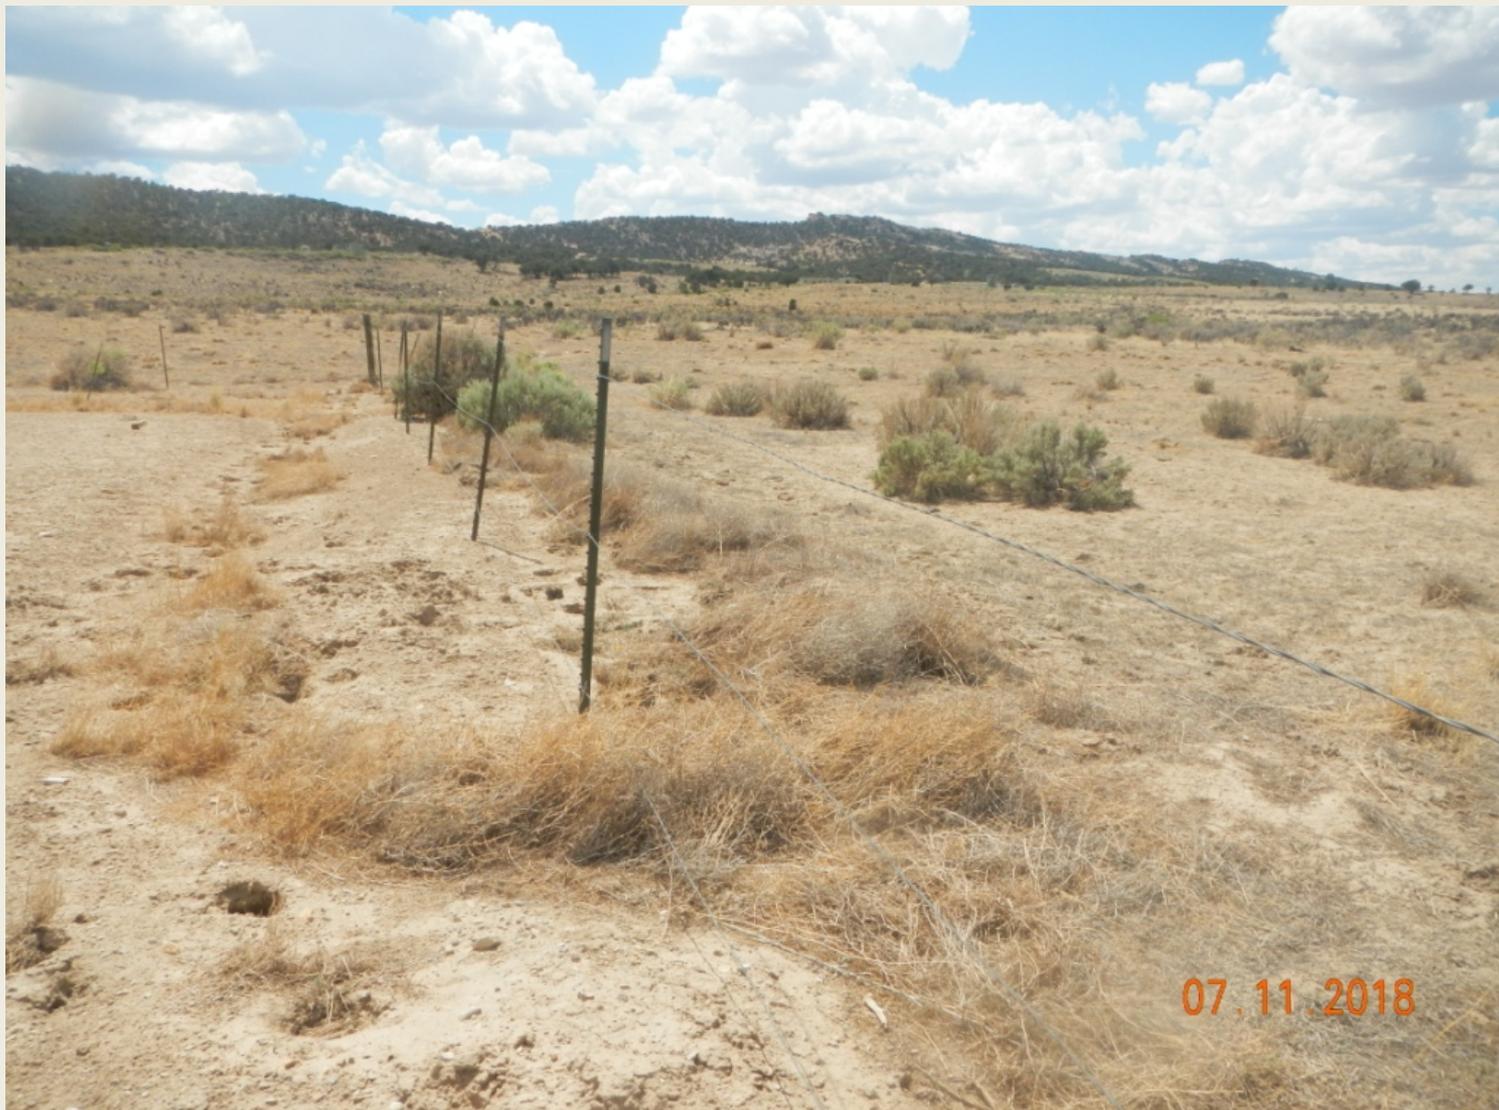
Photo 3. View of the western portion of the project area from the northwestern corner facing southward.

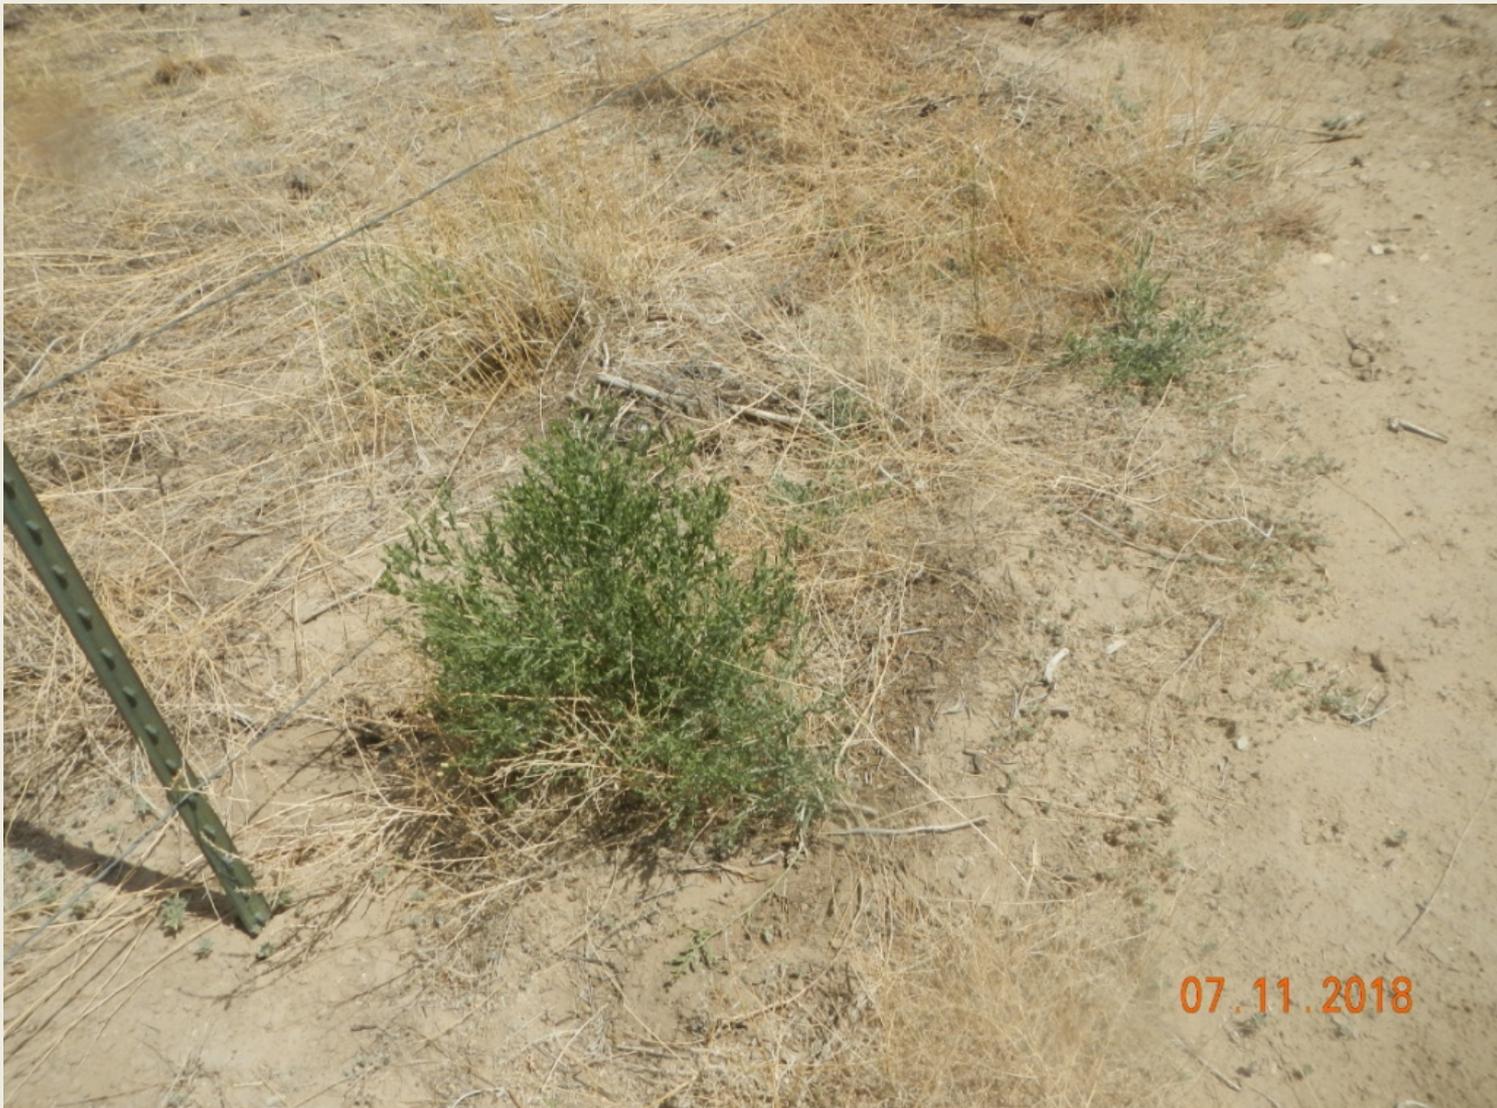
Photo 4. View of single individual Russian knapweed along the southeastern edge of the project area. Russian knapweeds appear to have been treated. Scattered individuals remain.
