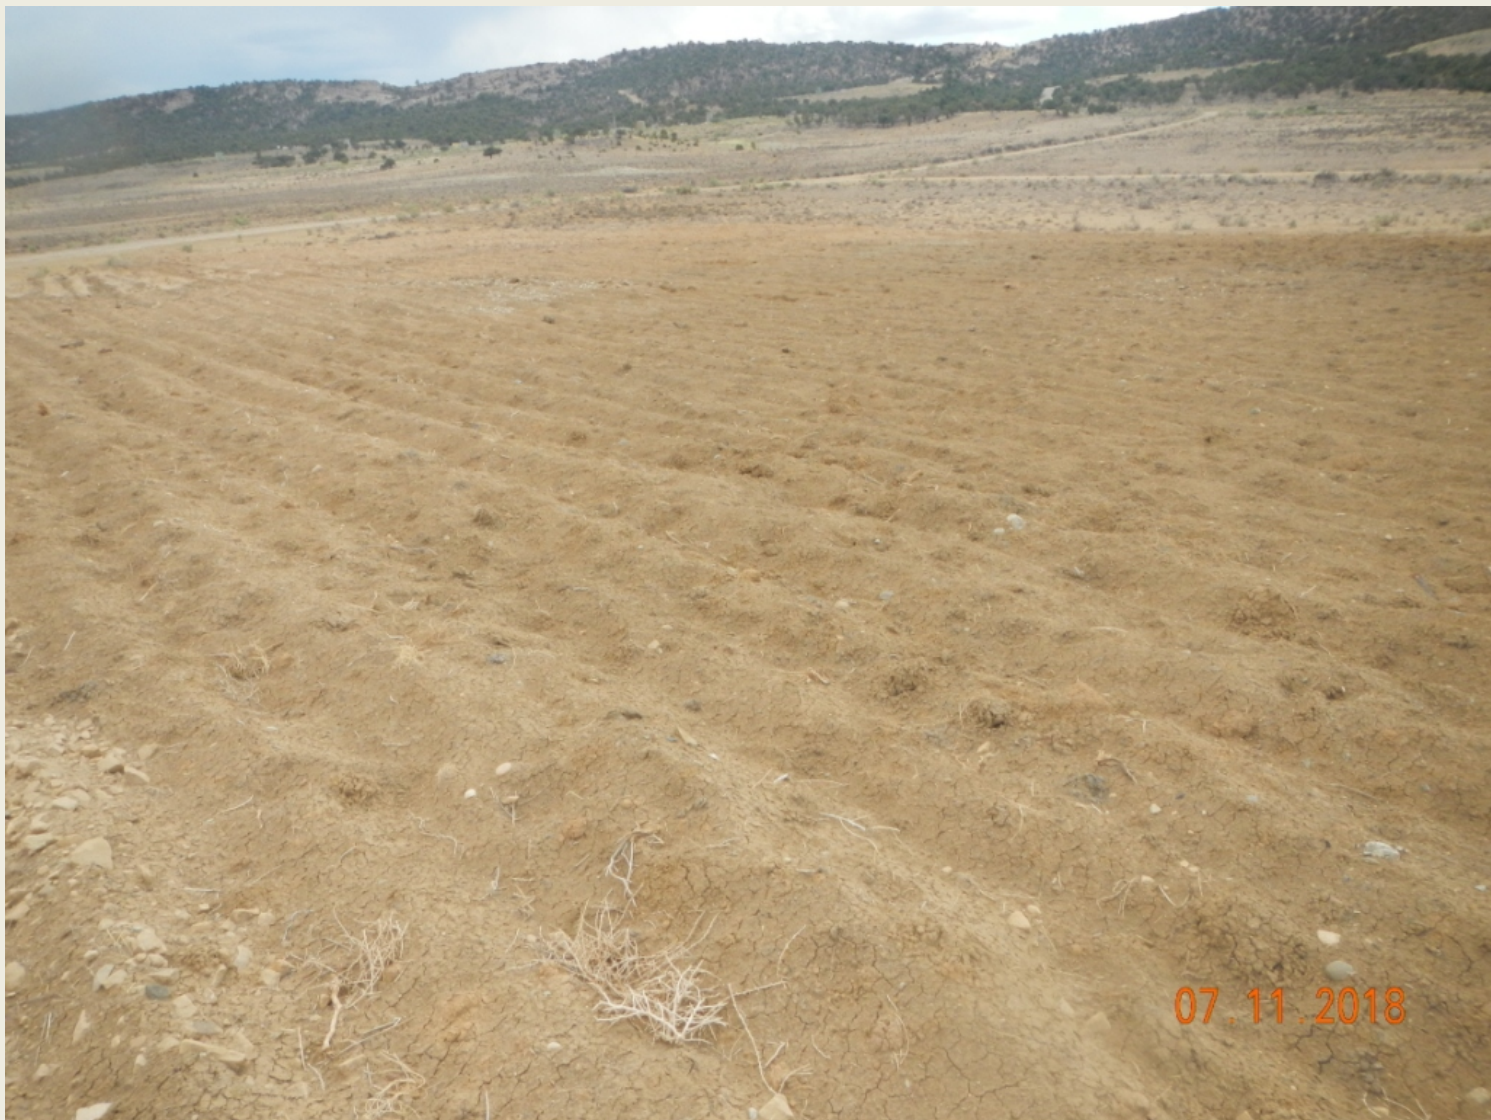
Photo 1. View of the reclaimed project area from the northeastern corner facing center. Area is in process of reclamation, but little germination observed.

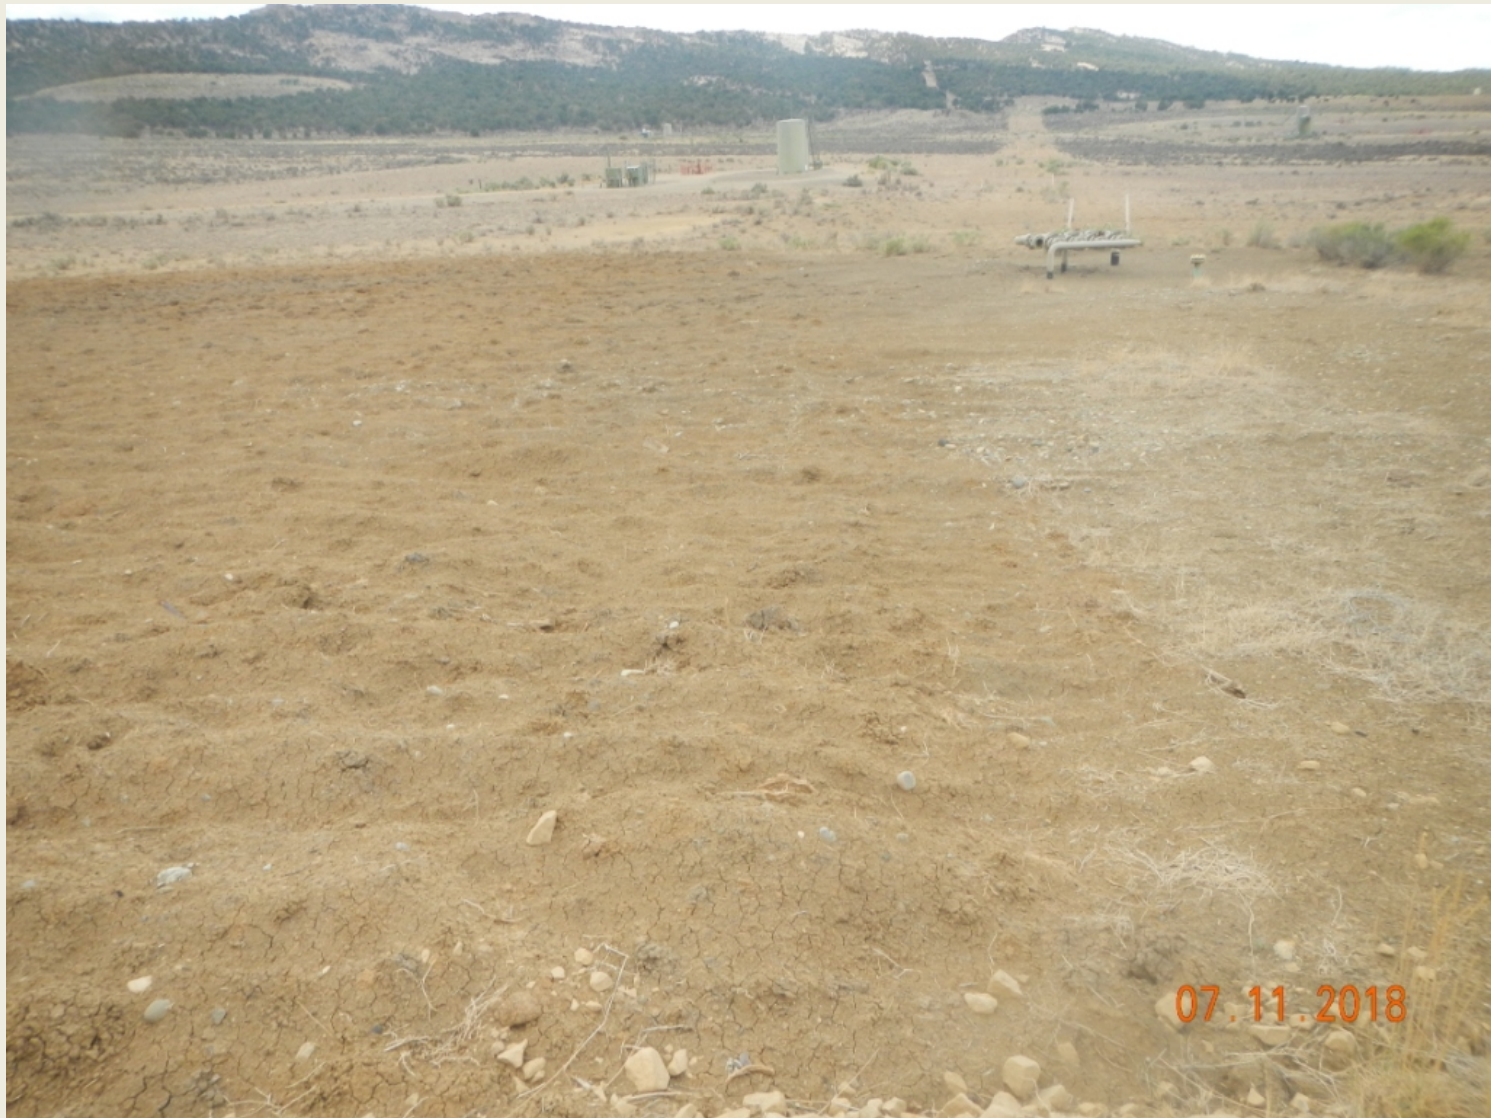
Photo 2. View of the northern portion of the project area from the northeastern corner facing westward. Facilities in background appear to be associated with pipeline right of way.

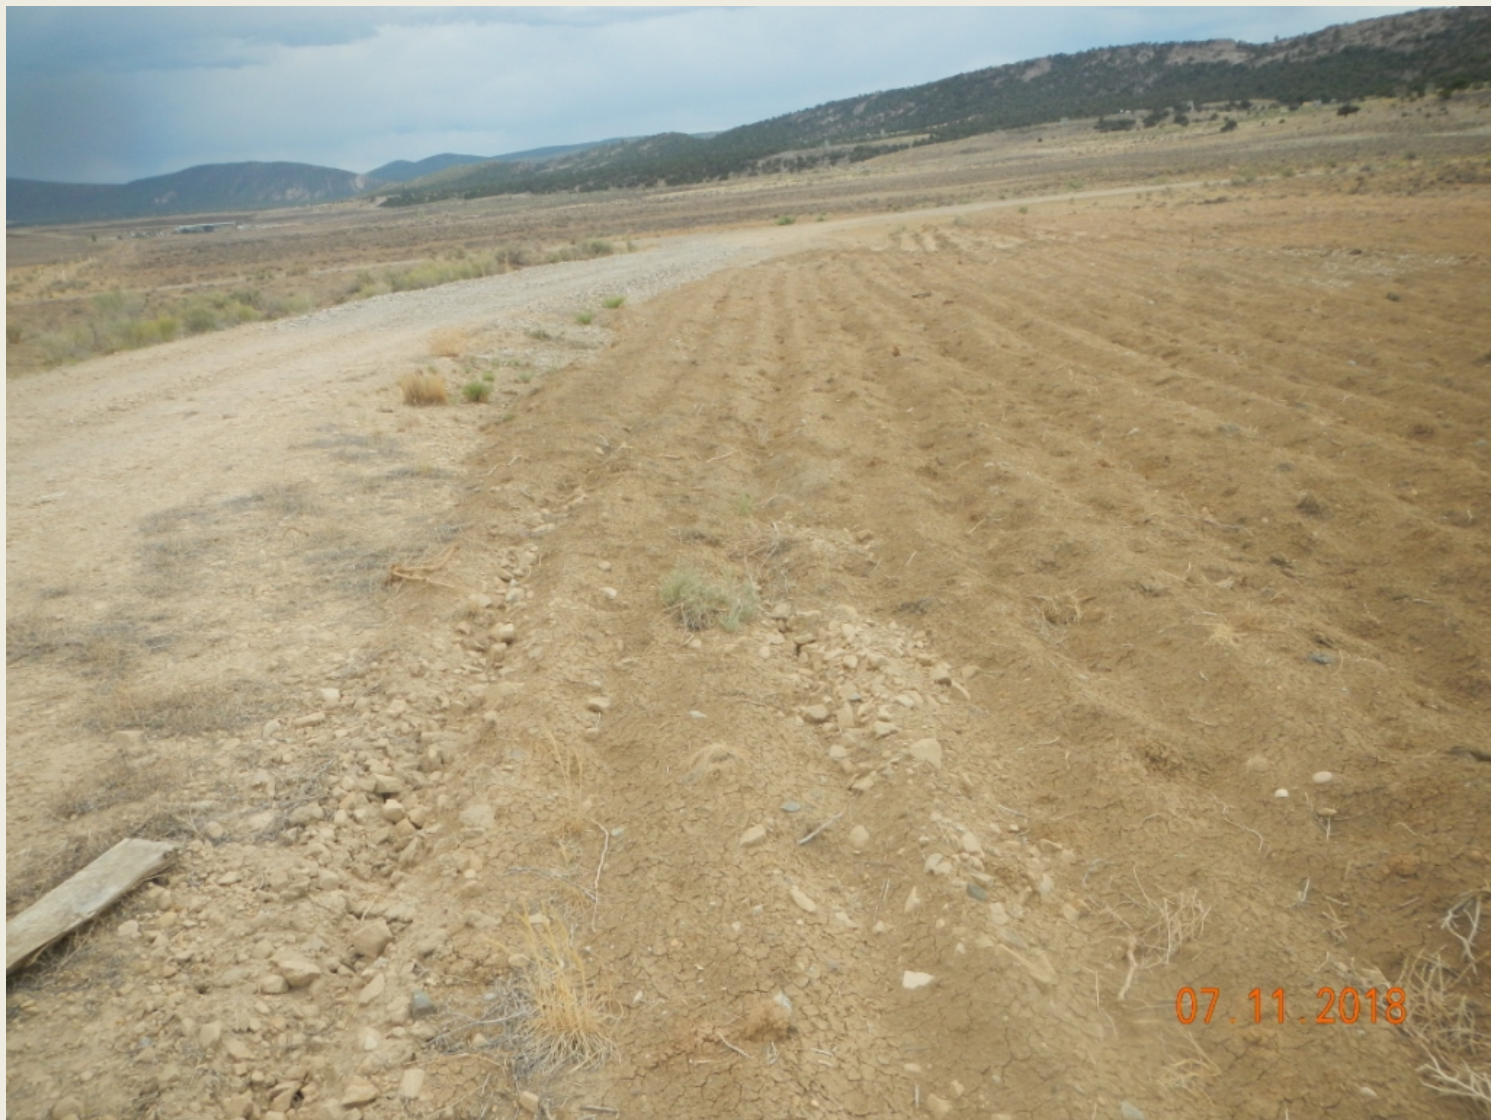
Photo 3. View of the eastern portion of the project area from the northeastern corner facing southward.

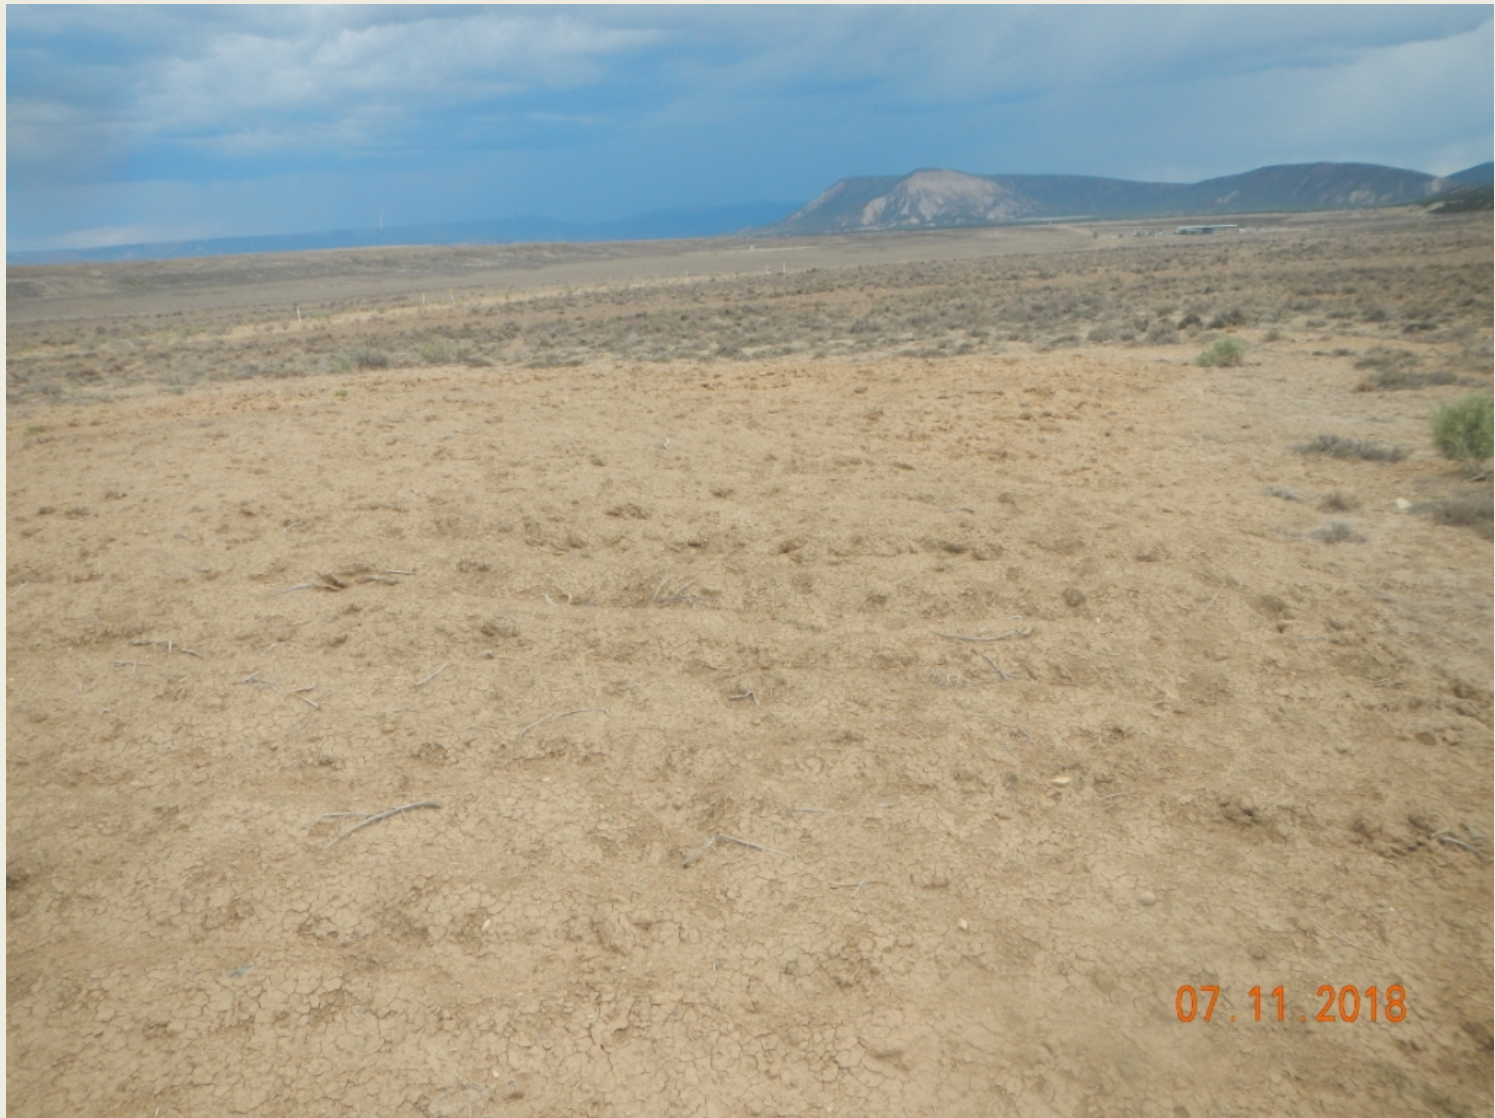
Photo 4. View of reclaimed portion of project area where facilities were located southeast of the well pad.
