Inspection Photos
Location Name: Duncan Unit 2 1
API: 05-081-05546

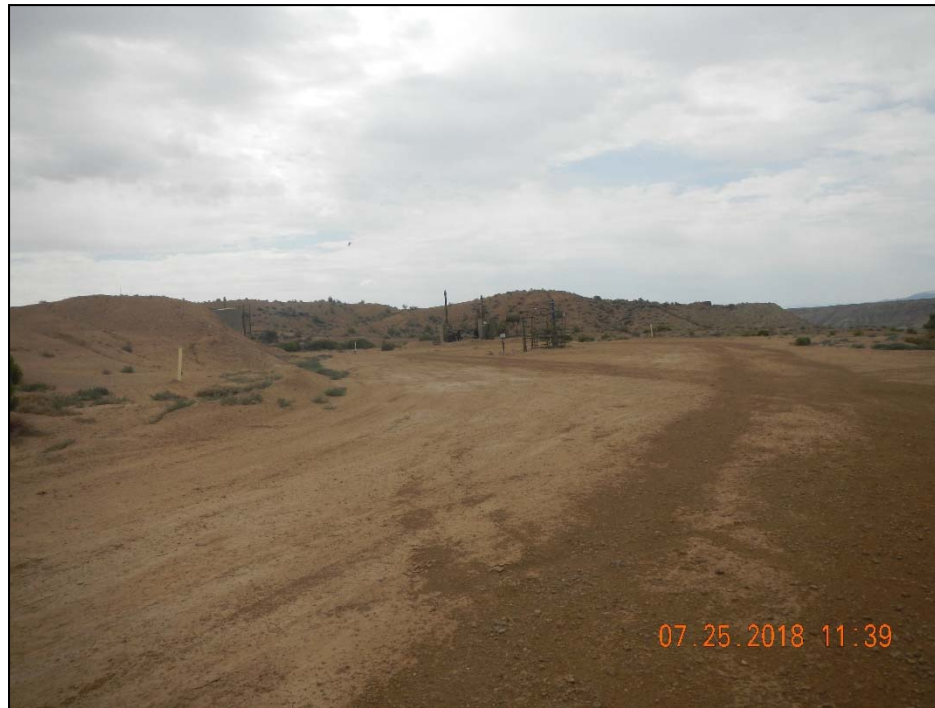
Photo 1. Overview of location taken at entrance facing southeast.
