Inspection Photos
Location Name: Duncan 5
API: 05-081-07064

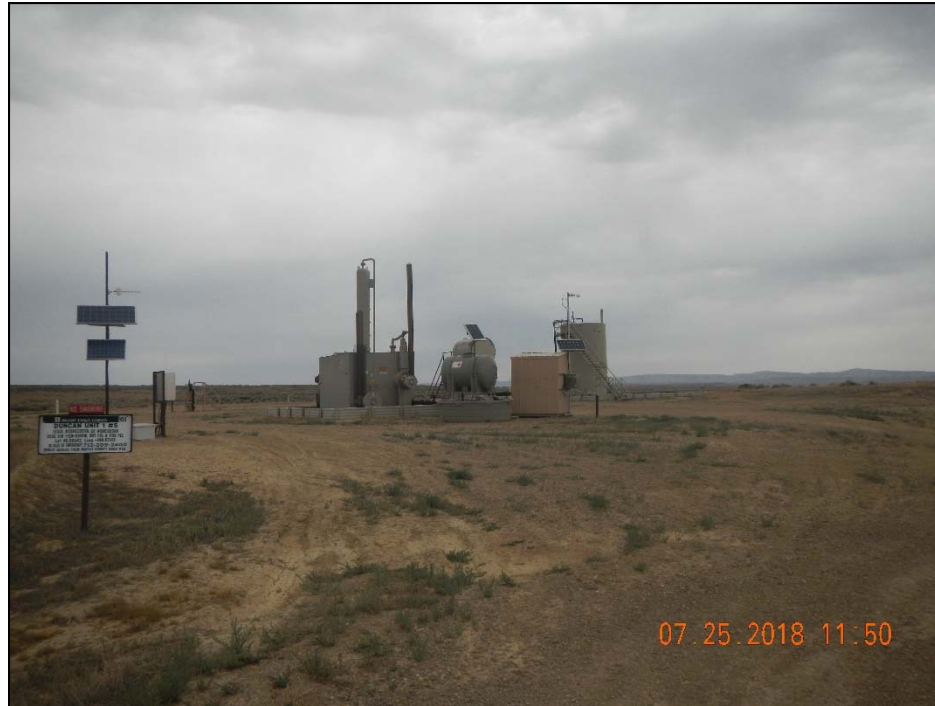
Photo 1. Overview of location taken at entrance facing northeast.
