Inspection Photos

Location Name: Federal Plover - 68N60W / 28SWNW

Location #: 331082

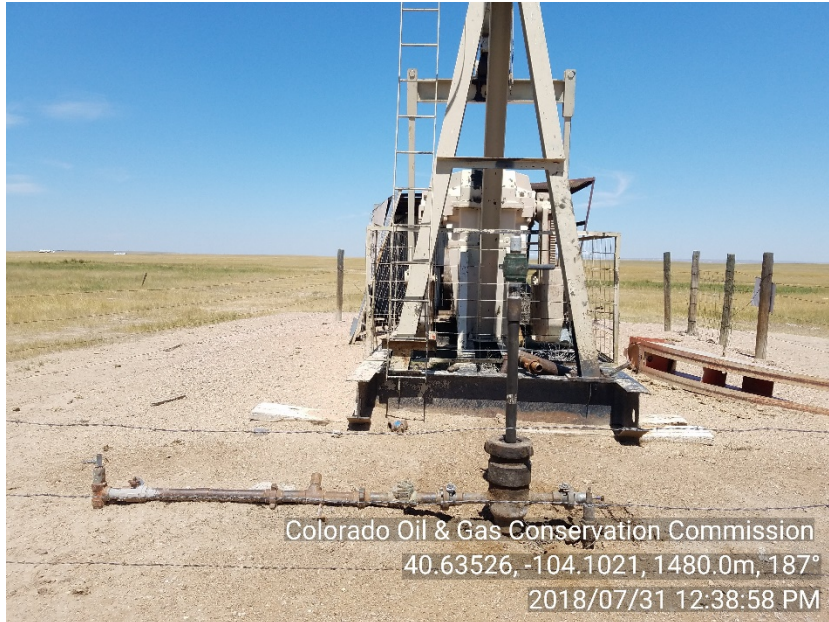
Photo #1

Federal Plover 28-5 X (API # 05-123-20126) wellhead

Flowline is closed & locked.

Bradenhead is plumbed to surface

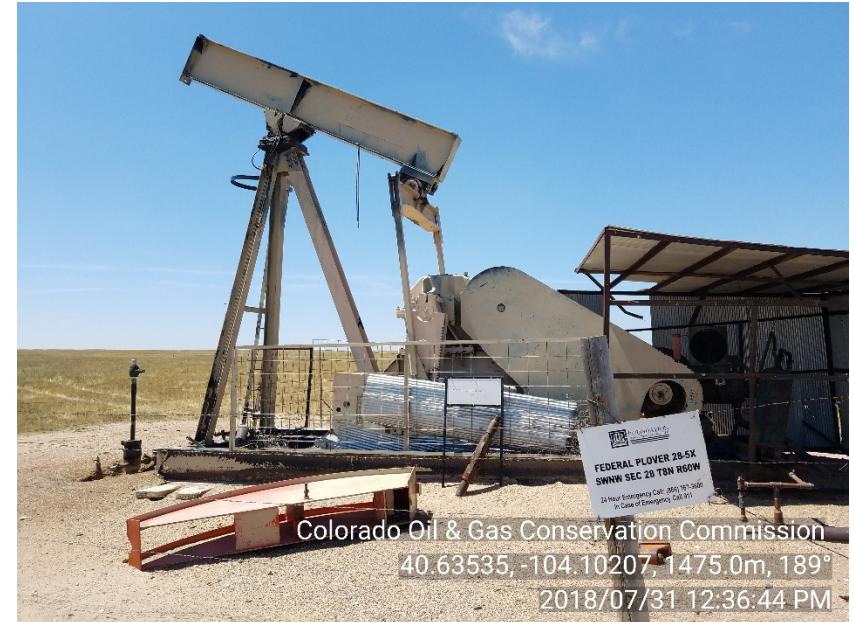
Photo #2

Federal Plover 28-5 X (API # 05-123-20126) wellhead

View 2

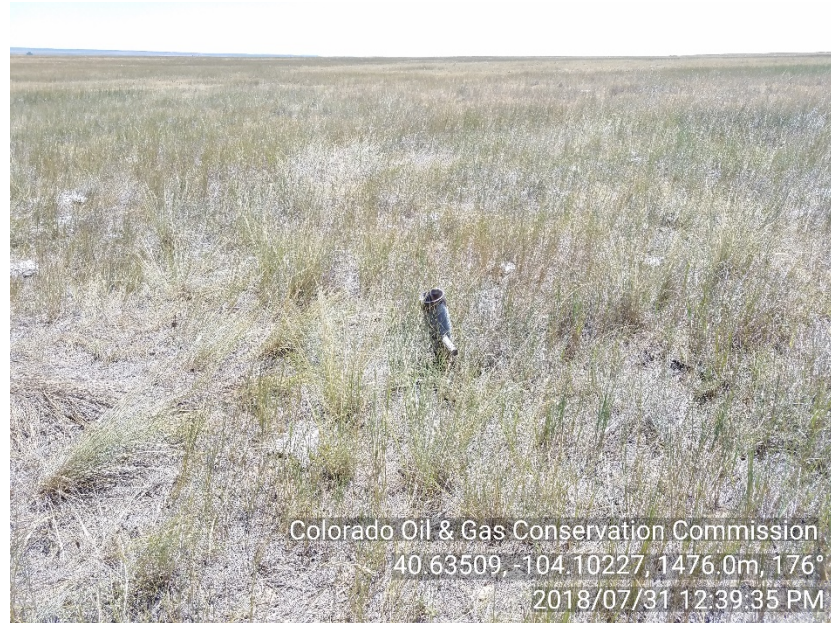
Photo #3

Federal Plover 28-5 X (API # 05-123-20126) wellhead

Unmarked deadman anchor
