Inspection Photos

Location Name: Sooner Unit - 68N58W / 28NWSE

Location #: 319078

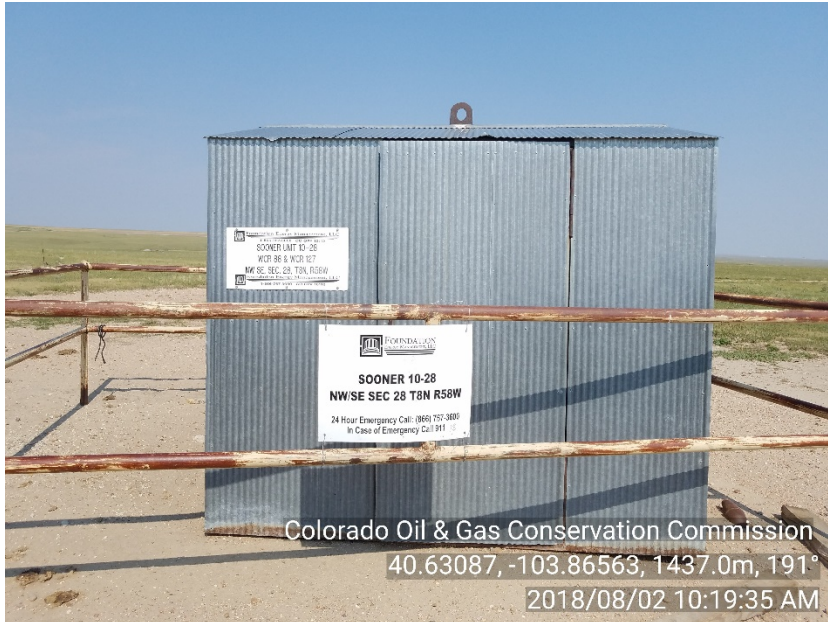
Photo #1

Sooner 10-28 (API 05-123-10637)

UIC injection wellsite

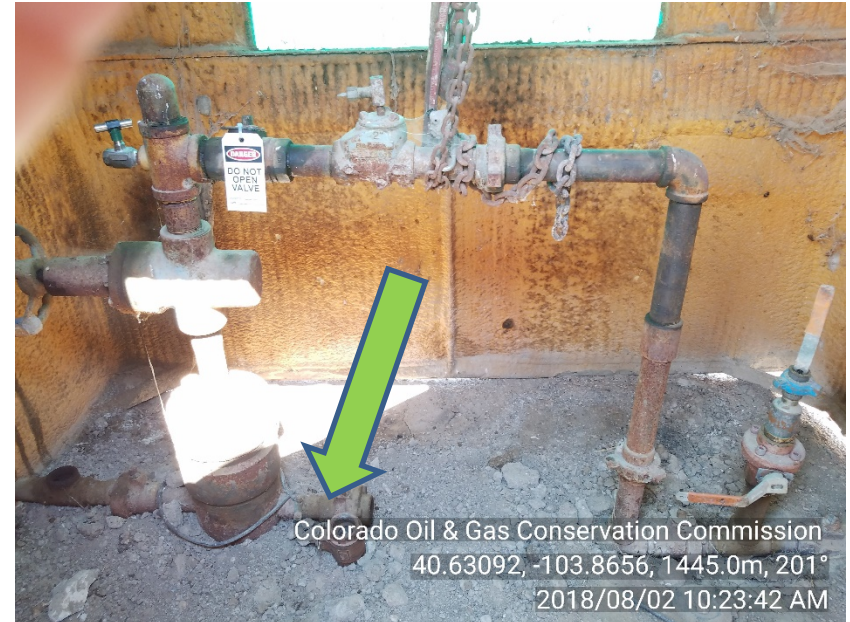
Photo #2

Sooner 10-28 (API 05-123-10637)

UIC injection well

Bradenhead has been plumbed to surface

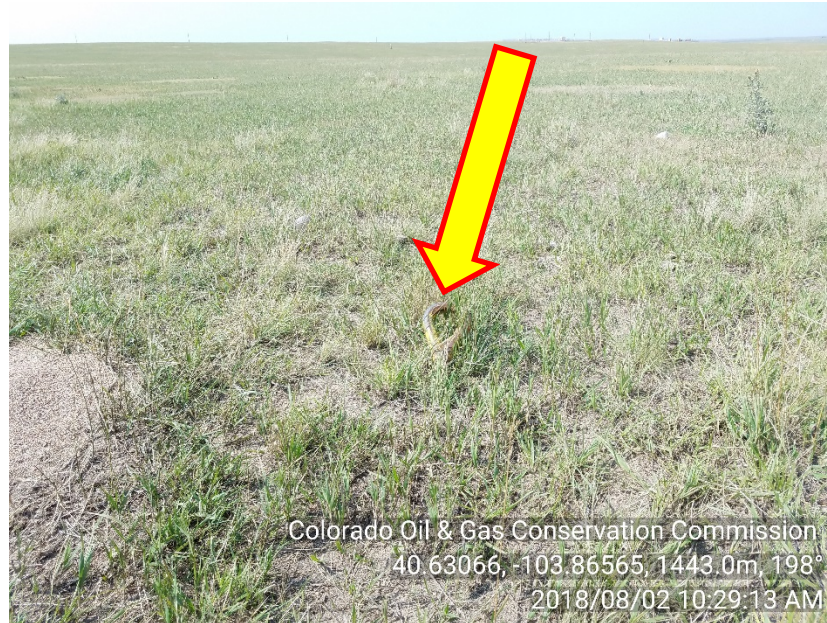
Photo #3

Sooner 10-28 (API 05-123-10637)

Unmarked deadman / anchor
