# Inspection Photos

Operator: PETRO-CANADA RESOURCES (USA)  
INC - 72085

Location ID: 311664

Inspection Doc. Number: 682503708  
Adams County, CO

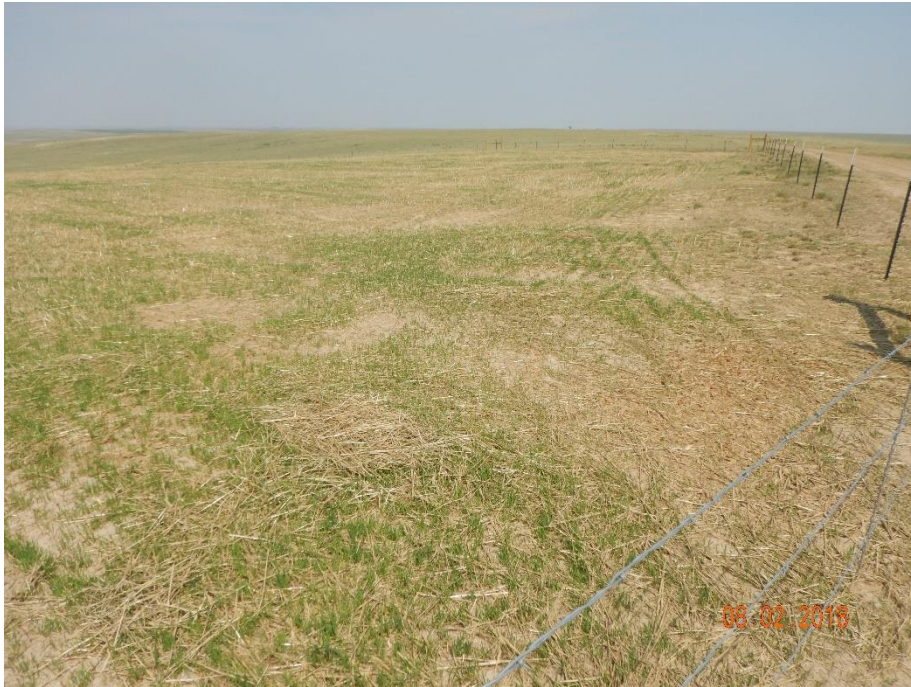
**Photo 1:** Photo taken from the east end of the northern degradation/spill area, facing north. Additional reclamation activities appear to have been conducted and germination evident.

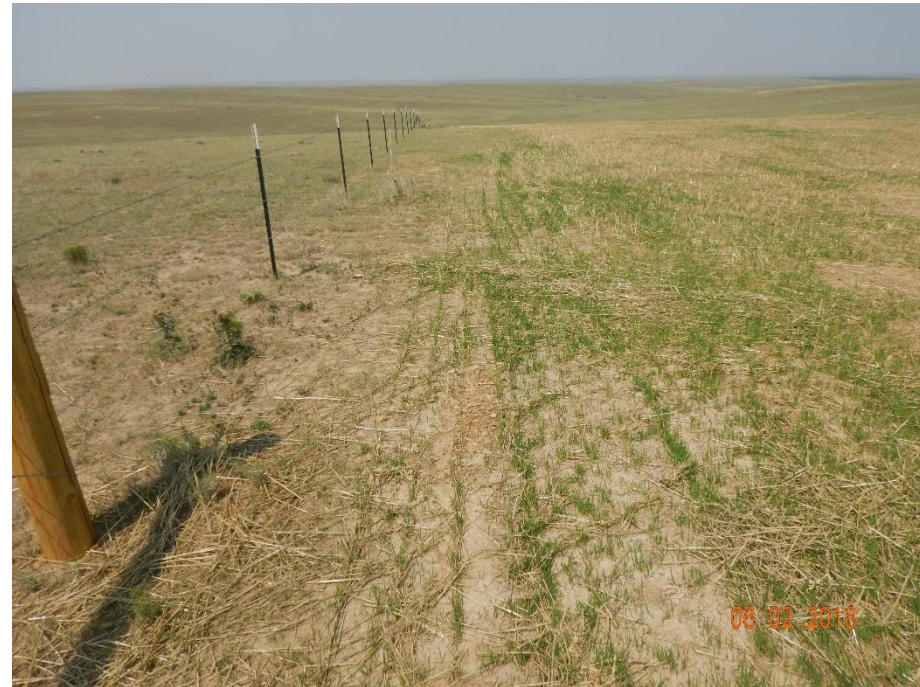
**Photo 2:** Photo taken from the east end of the northern degradation/spill area, facing west. Additional reclamation activities appear to have been conducted and germination evident.

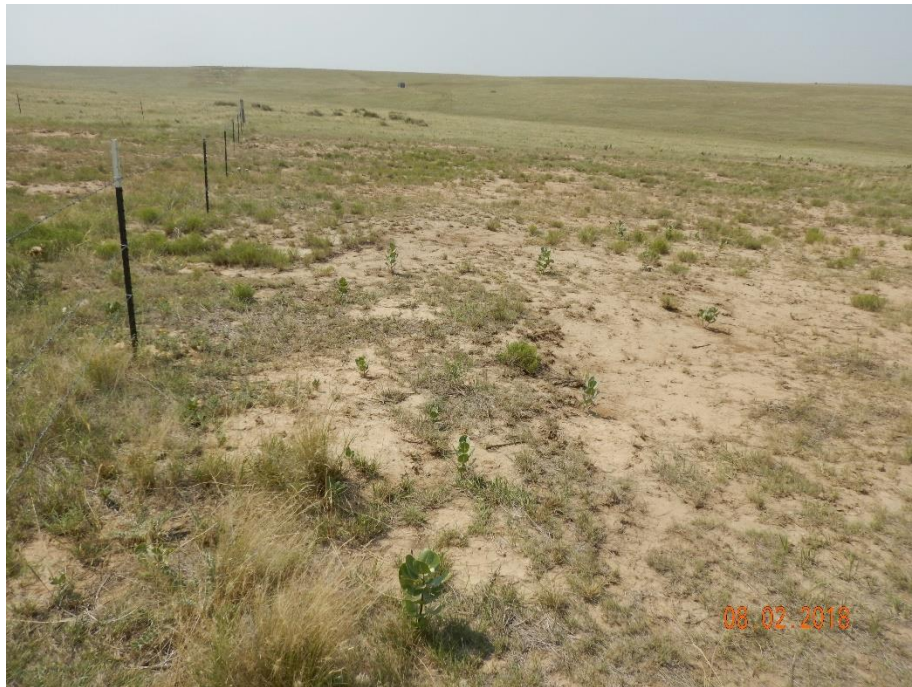
**Photo 3:** Photo taken from the western fence line, of the southern degradation (spill) area, facing south. Photo shows large areas of the spill area remain bare and exposed soil, or predominantly undesirable weedy plant species. Erosion degradation evident. Unable to find evidence that reclamation activities have been conducted in these area.

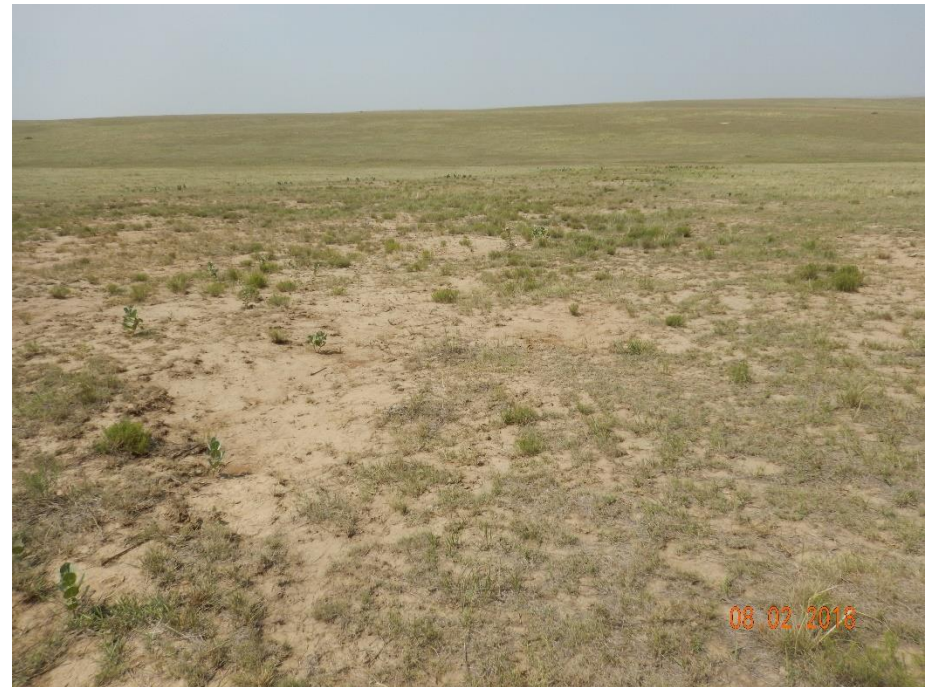
**Photo 4:** Photo taken from the western fence line, of the southern degradation (spill) area, facing west. Photo shows large areas of the spill area remain bare and exposed soil, or predominantly undesirable weedy plant species. Erosion degradation evident. Unable to find evidence that reclamation activities have been conducted in these area.

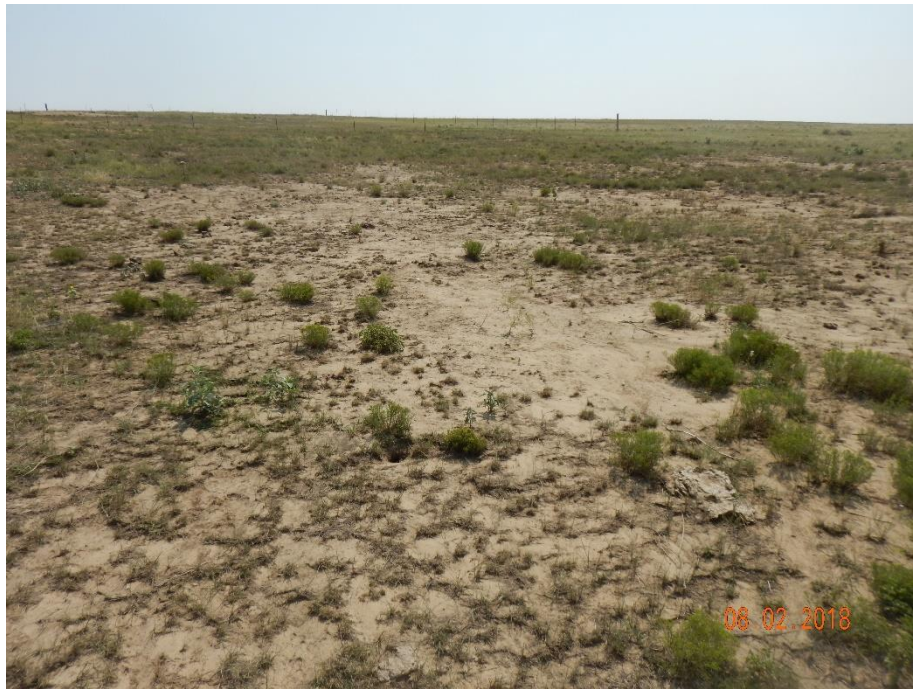
**Photo 5:** Photo taken from the southern spill area, facing east. See comments under photo 4.

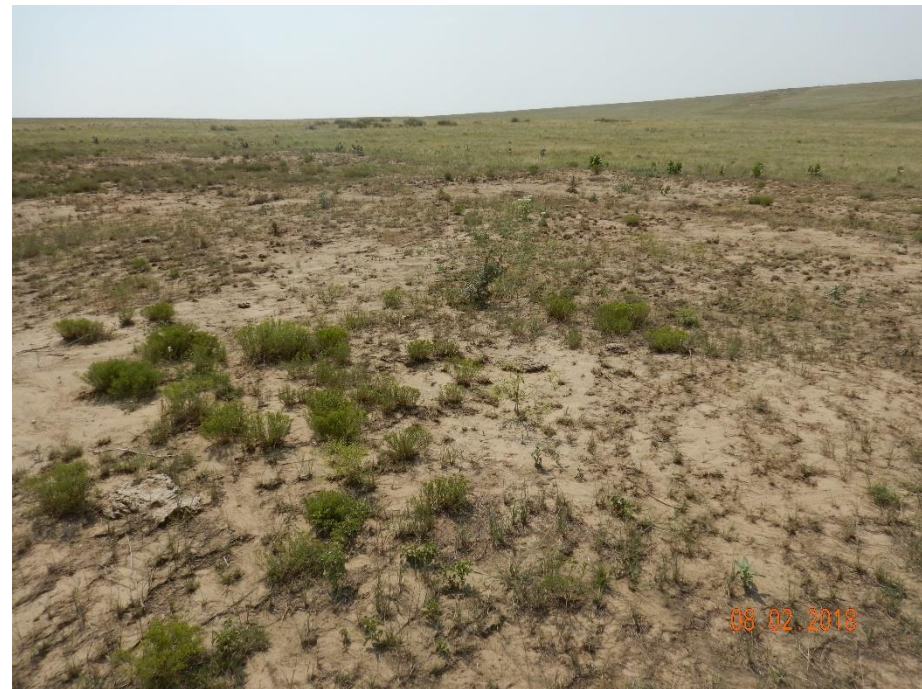
**Photo 6:** Photo taken from the southern spill area, facing south. See comments under photo 4.

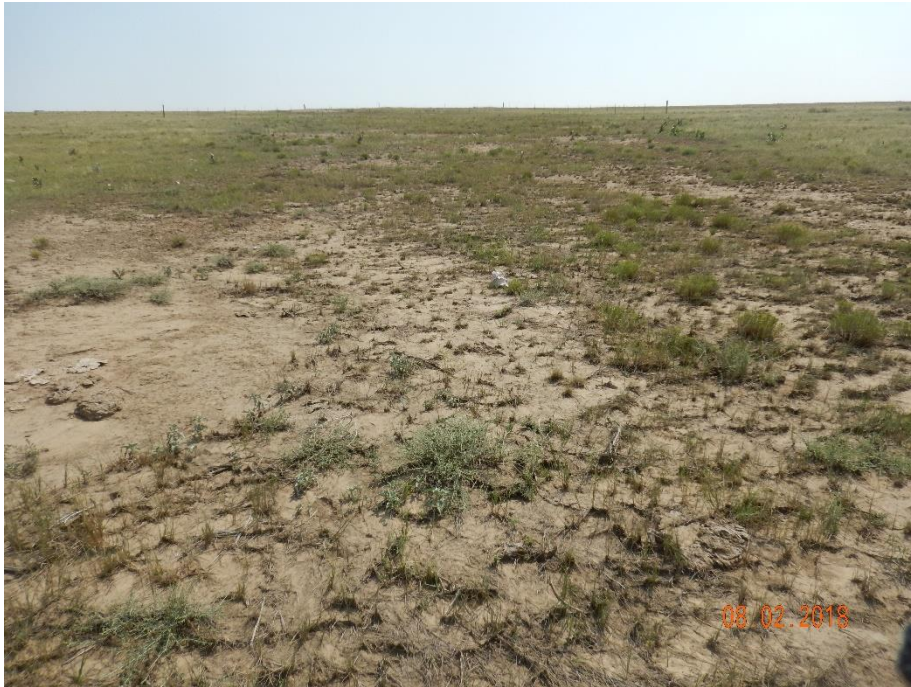
**Photo 7:** Photo taken from the southern spill area, facing east. See comments under photo 4.

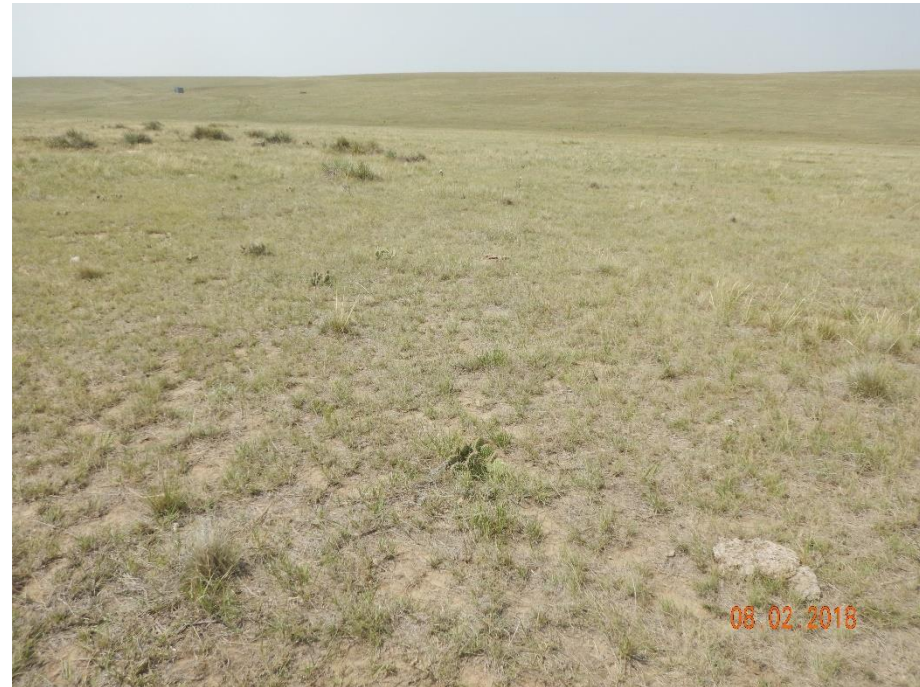
**Photo 8:** Photo taken from the adjacent reference area, facing west. Photo shows vegetation over the reference area.

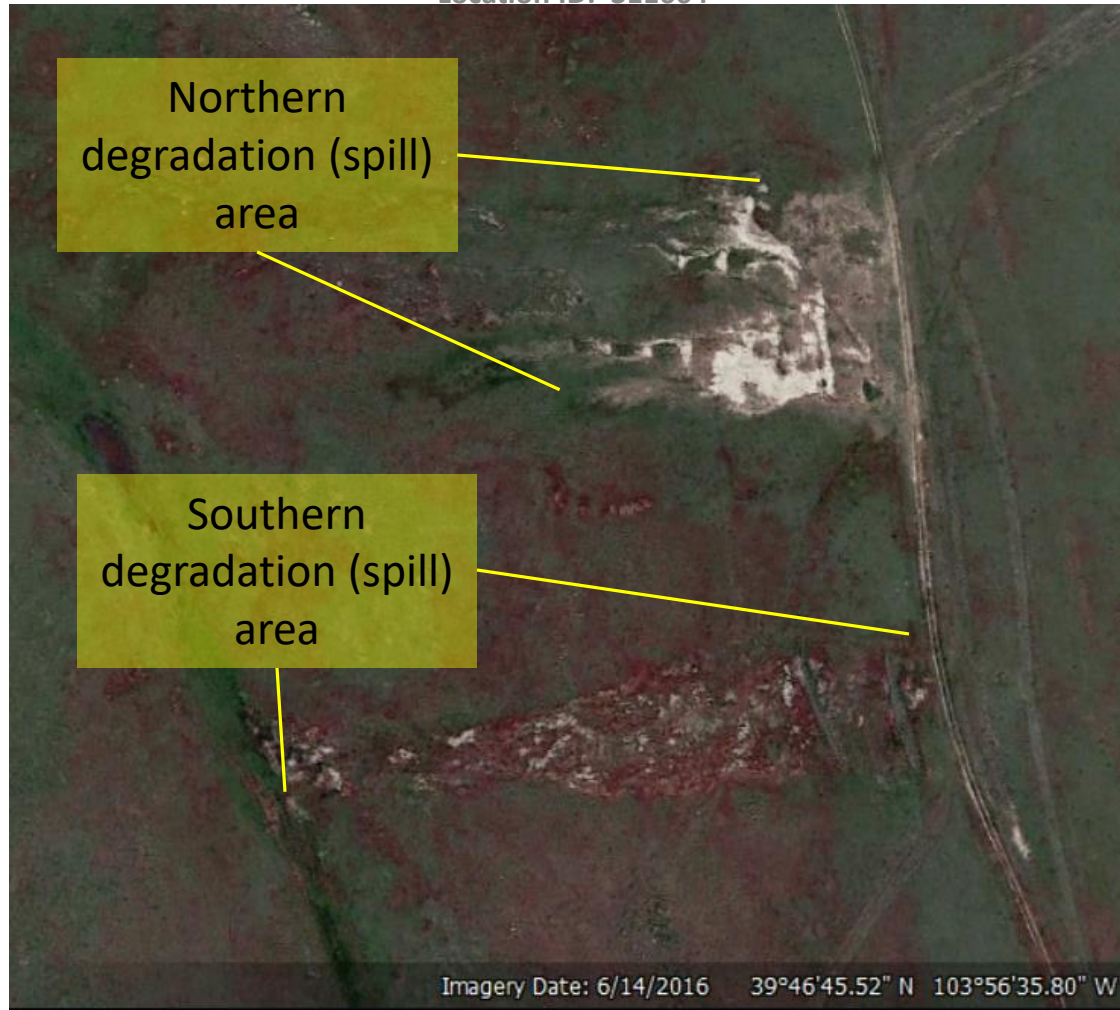
**Photo 9:** 2016 Google earth aerial imagery. Photo shows locations of the two degradation, or spill areas identified in the inspection, and in previous inspection. Additional reclamation activities appear to have been conducted on the northern spill area. Unable to find evidence of reclamation activities conducted the southern spill area; southern area remains bare and exposed soil or predominantly vegetated by undesirable weedy plant species. Stormwater erosion degradation patterns evident.
