Inspection Photo
Boulton 33-8A (G33NE)
API # 045-10264
Inspection # 689301679

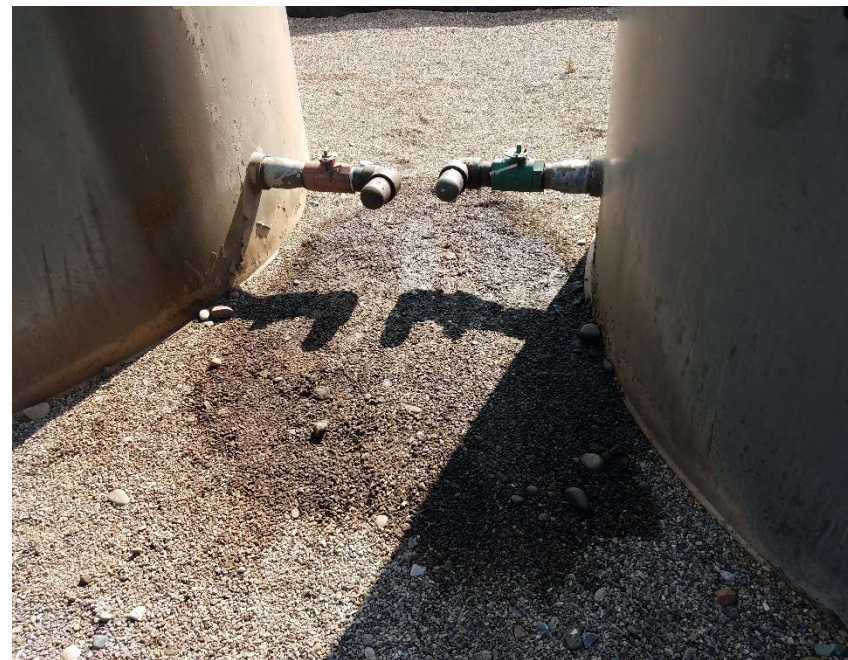
Location Photo #4, Oil stained rock in tank containment.

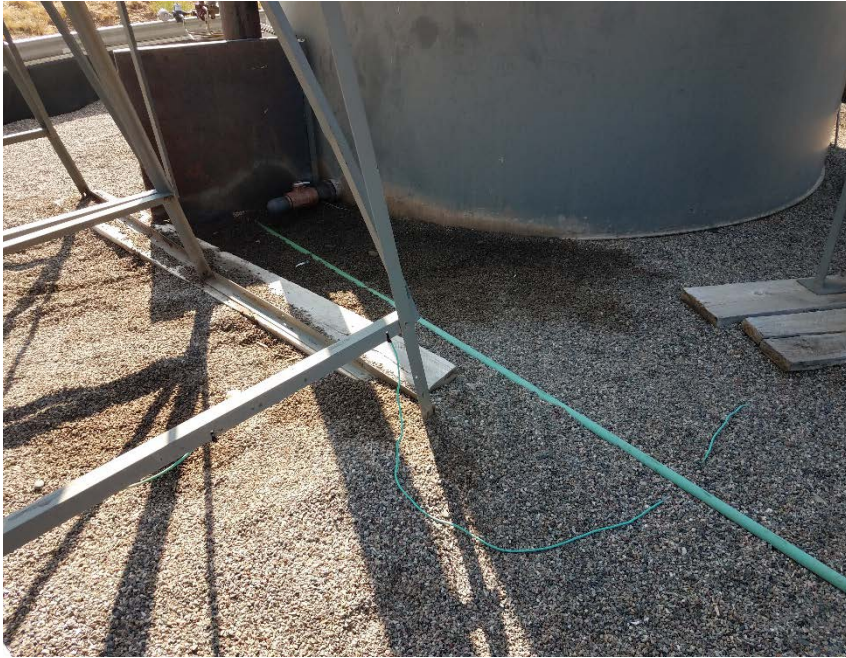
Location Photo #5, Oil stained rock in tank containment.

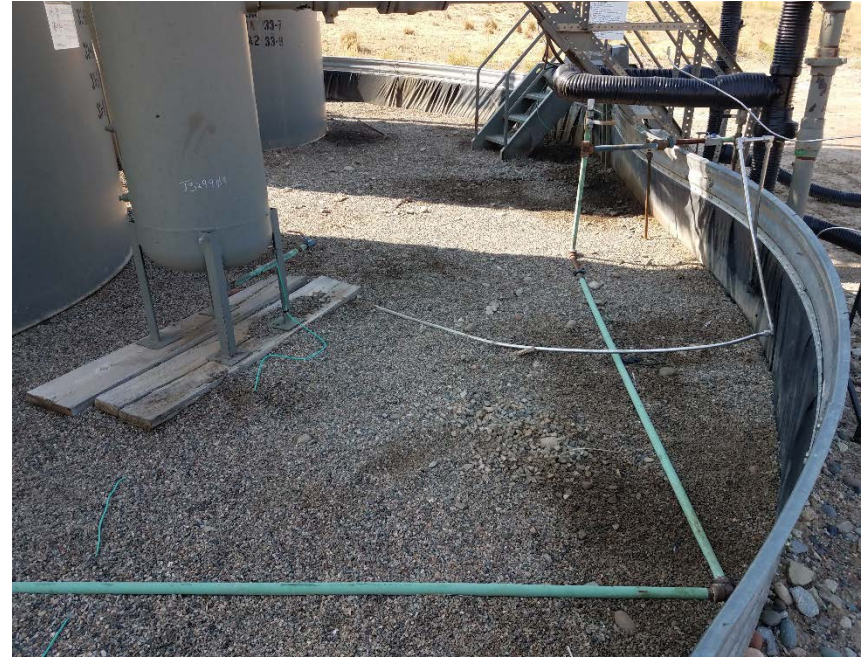
Location Photo #6, Stained rock in tank containment.

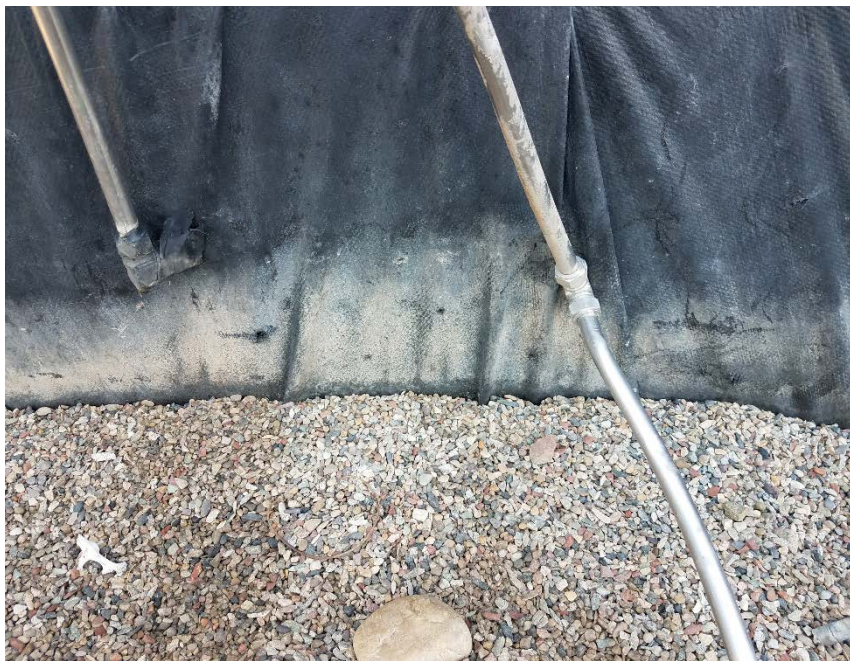
**Location Photo #7, Holes in secondary
containment liner.**
