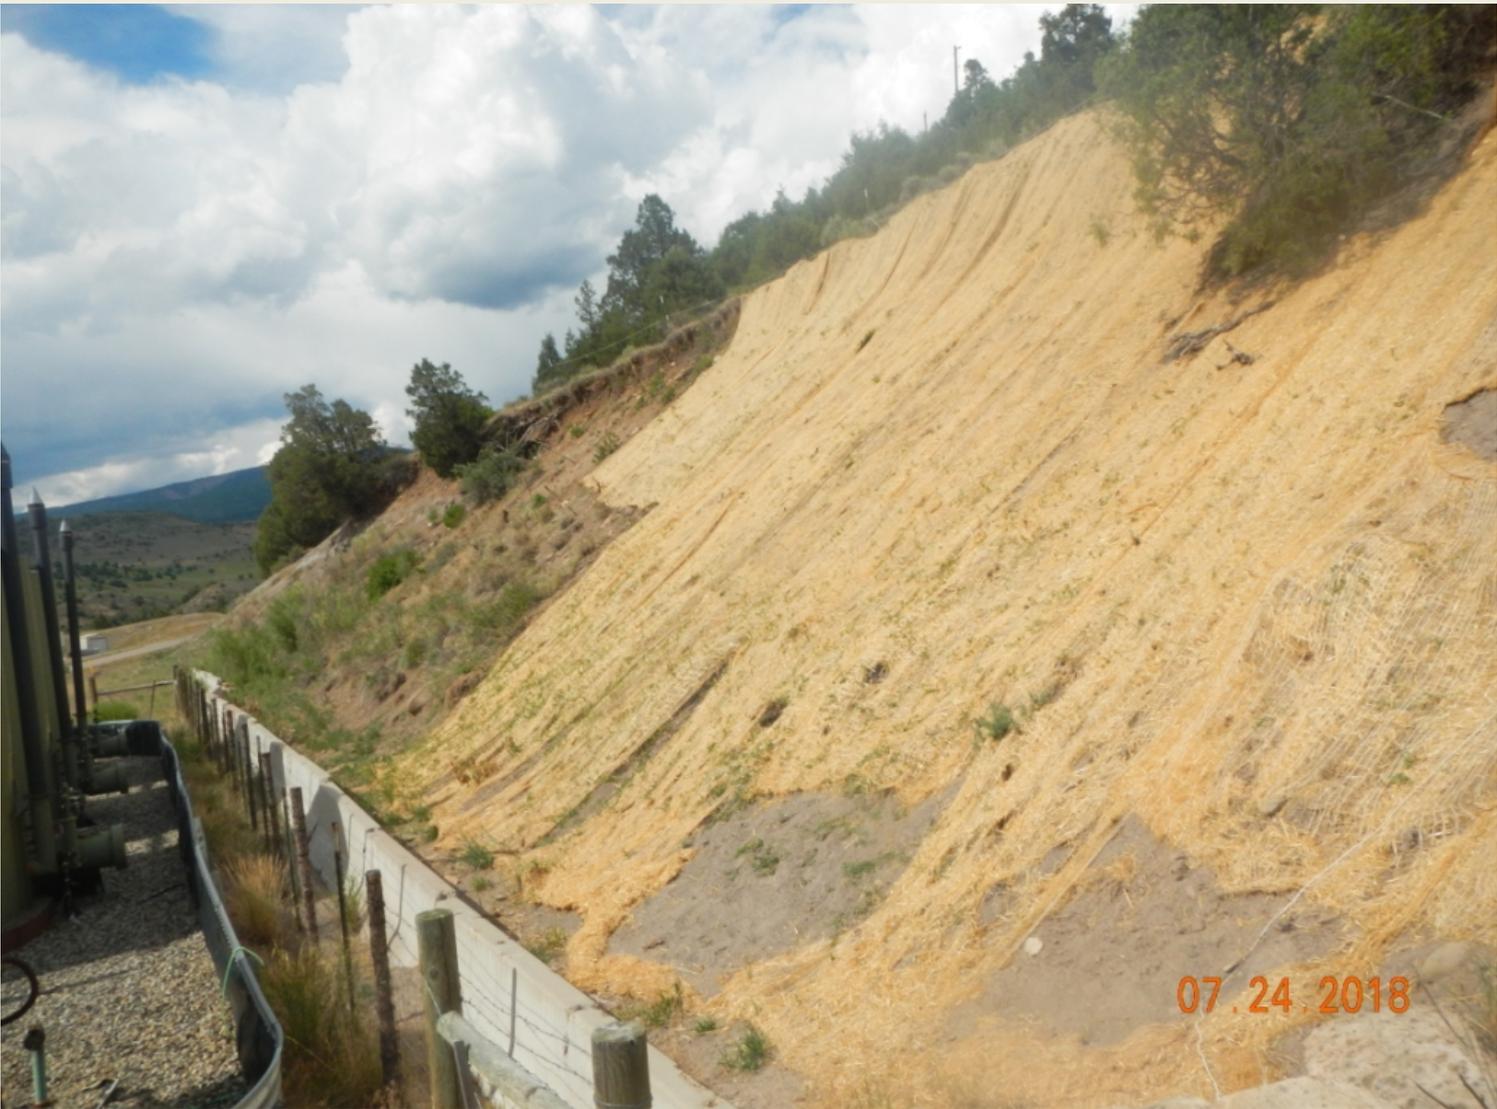
Photo 1. View of the eastern cut-slope from the southeastern corner facing northward. Erosional blanket is installed.

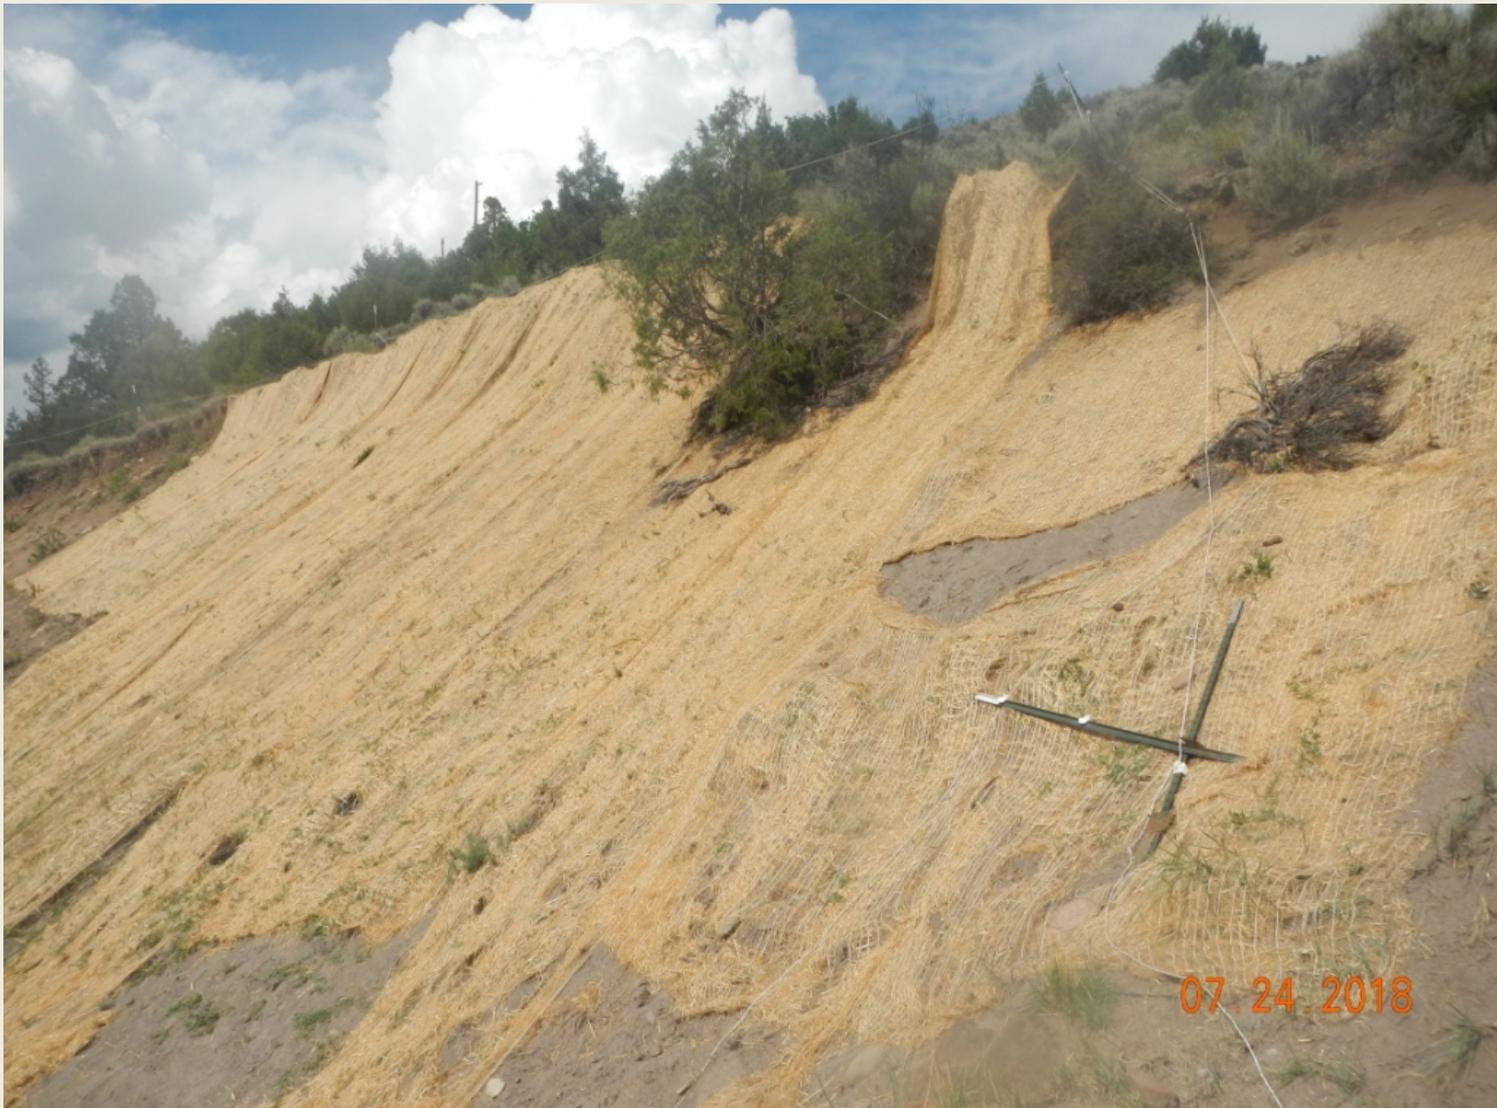
Photo 2. Another view of cut-slope with recently installed blanket. Portions of blanket are torn and insufficiently anchored.

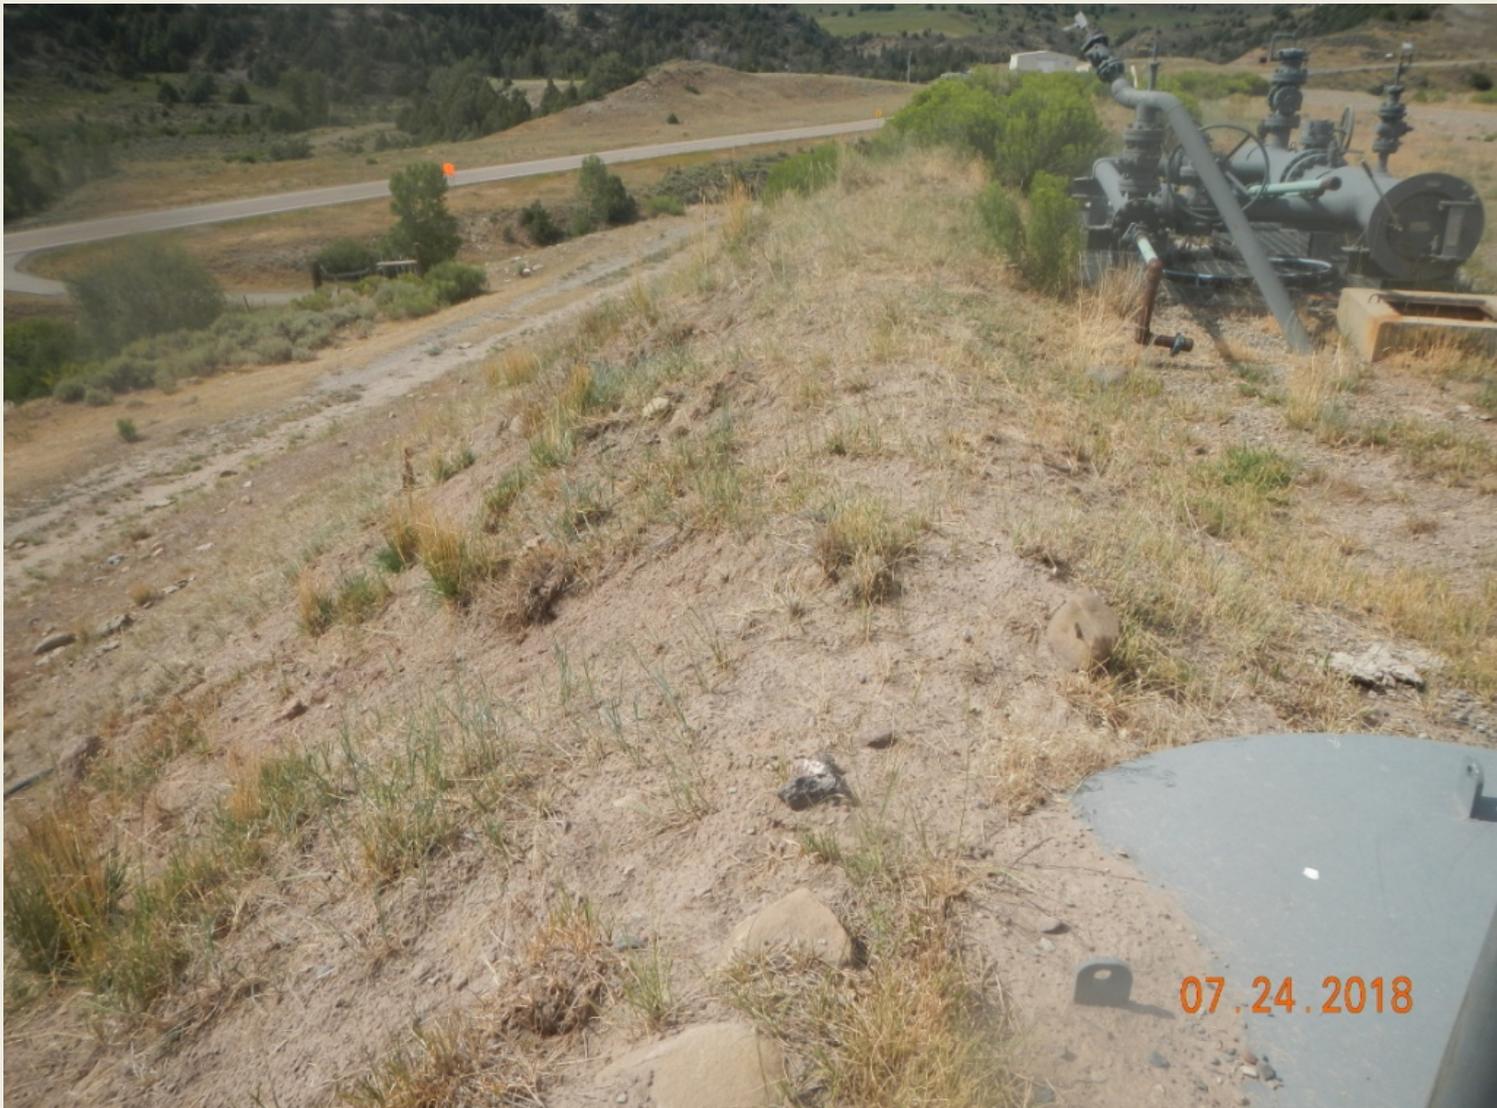
Photo 3. View of the western portion of the project area from the southwestern corner facing northward.

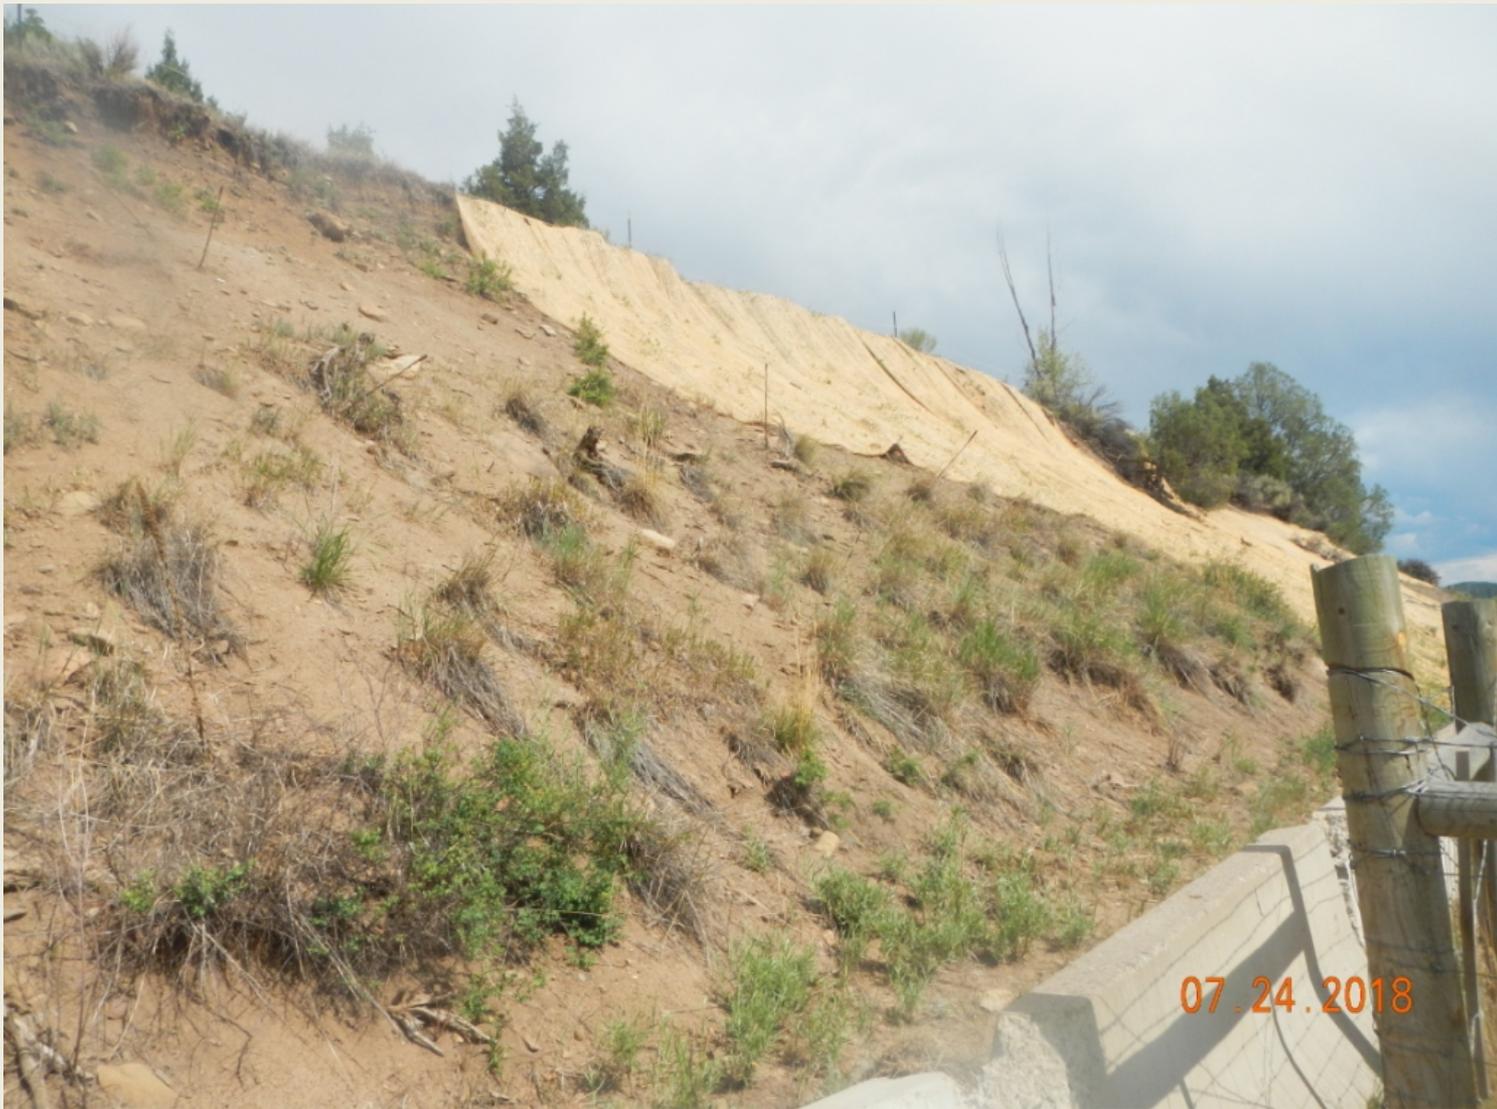
Photo 4. View of the northeastern cut-slope showing areas that are not stabilized with jute mat.

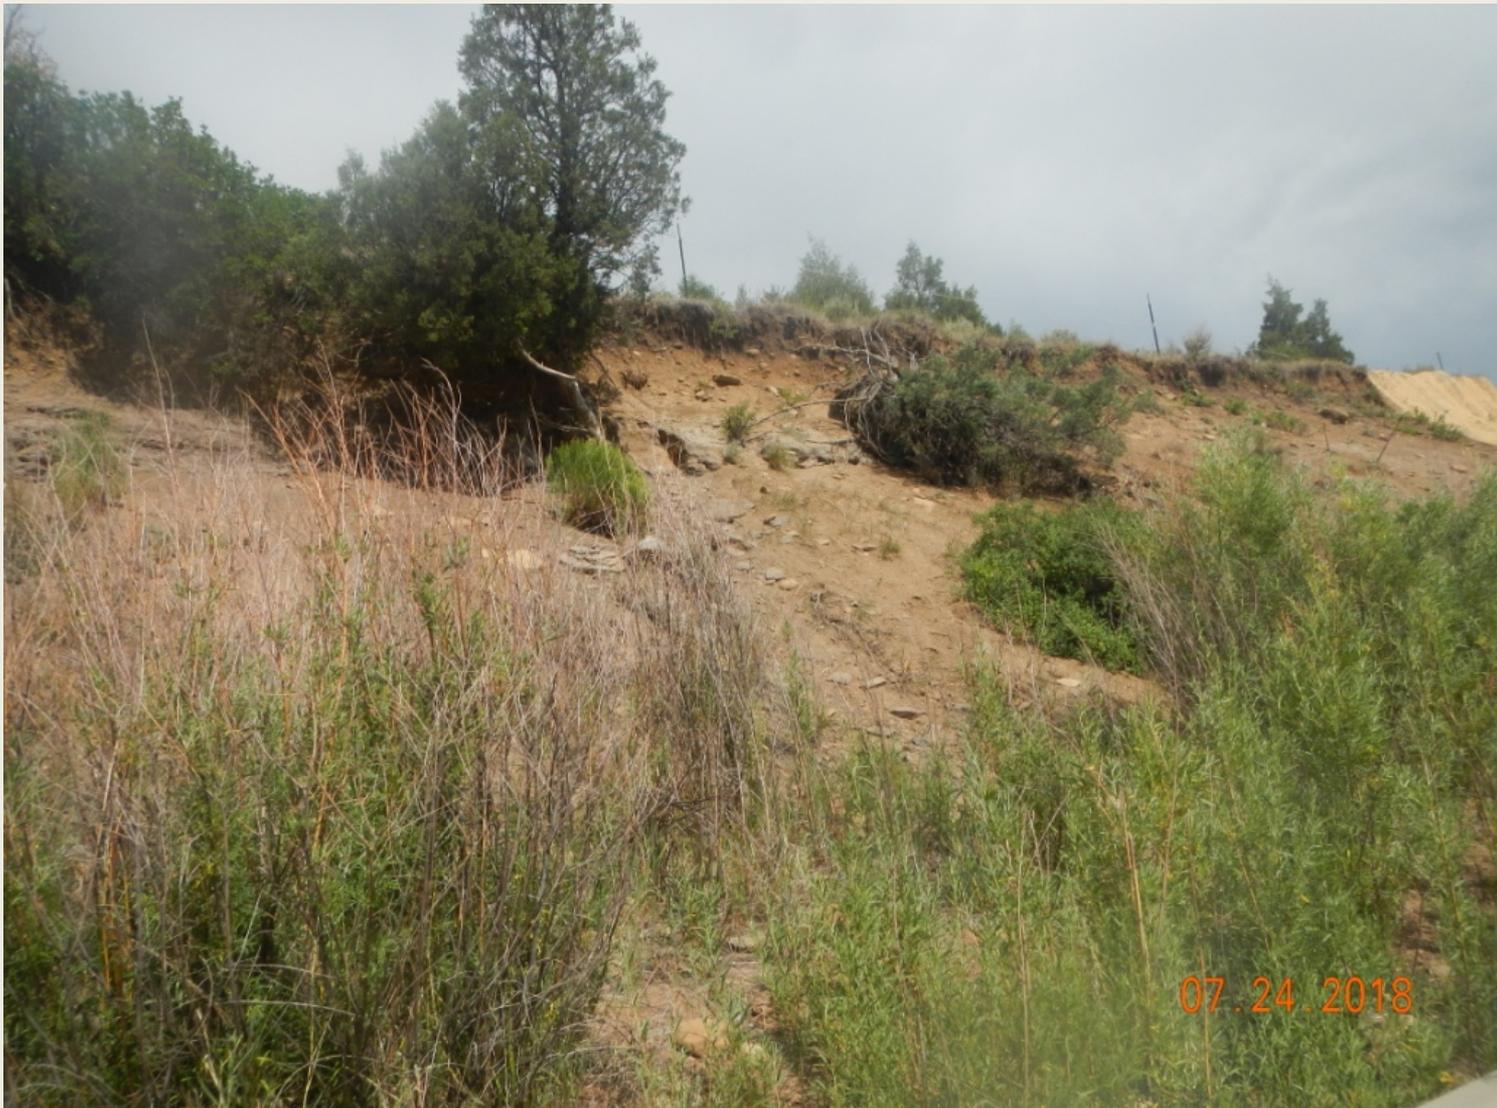
Photo 5. Another view of northeastern cut-slope showing areas that are not stabilized. Trees on the slope have either fallen or have exposed roots from erosion. Additional stabilization measures are needed to stabilize these areas, especially at the top of the slope.
