Final Reclamation Inspection

Operator: SRC ENERGY INC- #10311

Location ID: 333039

Location Name: LOWE-66N66W /31SESE

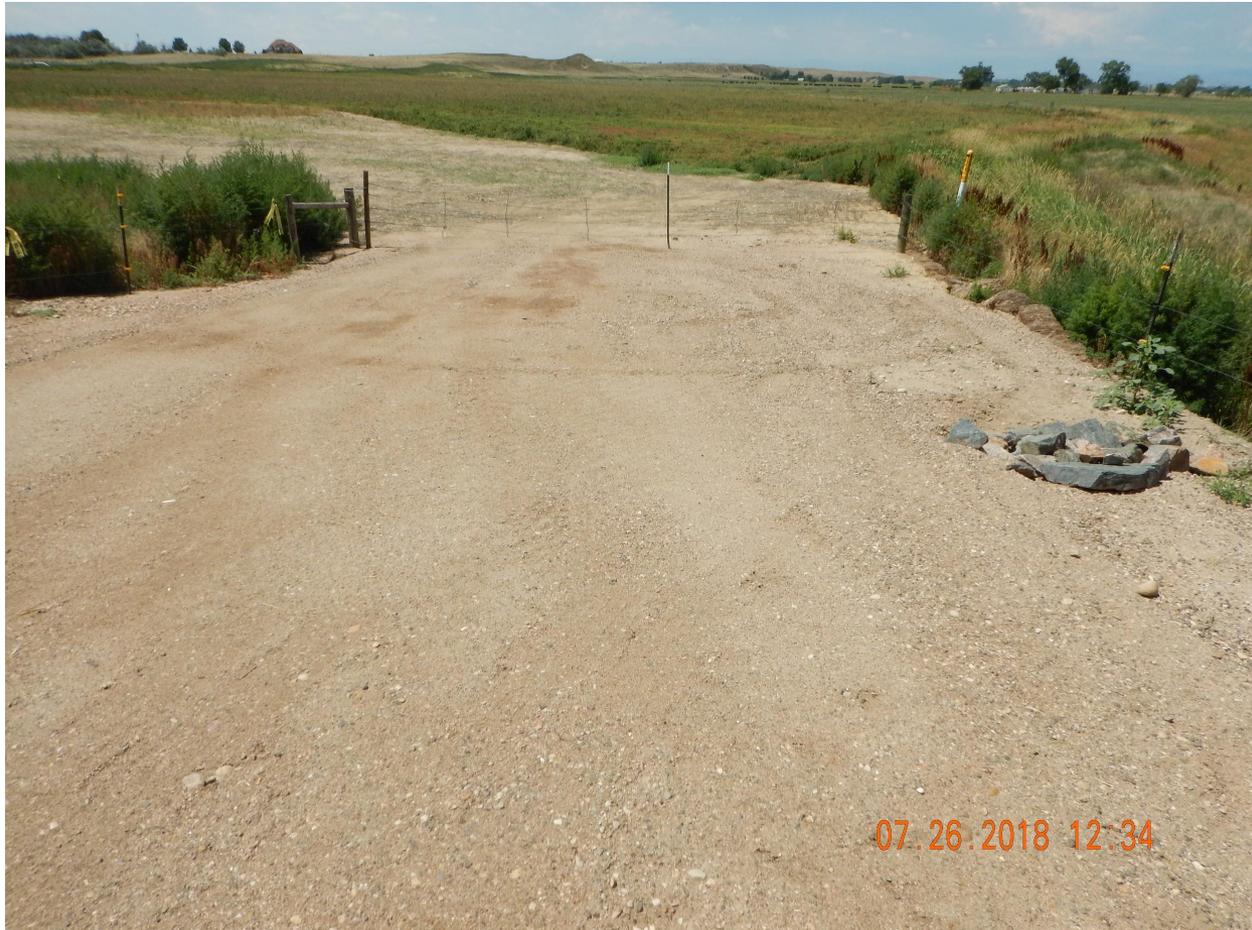
Photo 1. Photo taken from the entrance of the location, facing West. Operator failed to reclaim the approach entrance to the location. Stormwater erosion was also observed along the approach entrance. Operator indicated on August 14, 2018 that stormwater erosion was fixed. A follow-up stormwater inspection will be conducted to ensure compliance with Rule 1002.f. standards.

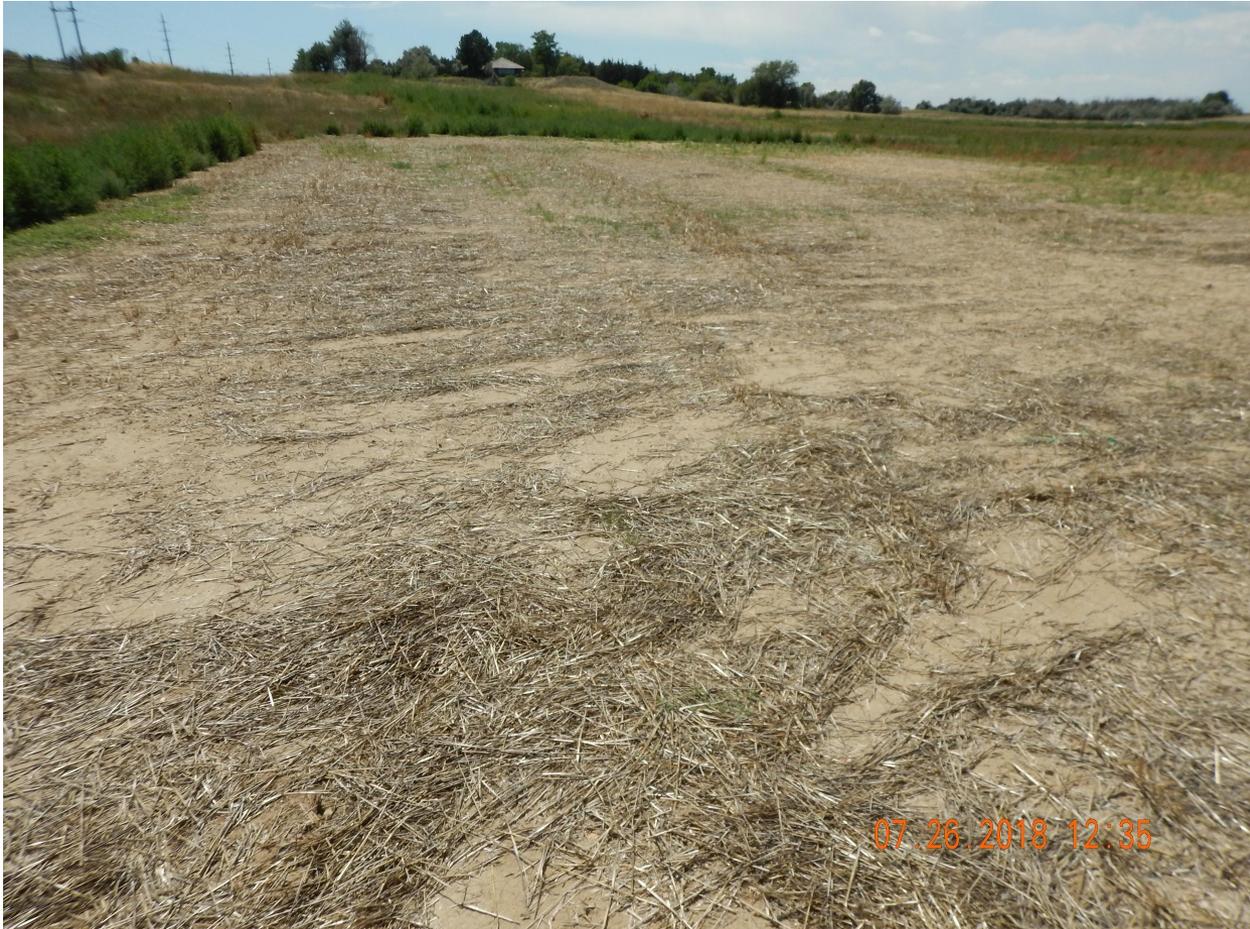
Photo 2. Photo taken of the eastern location, facing South. Appears the Operator has performed final reclamation activities. No equipment was observed at the location. Germination was sparse throughout the disturbance area and will remain in-process until the location meets Rule 1004 standards.
