# Interim Reclamation Inspection

Operator: KERR MCGEE OIL & GAS ONSHORE LP- #47120

Location ID: 439944

Inspection Document #: 682403848

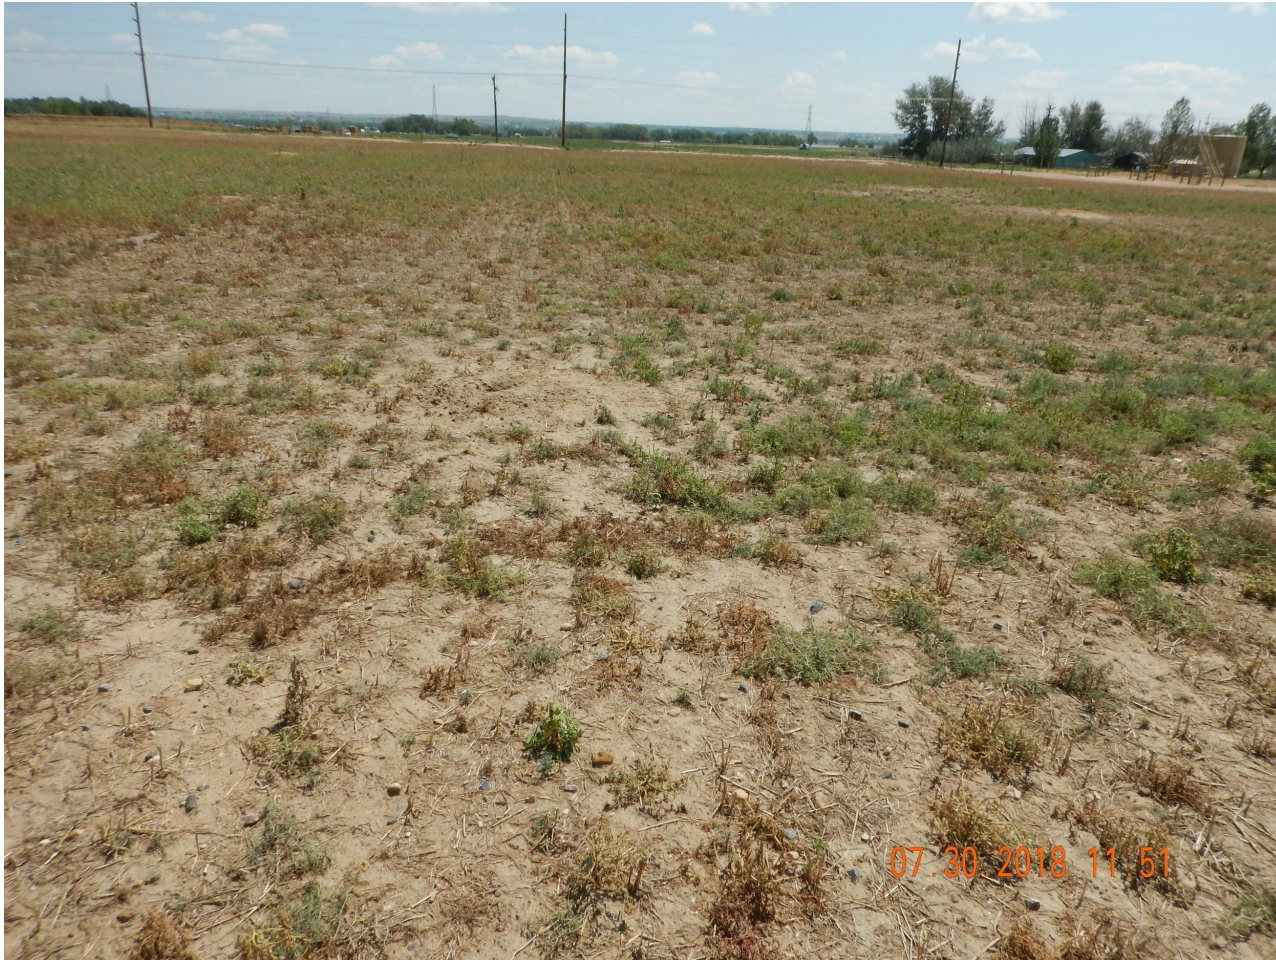
**Photo 1.** Photo taken of the southeastern interim area, facing East. Appears the Operator has performed interim reclamation activities to reduce disturbance areas only needed for production operations. Interim areas consists mostly of weedy, annual vegetation. Reference areas appears to be cropland but it does not appear any crops have been planted yet.

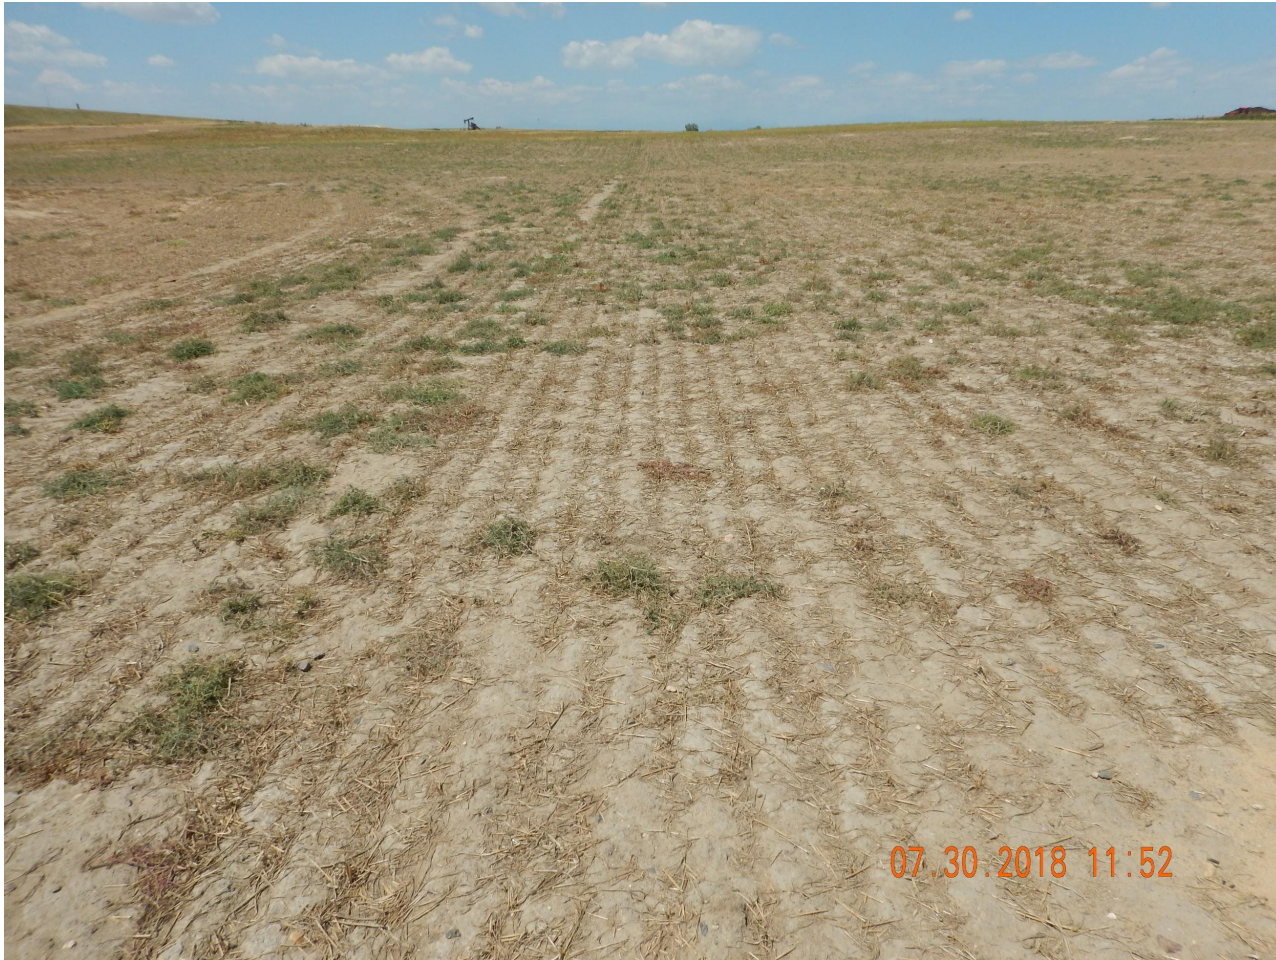
**Photo 2.** Photo taken of the southwestern interim area, facing West. See comments under Photo 1.

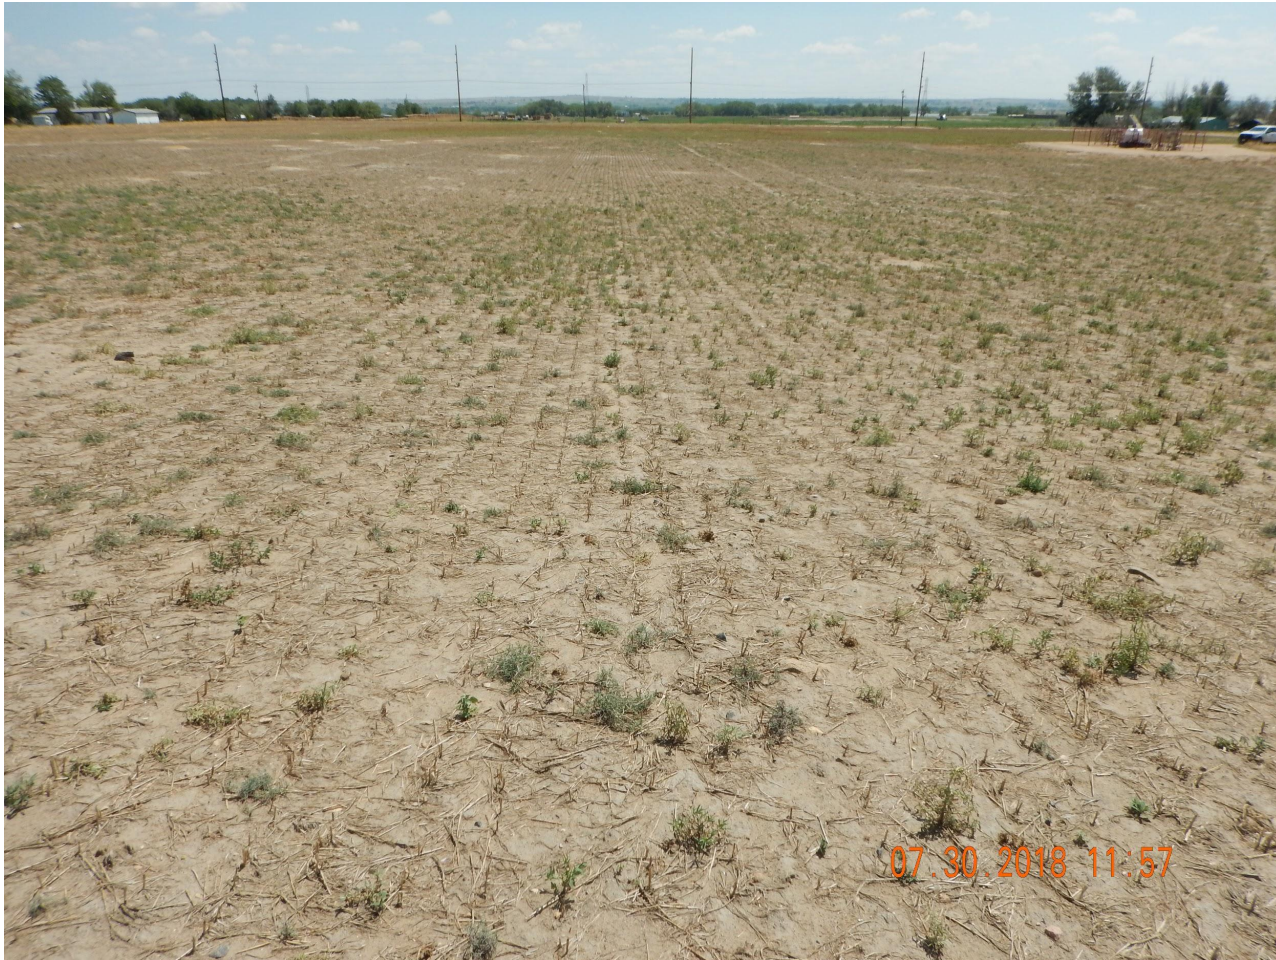
**Photo 3.** Photo taken of the northeastern interim area, facing South. See comments under Photo 1.

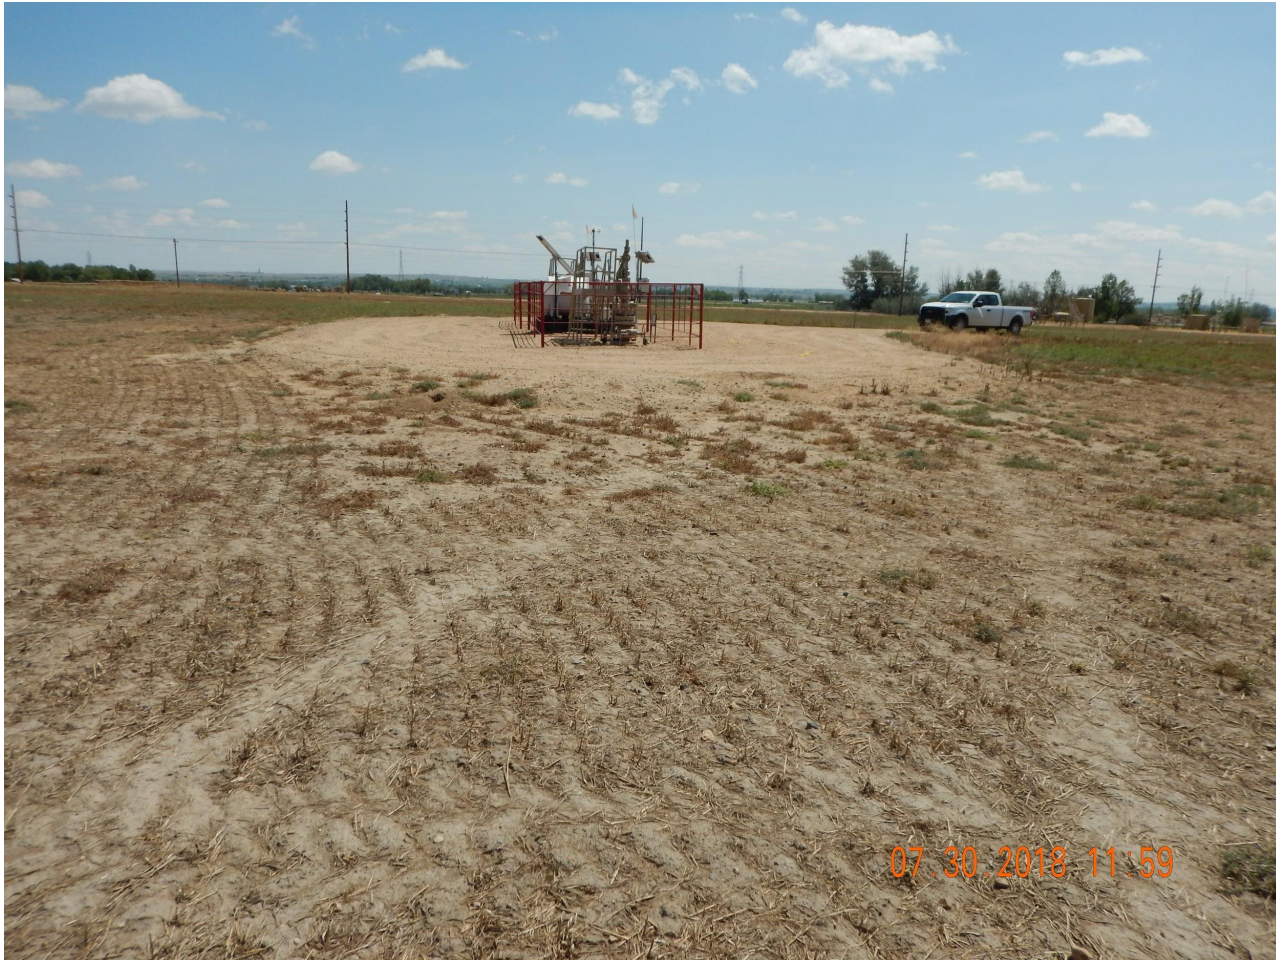
**Photo 4.** Photo taken of the western interim area, facing East. Photo illustrates interim areas have been reduced to only areas needed for production operations.

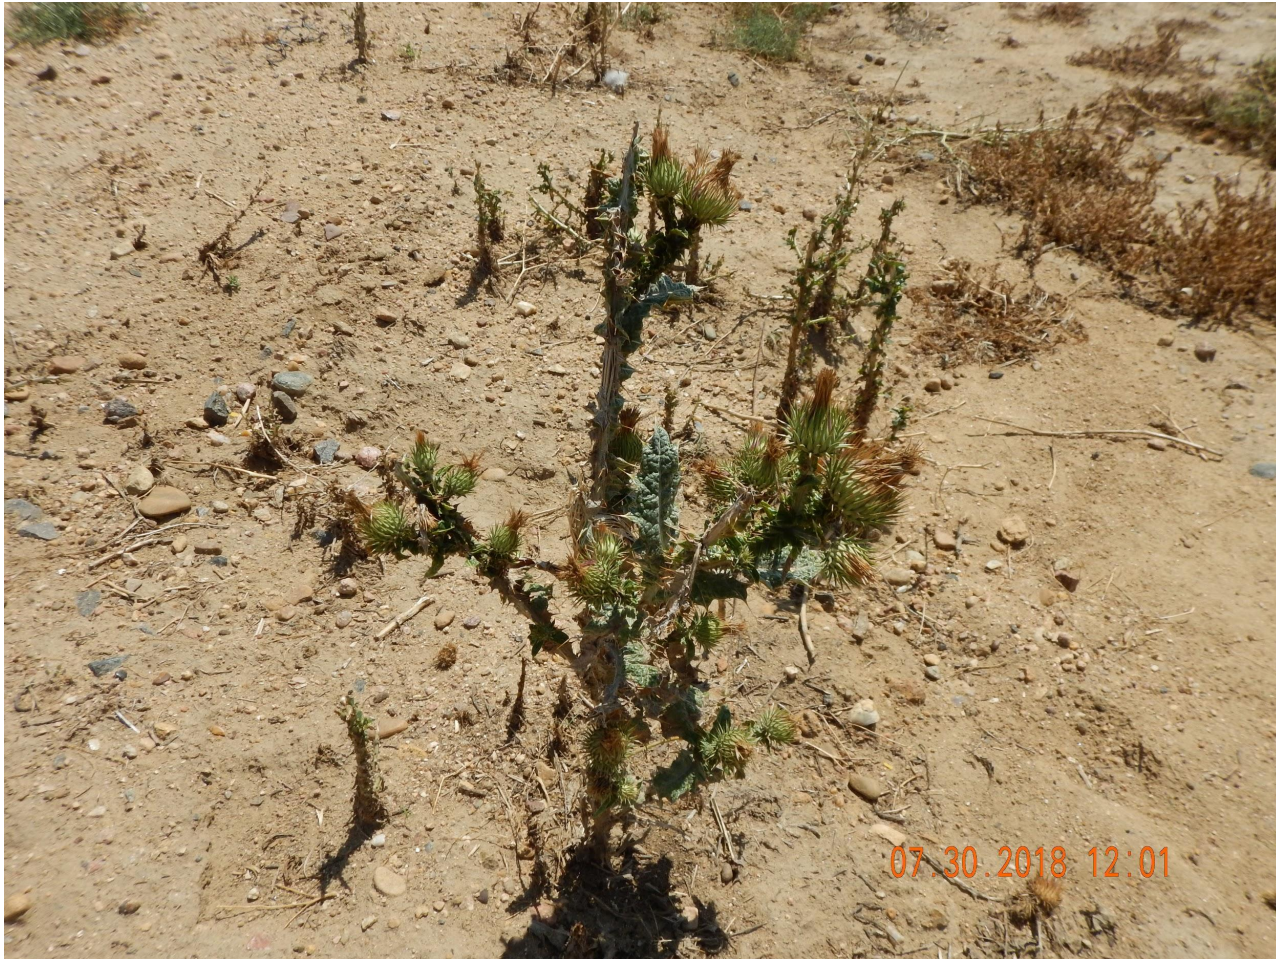
**Photo 5.** Photo taken along a portion of the access road. Photo illustrates a List B Colorado Noxious weed, Scotch thistle. Appears the Operator was managing weeds at the location but a few still need to be controlled.

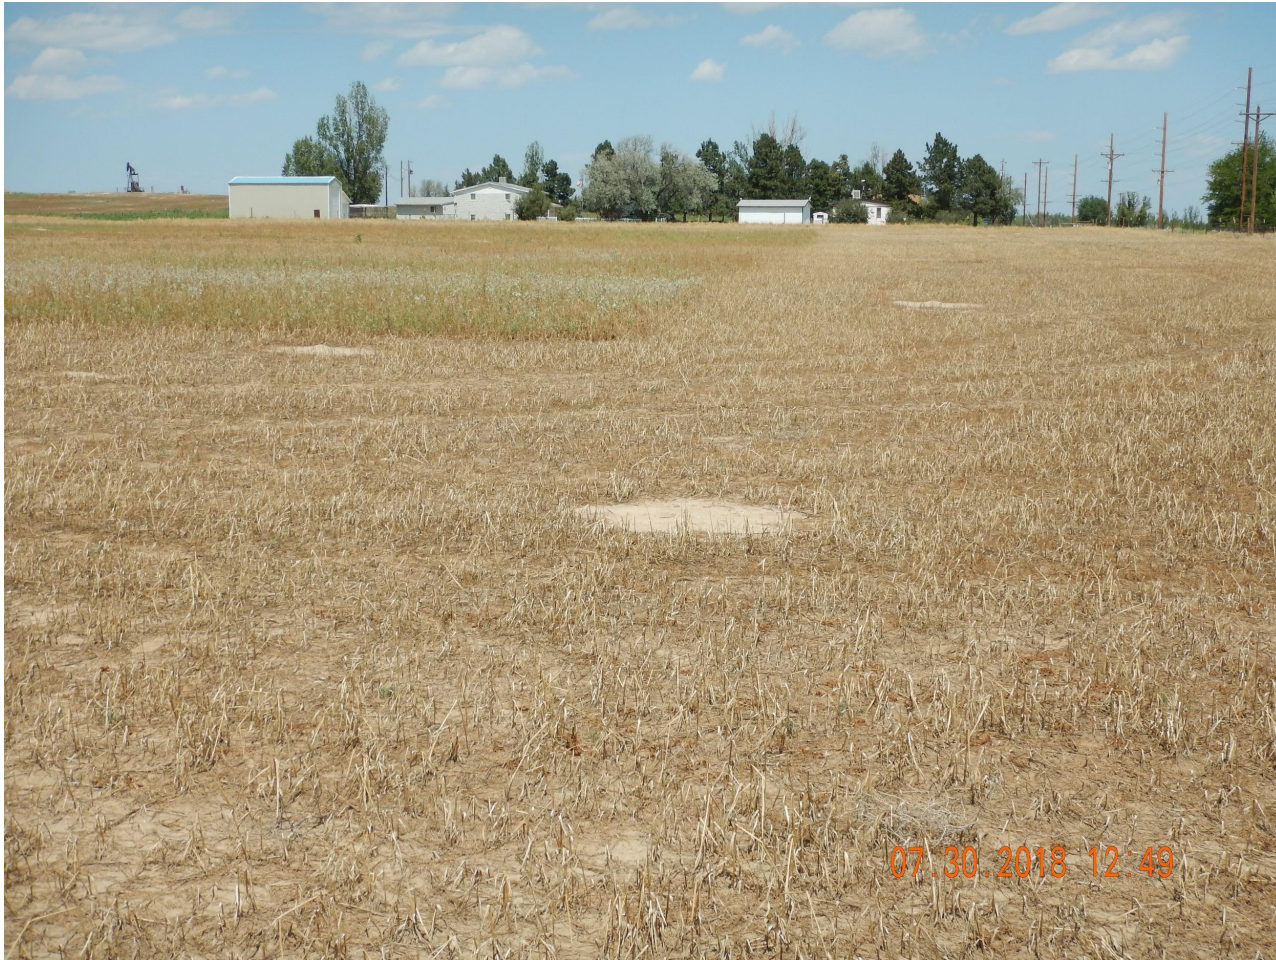
**Photo 6.** Reference photo taken southeast of the location, facing North. Appears the reference areas were a wheat crop but nothing has been planted yet.
