# *Inspection Photos*

*API#045-06481*

*Operator: Maralex*

*Inspection Number: 692400004*

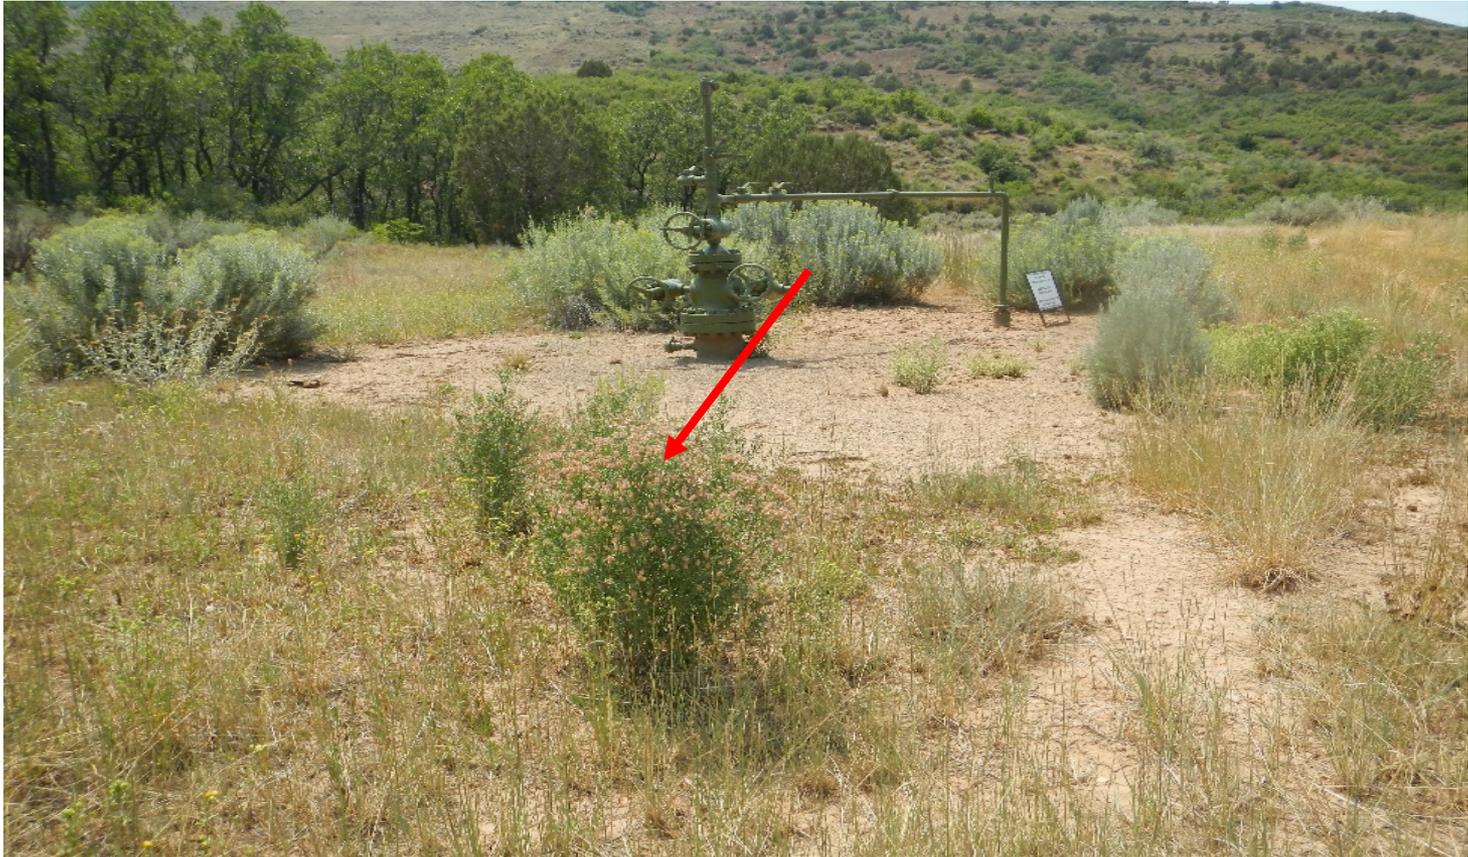
Photo#1:  
Overview of Location from to West. Note Knapweed indicated by arrow

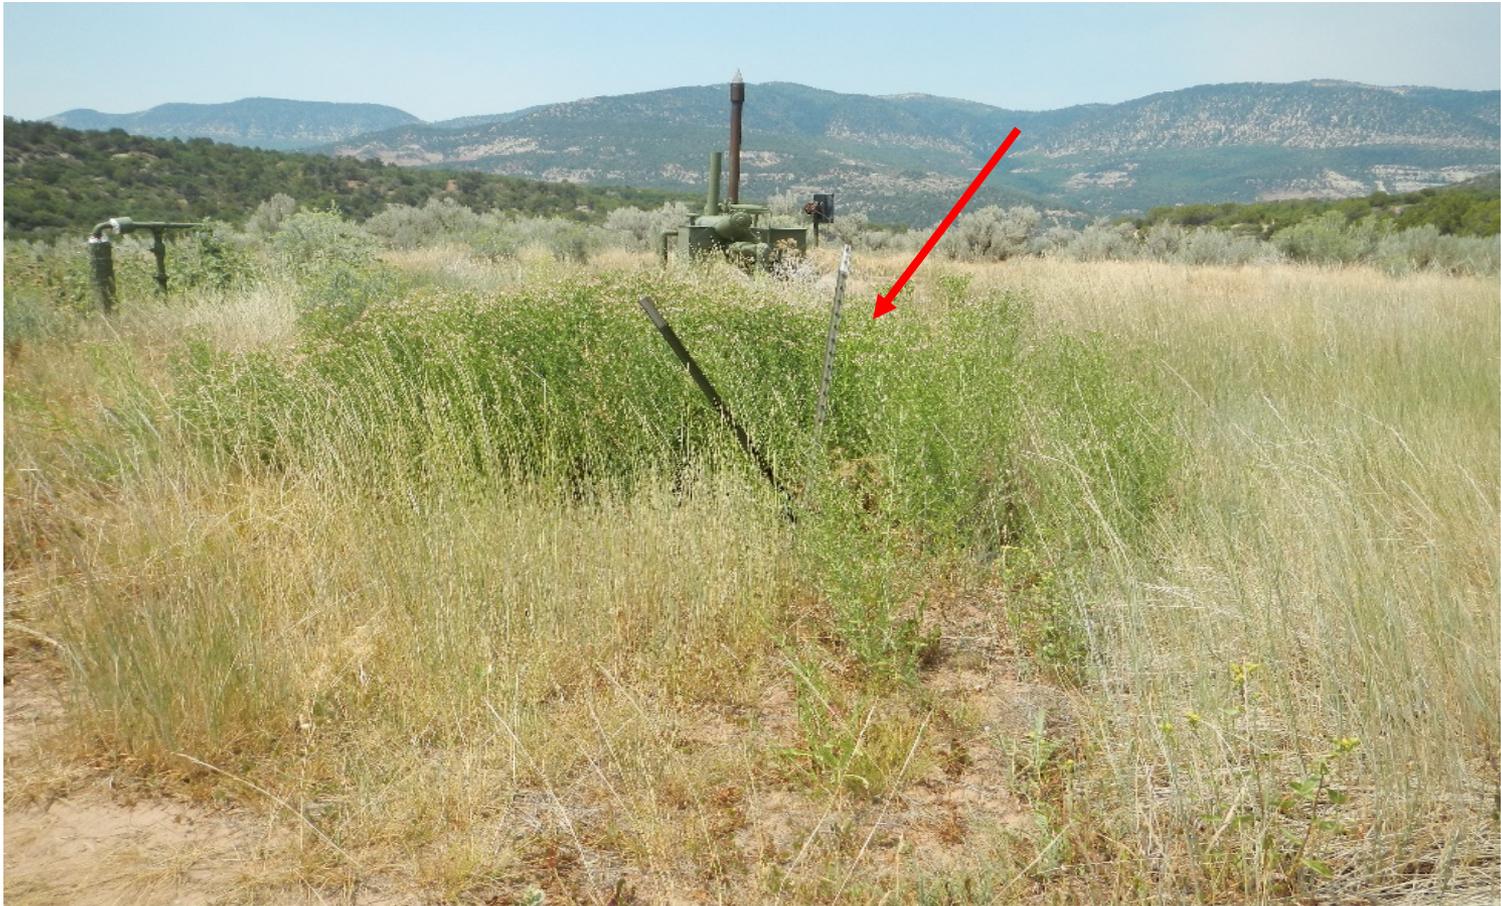
Photo#2:

B list Noxious weed, Russian Knapweed, indicated by arrow is established on Location.

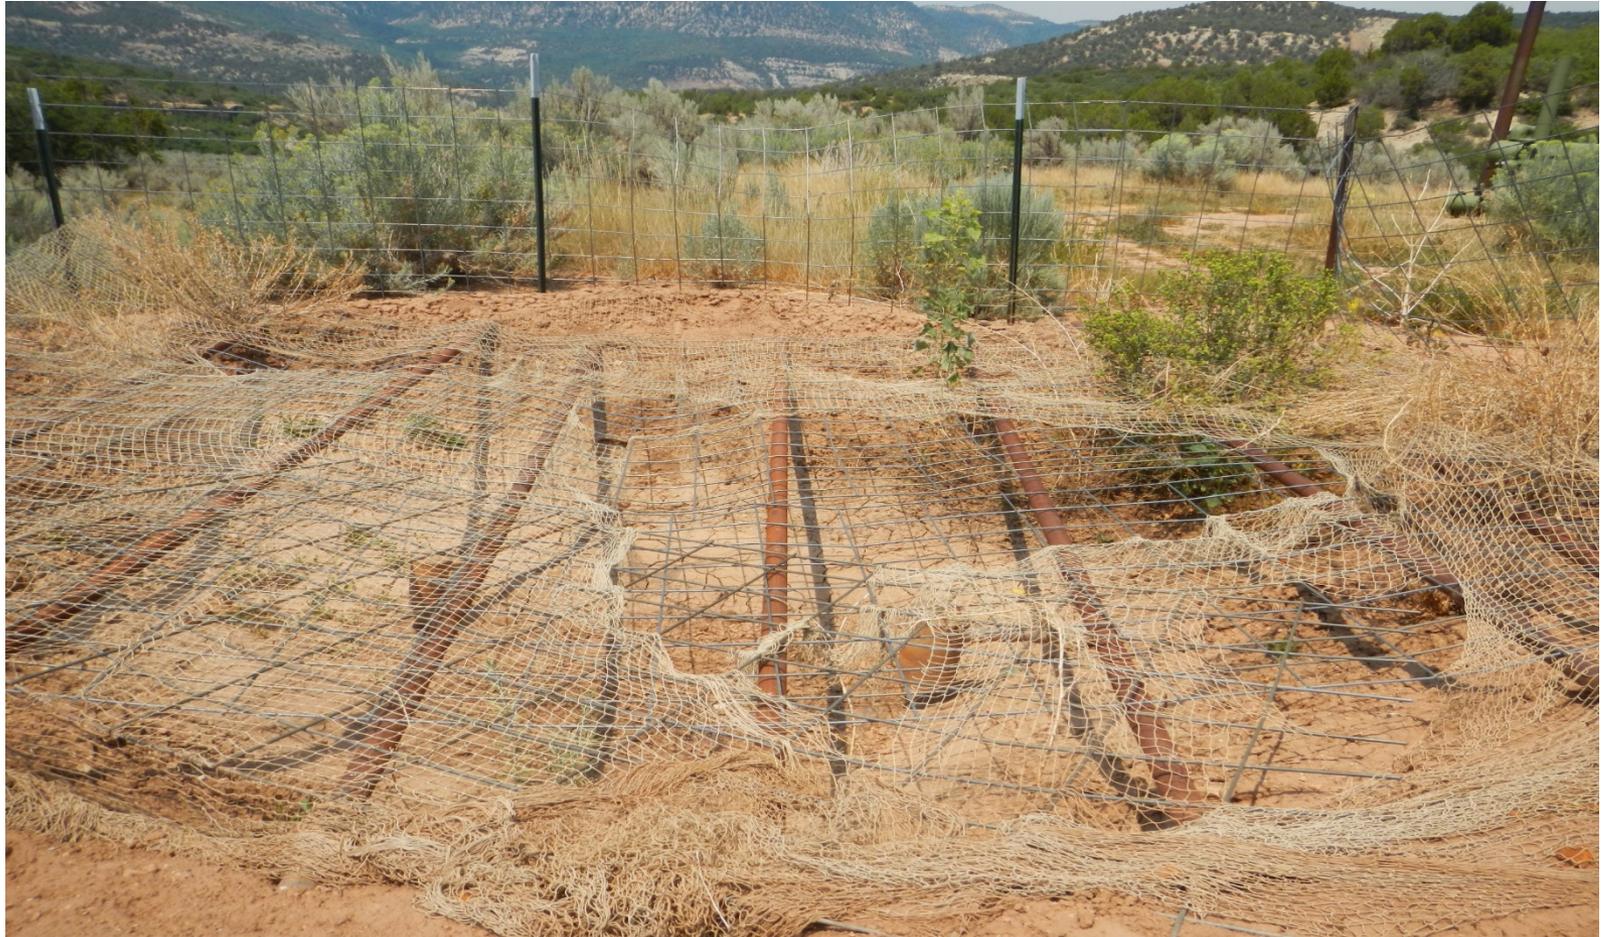
**Photo#3:**

There are holes in netting that is layered on panels, allowing ingress of smaller Wildlife, who even though Pit is dry at this time would not be able to find egress.

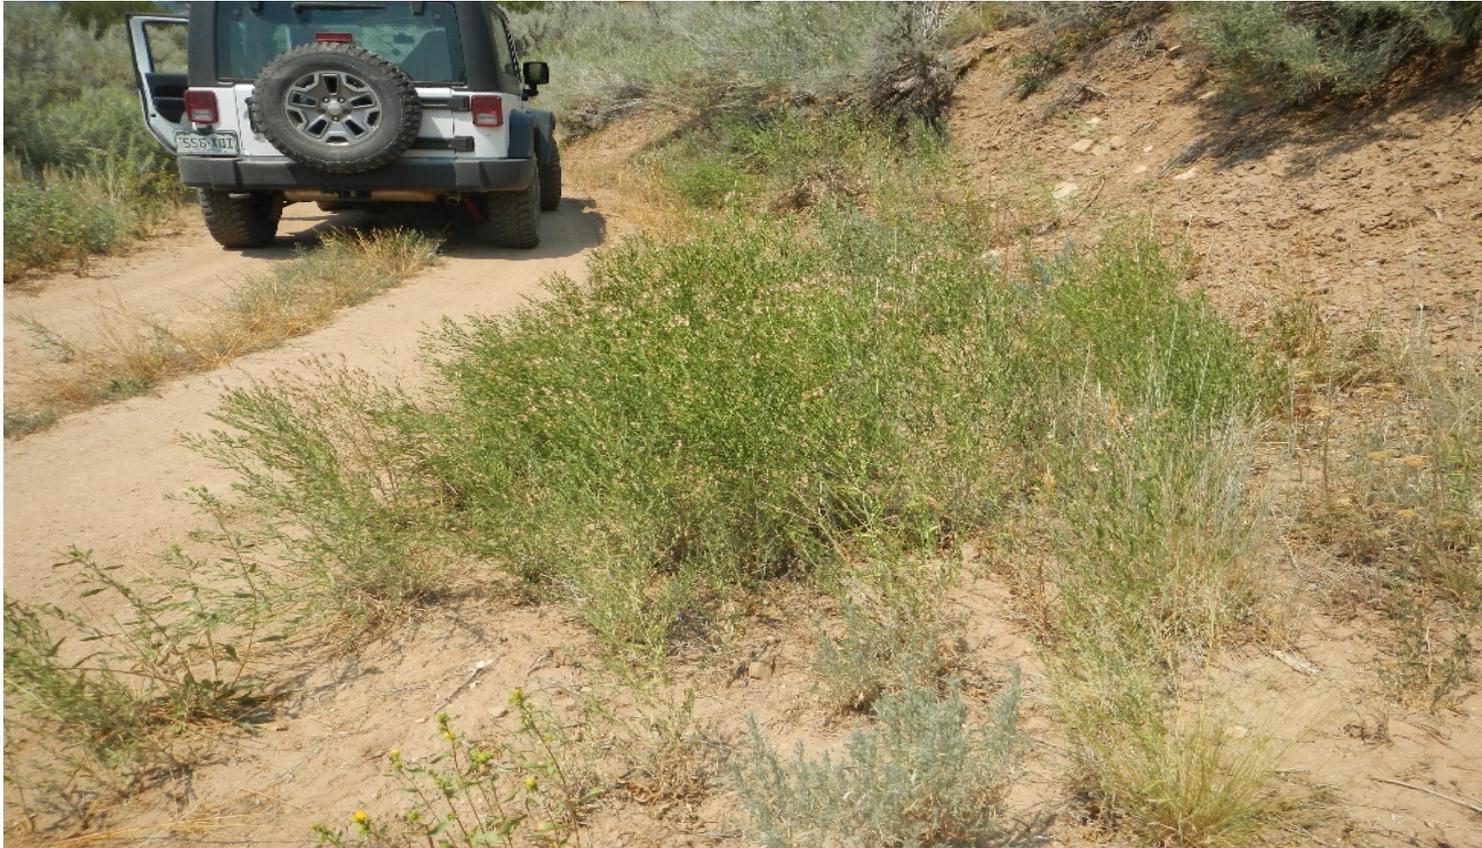
Photo#4:  
Knapweed is established on access road.

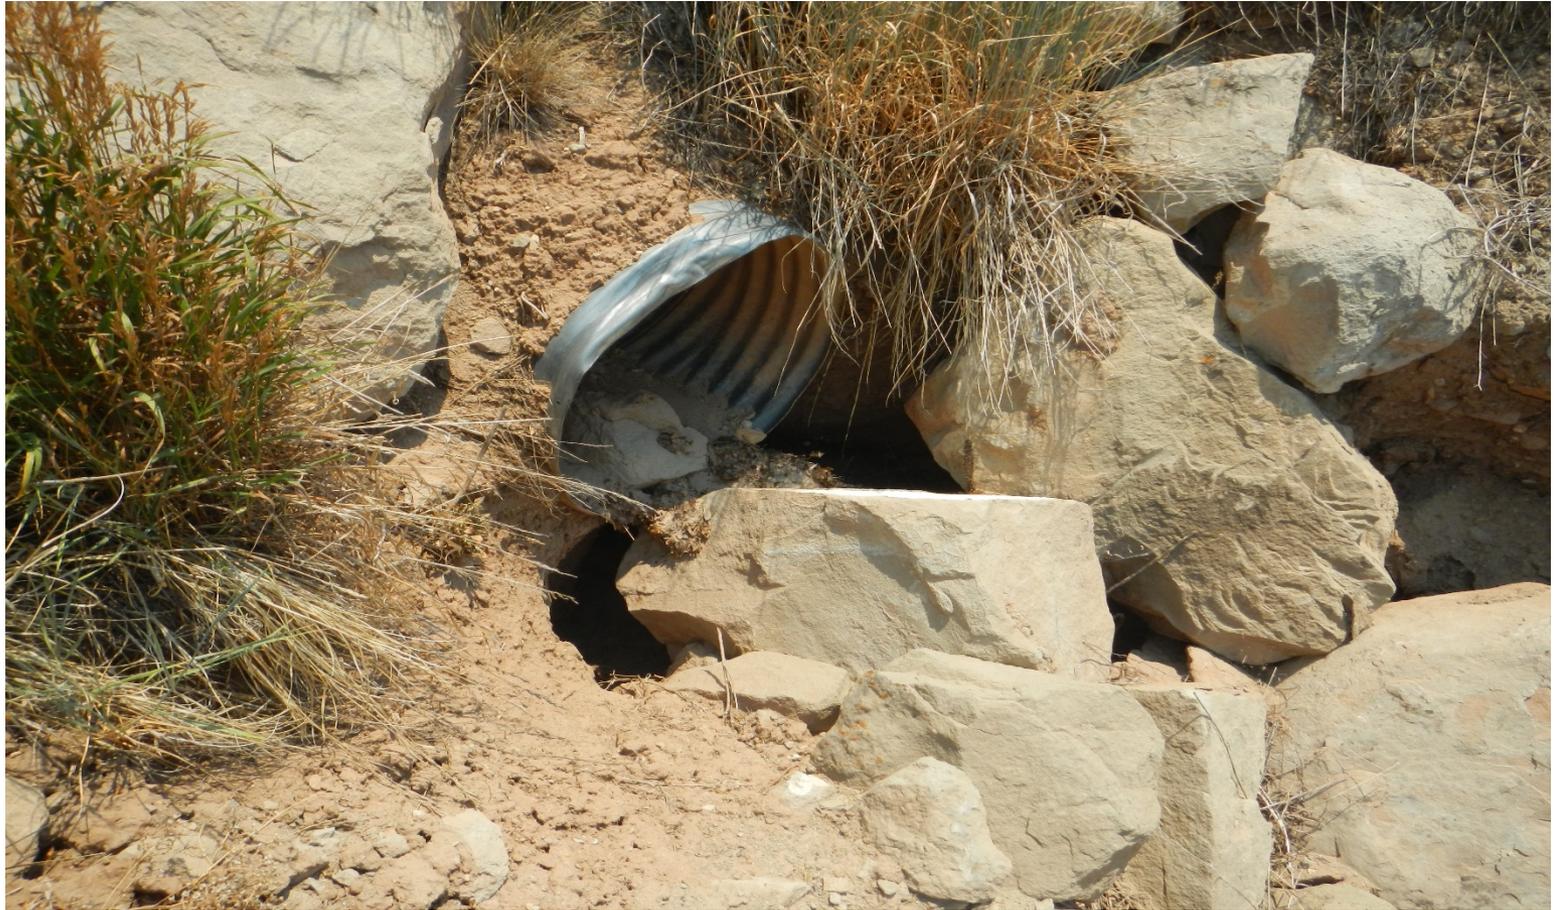
**Photo#5**

Stormwater is undercutting Rip Rap at NW side of acces road culvert & eroding ditch.

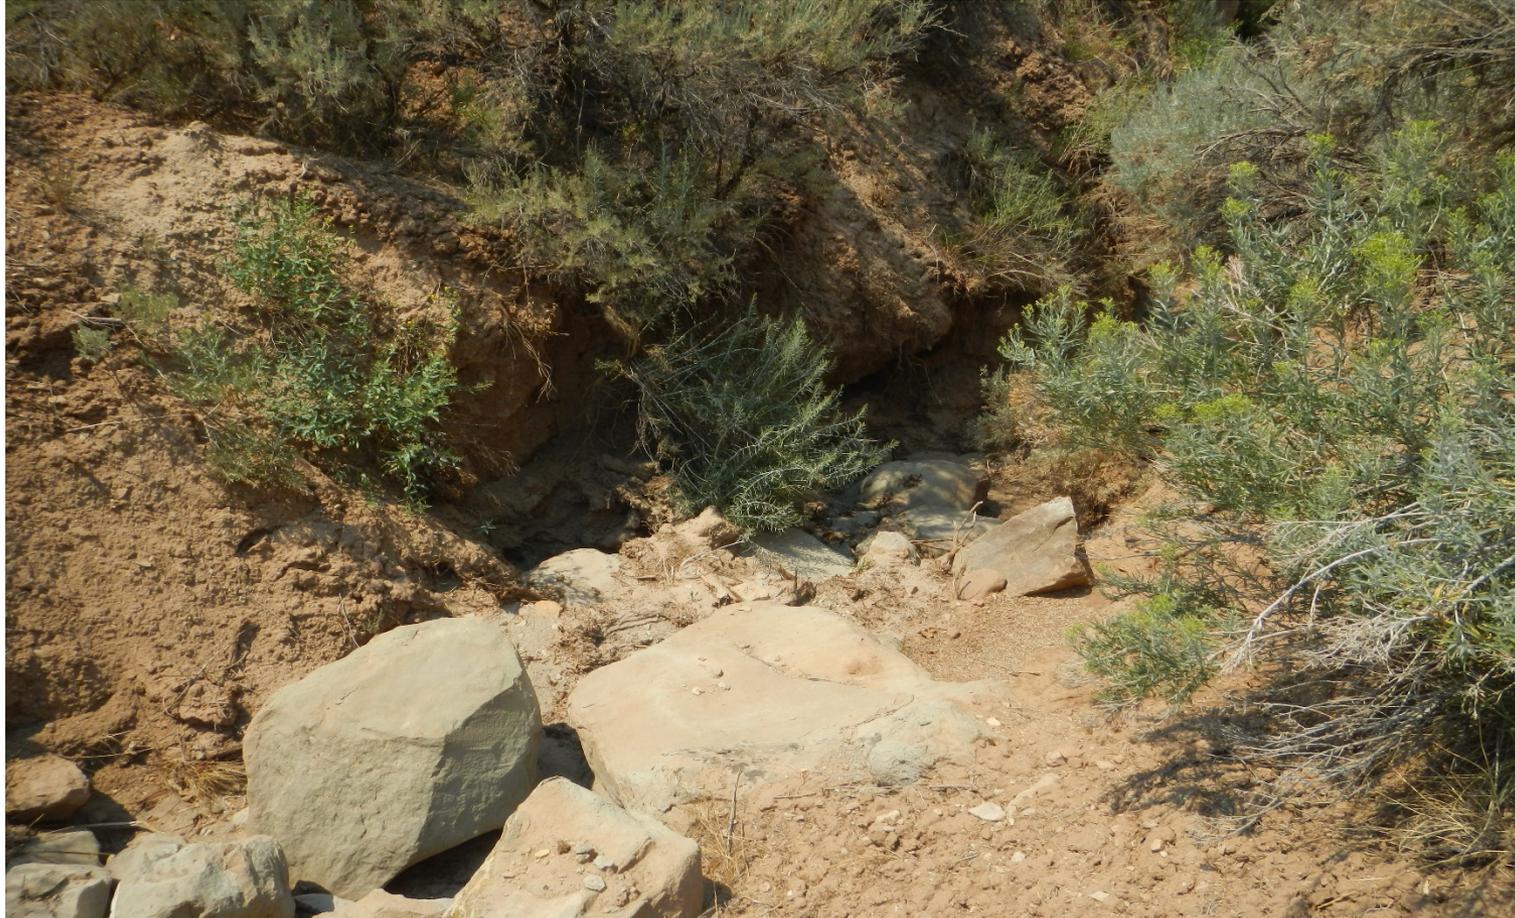
**Photo#6:**

Stormwater is undercutting Rip Rap at NW side of access road culvert & eroding down gradient ditch.
