Inspection Photos

Loc#430698

Operator: Maralex

Inspection Number: 692400006

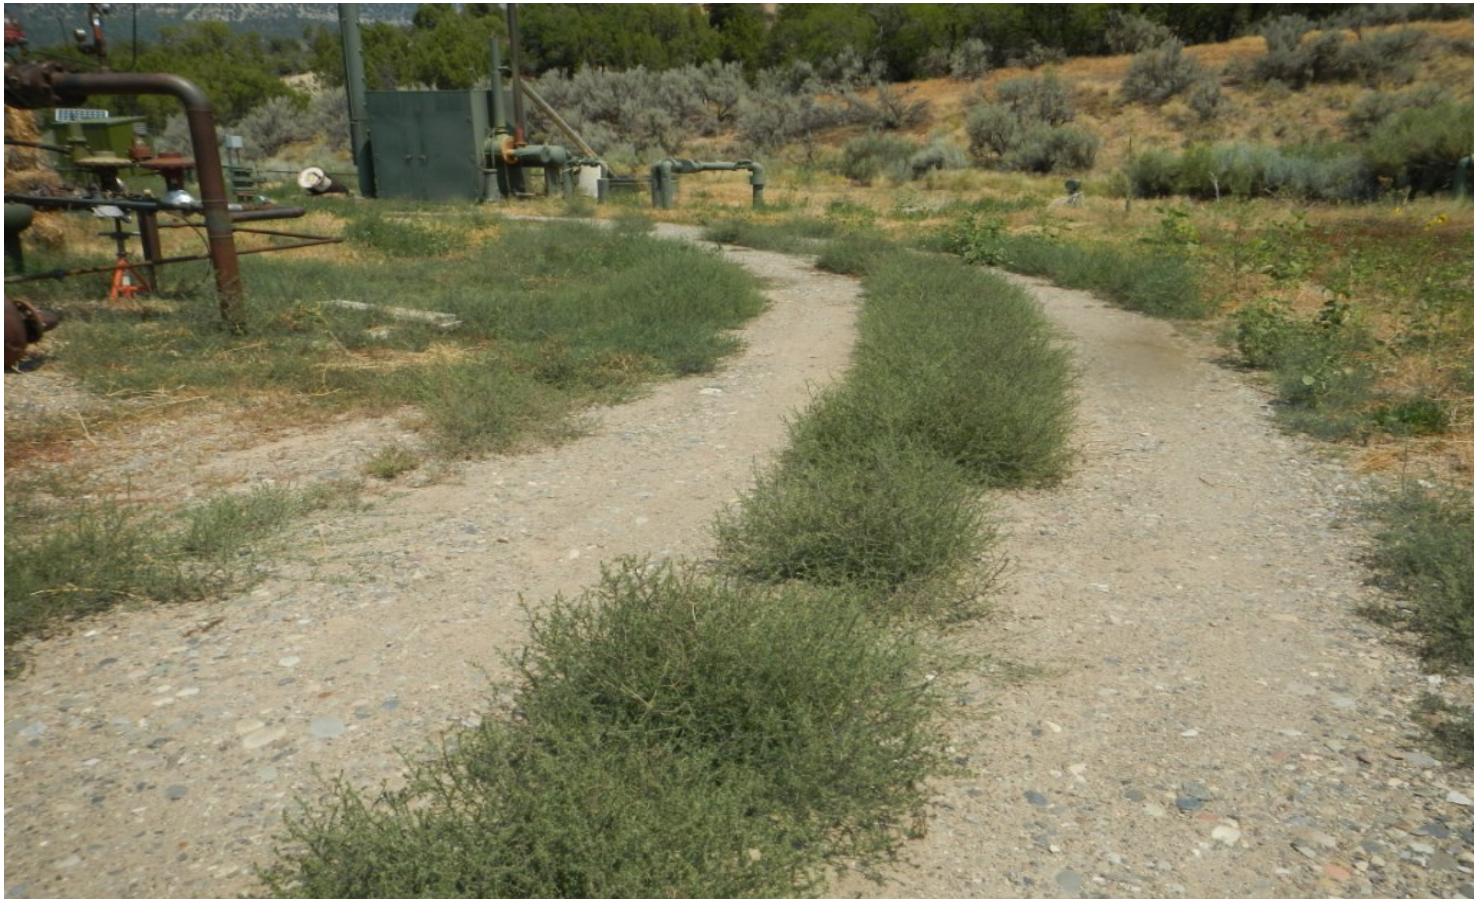
Photo#2:
Russian thistle on road, in interim Reclamation & equipment areas.

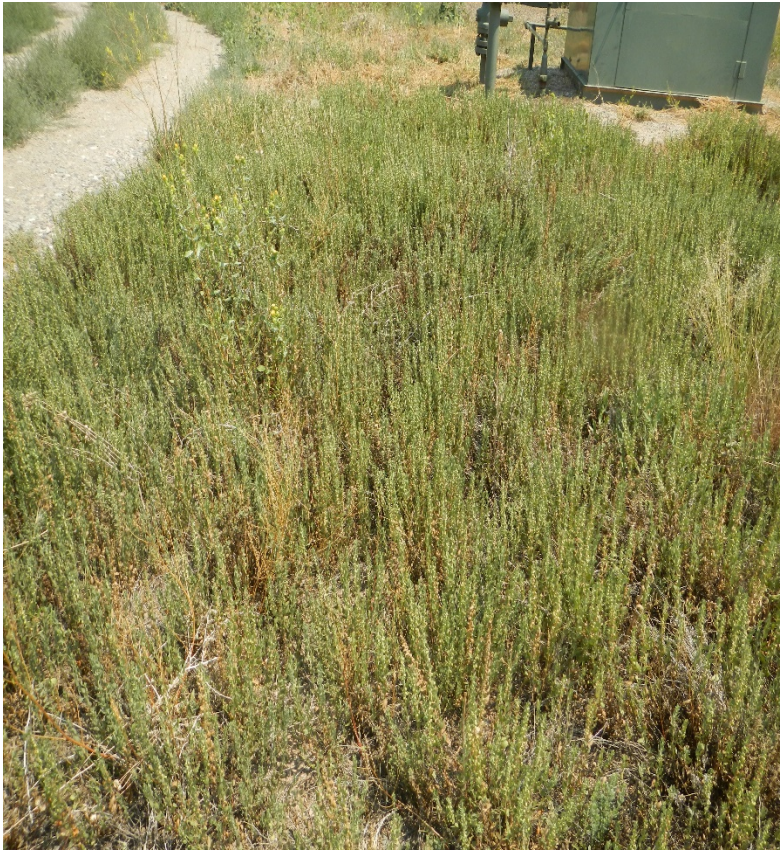
Photo#3: Poverty sumpweed

Majority of Vegetation within Interim Reclamation Area is Russian thistle, Kochia, Marsh elder & Poverty sumpweed that are not acceptable Vegetative cover.

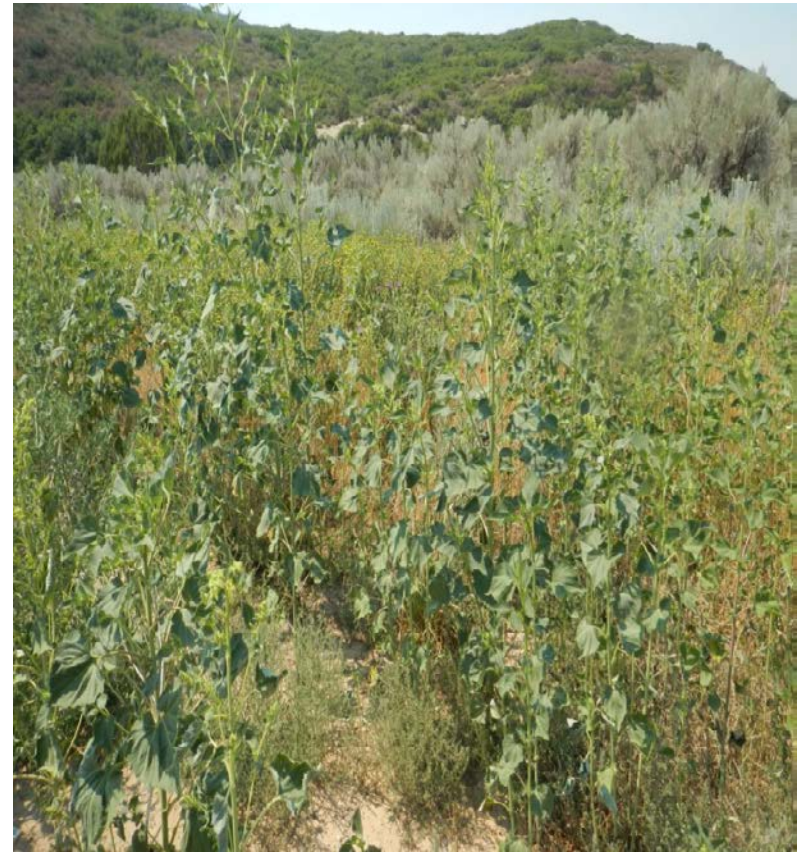
Photo#4: Marsh Elder.

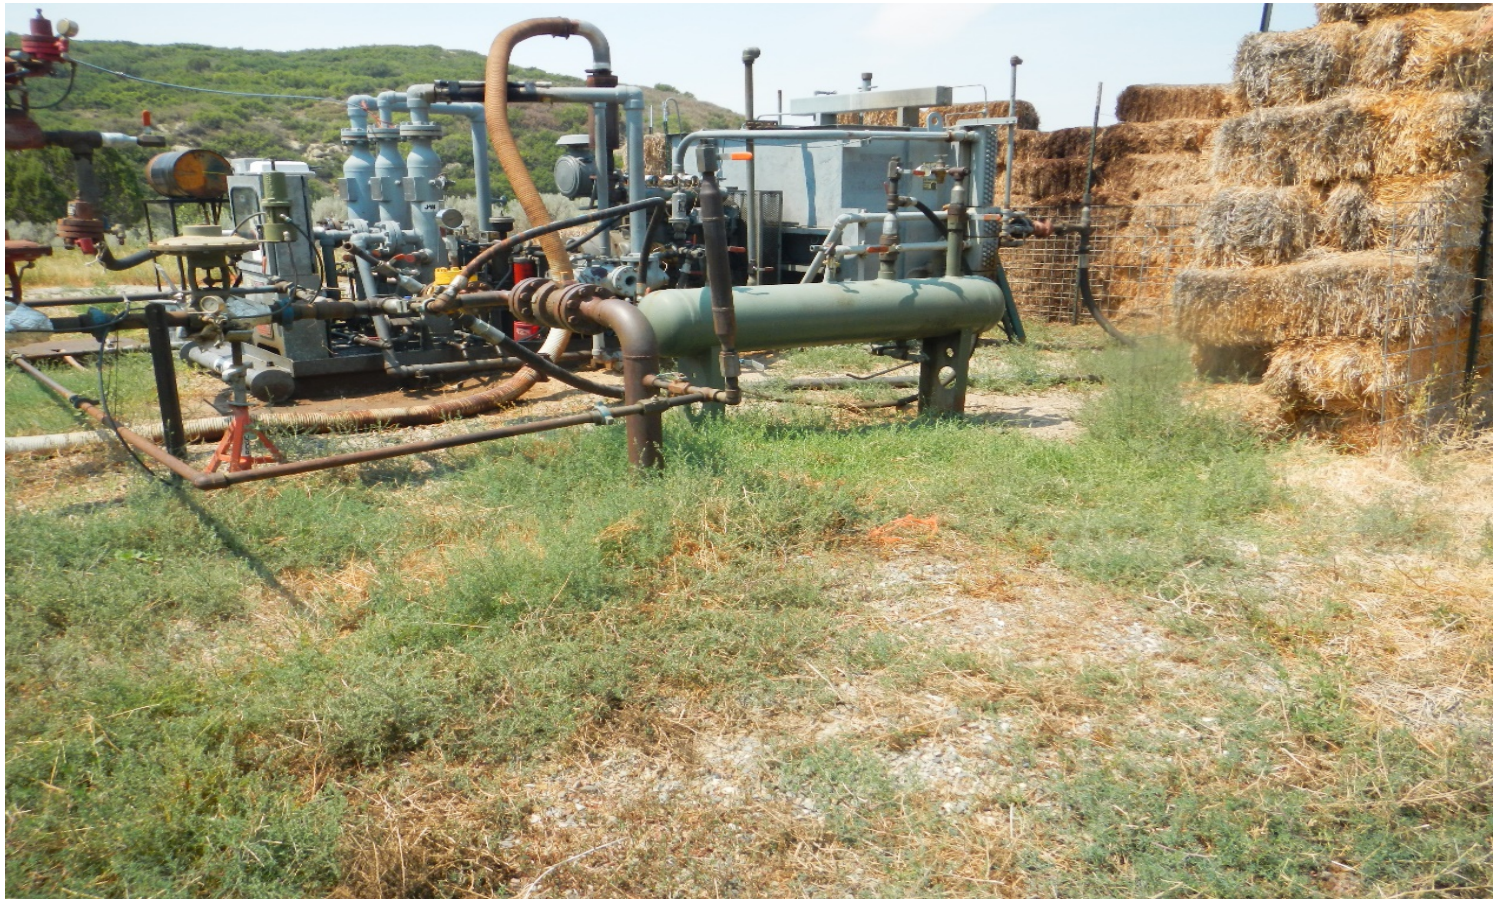
Photo#5:
View of Compressor & Sound Wall; note weeds growing in and around equipment.

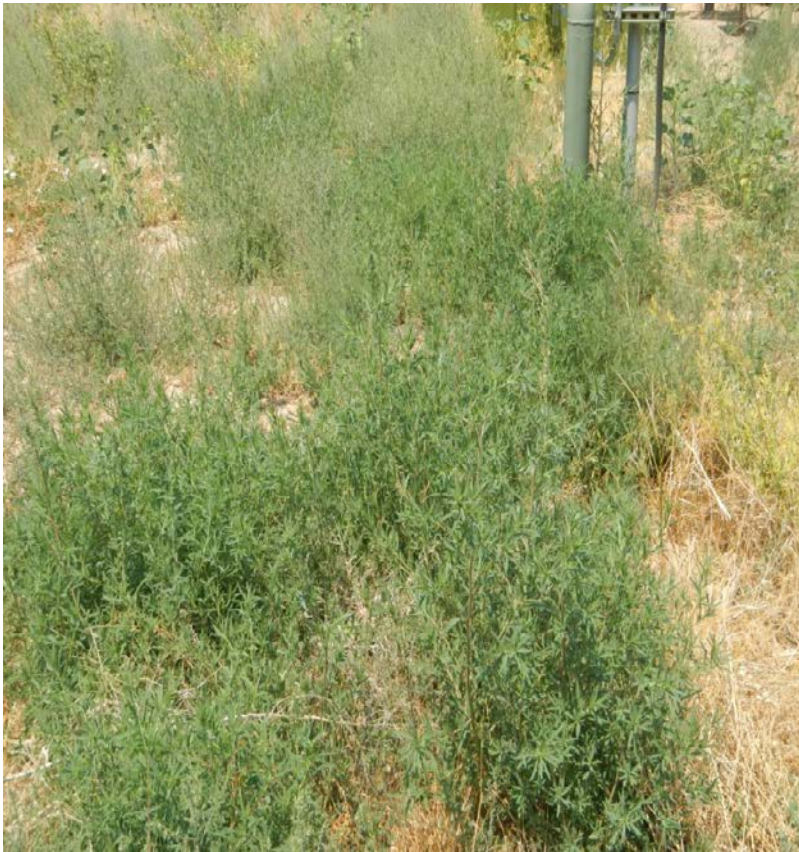
Photo#8:
Weeds growing in and around equipment.

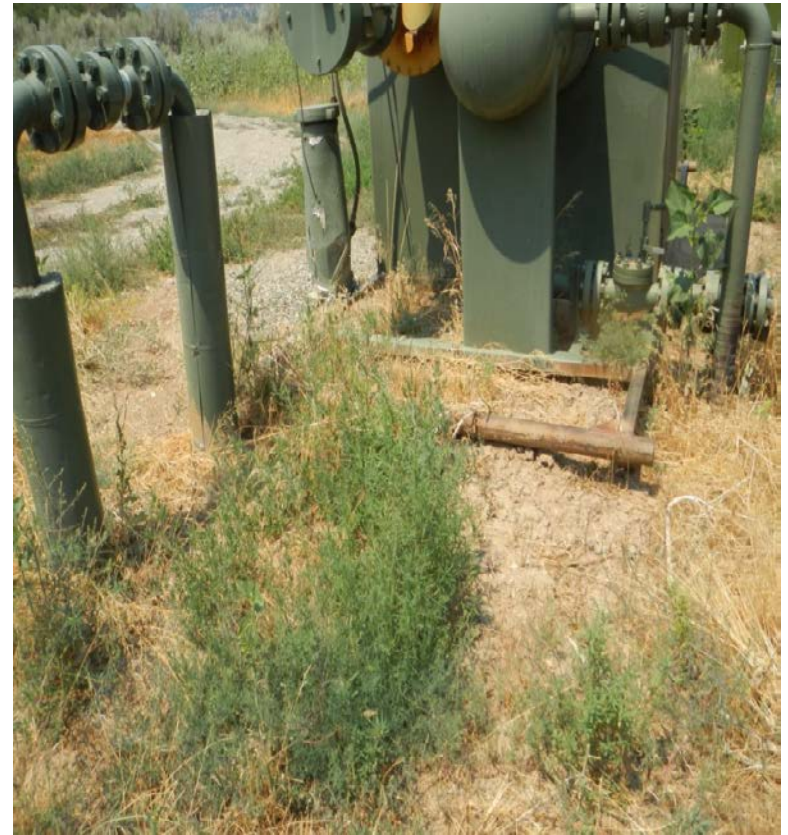
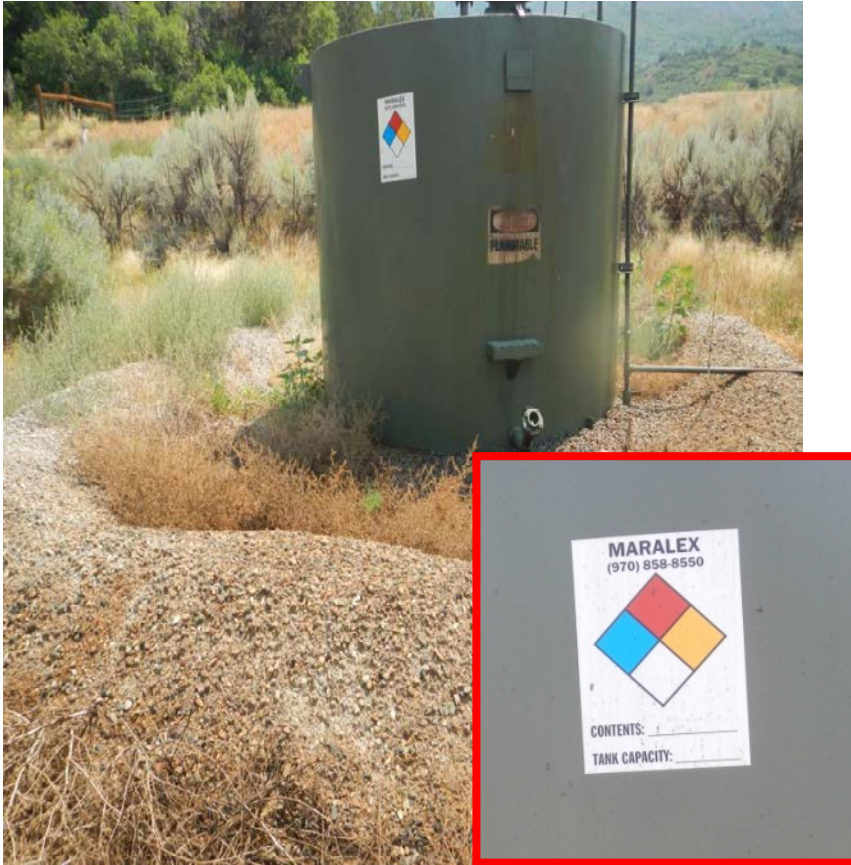
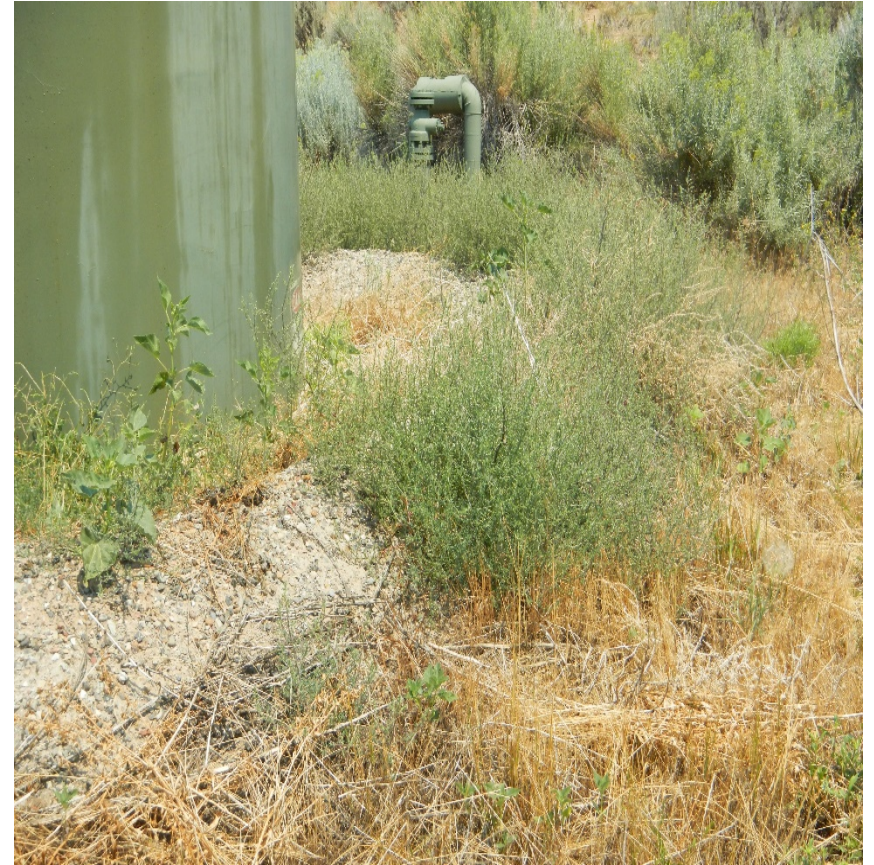
Photo#9:

Views of dead & growing weeds on berms and in Tank area. Insert is of tank label missing Capacity and Contents.

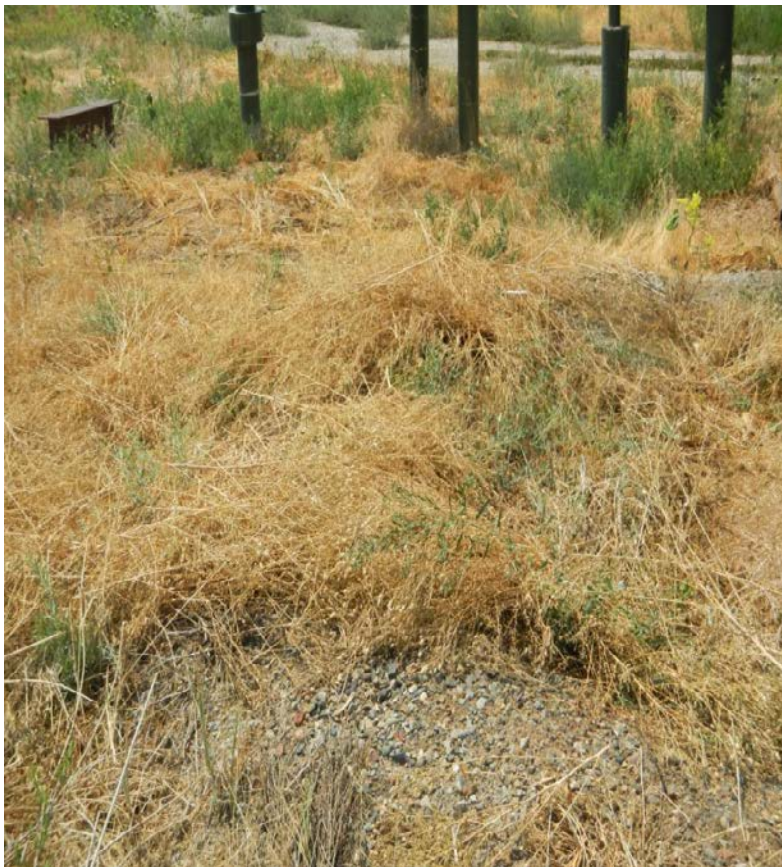
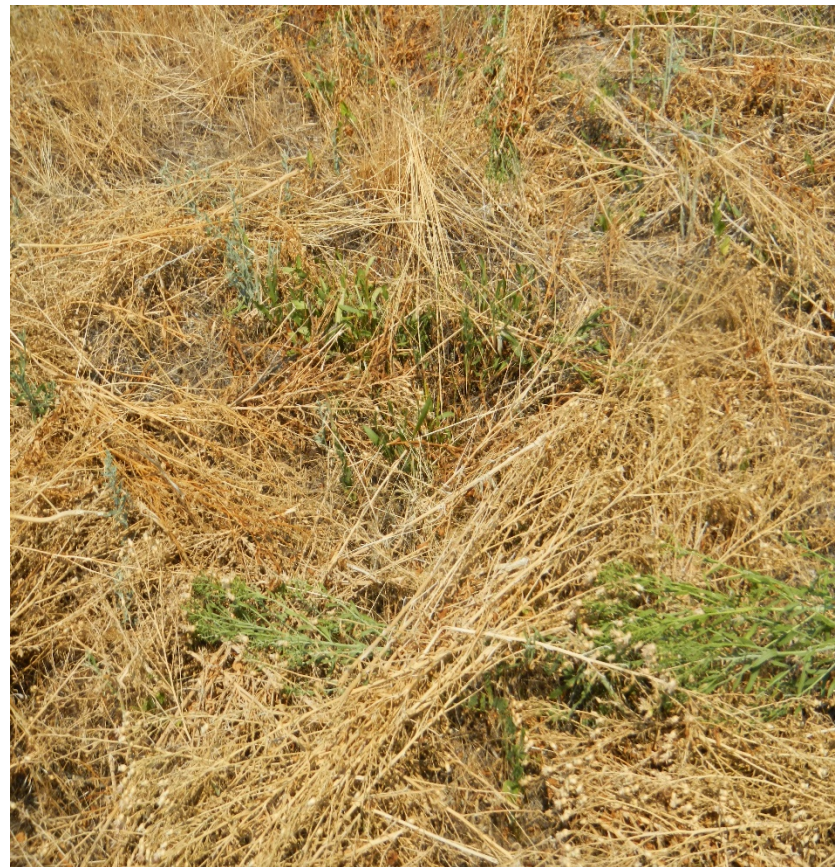
Photo#12:

Mature weeds (Knapweed) have been cut off, left on site & now dead, have become Debris.

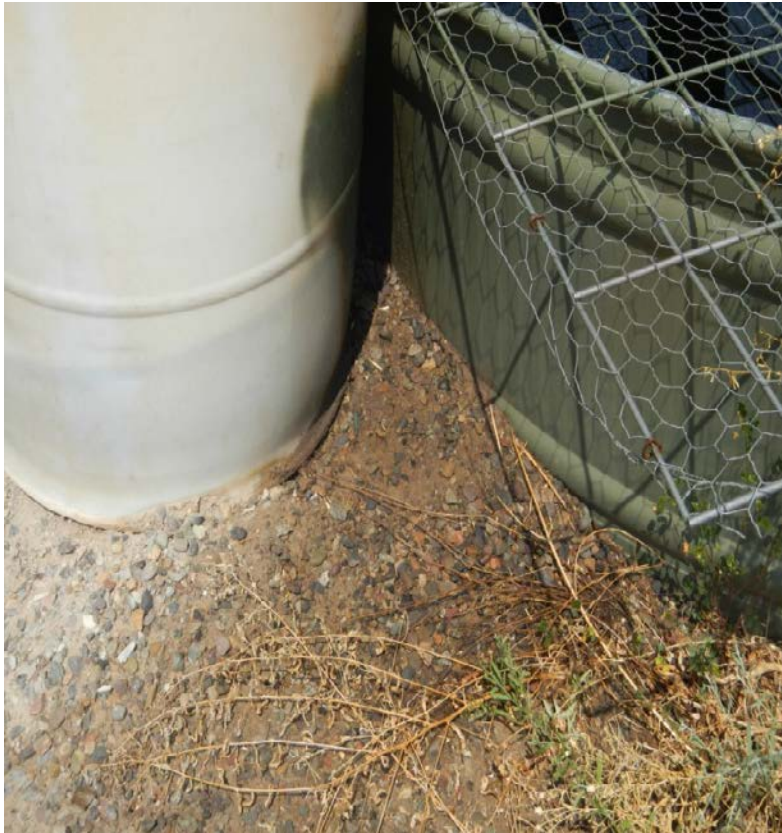
Photo#14:
Staining and impacted soil were observed around multiple pieces of equipment.

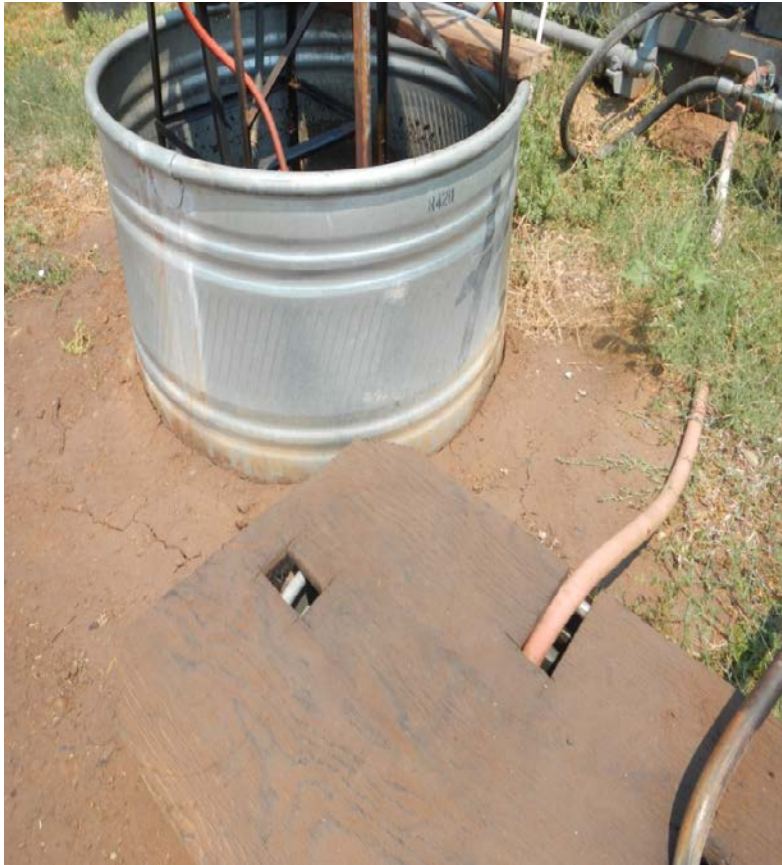
Photo#16:
Staining and impacted soil were observed around multiple pieces of equipment.

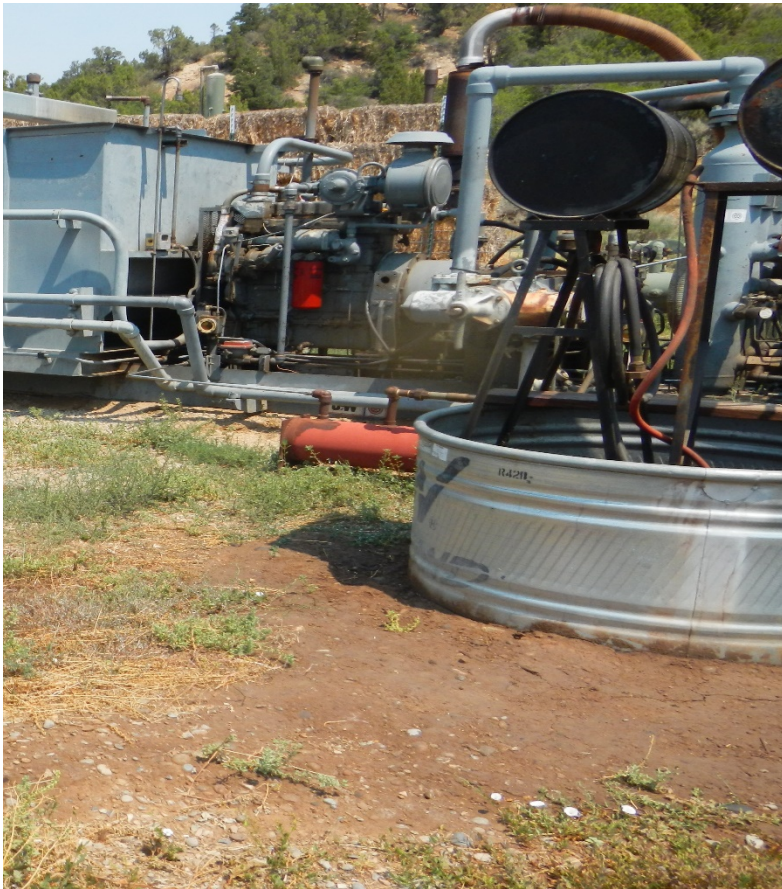
Photo#18:
Staining and impacted soil were observed around multiple pieces of equipment.

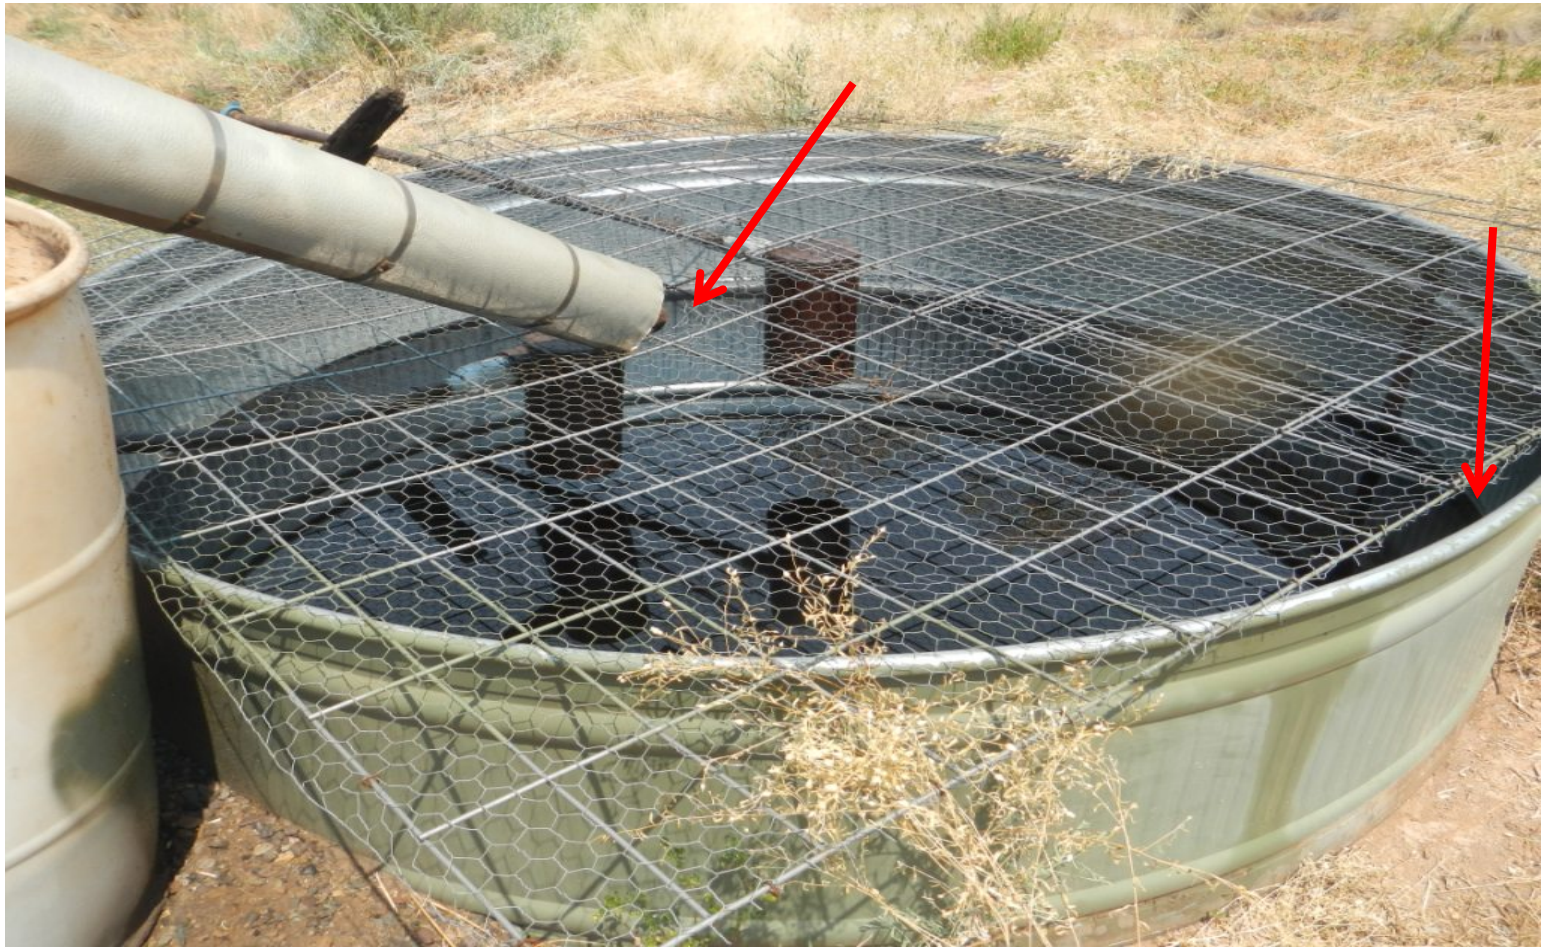
Photo#20:

Gaps in netted panel that covers stock tank used for fluid storage from separator unit, allows ingress of smaller Wildlife.
