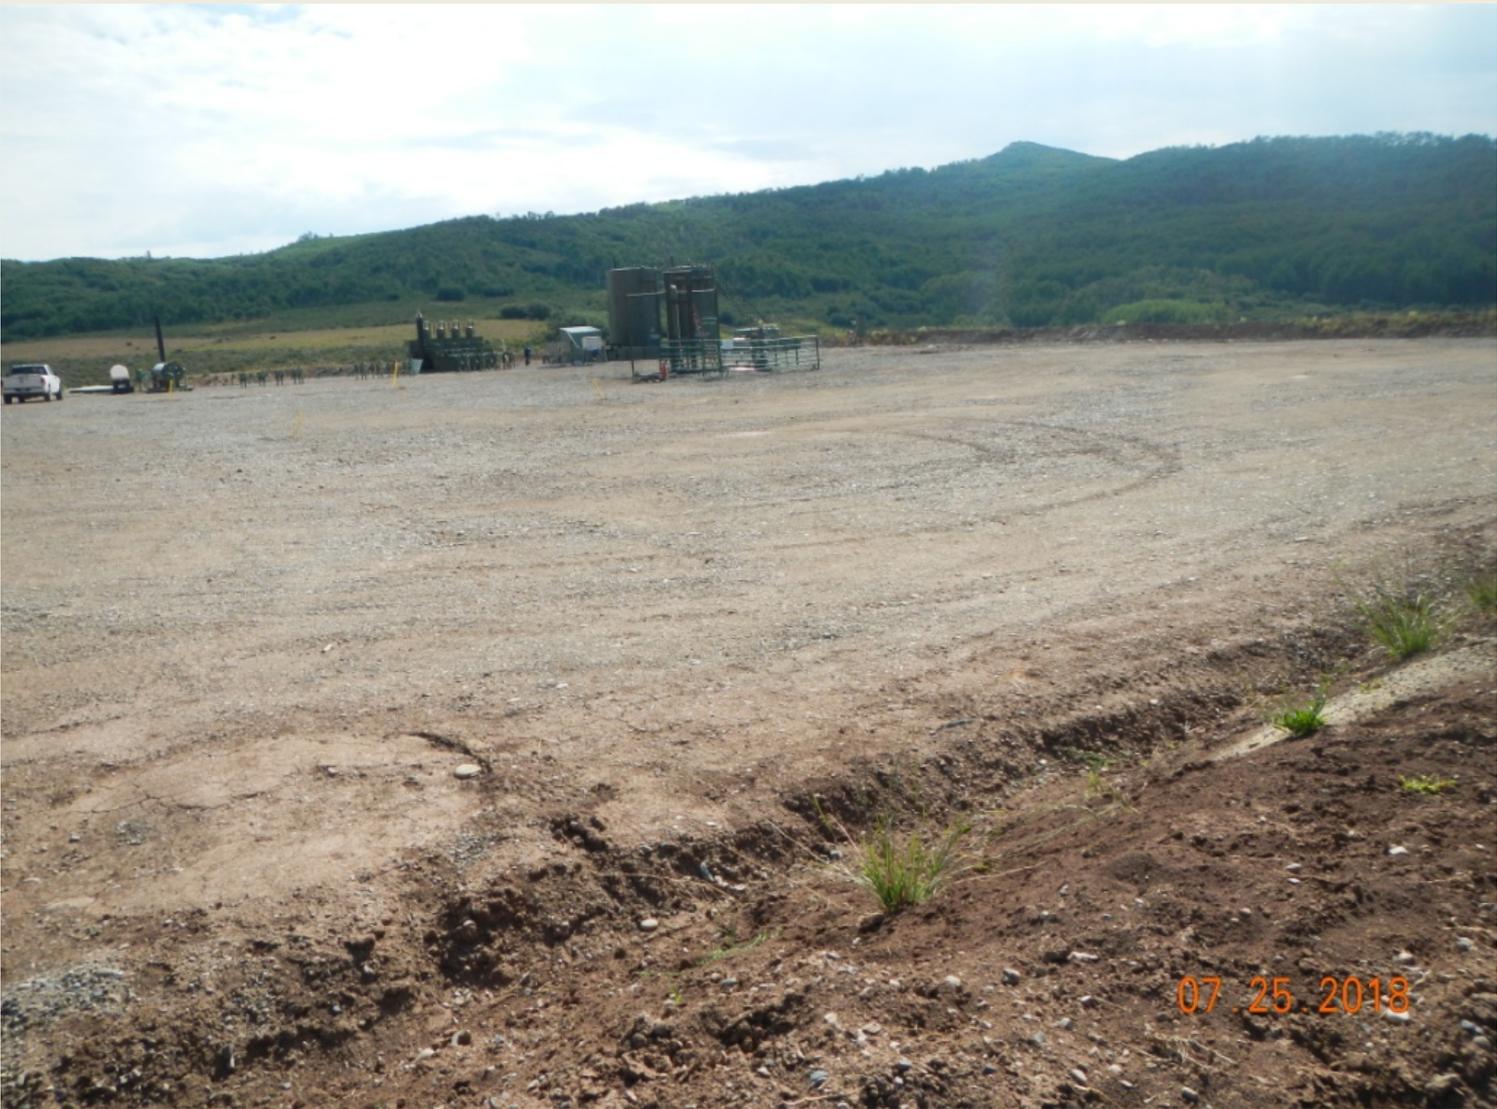
Photo 1. View of the project area from the western corner facing center.

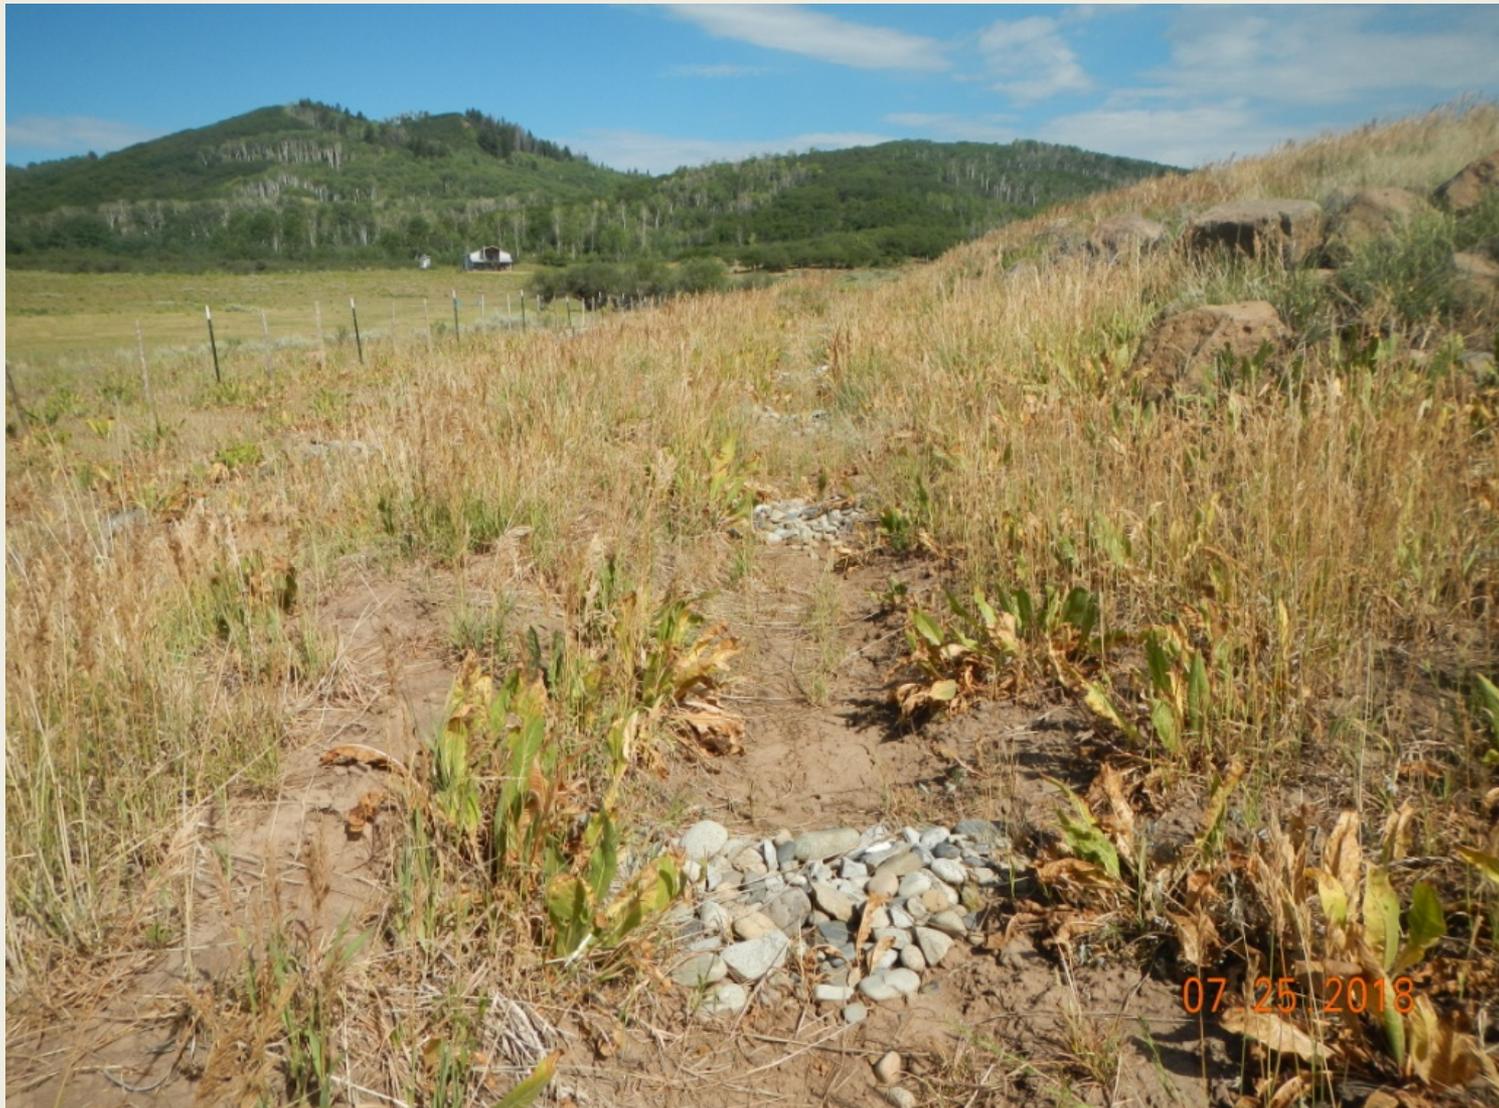
Photo 2. View of the southwestern portion of the project area from the southern corner facing northwestward. Rock check dams appear to be functioning. Vegetation is becoming established on fill slopes with grasses, shrubs, and forbs such as smooth brome (*Bromus inermis*), snowberry (*Symphoricarpos albus*), and mules ears (*Wyethia* sp.).

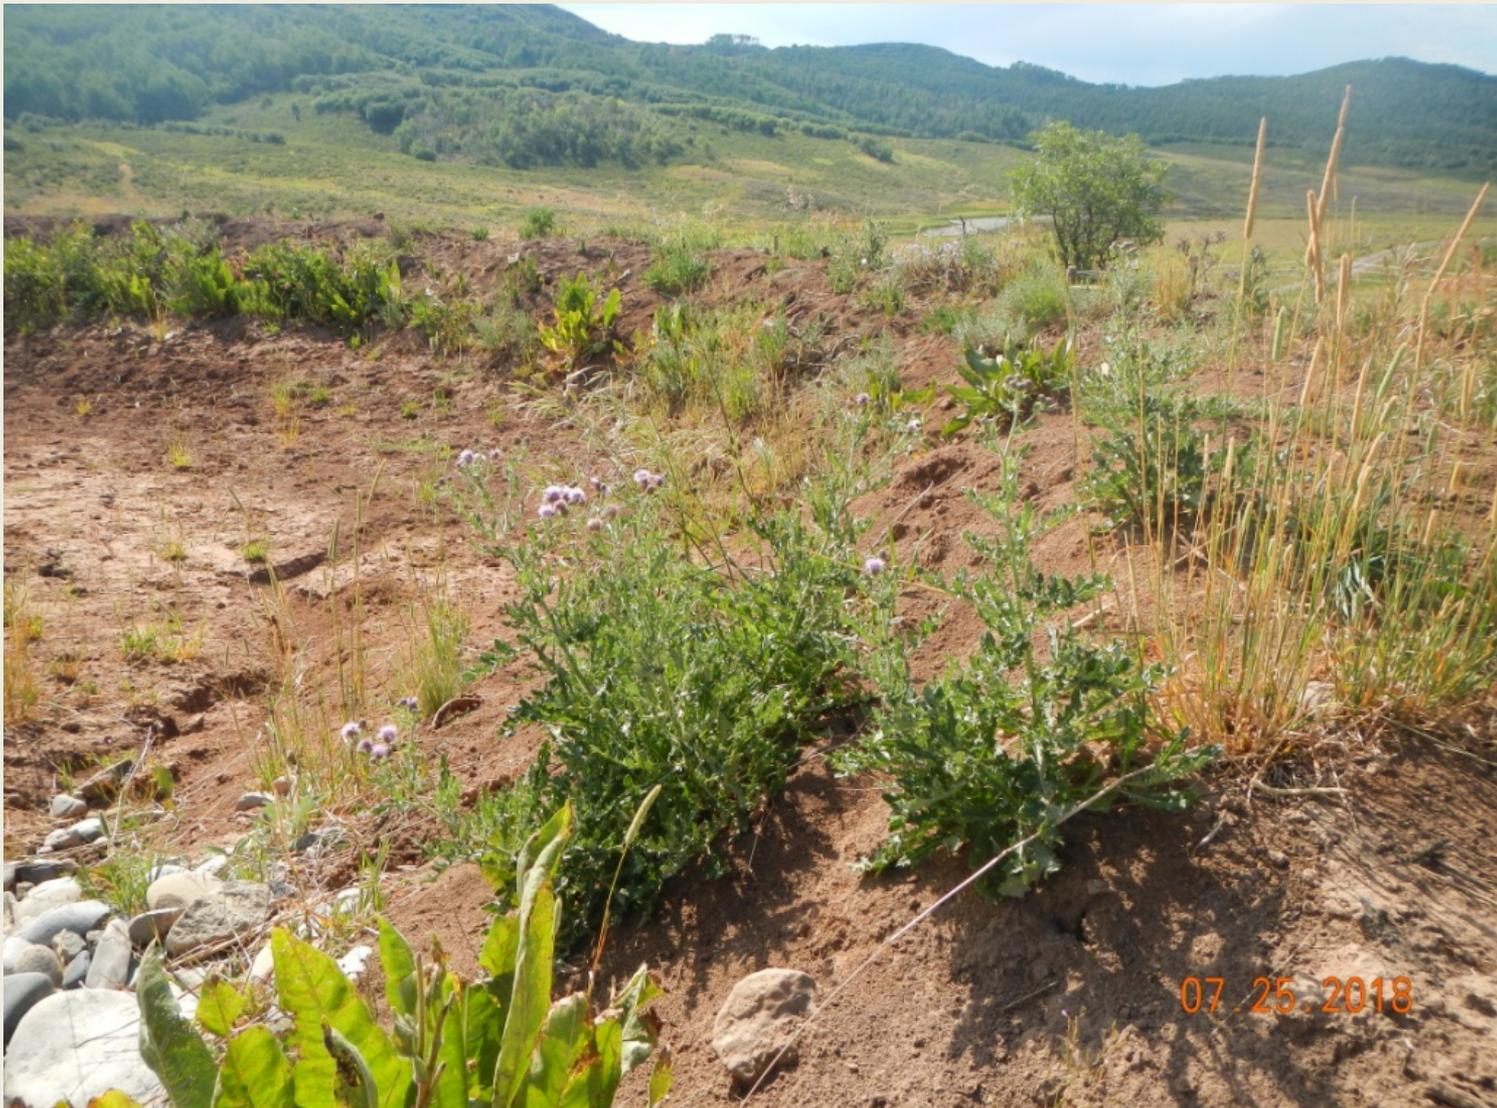
Photo 3. View of Canada thistles (*Cirsium arvense*) within the southern silt trap.

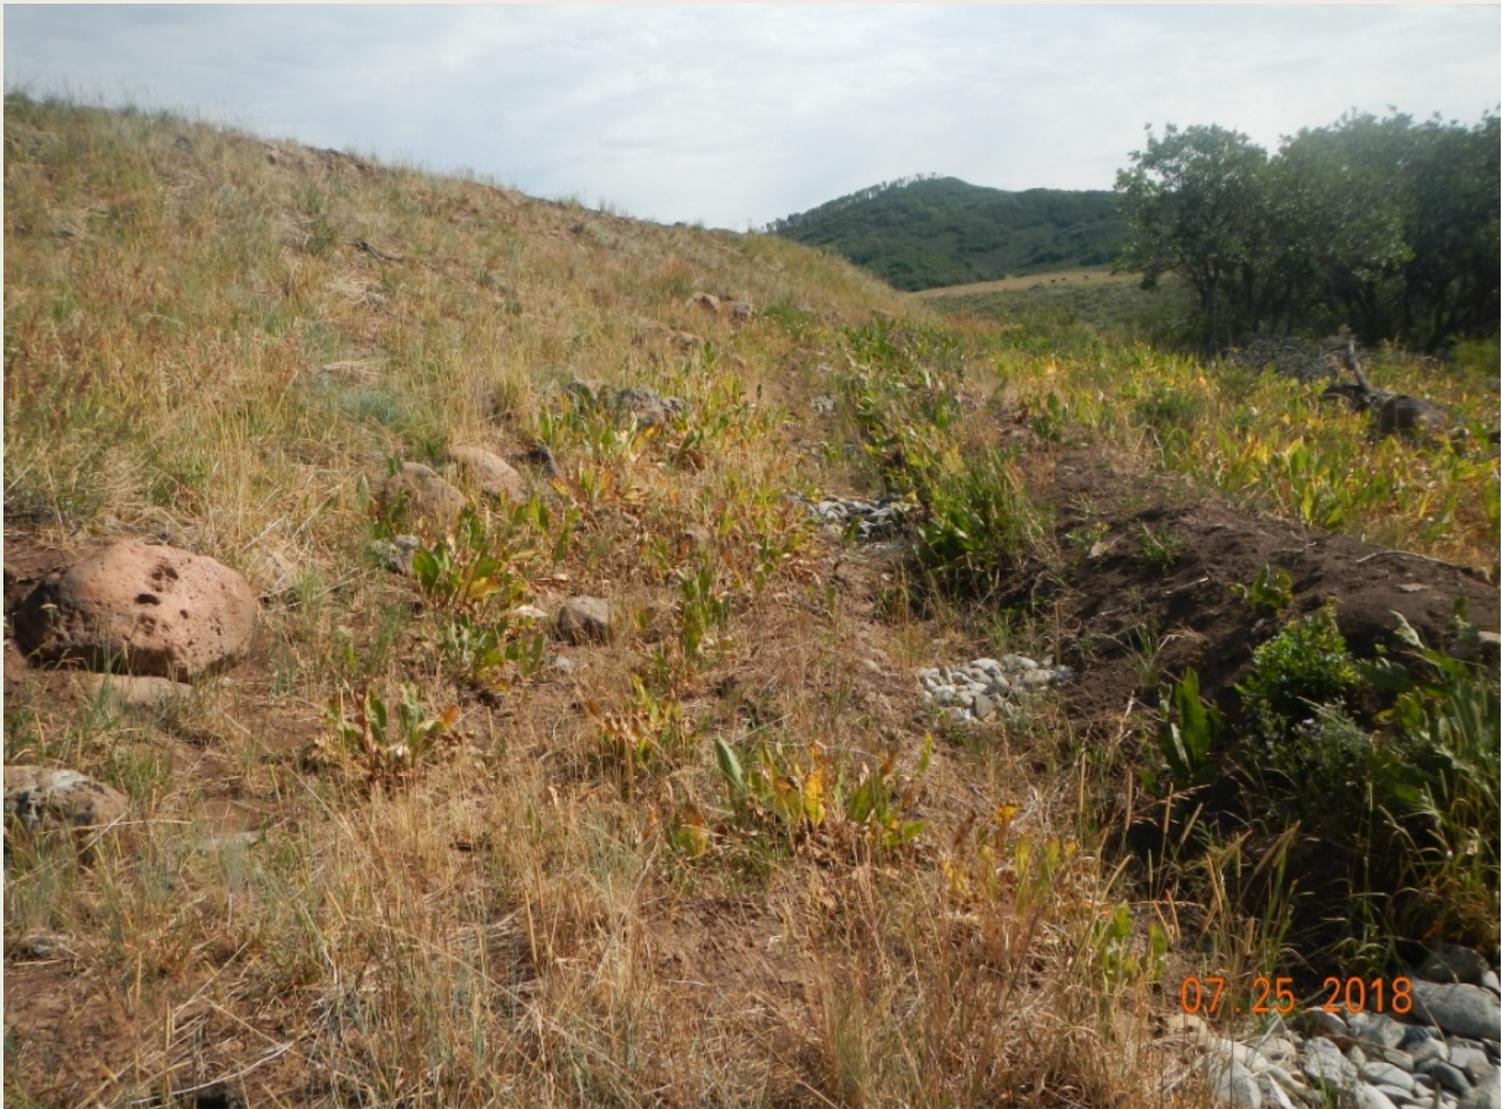
Photo 4. View of the southeastern portion of the project area from the southern corner facing northeastward.

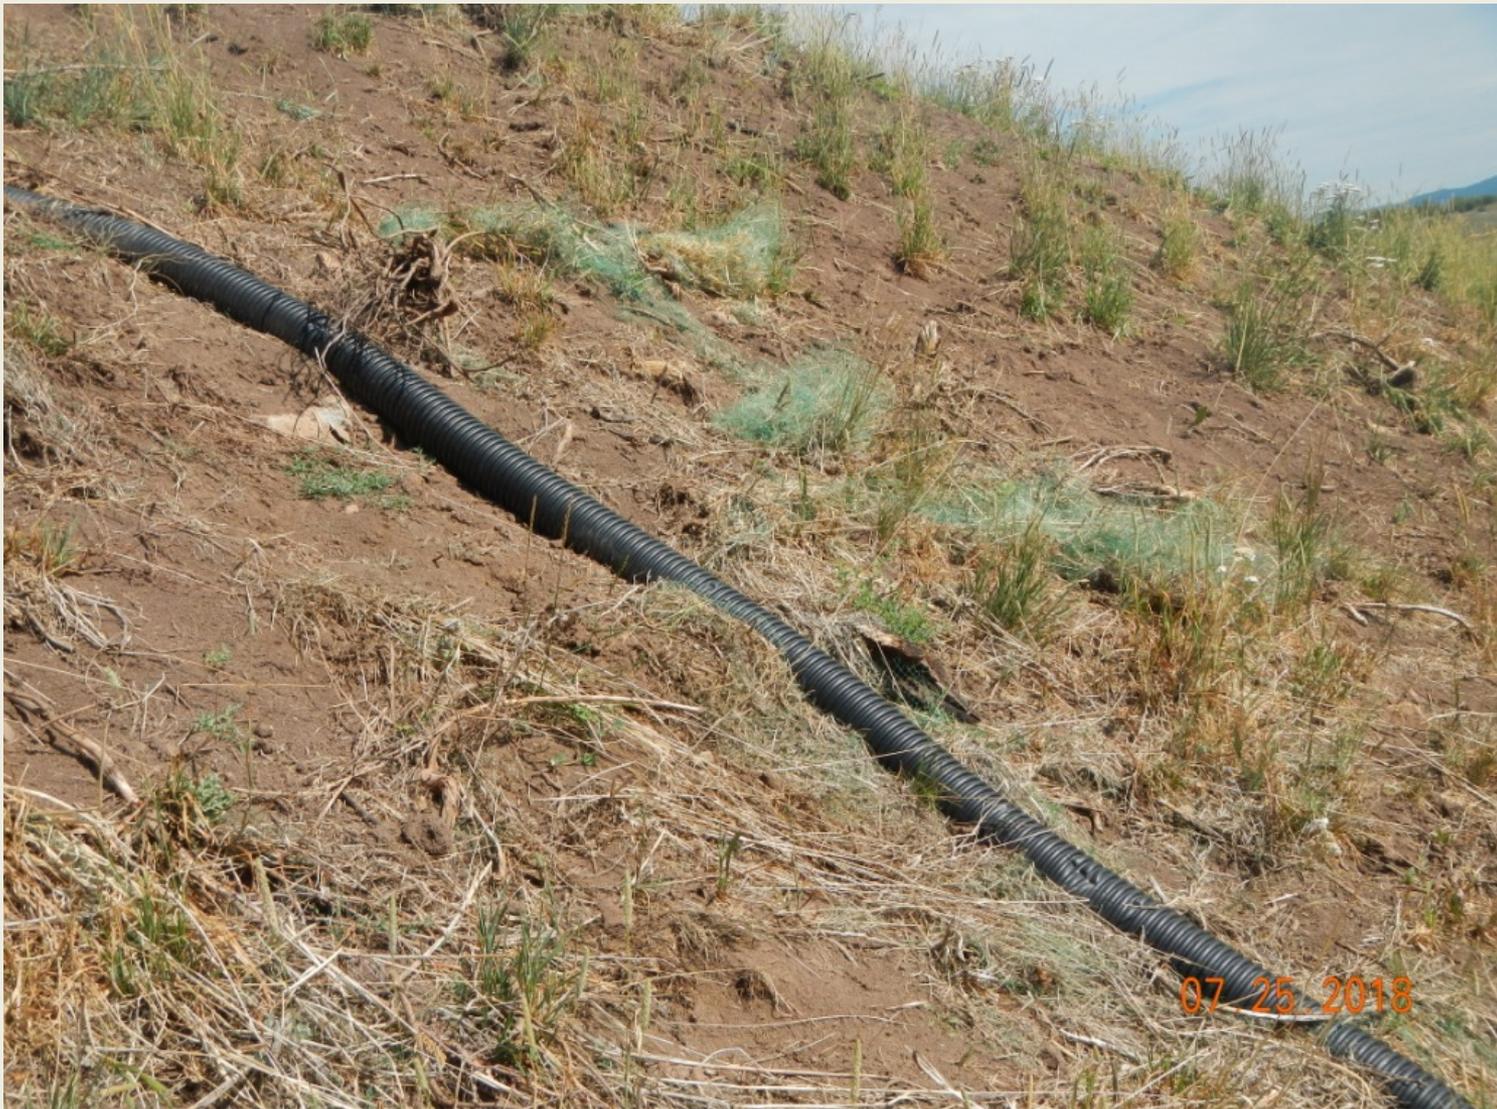
Photo 5. View of green plastic netting debris on the eastern fill slope revegetation area.

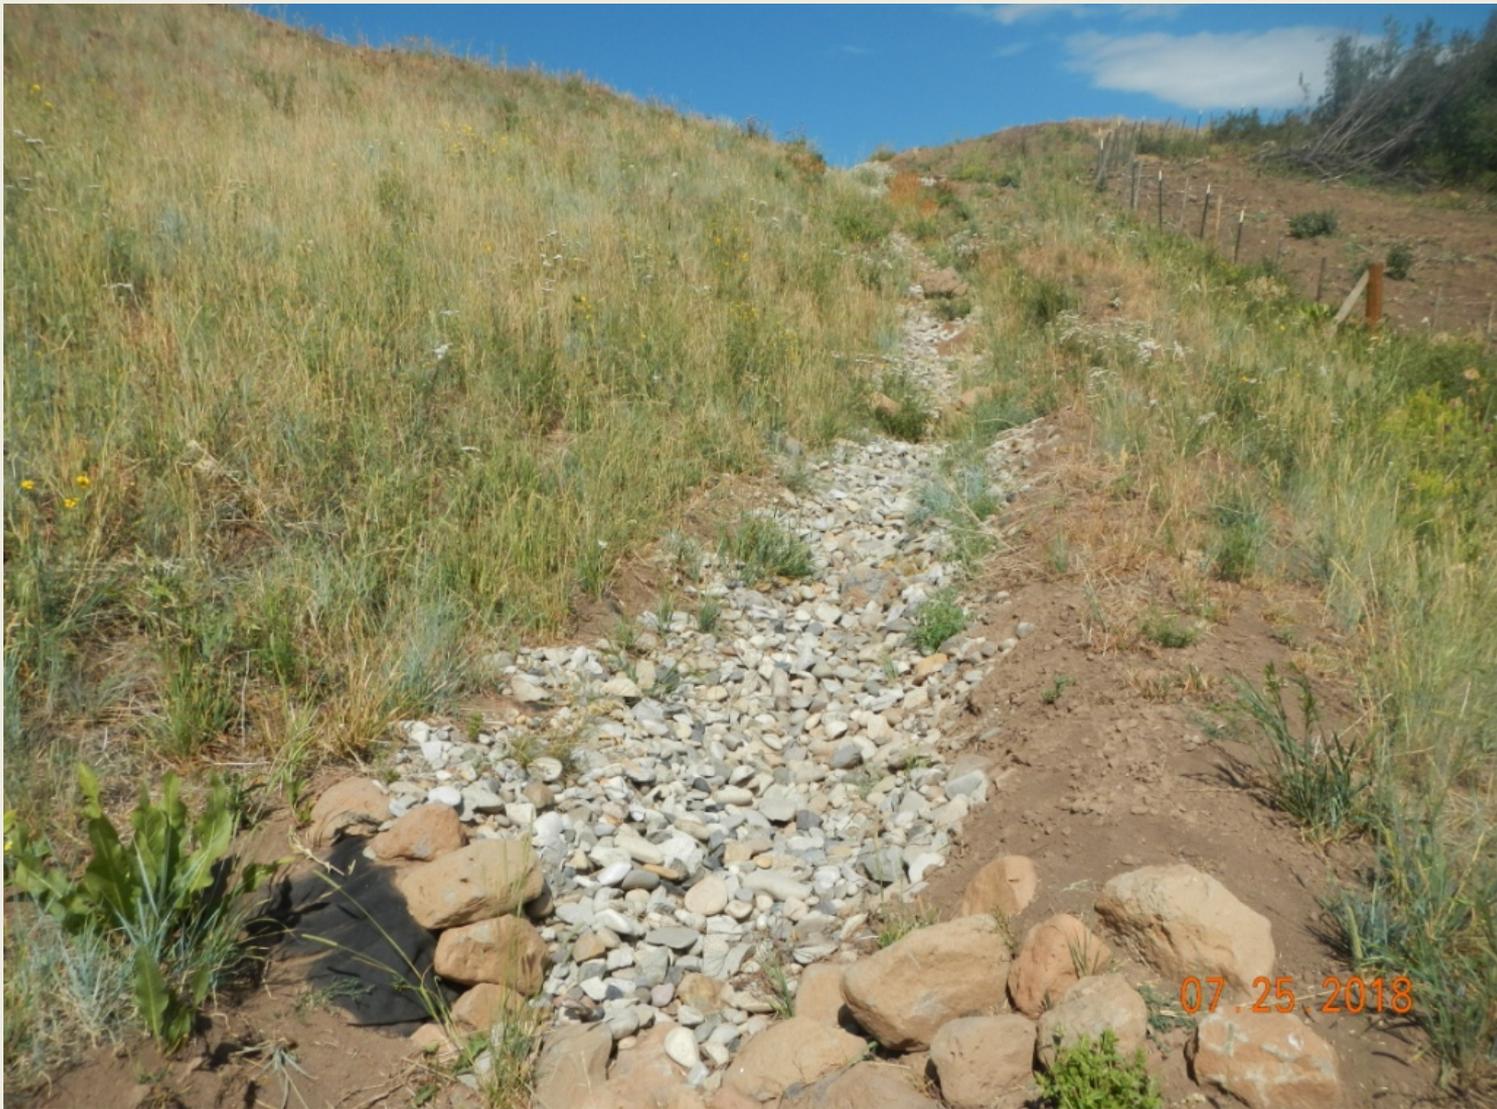
Photo 6. View of the northeastern portion of the project area rock run-down appears to be functioning.

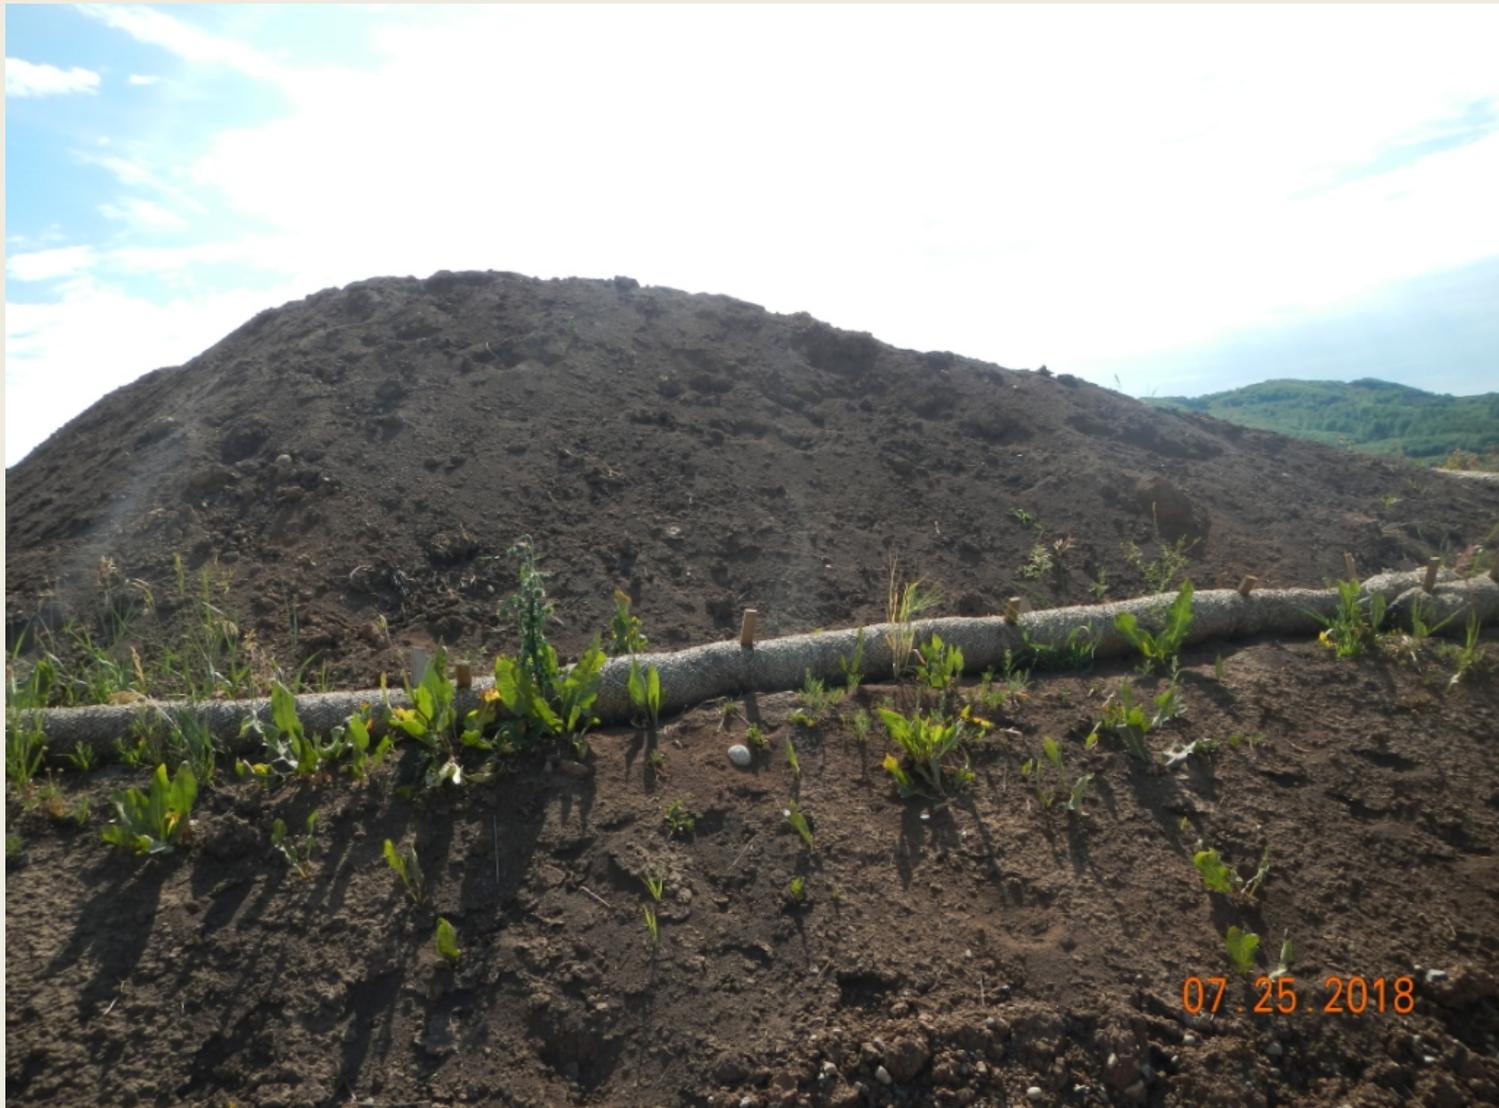
Photo 7. View of topsoil storage in the northern portion of the project area.
