Inspection Photos
Location Name: Elk Springs Unit 1-17
API: 05-081-06779

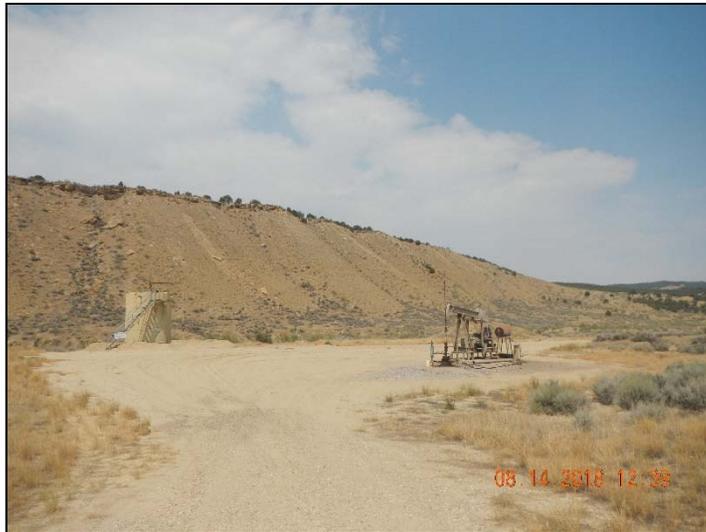
Photo 1. Overview of location taken at entrance facing northeast.

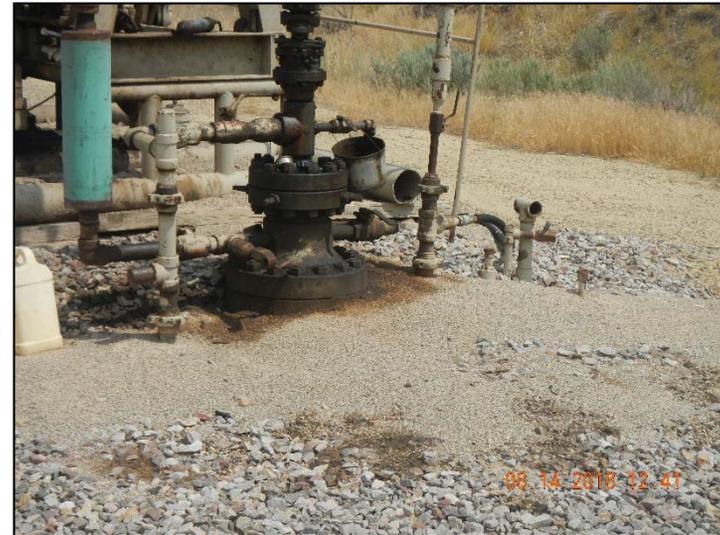
Photo 2. Stained soil and fresh gravel at wellhead. 3 – 1” and 1 – 2” steel risers on right side of wellhead.
