Inspection Photos
Well Name: Horseshoe Canyon 5
Location ID: 312445

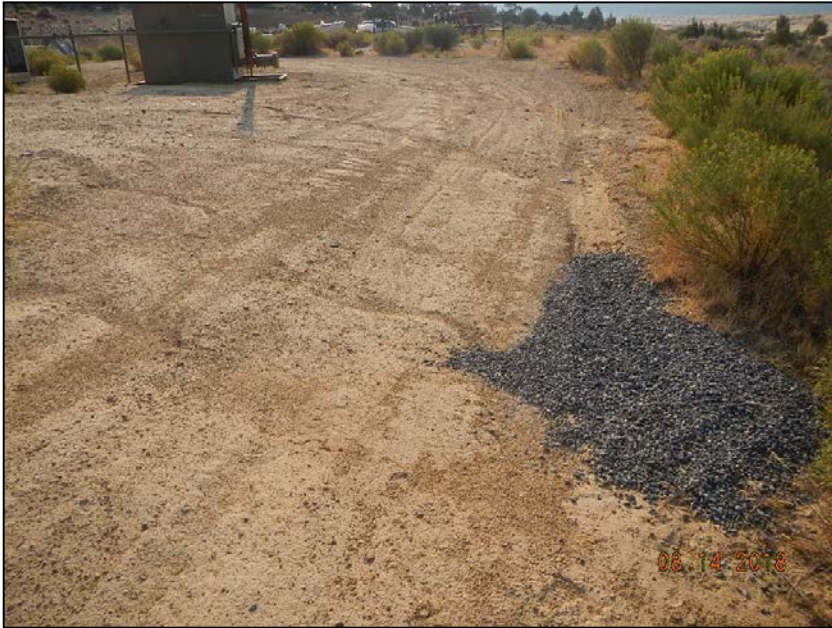
Photo 1. Gravel added to area of erosion and sediment migration. Continued monitoring will be necessary to determine if it is effective.

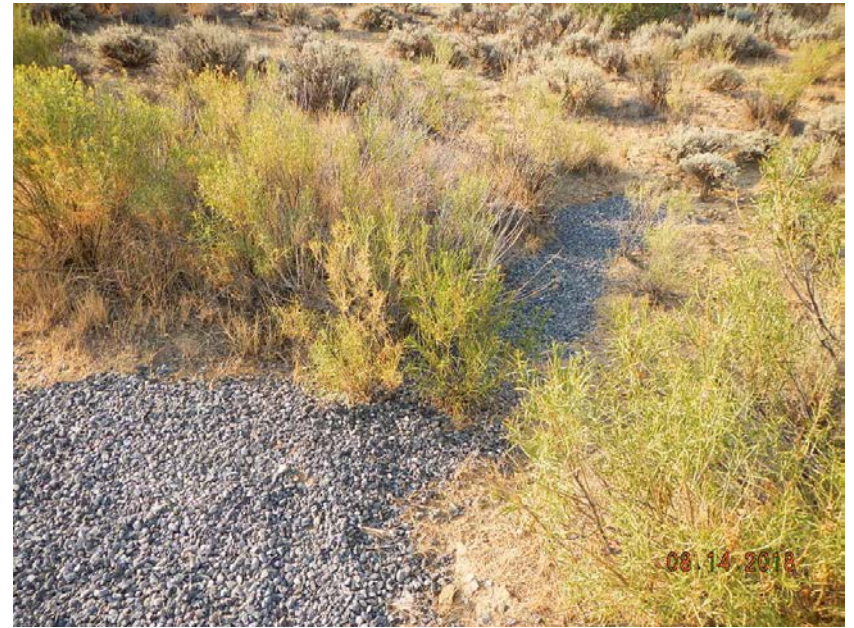
Photo 2. Gravel added to area of erosion and sediment migration. Continued monitoring will be necessary to determine if it is effective.

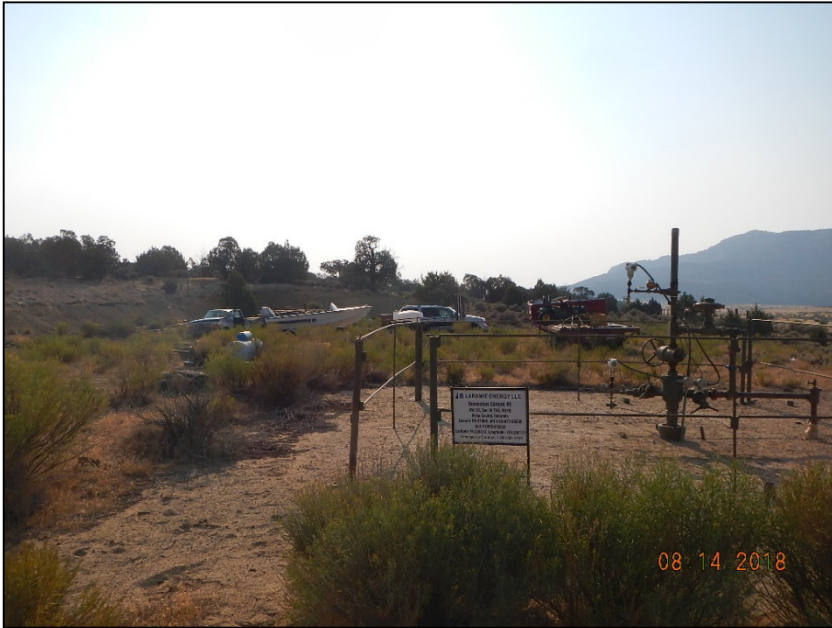
Photo 3. Equipment, supplies and debris still on location.

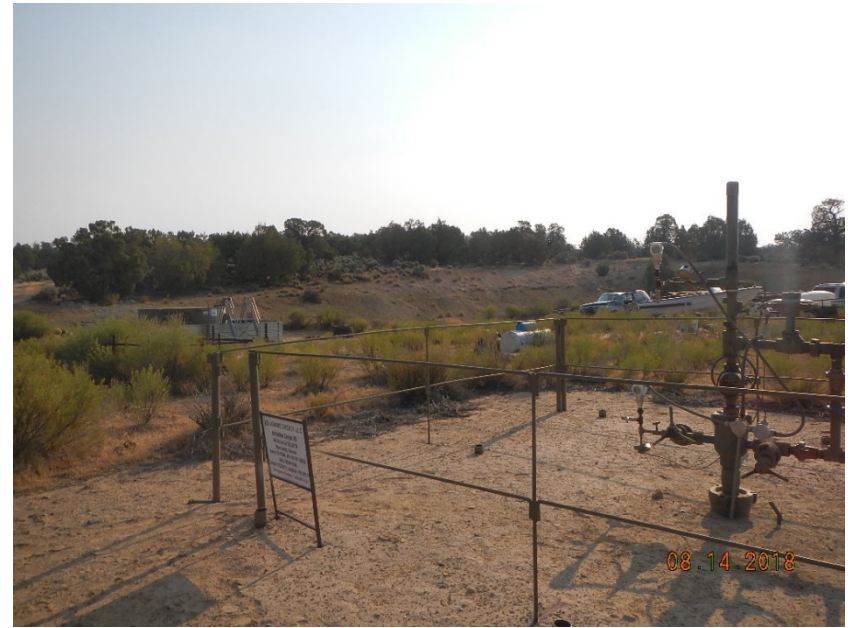
Photo 4. Equipment, supplies and debris still on location.
