Interim Reclamation and Stormwater Inspection

Operator: BURLINGTON RESOURCES OIL & GAS LP- #26580

Location ID: 429810

Inspection Photos
Location Name: WATKINS /30-5-5H H
Location ID: 429810

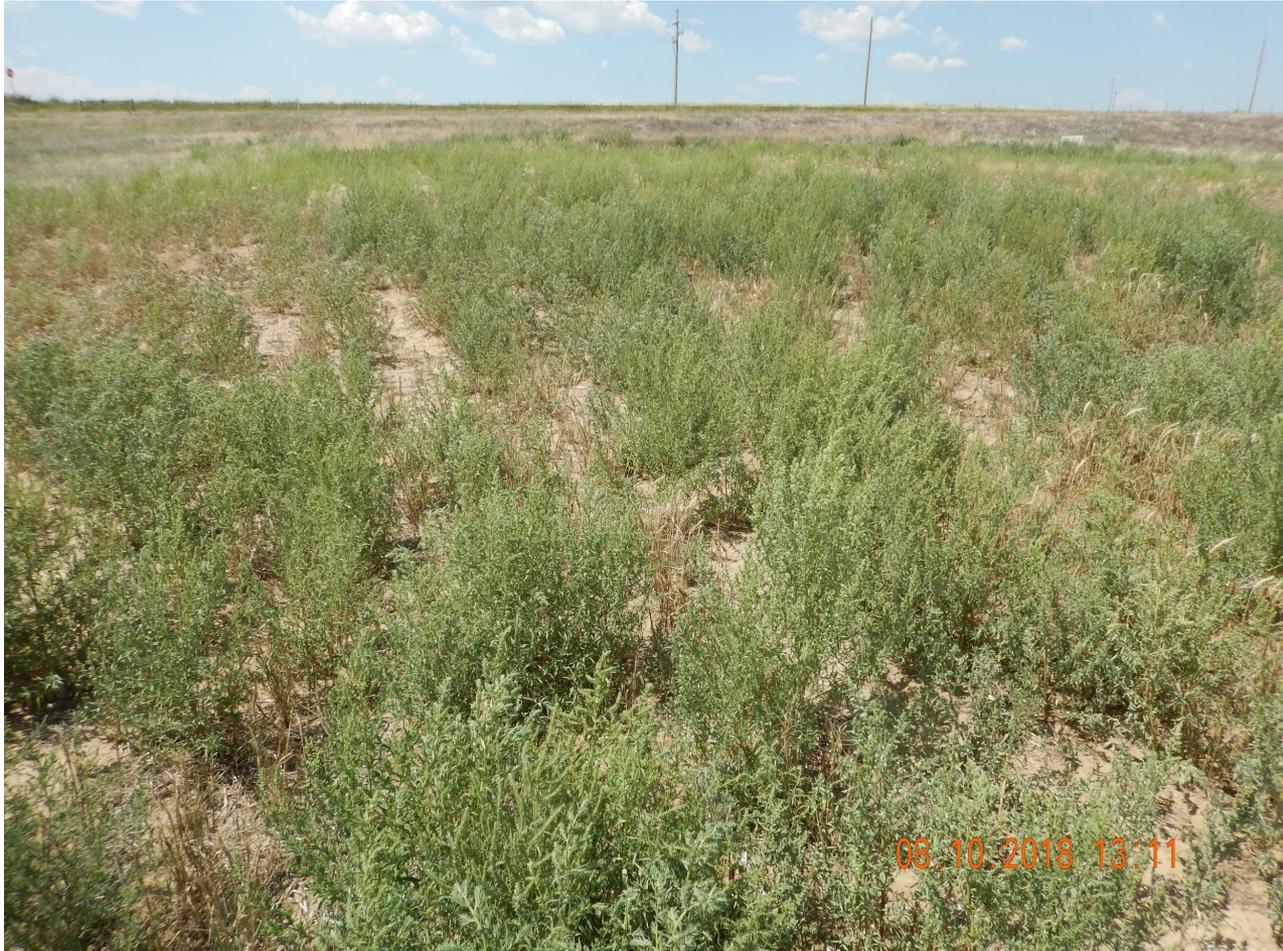
Photo 1. Photo taken from the entrance of the location, facing West. Photo illustrates a weedy area which may have been the soil stockpile area. Germination of grass species was observed within the weed growth but Operator shall control and manage weeds per Rule 1003 standards.

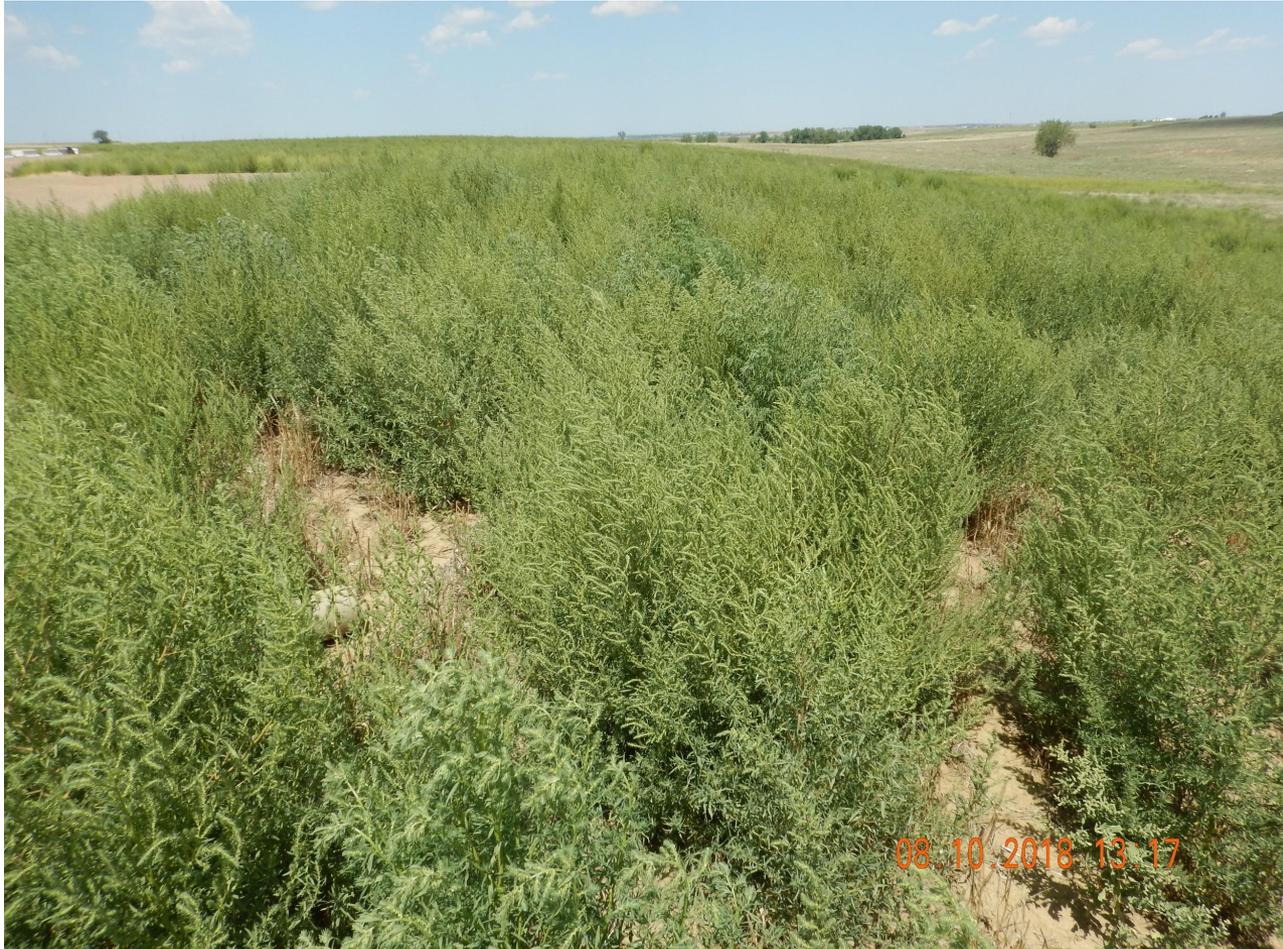
Photo 2. Photo taken from the eastern interim area, facing North. Operator has failed to manage and control Kochia and Russian thistle throughout the interim area. Germination of grass species was observed within the weed growth but an assessment was not made throughout due to the high density of weeds.

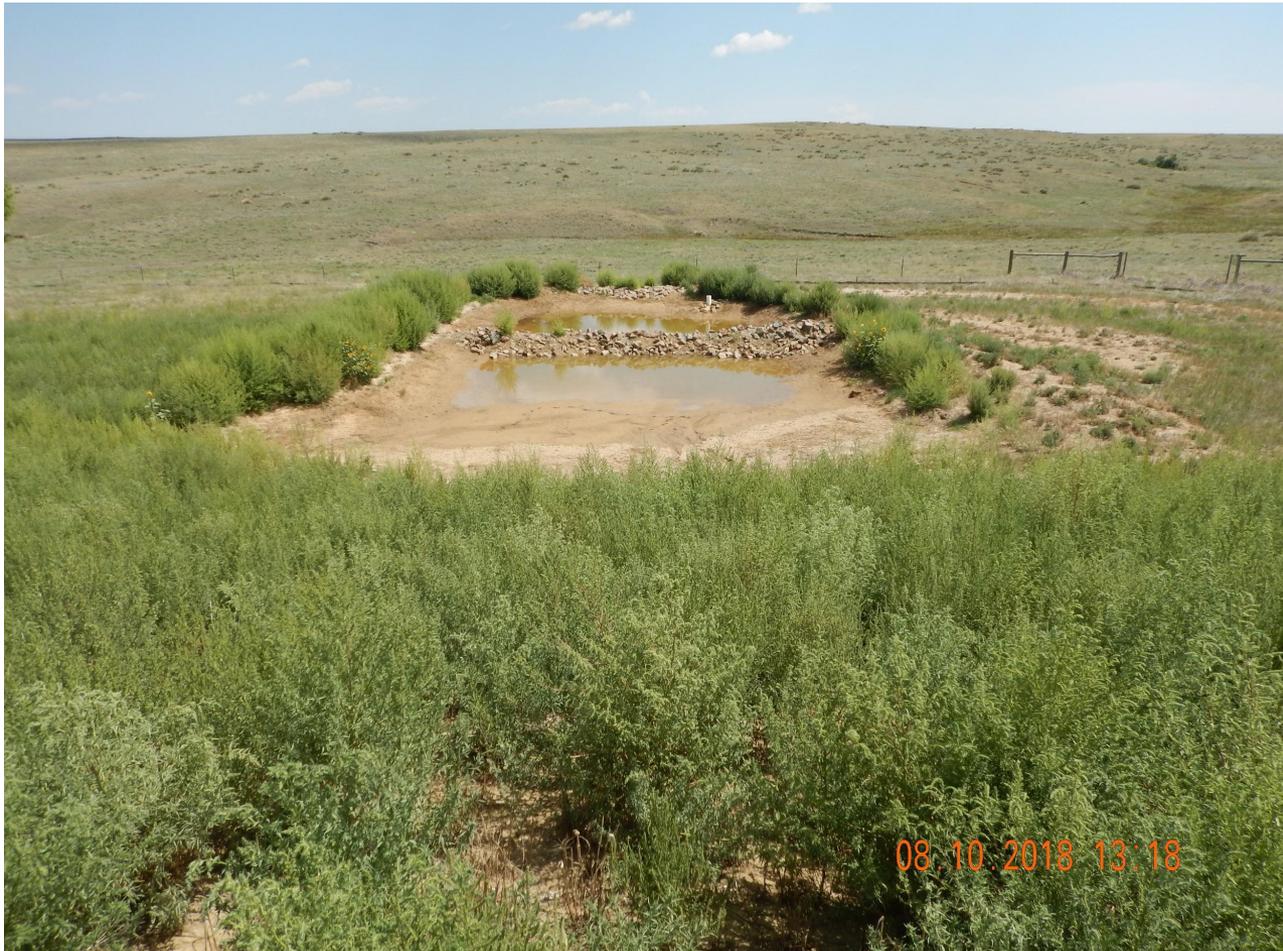
Photo 3. Photo taken from the eastern perimeter of the location, facing East. Sediment basin appears to be properly functioning. No sediment discharge was observed off location.

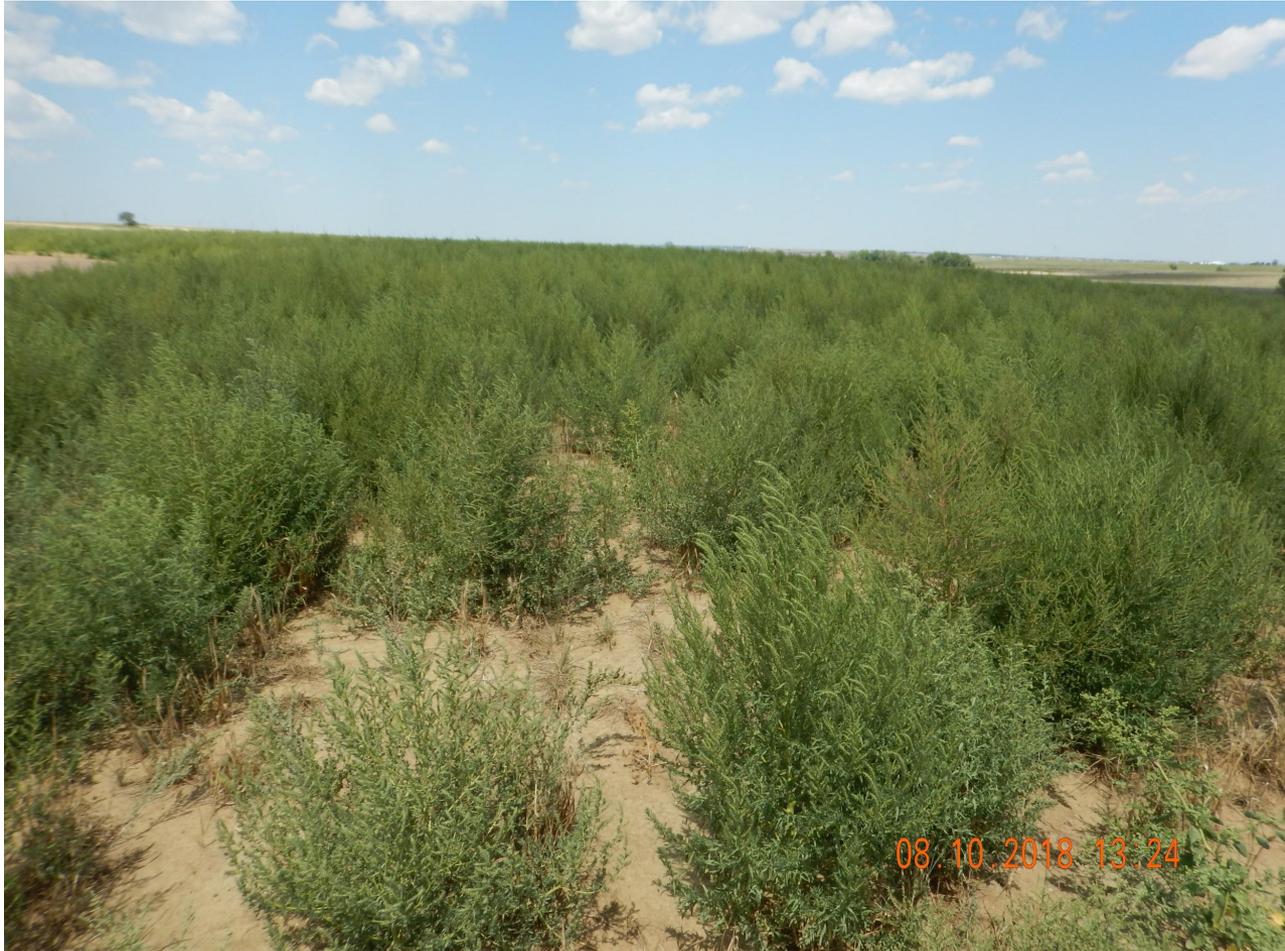
Photo 4. Photo taken from the northern interim area, facing West. See comments under Photo 2.

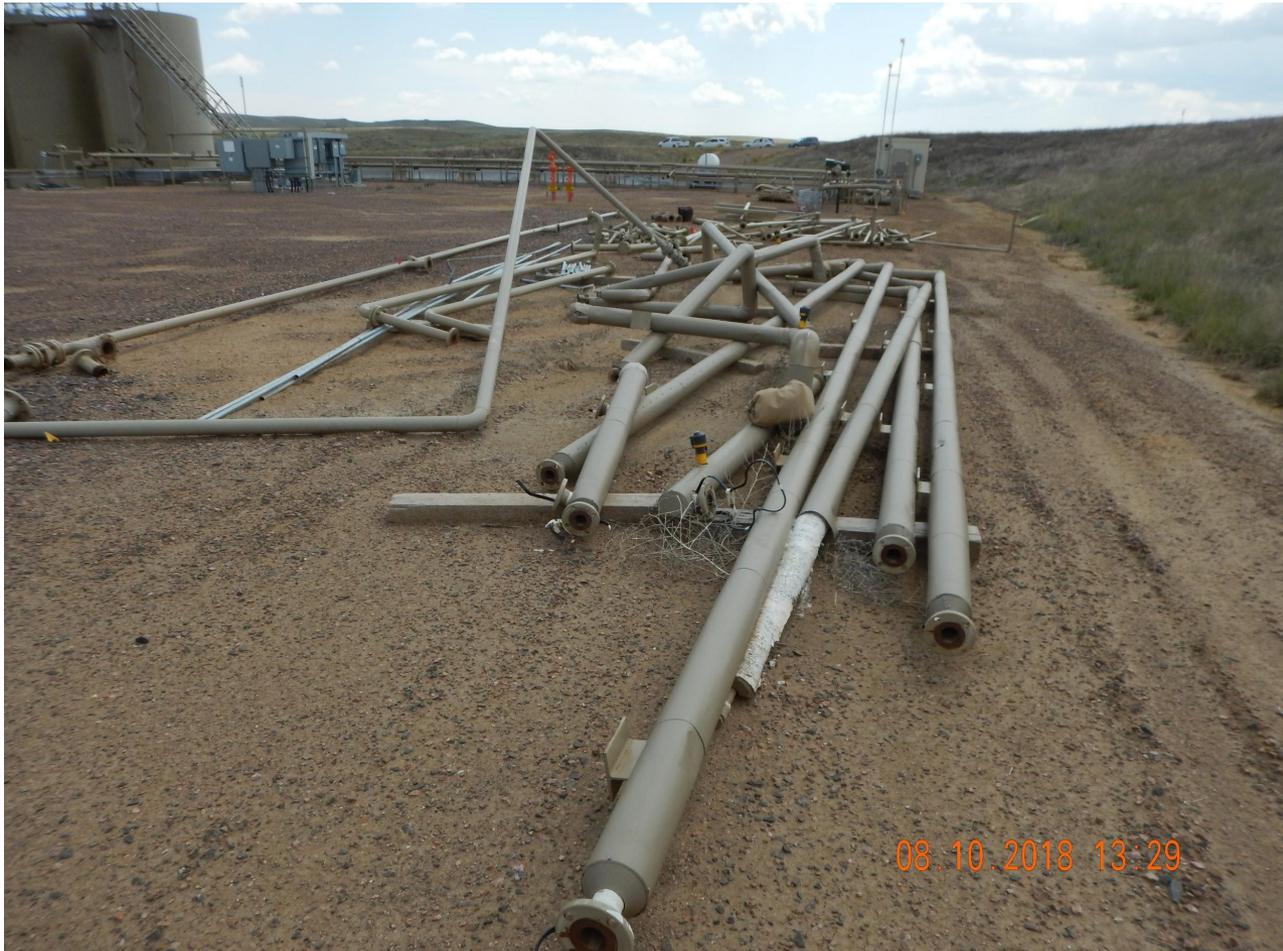
Photo 5. Photo taken from the western production area, facing South. Appears Operator has recently removed equipment (separators). Operator shall remove any unused equipment not necessary for production operations.

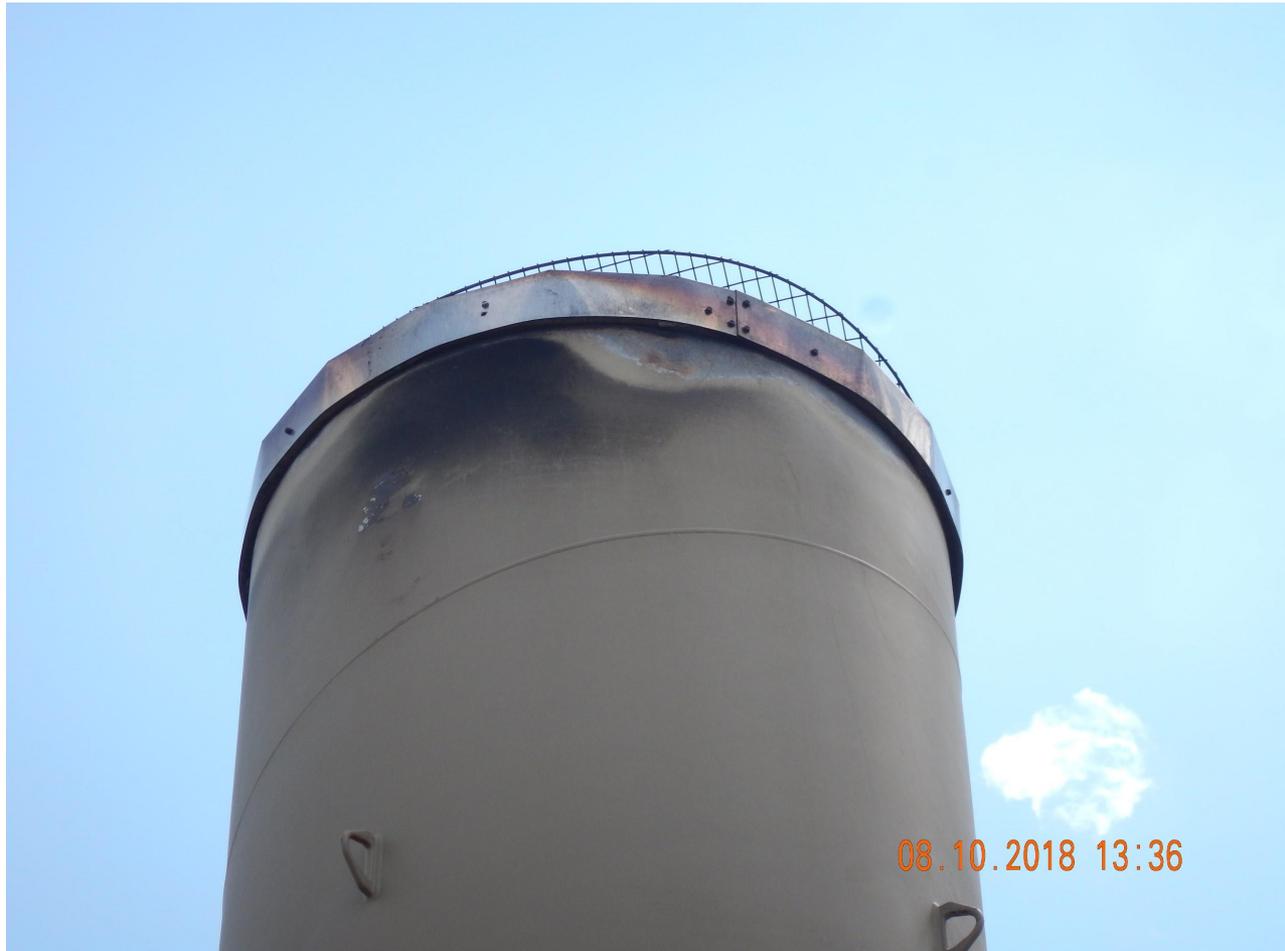
Photo 6. Photo taken from the eastern production area. Wildlife screen does not appear to be centered. Operator shall comply with Rule 605.b.(7).
