Stormwater Inspection Report

Operator:	Laramie Energy, LLC
Project:	Horseshoe Canyon Project Area
Location:	Oxbow 18-1E Pad and Access Road
Date:	Tuesday, August 14, 2018
Weather:	Partly Cloudy, Light Winds, High 91° Lo 54°

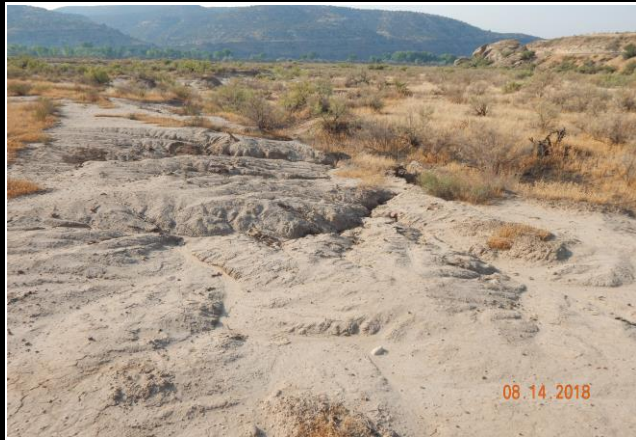
Photo 1

*Existing Erosion on the West Side of the Pad***Photo 2**

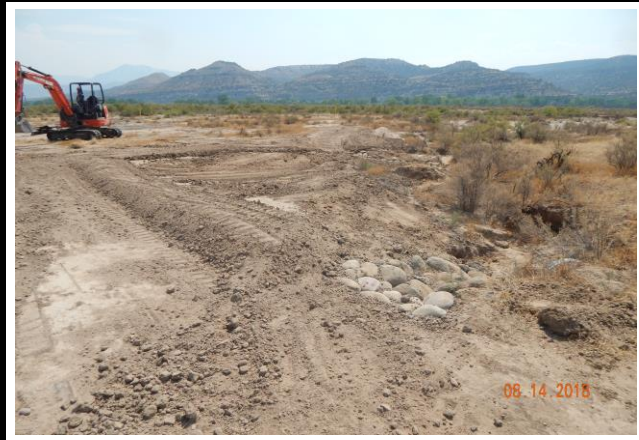
*Erosion Repair & Berm Installation on the West Side of the Pad***Photo 3**

Comments / Descriptions / Explanations
<p>Corrective actions were completed today on the Oxbow 18-1E access road and pad. Erosion repairs were completed on the west side of the pad area and minor erosion was repaired and the south and east sides. Berms were installed on the west side of the pad to help reduce erosion and to divert stormwater runoff through the newly installed rock apron outlets. The areas of erosion on the access road were repaired and areas of the roadside bar ditch were maintained. The crew removed garbage and litter from the project site, completed final cleanup, and then mobilized from the project area.</p>

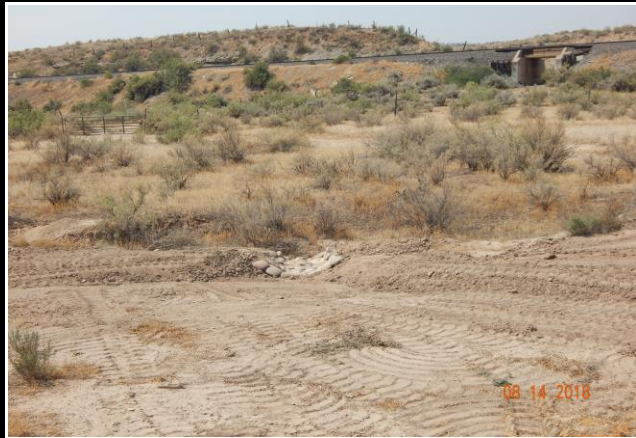
*Rock Apron Outlet Installed***Photo 4**

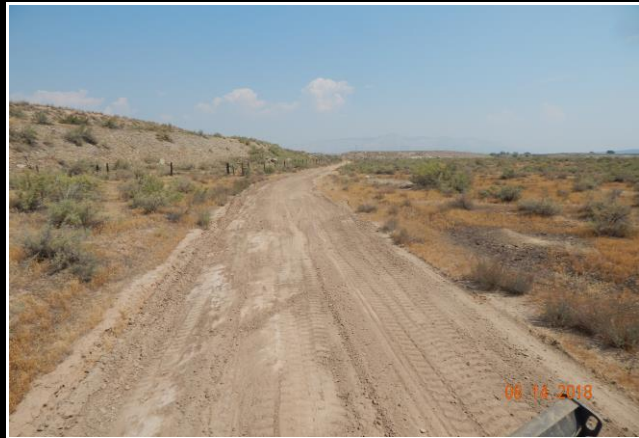
*Erosion Repaired on Access Road*
