Well Name : Marquez A 1  
API # : 007-06165

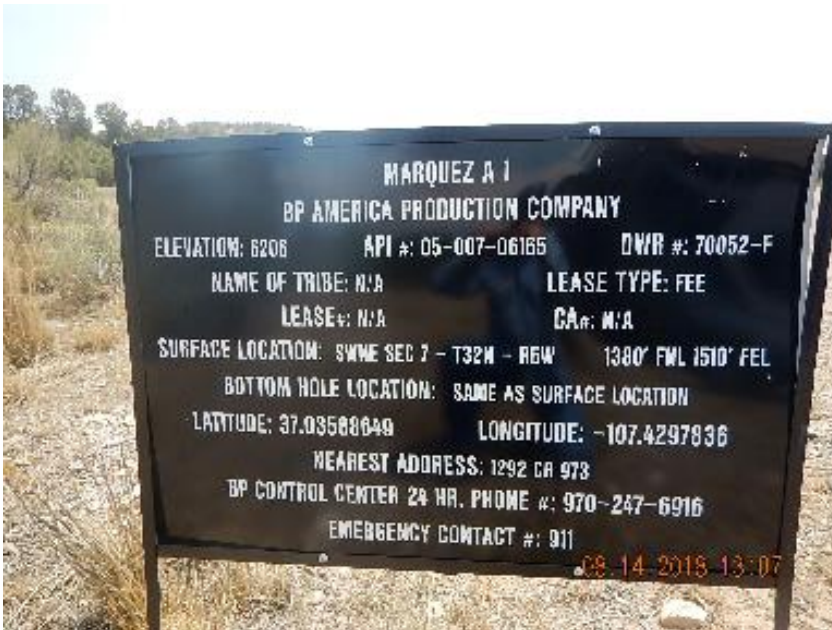
Photo 1: New wellhead sign.

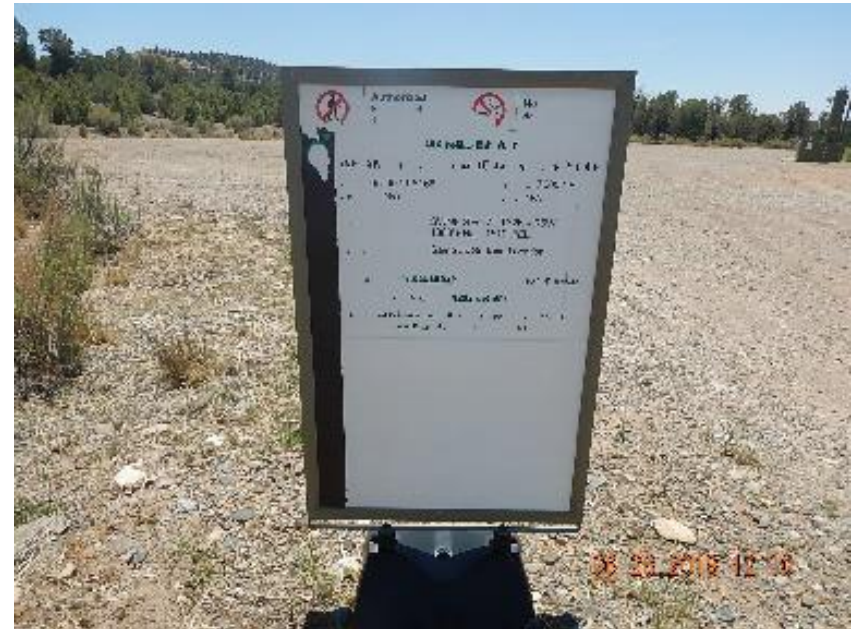
Photo 2: Wellhead sign from previous inspection.

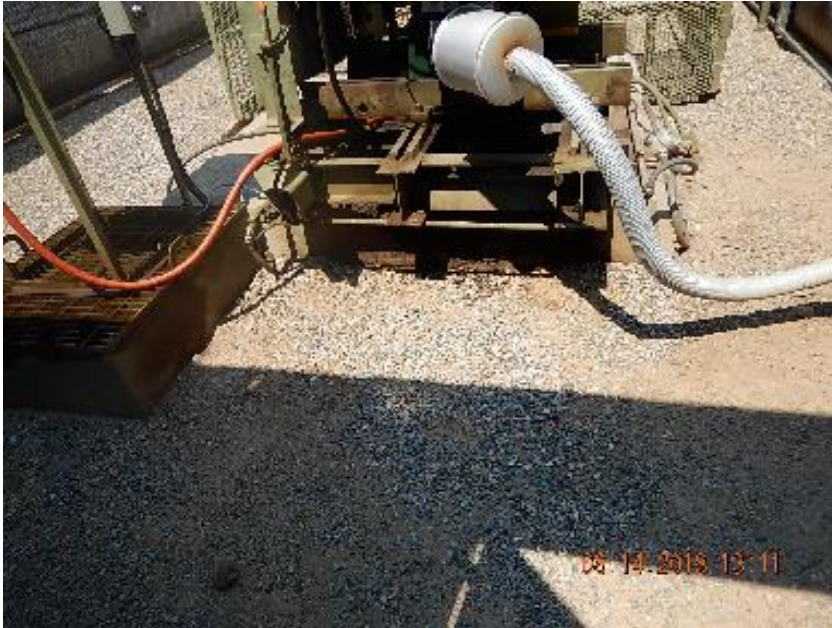
Photo 3: Cleaned up area at rear of pump jack.

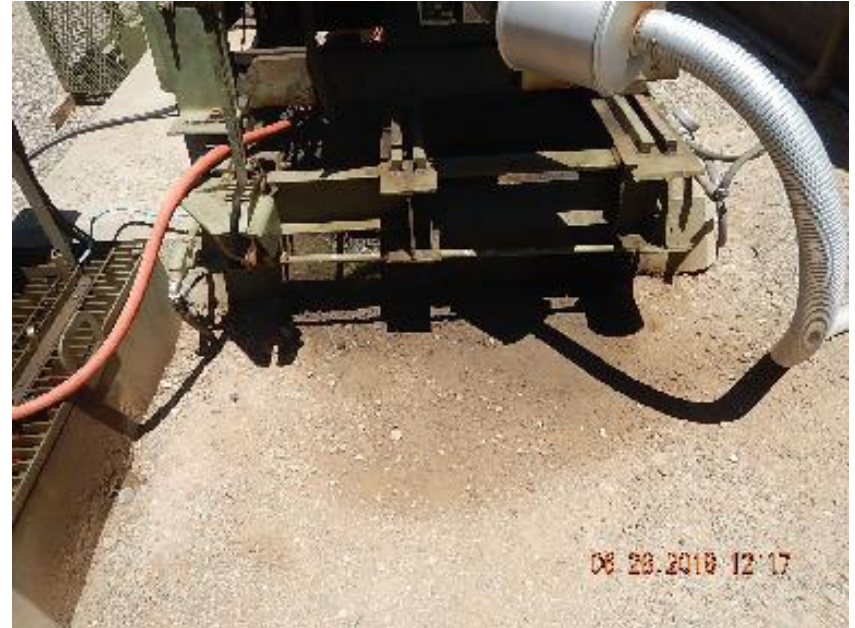
Photo 4: Impacted soil and gravel at rear of pump jack from previous inspection.

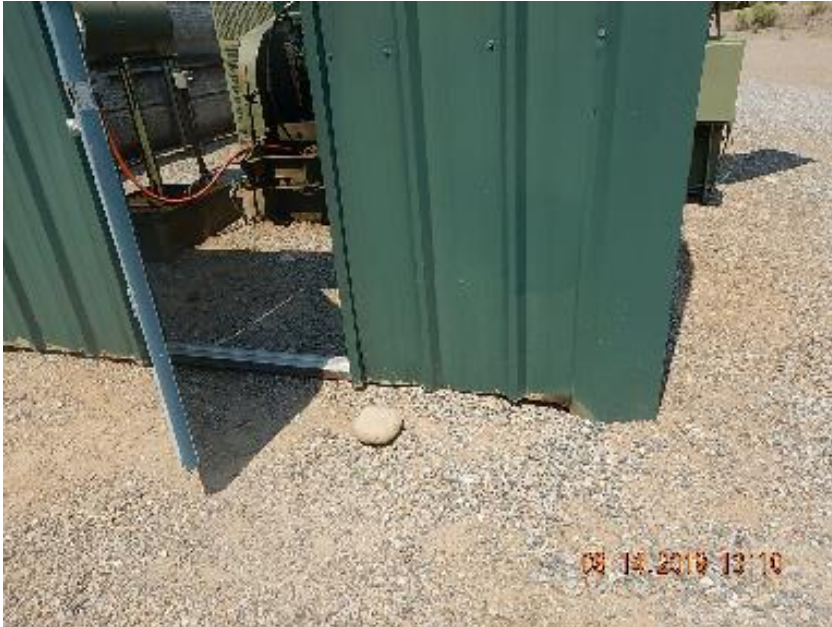
Photo 5: Cleaned up area at old exhaust outlet.

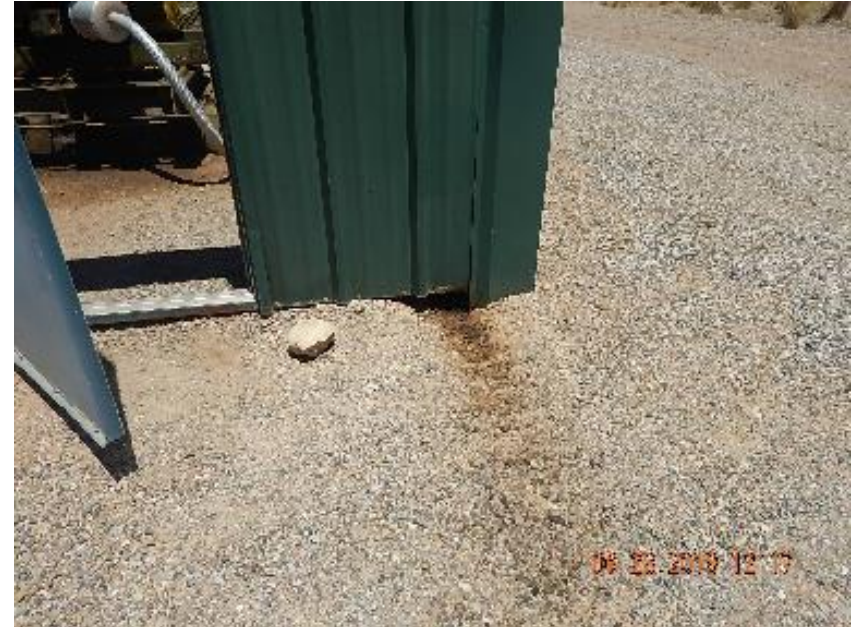
Photo 6: Impacted soil and gravel at exhaust outlet from previous inspection.

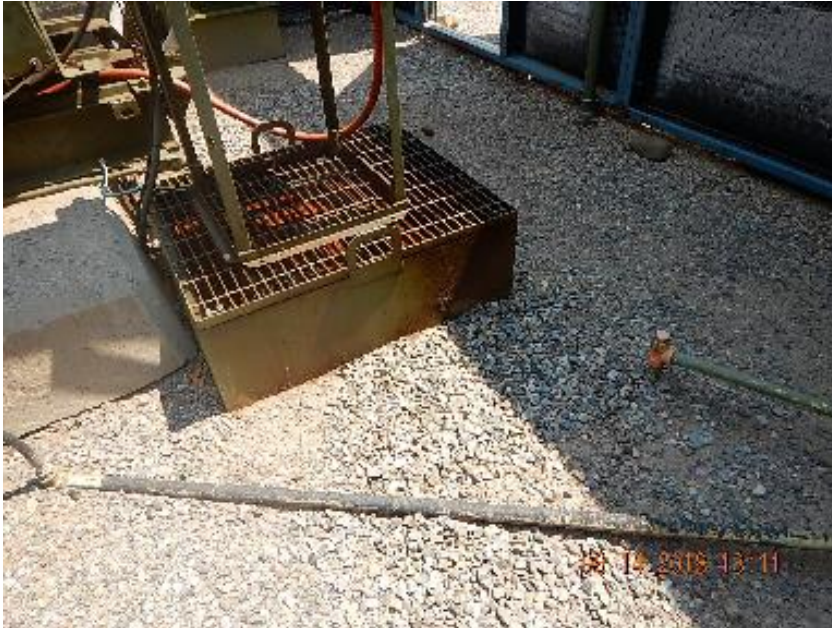
Photo 7: Cleaned up area at lube oil tank.

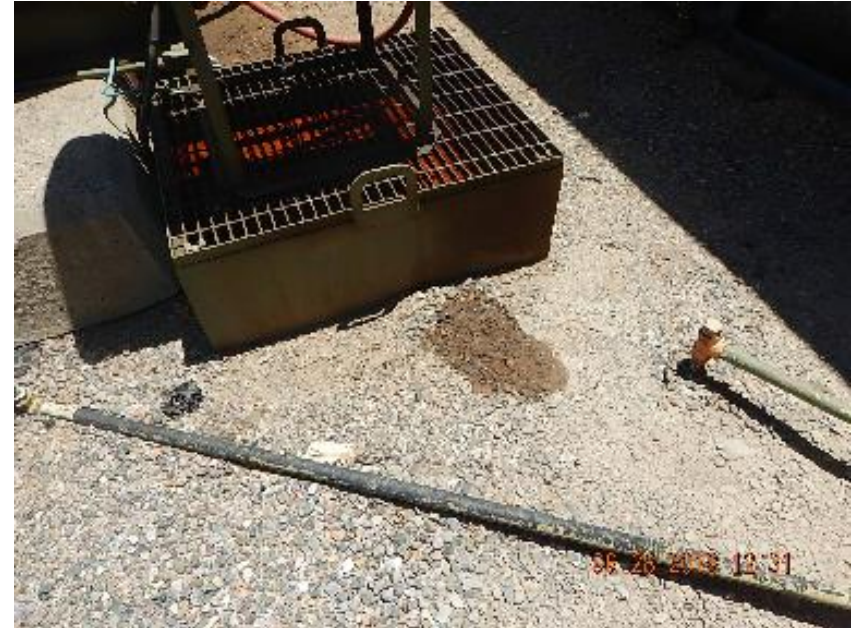
Photo 8: Impacted soil and gravel at lube oil tank previous inspection.

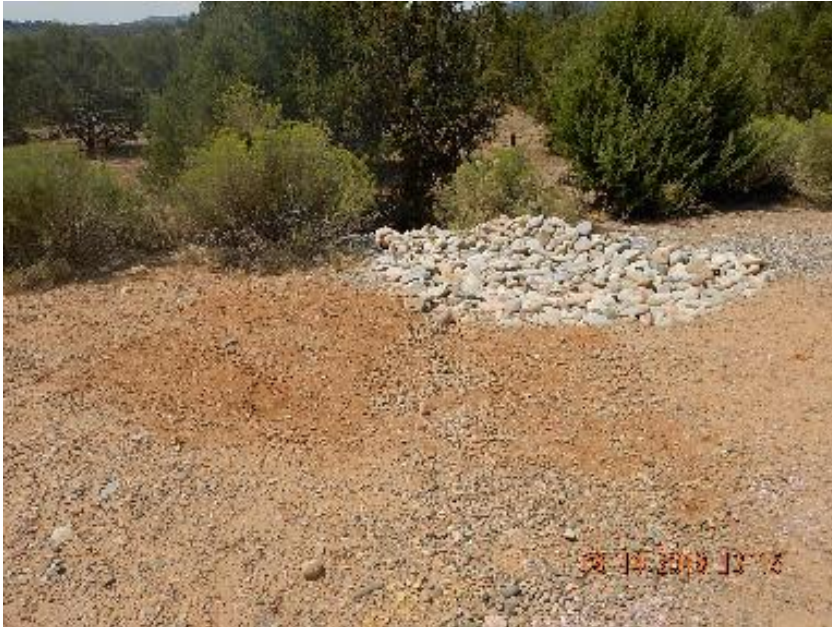
Photo 9: Repaired erosion channel.

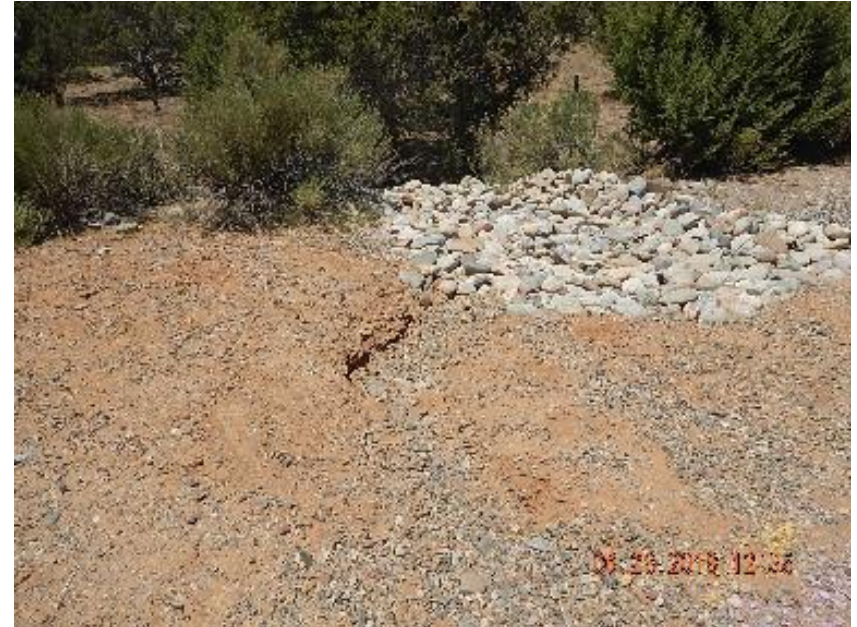
Photo 10: Erosion channel at front of rock run down from previous inspection.

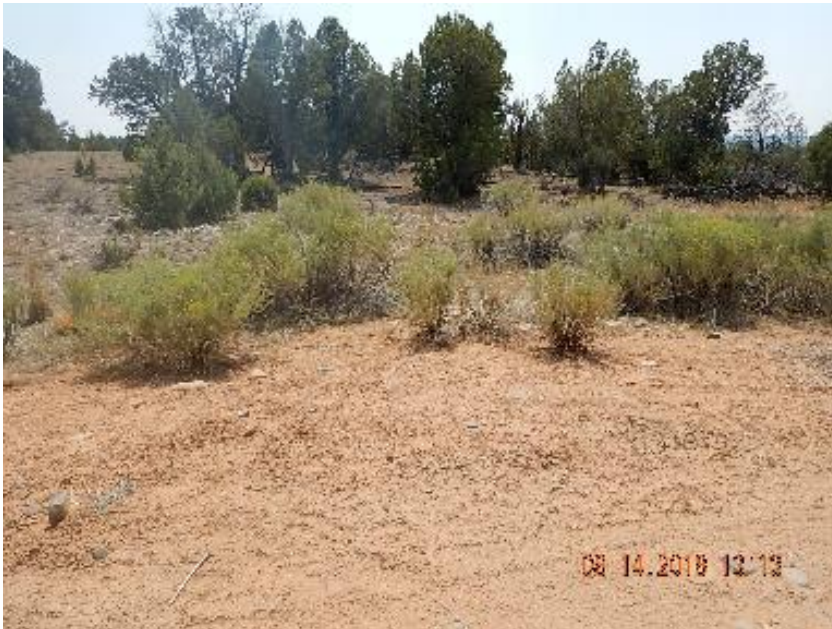
Photo 11: Debris removed from S perimeter.

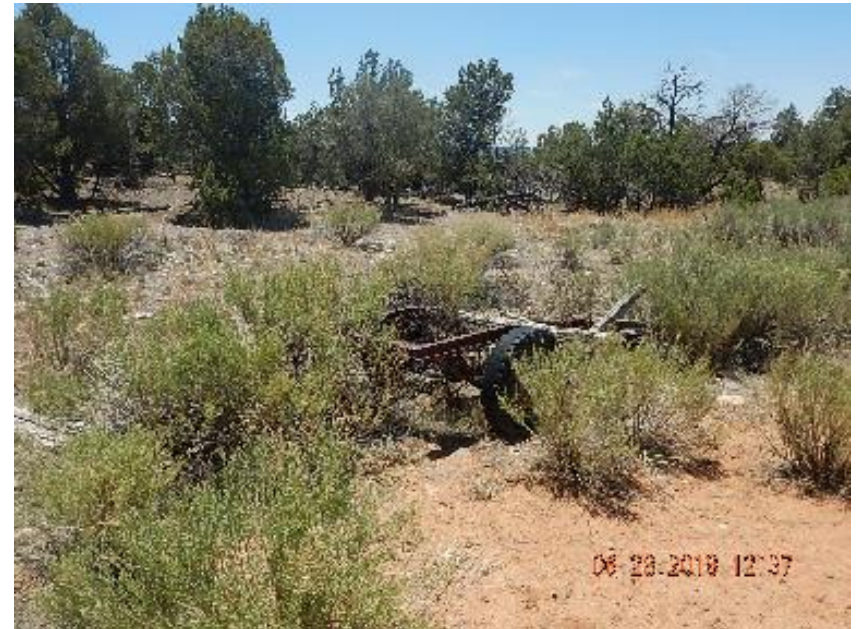
Photo 12: Vehicle frame in S perimeter from previous inspection.
