Well Name : Argenta Fee 18  
API # : 007-06049

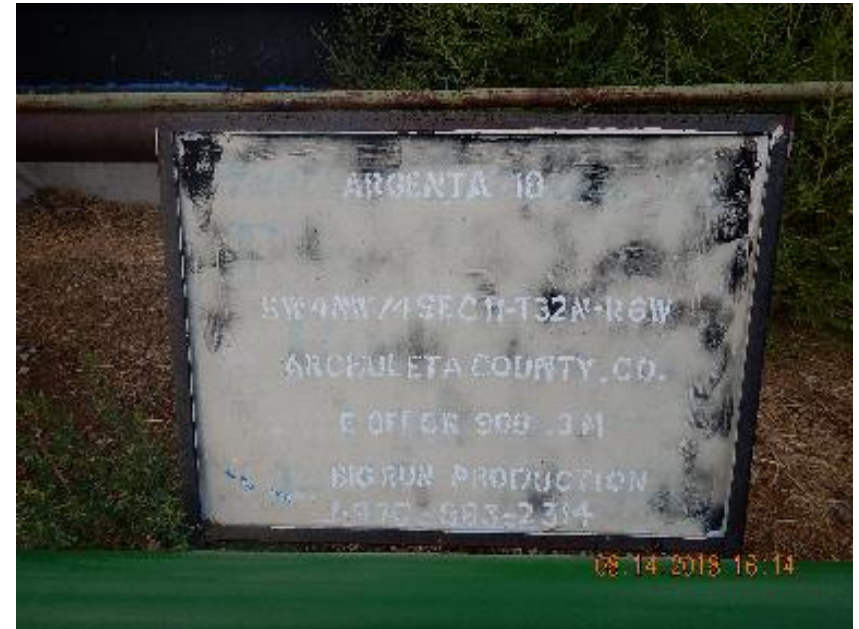
Photo 2: Argenta 18 wellhead sign.

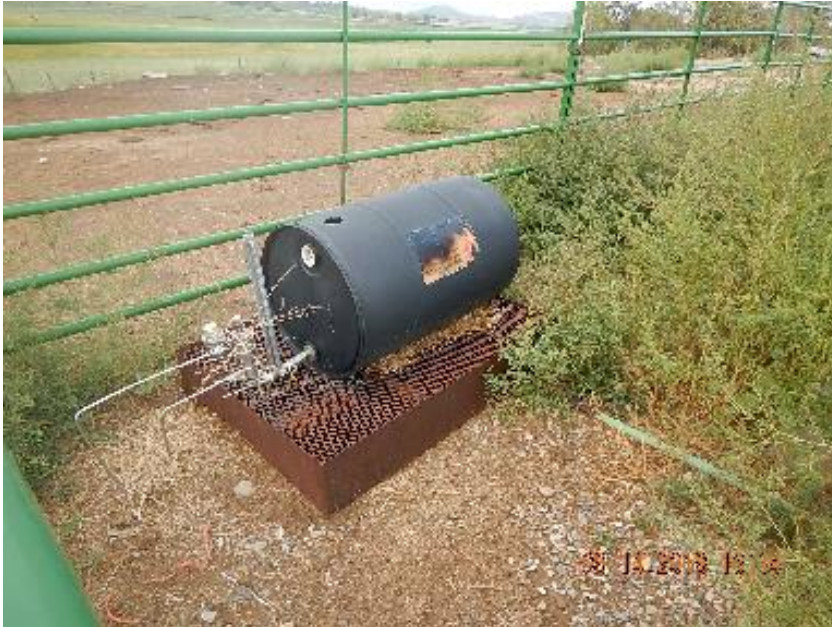
Photo 3: Unreadable chemical tank label and missing filler cap at the Argenta 18.

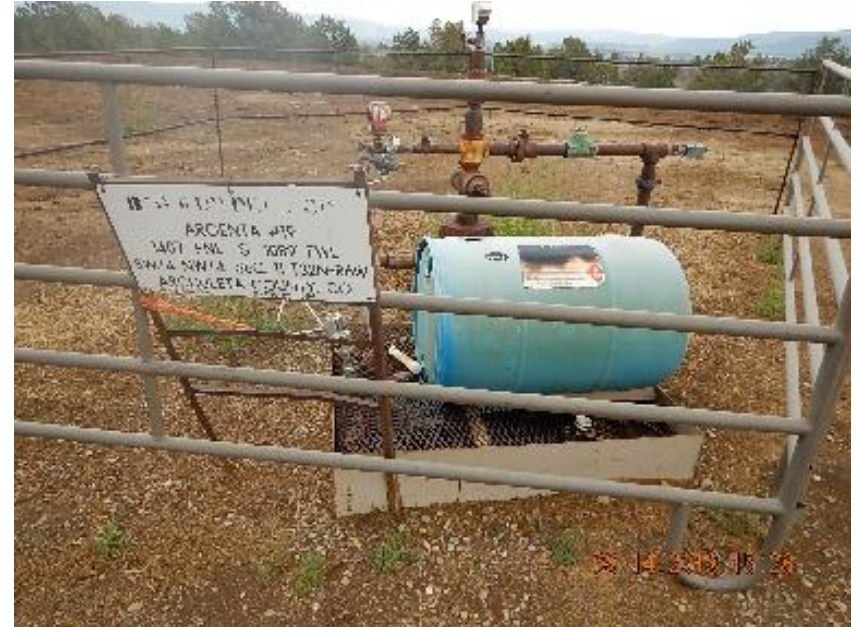
Photo 4: Unreadable chemical tank label at the Argenta 19.

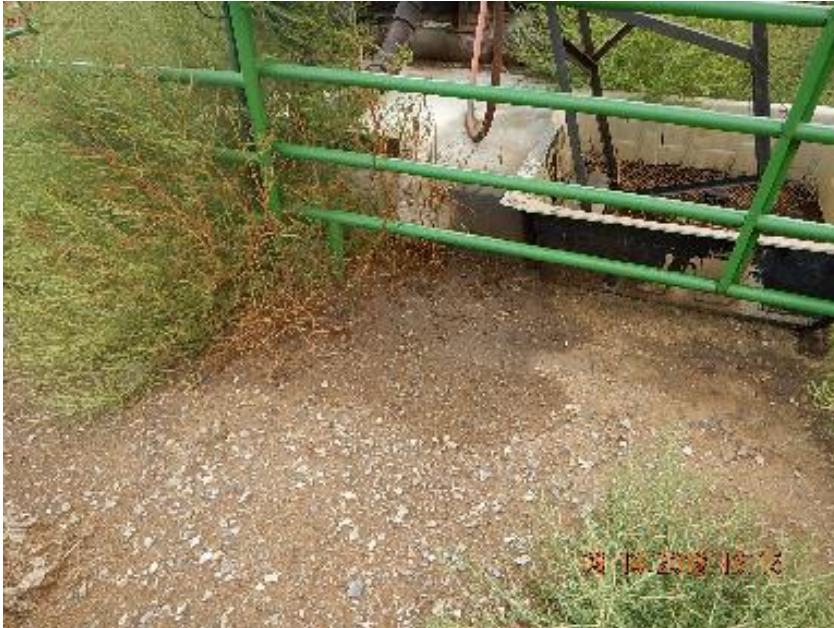
Photo 5: Impacted soil and gravel at rear of pump jack.

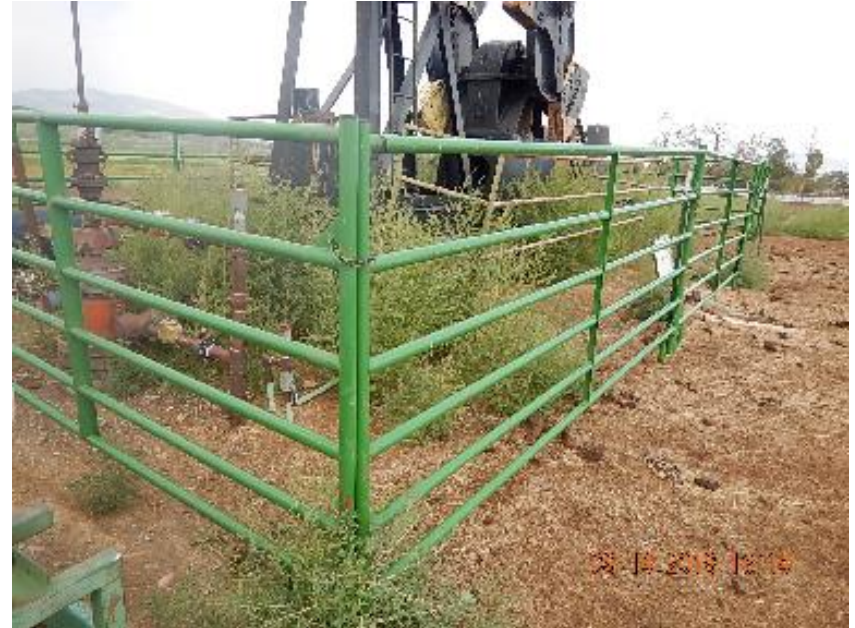
Photo 6: Weeds inside fencing at Argenta 18.

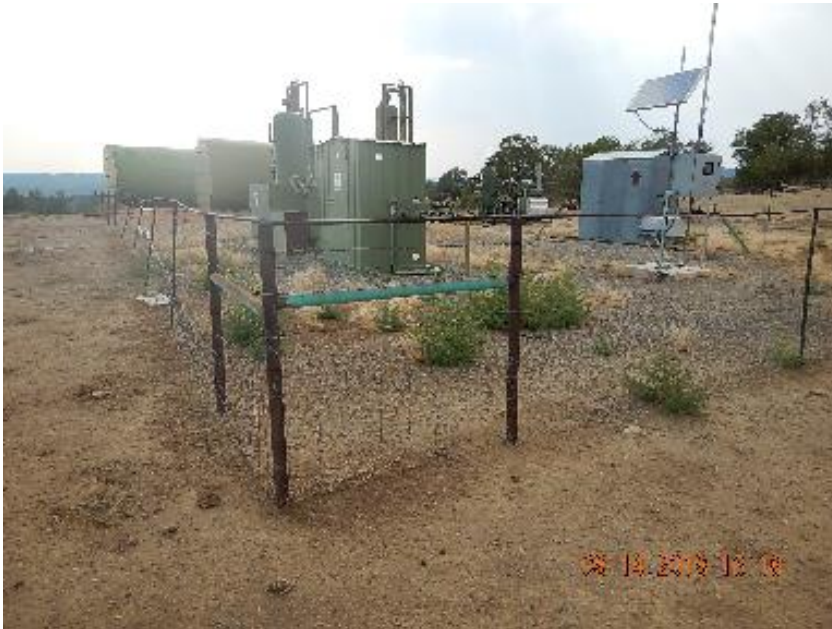
Photo 7: Weeds and dried cheat grass inside production equipment fencing.

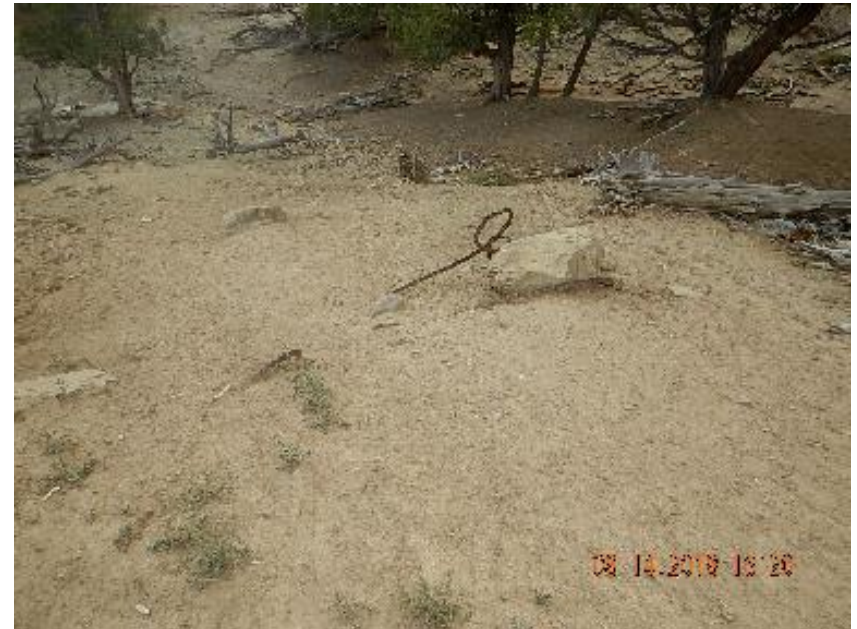
Photo 8: Steel 1" cable in perimeter of location.

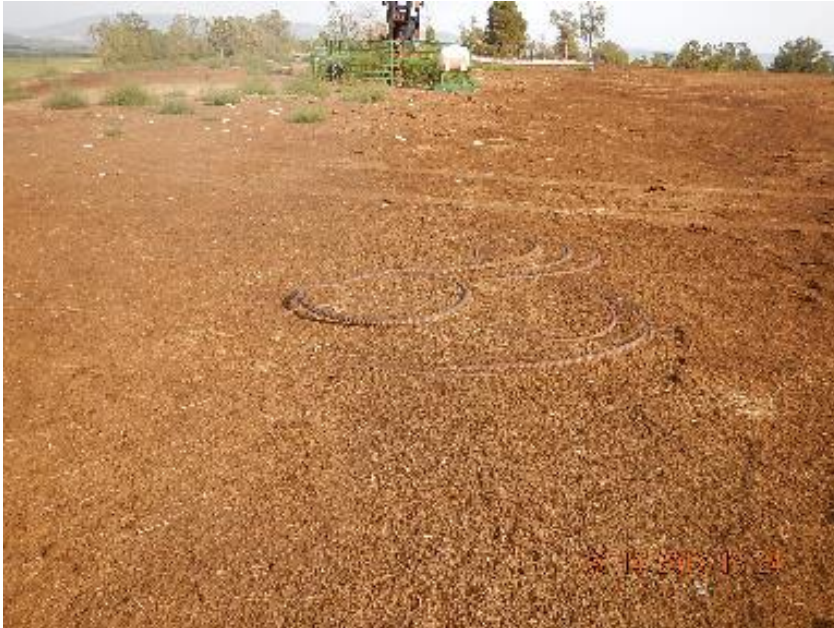
Photo 9: Steel cable in perimeter of location.

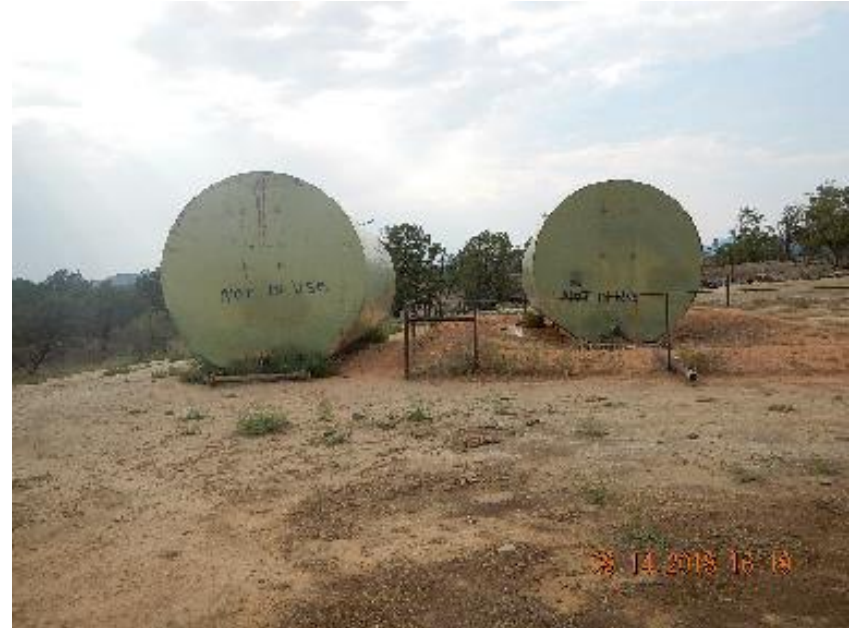
Photo 10: Unused production tanks.

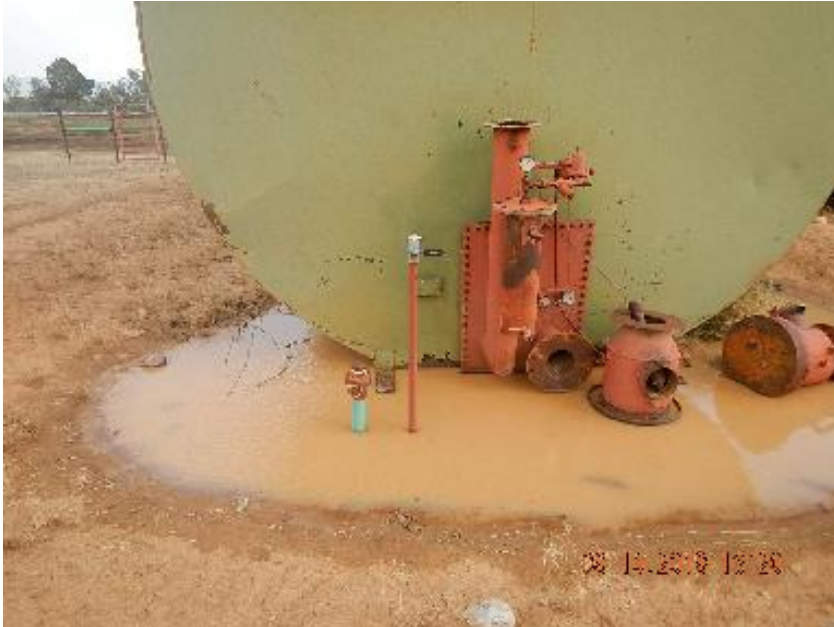
Photo 11: Disconnected risers at back of production tank.

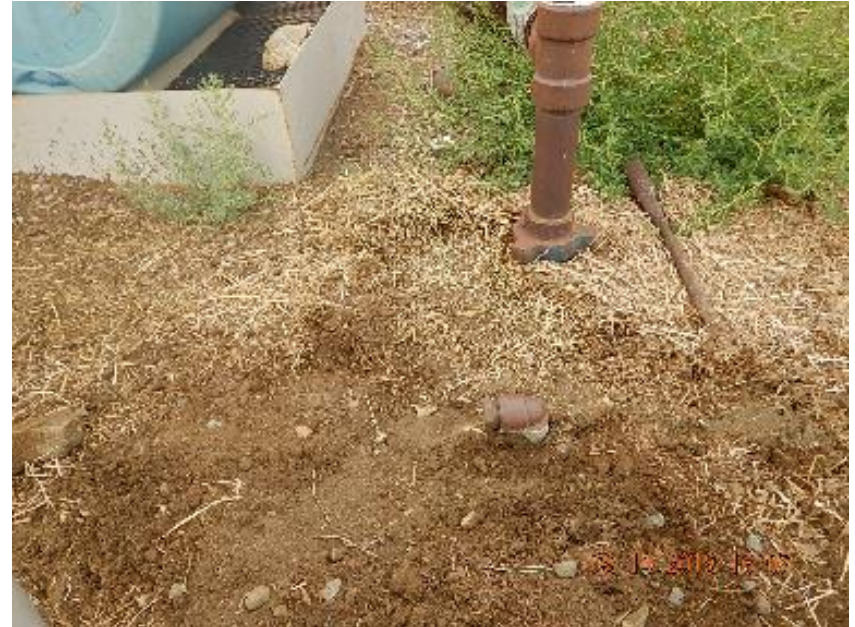
Photo 12: Unused 1" steel riser at Argenta 19 wellhead.

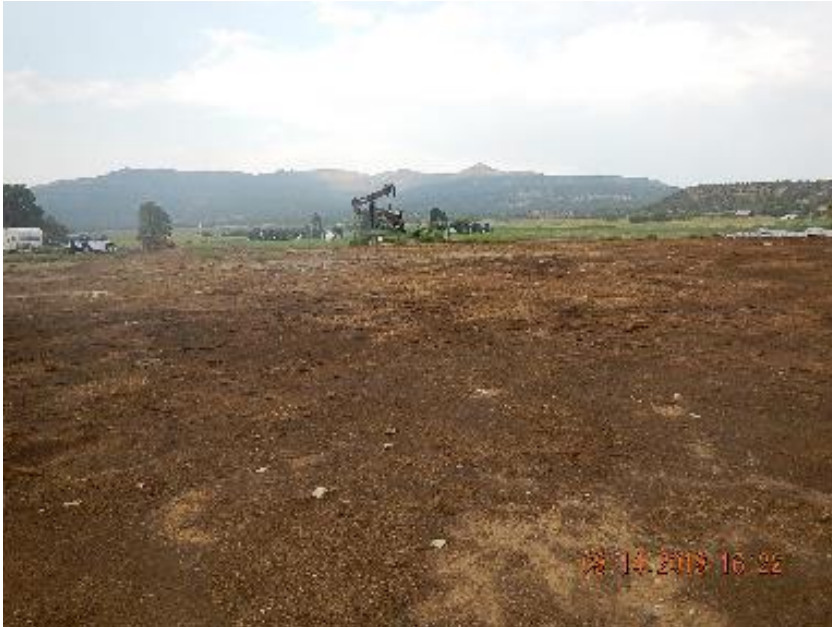
Photo 13: Location overview.

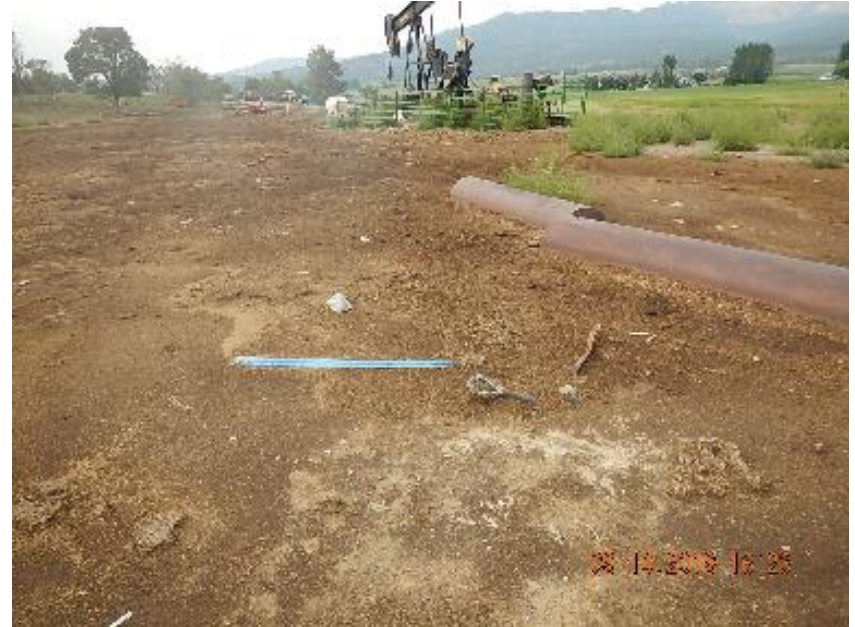
Photo 14: Location overview with anchor marker down and feed troughs visible.

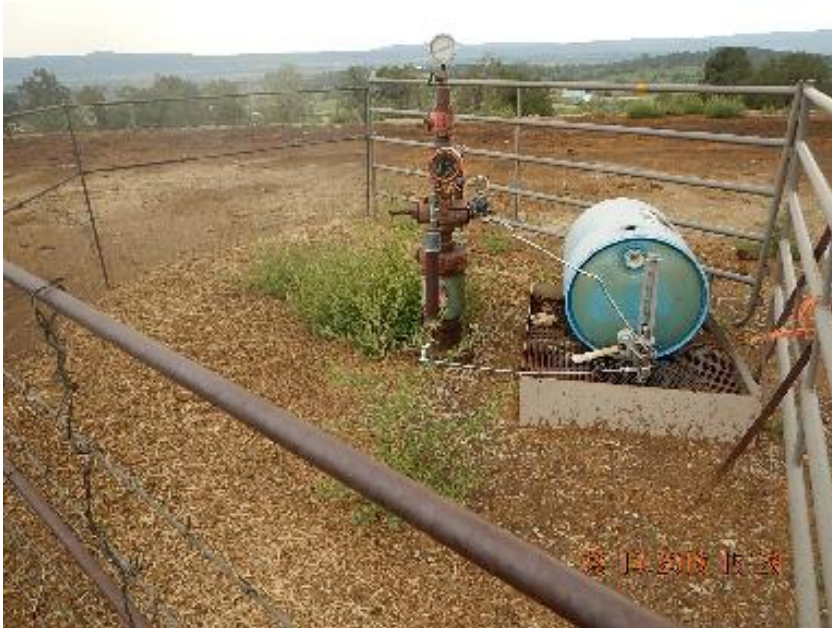
Photo 15: Chemical tank at Argenta 19 missing filler cap.

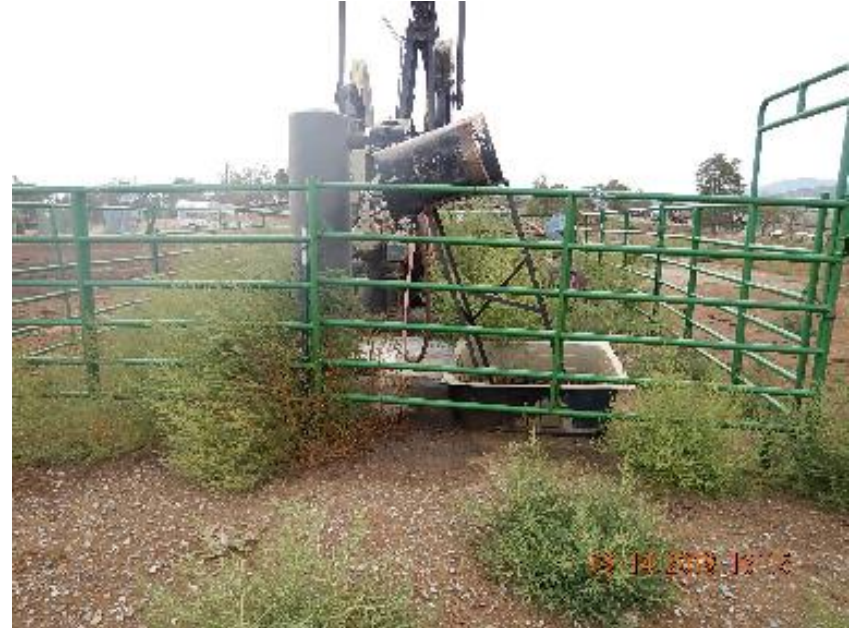
Photo 16: Leaning lube oil tank at the Argenta 18.
