Interim Reclamation and Stormwater Inspection

August 10, 2018

Operator: K P KAUFFMAN COMPANY INC - 46290

Location ID: 320780

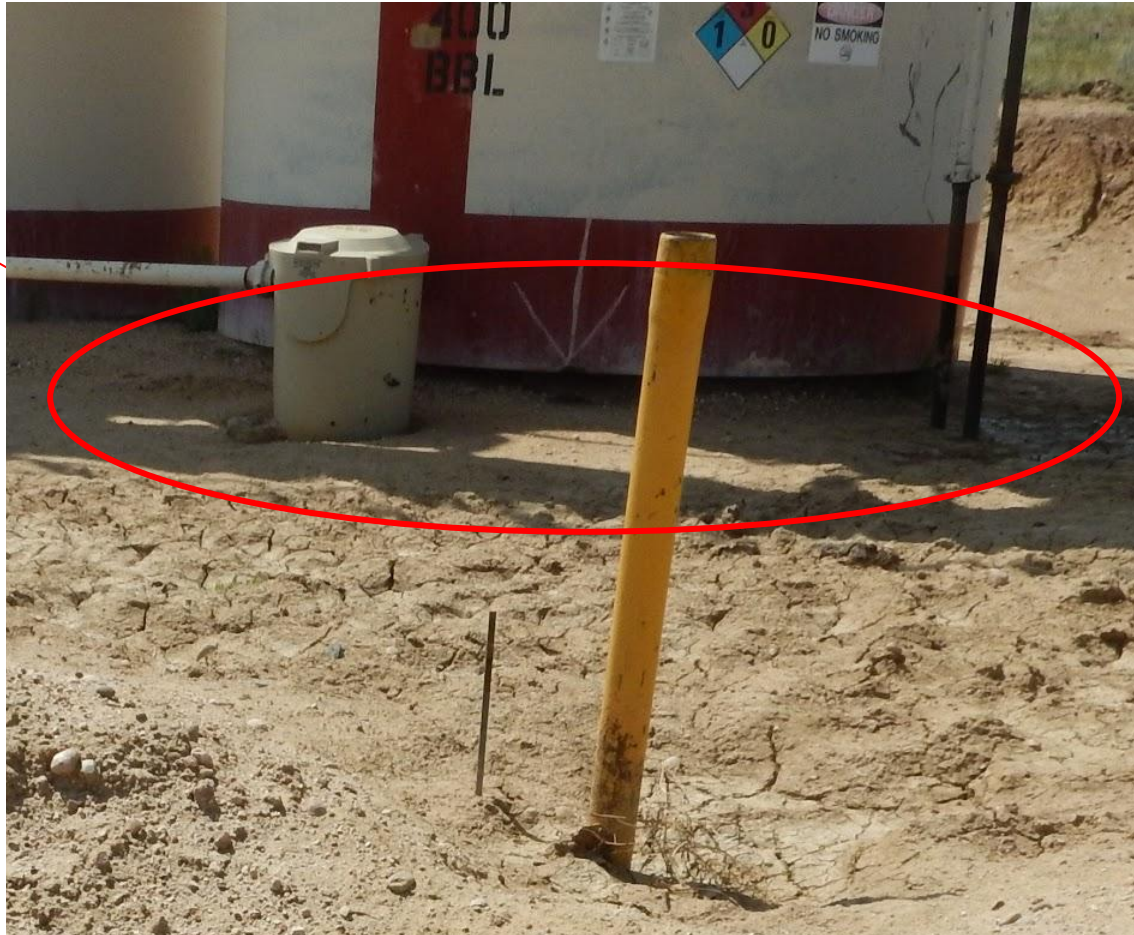
Photo 1. Photo taken from the southern location, facing West. Photo illustrates inadequate berms around tanks. Stormwater has eroded the berm and is eroding underneath one of the tanks- see next photo for a close up.

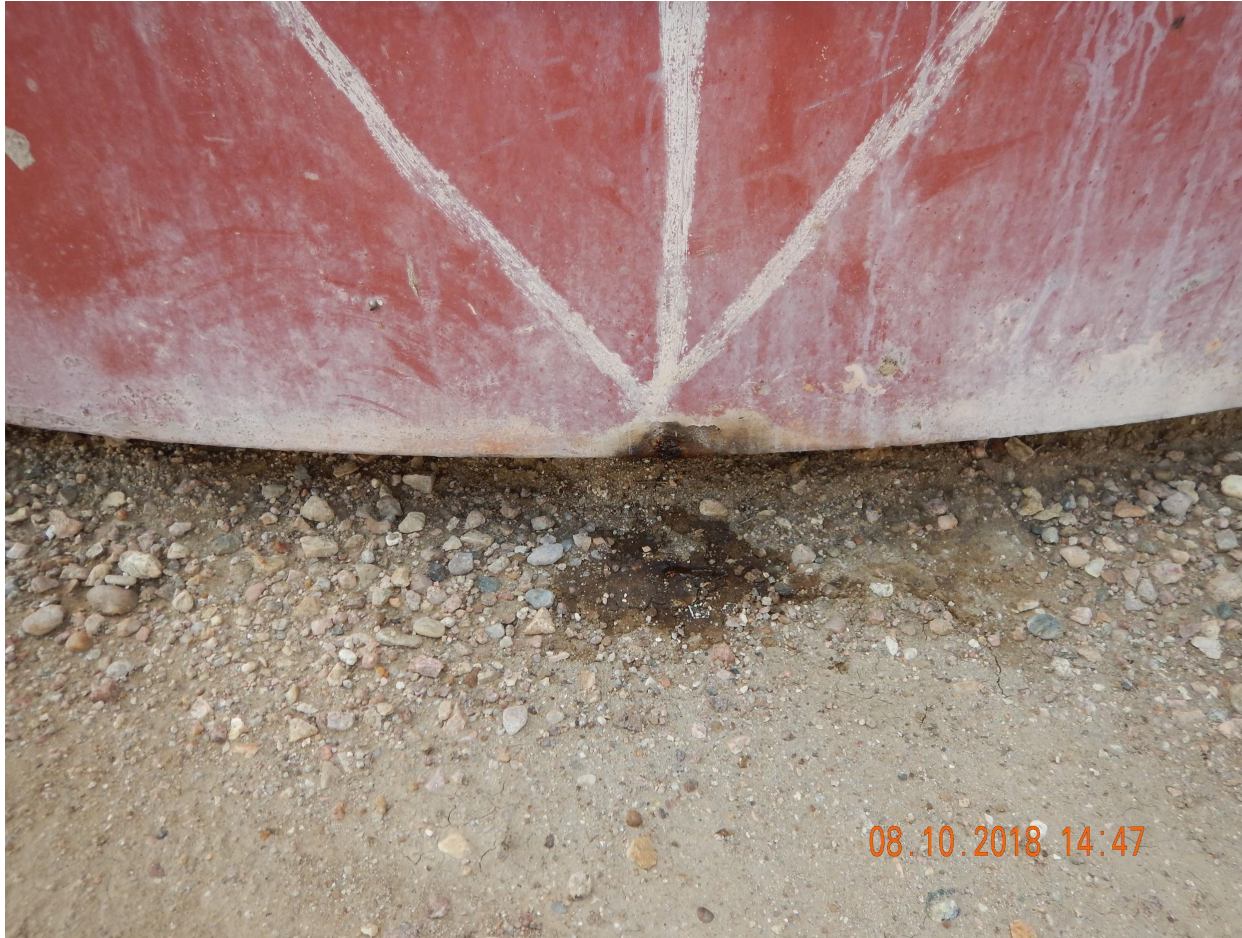
Photo 2. Close up photo illustrating stormwater eroding underneath the tank.

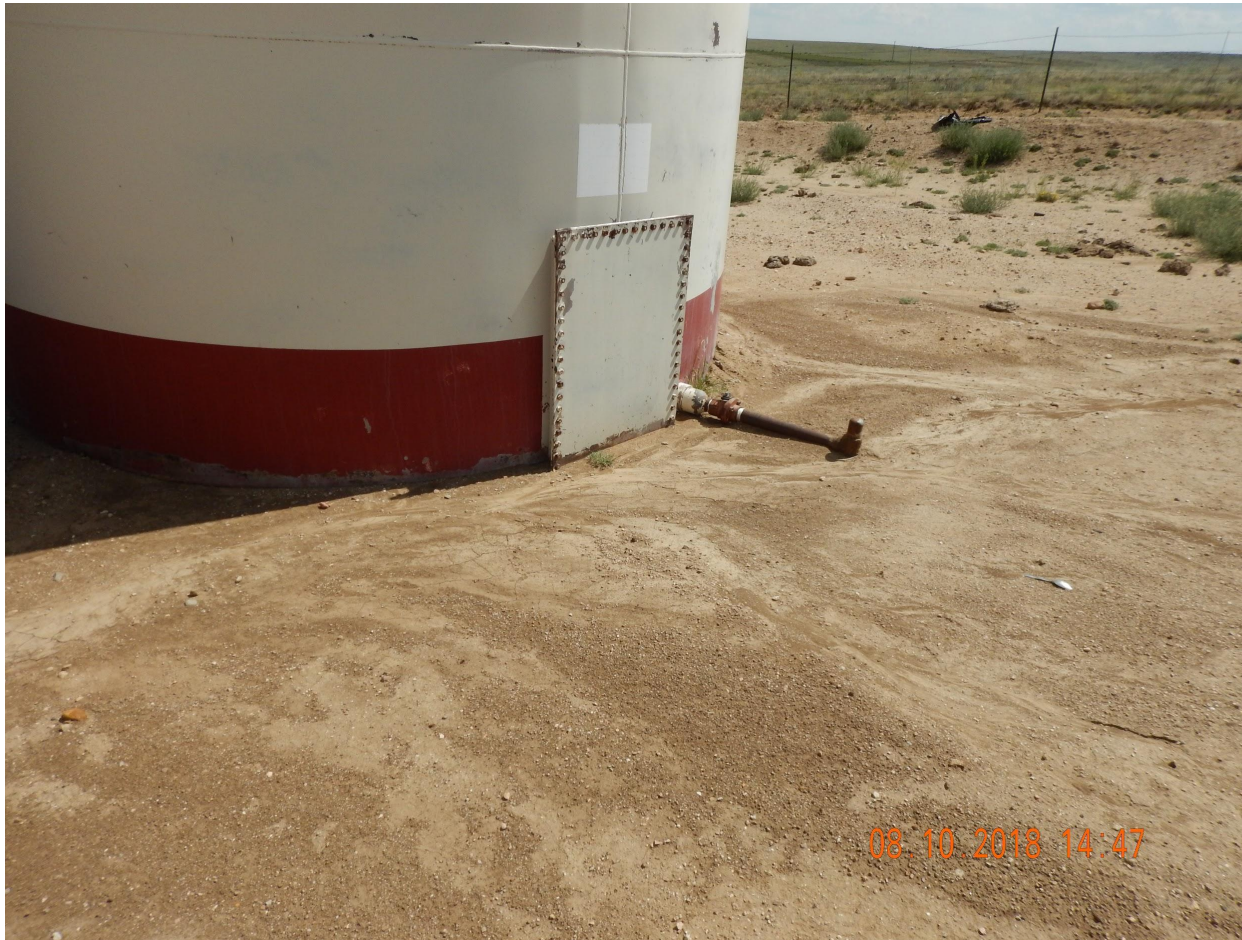
Photo 3. Close up photo taken of the previous tank illustrating a leak needing repair.

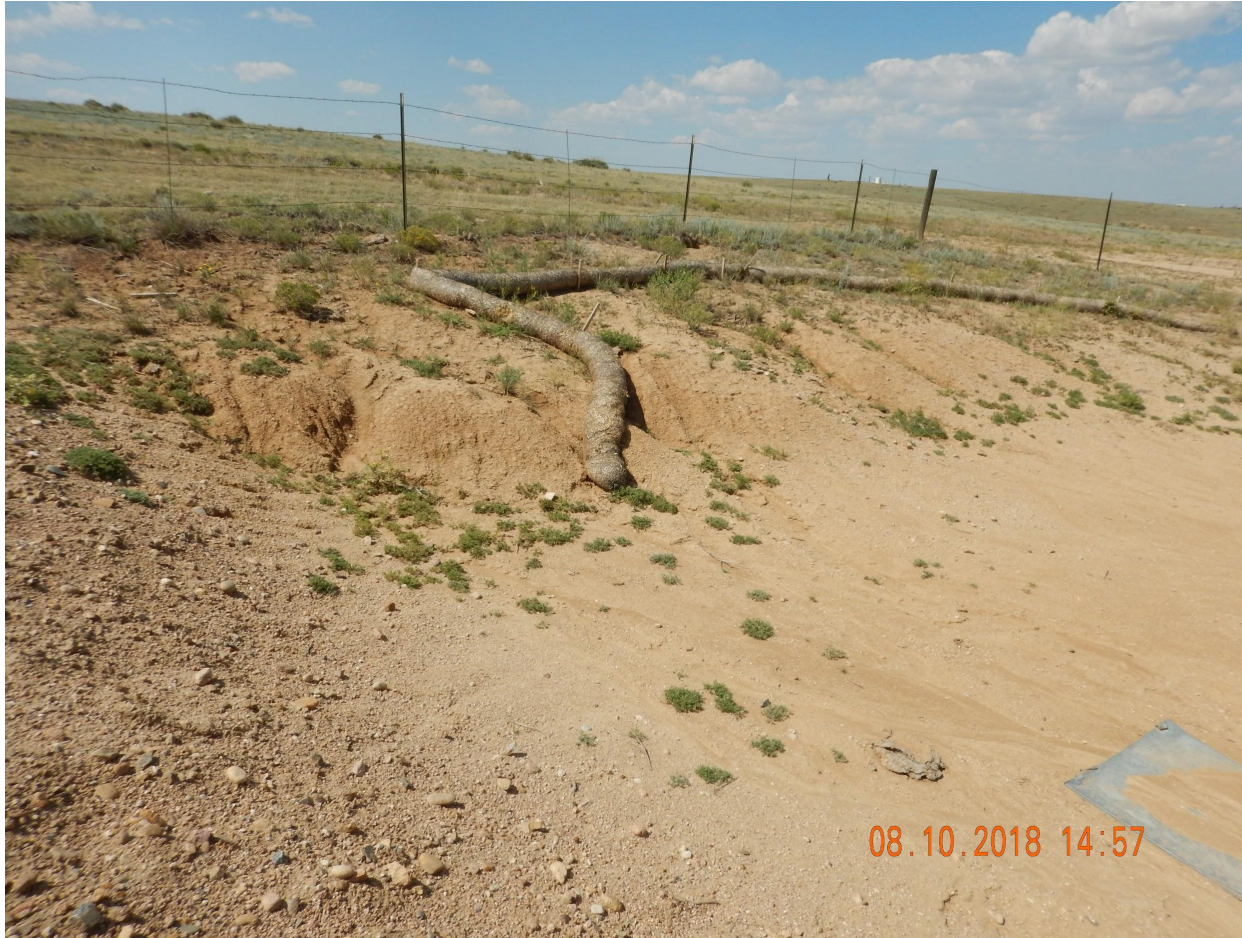
Photo 5. Photo taken of the southwestern tank battery berm, facing South. Stormwater has eroded the berm and sediment filling the containment area.

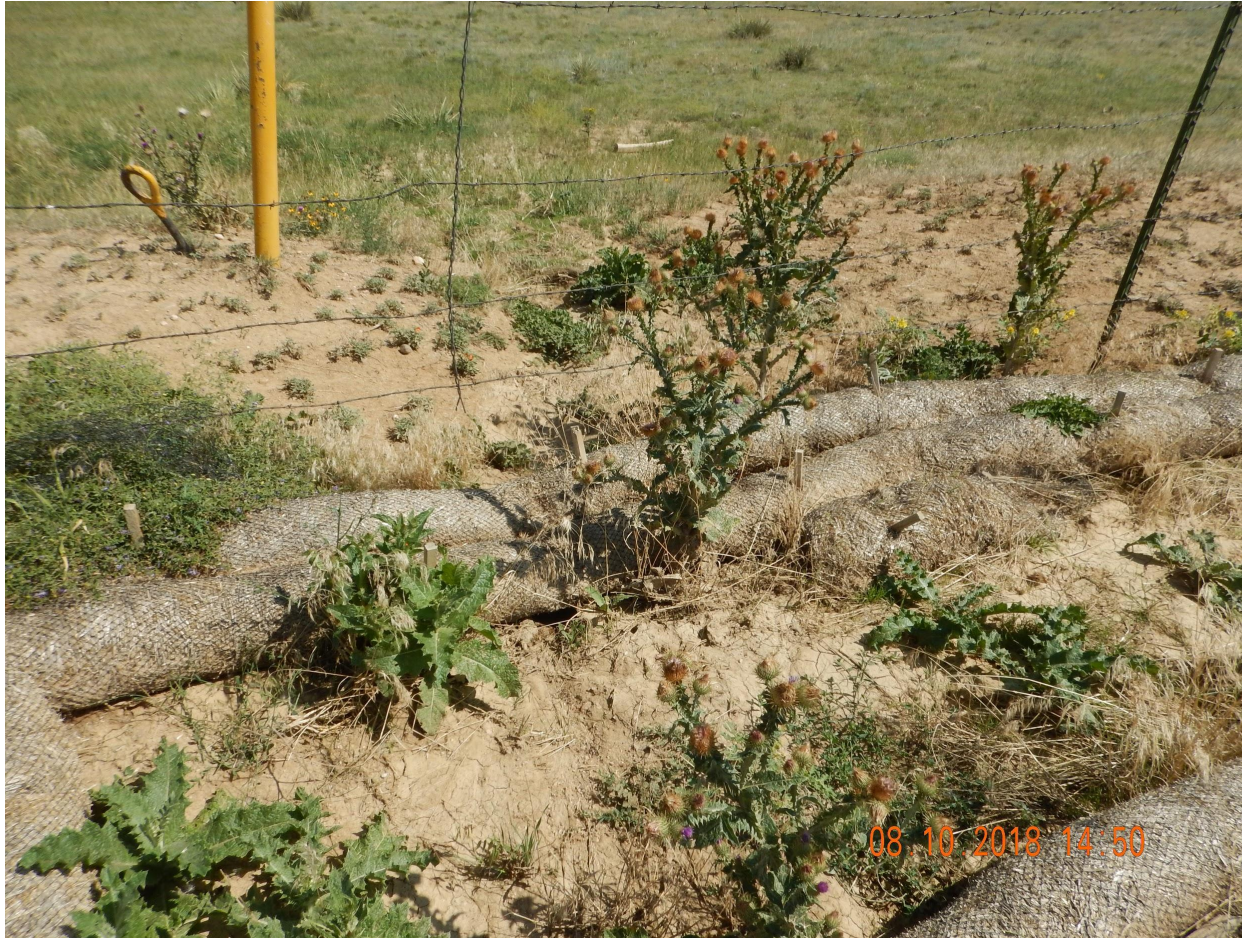
Photo 6. Photo taken of the western cut slope, facing West. Operator has failed to maintain the location to reasonably control and minimize erosion, alteration of natural features and removal of surface materials. Previous inspections required the Operator to repair the rill erosion and stabilize the cut slope. Operator has failed to perform those corrective actions. Also, previous inspections noted the Operator did not properly install wattle BMPs, as this photo illustrates.

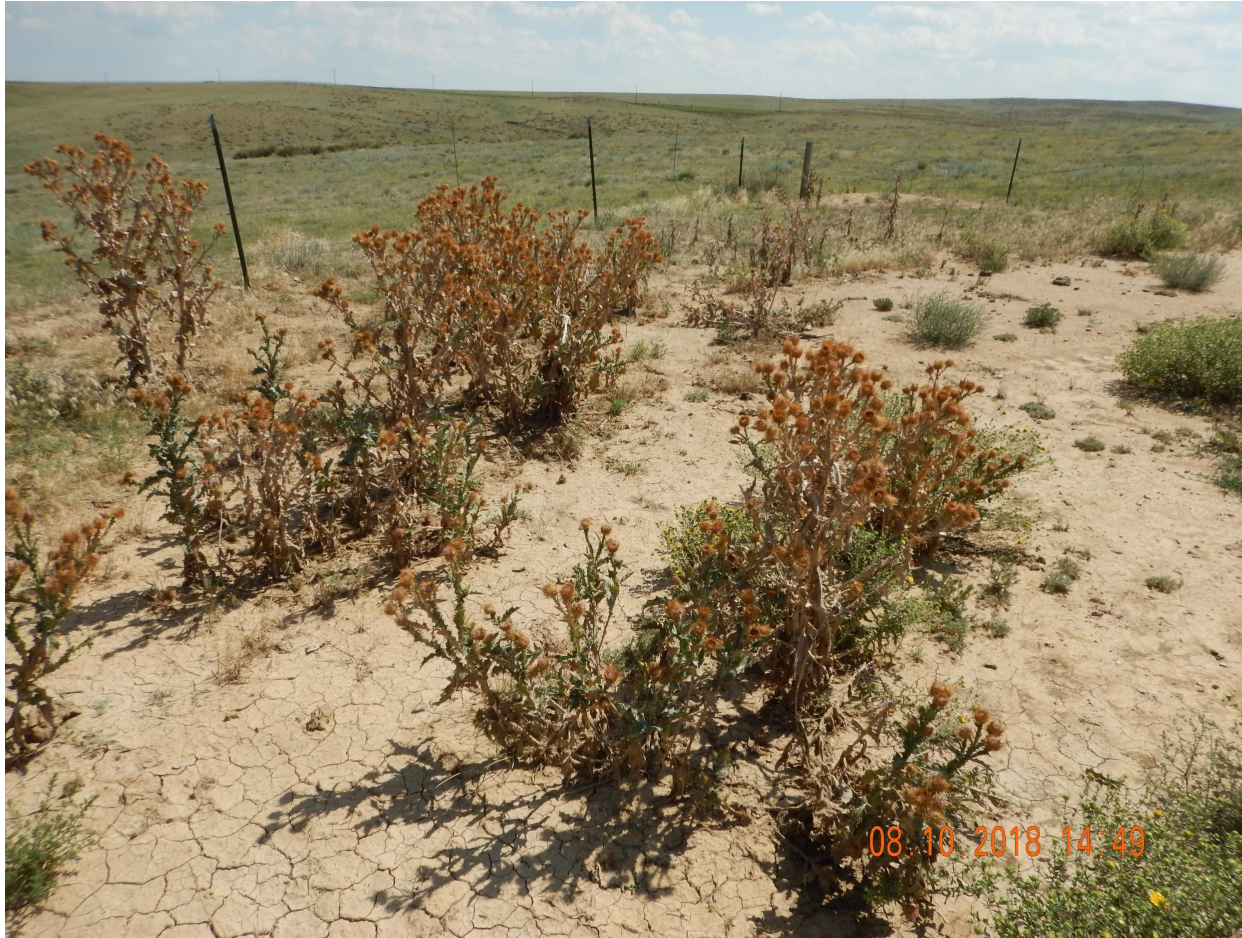
Photo 10. Photo taken from the second discharge point off the access road, facing East. Photo illustrates sediment discharging into the adjacent land with no stormwater control BMP.
