Inspection Photos

Operator: ABILENE PERFECT ENERGY JV LLC -
10581

Location ID: 433129

Inspection Doc. Number: 682503730
Lincoln County, CO

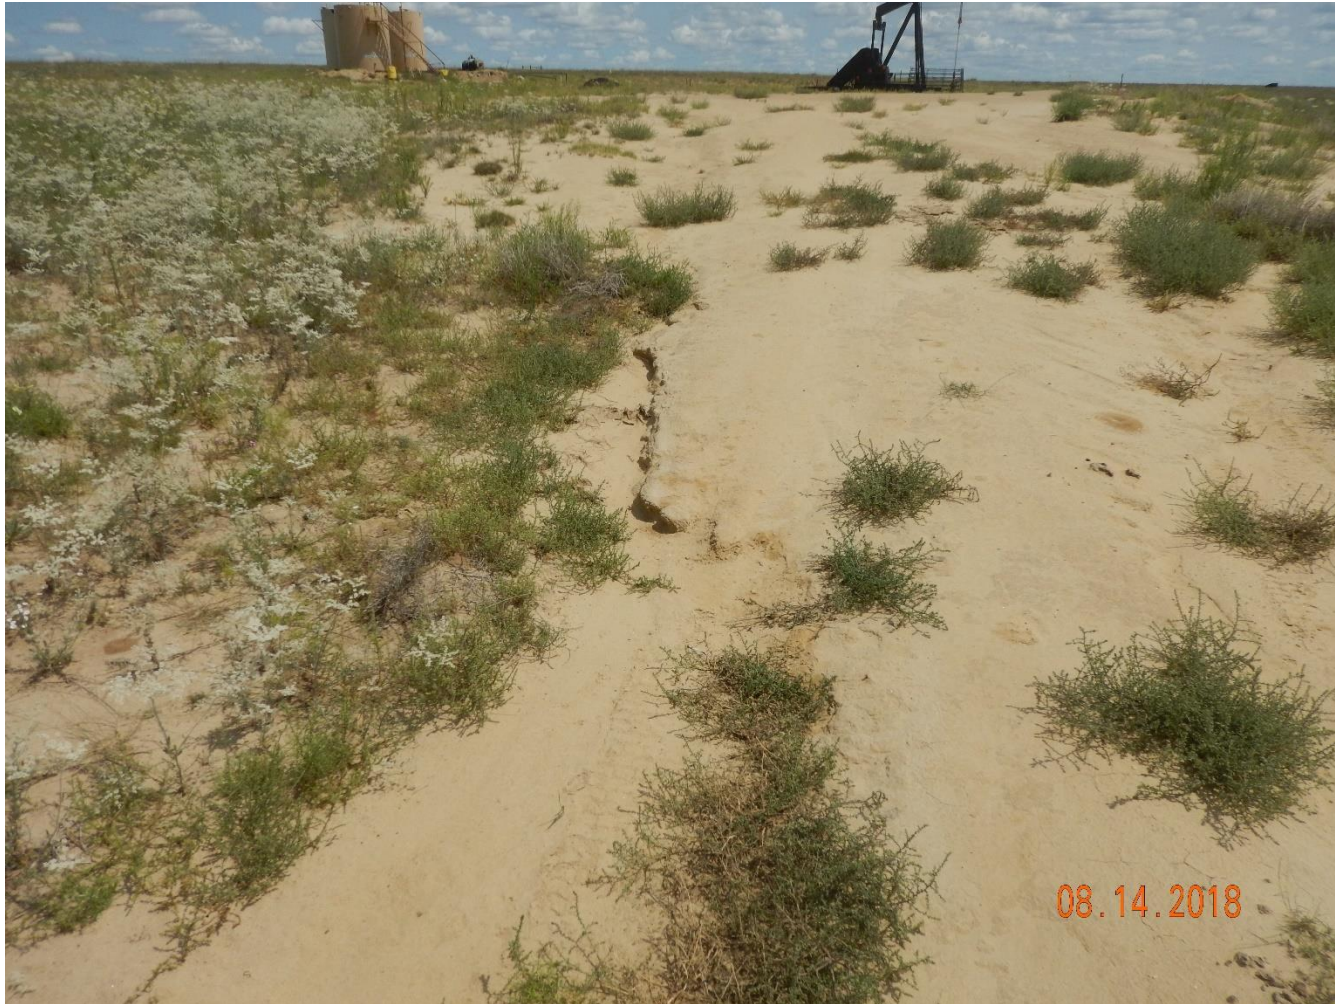
Photo 1: Photo taken from the north end of the location. Photo shows erosion has continued to degrade access road and location. Unable to find evidence of maintenance or evidence that the required BMPs have been installed per 1002.f

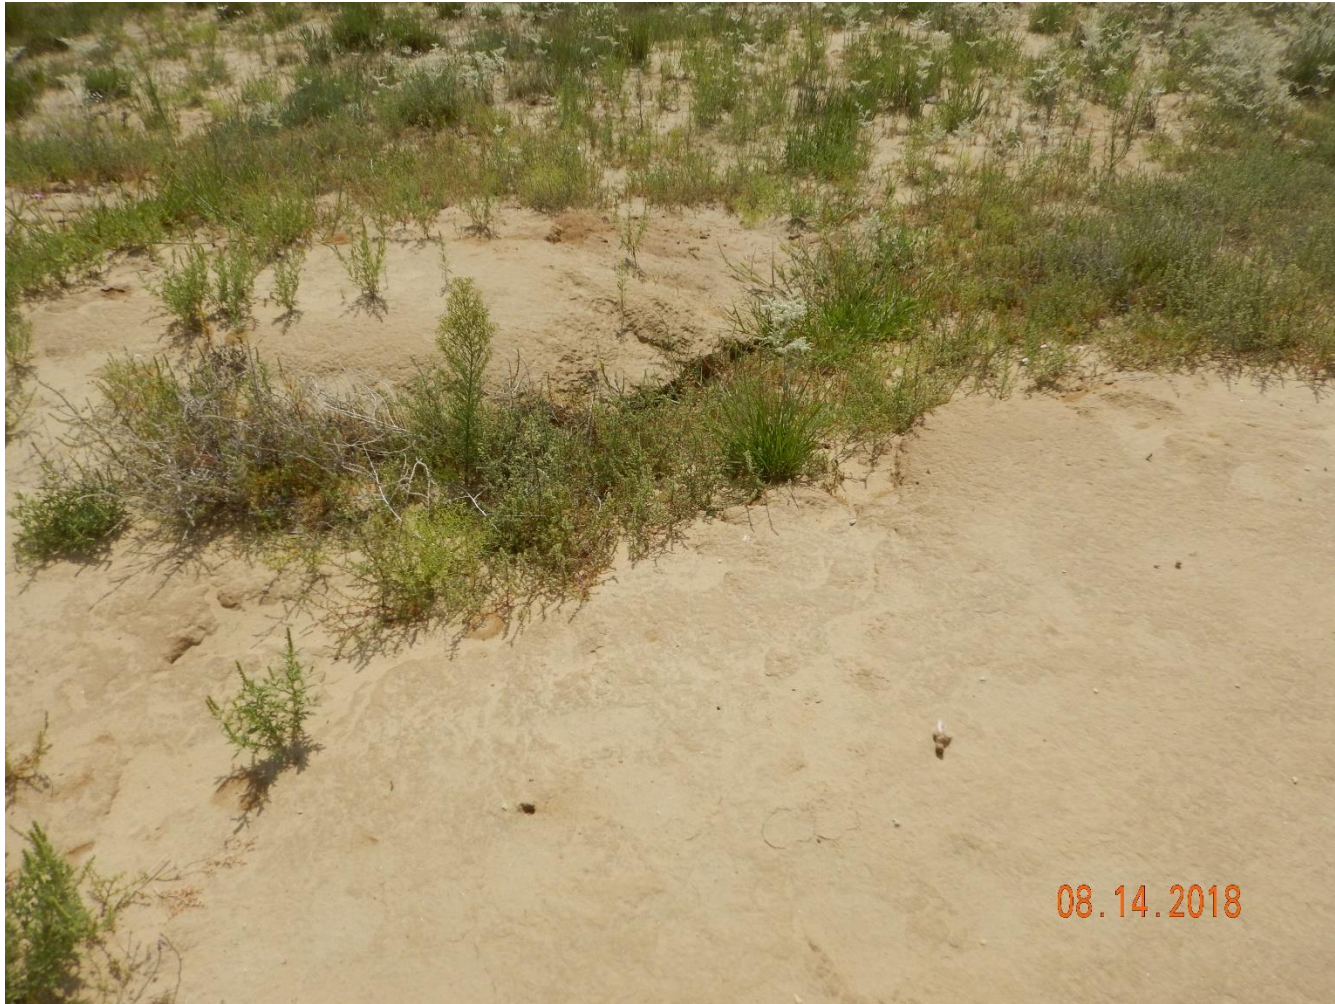
Photo 2: Photo taken from the access road on the north end of the location. Photo shows erosion has continued to degrade access road and location. Unable to find evidence of maintenance or evidence that the required BMPs have been installed per 1002.f

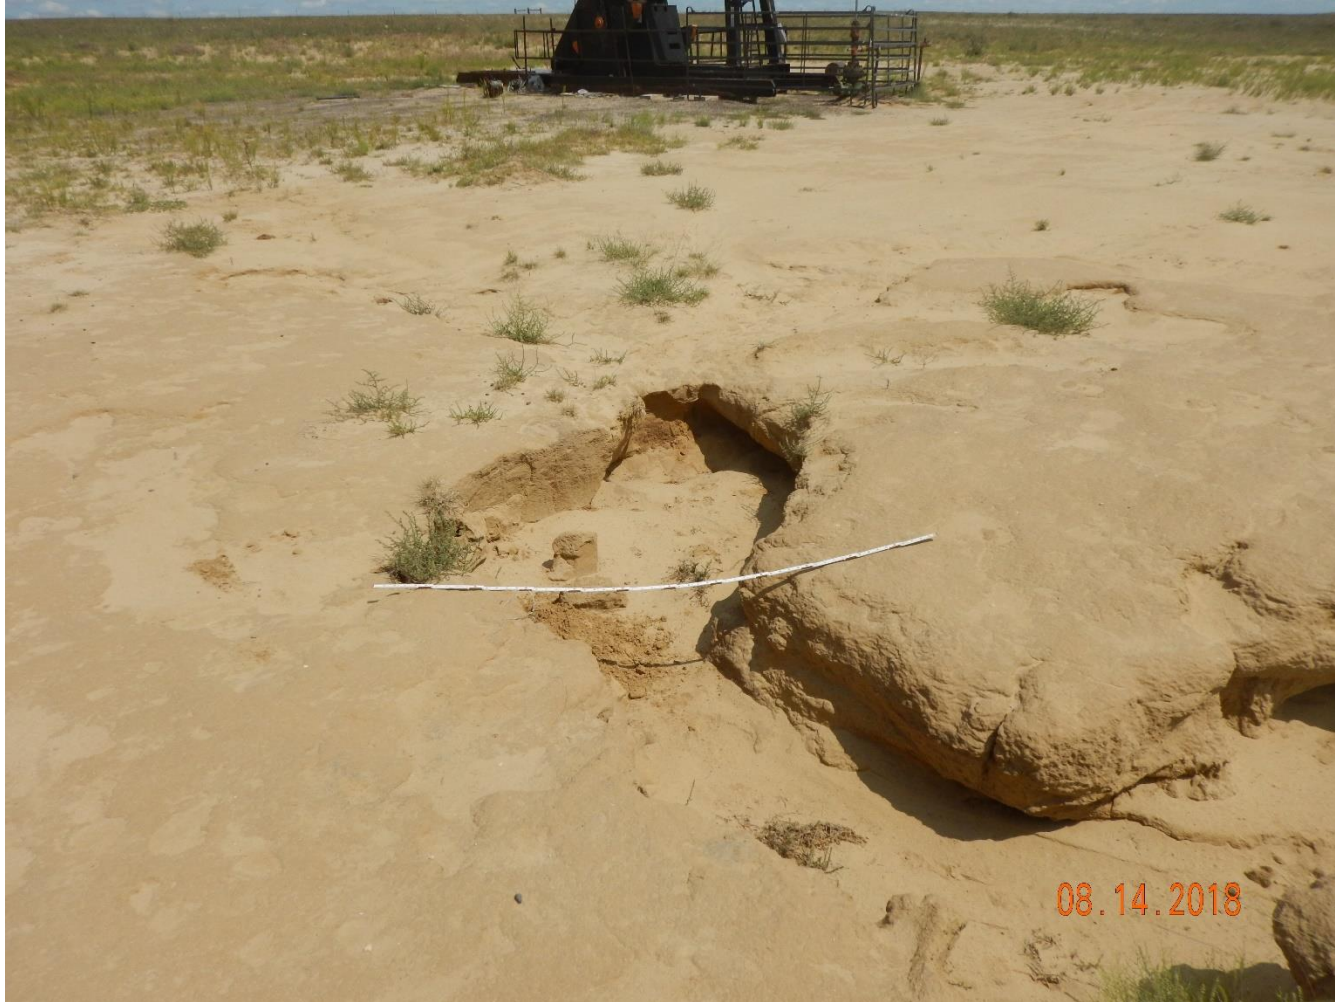
Photo 3: Photo taken from the northwest end of the production area, facing south east. Stormwater erosion has created a large gully on the northwest end of the location (see photos 4-5). Photo shows the “head” of the erosion. Photo shows stormwater erosion has been allowed to continue causing degradation to the location and interim areas. Unable to find evidence of maintenance and stabilization, or evidence that the required BMPs have been installed per 1002.f. 6 foot measuring stick for reference.

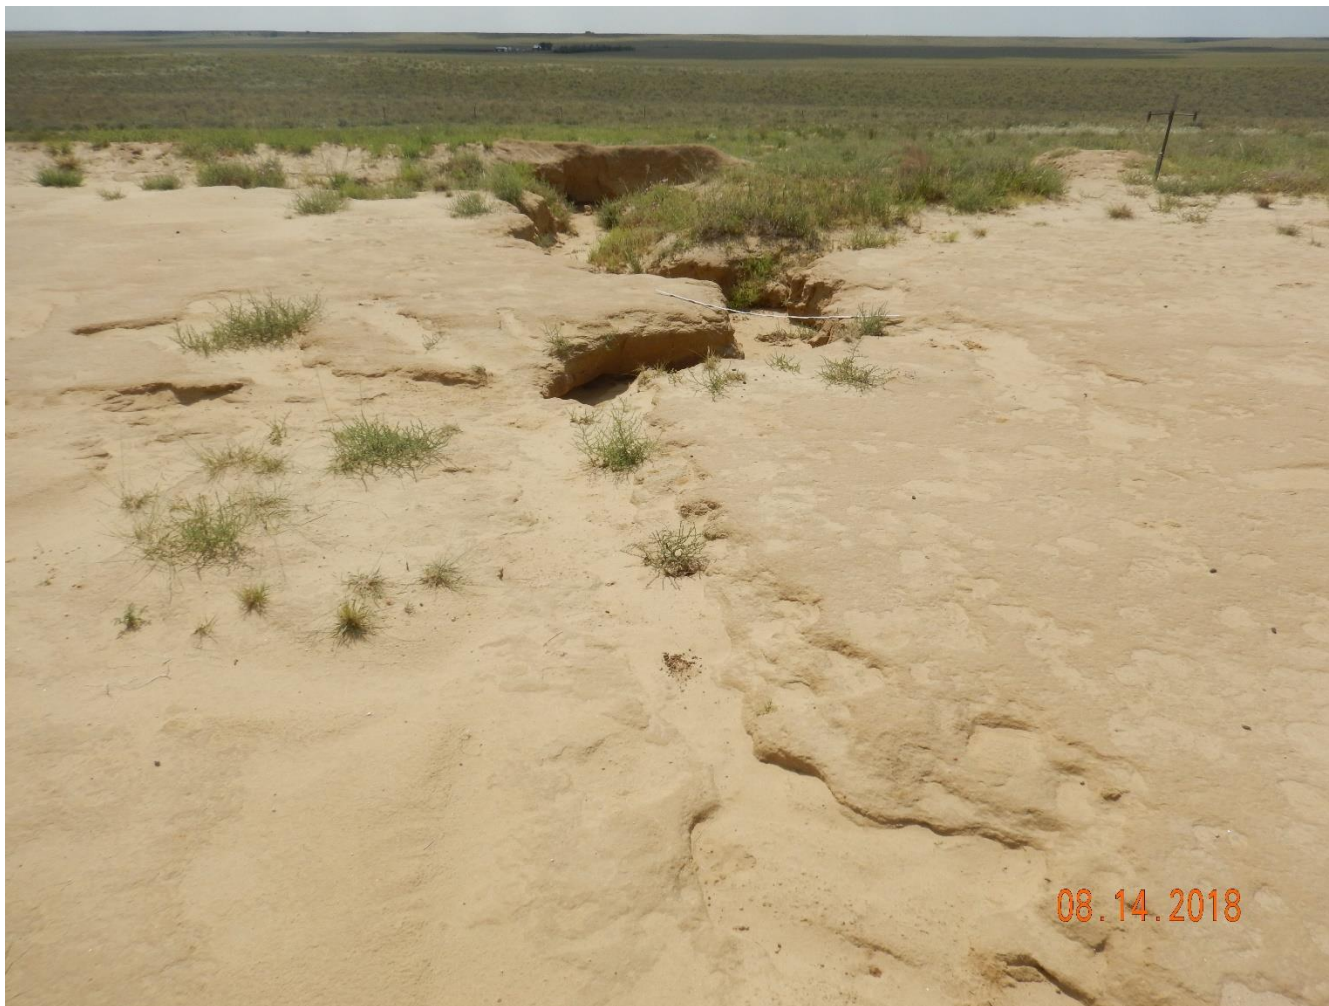
Photo 4: Continued from photo 3, facing west. See comments under photo 3.

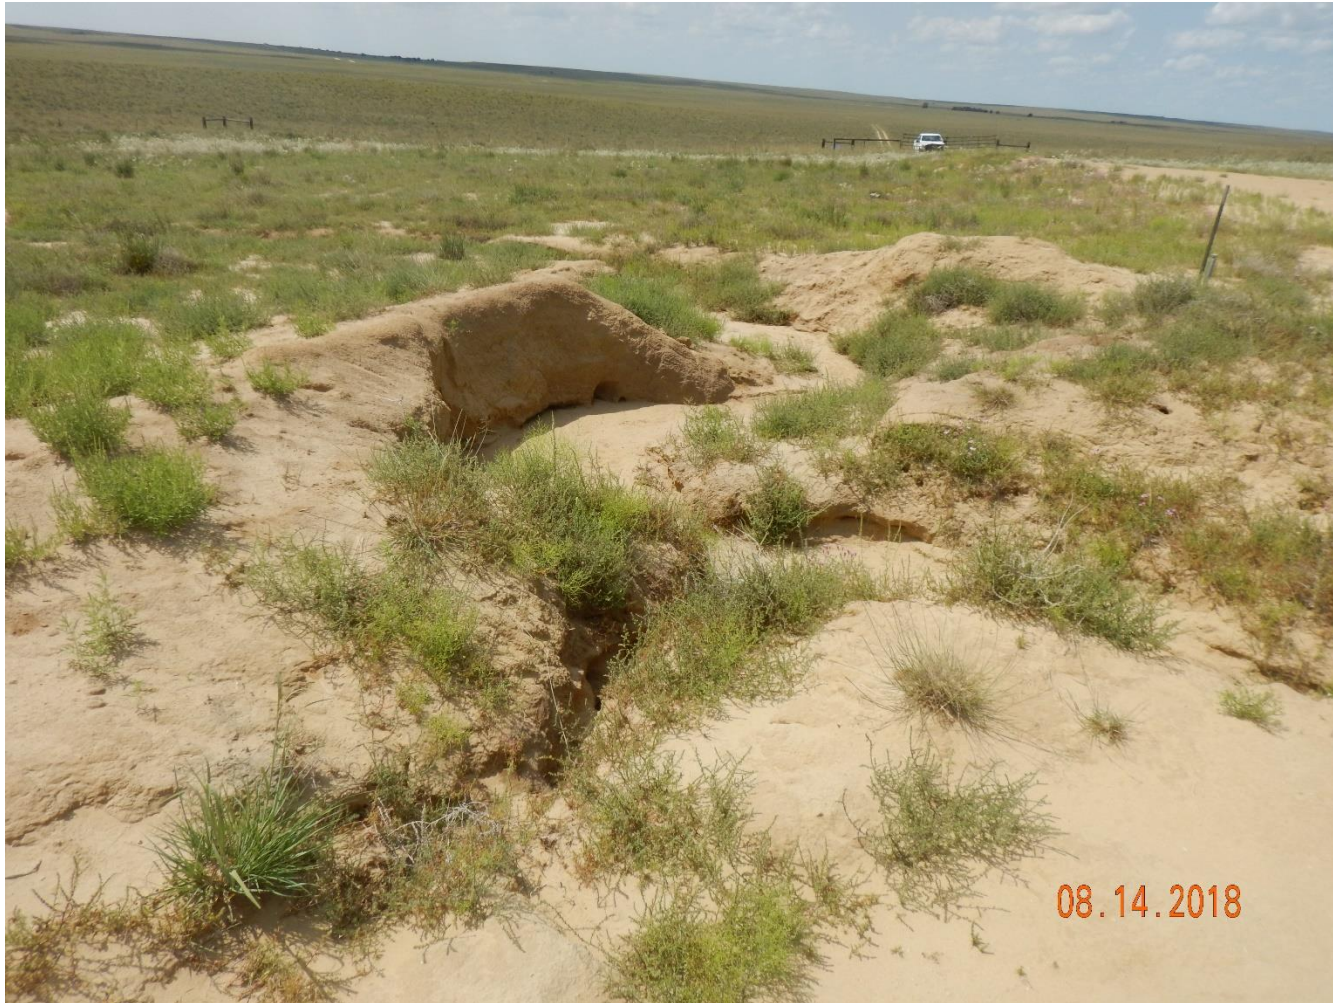
Photo 5: Continued from photo 3, facing north. See comments under photo 3.

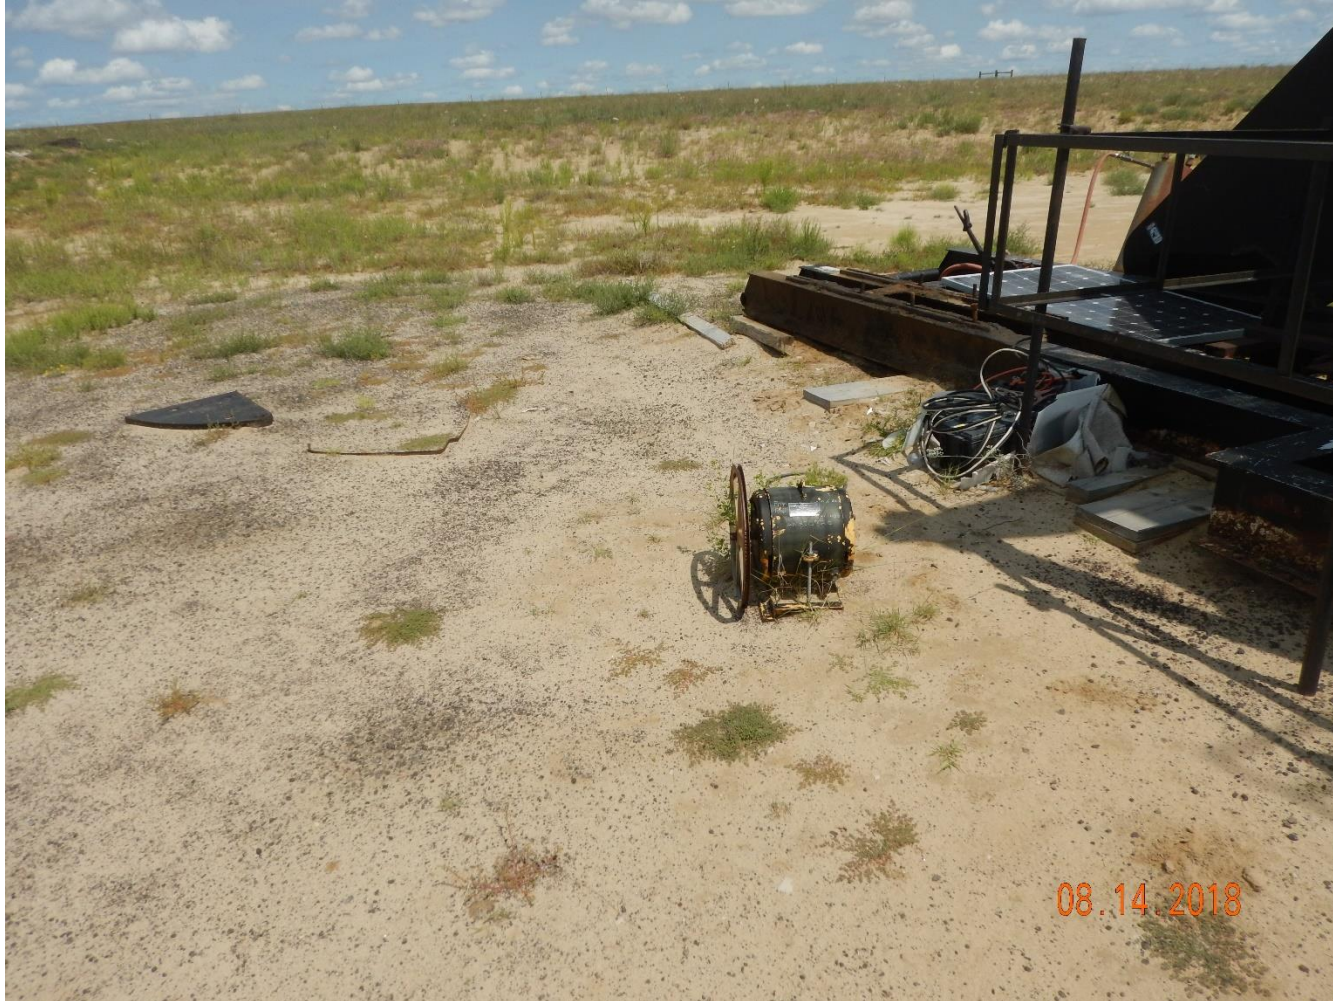
Photo 6: Photo taken from the north end of the pump unit, facing east. Previous inspections documented various trash debris and unused equipment strewn about the well. Photo shows trash debris and unused equipment has not been properly removed and stored, or disposed, per corrective actions.

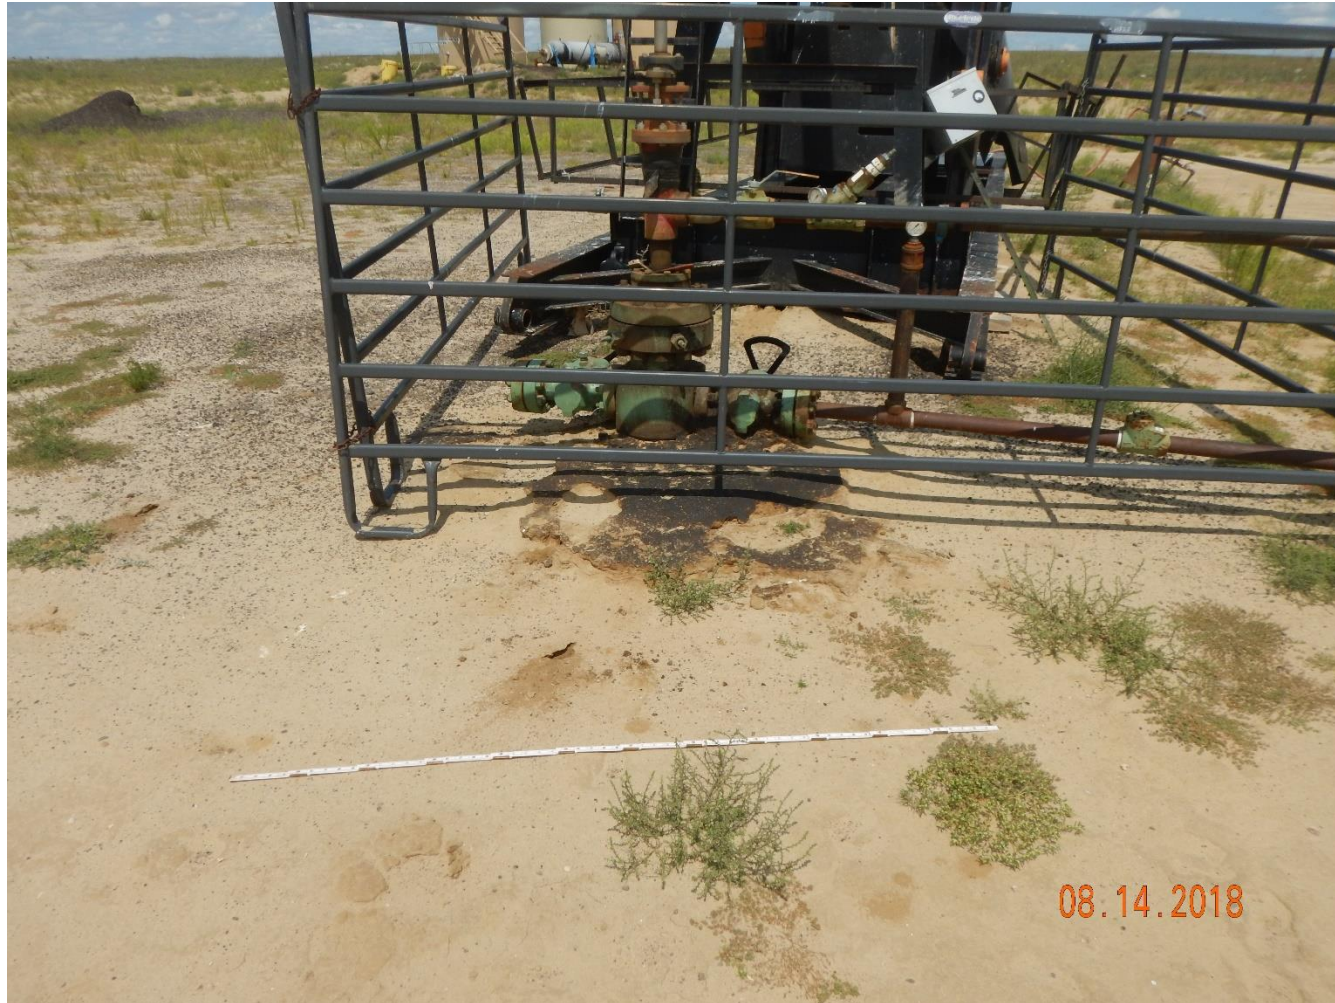
Photo 7: Photo taken from the west end of the well. Previous inspections documented stained soil at wellhead and required operator to remove and/or remediate stained soil. Photo shows soils at wellhead have not been removed, or remediated. Stained soils can also be found in areas surrounding the well. 6 foot measuring stick for reference.

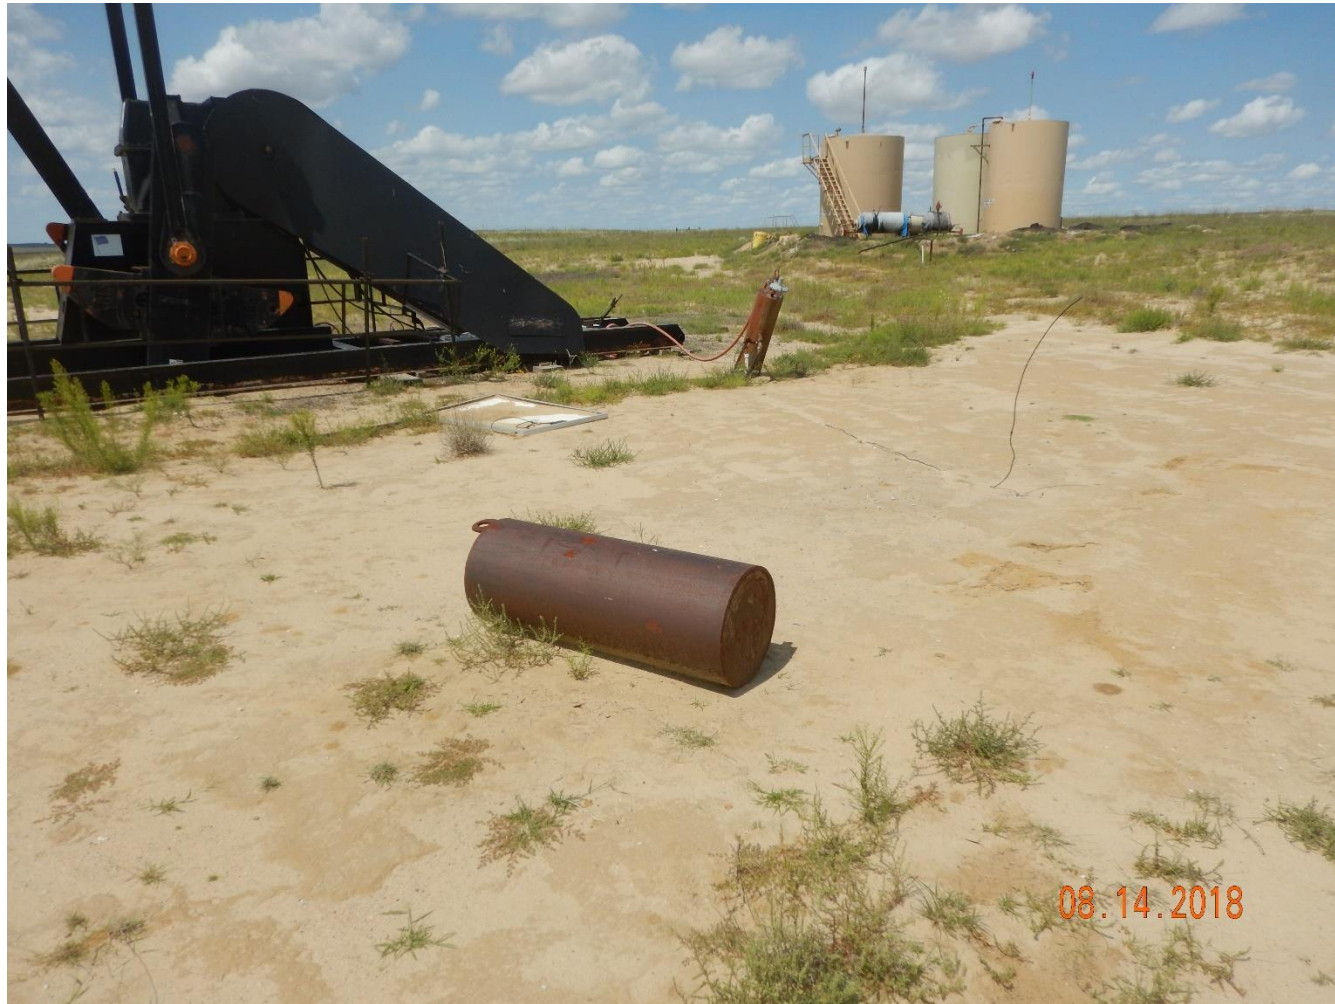
Photo 8: Photo taken from the south end of the pump unit, facing northeast. Previous inspections documented various trash debris and unused equipment strewn about the well. Photo shows trash debris and unused equipment has not been properly removed and stored, or disposed, per corrective actions. Large propane tank in area has been removed.

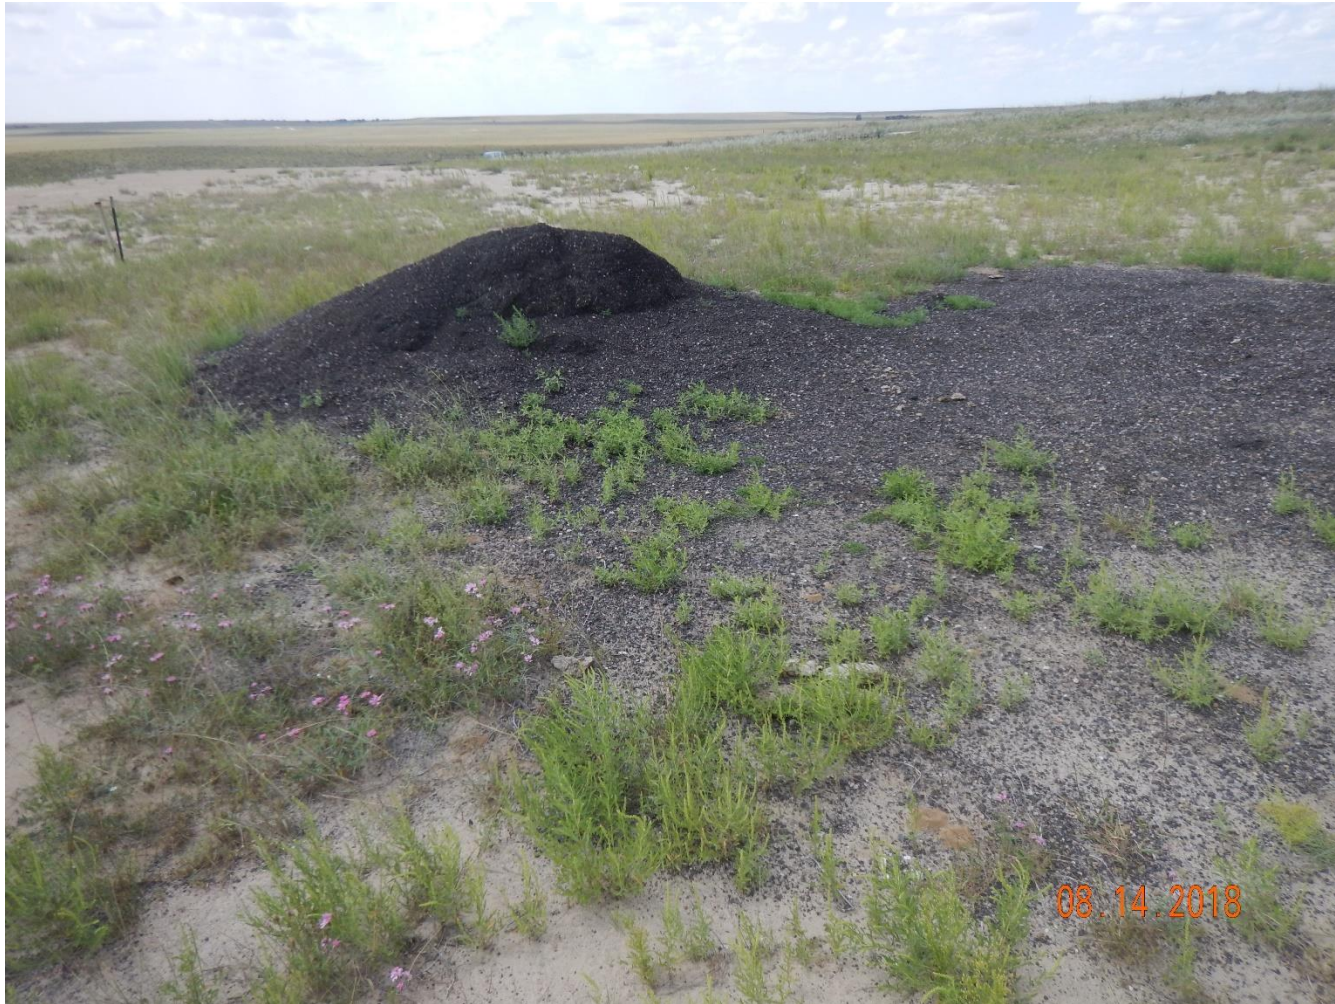
Photo 9: Photo taken from the central area of the pad, facing northwest. Previous inspections required operator to remove gravel pile from location. Photo shows pile remaining.

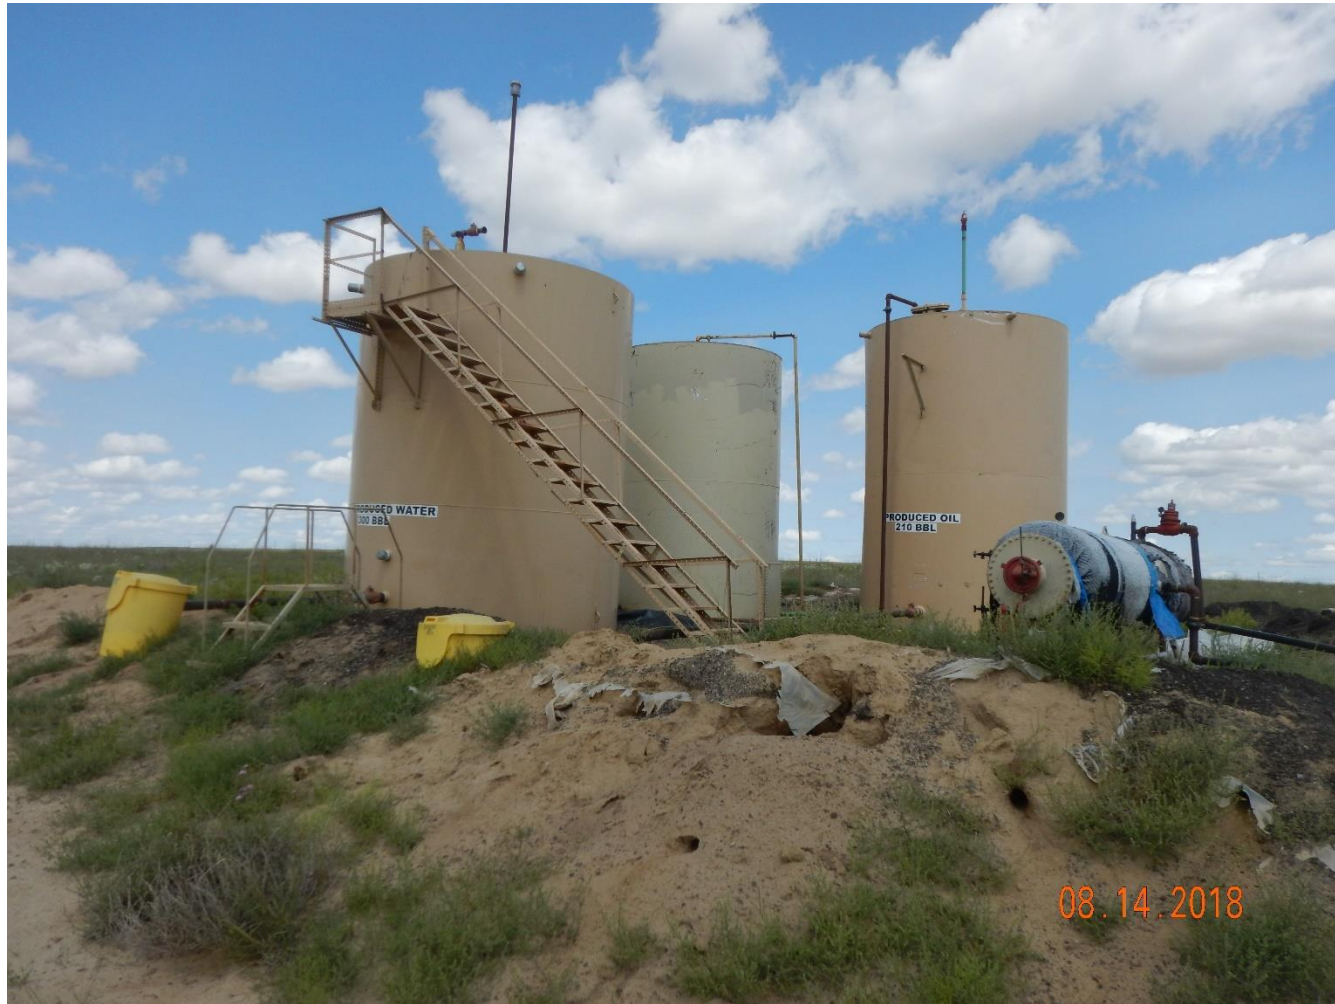
Photo 10: Photo taken from the southwest end of the tanks on location, facing northeast. Previous inspections documented incomplete signage on tanks, including NFPA diamond labeling, and required operator to implement proper signage. Photo shows additional signage has not been implemented.

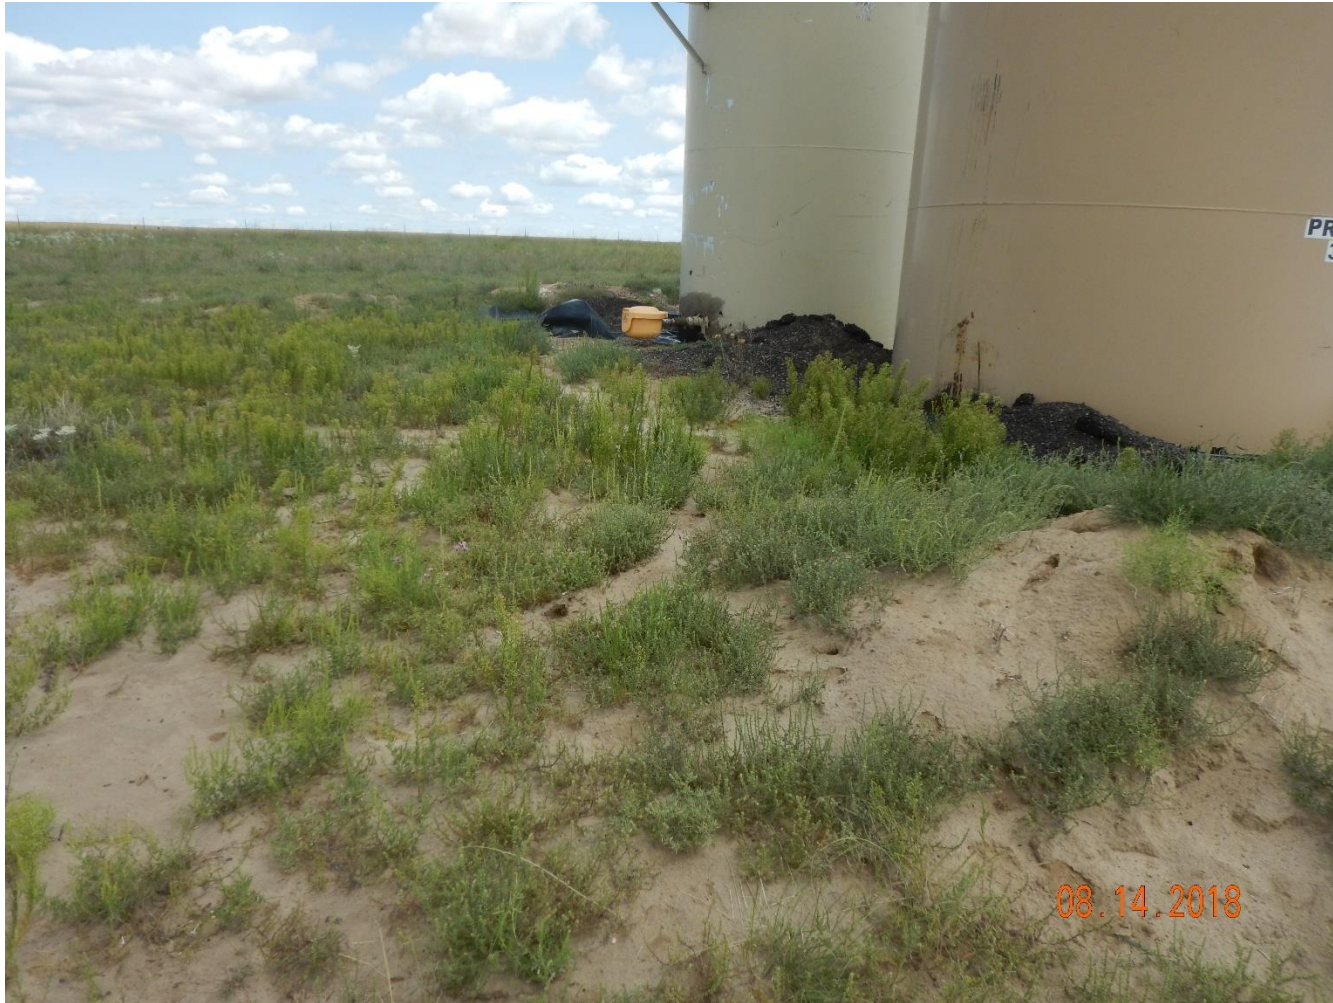
Photo 11: Photo taken from the northwest end of the tanks on location, facing east. Previous inspections documented that the berms around the tanks were inadequate and required operator to repair or install berms, or secondary containment devices. Photo shows berms, or other secondary containment devices have not been repaired or installed; berm missing from the northern end of the tanks. Photo shows additional signage on tanks has not been implemented.

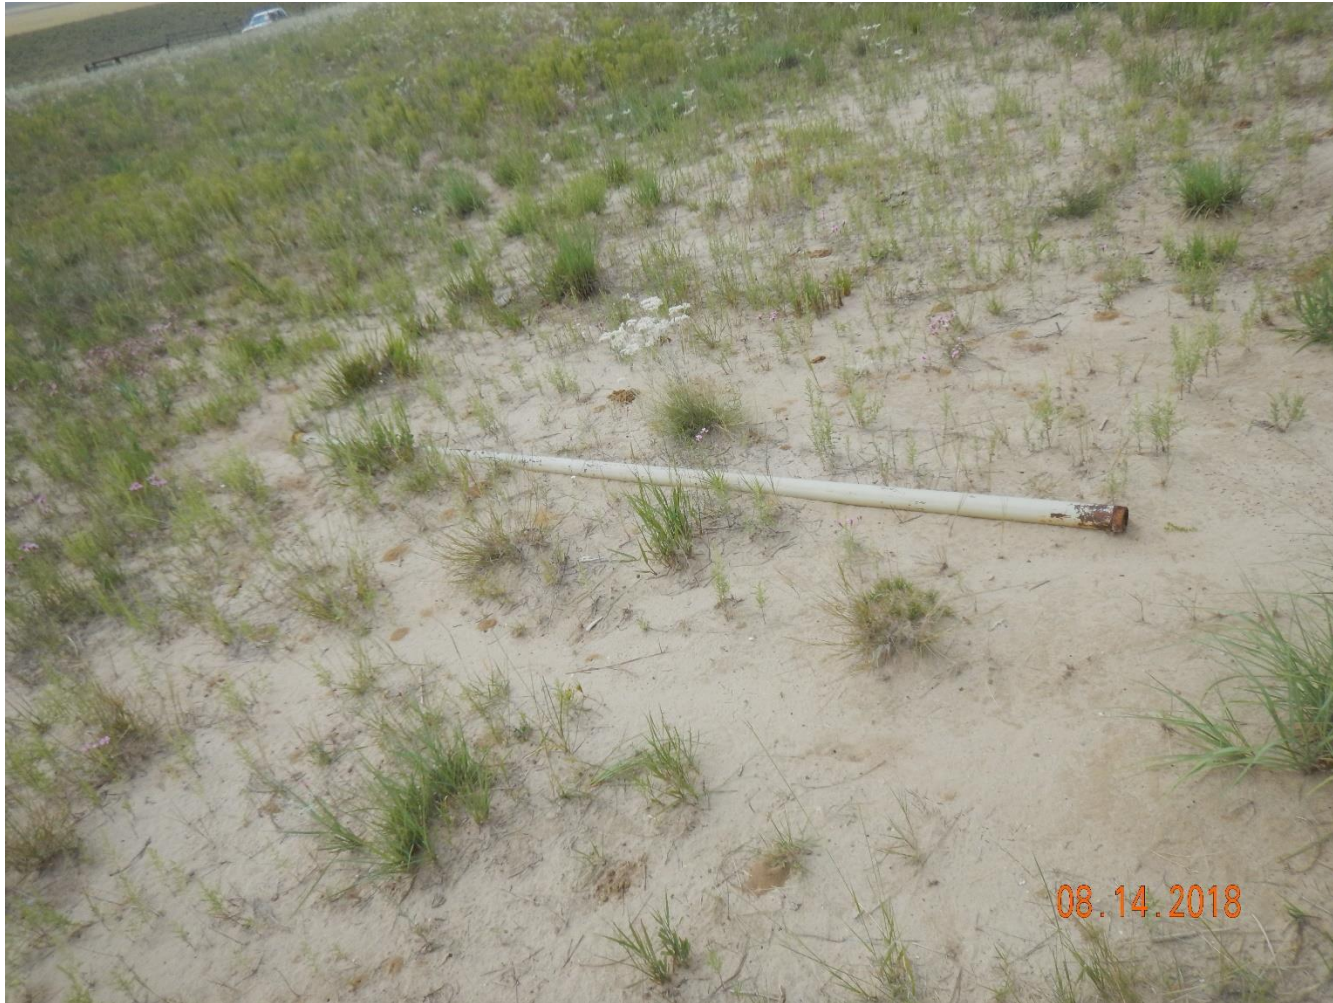
Photo 12: Photo taken from the north end of the location. Previous inspections documented various debris and unused equipment remaining on the location and required removal. Photo shows equipment/debris has not been removed.

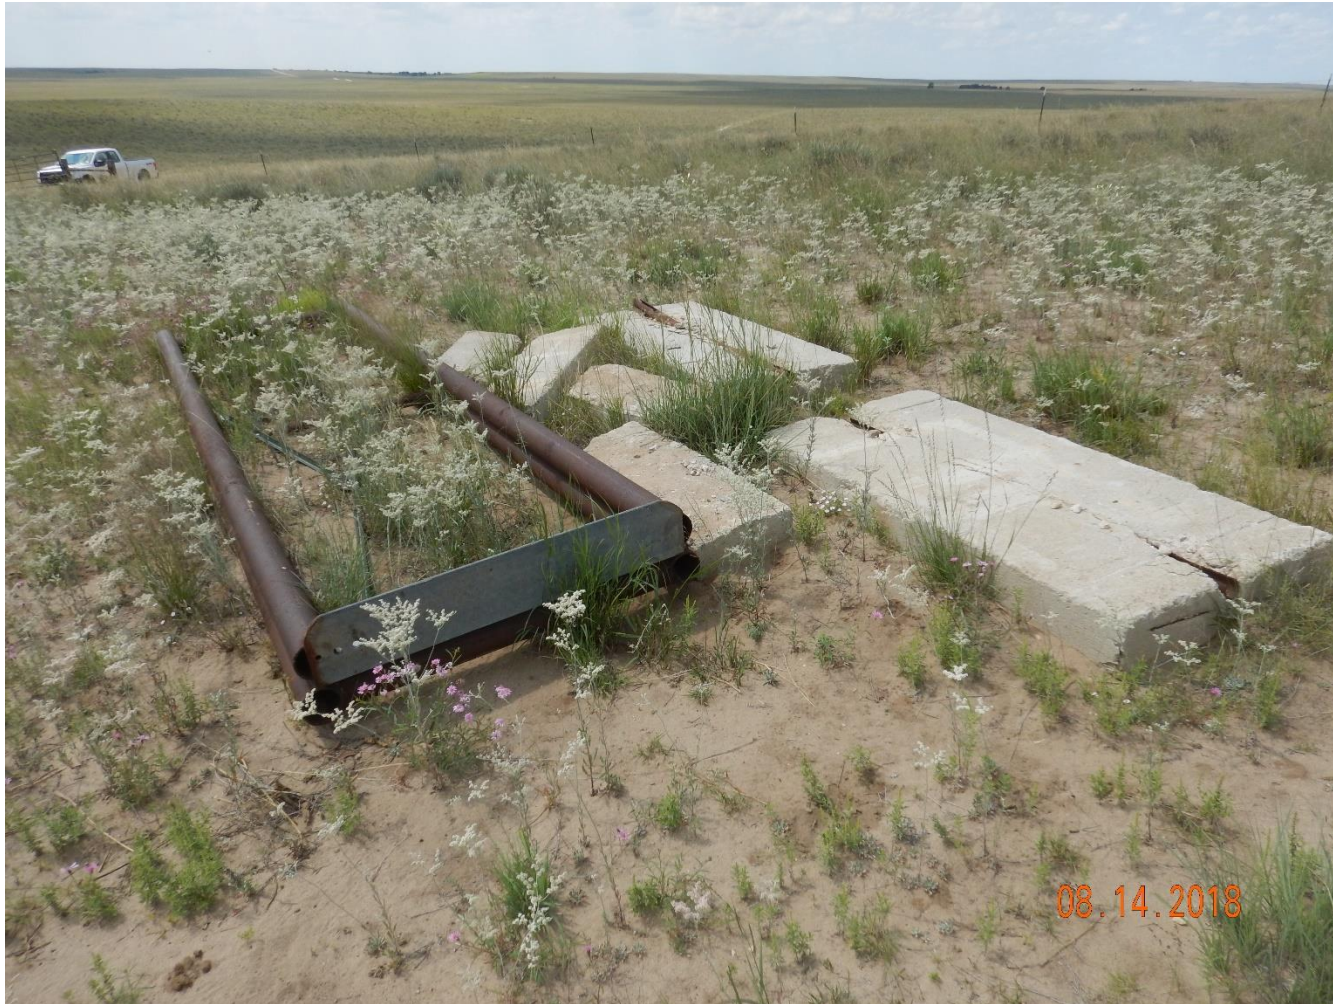
Photo 13: Photo taken from the north end of the location, facing northwest. Previous inspections documented various debris and unused equipment remaining on the location and required removal. Photo shows equipment/debris has not been removed.

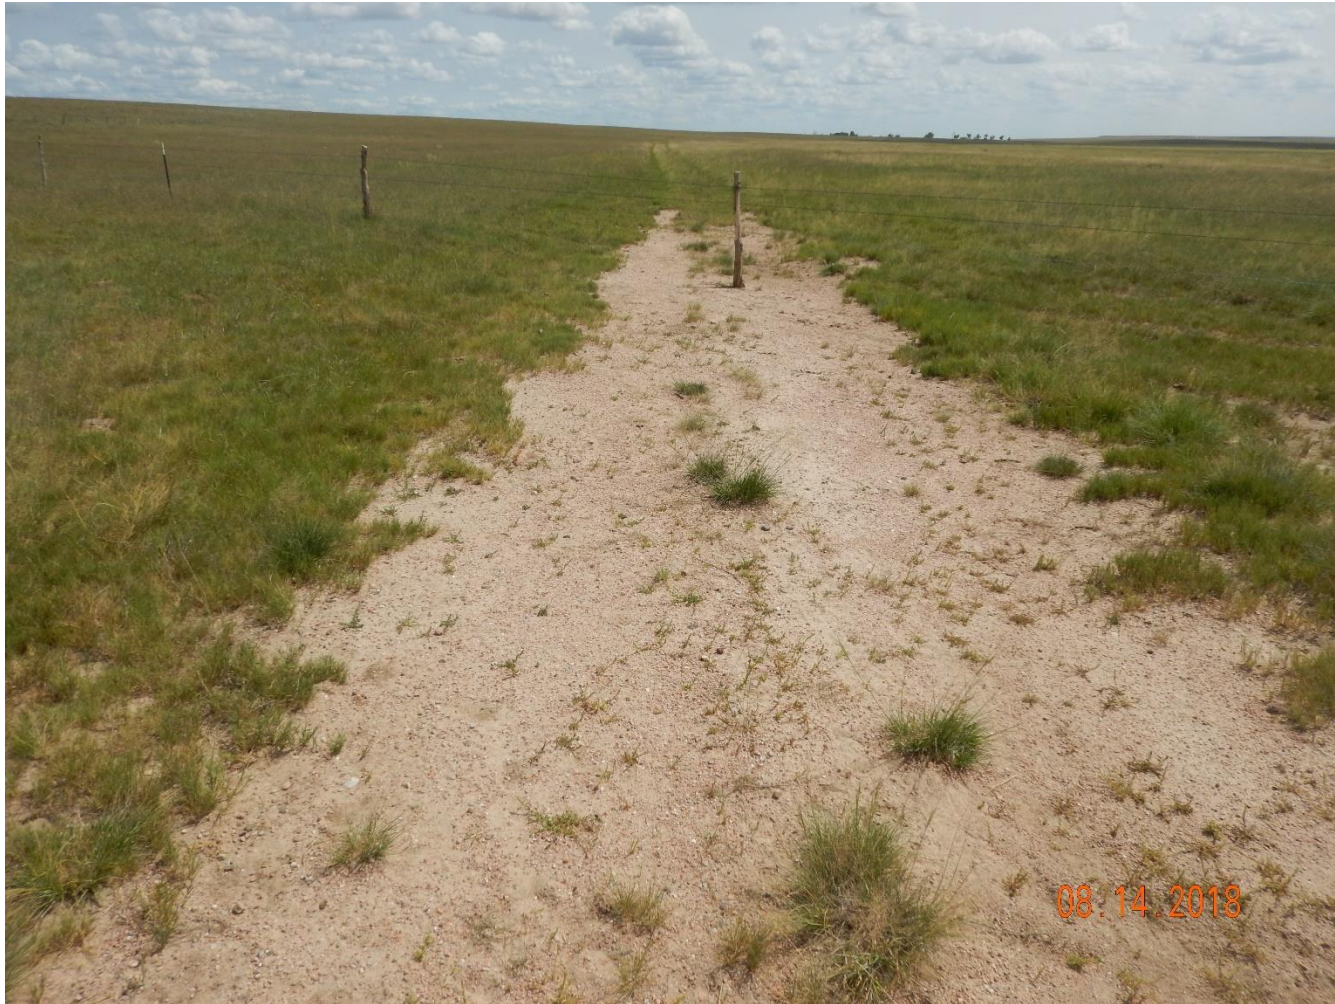
Photo 14: Photo taken from the access road, southwest of the location at coordinated 38.94974 / - 103.39839. Previous inspections documented that the fence blocks off access road, forcing vehicles to travel off road at a corner of the fence to the east. Previous inspections required operator to install gate to minimize and mitigate surface disturbance in accordance to 1002.e(4). Photo shows gate has not been installed to mitigate surface disturbance.

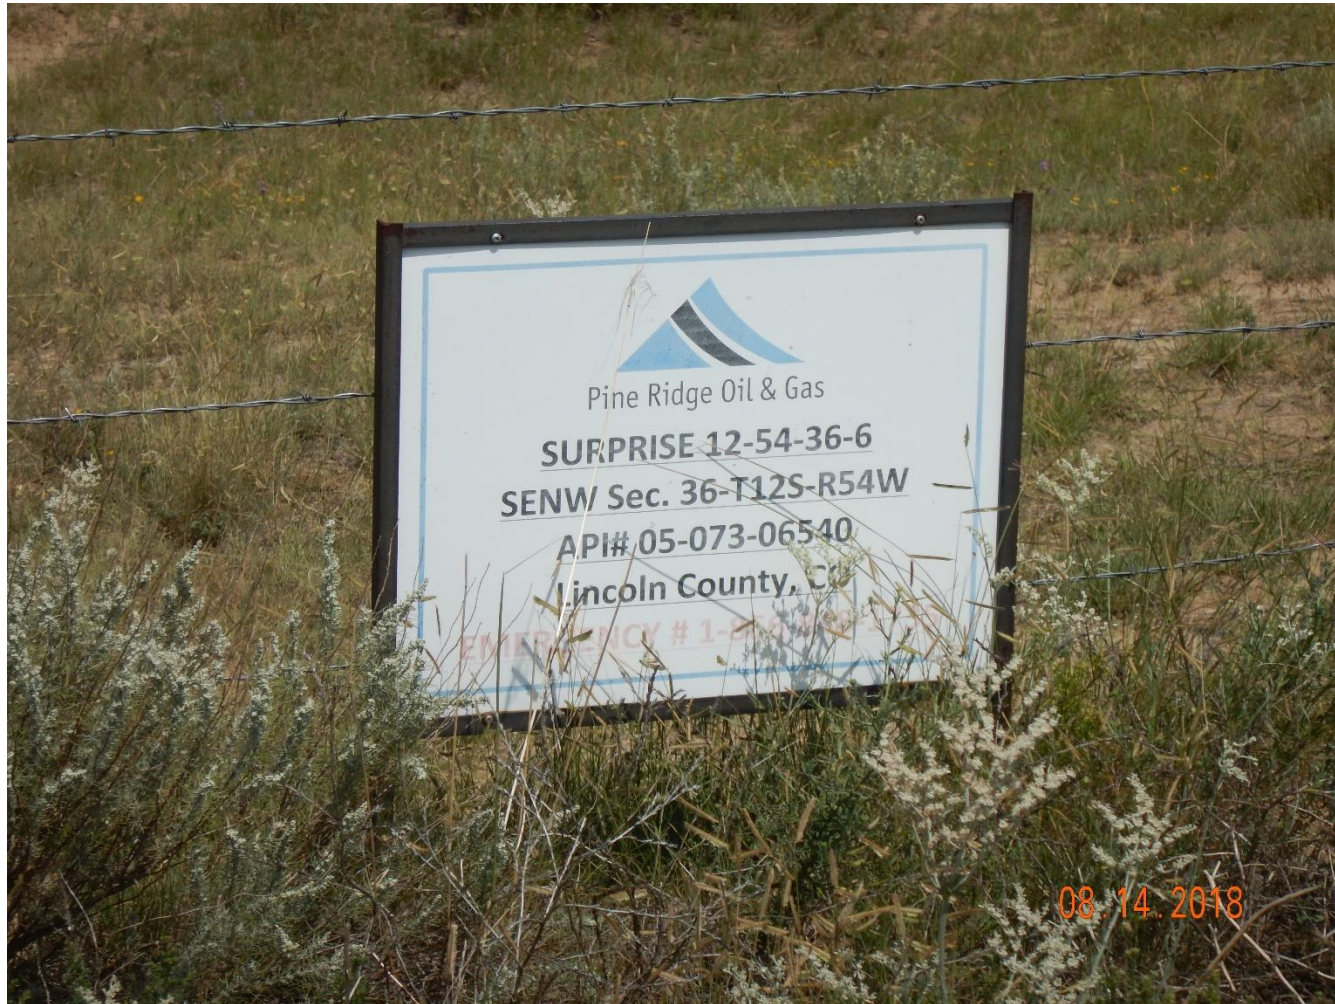
Photo 15: Photo taken from the access road entrance at CR 26. Previous inspections required operator to update signage with correct operator information. Photo shows signage has not been updated.
