Inspection Photos

08/14/2018

Operator: ABILENE PERFECT ENERGY JV LLC -
10581

Location ID: 414589

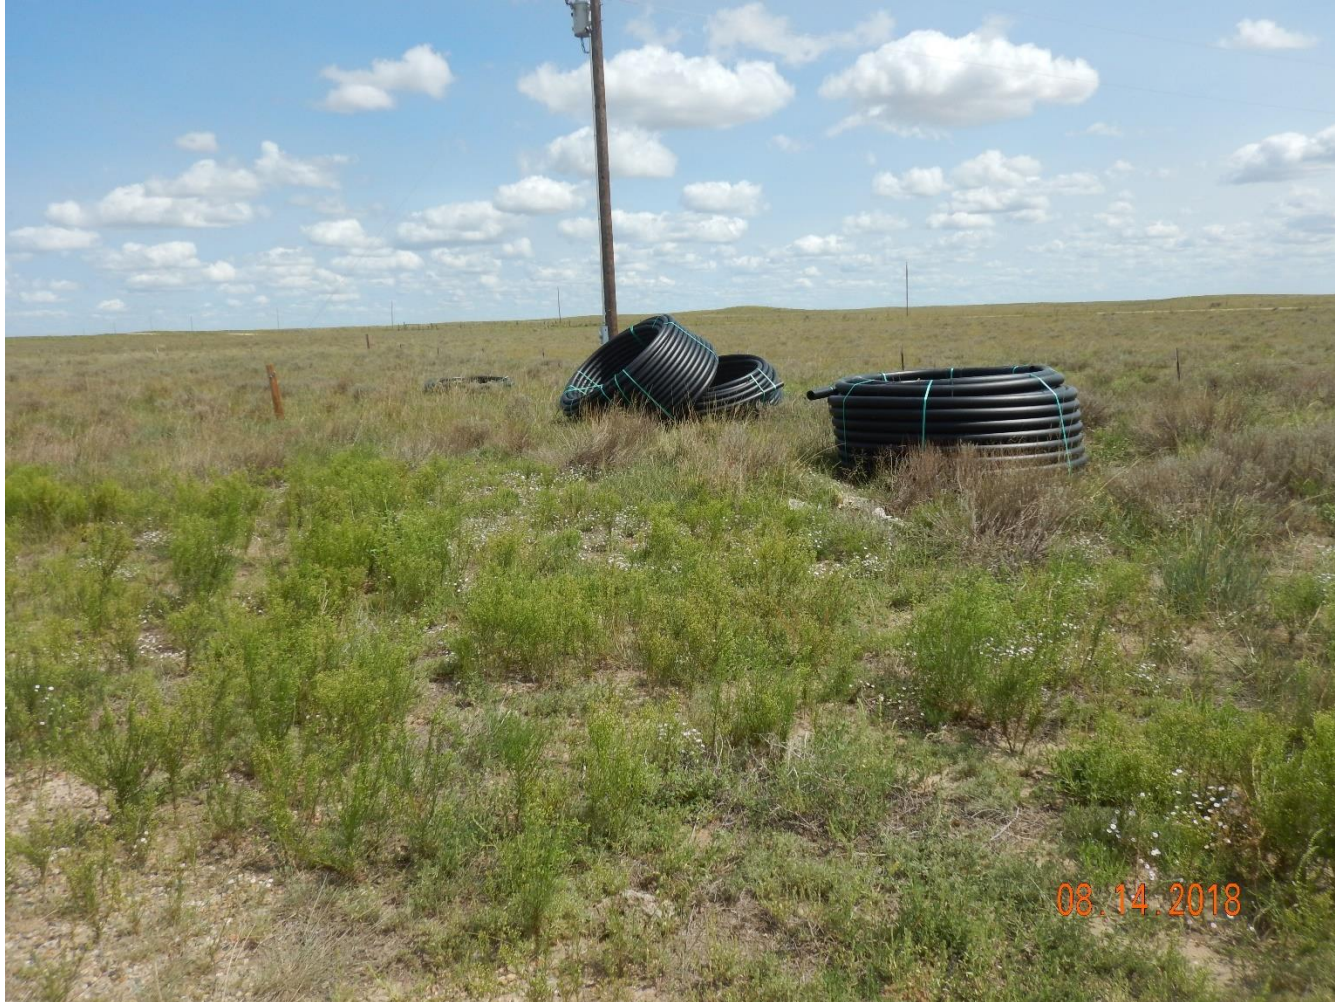
Photo 1: Photo taken from the south end of the location, facing east. Photo shows what appears to be four (4) bundles of pipe stored on the southern interim area. Previous inspections documented that this is unused equipment not needed for production and that needs to be removed from location. Photo shows equipment has not been removed.

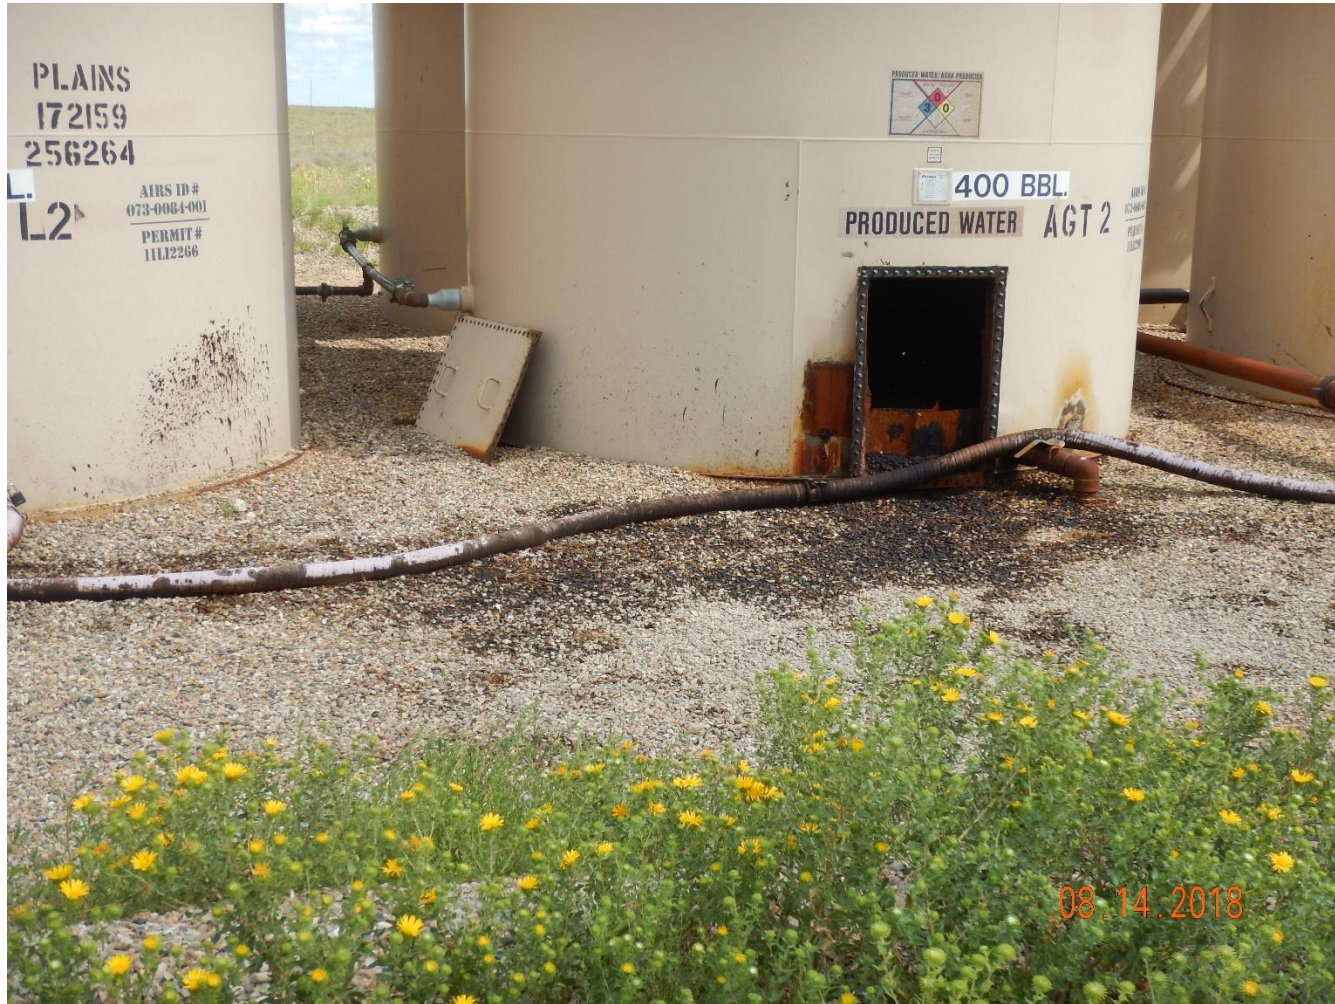
Photo 2: Photo taken from the west end of the tank battery. Previous inspections documented stained soils within the berm, and that the manway cover has been removed from the tank. Photo shows cover has not been replaced and stained soils remain.

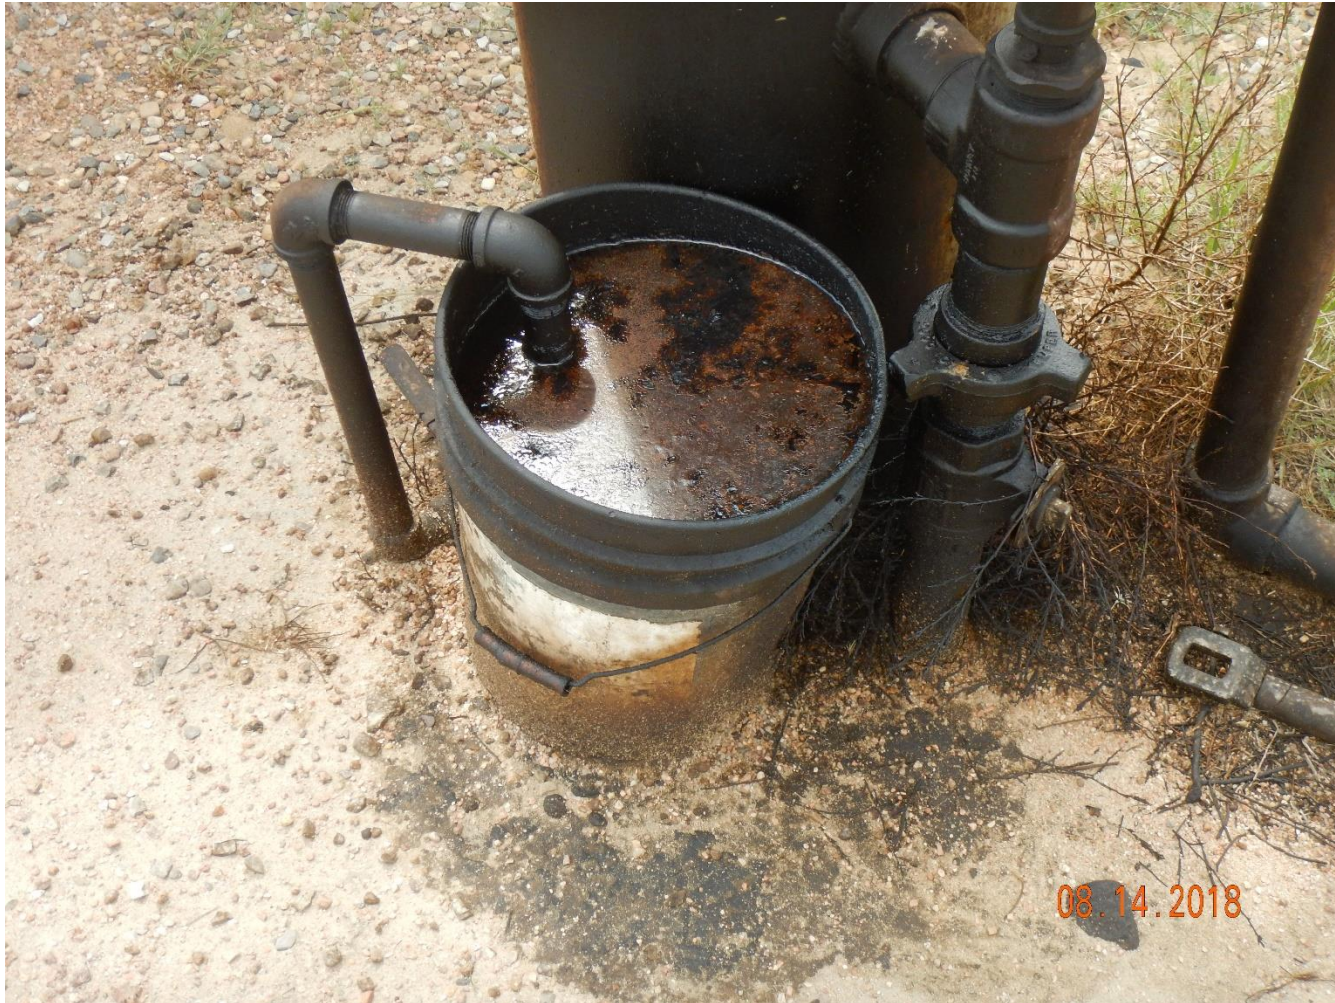
Photo 3: Photo taken from the west end of the location. Previous inspections documented this 5 gallon bucket being used to collect chemicals from equipment and stained soils at the base. Inspections required that equipment needs to be repaired to fix leaks, and bucket needs to be removed and properly disposed or placed in containment. Photo shows bucket and stained soils remain.

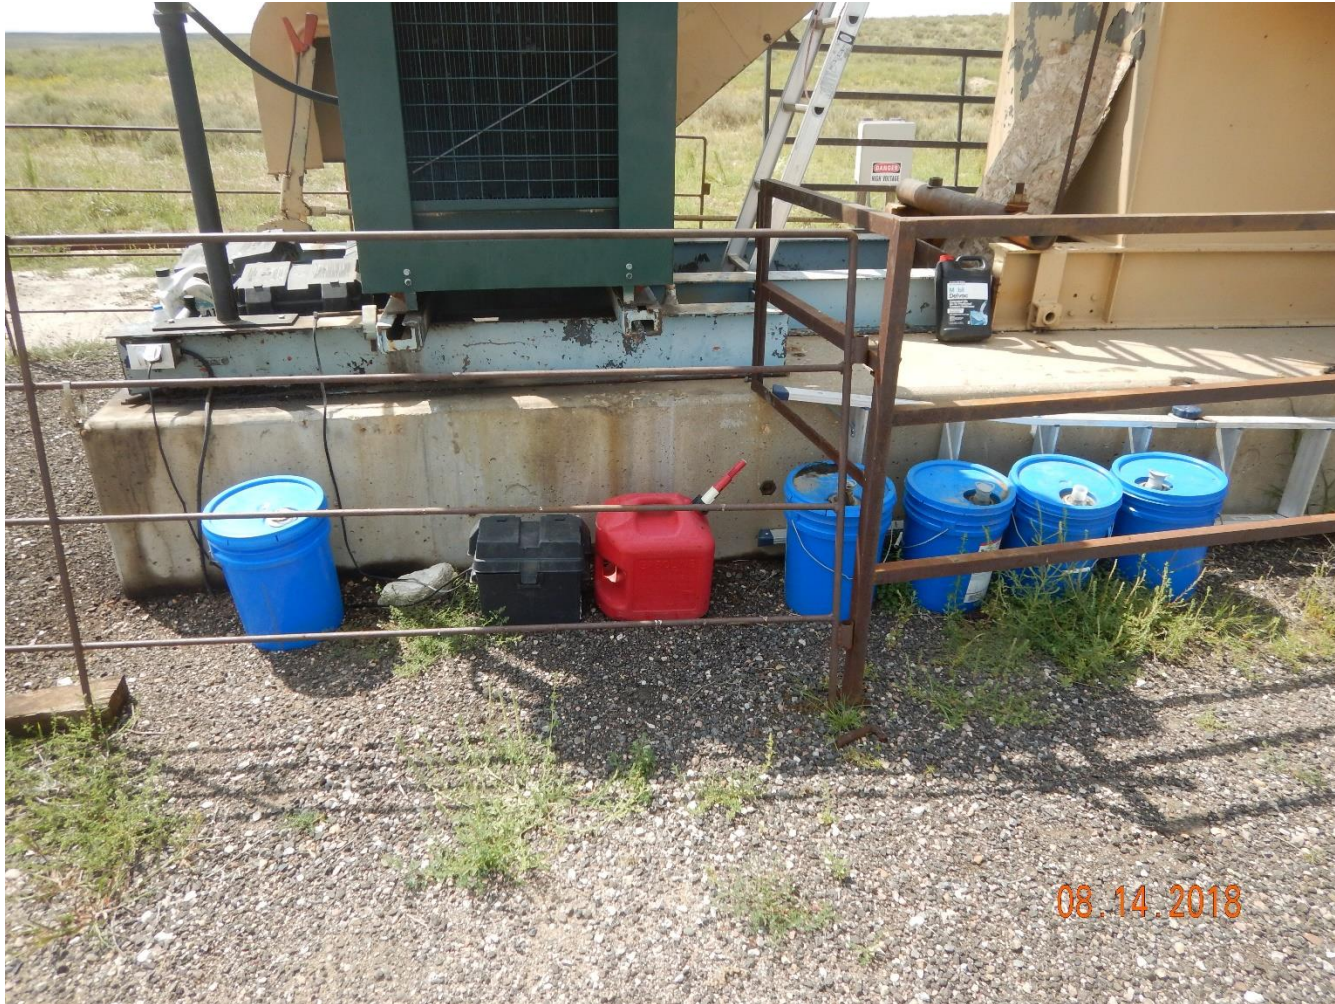
Photo 4: Photo taken from the east end of the pump jack, facing west. Previous inspections documented numbers 5 gallon buckets w/ chemical and oil jugs found around pump jack, and required containers to be properly removed and disposed, or placed into containment. Photo shows containers have not been removed or placed into containment.

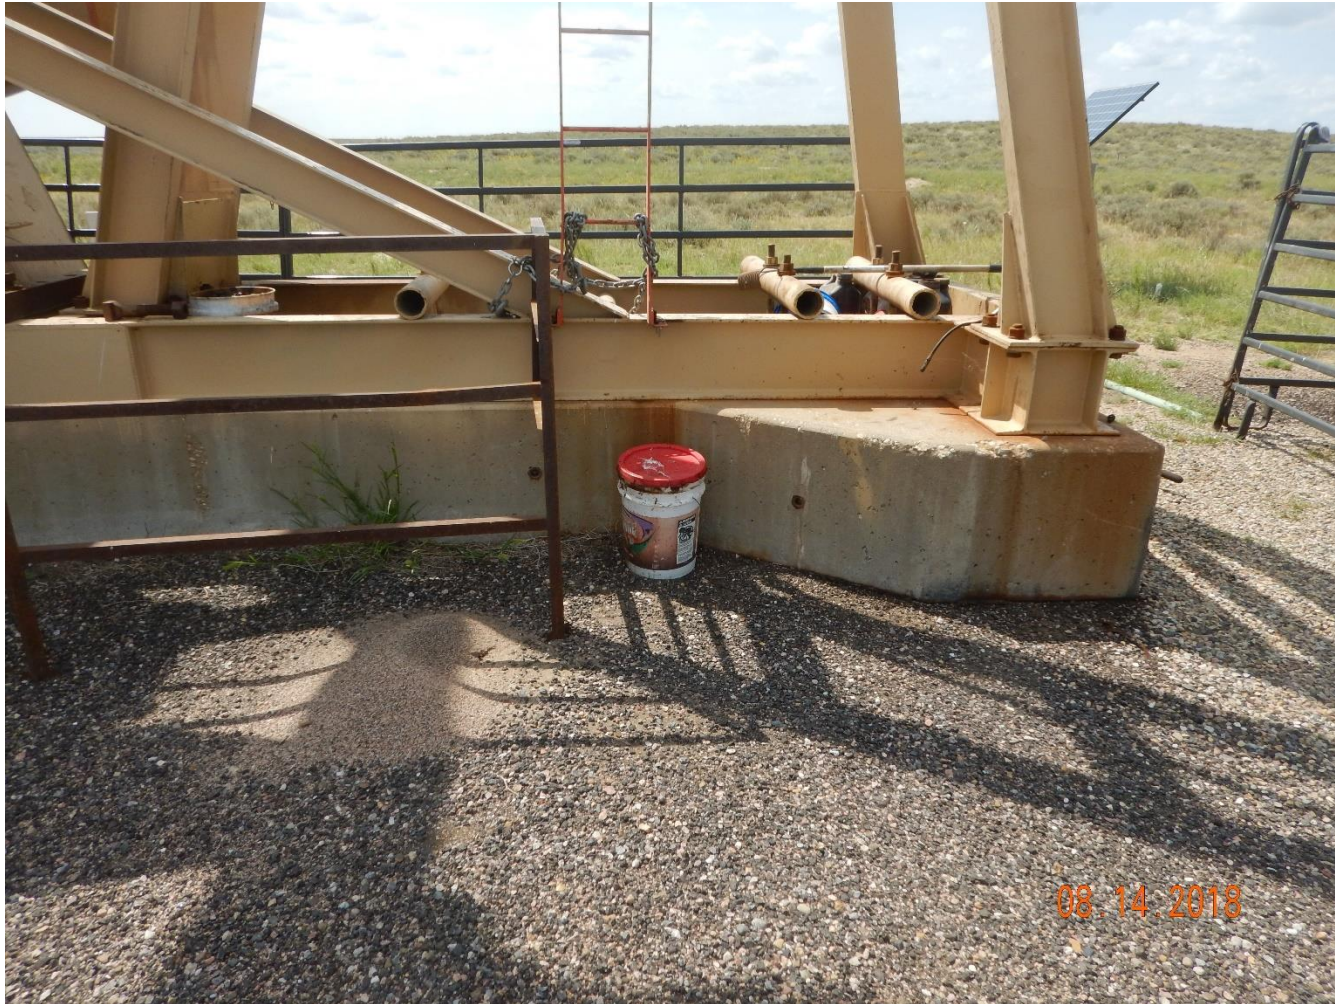
Photo 5: See comments under photo 4.

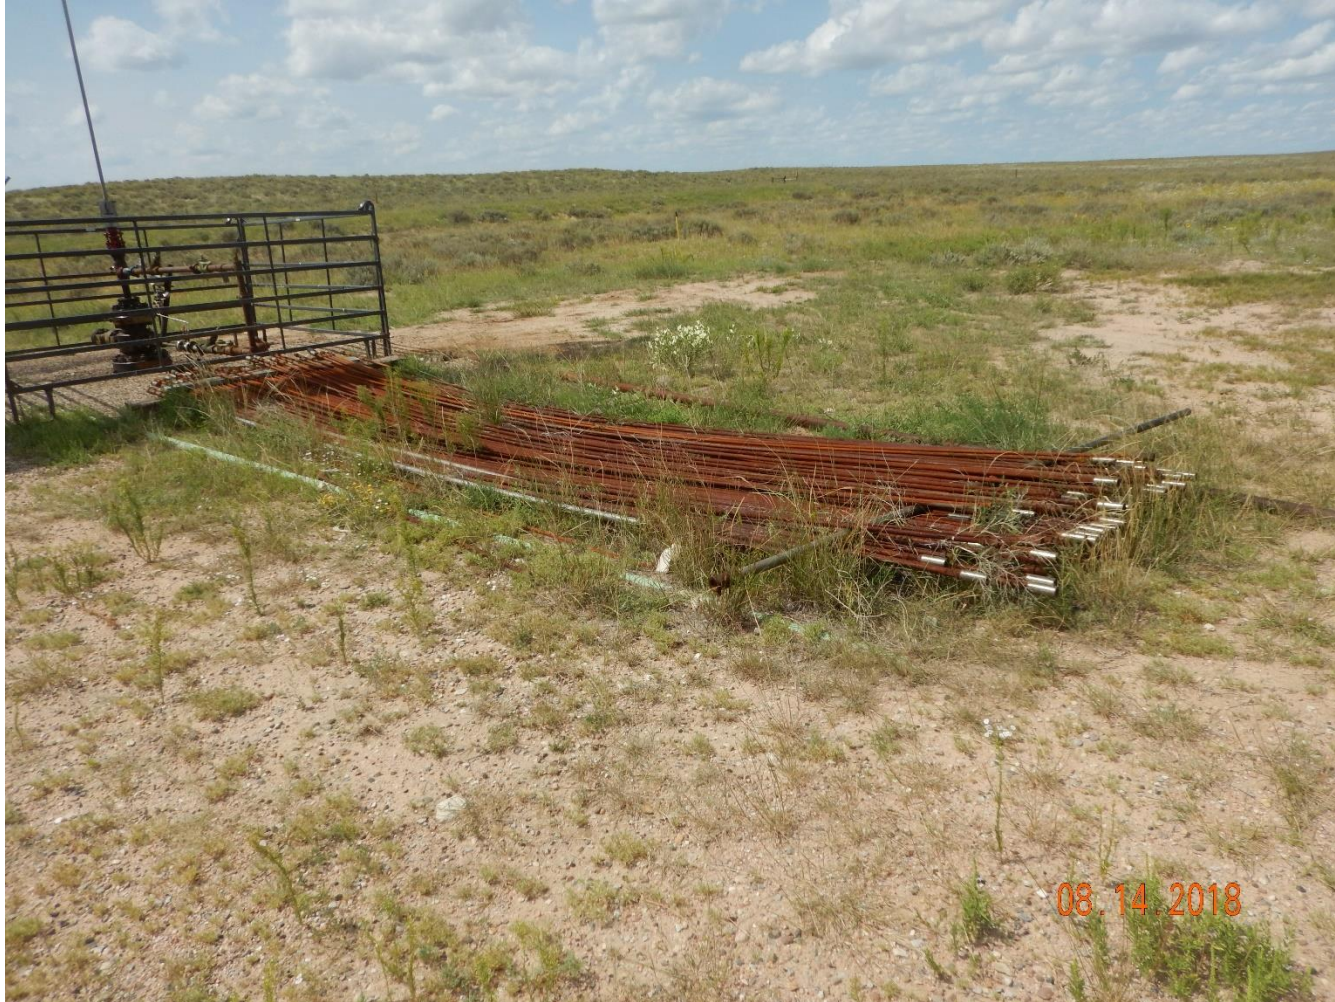
Photo 6: Photo taken from the east end of the pump, facing northwest. Photo shows unused equipment stored on location. Equipment is not needed for production and needs to be removed.

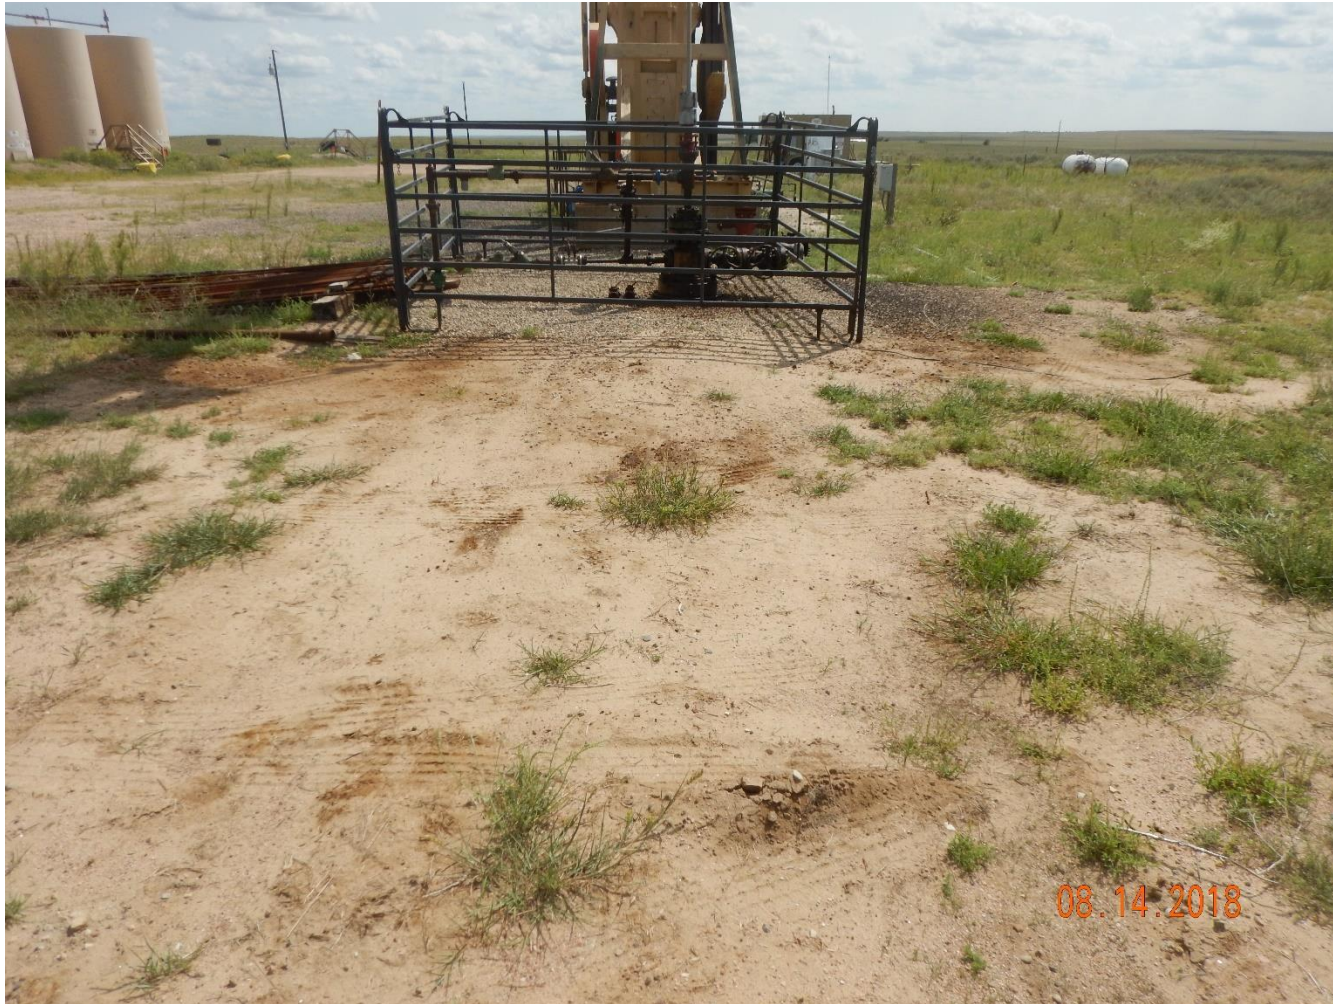
Photo 7: Photo taken from the north end of the well, facing south. Previous inspections documented contaminated soils around well and required stained soils to be cleaned. Photo shows contaminated soils remain.

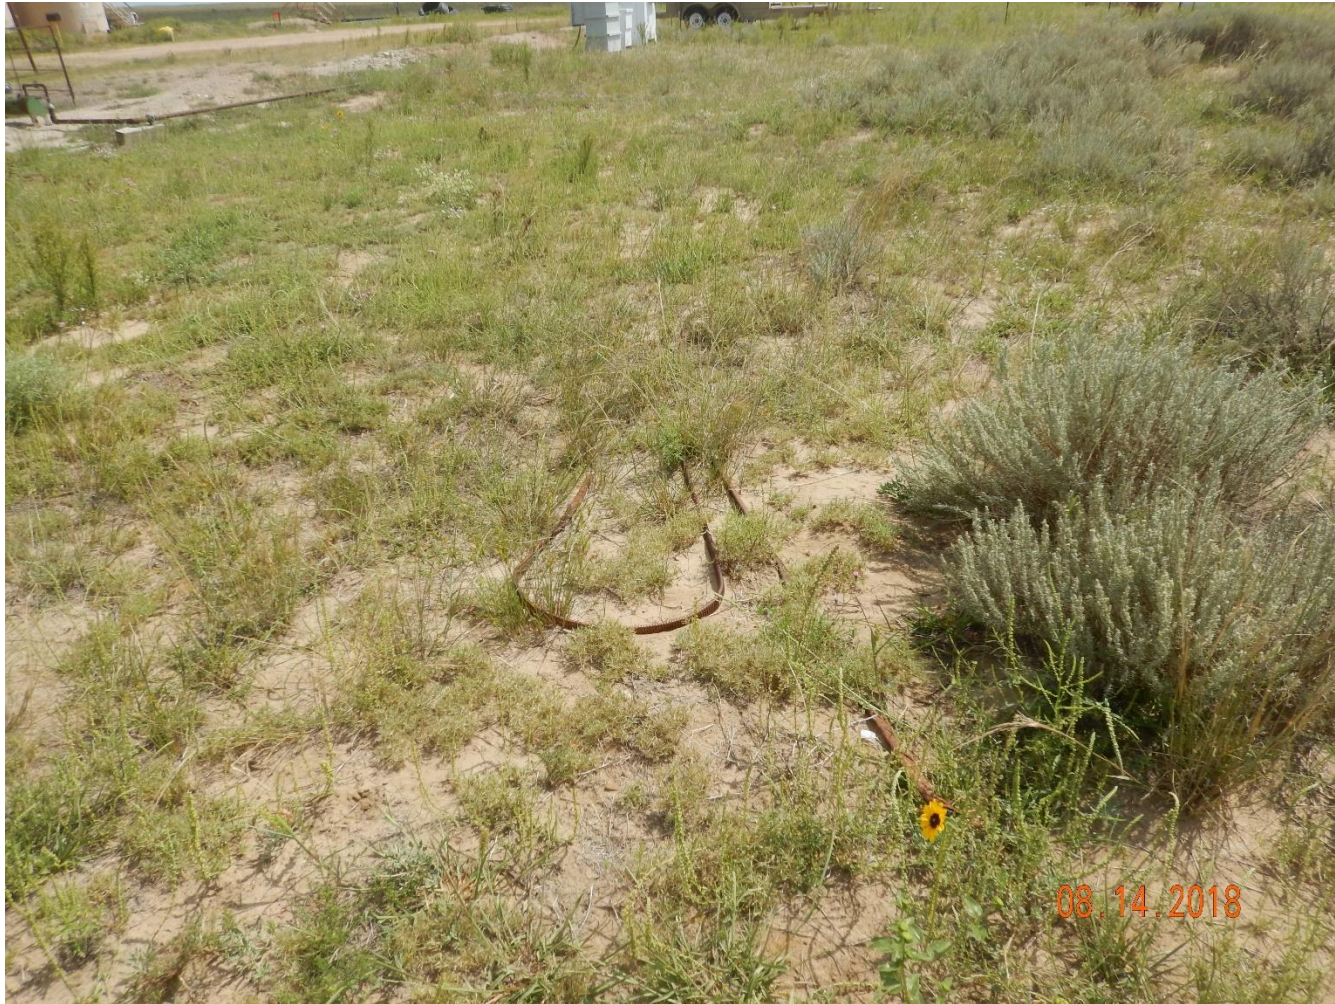
Photo 8: Photo taken from the west end of the pump unit, facing south. Previous inspections documented various trash debris on location and interim areas and required removal. Photo shows trash debris remaining.

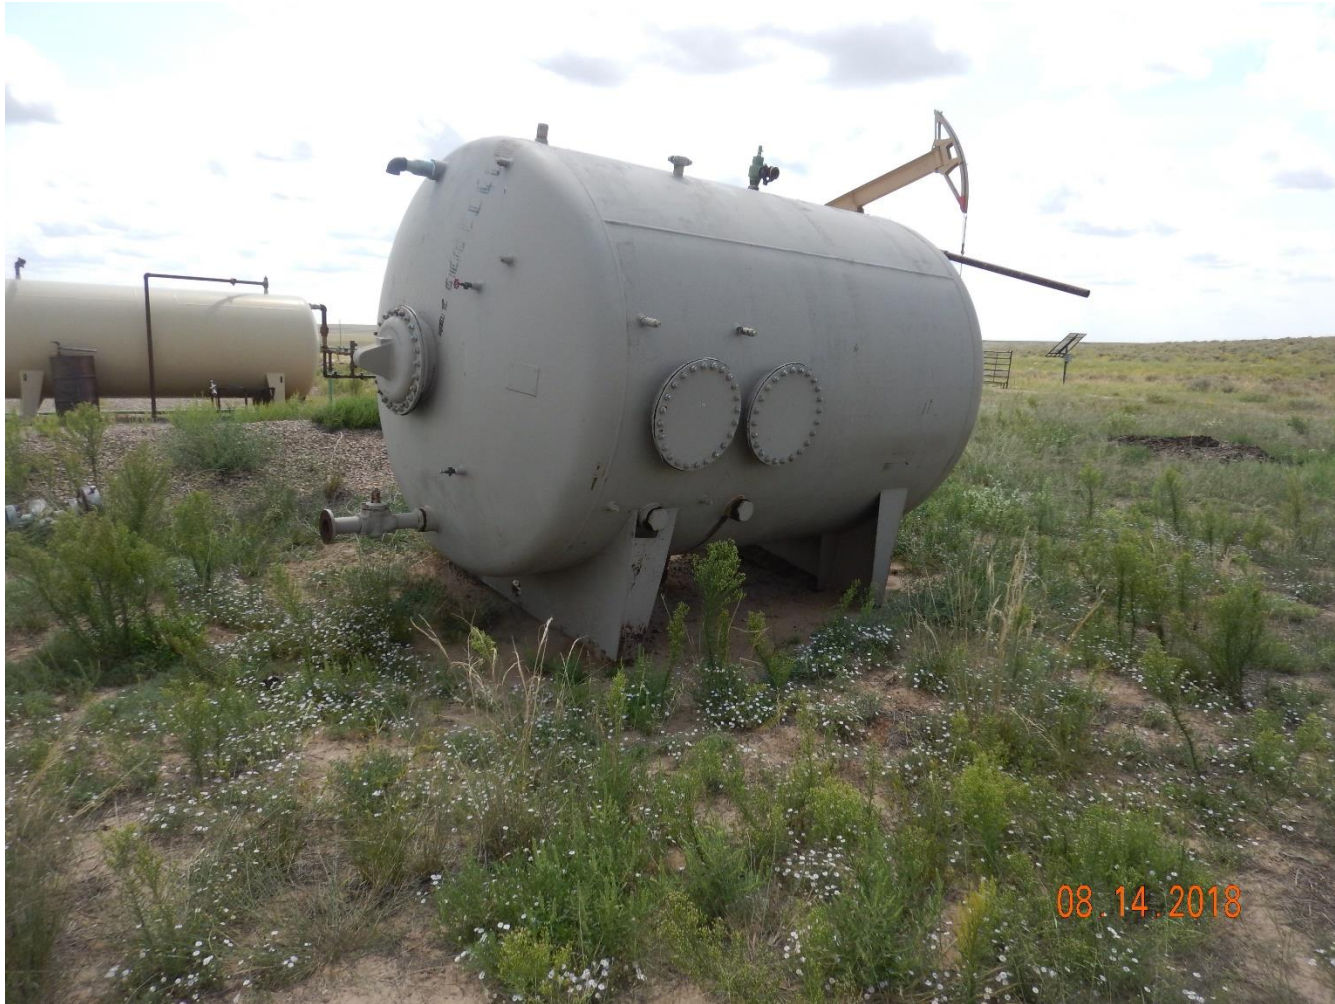
Photo 9: Photo taken from the north end of the location, facing southwest. Photo shows unused equipment not needed for production remains on location.

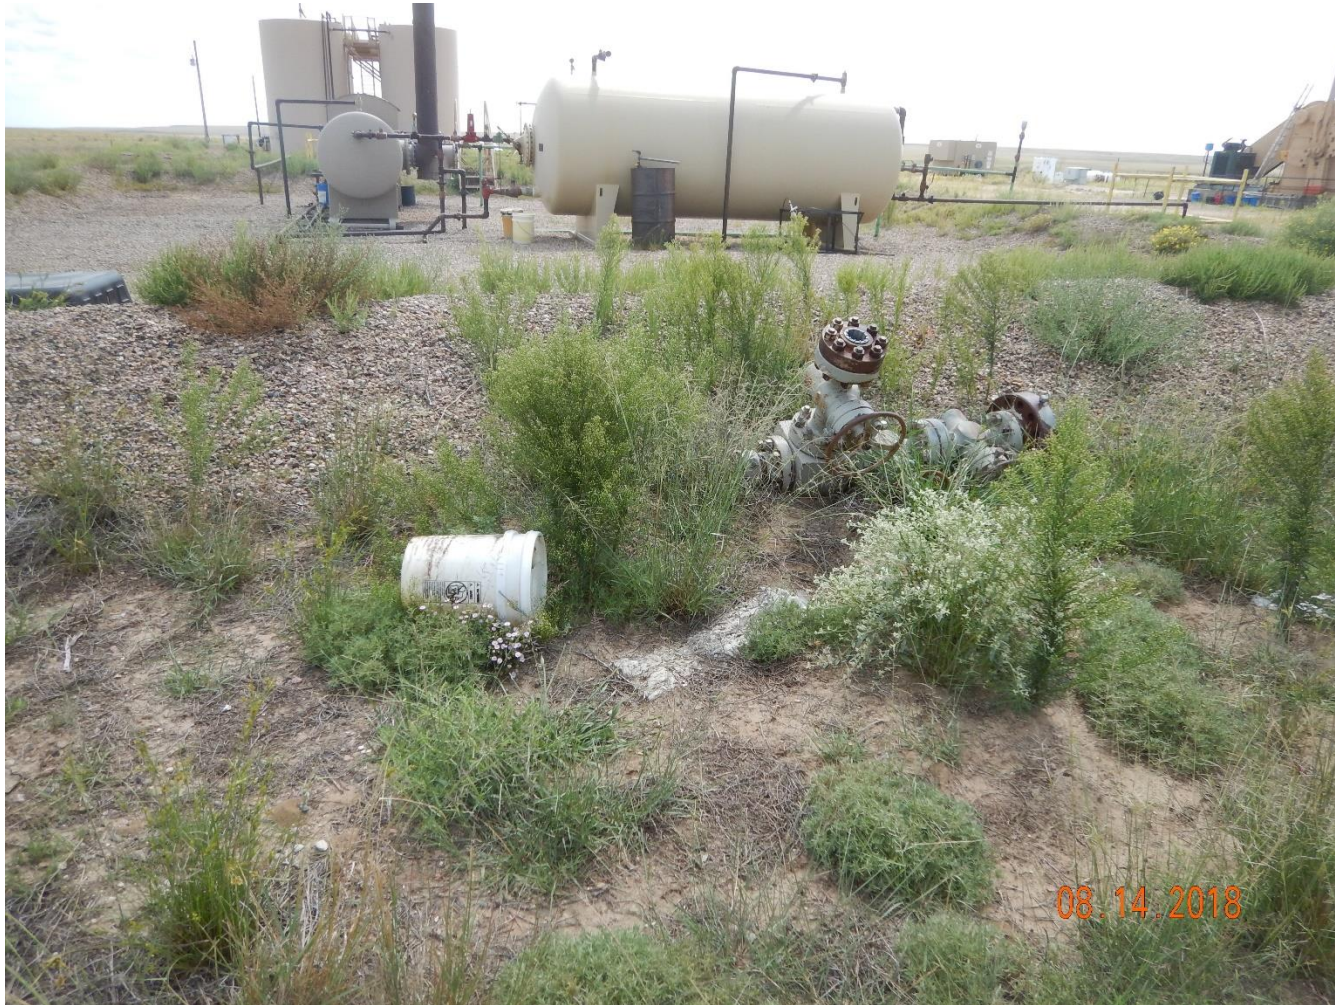
Photo 10: Photo taken from the north end of the location, facing southwest. Photo shows unused equipment not needed for production remains on location. Photo also shows 5 gallon bucket that appears to be empty has not been properly removed and disposed, or placed into containment.

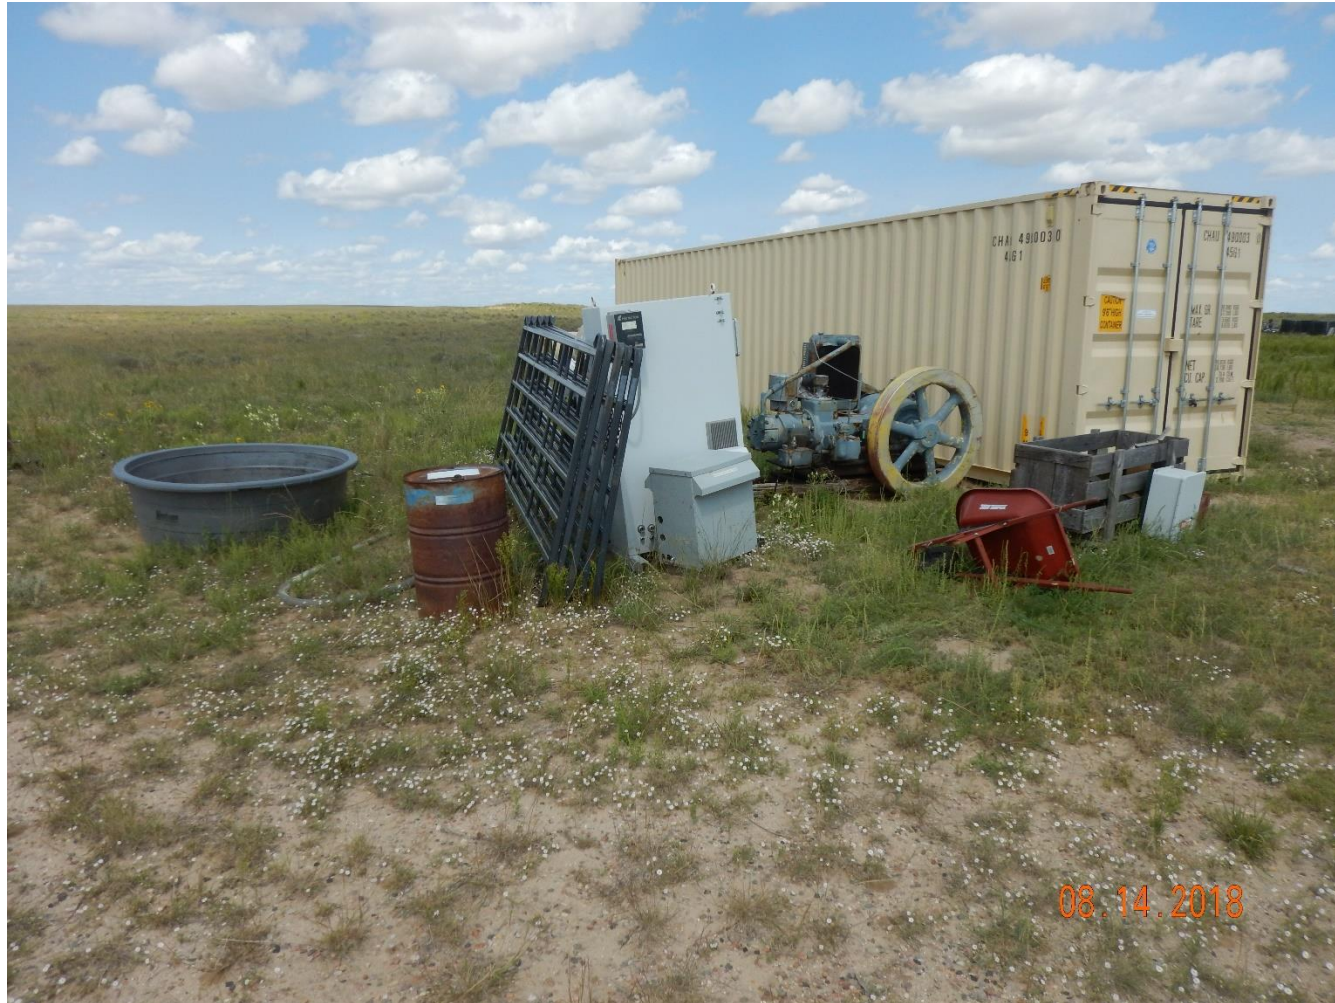
Photo 11: Photo taken from the north end of the location, facing north. Photo shows unused equipment not needed for production remains on location.

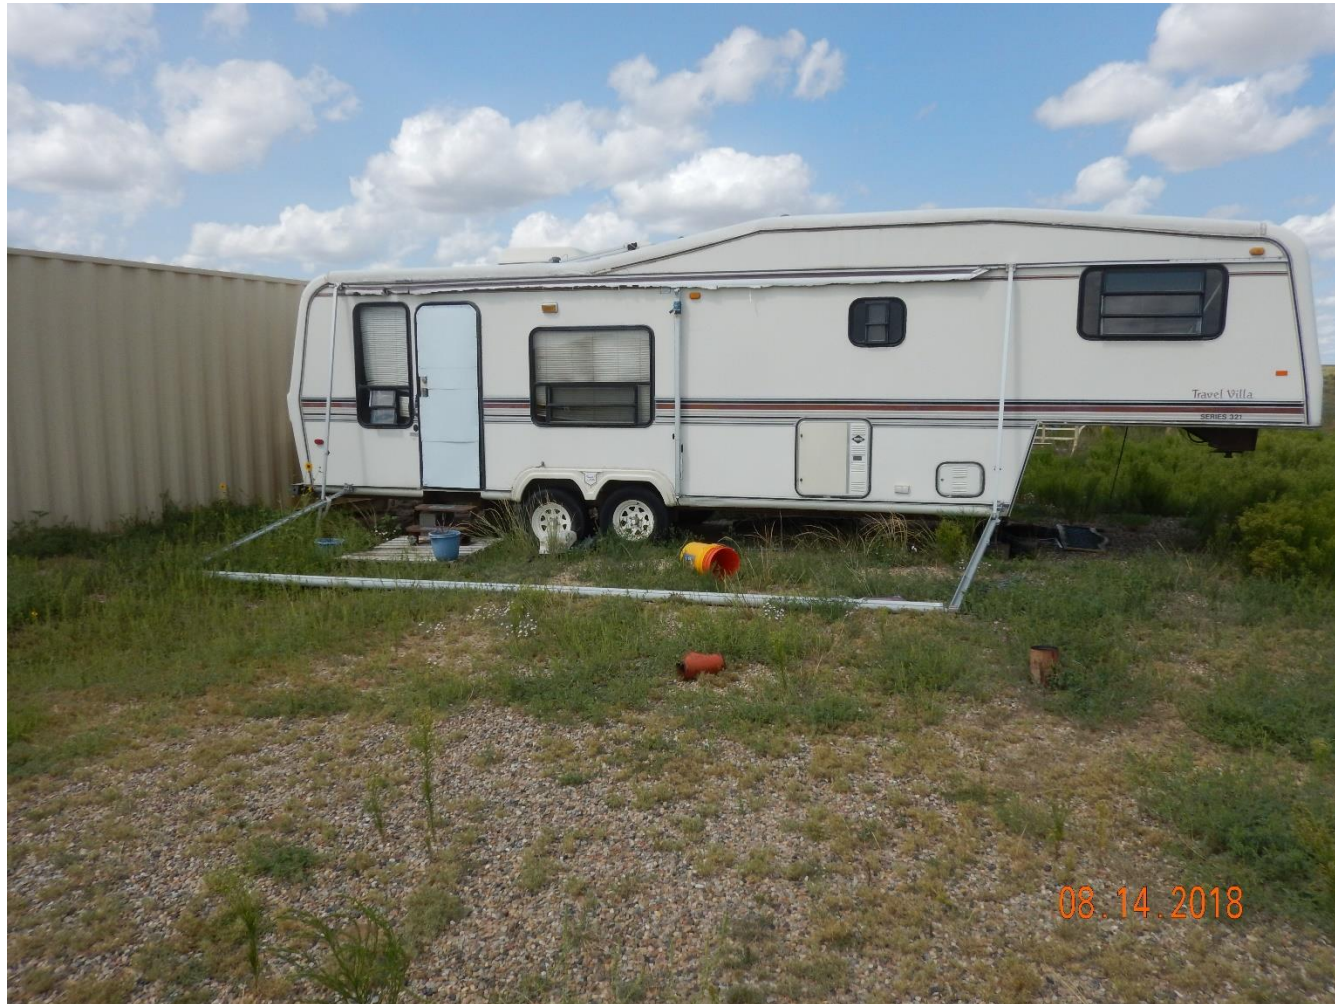
Photo 12: Photo taken from the north end of the location, facing north. Previous inspection documented camper trailer being stored on location. Trailer is not needed for production and was required to be removed. Camper trailer remains. Photo also shows various trash debris around camper trailer.

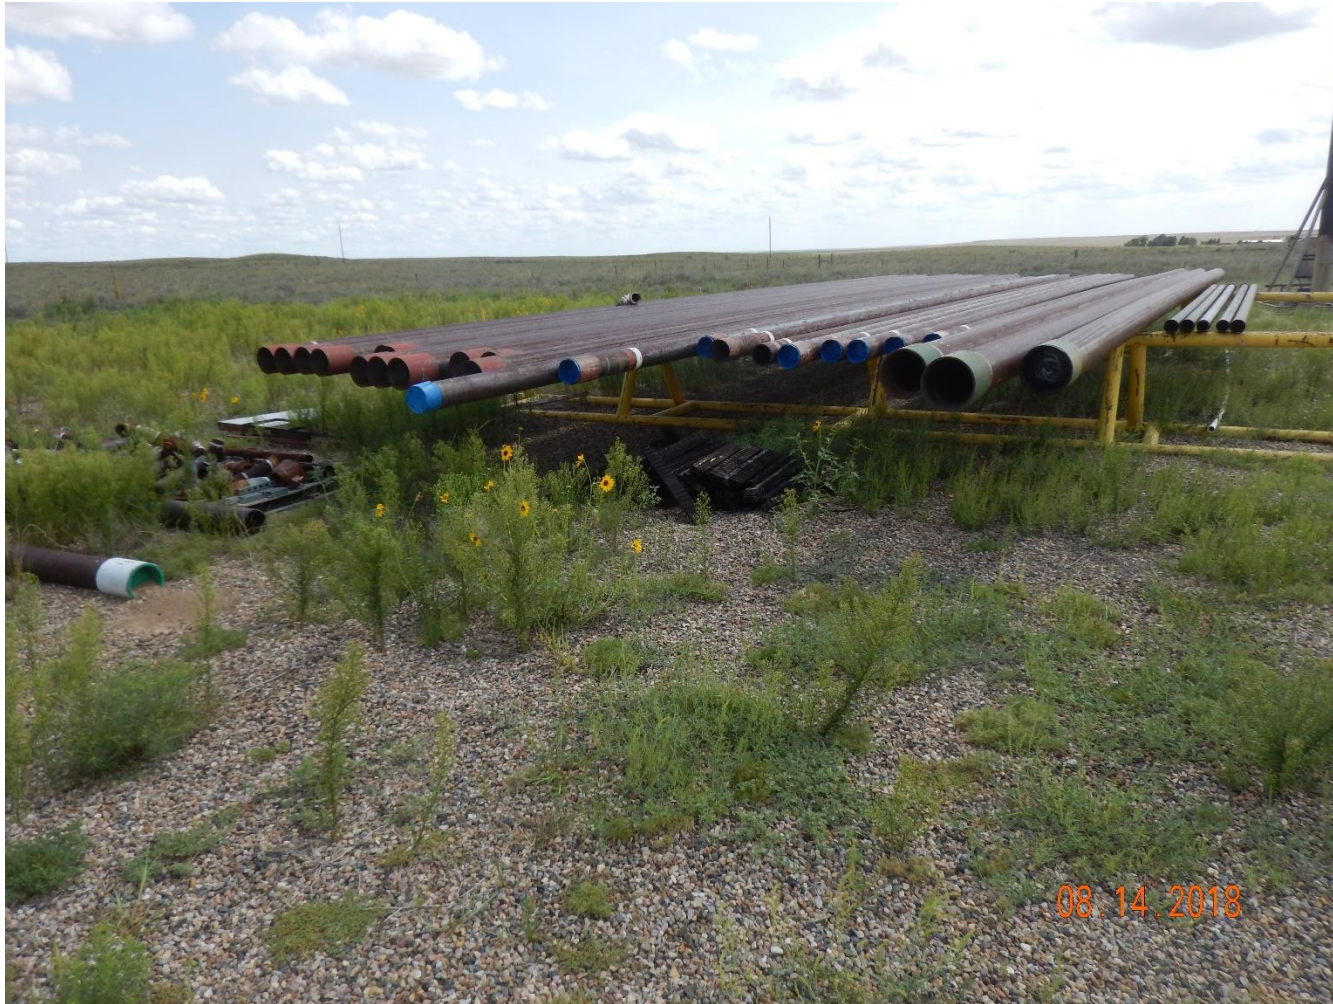
Photo 13: Photo taken from the north end of the location, facing south. Photo shows various unused equipment not needed for production stored on location.

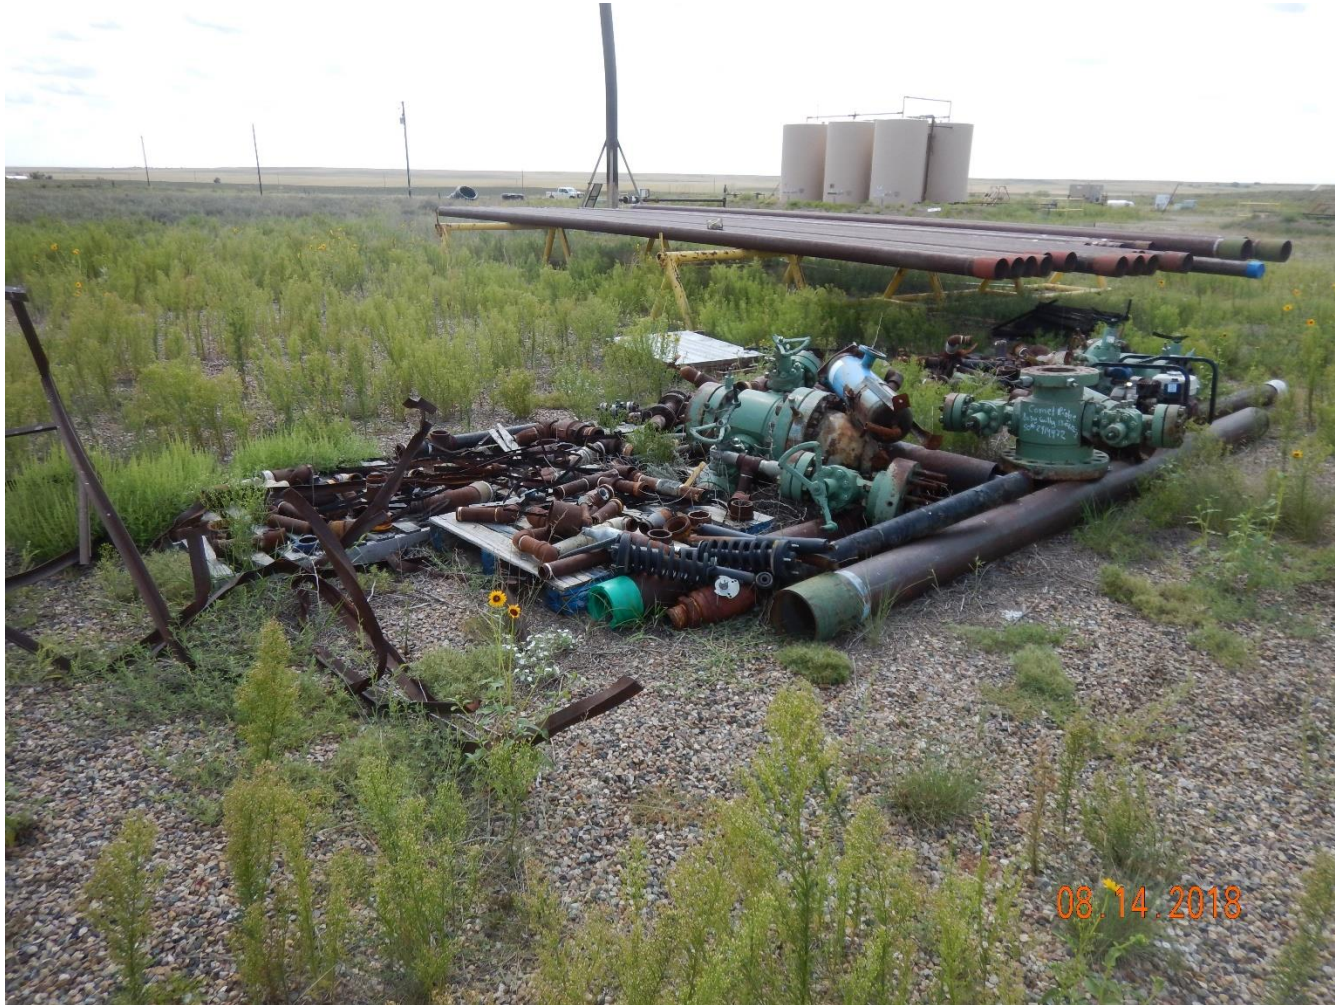
Photo 14: Photo taken from the north end of the location, facing southwest. Photo shows various unused equipment not needed for production stored on location.

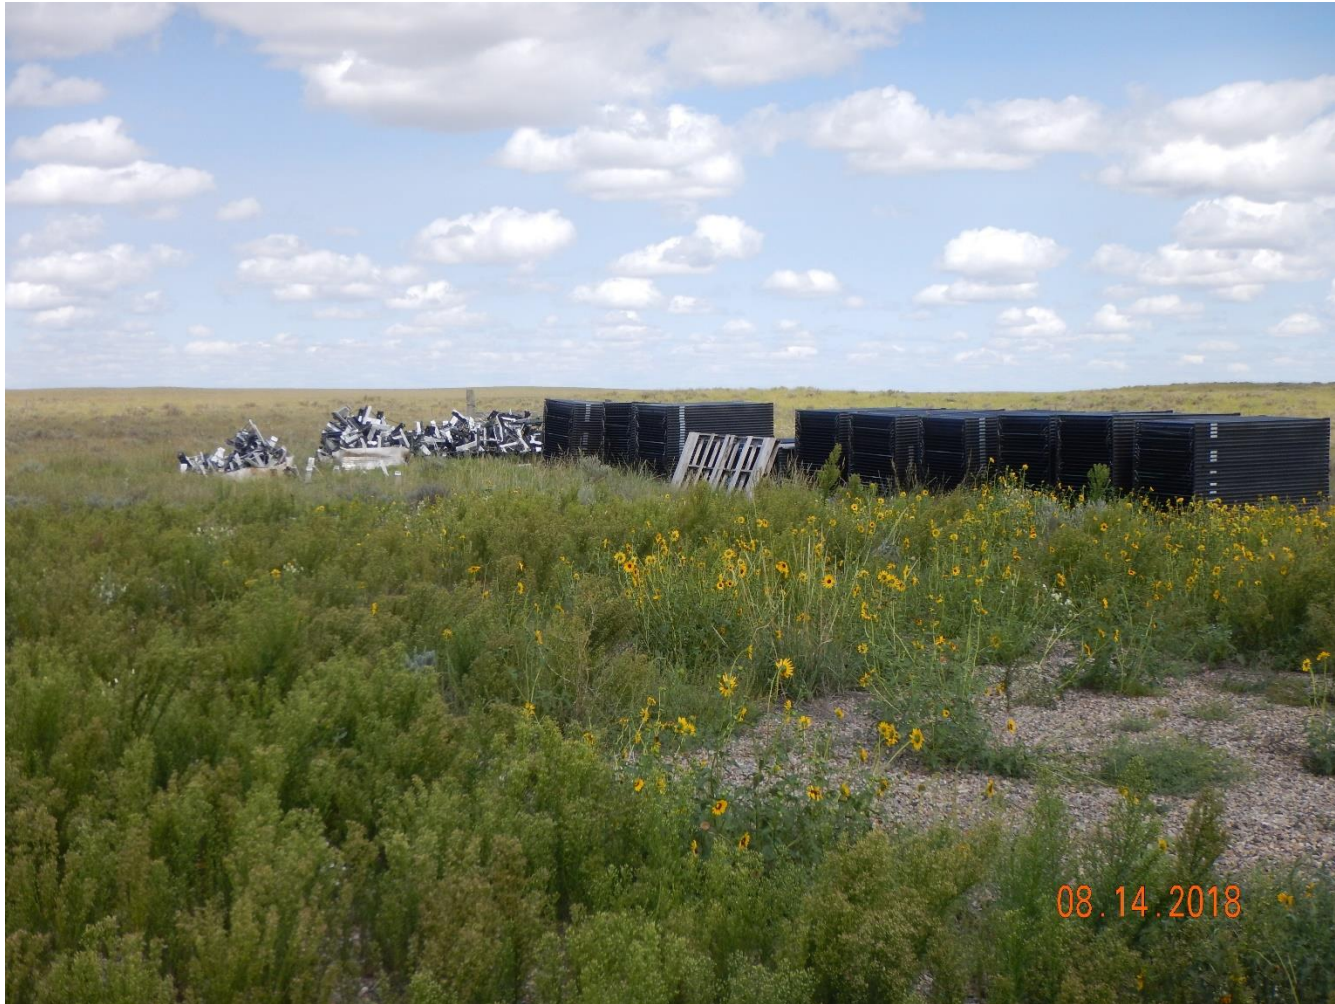
Photo 15: Photo taken from the north end of the location, facing northeast. Photo shows various unused equipment not needed for production stored on location.

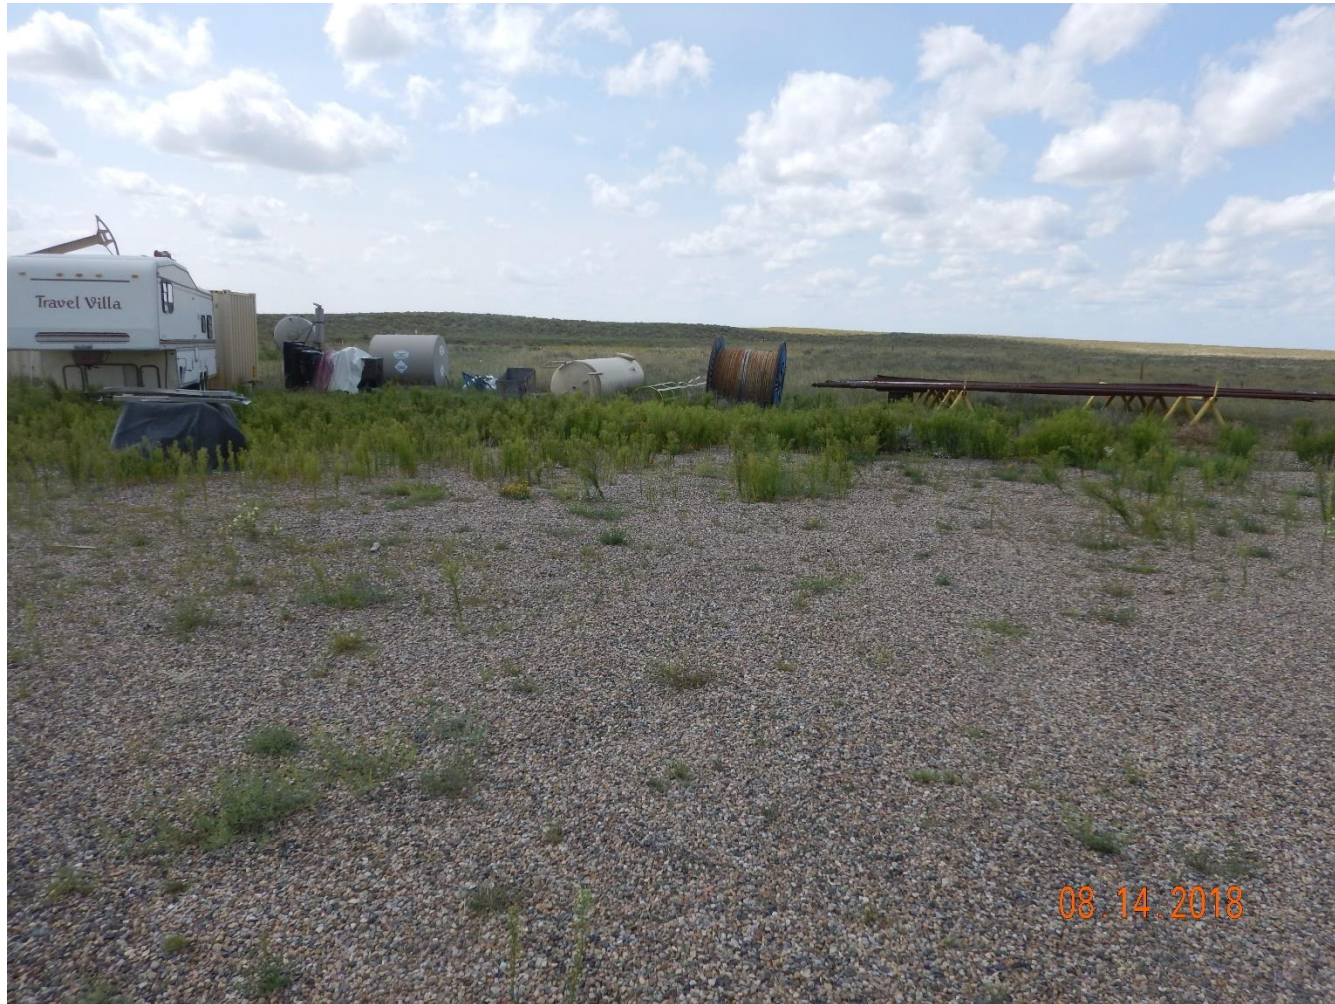
Photo 16: Photo taken from the north end of the location, facing west. Photo shows various unused equipment not needed for production stored on location.
