Inspection Photos

08/14/2018

Operator: ABILENE PERFECT ENERGY JV LLC -
10581

Location ID: 414589

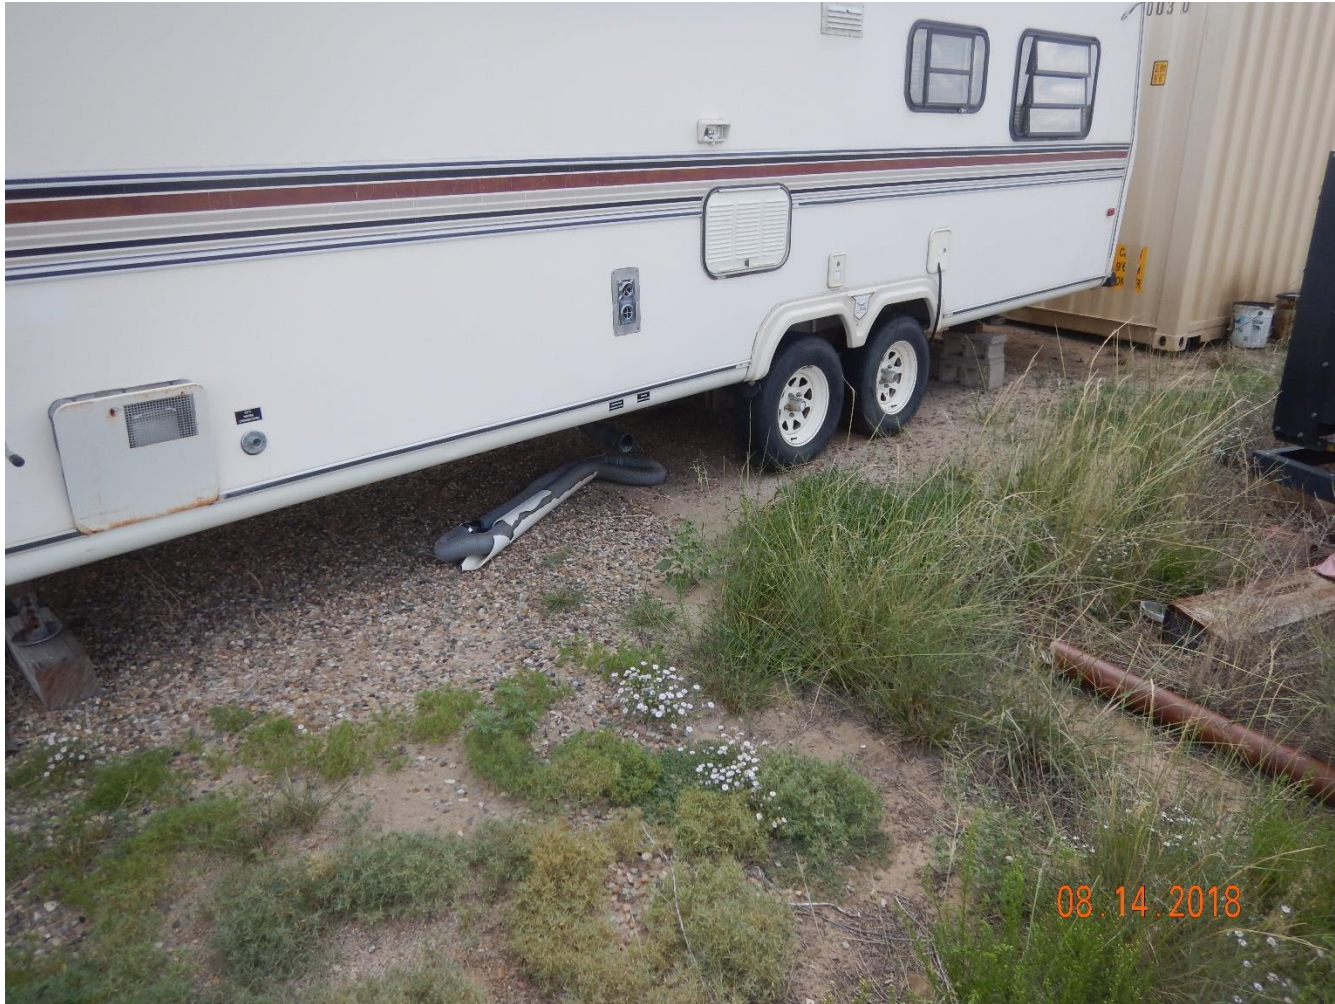
Photo 17: Photo taken from the north side of the camper trailer. Photo shows hose that appeared to have been attached to the grey/waste water valve of the camper has been disconnected.

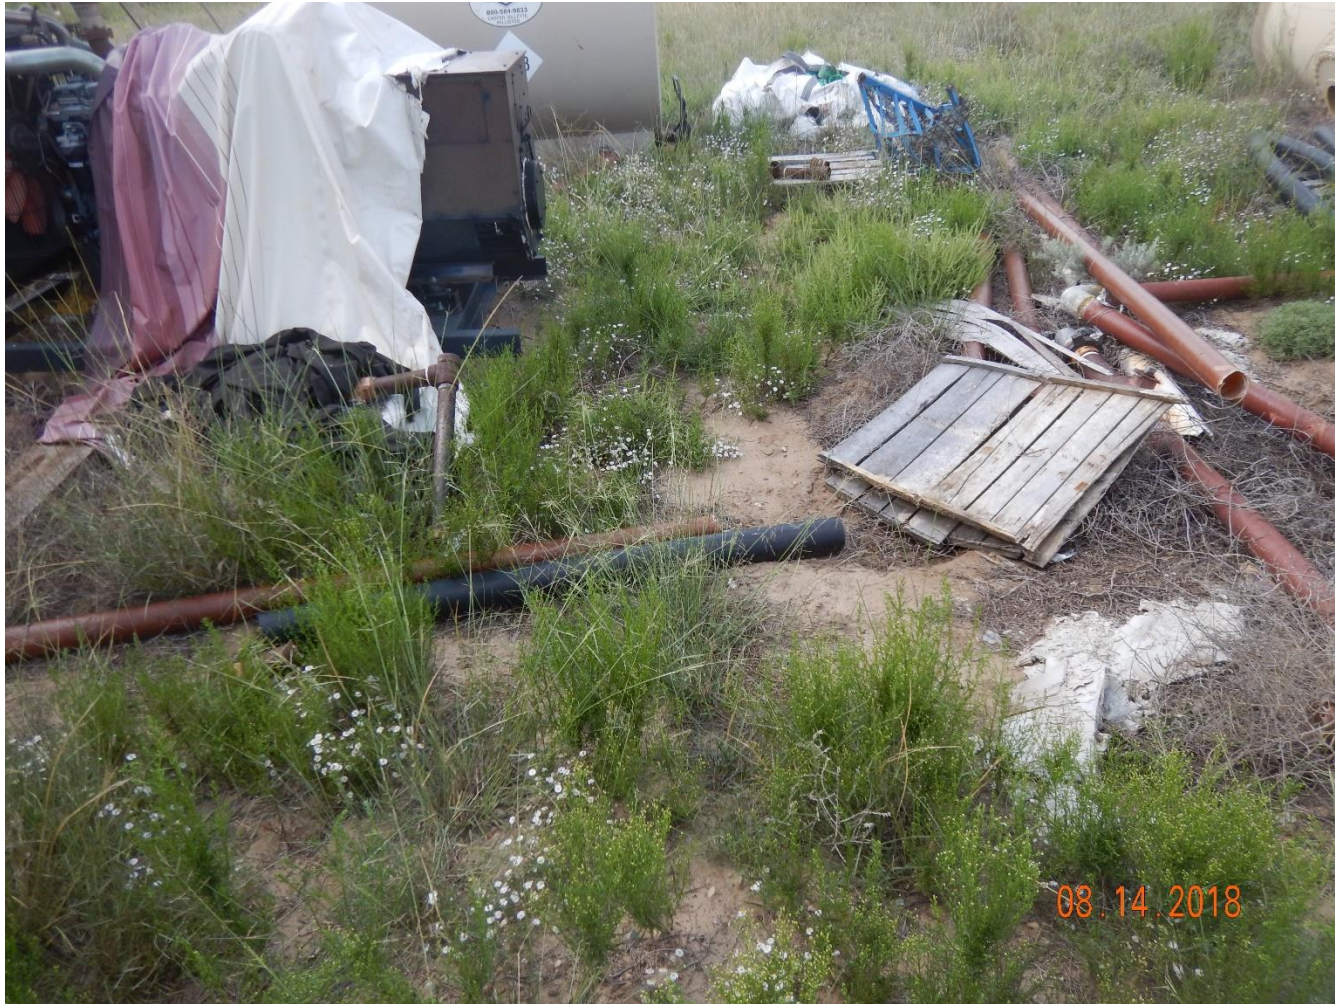
Photo 18: Photo taken from the north side of the camper trailer. Photo shows area where hose attached from camper lead to. Photo also shows various trash debris and unused equipment remaining on location.

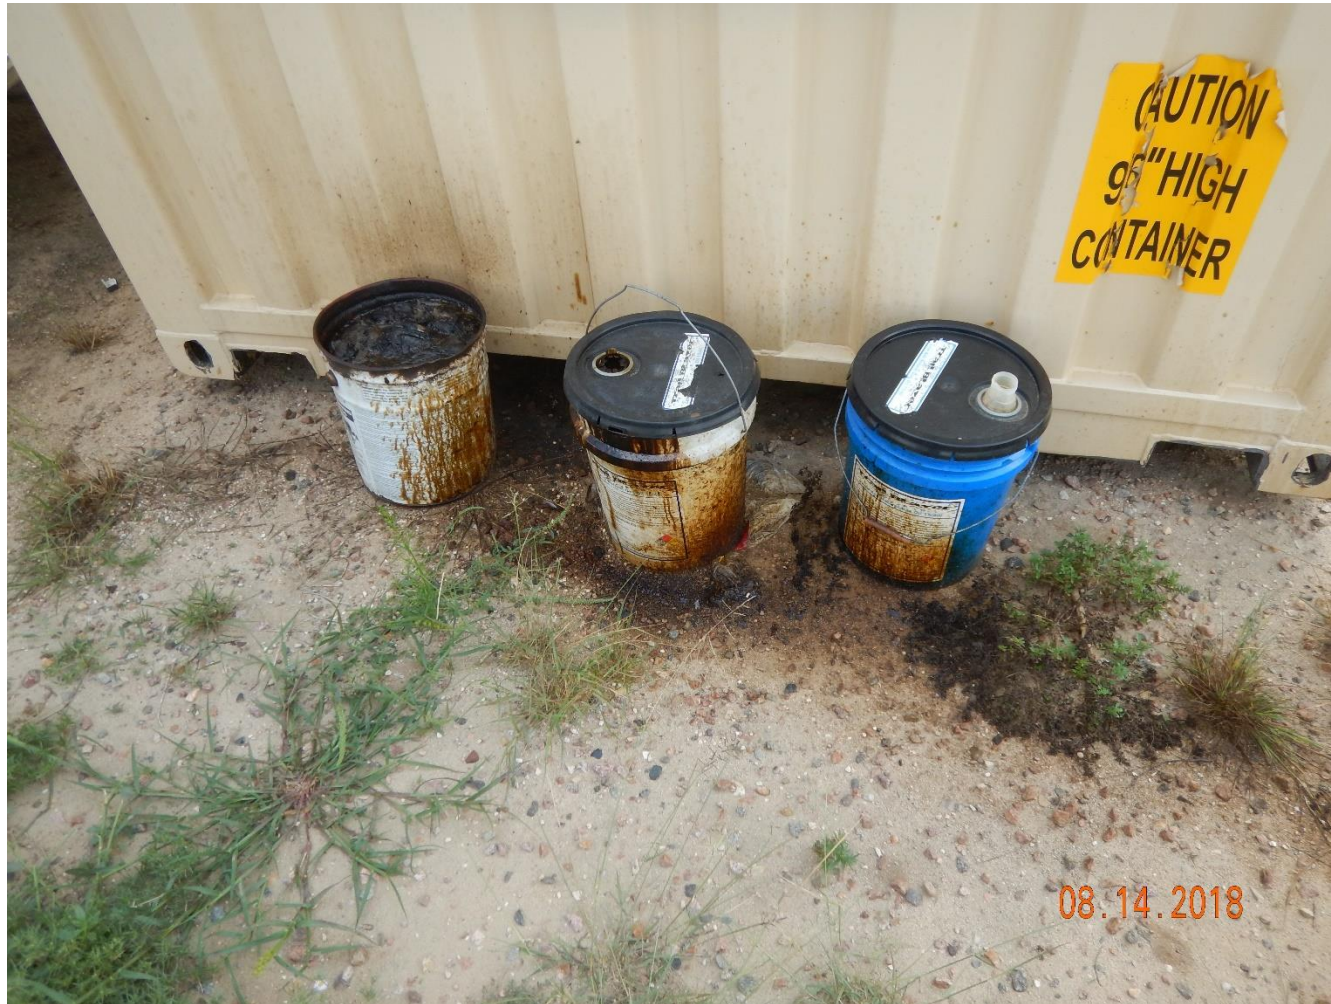
Photo 19: Photo taken from the north end of the location. Previous inspections documented 5 gallon buckets w/ chemical and stained soils and required buckets to be properly removed and disposed, or placed into containment and soil cleaned. Photo shows buckets and contaminated soils remain.

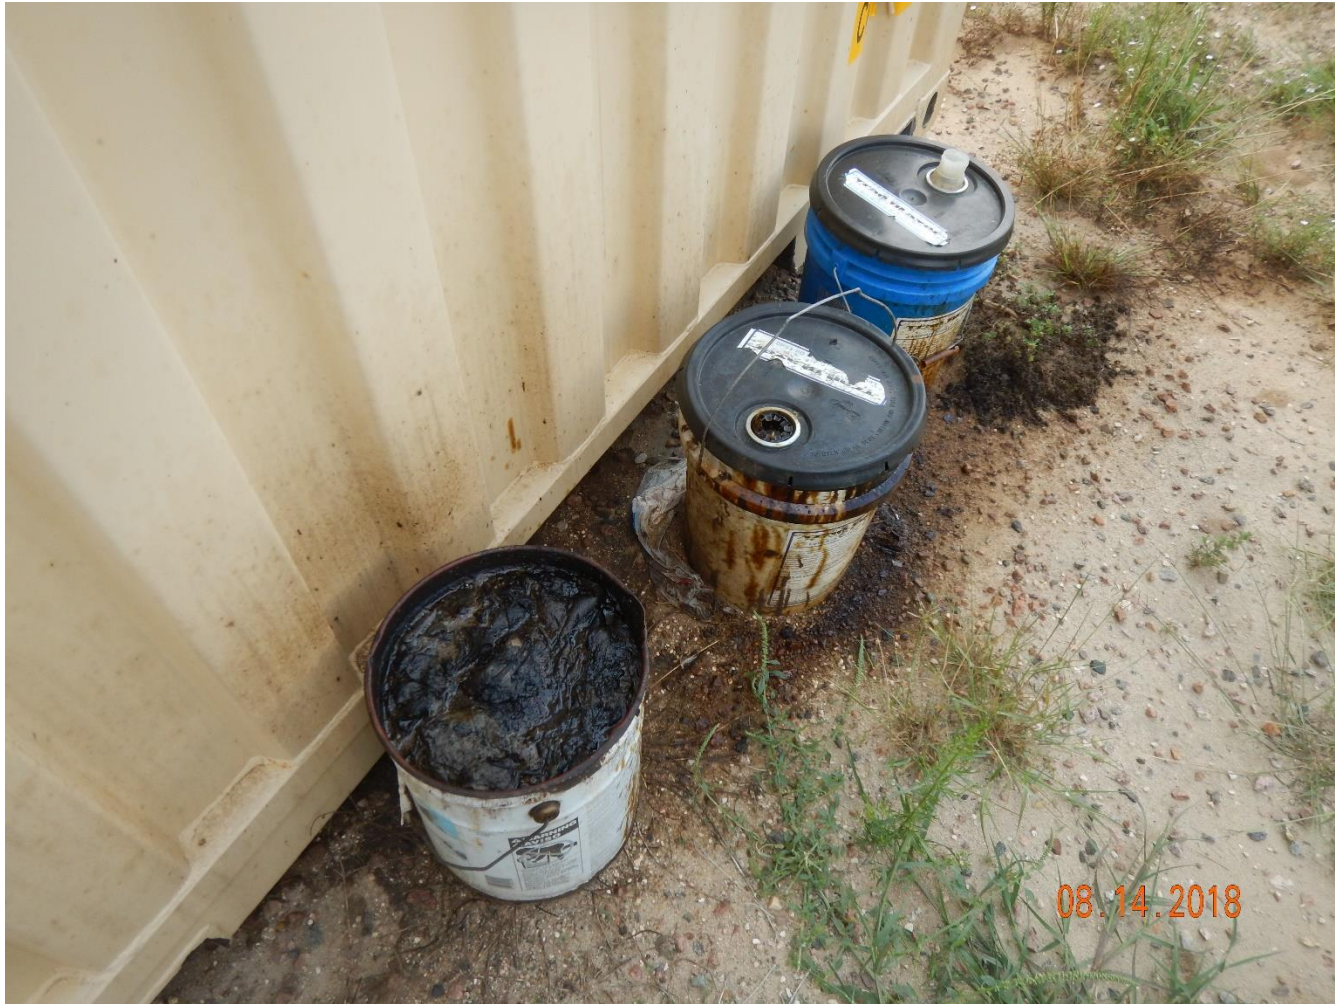
Photo 20: Continued from photo 19.

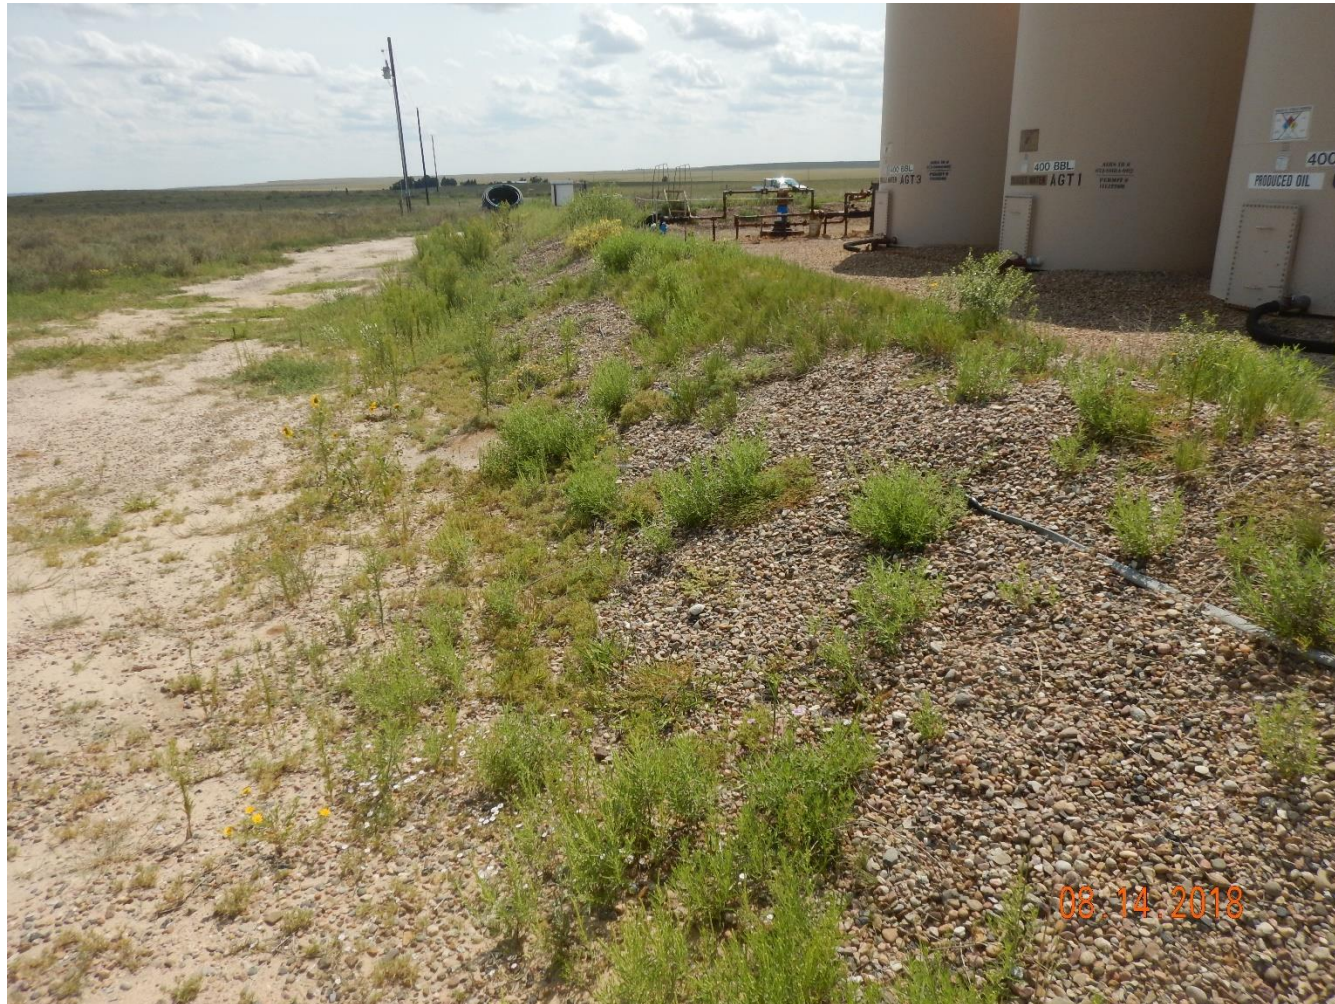
Photo 21: Photo taken from the northeast corner of the tank battery, facing south. Previous inspections required operator to remove vegetation from the berms of the battery and production equipment; vegetation compromises the integrity of the containment berms. Photo shows vegetation has not been removed.

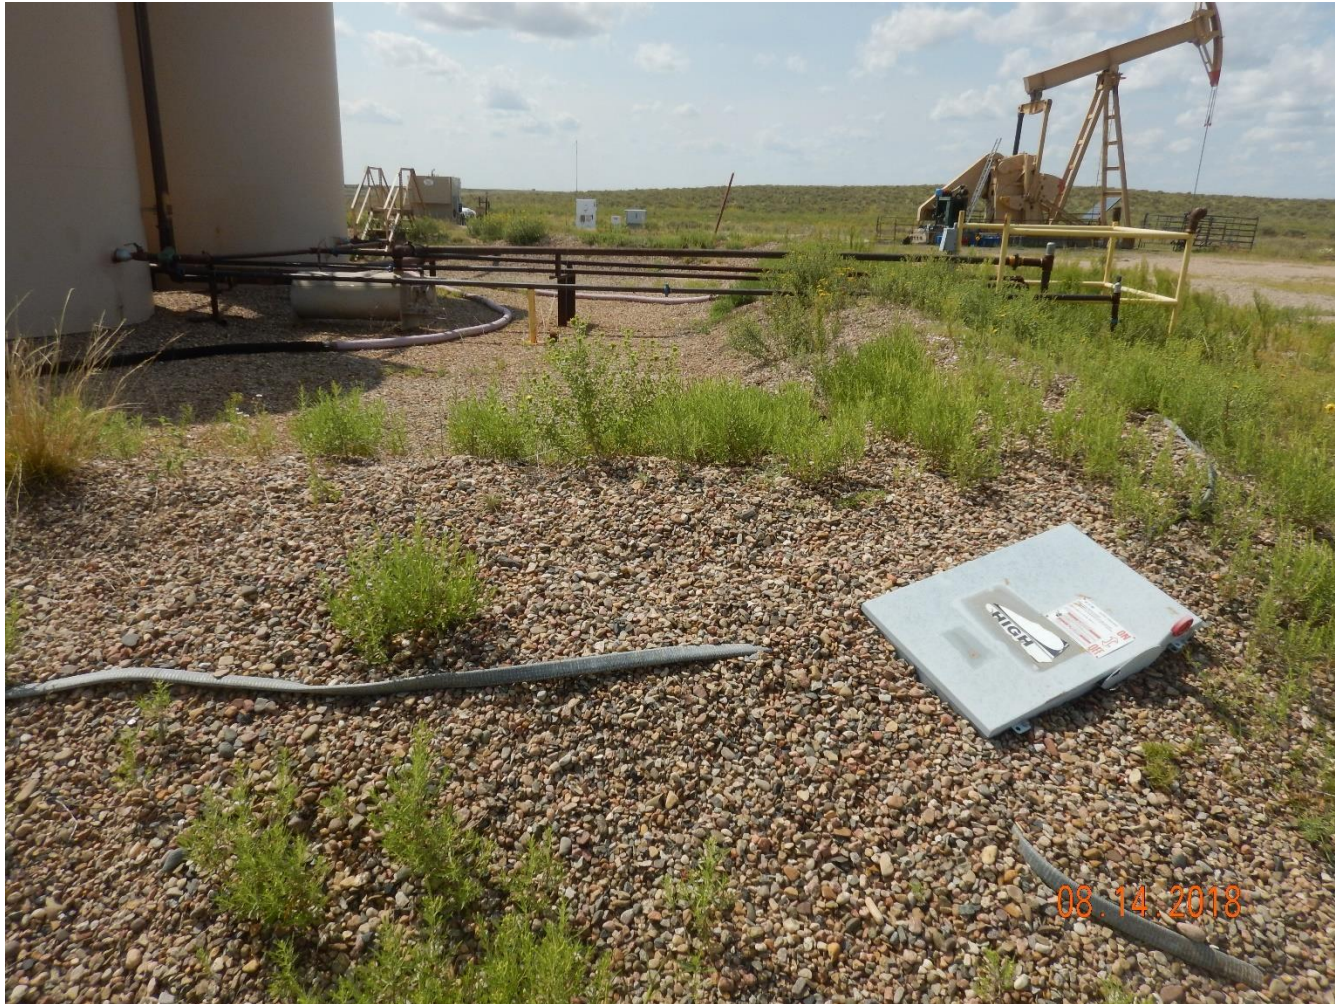
Photo 22: Photo taken from the northeast corner of the tank battery, facing west. See comments under photo 21.

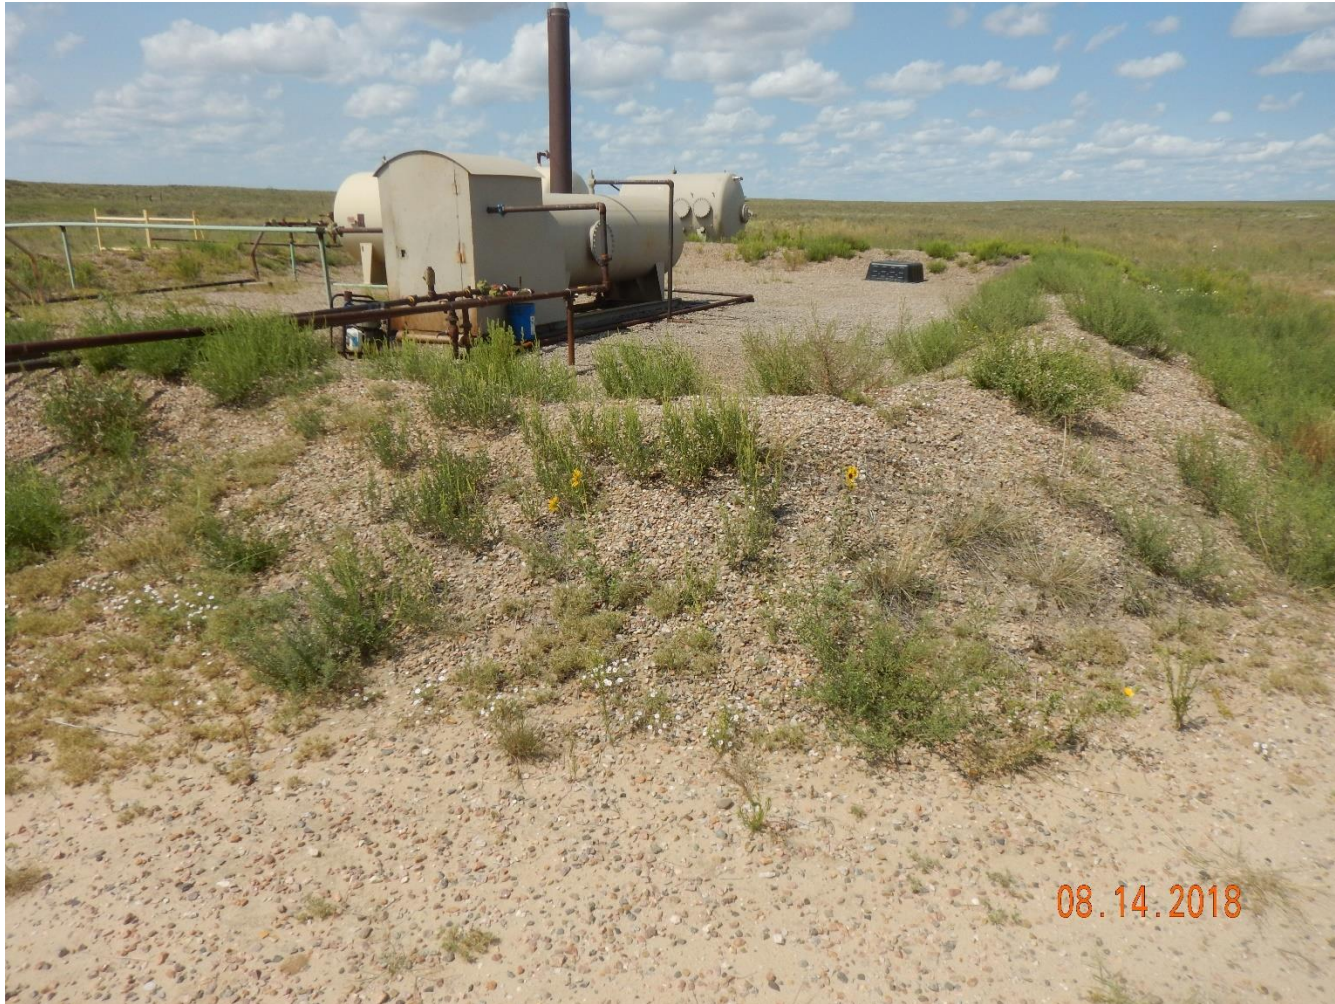
Photo 23: Photo taken from the north end of the location, facing north. See comments under photo 21.

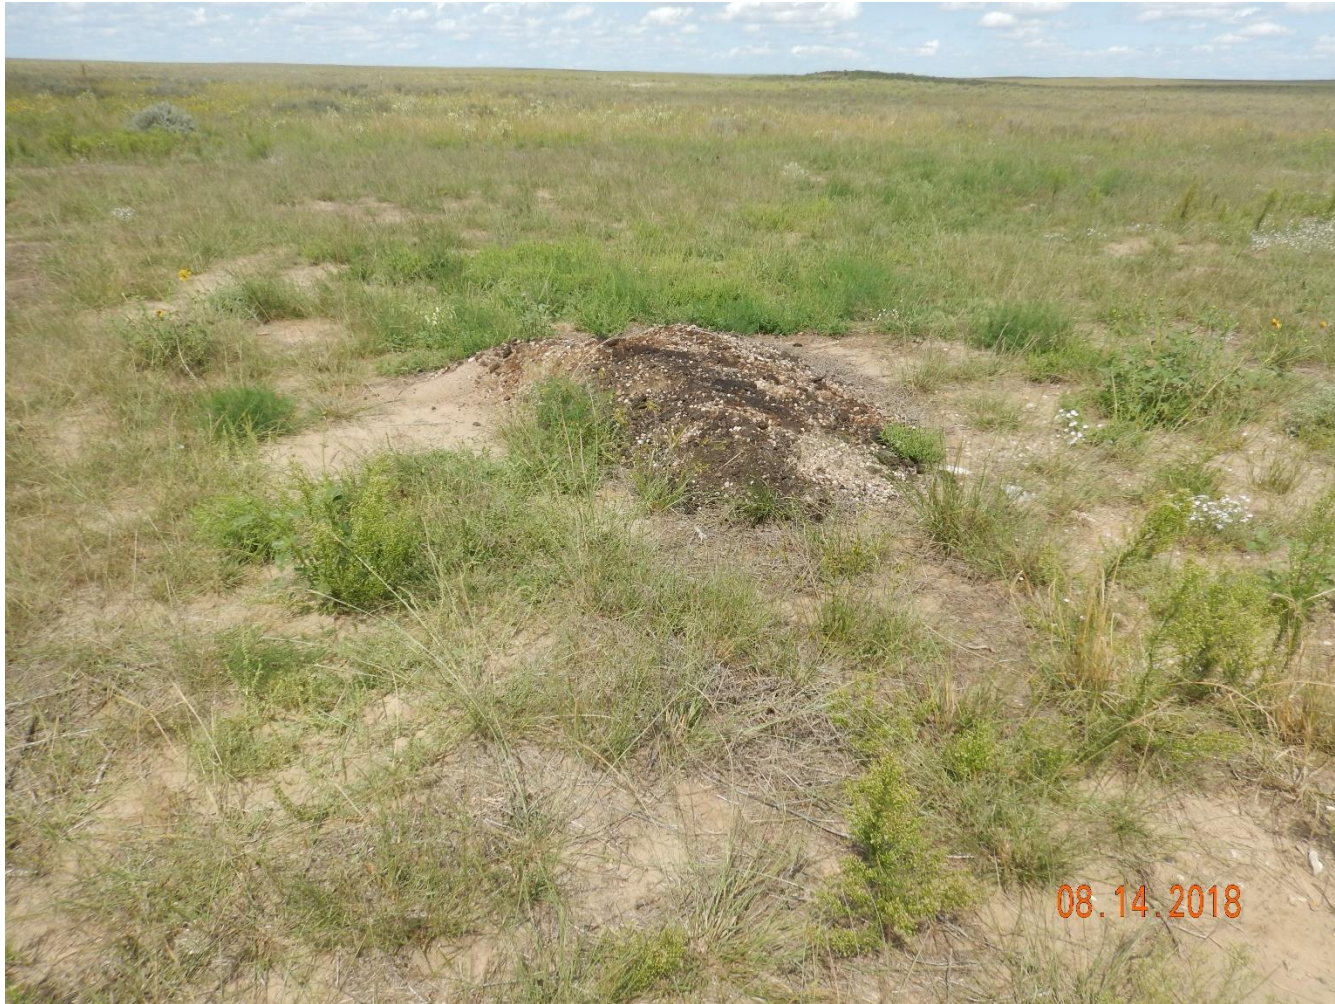
Photo 24: Photo taken from the north end of the location. Previous inspections documented stained (E&P waste) soil piled on the north end of the location and required operator to properly treat or dispose. Photo shows pile remains.
