Inspection Photos

Operator: SG Interests

API: 05-051-06059

Date: 7/25/2018

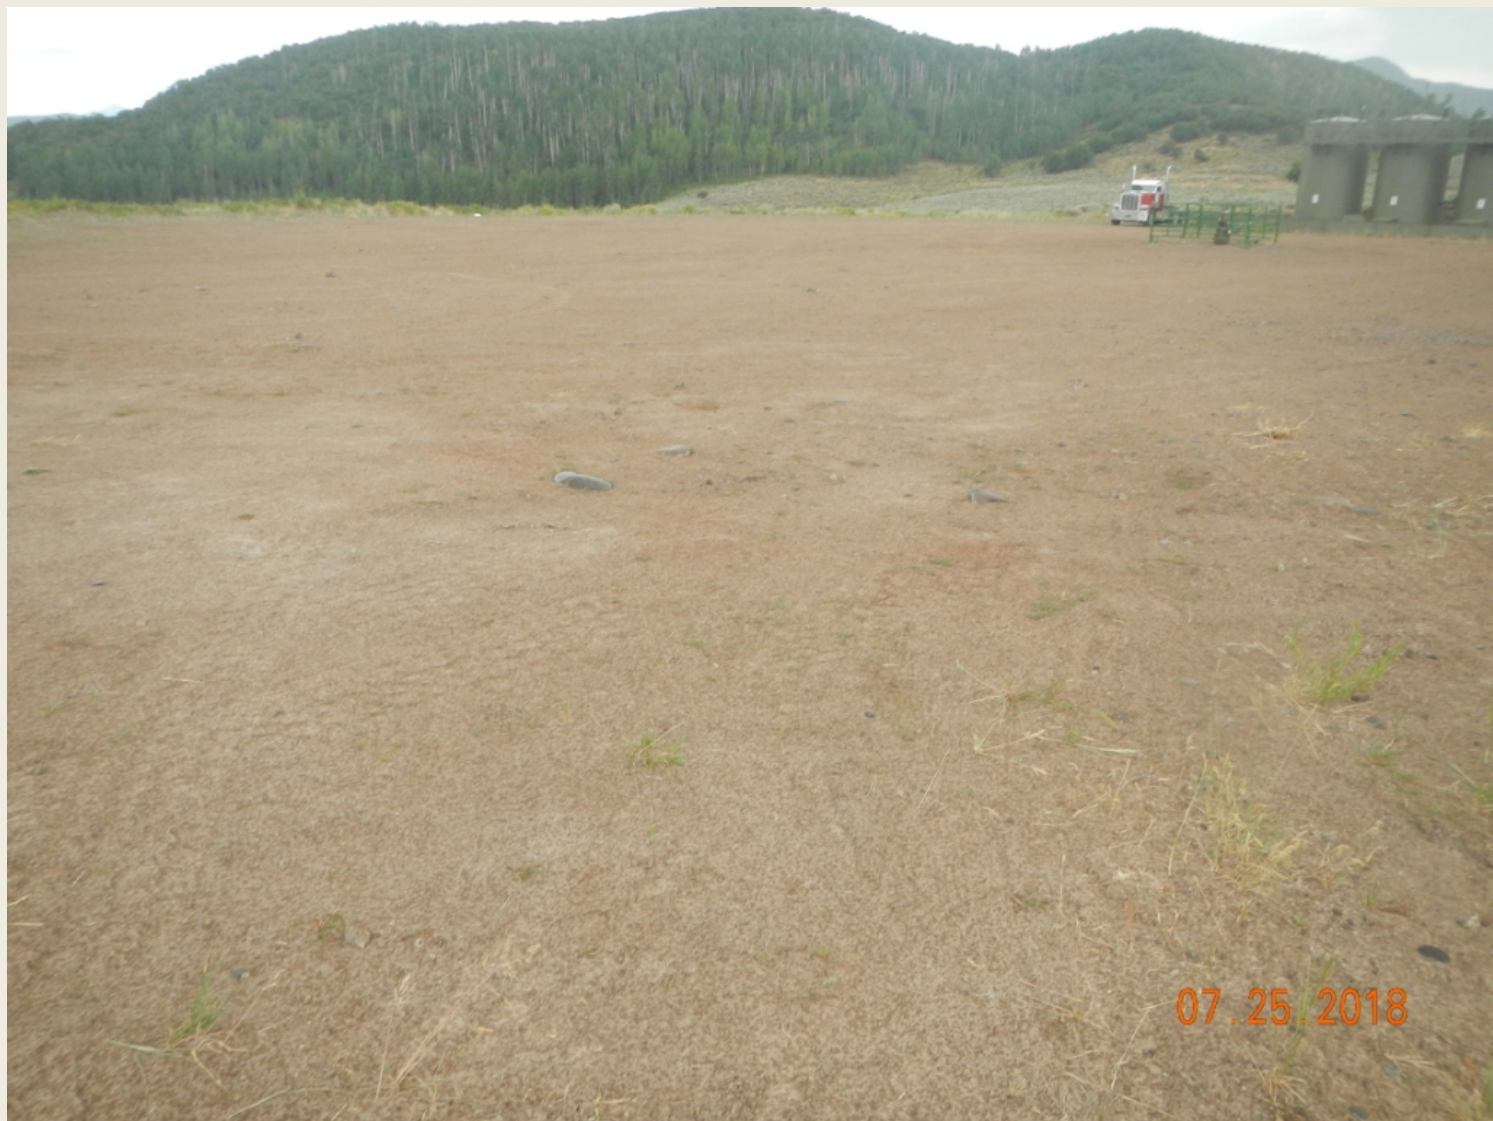
Photo 1. View of the project area from the northeastern corner facing center.

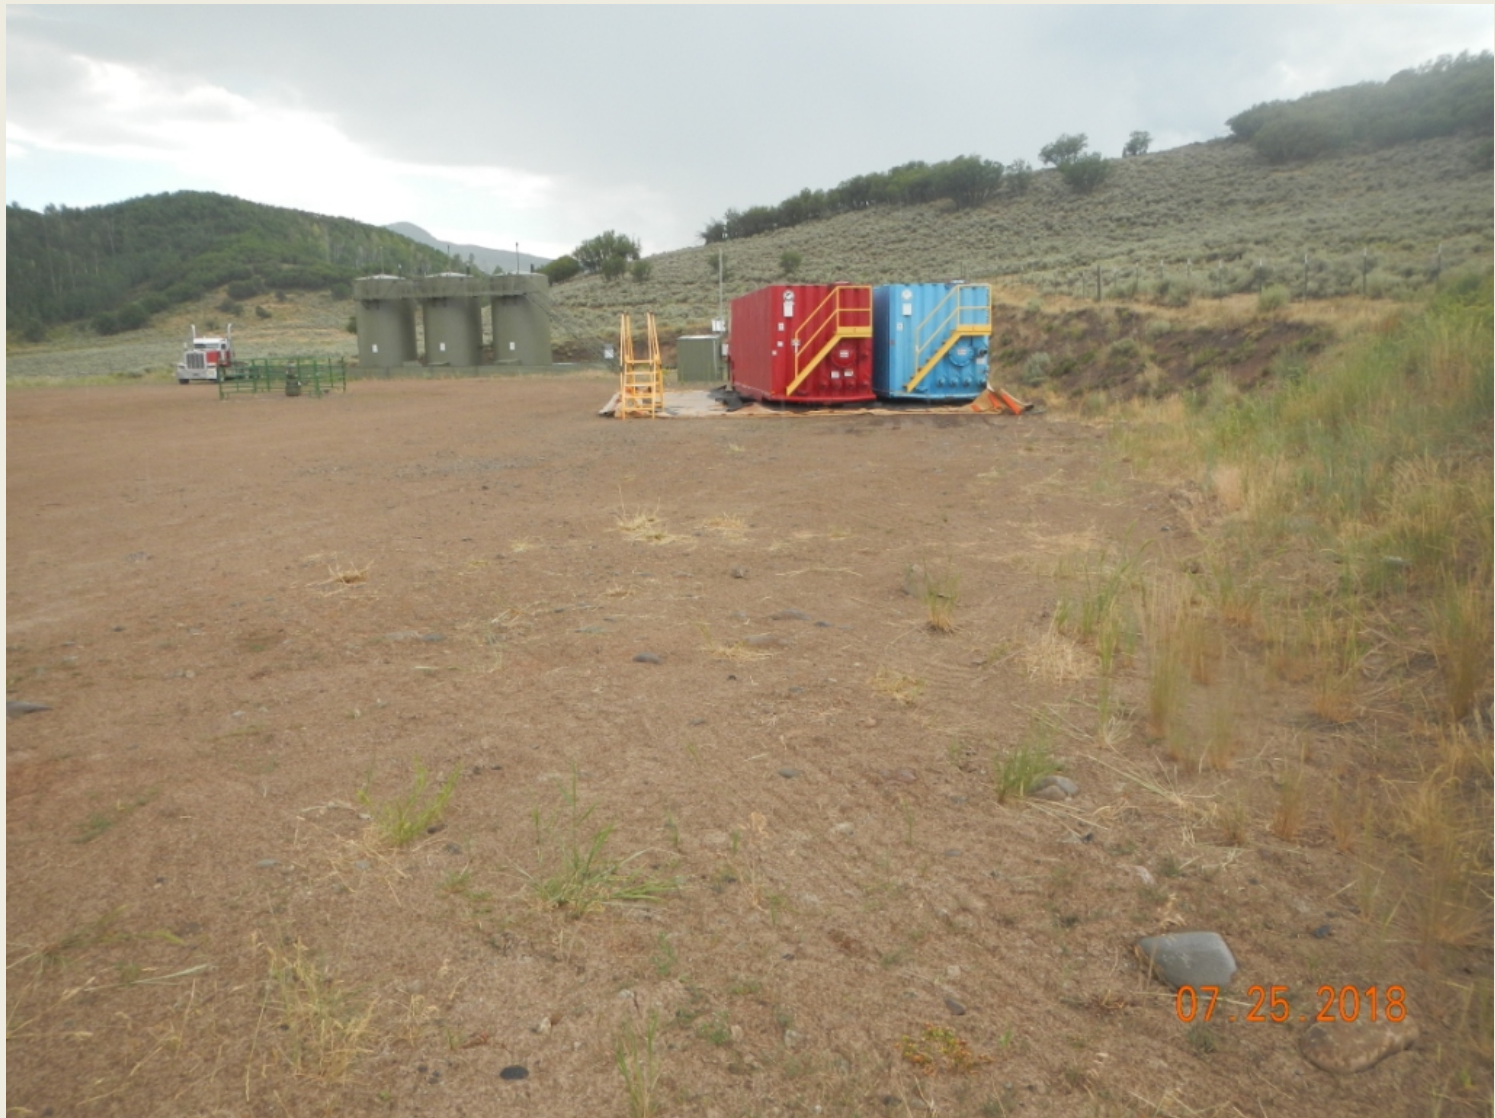
Photo 2. View of the northern portion of the project area from the northeastern corner facing westward.

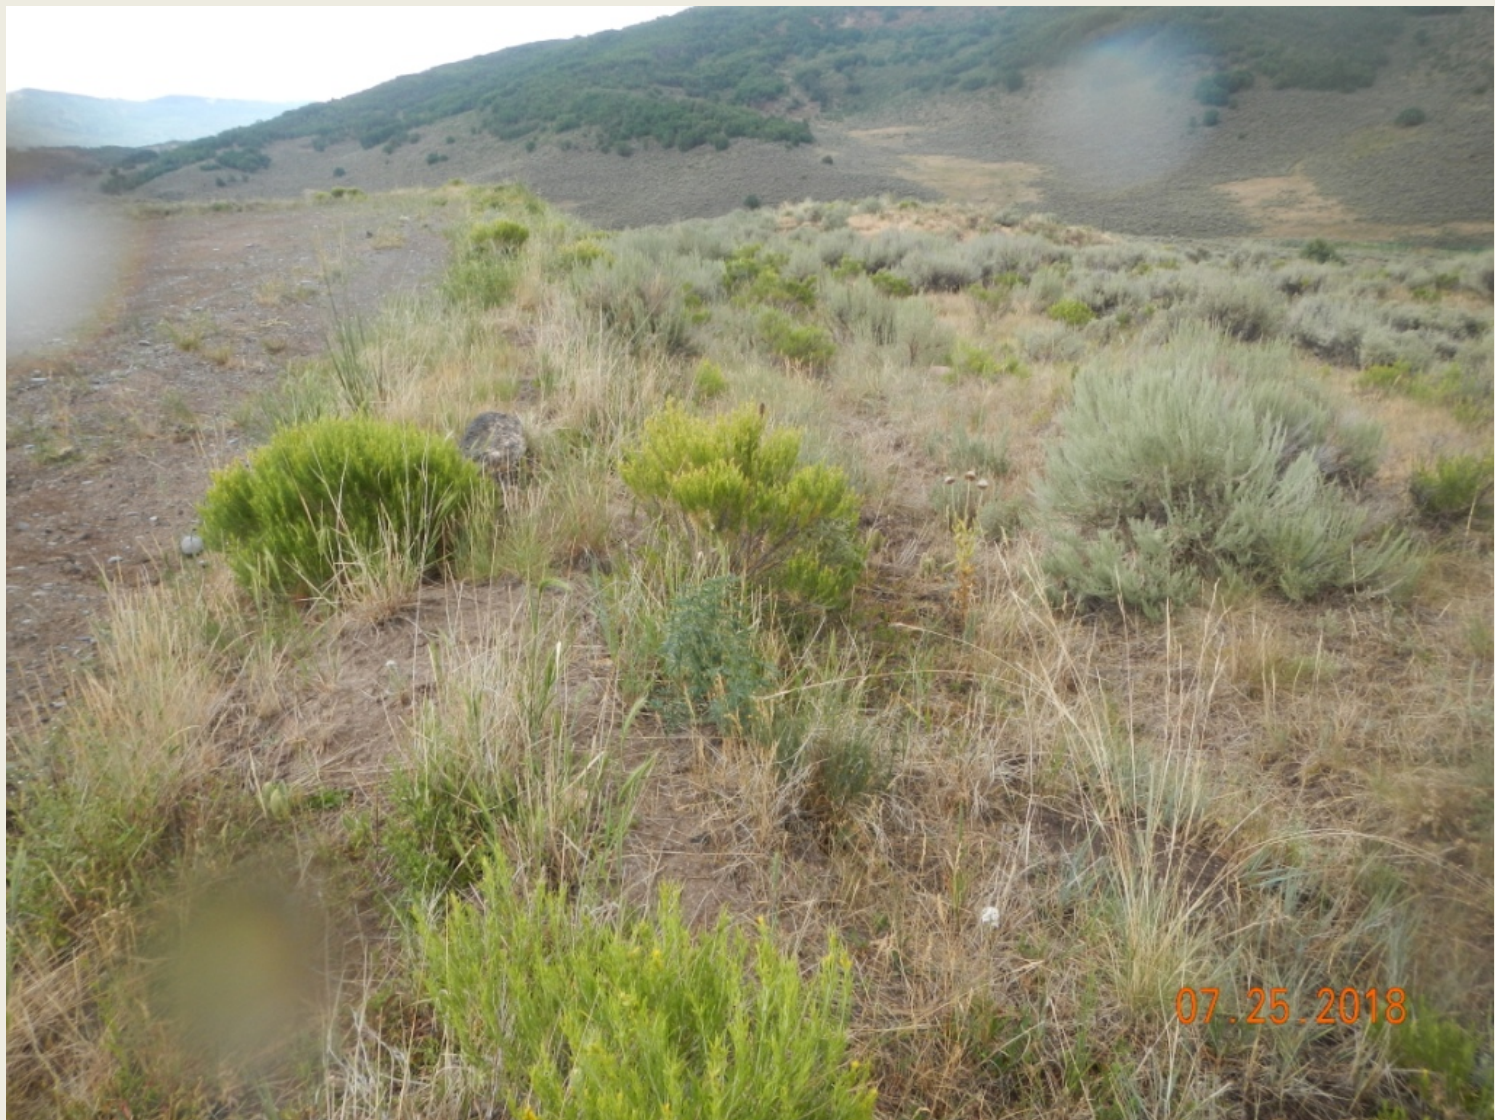
Photo 3. View of the southern portion of the southwestern corner facing eastward.

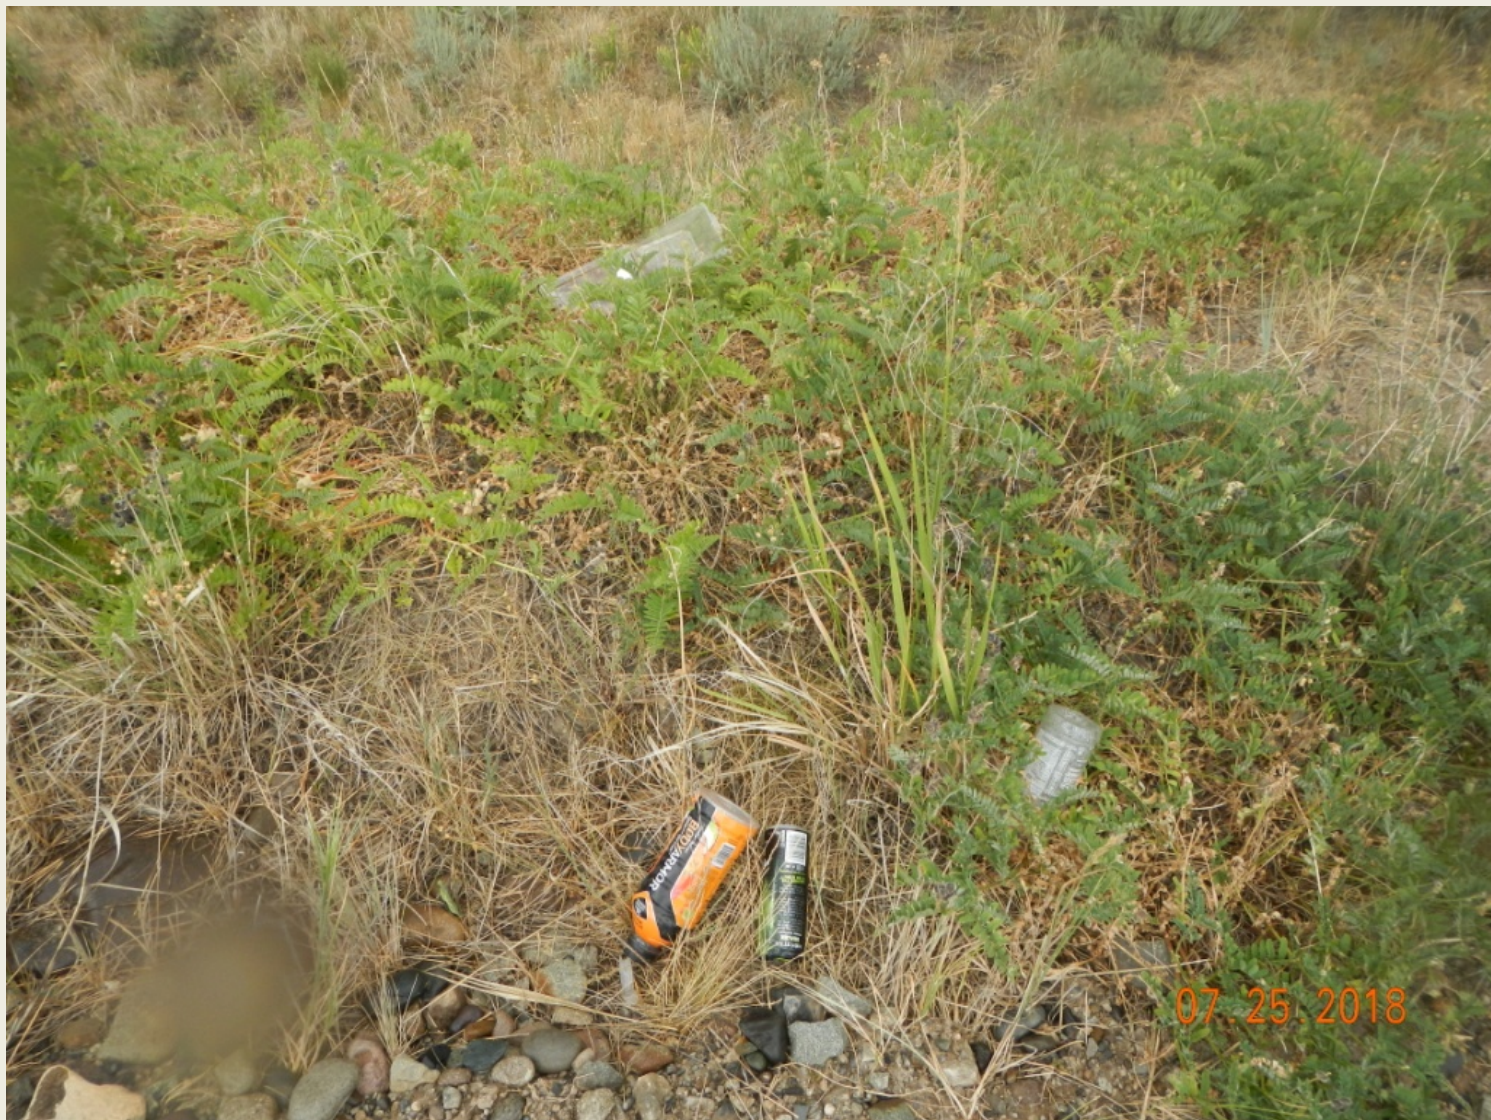
Photo 4. View of small pieces of trash in the southern interim reclamation area.

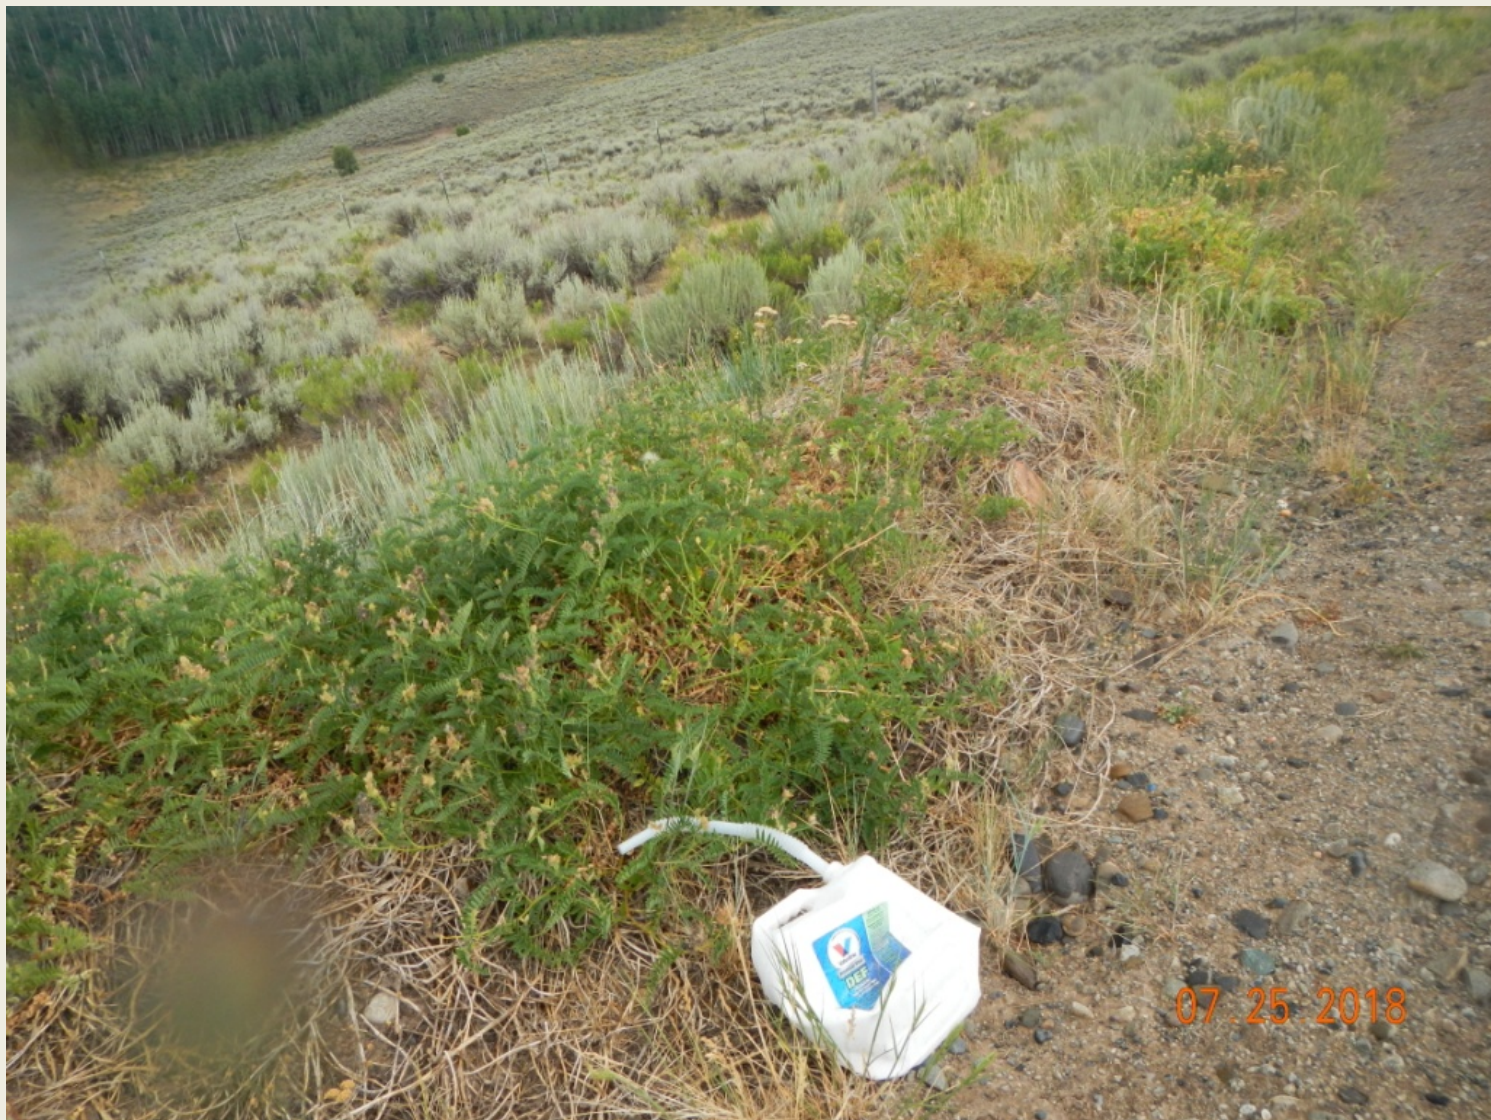
Photo 5. View of trash along the southern edge of the well pad.

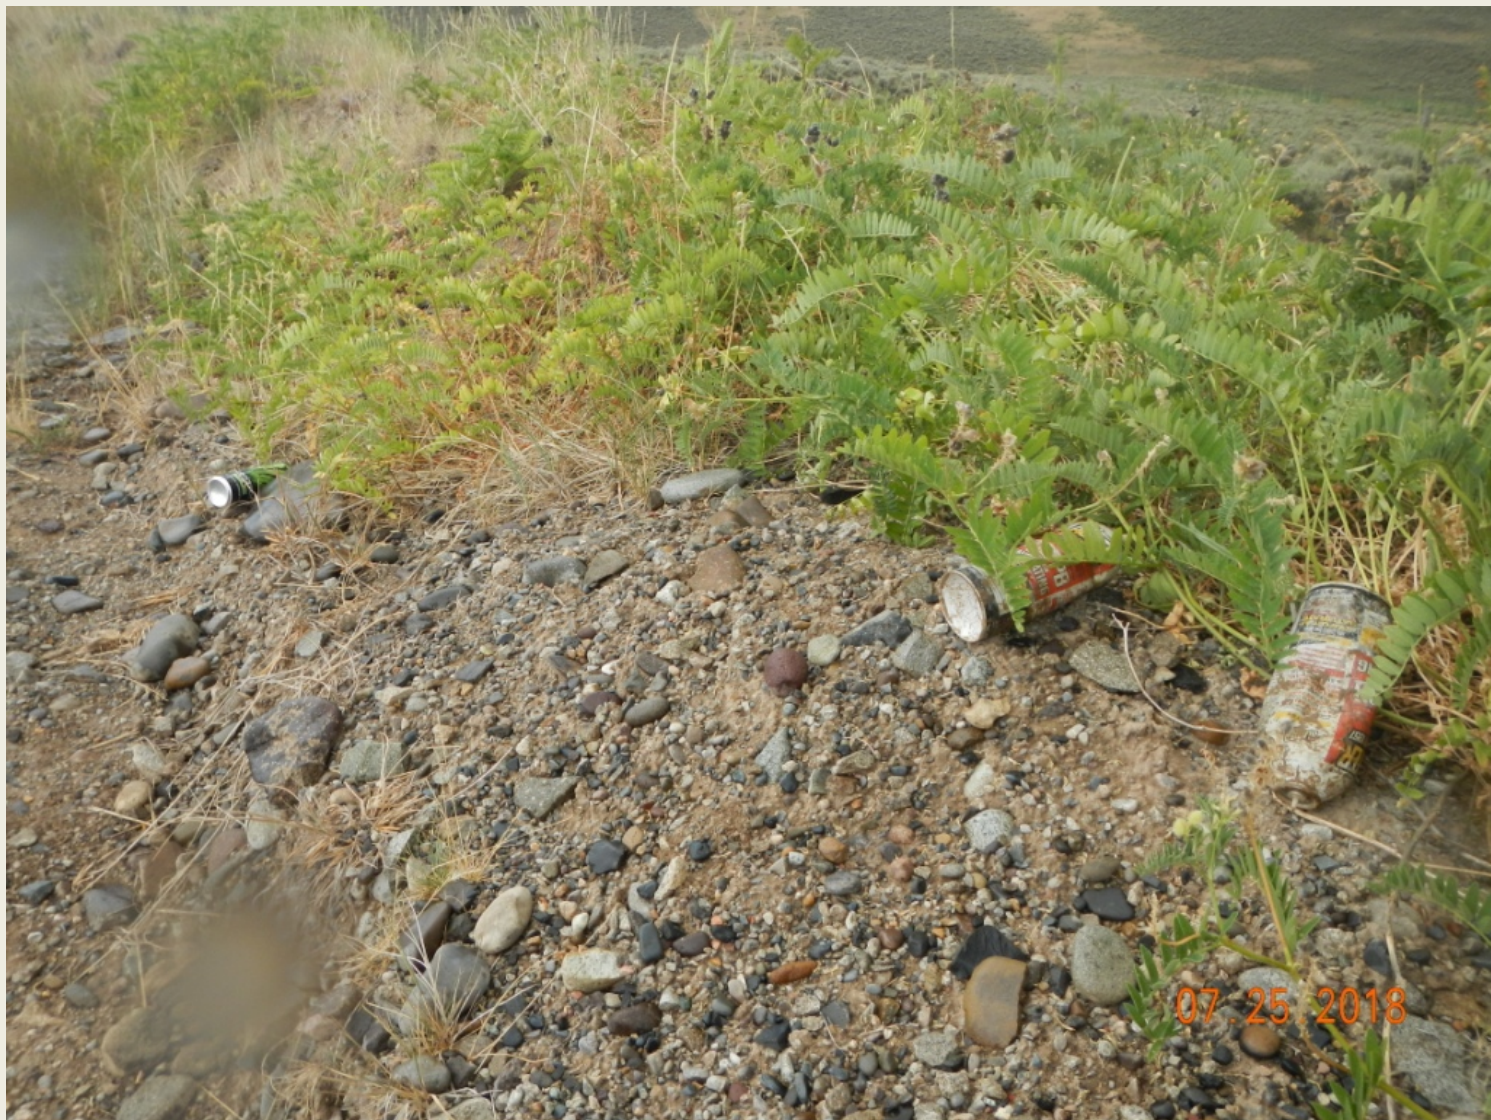
Photo 6. View of more small trash on the southern edge of the project area.

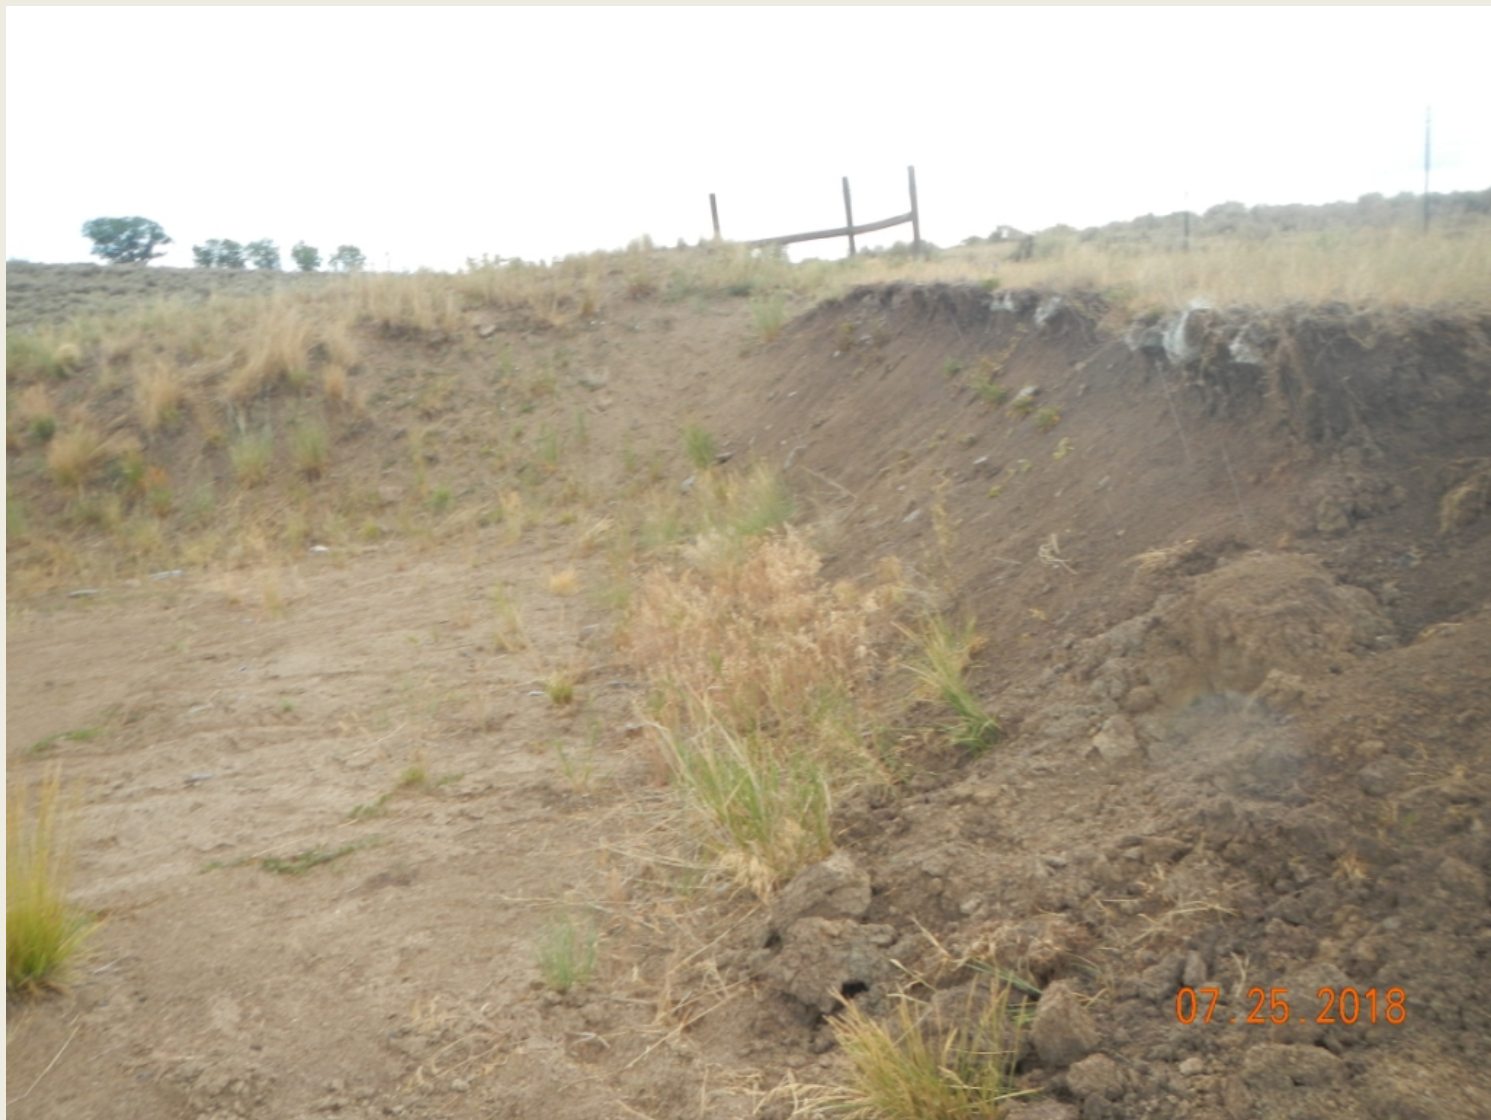
Photo 7. View of cut-slope along northeastern edge of project area that is sloughing and eroding. Erosion controls are needed to stabilize this slope.
