Inspection Photos

Operator: SG Interests

API: 05-051-06070

Date: 7/26/2018

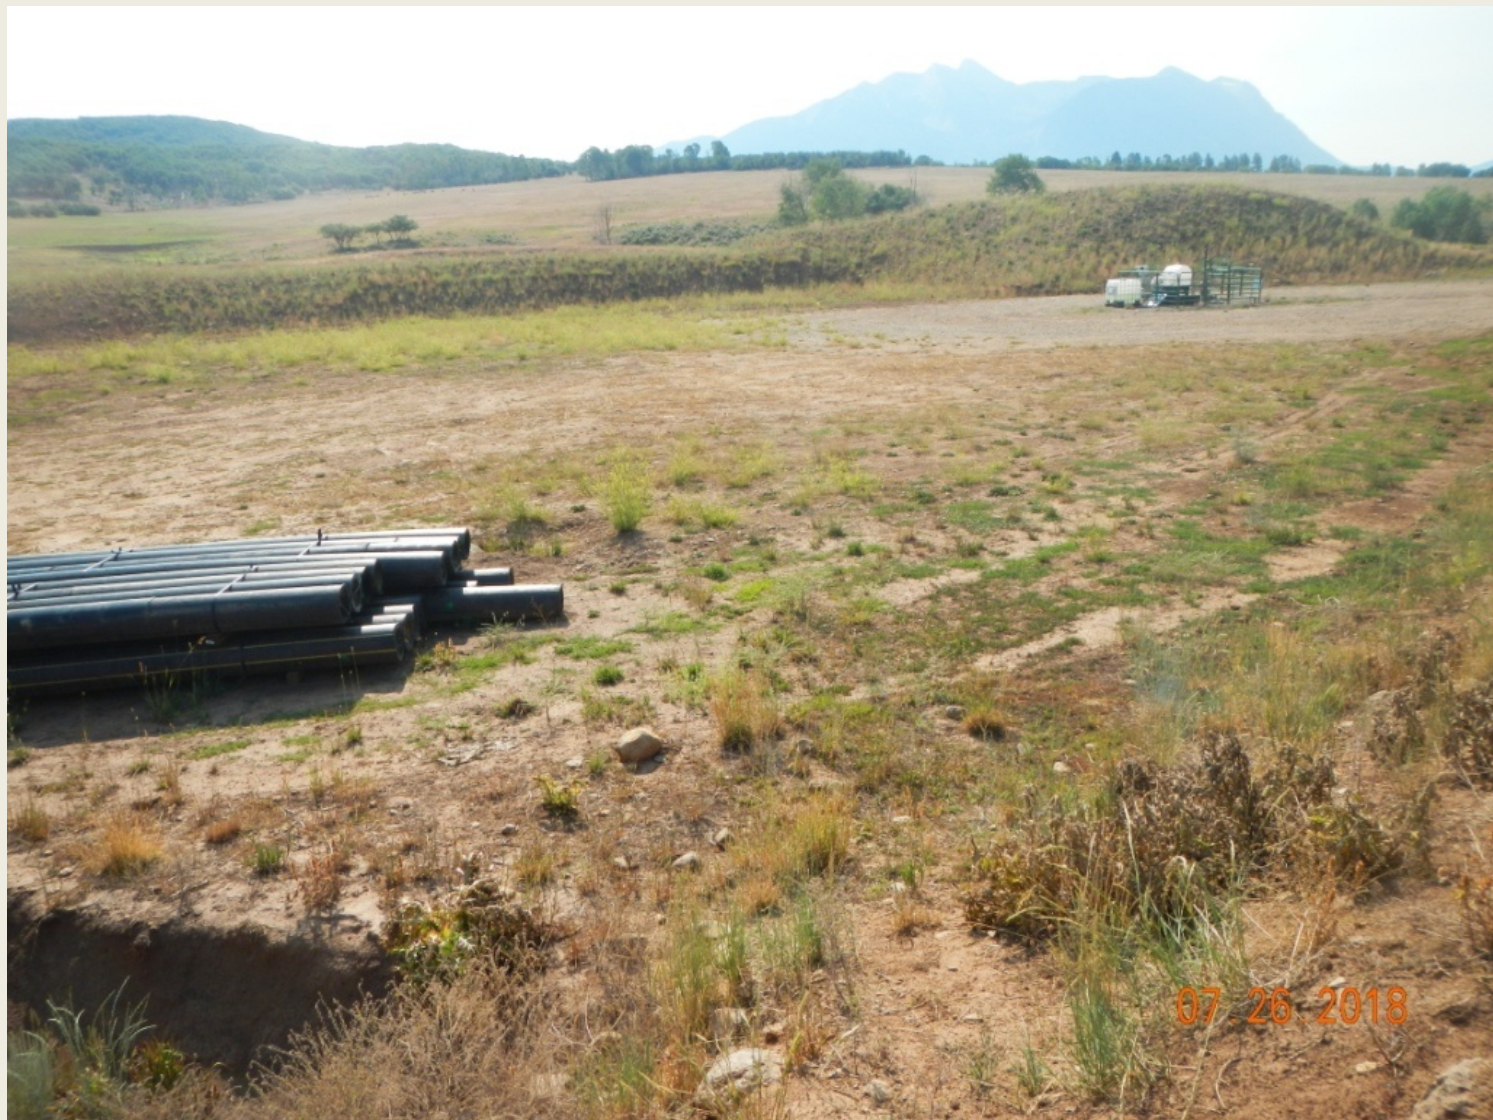
Photo 1. View of the project area from the northwestern corner facing center.

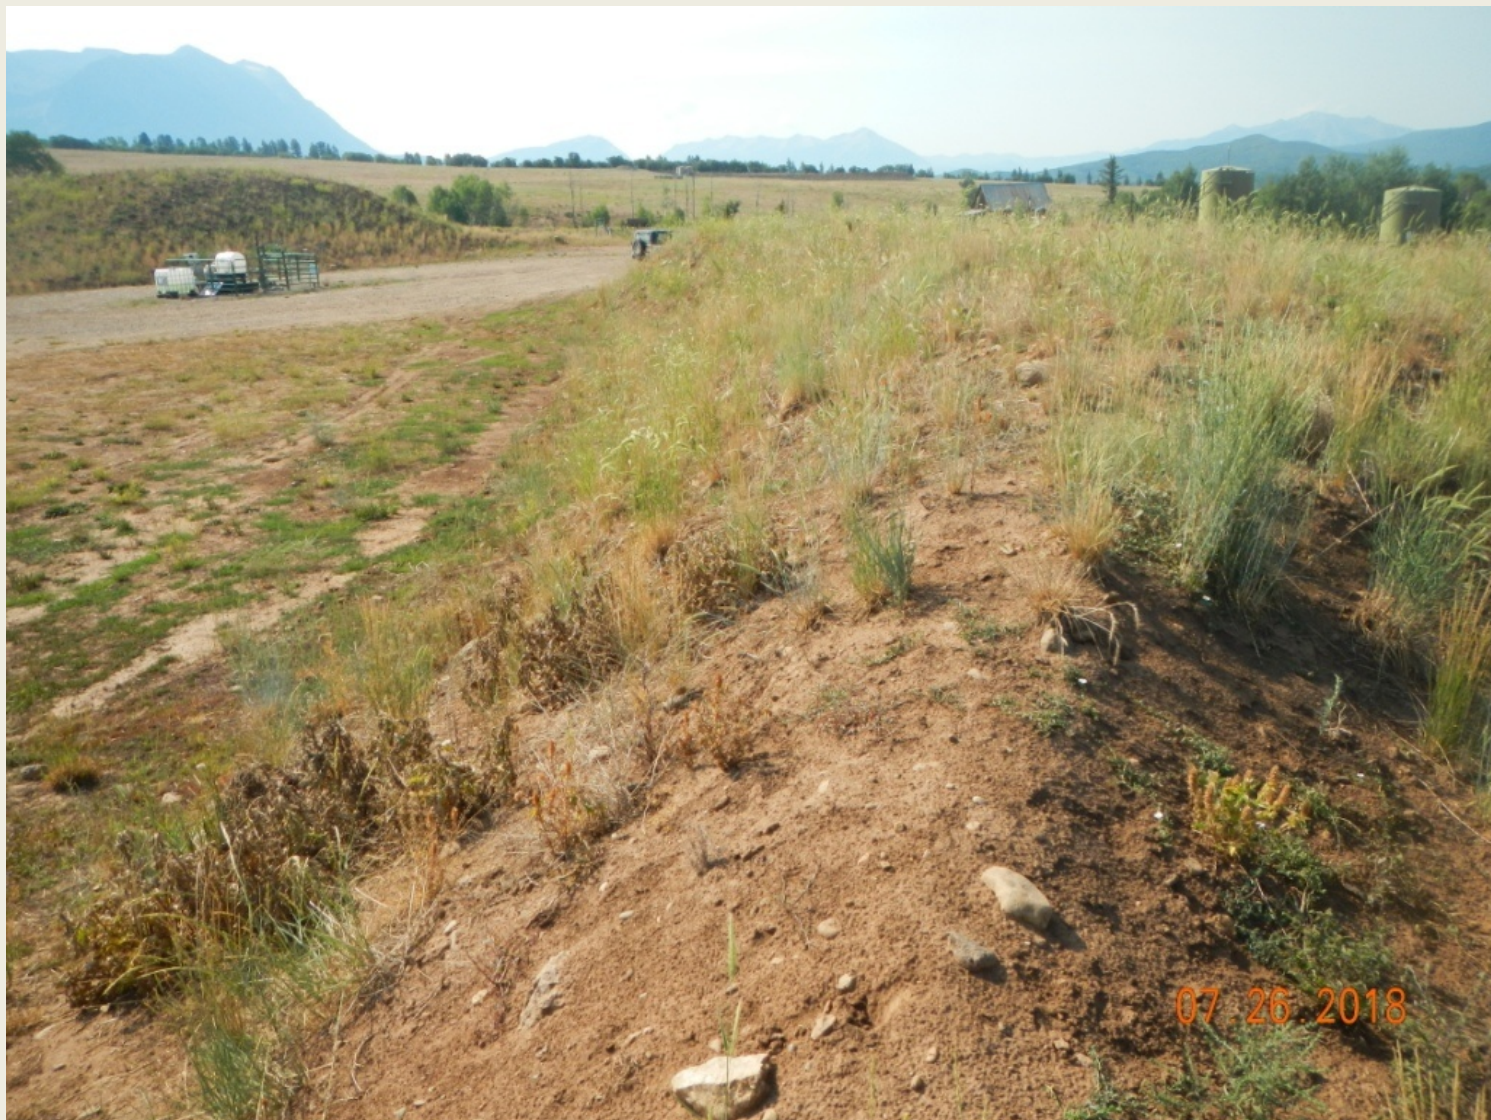
Photo 2. View of the western portion of the project area from the northwestern corner facing southward.

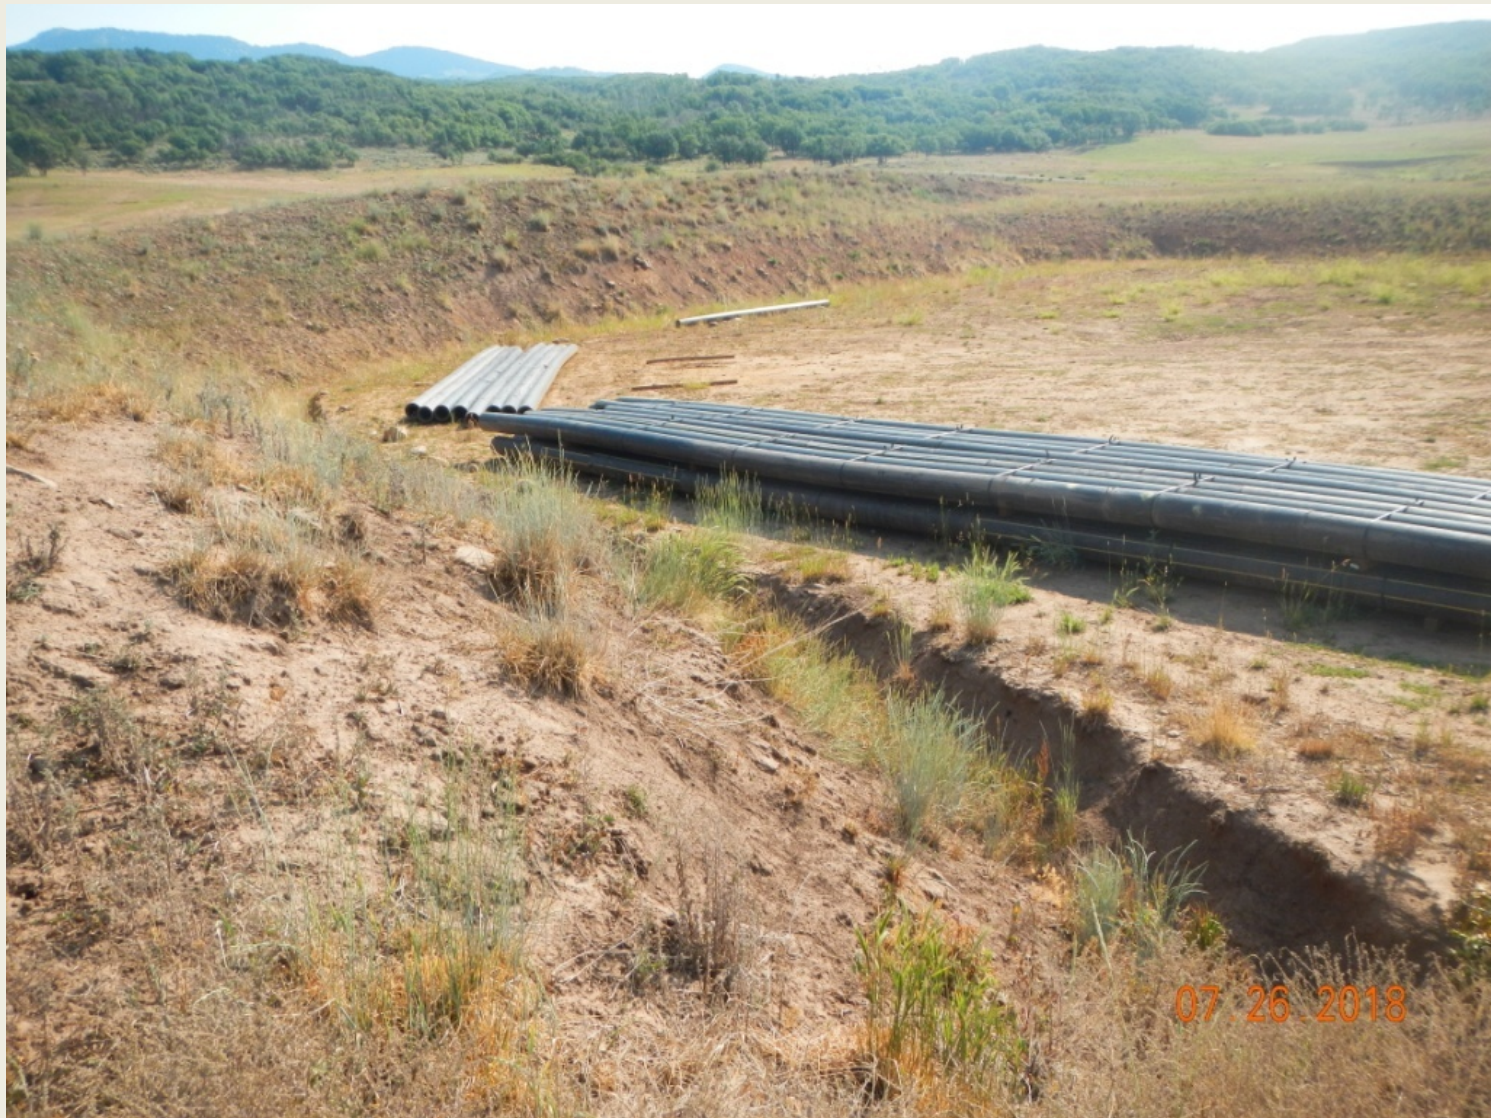
Photo 3. View of the northern portion of the project area. Black tubing stored on location.

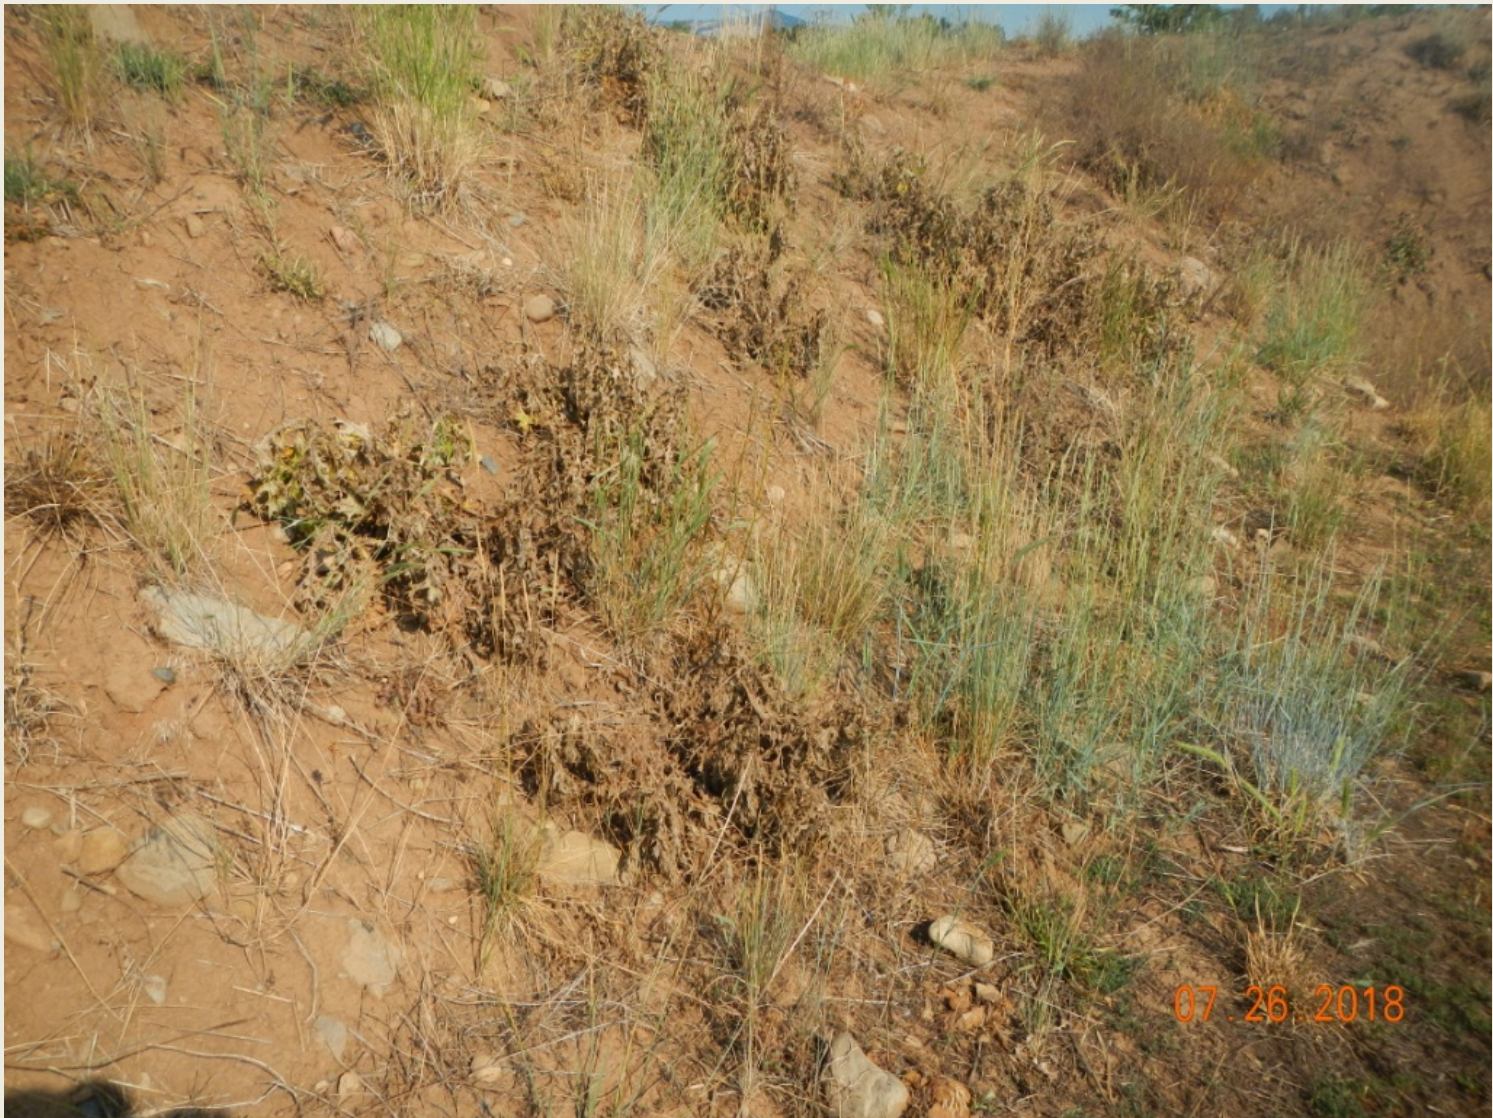
Photo 4. View of musk thistles that appear to be treated in the northern project area. Some untreated rosettes observed. Subsequent treatments will be needed.
