Inspection Photos

Operator: SG Interests

API: 05-051-06107

Date: 7/25/2018

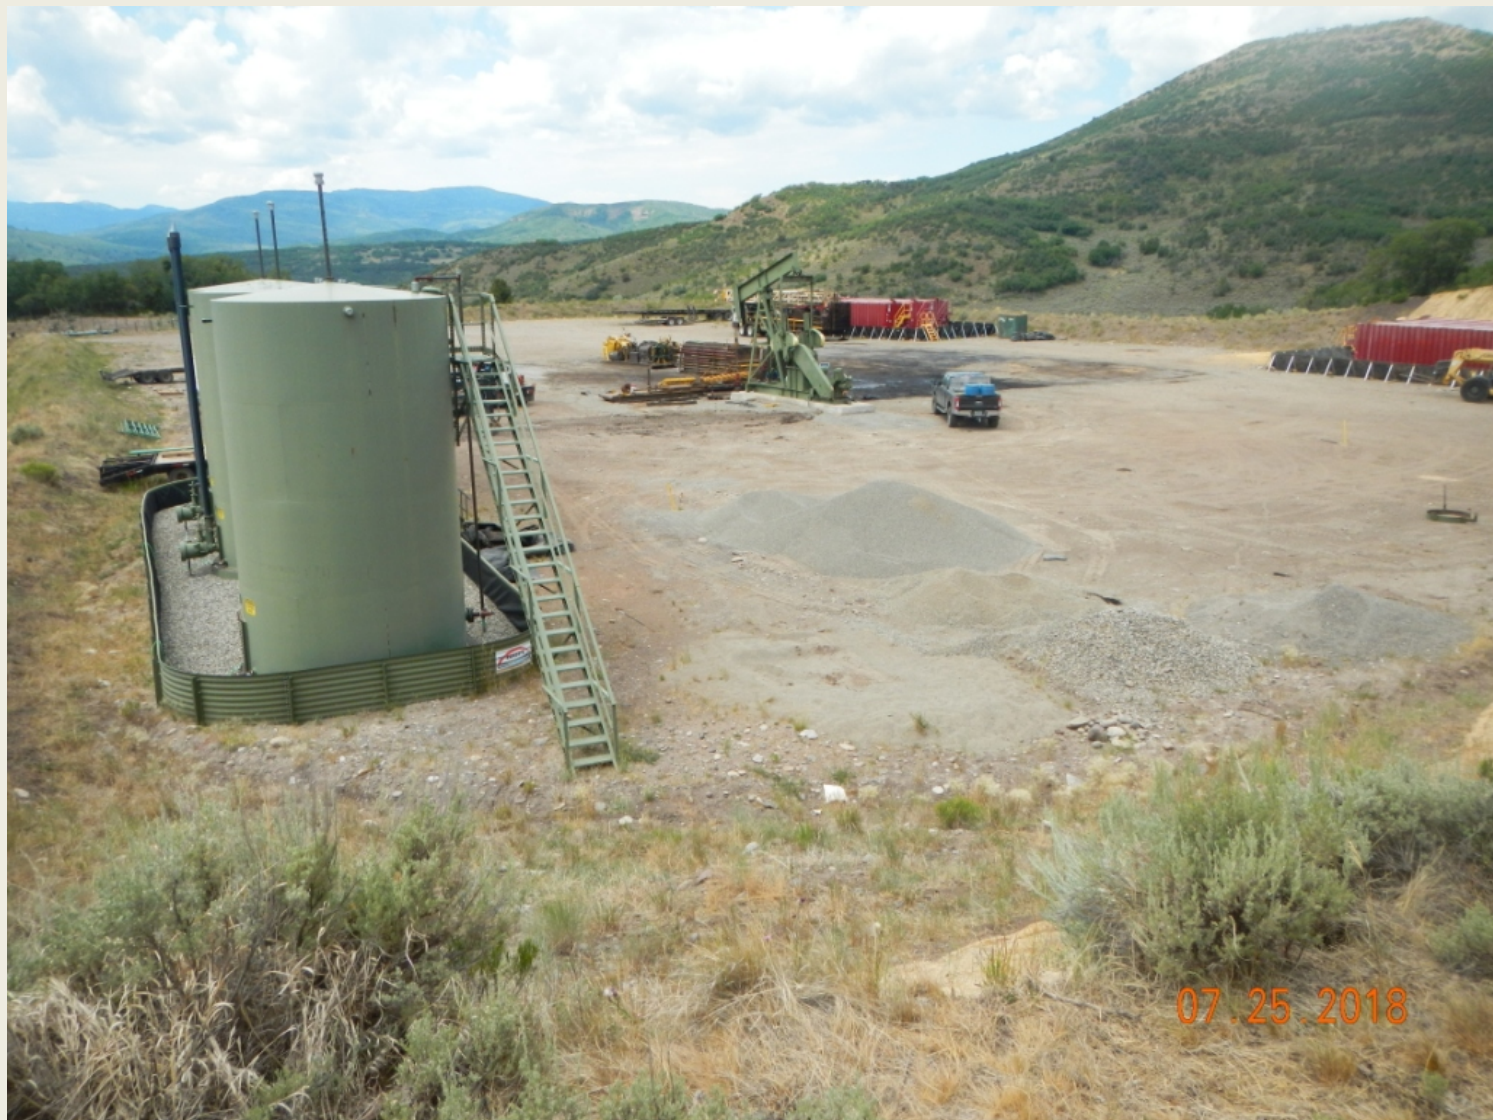
Photo 1. View of the project area from the southeastern corner facing center.

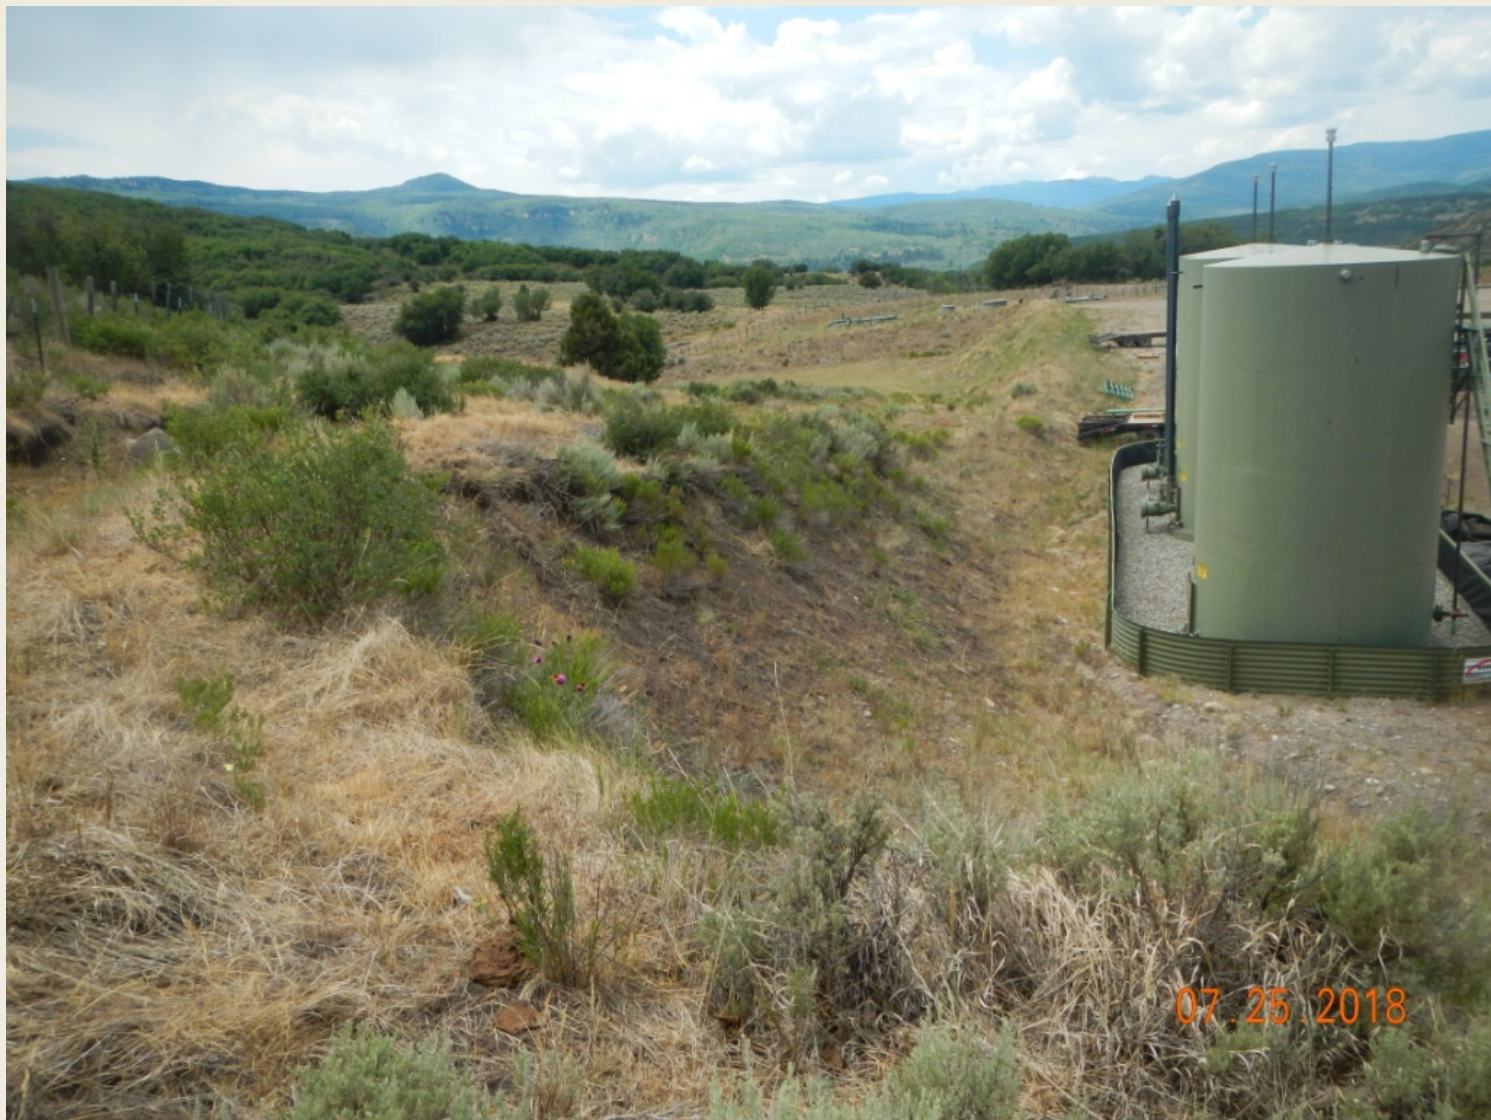
Photo 2. View of the southern portion of the project area from the southeastern corner facing westward.

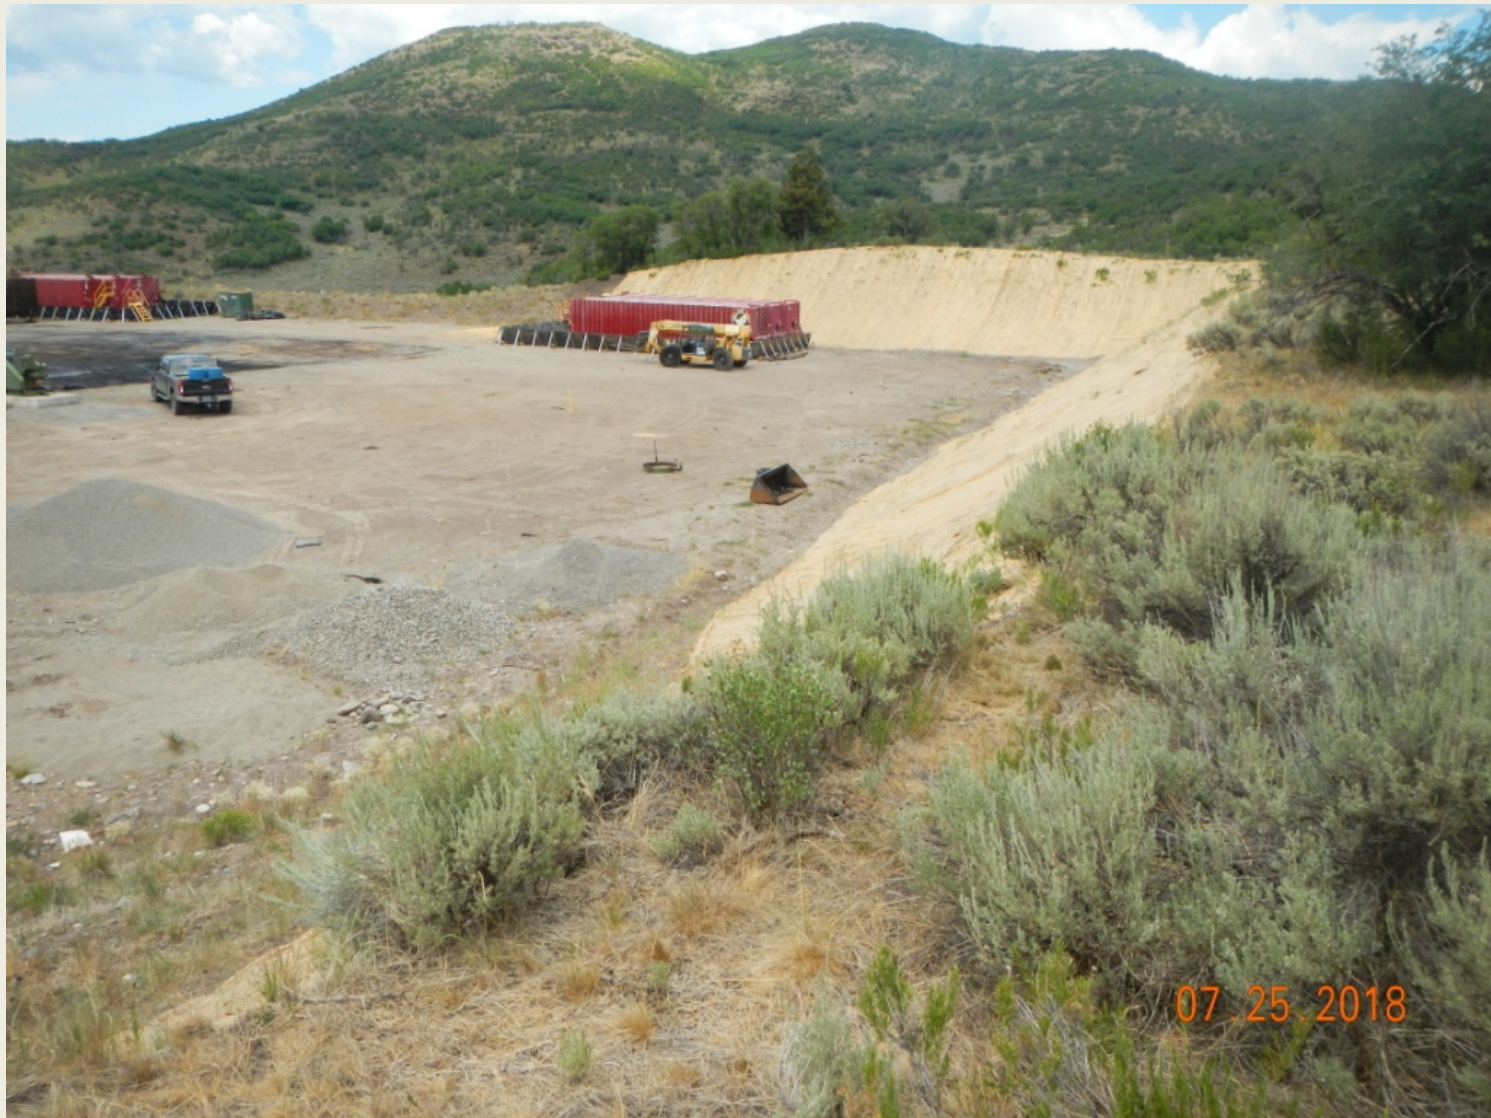
Photo 3. View of the eastern portion of the southeastern corner facing northward. Straw blankets and diversion ditch are in place and appear to be functioning at this time.

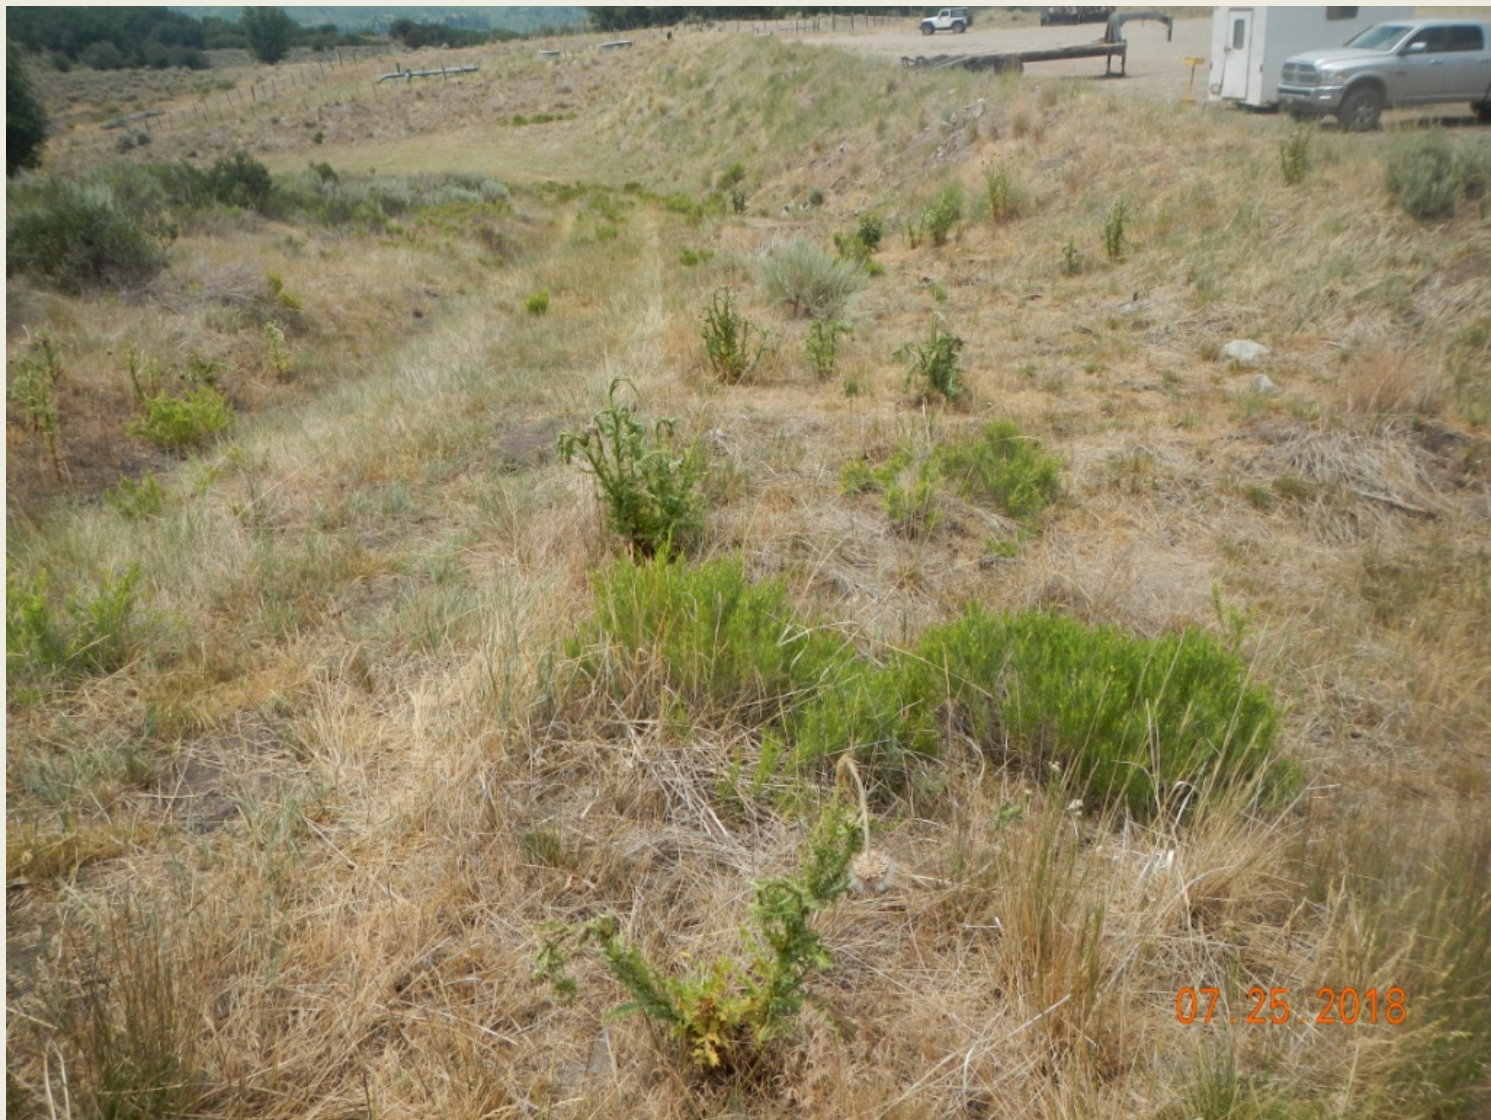
Photo 4. View of musk thistles that appear to be treated in the southern project area. As many have flowered subsequent treatments will be needed.

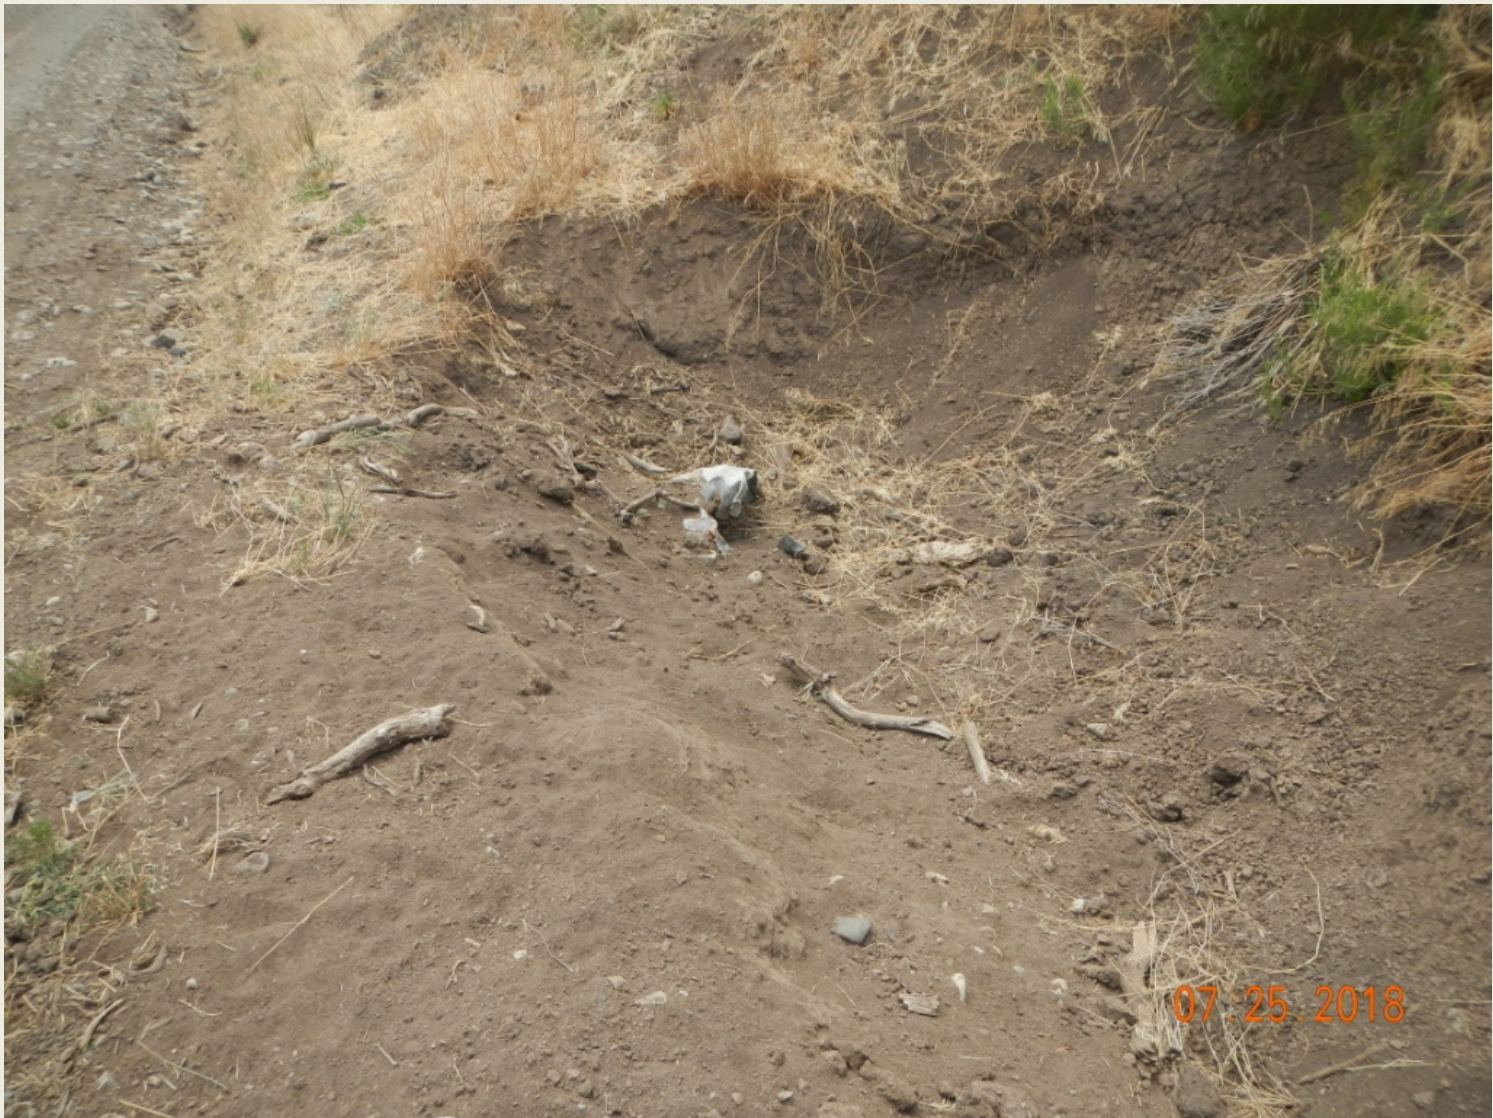
Photo 5. View of culvert along access road, appears damaged. If damage is preventing flow, replacement may be needed.

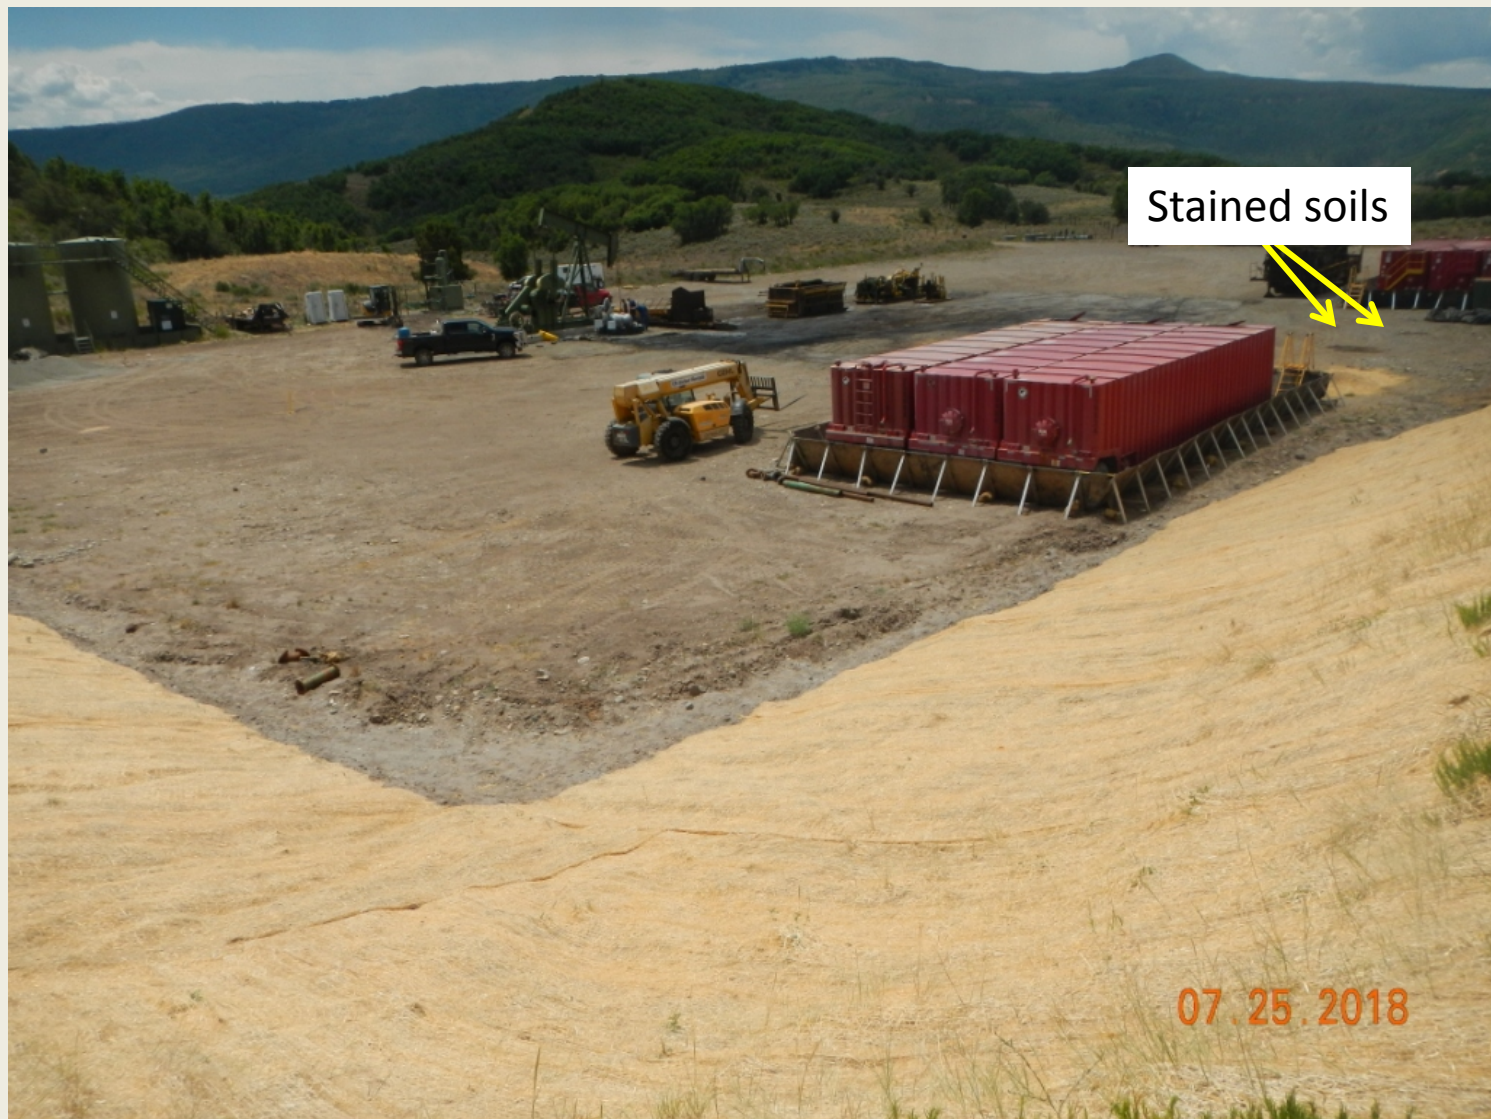
Photo 6. View of the project area from the northeastern corner facing center. Stained soils present on location. Multiple areas with stained soils observed on location.
