Inspection Photos

Operator: Gunnison Energy

API: 05-029-06095

Date: 7/26/2018

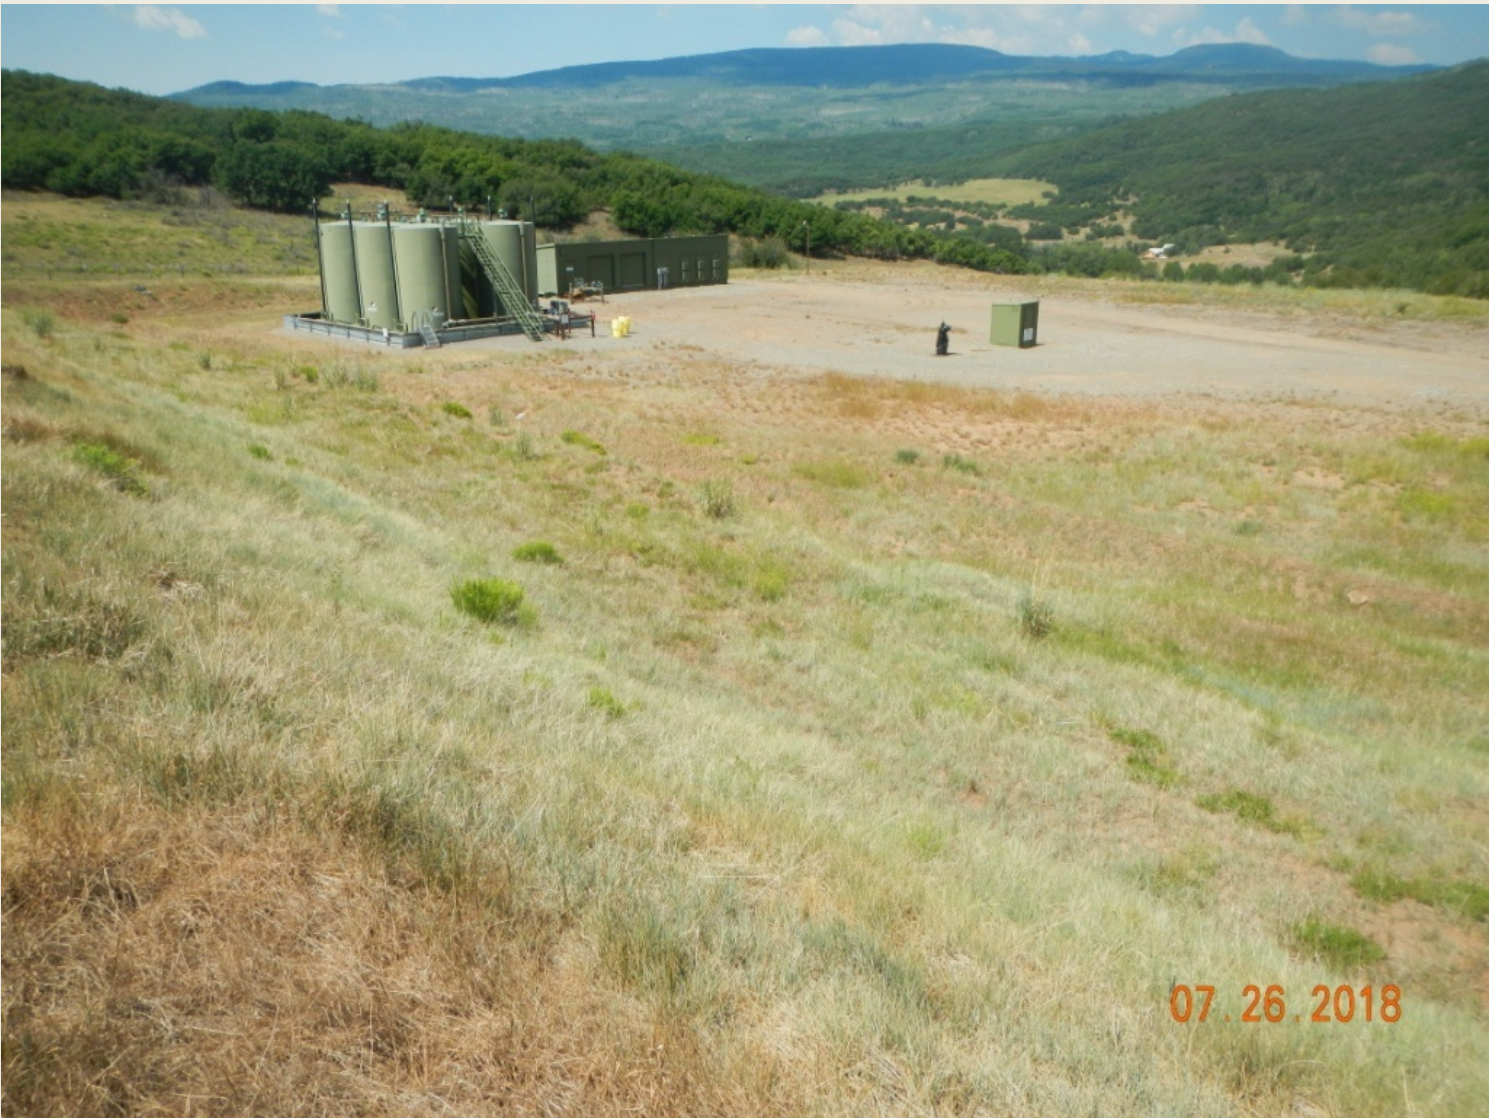
Photo 1. View of the project area from the northeastern corner facing center.

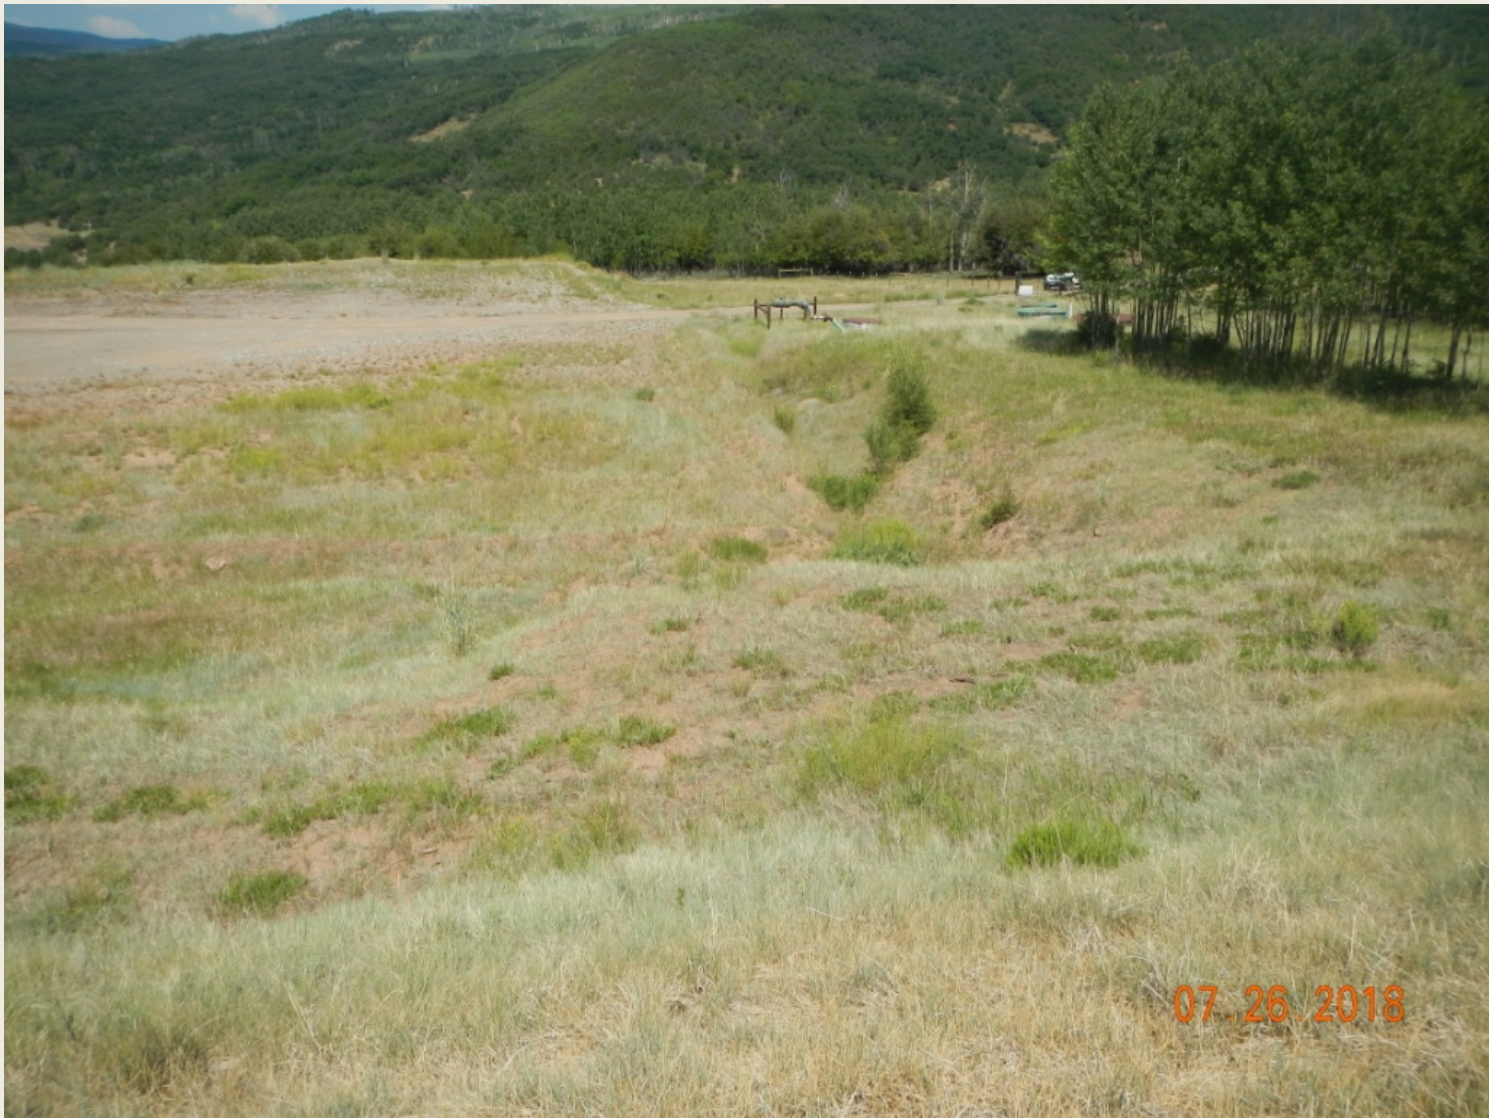
Photo 2. View of the northern portion of the project area from the northeastern corner facing westward.

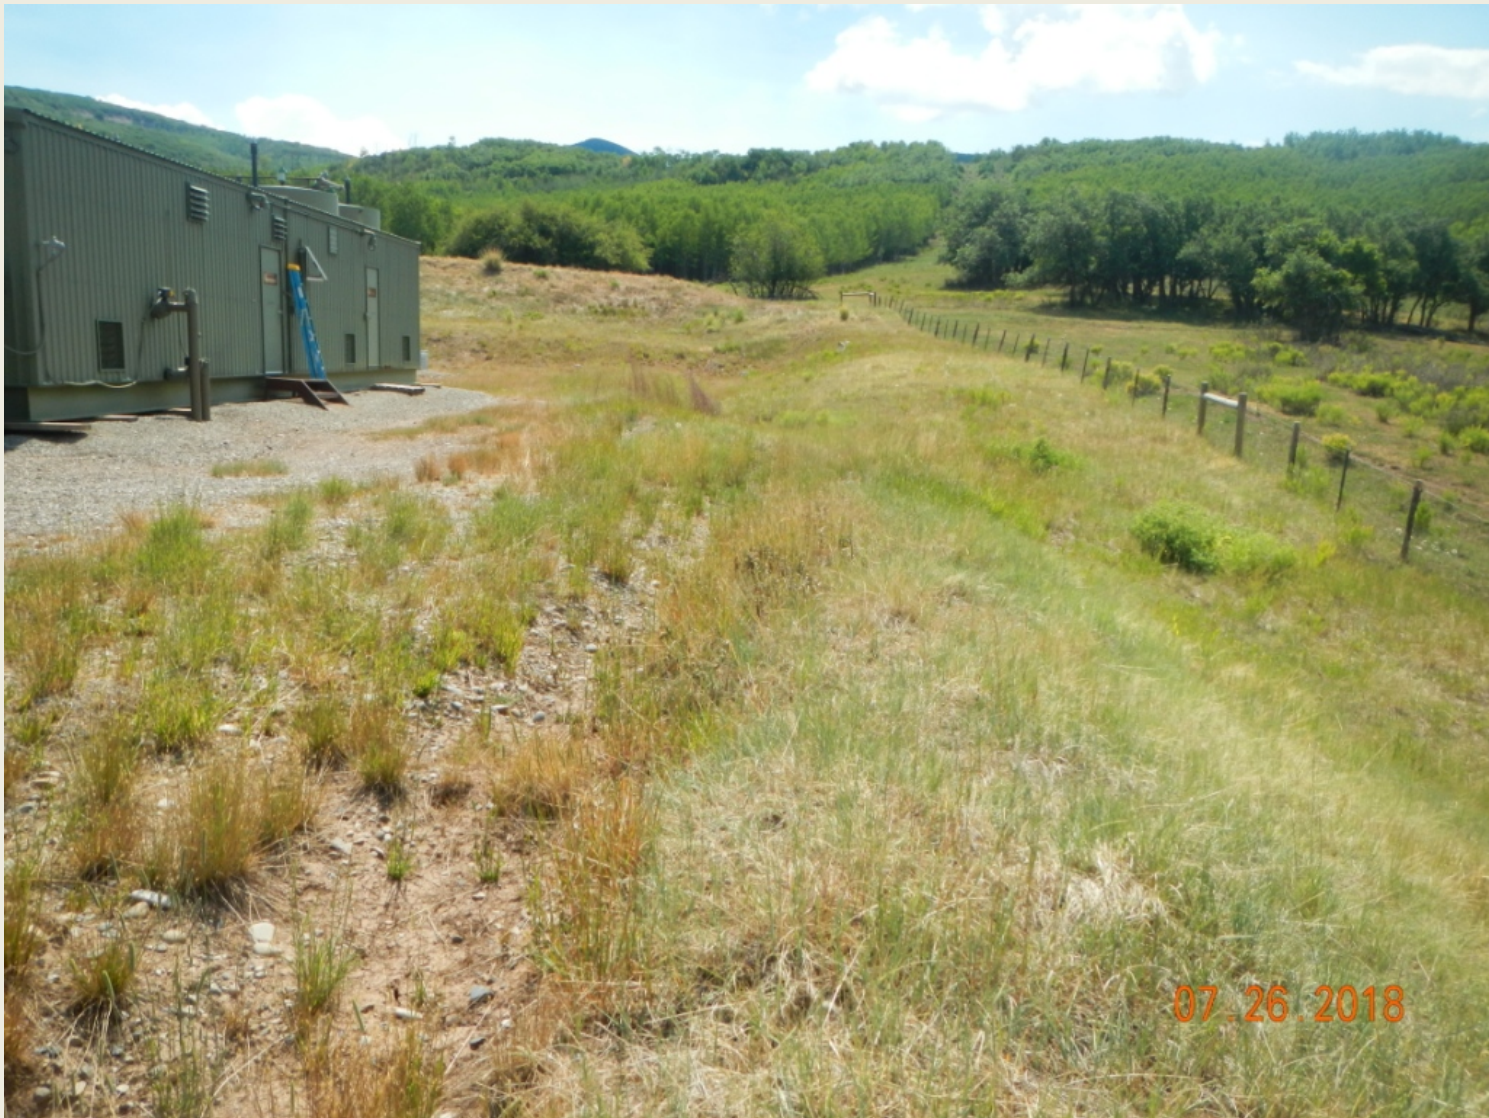
Photo 3. View of the southern portion of the project area from the southwestern corner facing eastward. Vegetation is well established.

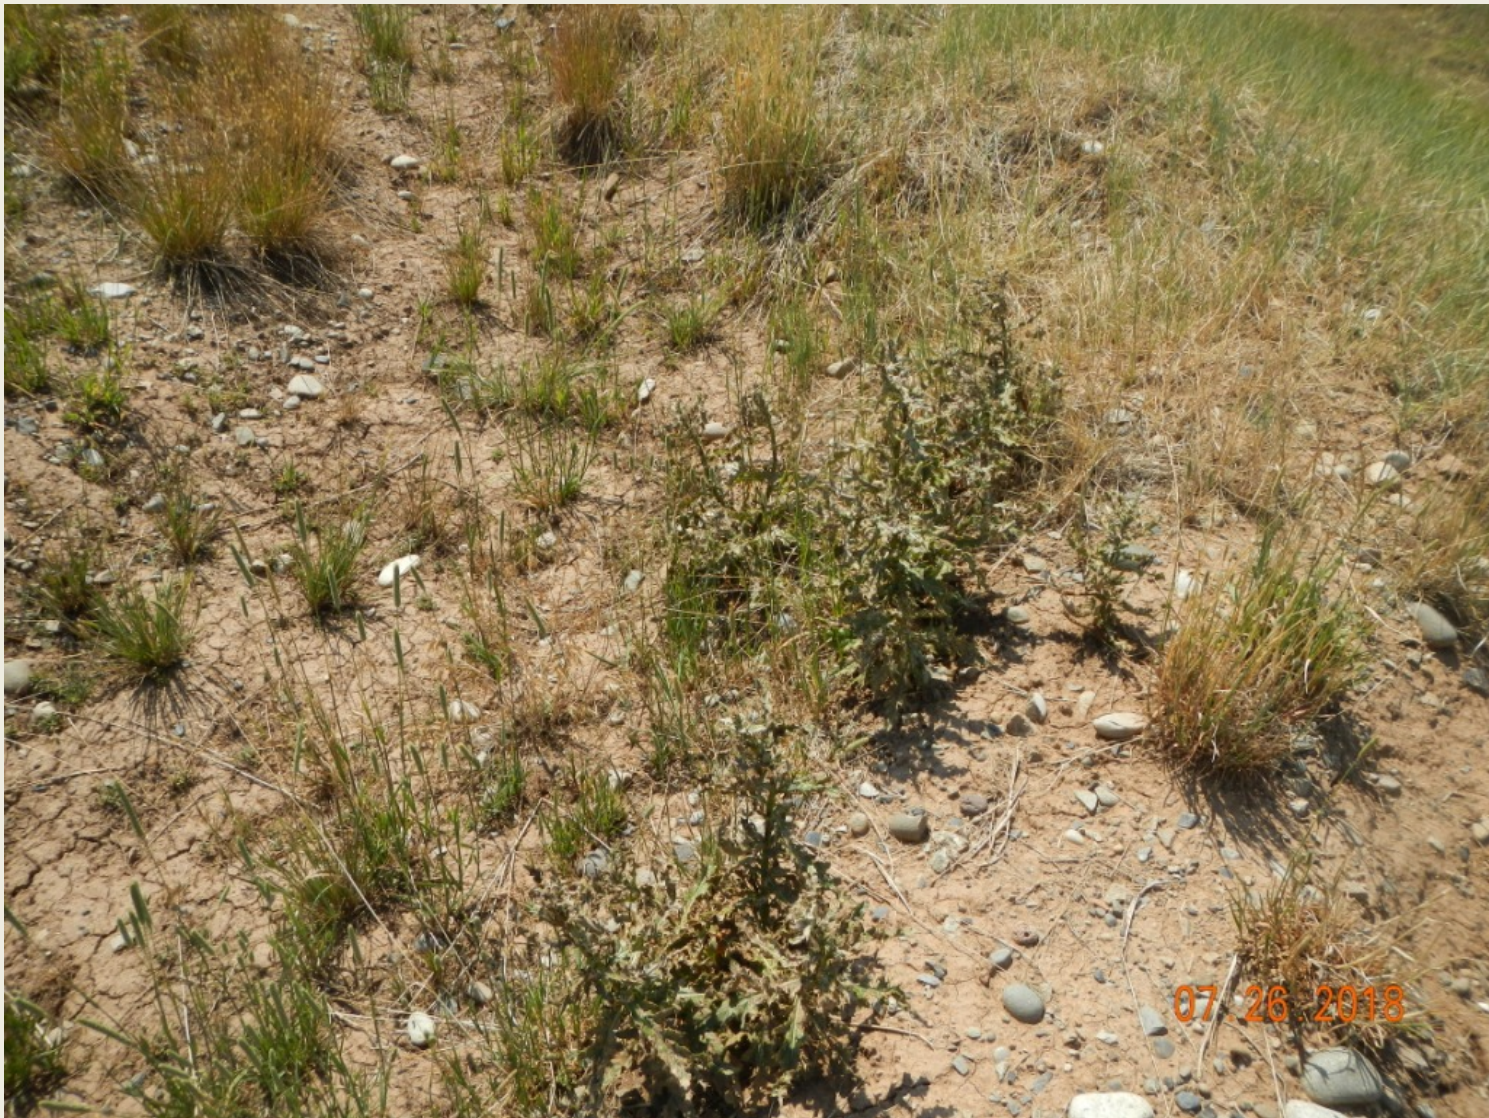
Photo 4. View of Canada thistles (*Cirsium arvense*) that do not appear treated with herbicide in the western interim reclamation area.
