Inspection Photos

Operator: Gunnison Energy

API: 05-051-06077

Date: 7/26/2018

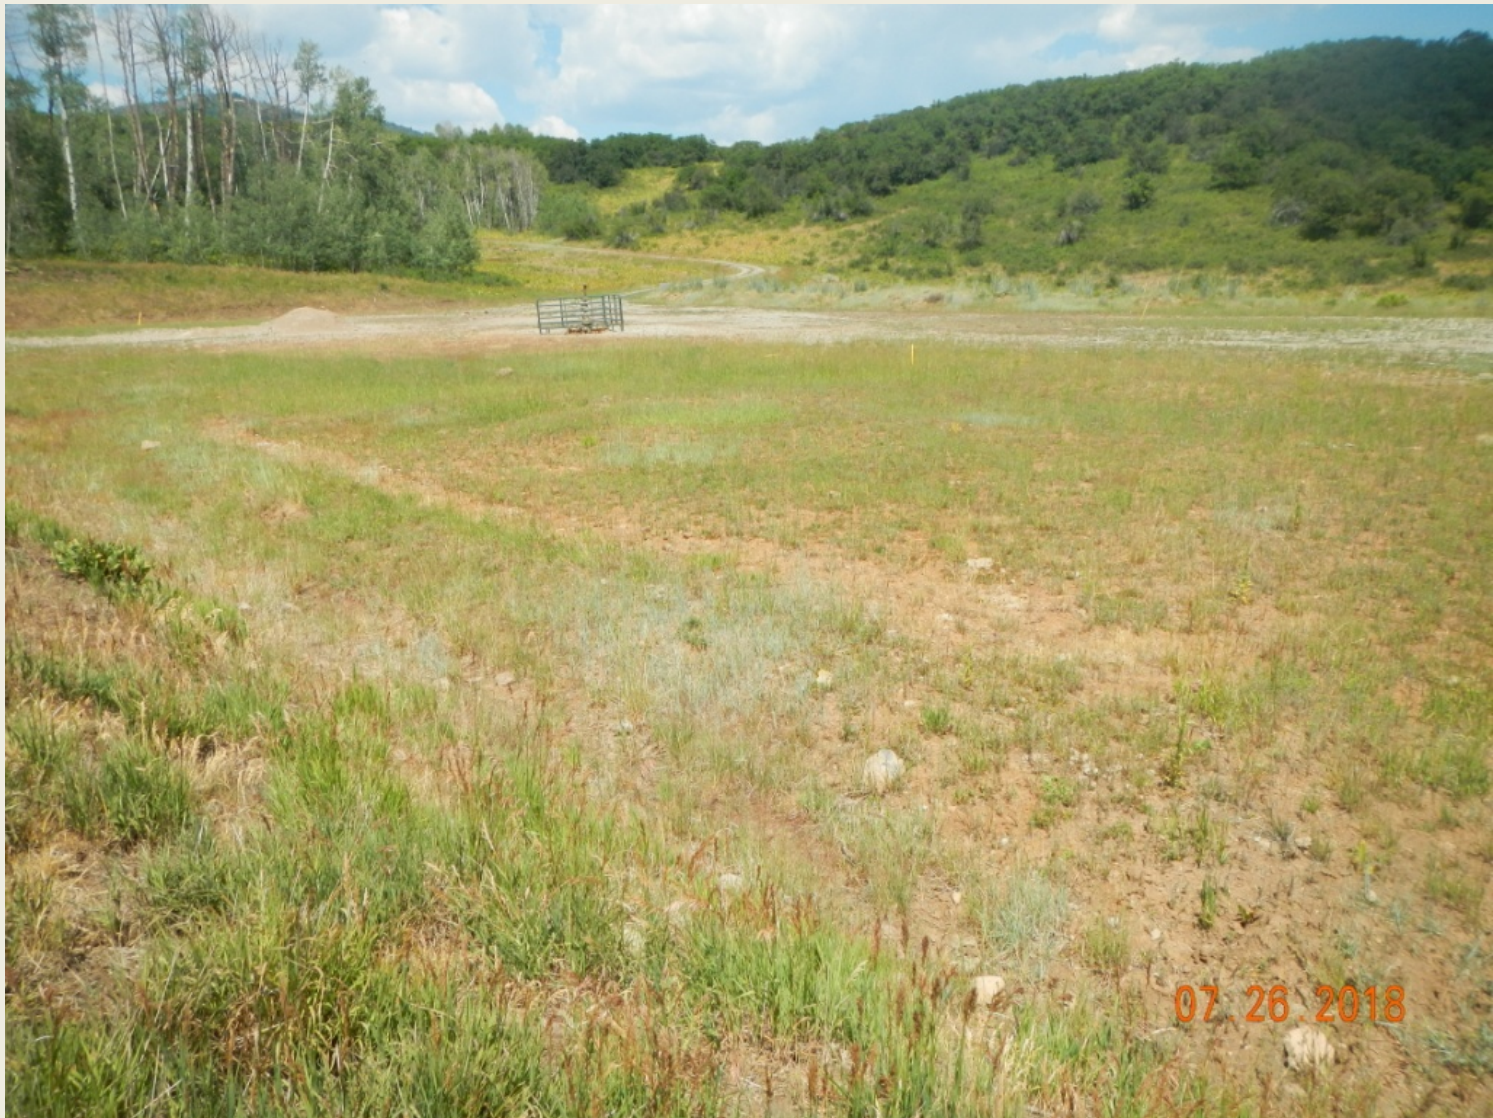
Photo 1. View of the project area from southeastern corner facing center. One well observed.

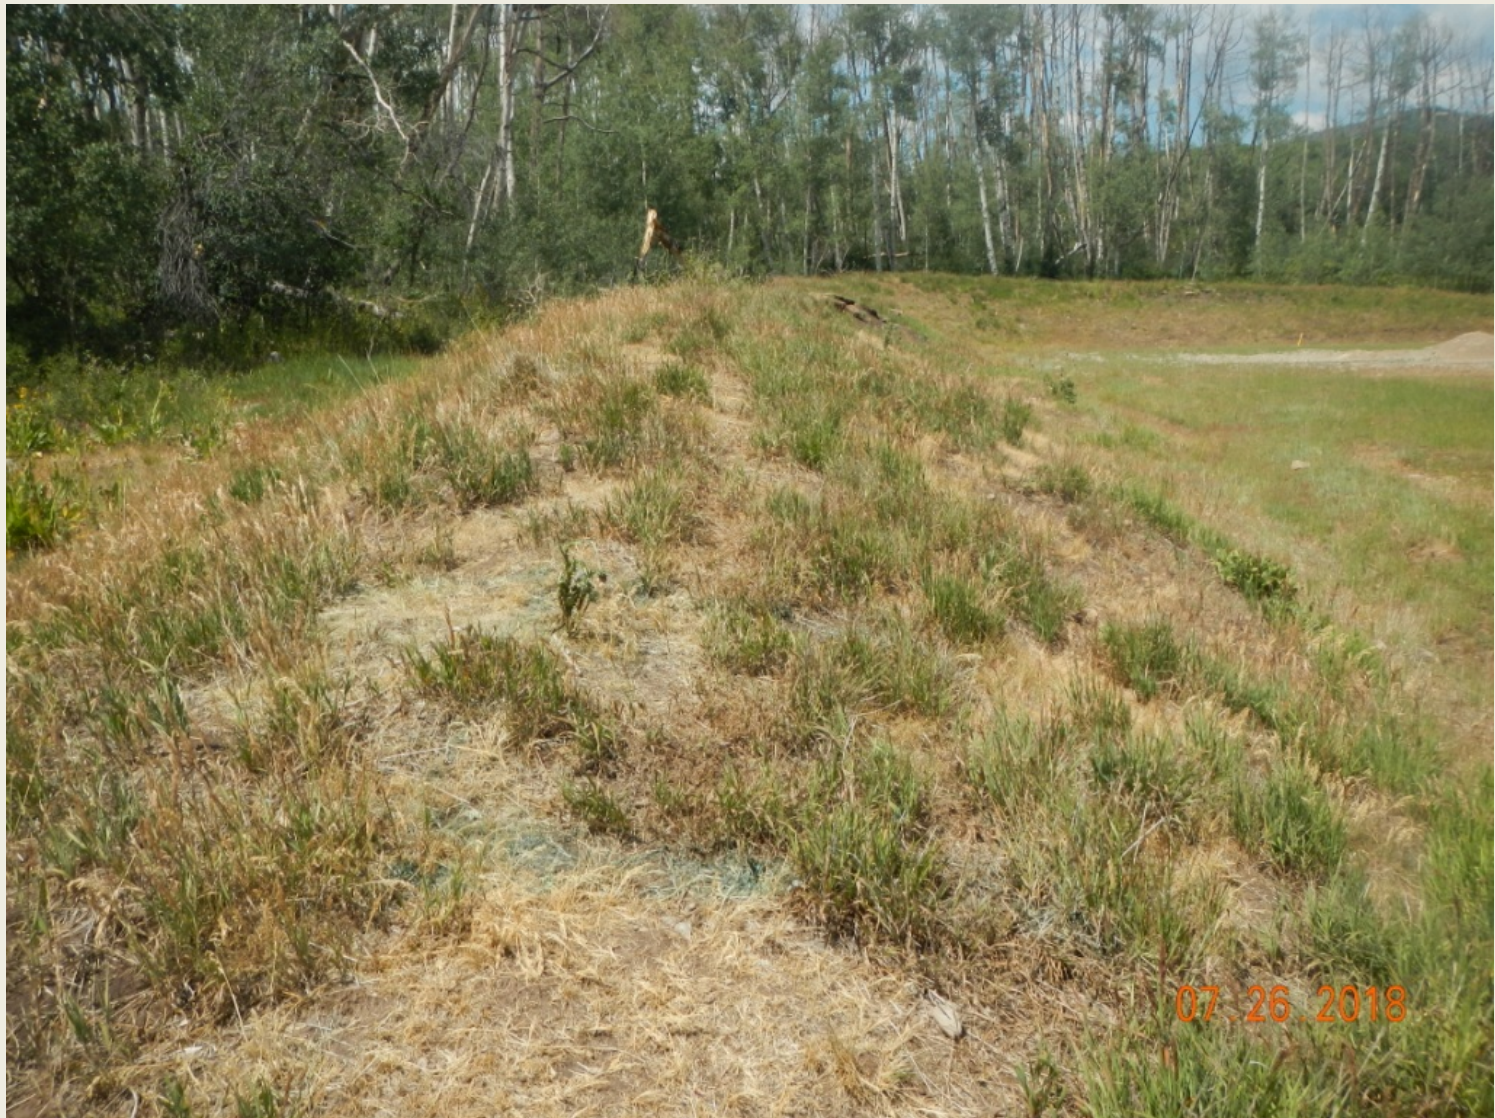
Photo 2. View of the southern portion of the project area from the southeastern corner facing westward. Revegetation is progressing with grasses such as smooth brome (*Bromus inermis*) and western wheatgrass (*Pascopyrum smithii*).

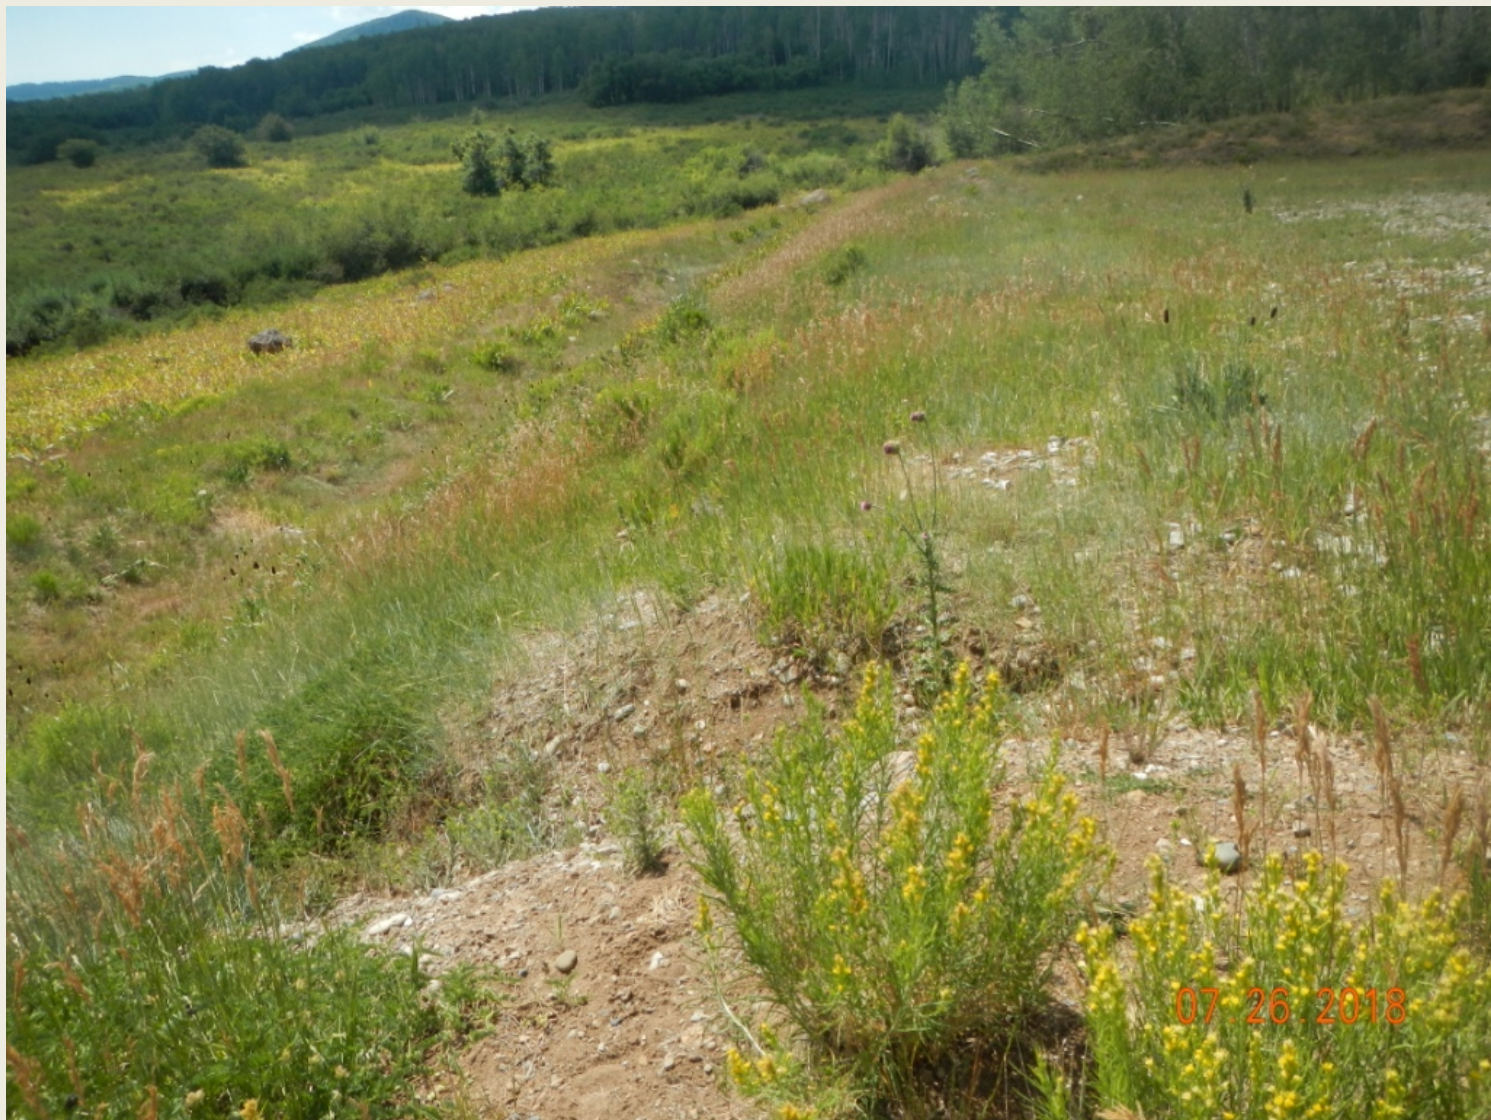
Photo 3. View of the eastern portion of the project area from the southeastern corner facing northward.

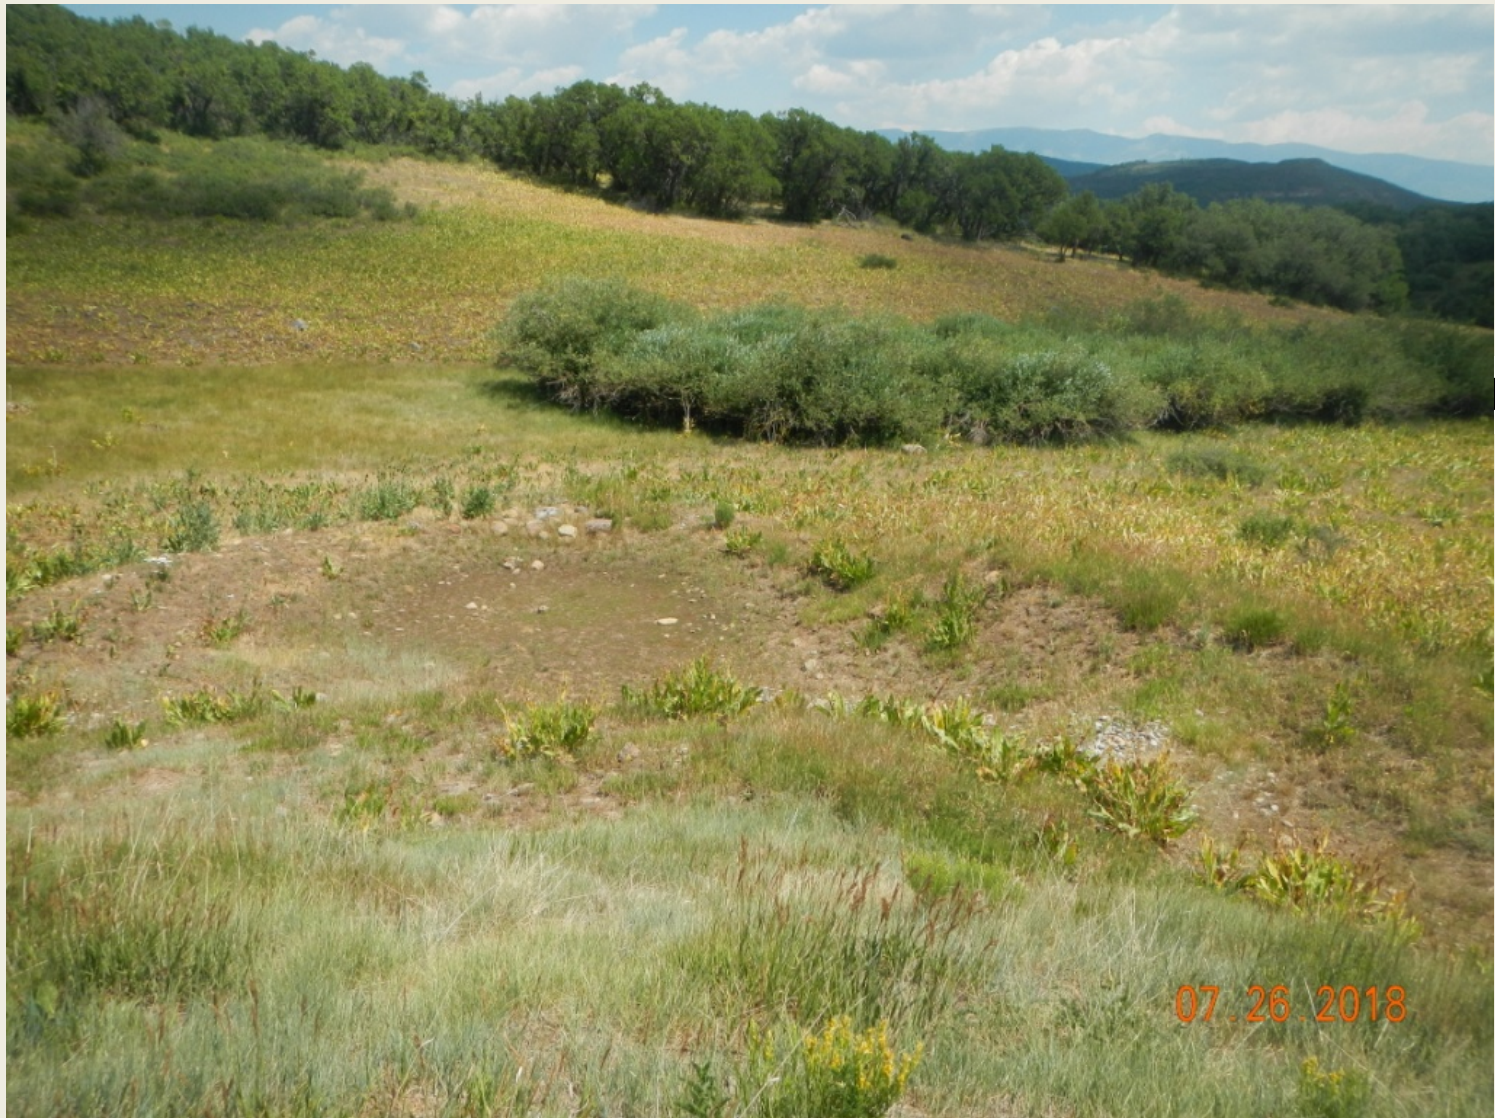
Photo 4. View of silt trap in the northeastern portion of the project area, appears to be functioning.

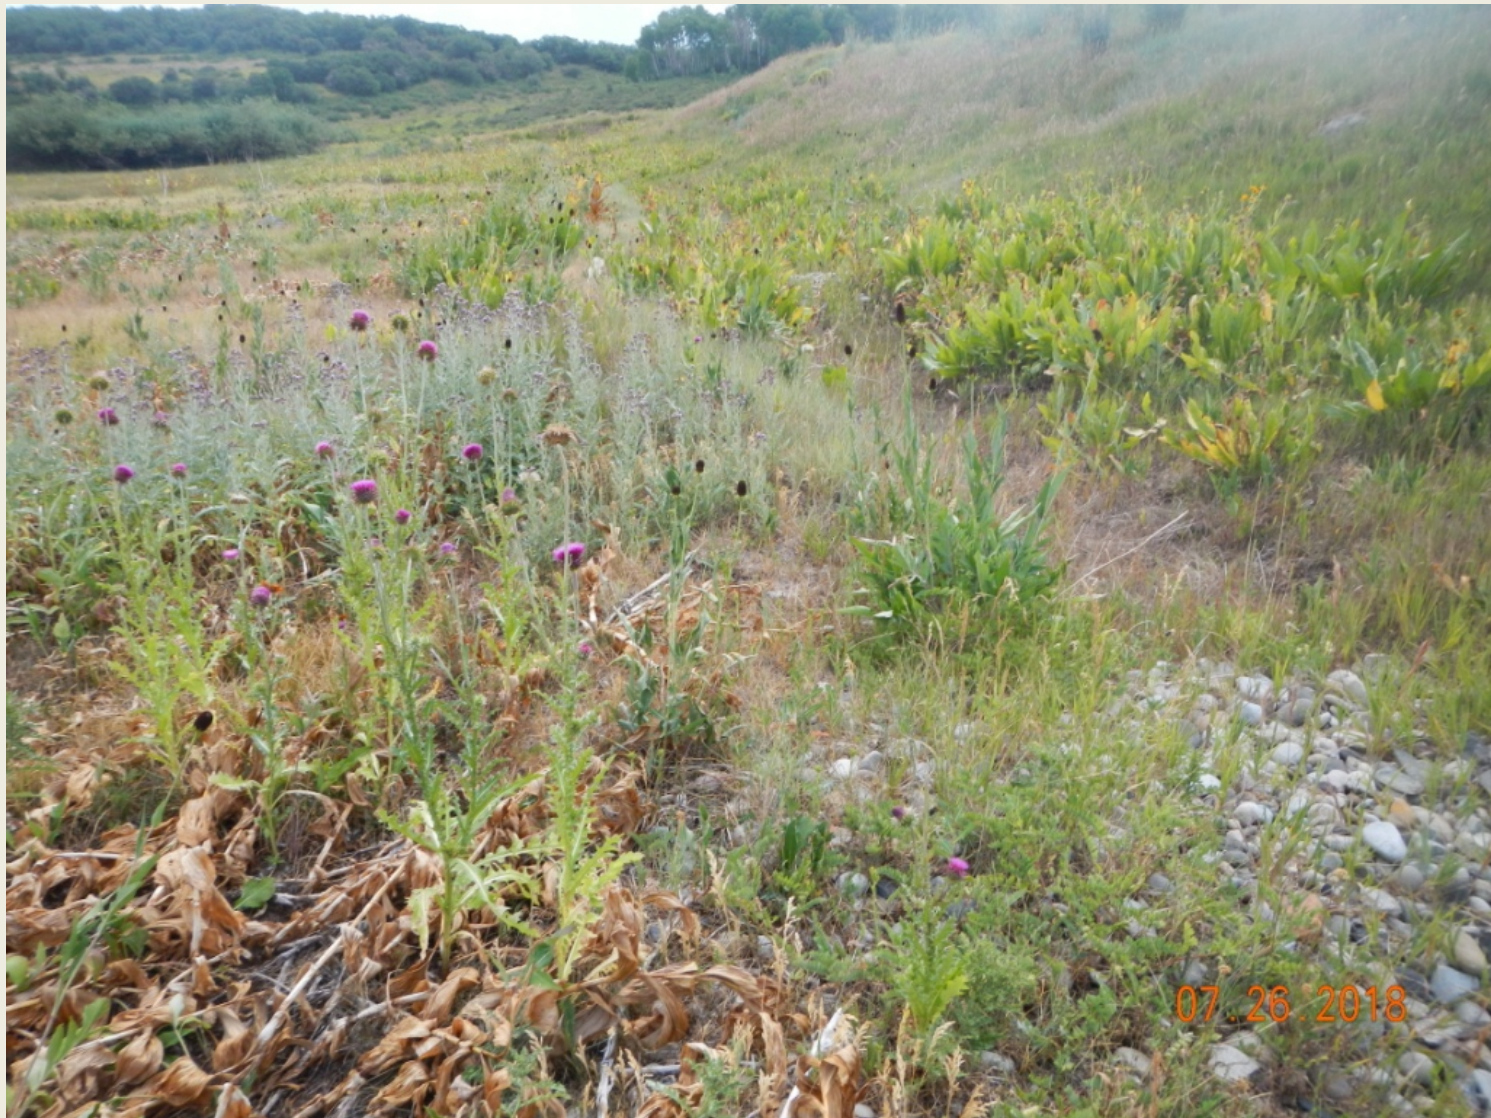
Photo 5. View of untreated musk thistles (*Carduus nutans*) and Canada thistles (*Cirsium arvense*) growing along the northern edge of the project area.
