**Inspection Photo
Gentry C9
API # 045-15271
Inspection # 689301780**

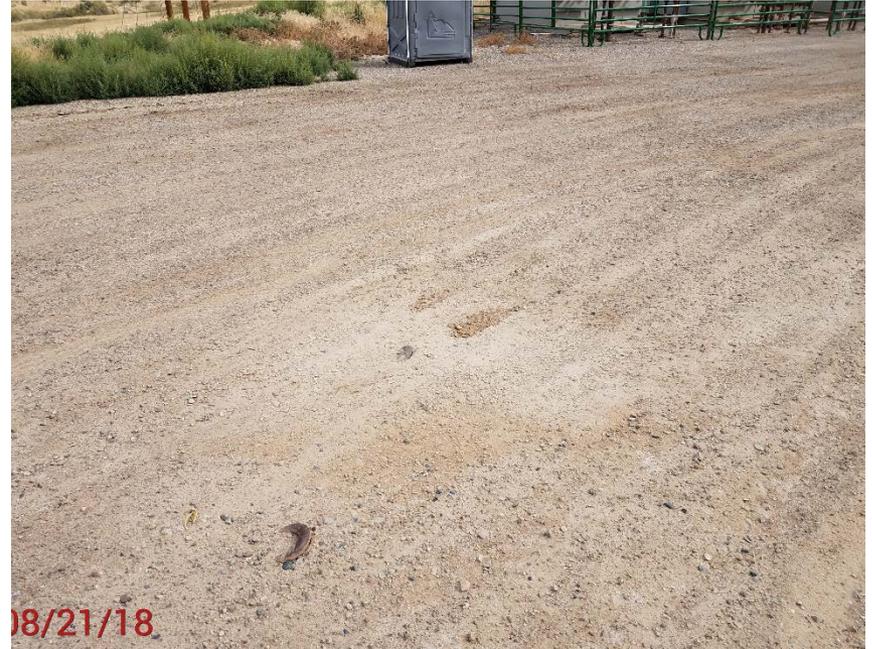
Location Photo #2, Mark anchor as required.

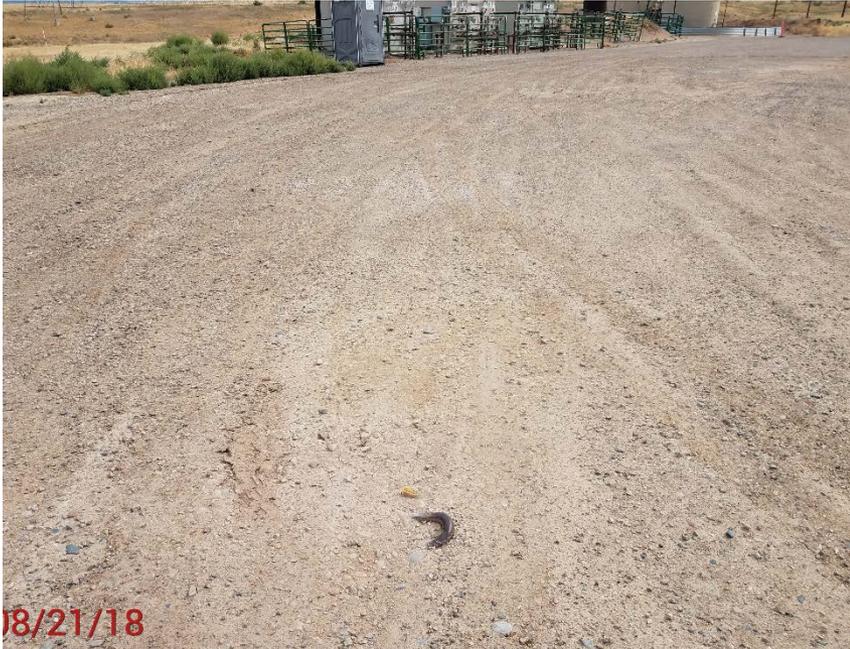
Location Photo #3, Mark anchor as required

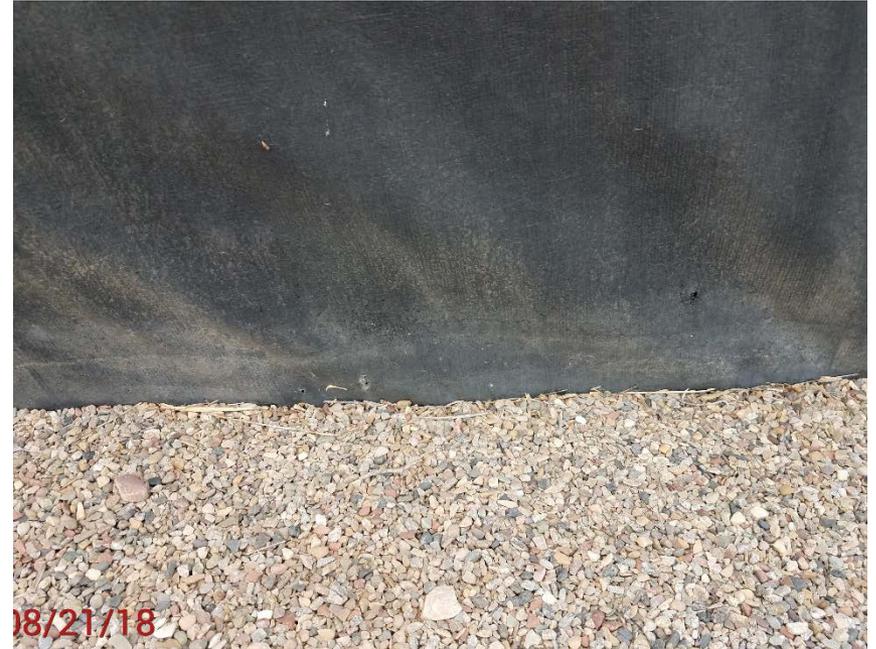
Location Photo #4, holes in secondary liner.

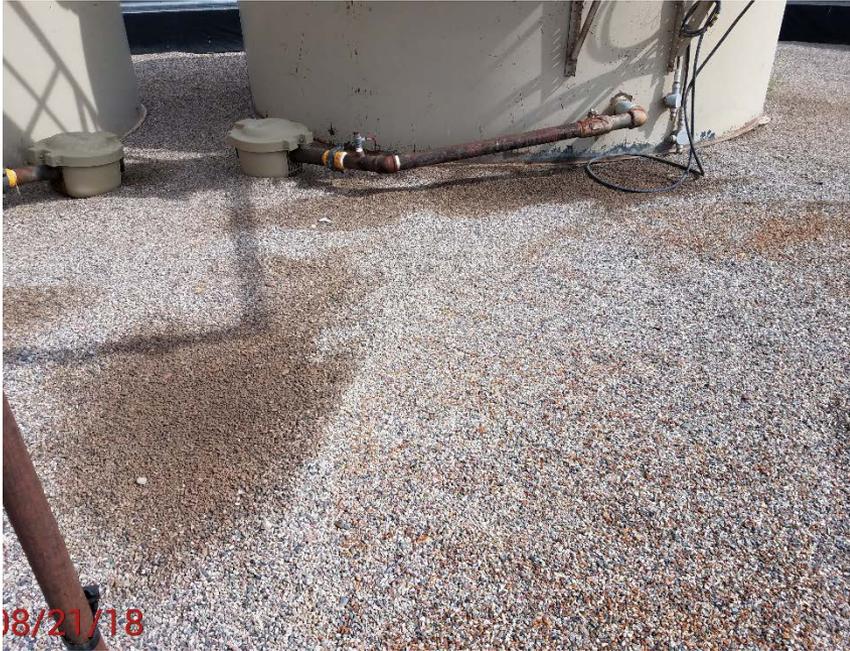
Location Photo #5, Stained material in battery containment.

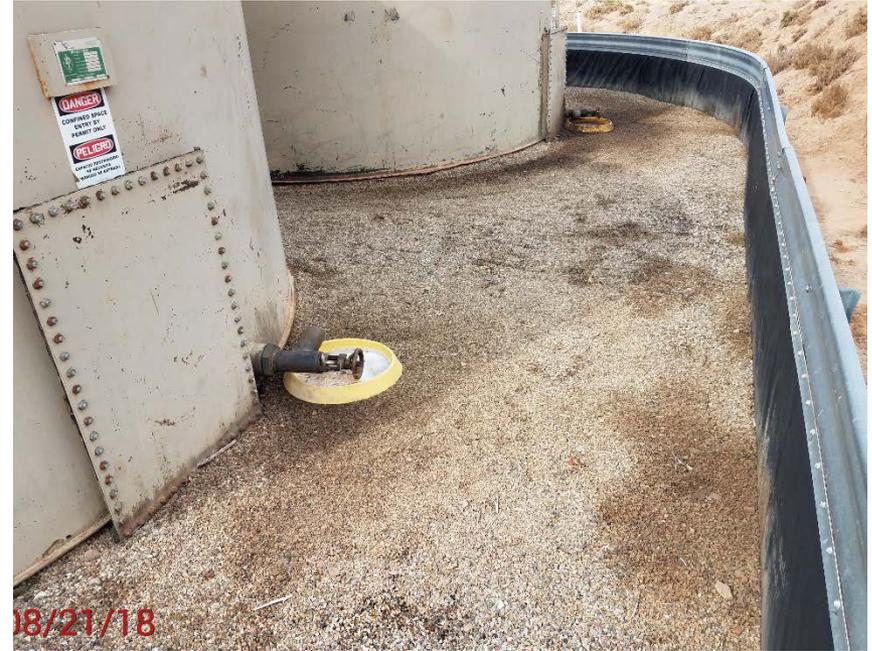
Location Photo #6, Stained Material in battery containment.

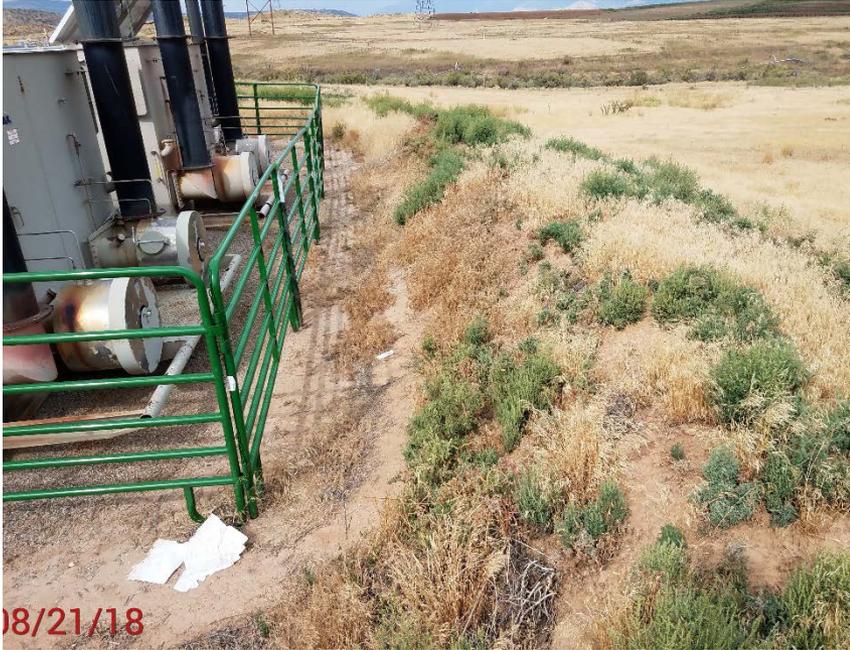
Location Photo #7, Weeds on location

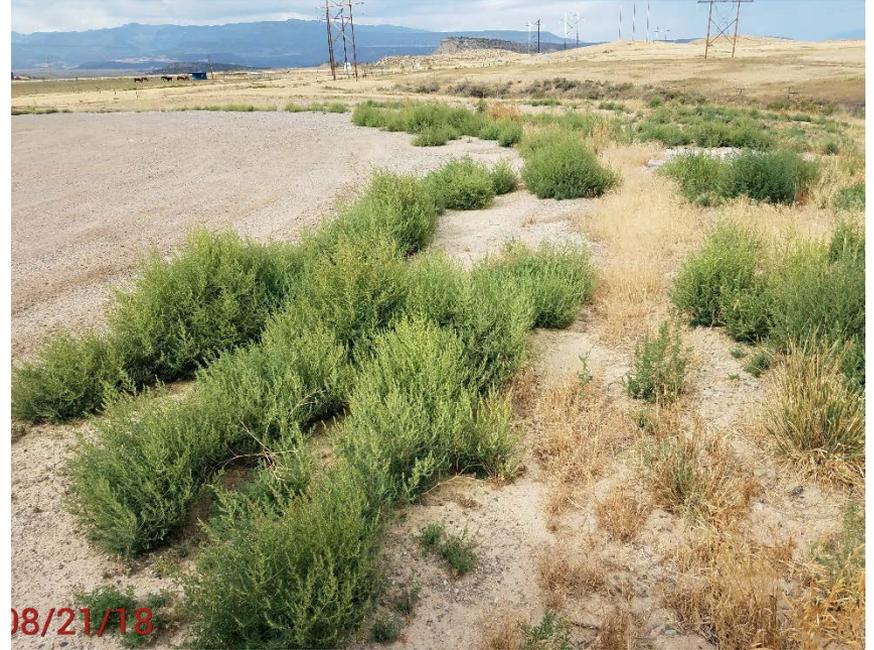
Location Photo #8, weeds on location

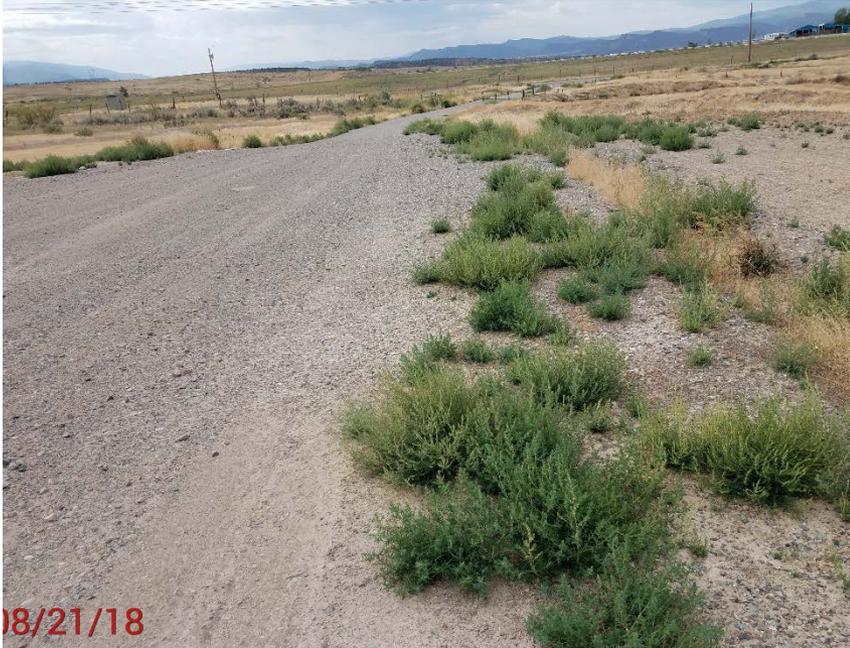
Location Photo #9, Weeds on access road

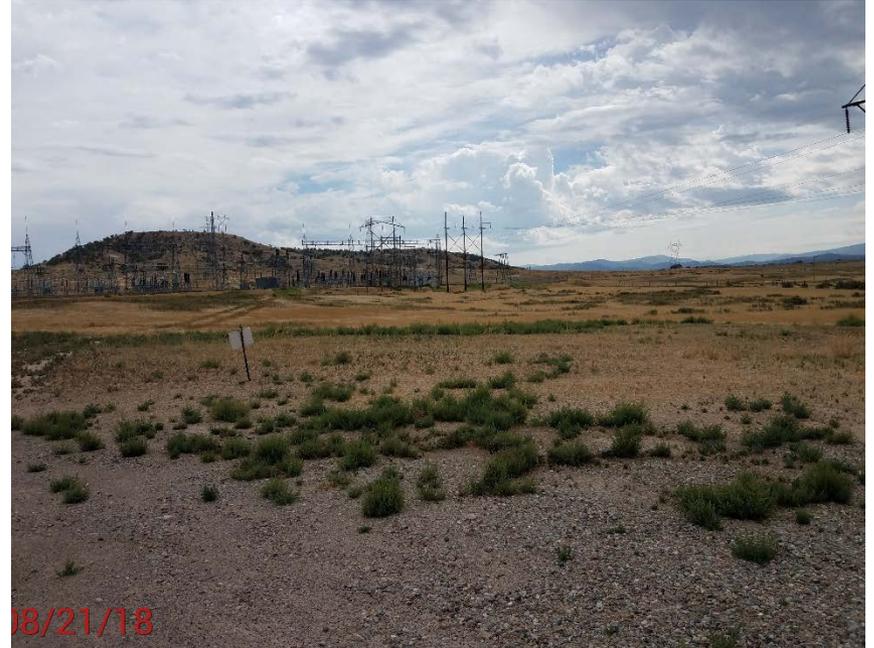
Location Photo #10, weeds on location.
