Final Reclamation Inspection

Operator: NANKE ENERGY LLC- #10662

API: 05-039-06608

Inspection Photos
Location Name: COGGINS #10-34
API: 05-039-06608

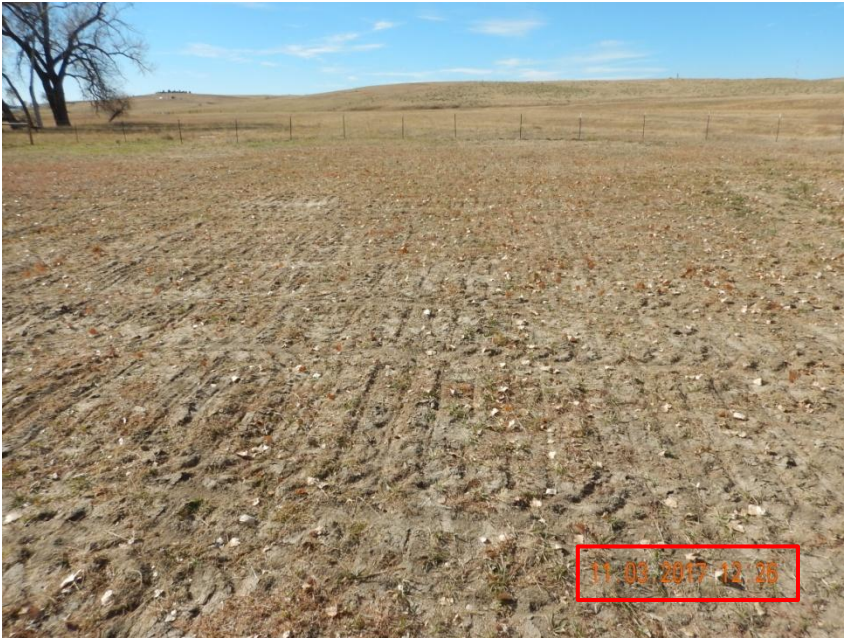
Photo 1. Photo taken from the northern location on November 3, 2017, facing South. Appears the Operator has mowed and seeded the location based on drill row markings.

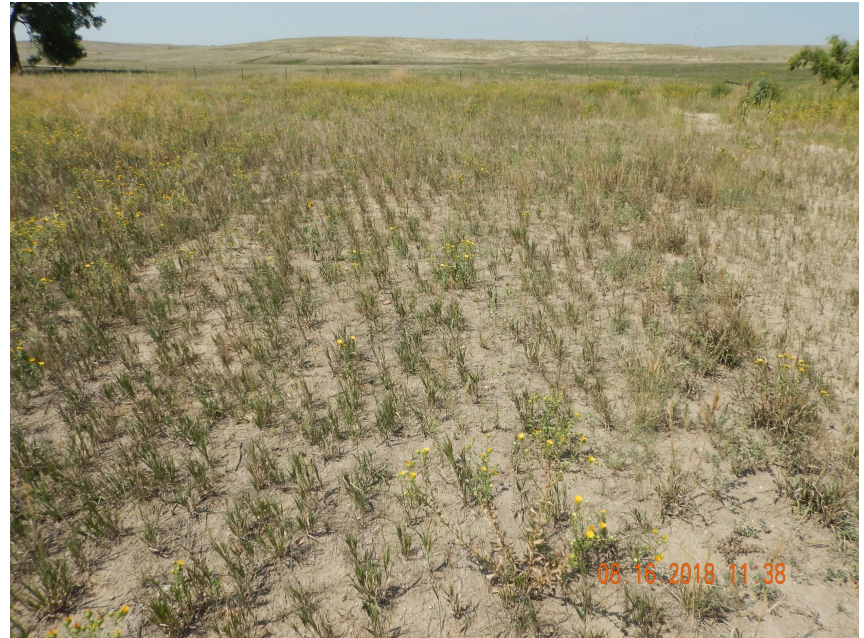
Photo 2. Photo taken from the northern location on August 16, 2018, facing South. Establishment of desirable species was observed throughout portions of the location. Bare patches were observed and uniform growth has not been achieved- see photos 6-8 and 10. Additional reclamation activities will be required.

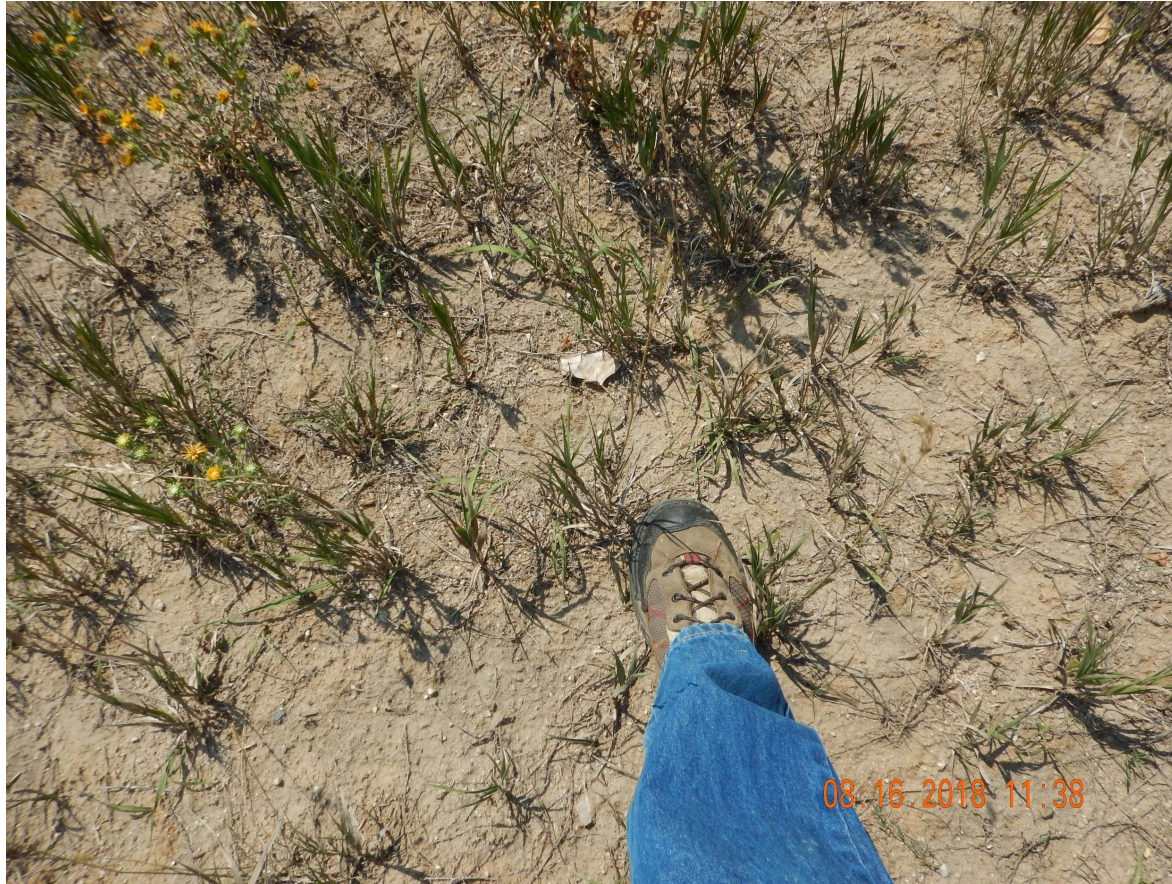
Photo 3. Close up photo taken from the northern location on August 16, 2018, illustrating establishment of desirable species, Smooth brome.

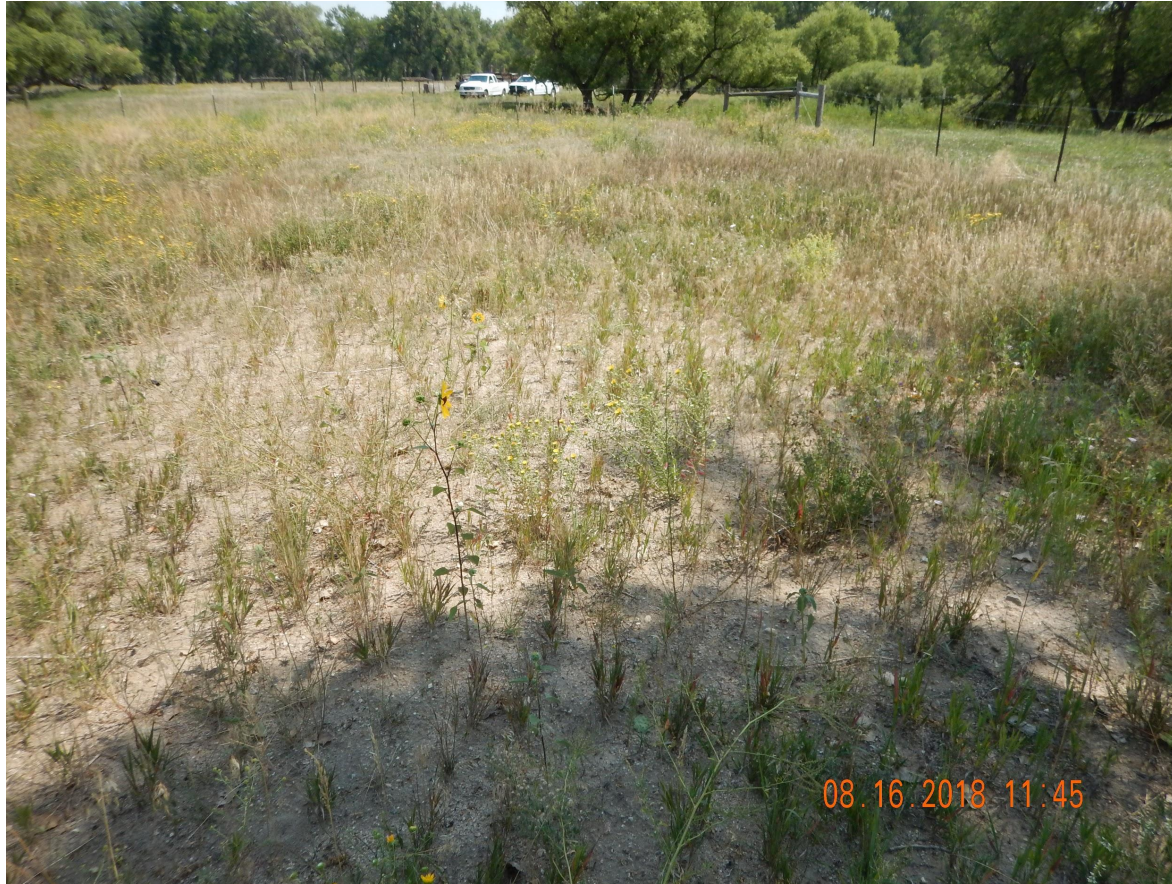
Photo 4. Photo taken from the southeastern location on August 16, 2018, facing North. See comments under Photo 2.

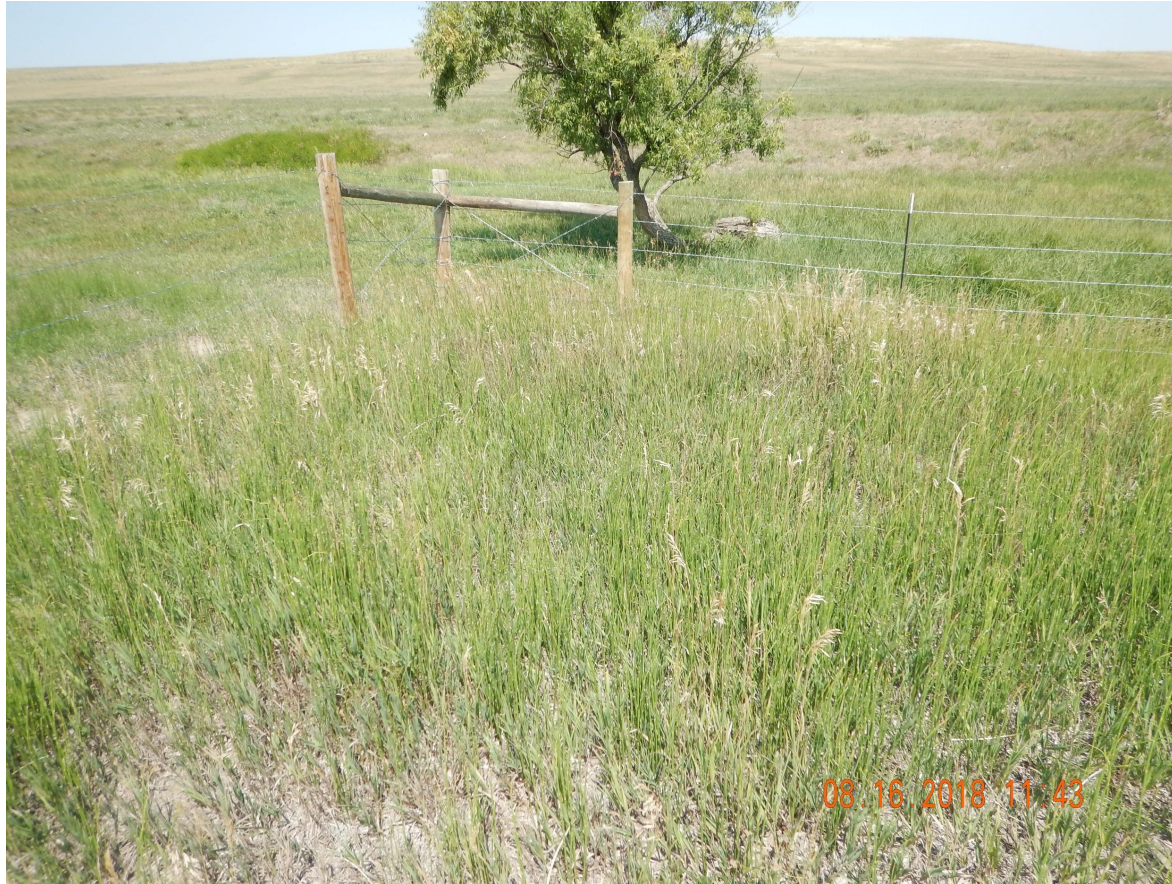
Photo 5. Photo taken from the southwestern location on August 16, 2018, facing West. This photo illustrates the vegetative goal that should be achieved throughout the entire location before releasing the location.

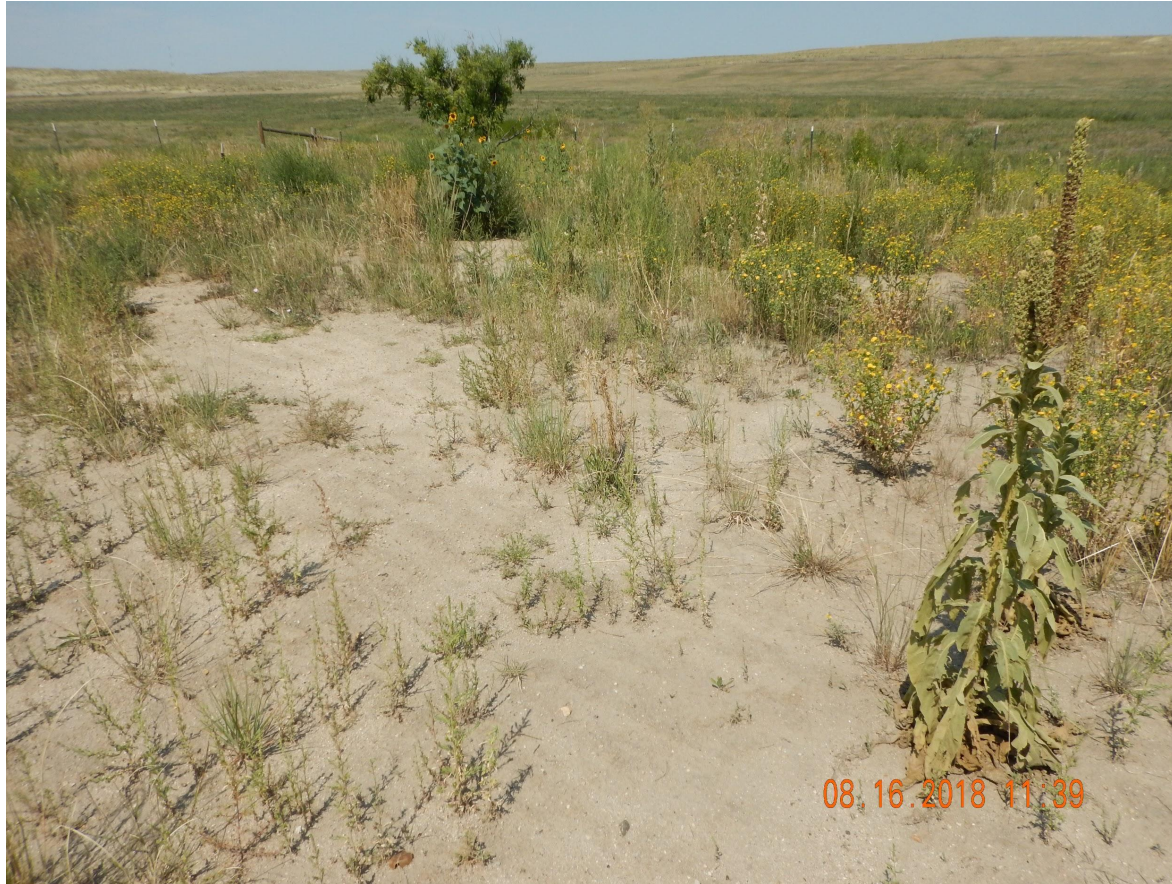
Photo 6. Photo taken from the western location on August 16, 2018, facing West. This photo illustrates a bare patch with little to no desirable vegetation establishment. Additional reclamation activities will be required.

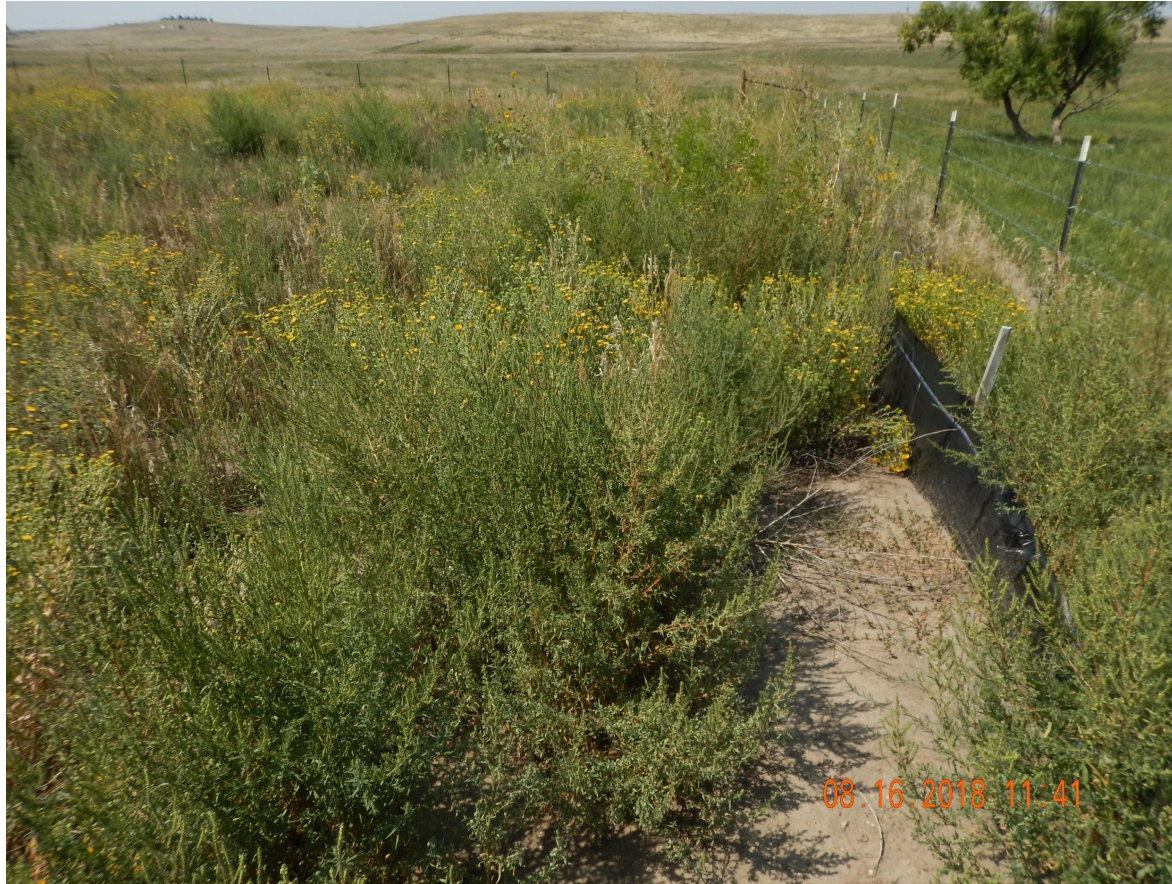
Photo 7. Photo taken from the western perimeter of location on August 16, 2018, facing South. This photo illustrates little to no desirable vegetative establishment, mostly weedy, annual vegetation that needs to be controlled (e.g., mowed).

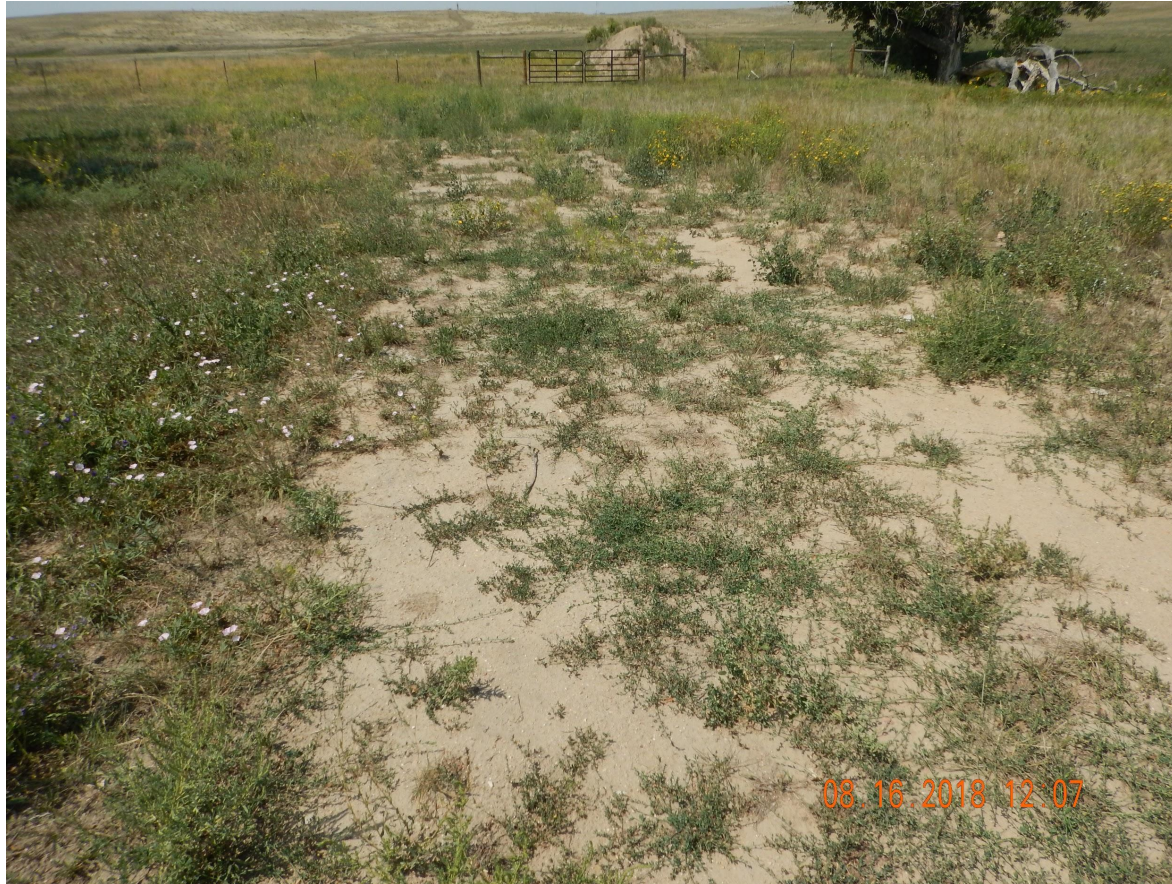
Photo 8. Photo taken from a portion of access road to the location on August 16, 2018, facing South. This photo illustrates a bare patch with little to no desirable vegetation establishment. Additional reclamation activities will be required.

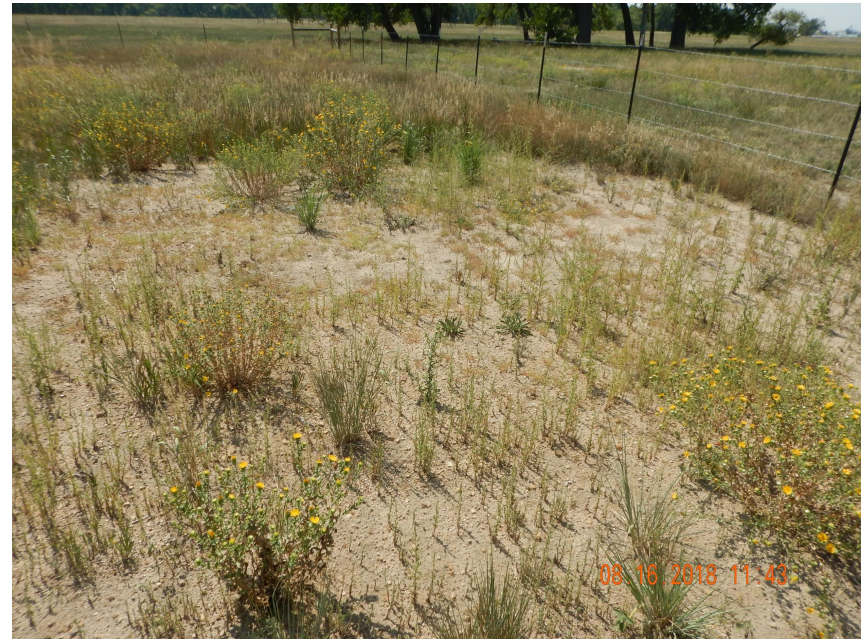
Photo 10. Photo taken from the southern location on August 16, 2018, facing East. This photo illustrates a bare patch with little to no desirable vegetation establishment. Additional reclamation activities will be required.

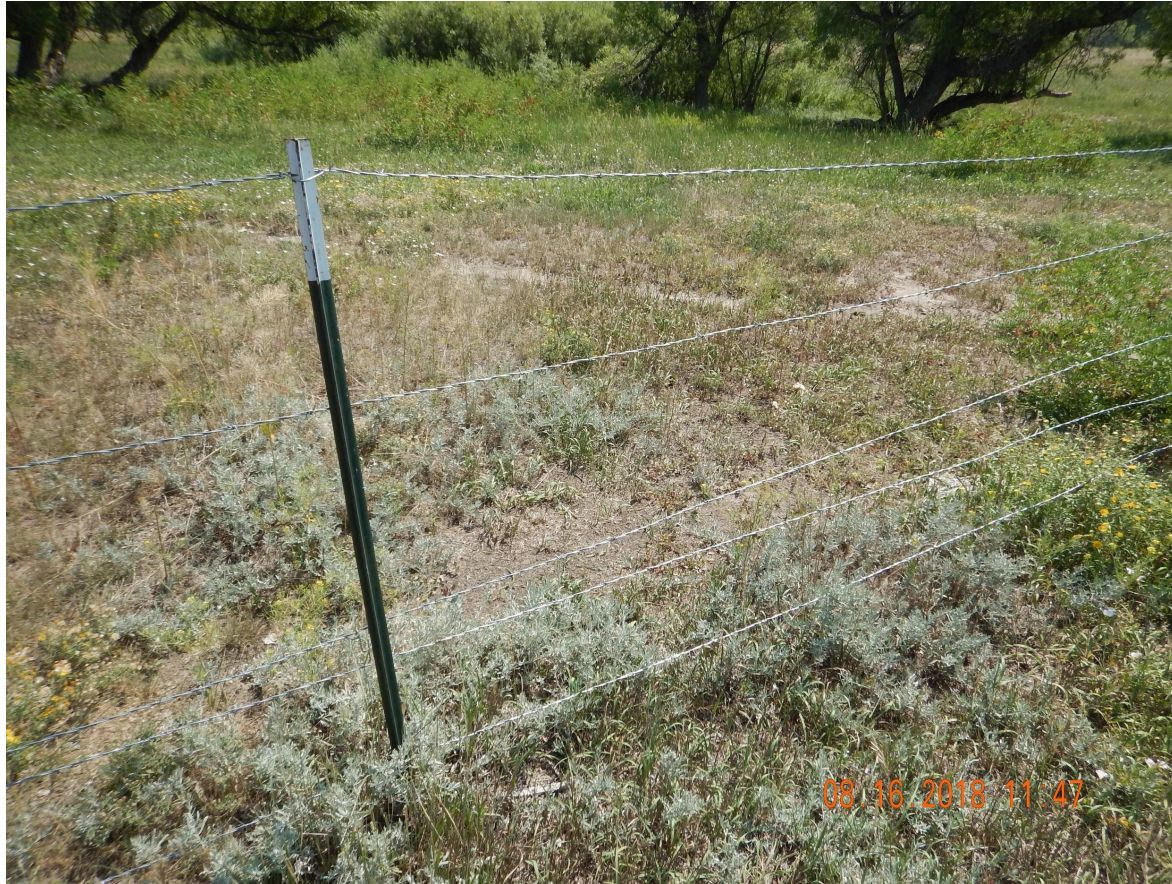
Photo 11. Photo taken from the northeastern perimeter of location on August 16, 2018. Fence repairs are needed to keep cattle out, as the surface owner grazes the adjacent lands.
