Inspection Photos
Location Name: Chavez #1
API: 05-007-06120

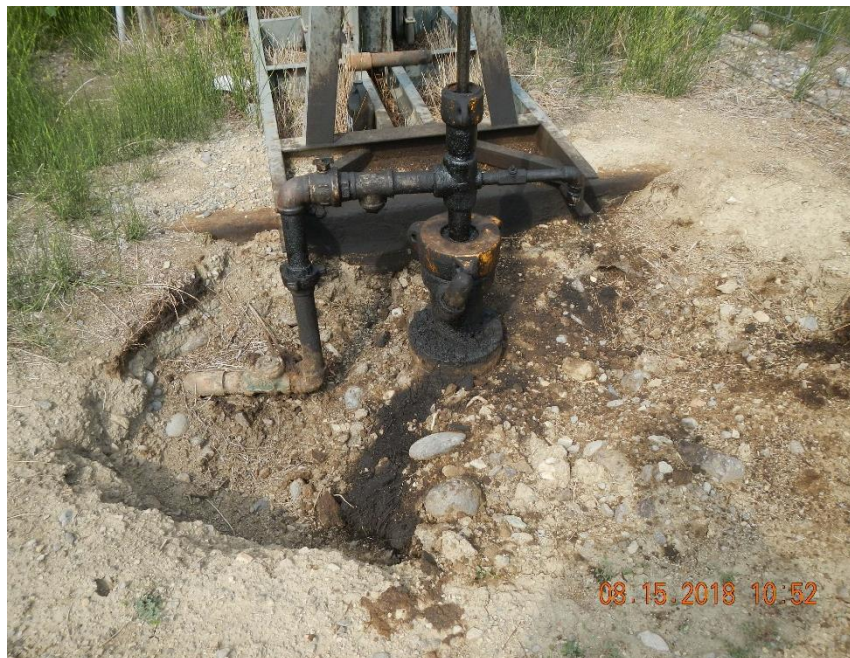
Condition of area surrounding Chavez #1 well head upon arrival on 8/15/18.

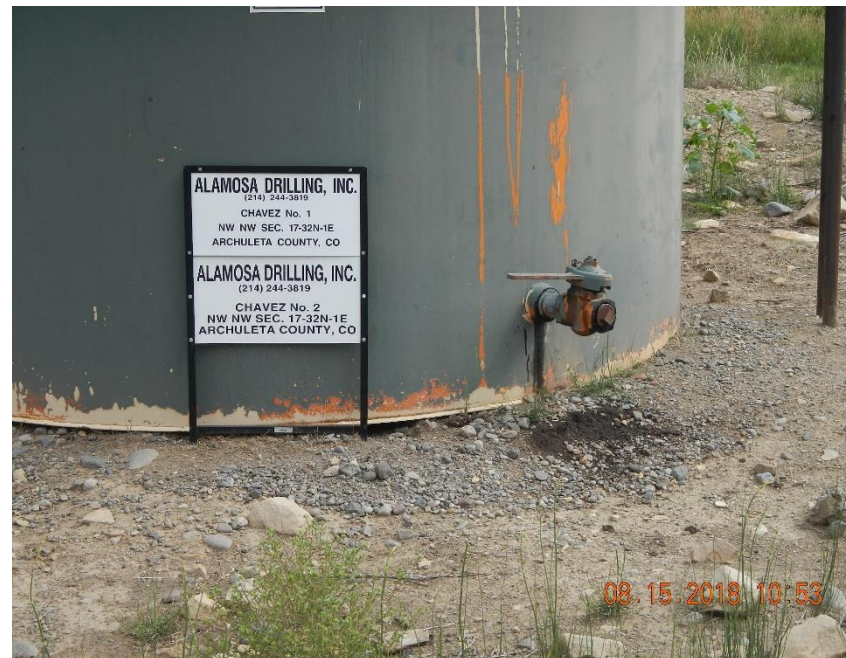
Impacted soil remains underneath truck load out valve on AST.

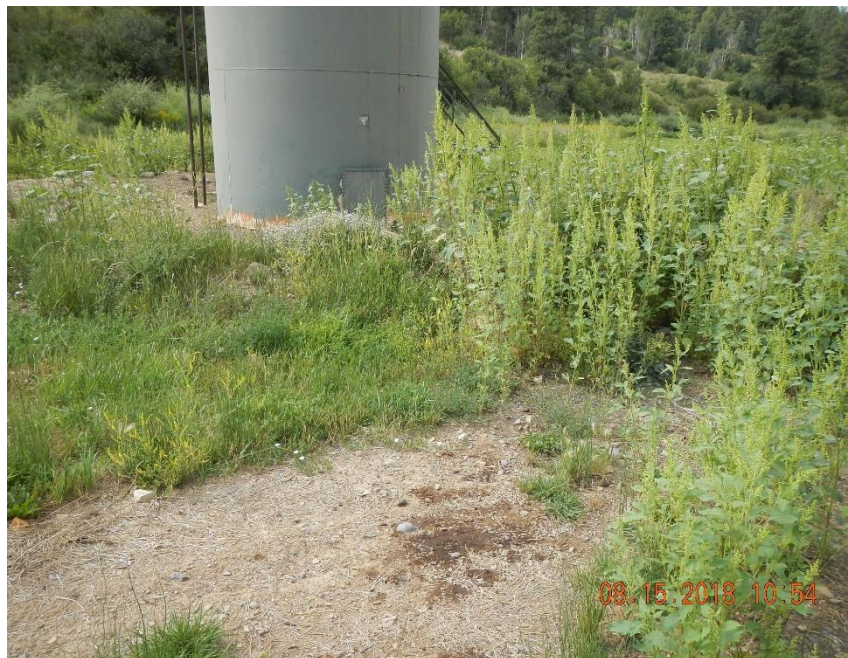
Weeds present across location as well as on and inside the secondary containment berm.

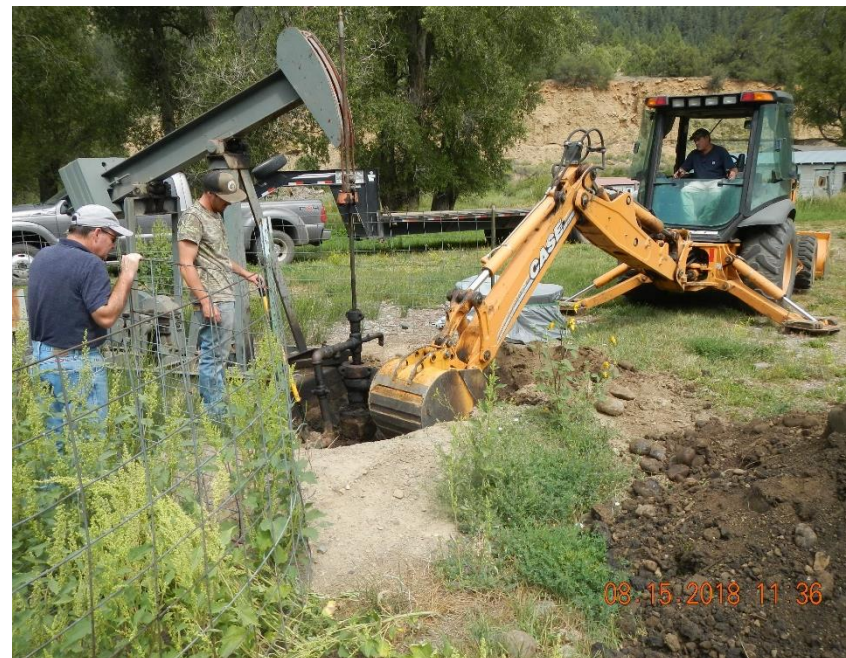
Rivas Earthworks beginning to excavate impacted soil from around the Chavez #1 well head.

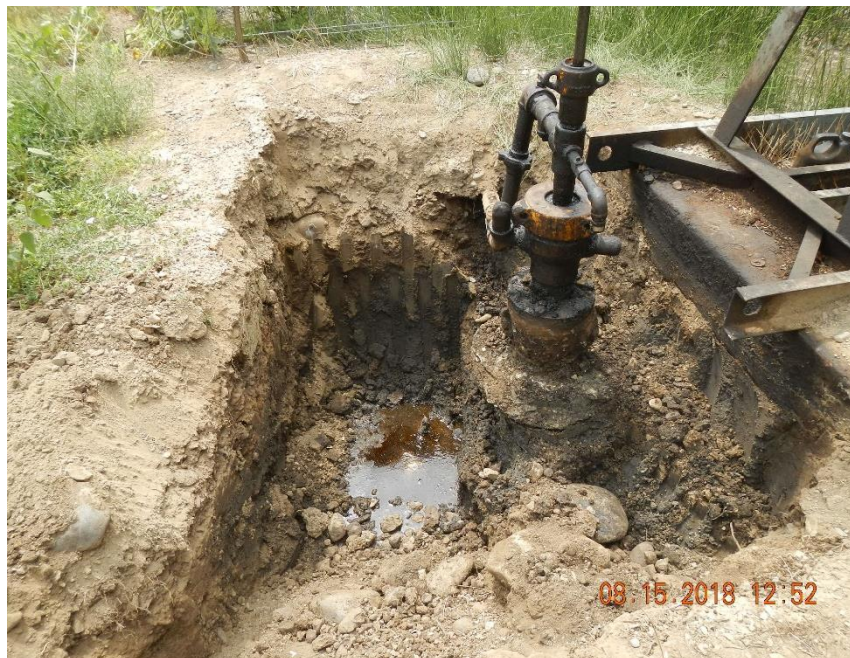
Excavation became wet at approximately 4' bgs.

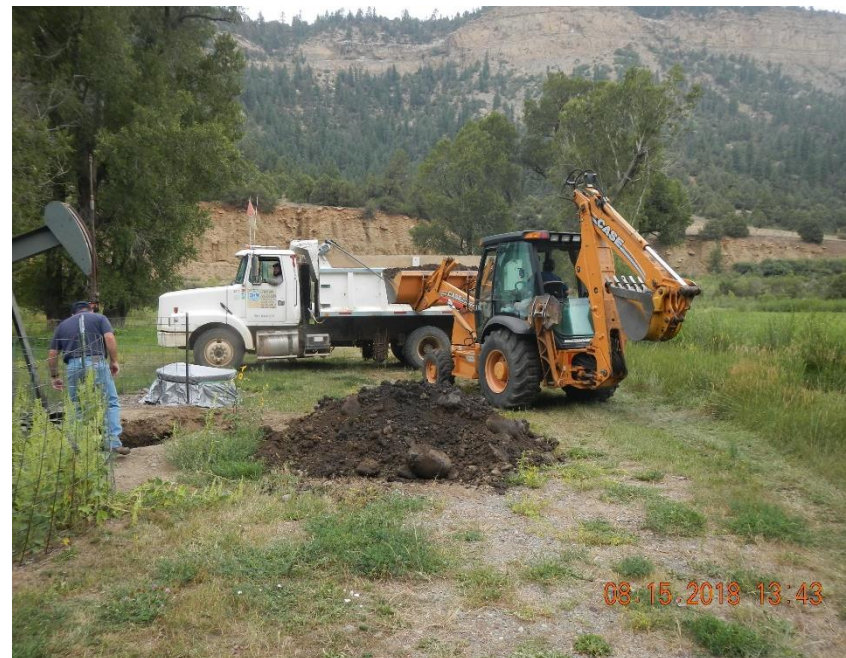
Stained soil being loaded onto 12 cy dump truck.

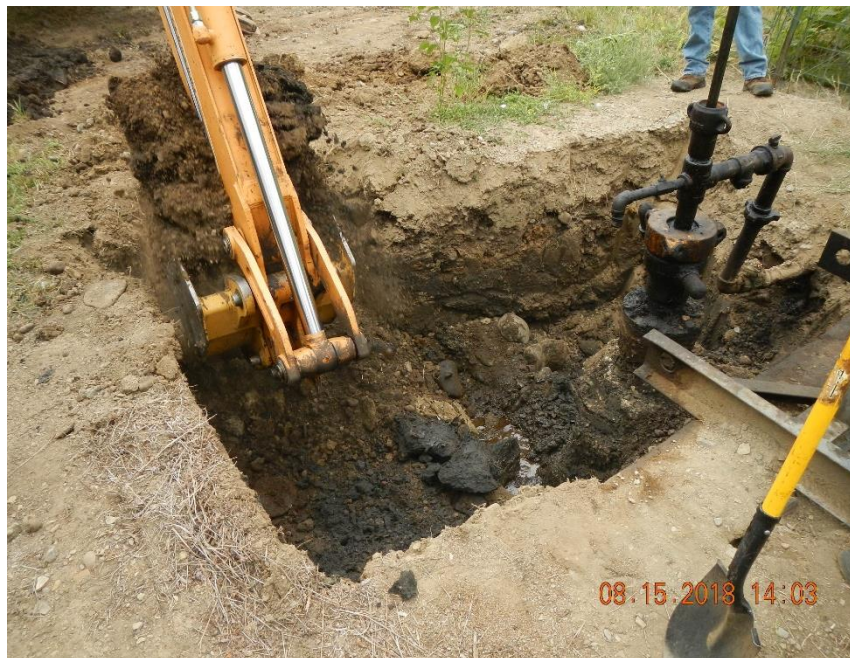
Material being removed from north side of well head.

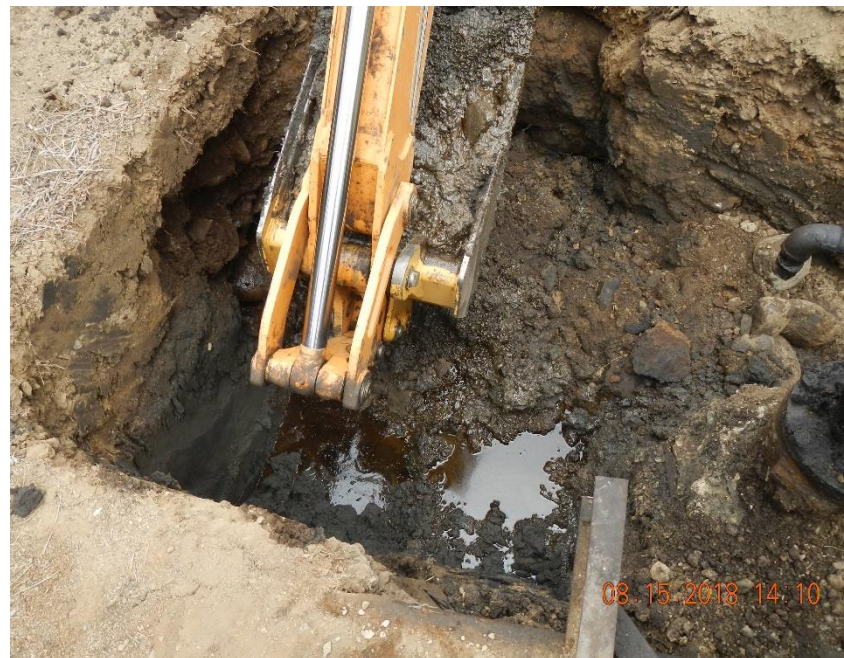
Excavation of stained soil with infiltration of ground water.

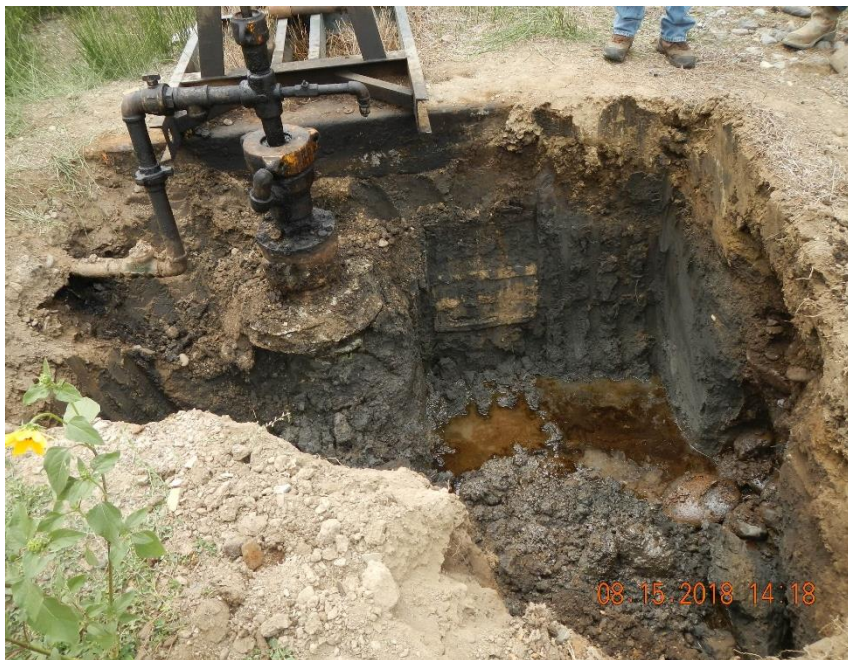
Extent of excavation on 8/15/18.

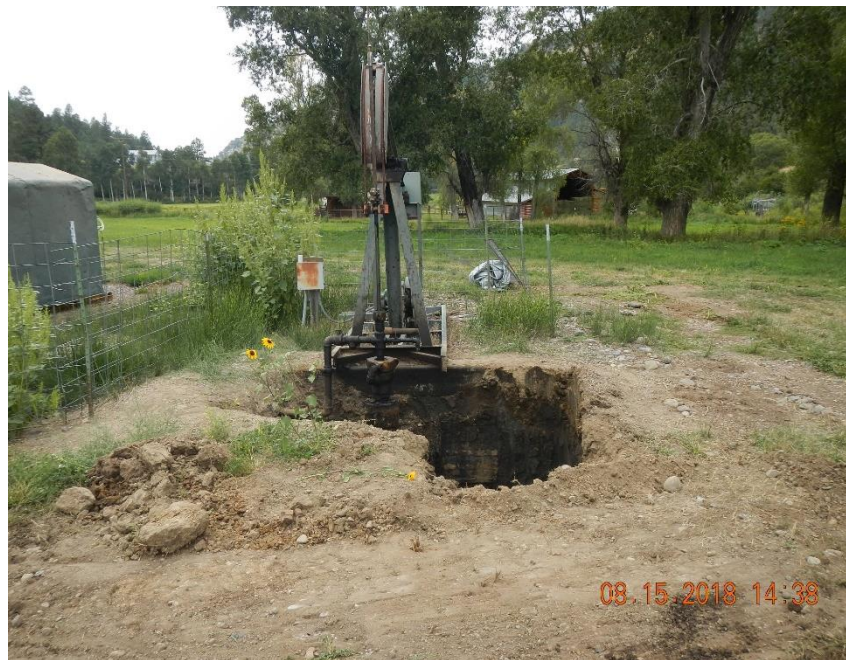
Open excavation around well head.
