Final Reclamation Inspection

Operator: PDC ENERGY INC - 69175

API: 05-123-14423

Inspection Photos
Location Name: SUCCO GAS UNIT #4-20
API: 05-123-14423

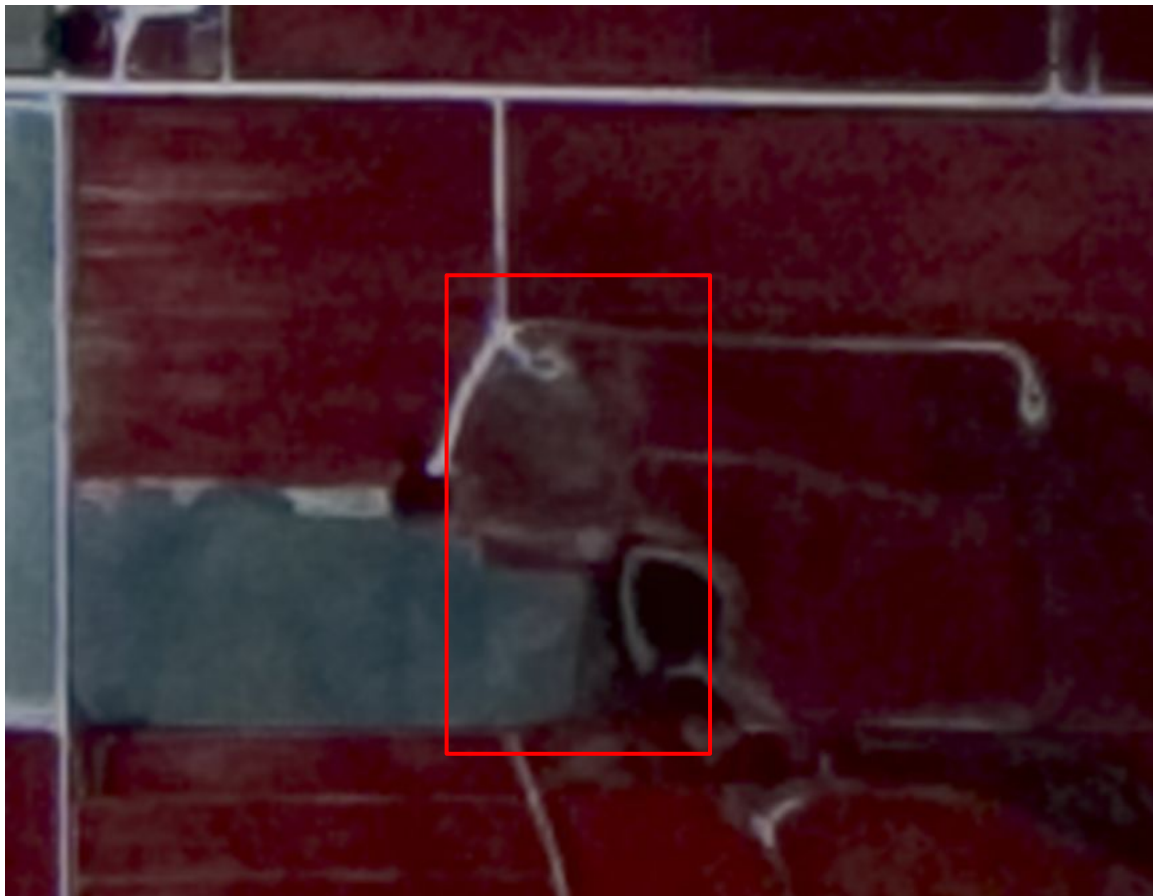
Aerial imagery from 1988 illustrates there was not a pre-existing road to the Succo Gas Unit.

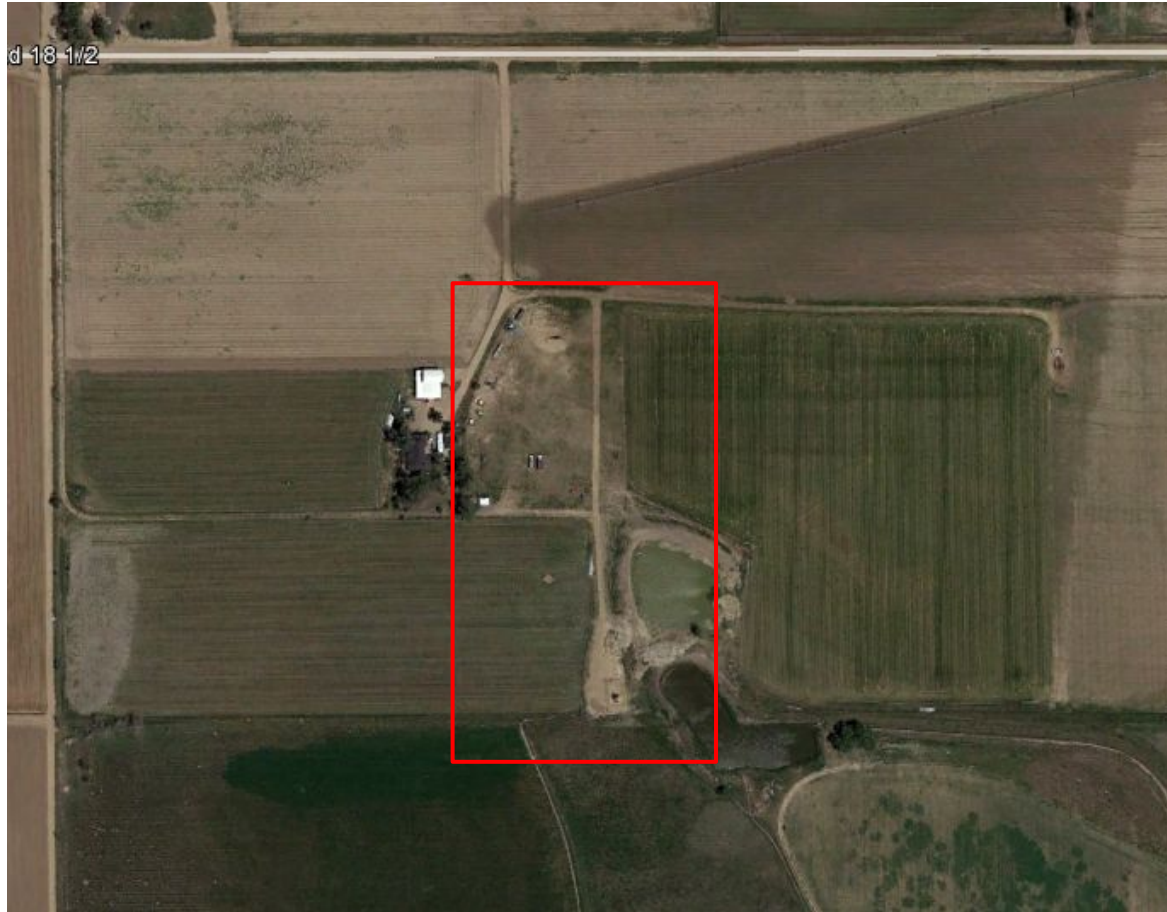
Aerial imagery from 2017 illustrates the Succo Gas Unit during active operations. Access road and tank battery location have not been reclaimed per Rule 1004.

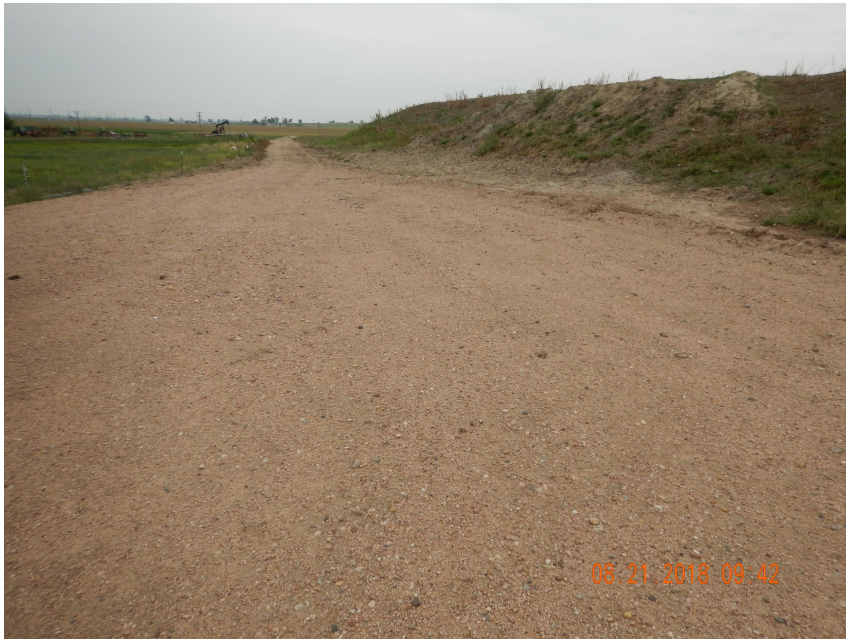
Photo 1. Photo taken from the tank battery location, facing South. Operator has failed to perform final reclamation activities at the tank battery and along the access road.

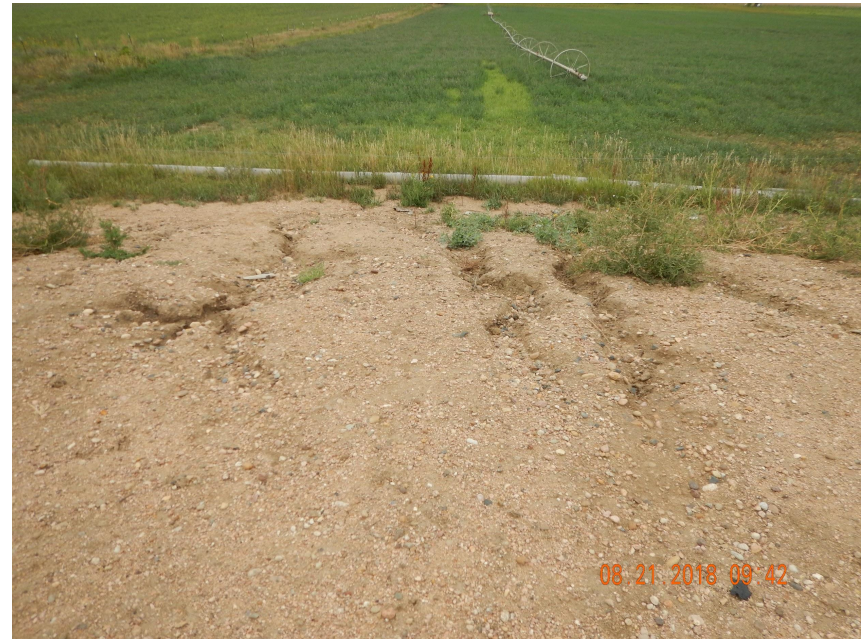
Photo 2. Photo taken from the western fill slope of the tank battery location, facing West. Photo illustrates rill erosion along the fill slope.

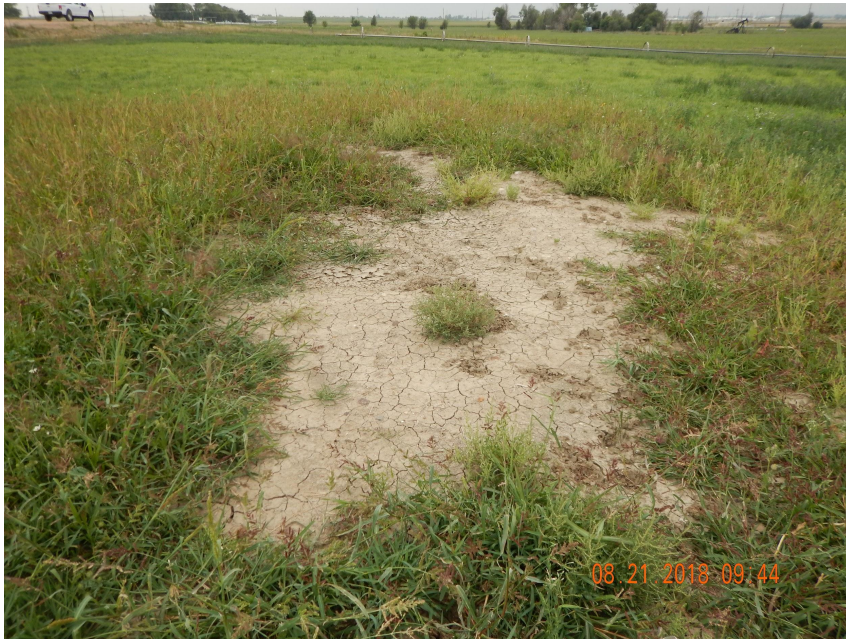
Photo 3. Photo taken from the well location, facing South. Well location will remain in-process as vegetation is not reflective of reference alfalfa areas. Bare soil patch was observed which may require the Operator to perform addition reclamation activities.

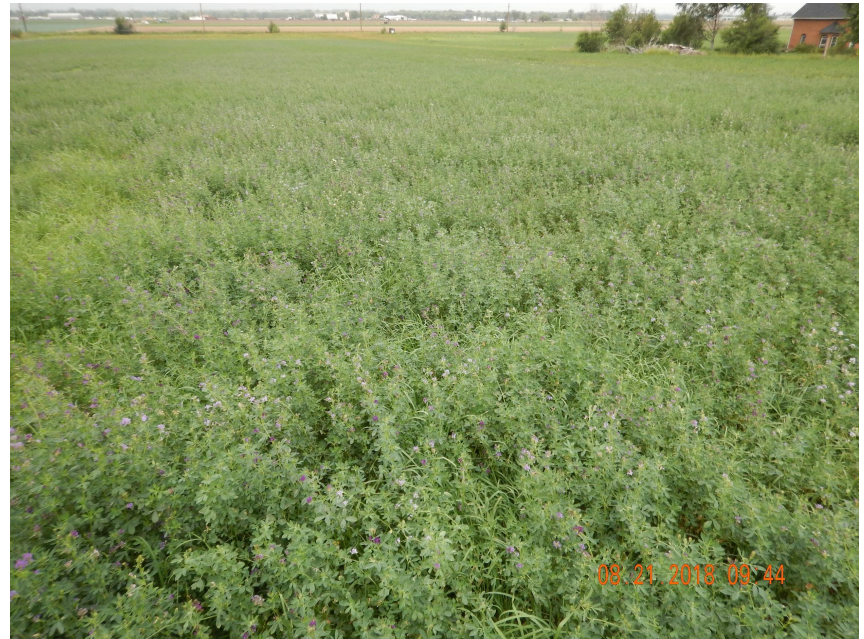
Photo 4. Reference area photo taken west of the well location, facing West.
