Inspection Photos

Location Name: Federal Goshawk - 68N60W / 28SWSW

Location #: 305200

COLORADO
Oil & Gas Conservation
Commission
Department of Natural Resources

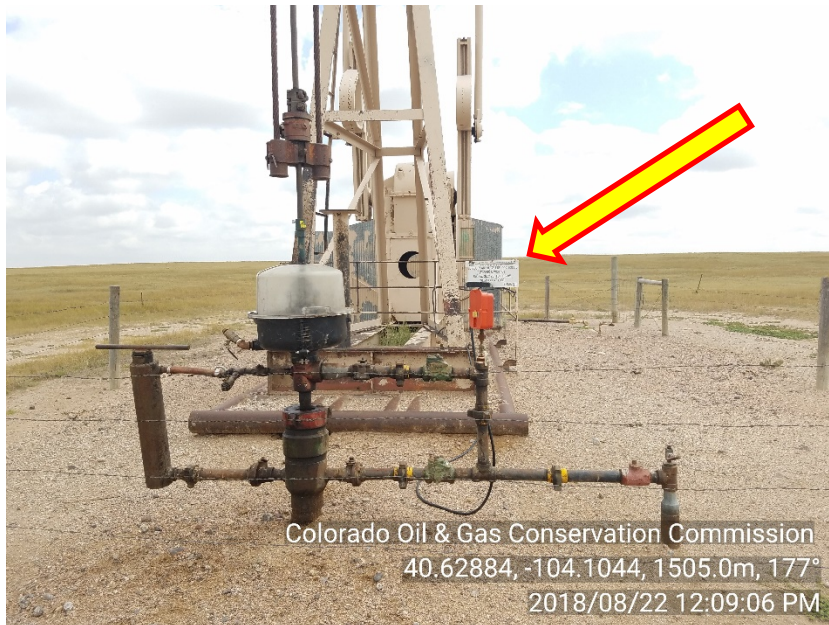
Photo #1

Federal Goshawk 28-14 (API # 05-123-22634) wellhead

Sign is illegible

Bradenhead NOT plumbed to surface

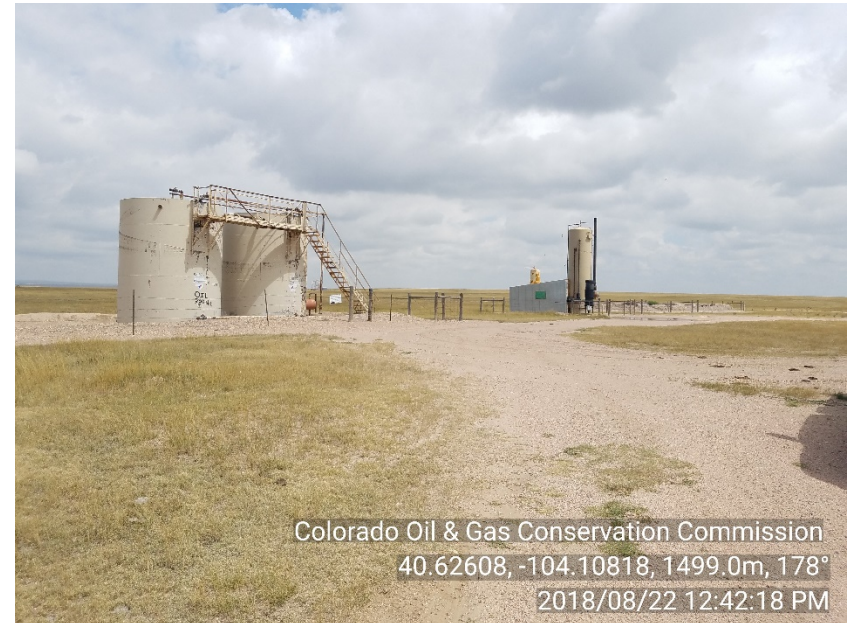
Photo #2

Federal Goshawk 28-14, Fed Plover 28-5X,

Fed Toucan 28-14

Battery

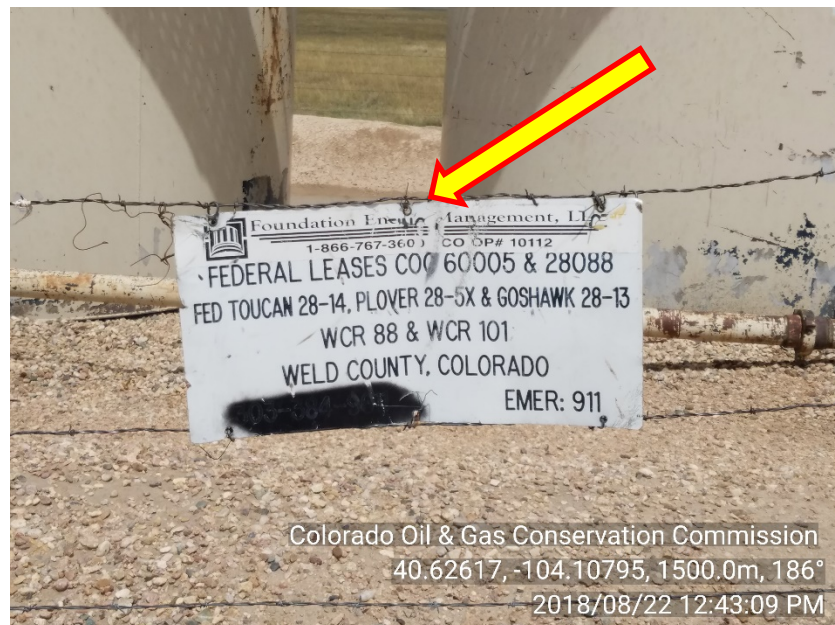
Photo #3

***Federal Goshawk 28-14, Fed Plover 28-5X,
Fed Toucan 28-14***

Battery Sign is illegible

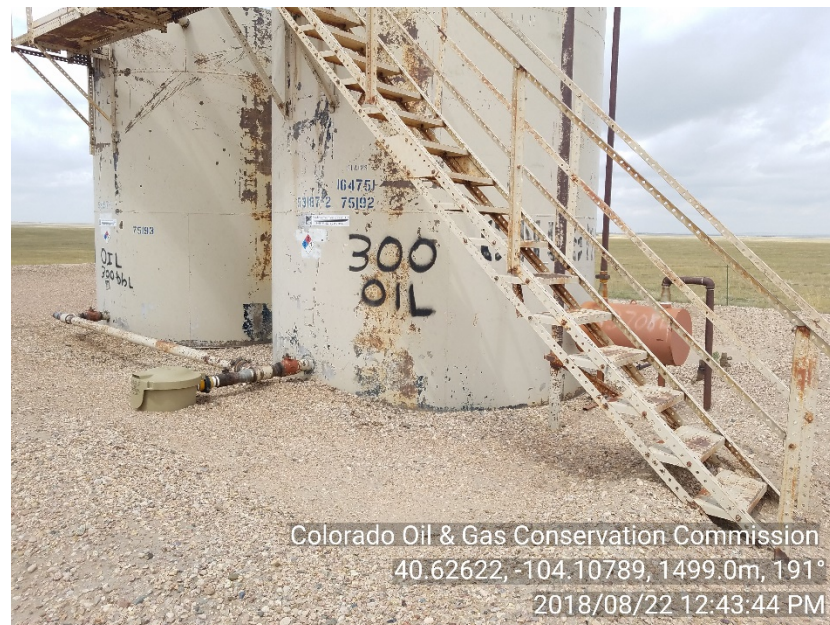
Photo #4

***Federal Goshawk 28-14, Fed Plover 28-5X,
Fed Toucan 28-14***

Oil Tanks – Rust, Poor paint condition

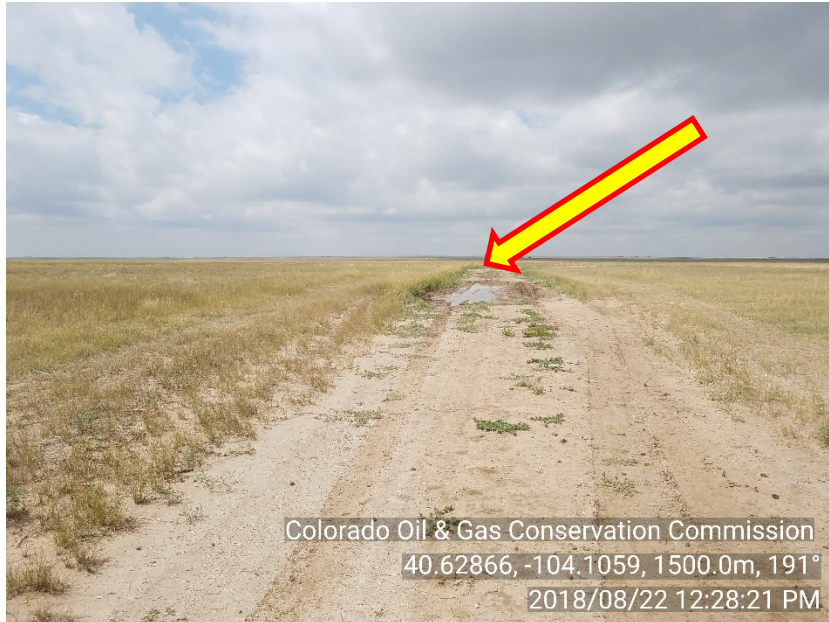
Photo #5

Federal Goshawk 28-14 Access road

Road needs repaired

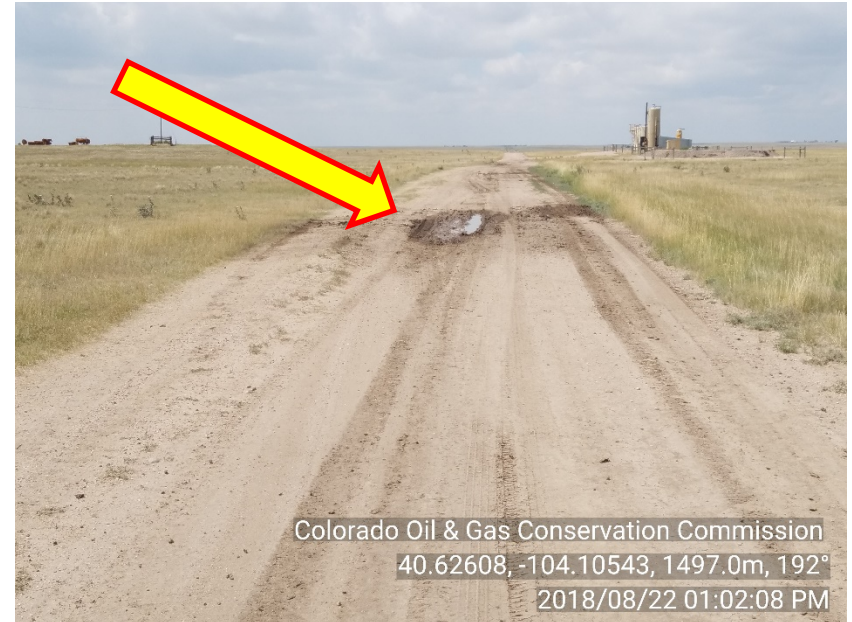
Photo #6

Federal Goshawk 28-14, Fed Plover 28-5X,

Fed Toucan 28-14

Branch roads need repaired

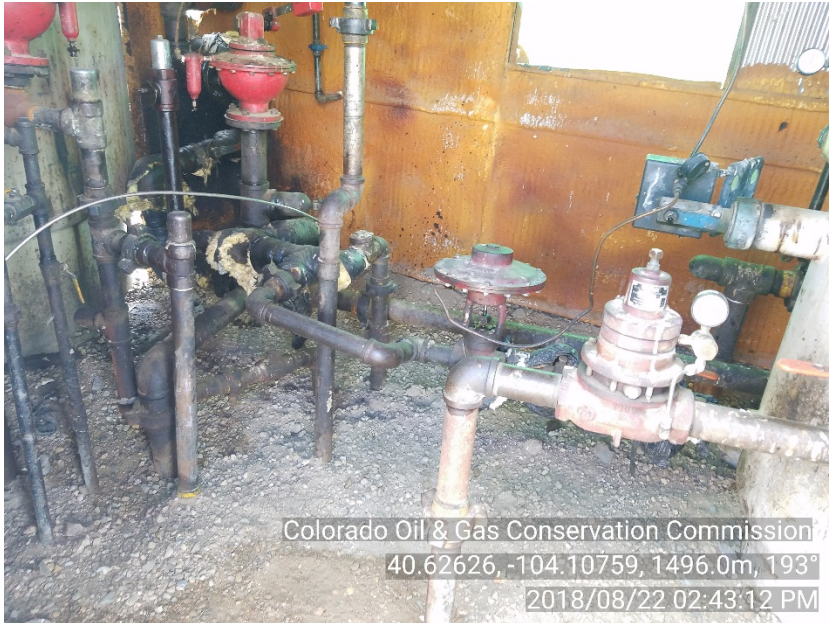
Photo #7

***Federal Goshawk 28-14, Fed Plover 28-5X,
Fed Toucan 28-14***

Treater soil appears remediated

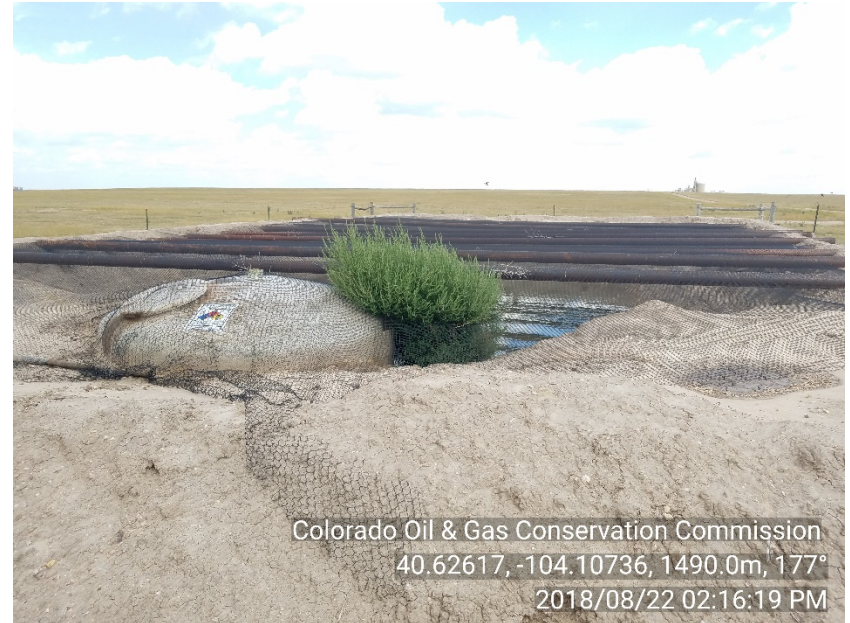
Photo #8

***Federal Goshawk 28-14, Fed Plover 28-5X,
Fed Toucan 28-14***

Weeds on pit bank
