Inspection Photos

08/21/2018

Operator: GRAND MESA OPERATING CO - 35080

Location ID: 453036

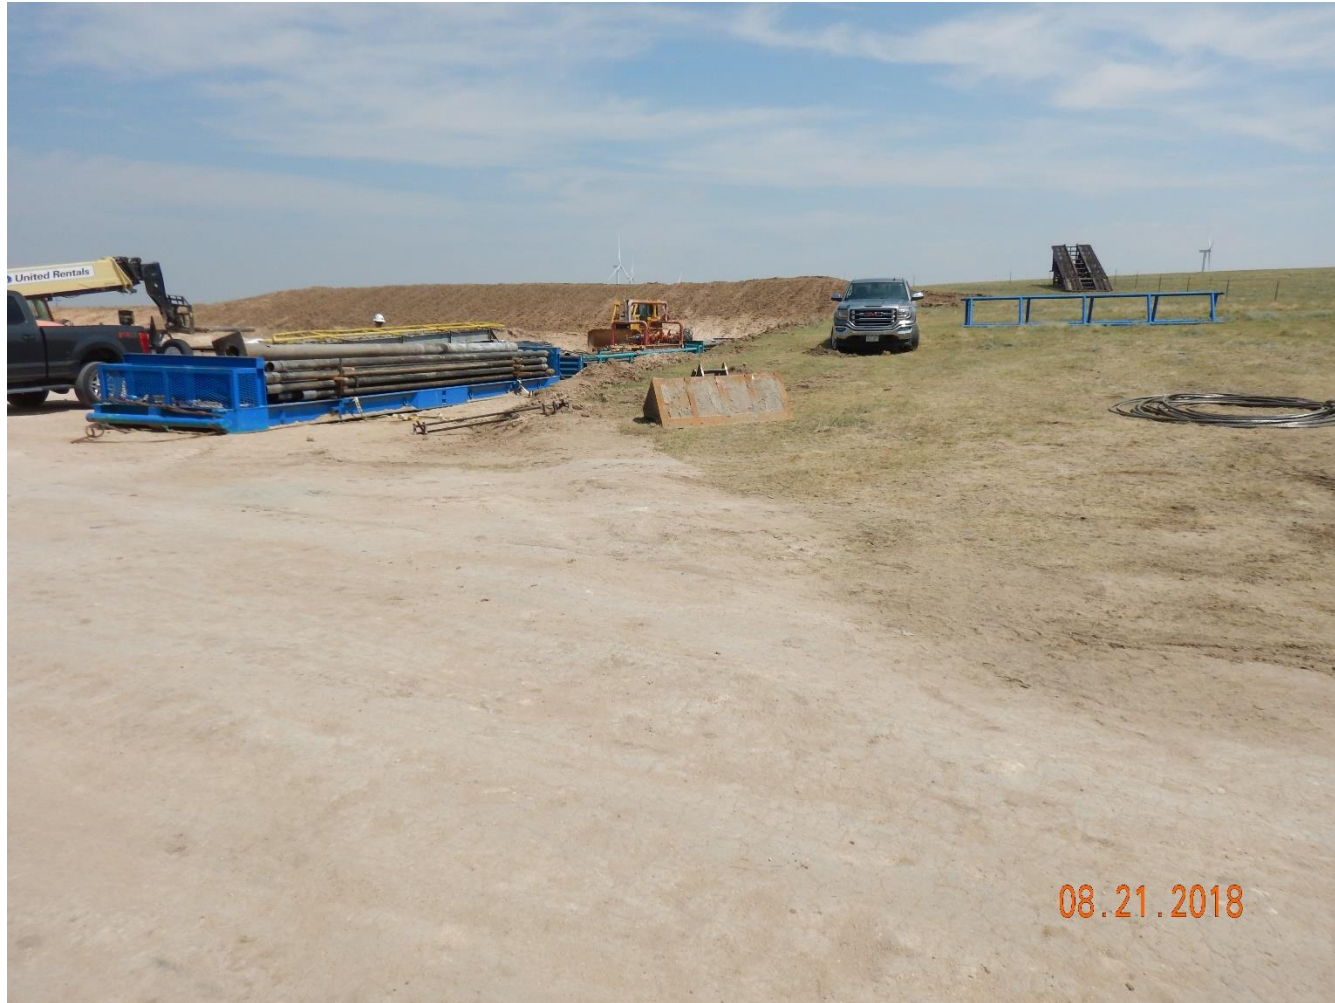
Photo 1: Photo taken from the south end of the location, facing east. Photos 1-4 provide an overview of the location from east, northeast, northwest to west.

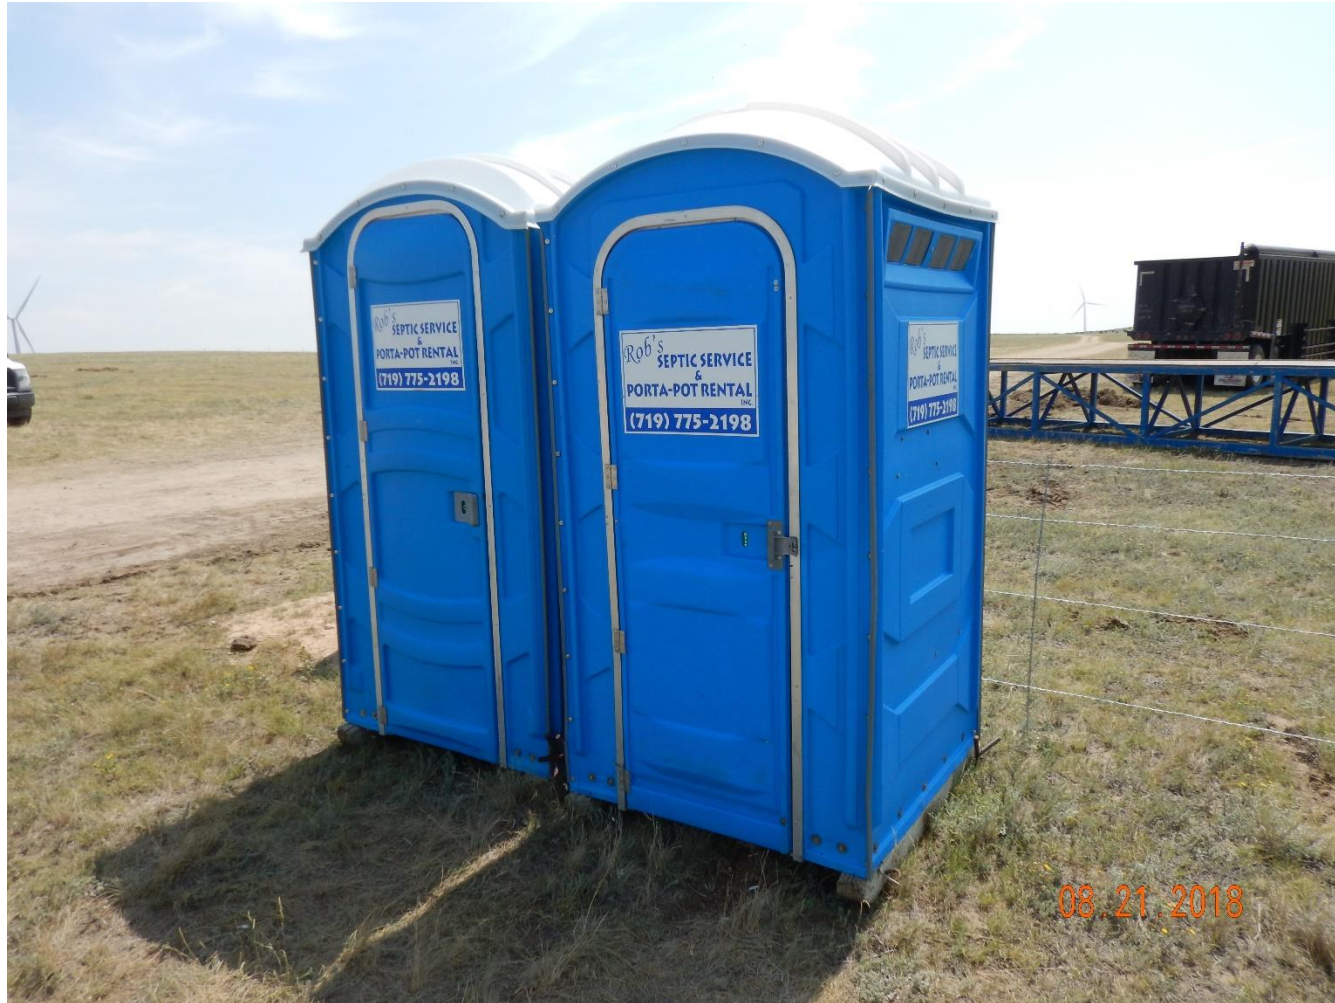
Photo 5: Photo taken from the south end of the location, facing south. Photo shows two (2) porta-johns on location.

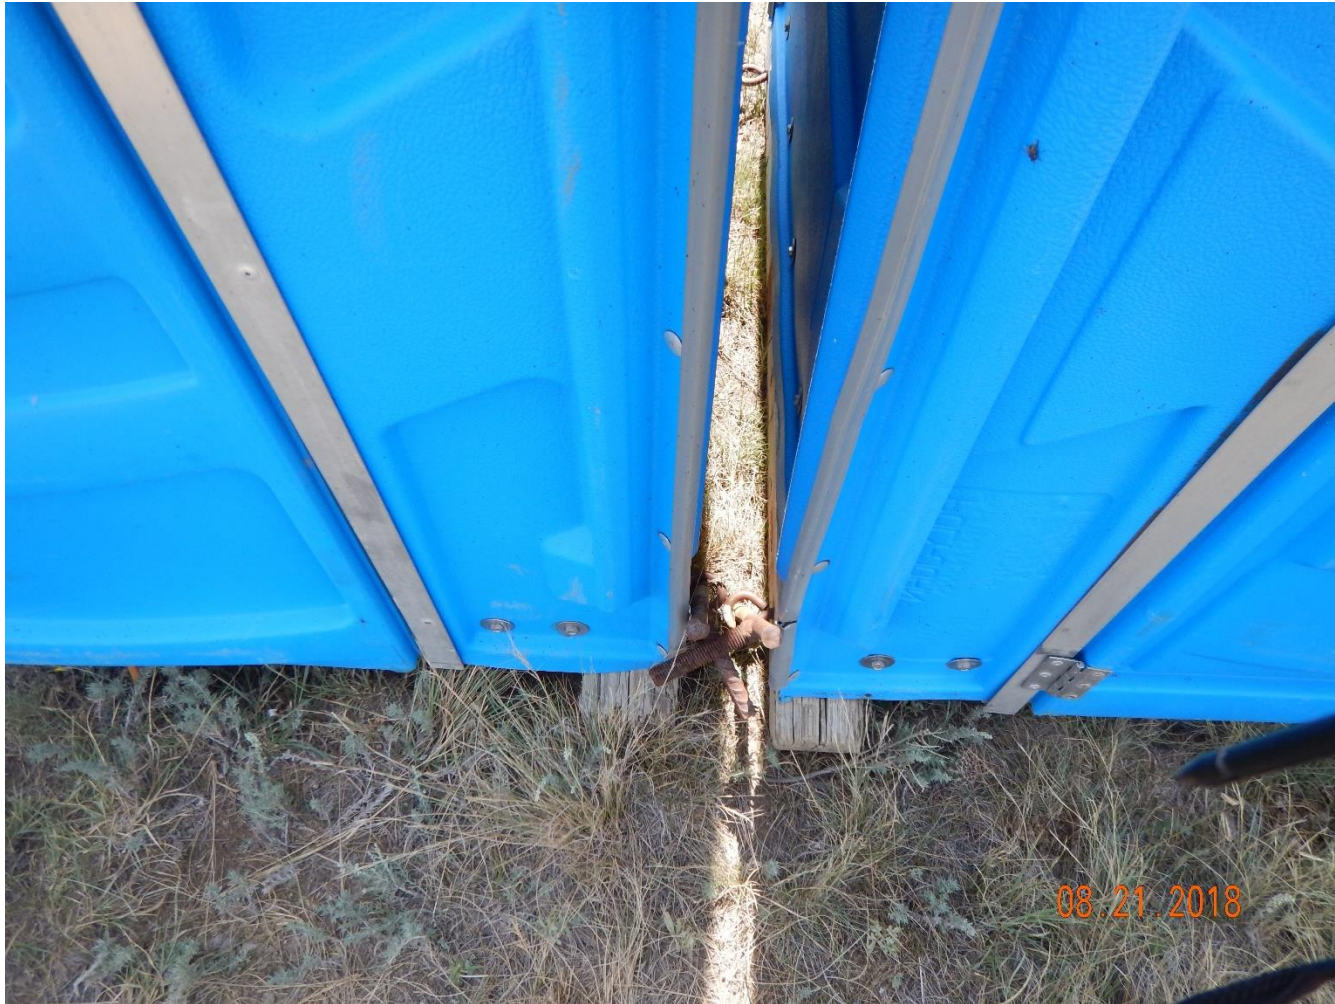
Photo 6: Continued from photo 5. Photo shows porta-johns have been secured down with stakes.

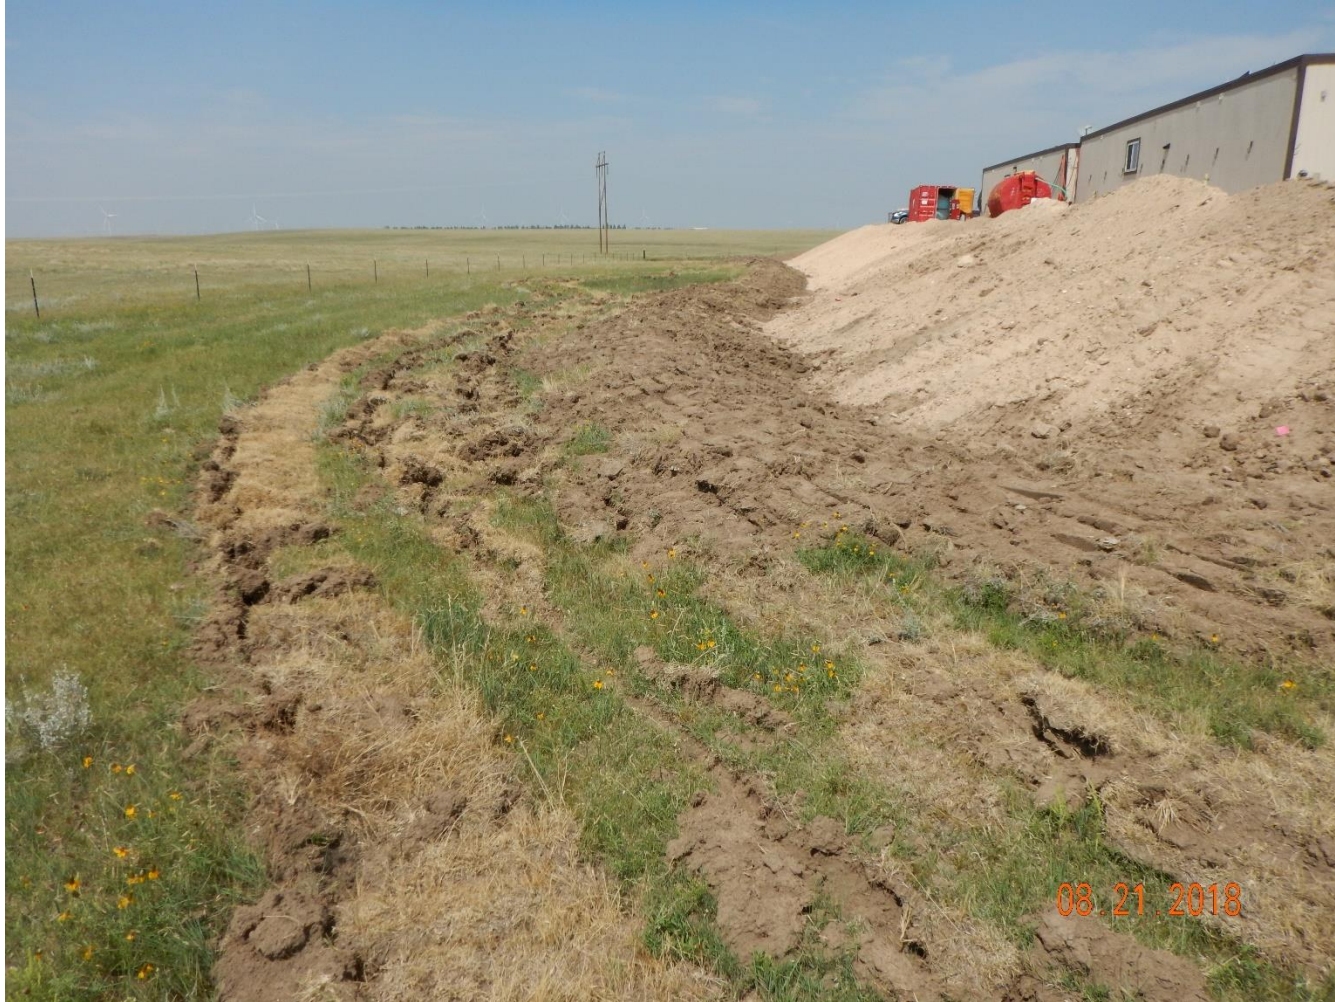
Photo 7: Photo taken from the southwest corner of the location, facing north. Photo shows surface roughening (ripping) has been used in conjunction with a ditch and berm. It is noted that the ditch and berm appear to have been constructed with topsoil from the location. This should be avoided to mitigate potential compaction concerns and sediment loss in the topsoil.

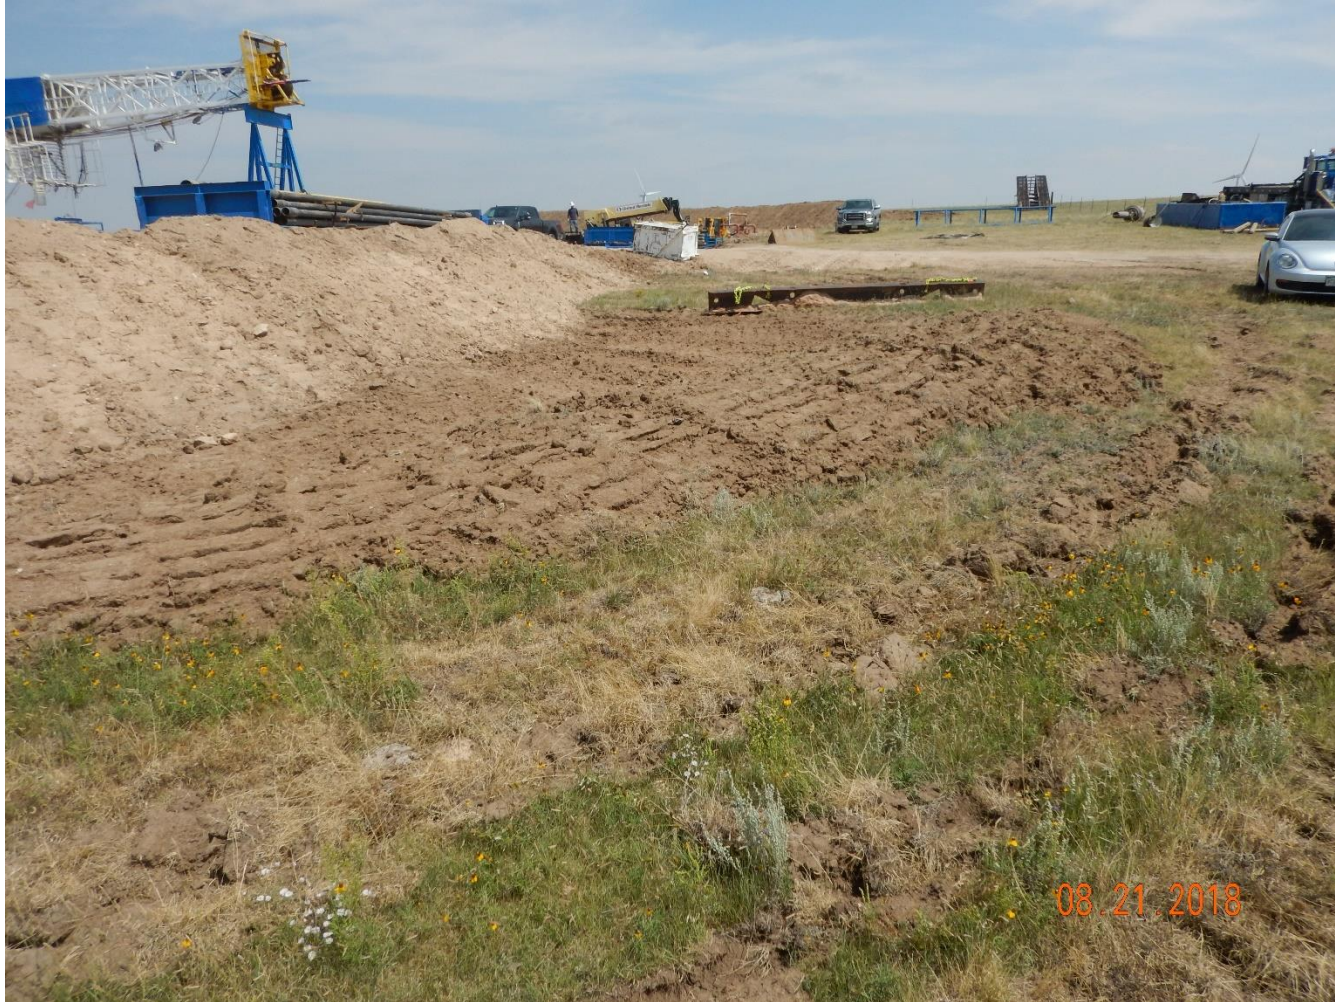
Photo 8: Photo taken from the southwest corner of the location, facing east. See comments under photo 7.

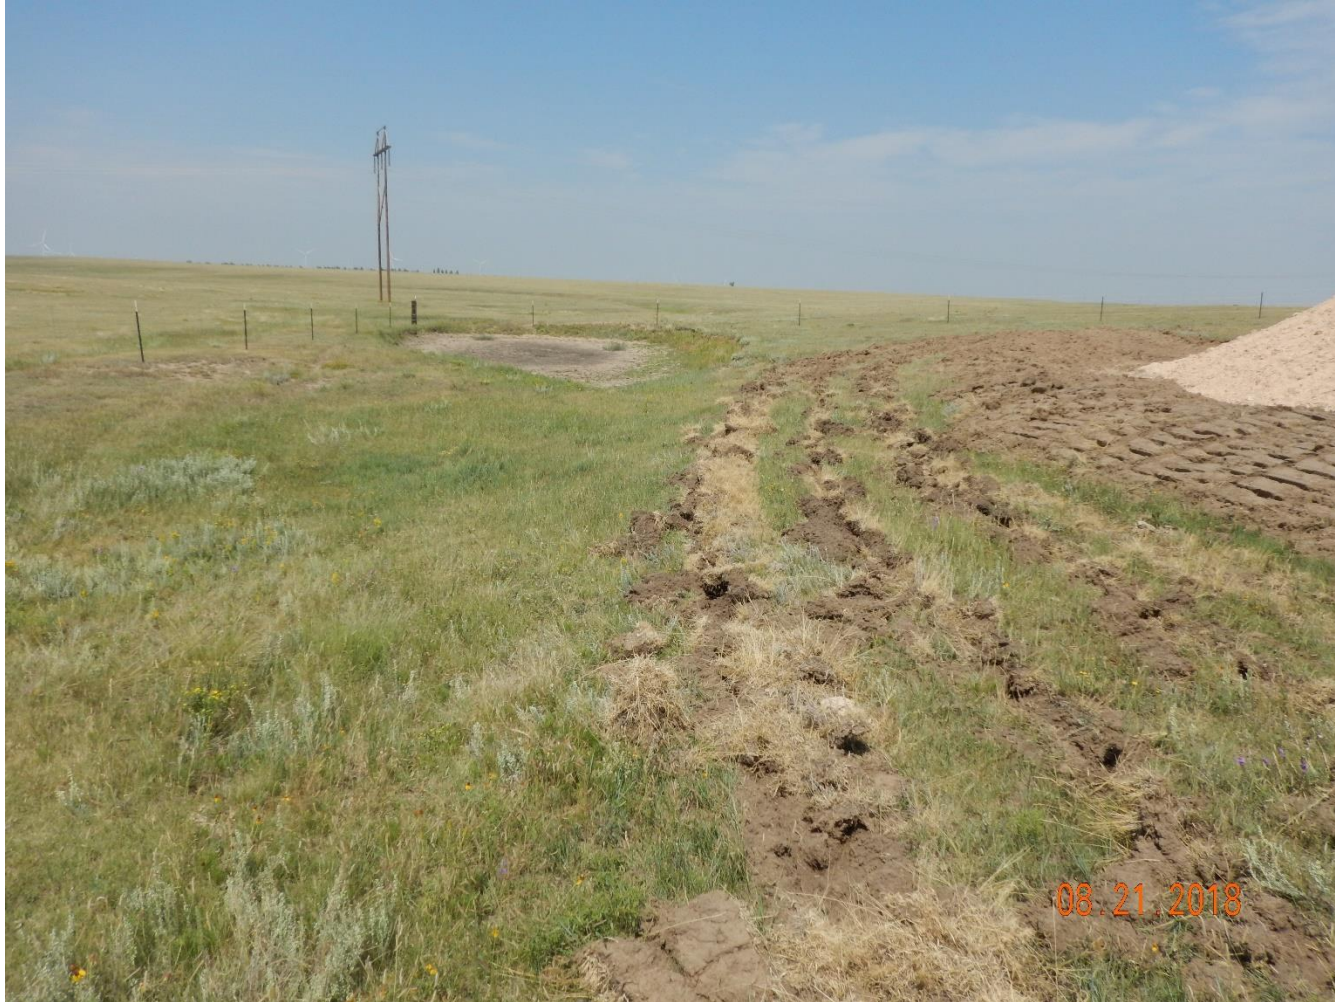
Photo 9: Photo taken from the west end of the location, facing north. Photo shows a shallow pond associated with a drainage to the west of the location. See photo 43

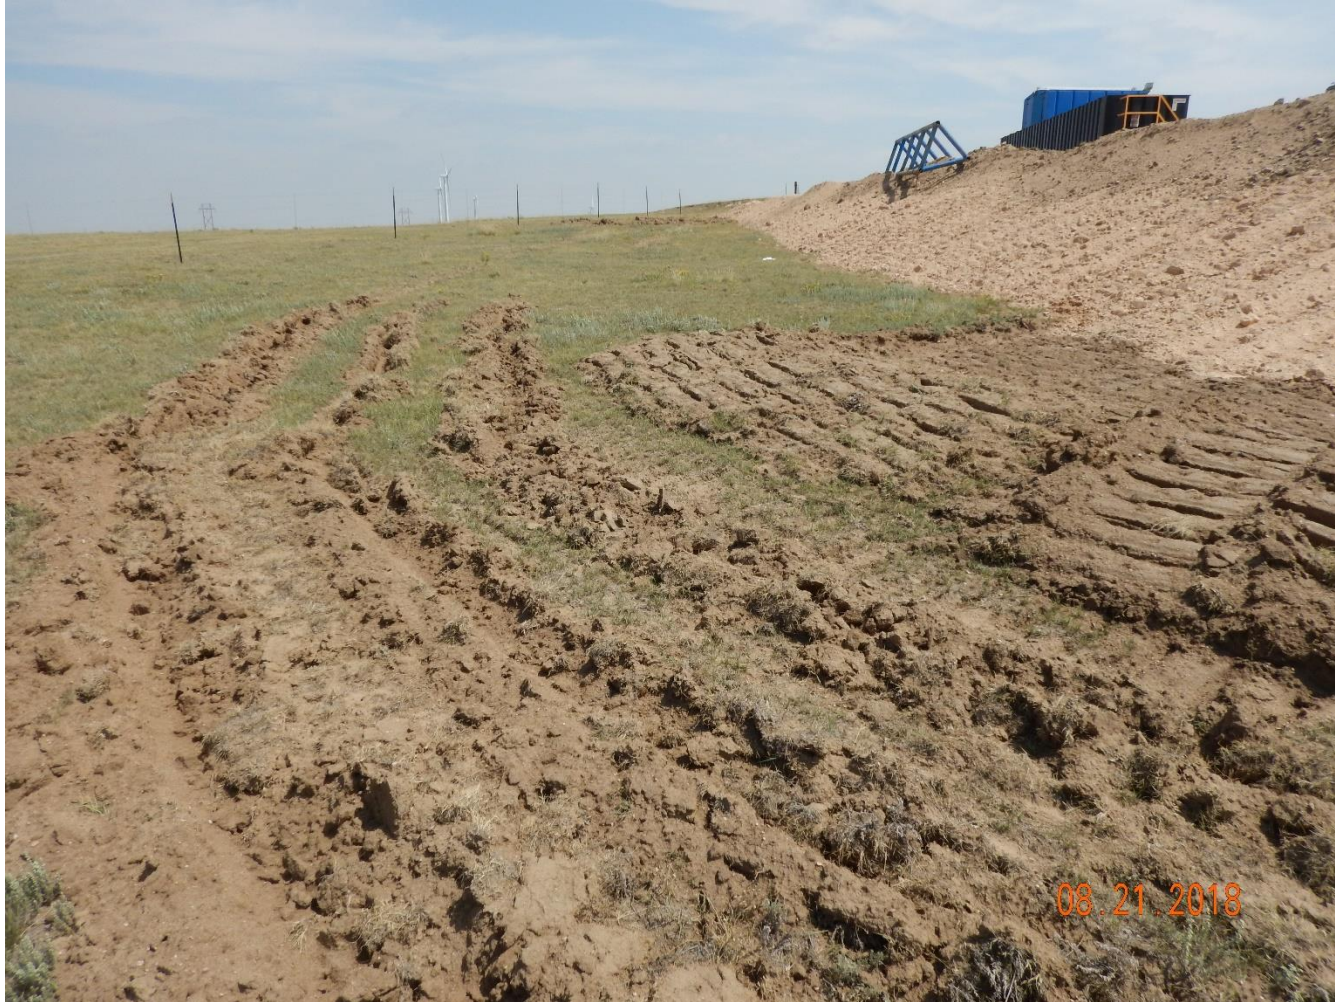
Photo 10: Photo taken from the northwest corner of the location, facing east. Photo shows perimeter controls do not continue on the northern perimeter of the location.

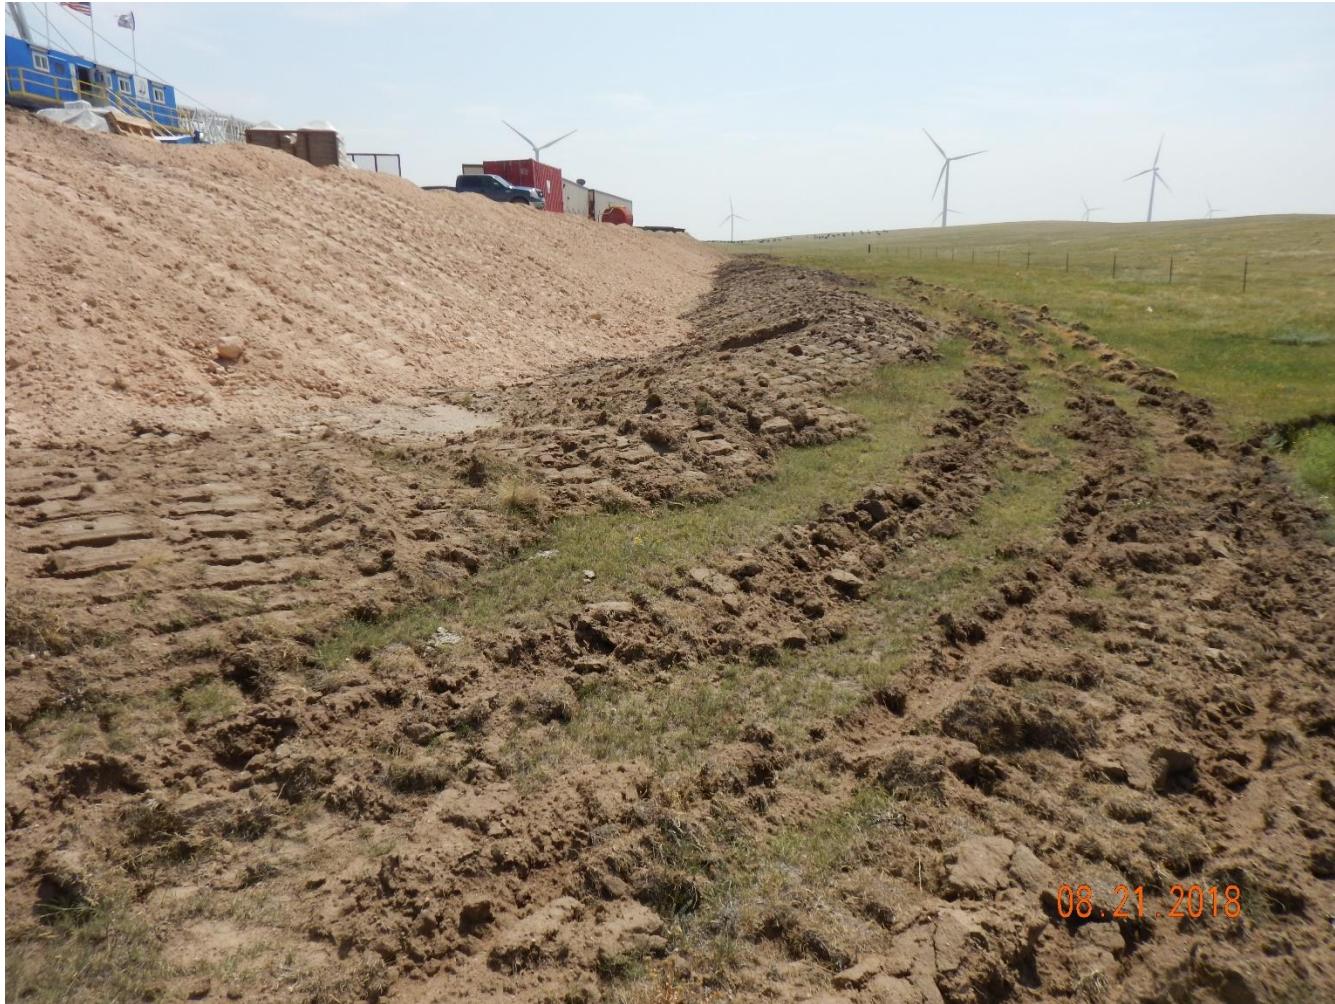
Photo 11: Photo taken from the northwest corner of the location, facing south. See comments under photo 7.

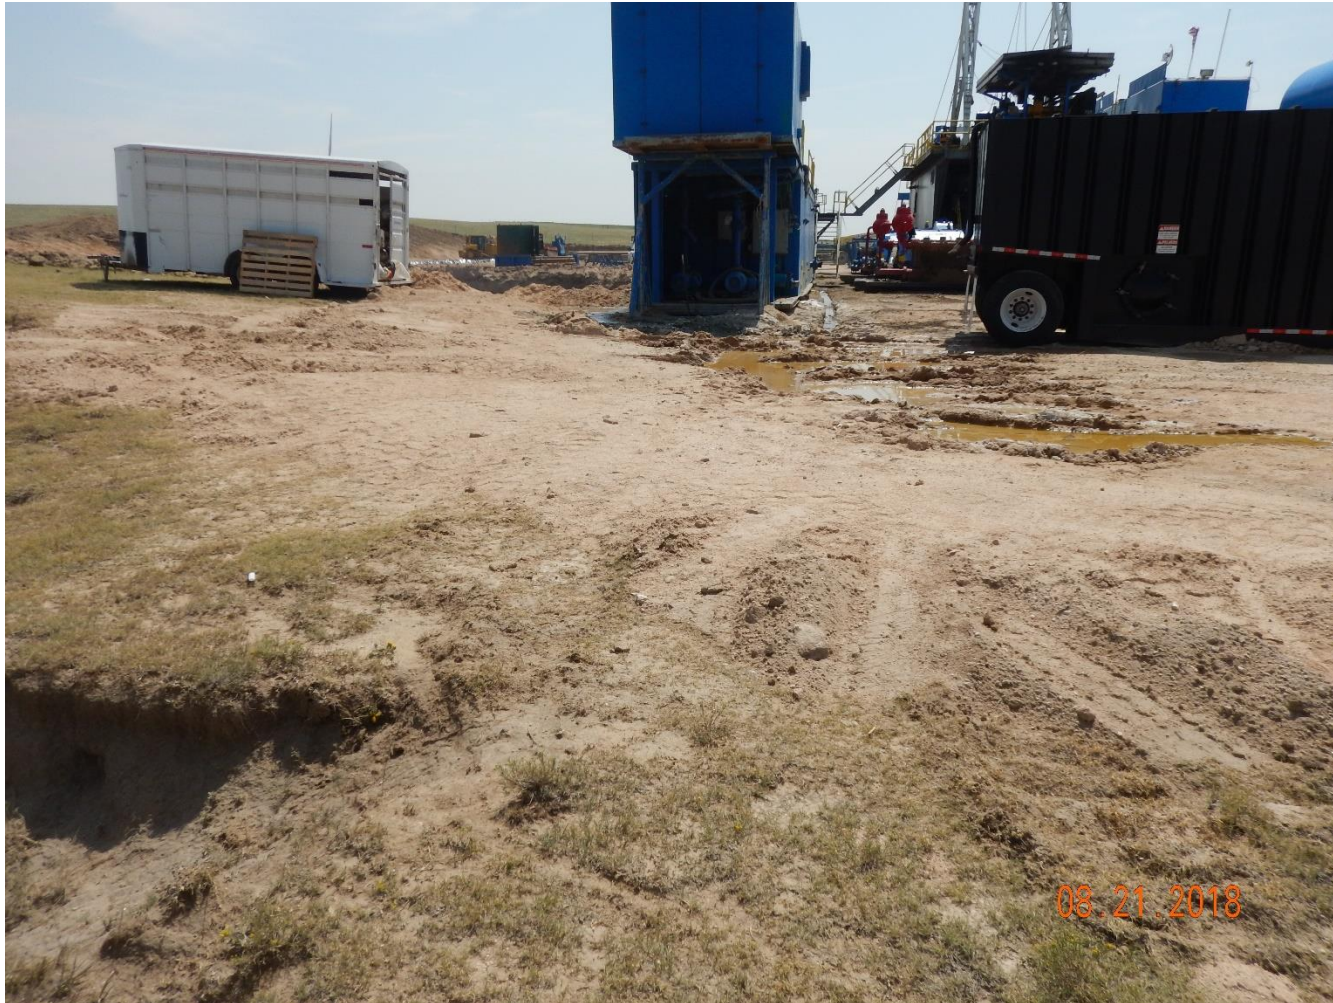
Photo 12: Photo taken from the north end of the location, facing south photo shows various fluids/chemicals from drilling operations ponding on then north end of the pad. Photo also shows the beginning of a drainage to the north of the location (see photo 43). COA in 2A doc. #401333215 states "Location lies within proximity to a tributary of the Lickdab Creek and 275 feet from Lickdab Creek. Operator shall use engineering controls and best management practices to mitigate potential contaminant, including sediment, migration into the nearby surface waters". Photo shows no stormwater or erosion controls have been installed on the north end of the location.

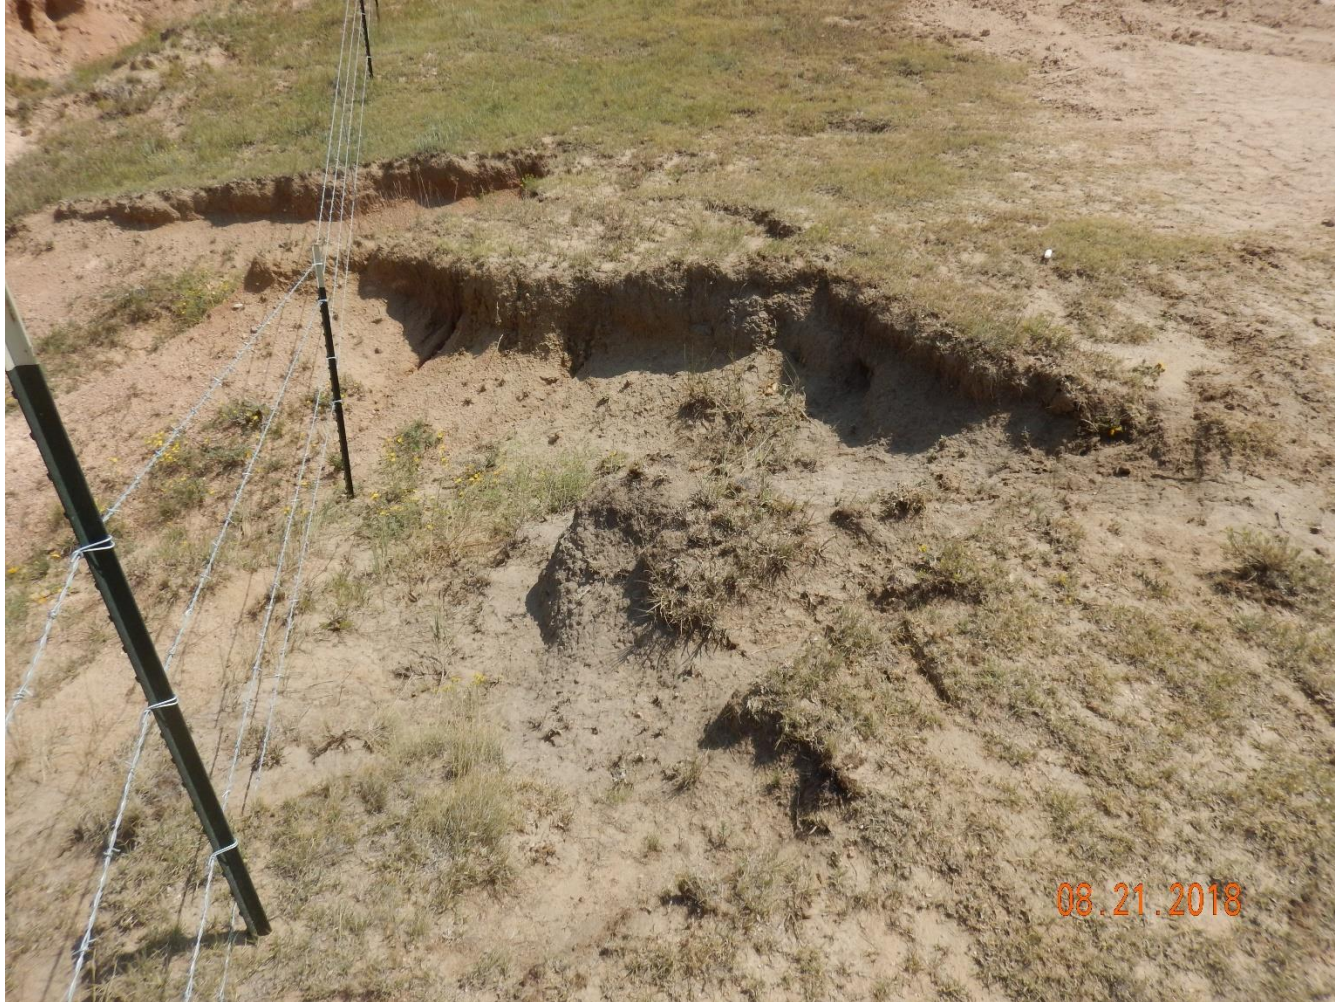
Photo 13: Continued from photo 12. Photo shows drainage. It is noted that the drainage is approximately 3-5 feet from the pad. Photo shows not stormwater or erosion controls have been installed on the north end of the location.

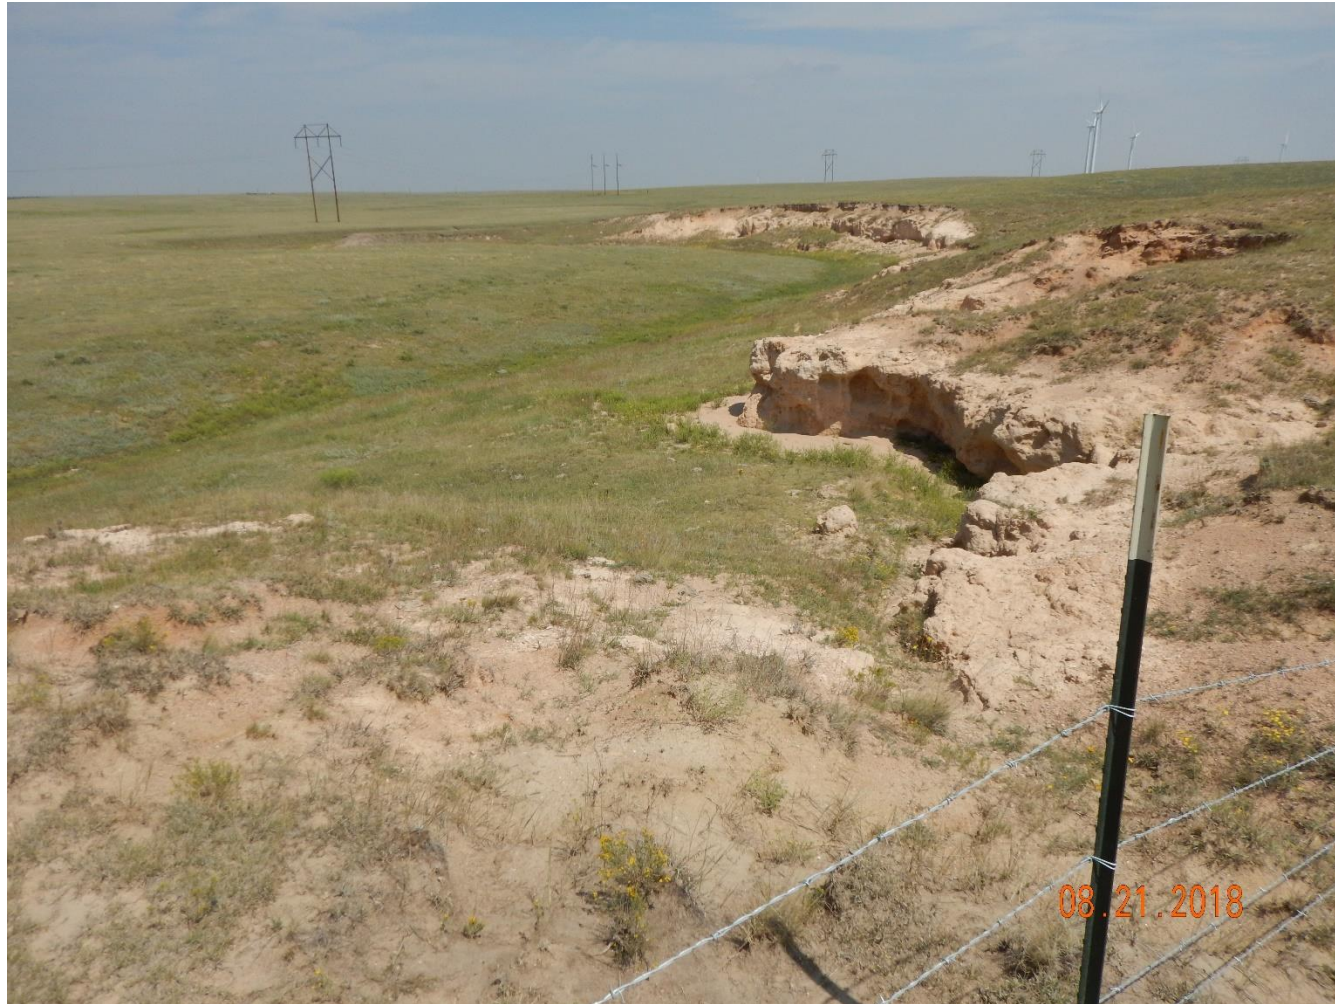
Photo 14: Continued from photo 12. Photo shows drainage to the north of the location.

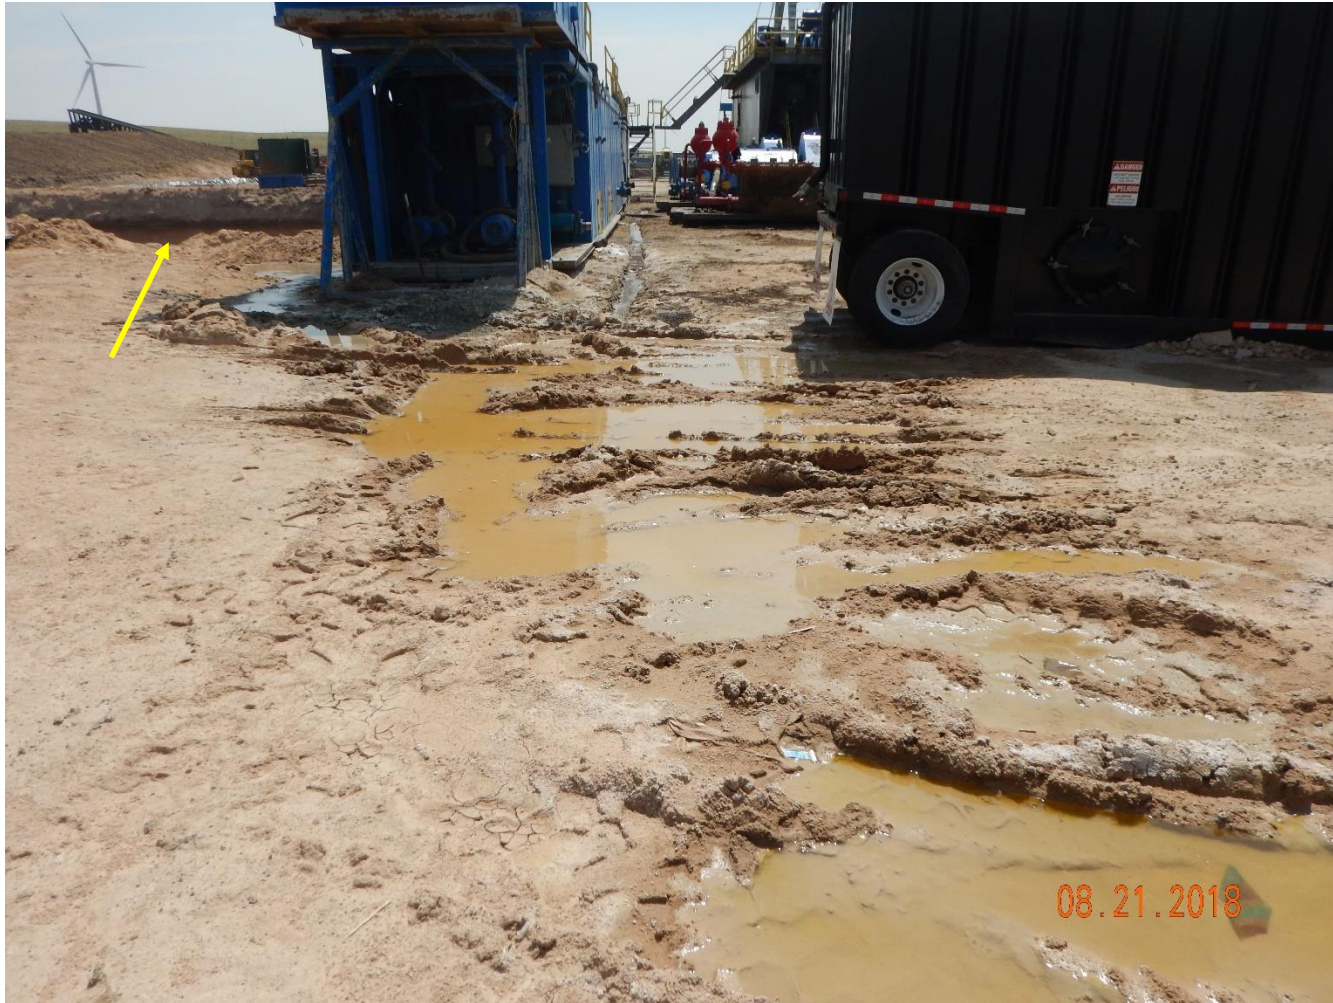
Photo 15: Photo taken from the north end of the location, facing south. Photo shows various fluids/chemicals from drilling operations ponding on then north end of the pad. Fluids appear to be traveling north from the drill rig, equipment and the intended production pit (arrow)

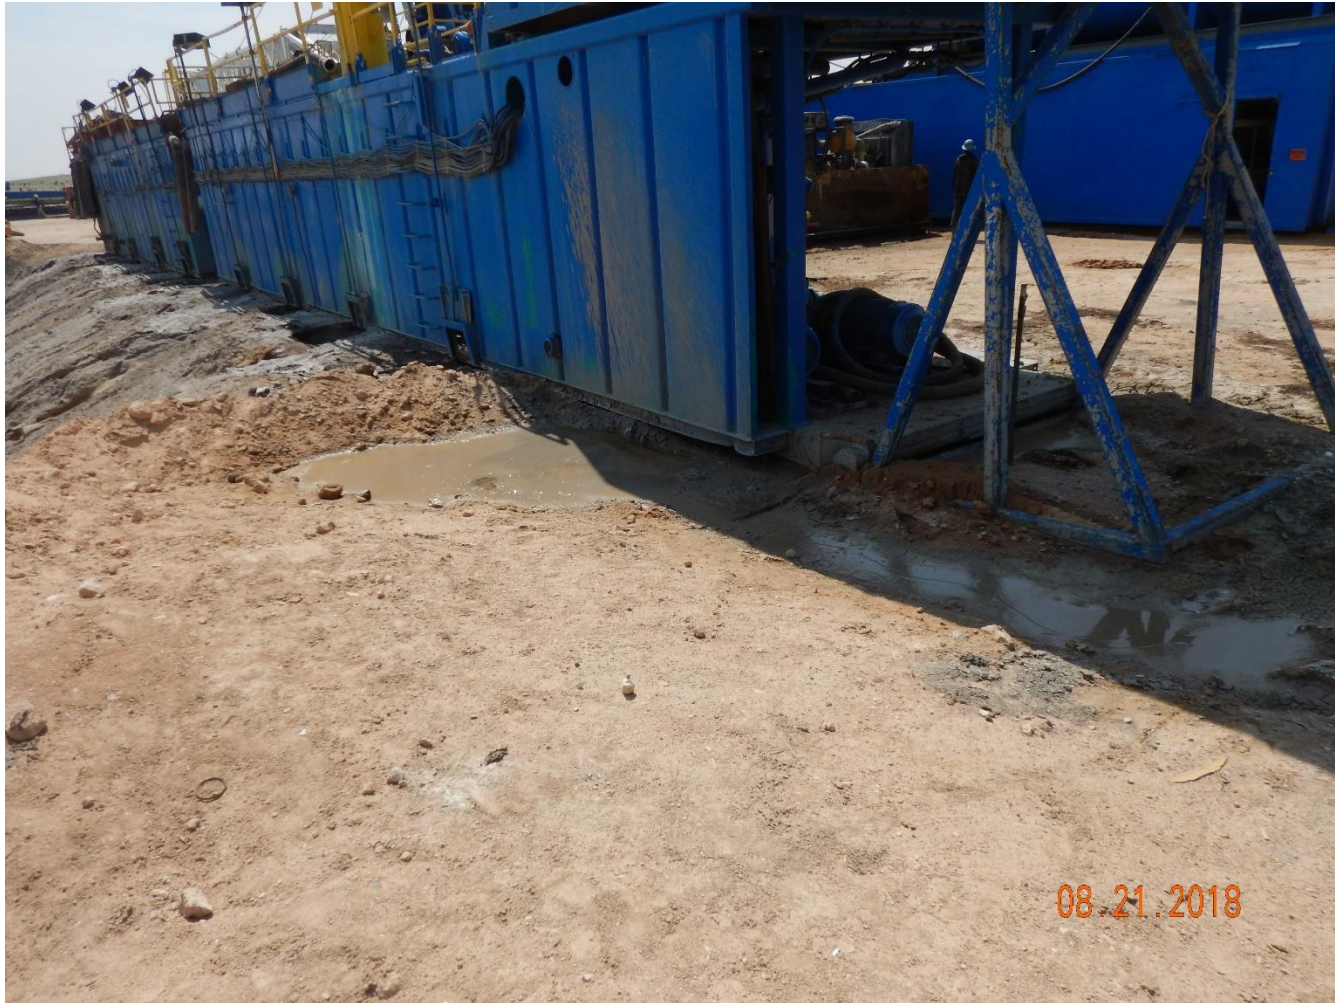
Photo 16: Photo taken from the north end of the location, facing southwest. Photo shows equipment and fluids/chemicals on the pad. See comments under photo 15.

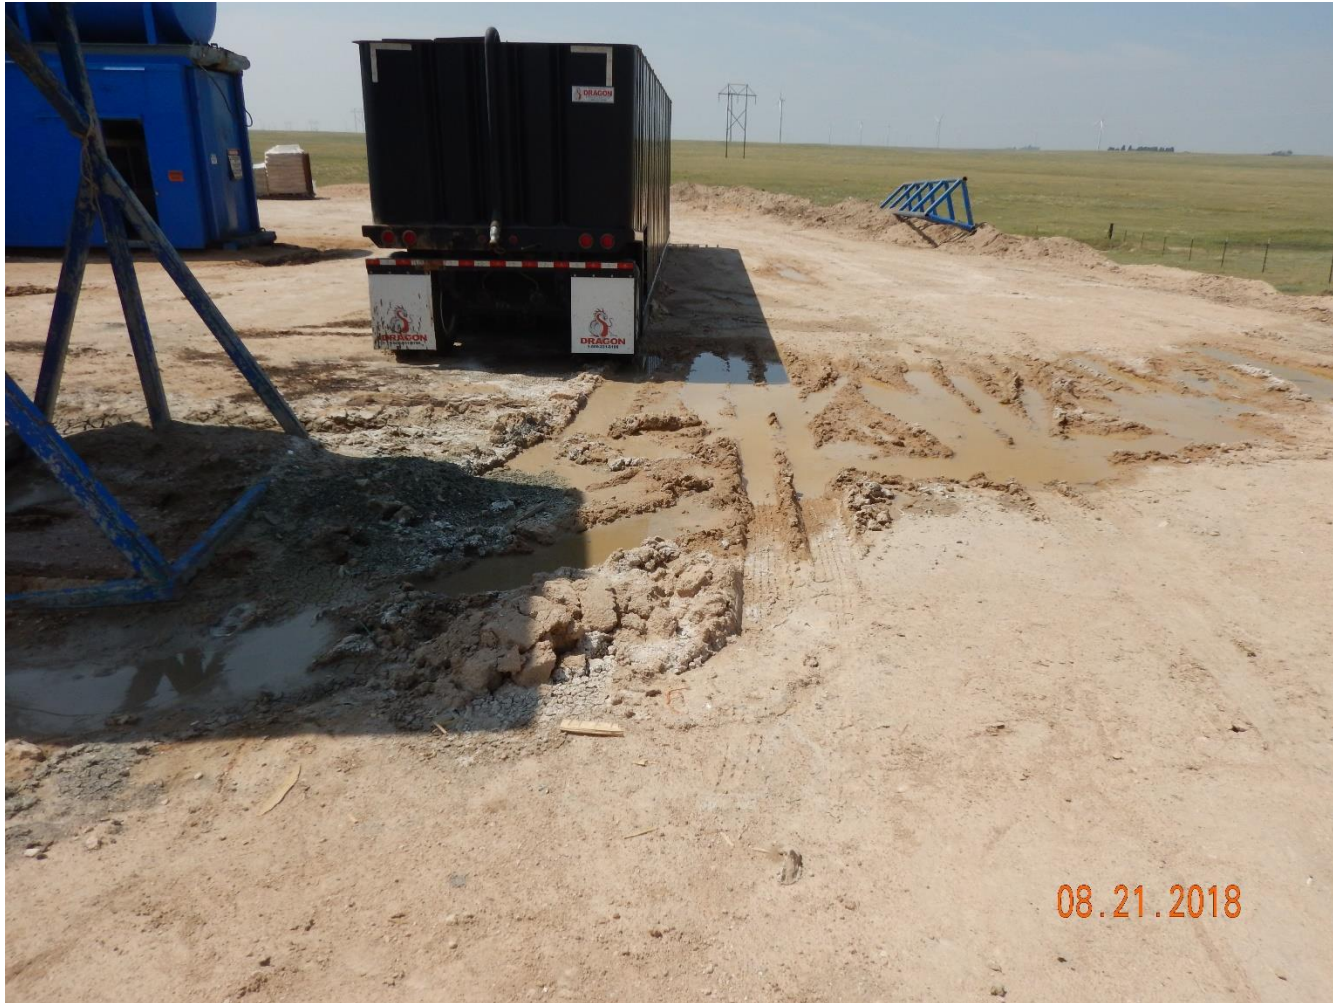
Photo 17: Photo taken from the north end of the location, facing west. Photo shows equipment and fluids/chemicals on the pad. See comments under photo 15.

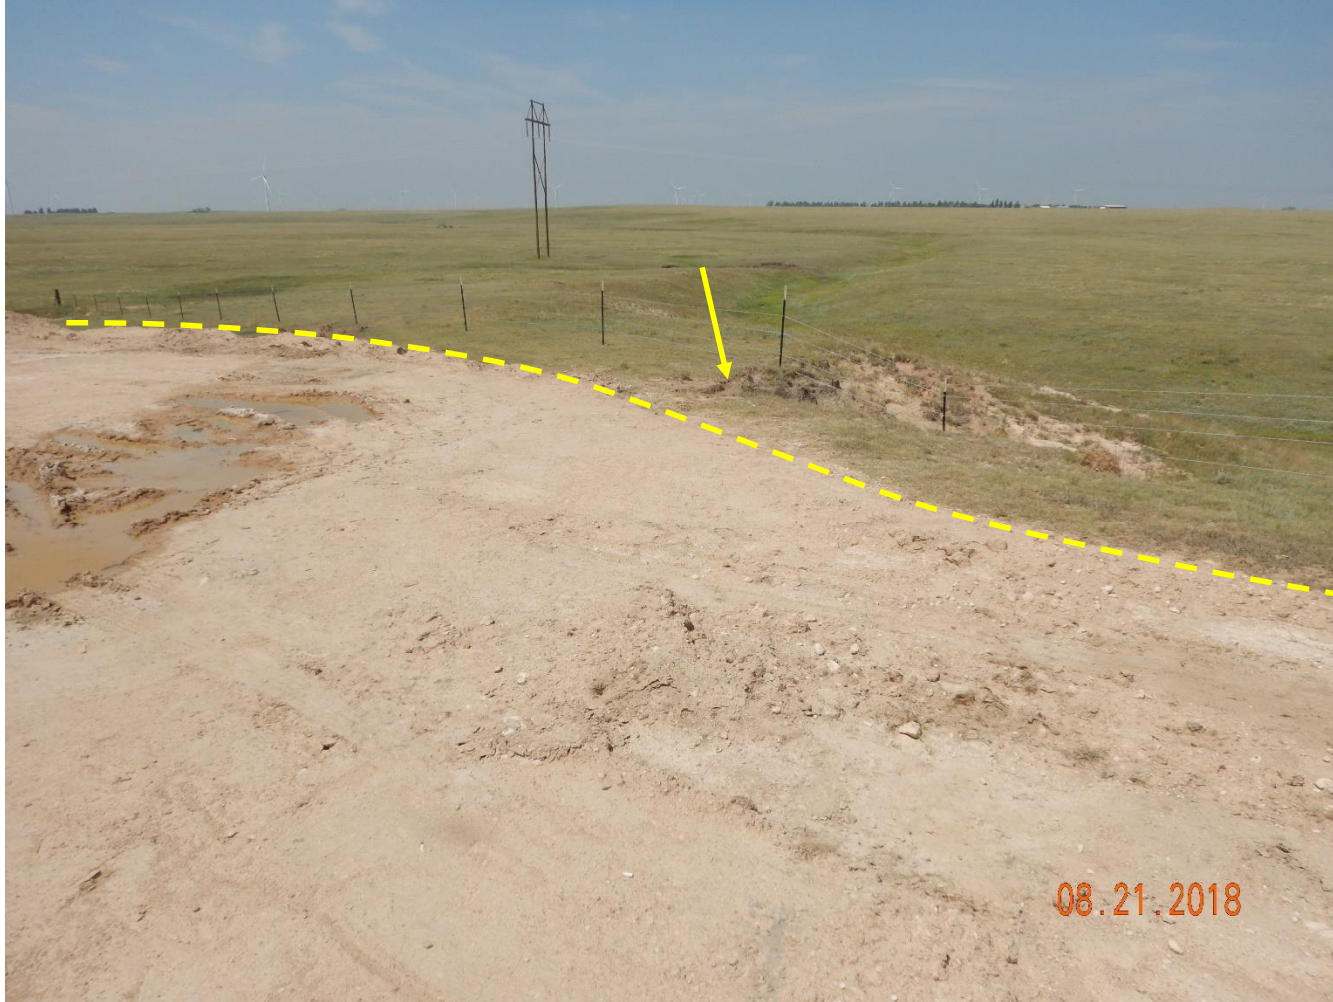
Photo 18: Photo taken from the north end of the location, facing southwest. Photo shows equipment and fluids/chemicals on the pad. See comments under photo 15. Photo also shows area where the pad ends and the beginning of the drainage to the north. Photo shows to stormwater or erosion control BMPs have been installed on the north end of the location.

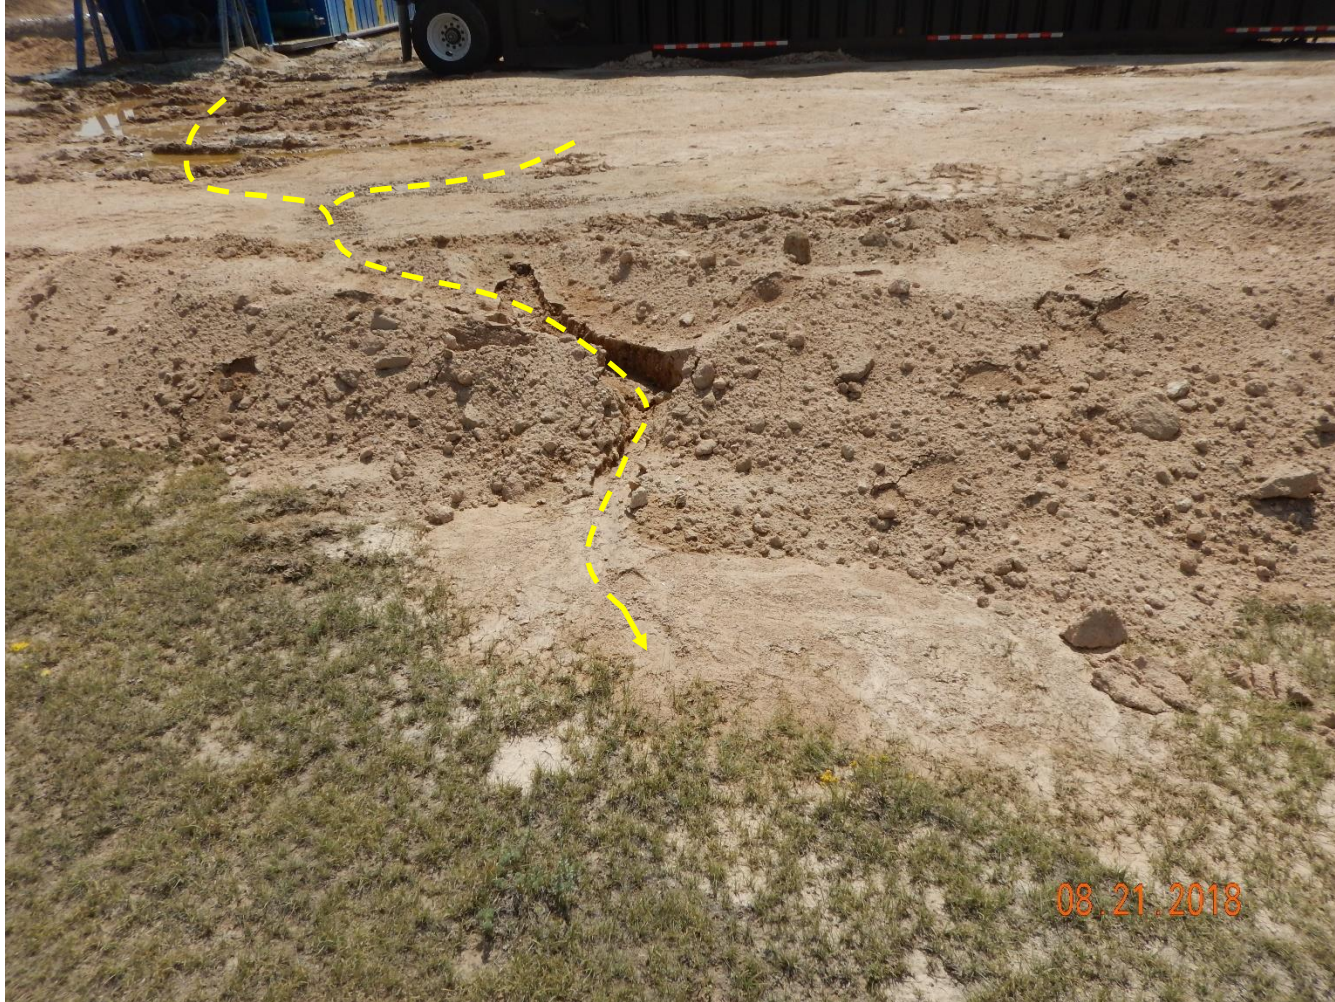
Photo 19: Photo taken from the north end of the location. Photo shows erosion degradation and sediment transport off location from stormwater discharge. Photo also shows water movement patterns from the location.
