Inspection Photos

08/21/2018

Operator: GRAND MESA OPERATING CO - 35080

Location ID: 453036

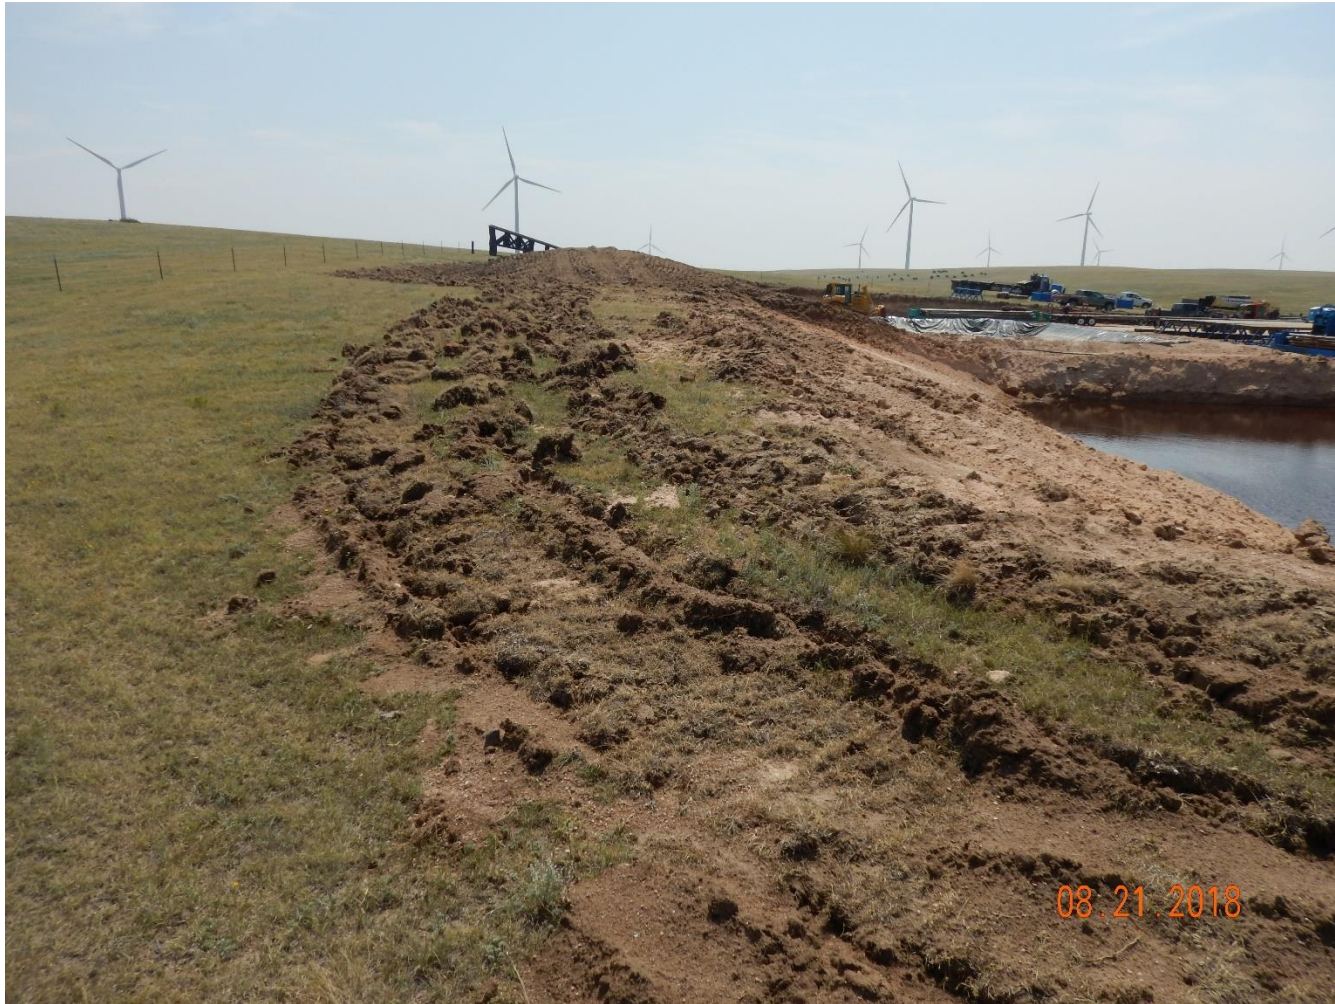
Photo 20: Photo taken from the southeast corner of the location, facing north. Photo shows surface roughening (ripping) has been used in conjunction with a ditch and berm on the east end of the location. . It is noted that the ditch and berm appear to have been constructed with topsoil from the location. This should be avoided to mitigate potential compaction concerns in the topsoil.

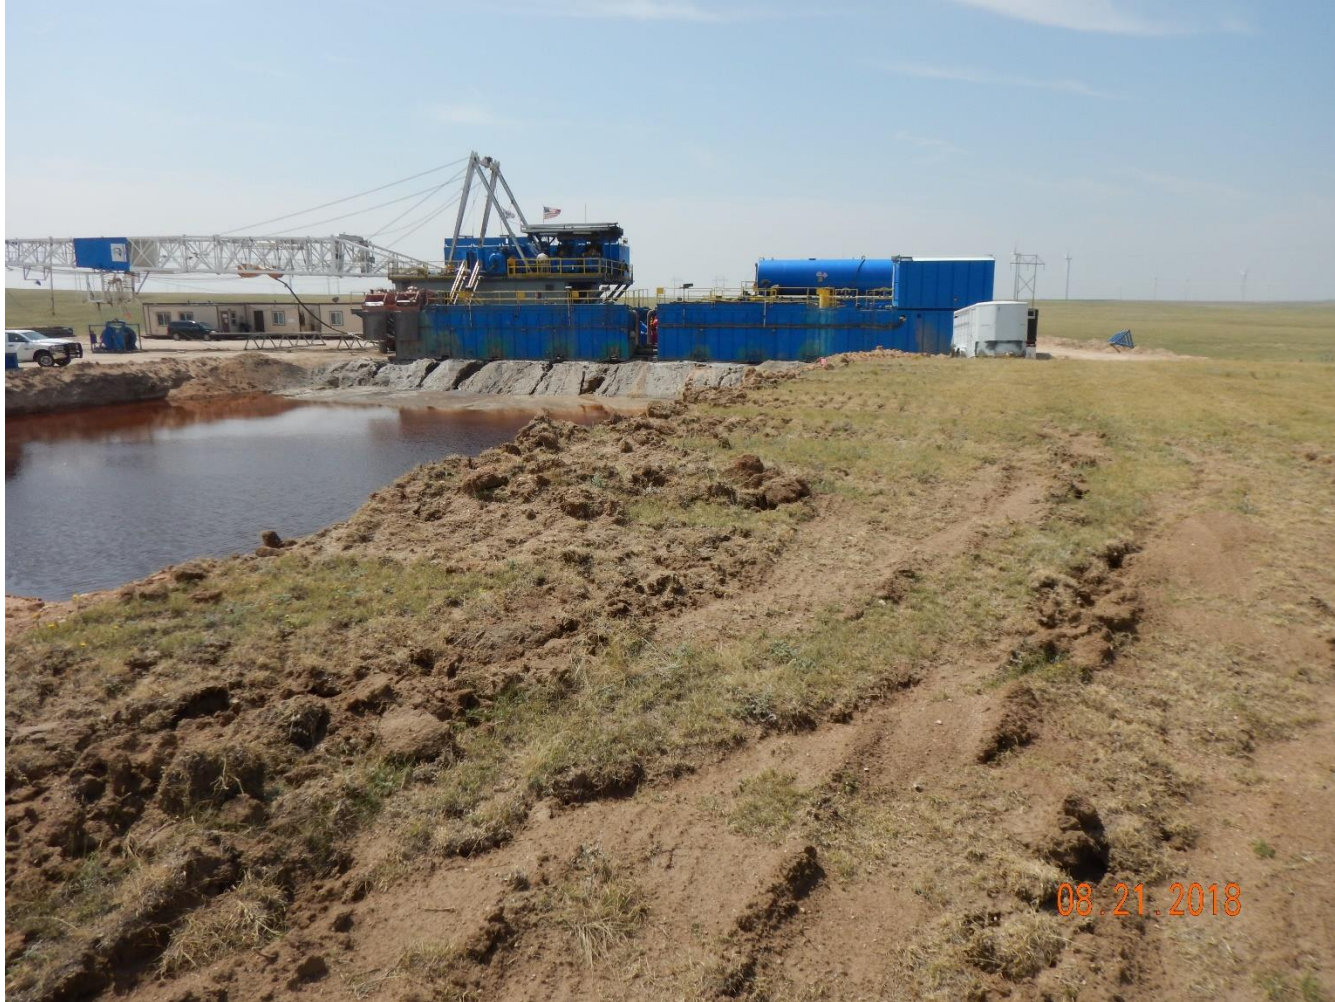
Photo 21: Photo taken from the northeast corner of the location, facing west. Photo shows drill rig, production pit. Photo also shows nor stormwater and erosion control BMPs have been installed on the north end of the location.

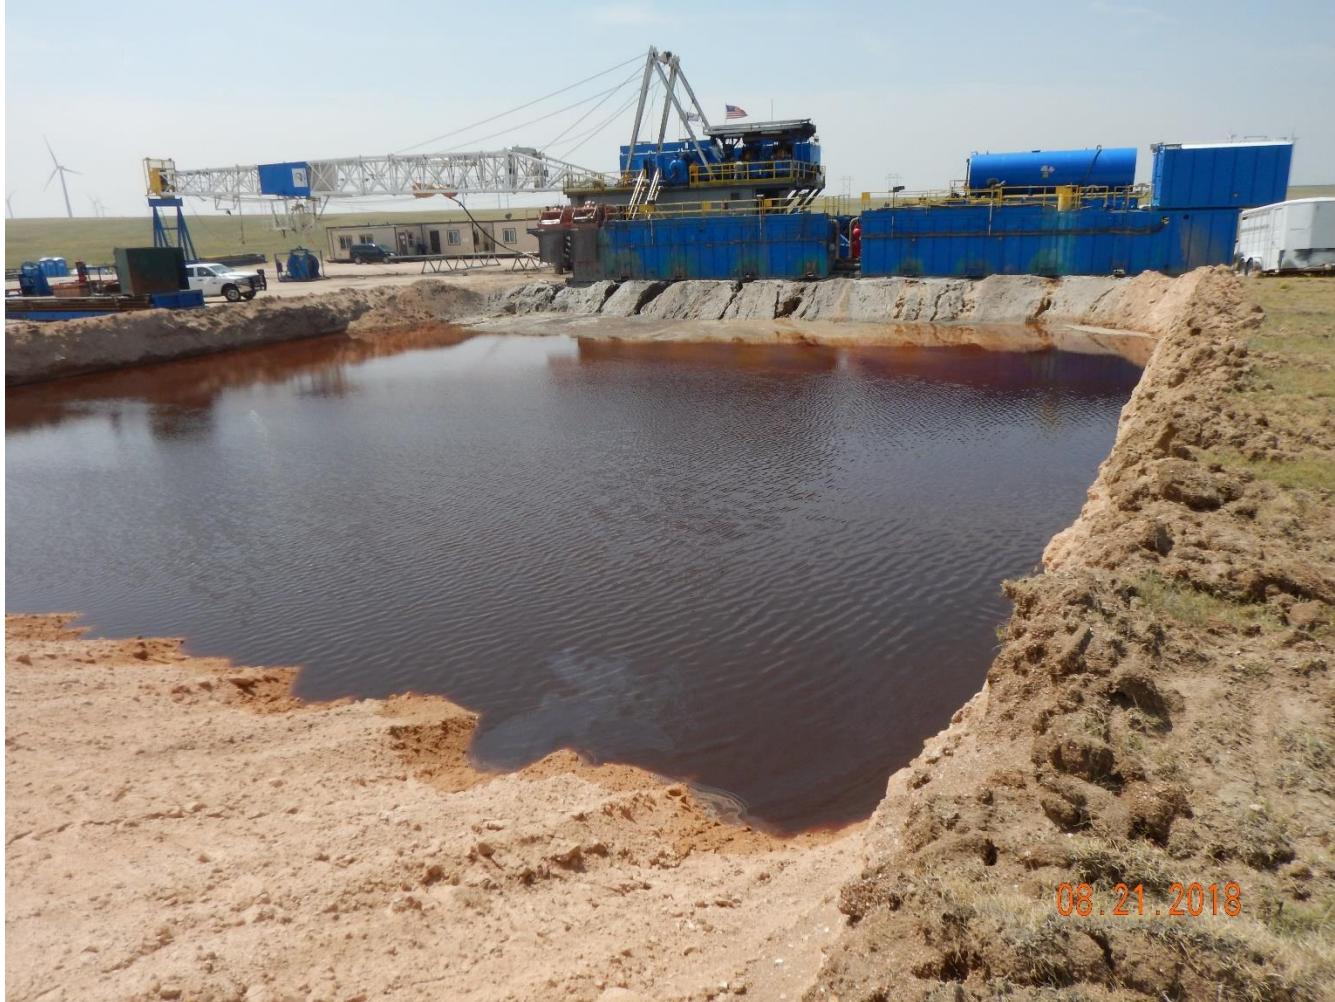
Photo 22: Photo taken from the northeast corner of the location, facing southwest.
Photo of production pit and drill rig.

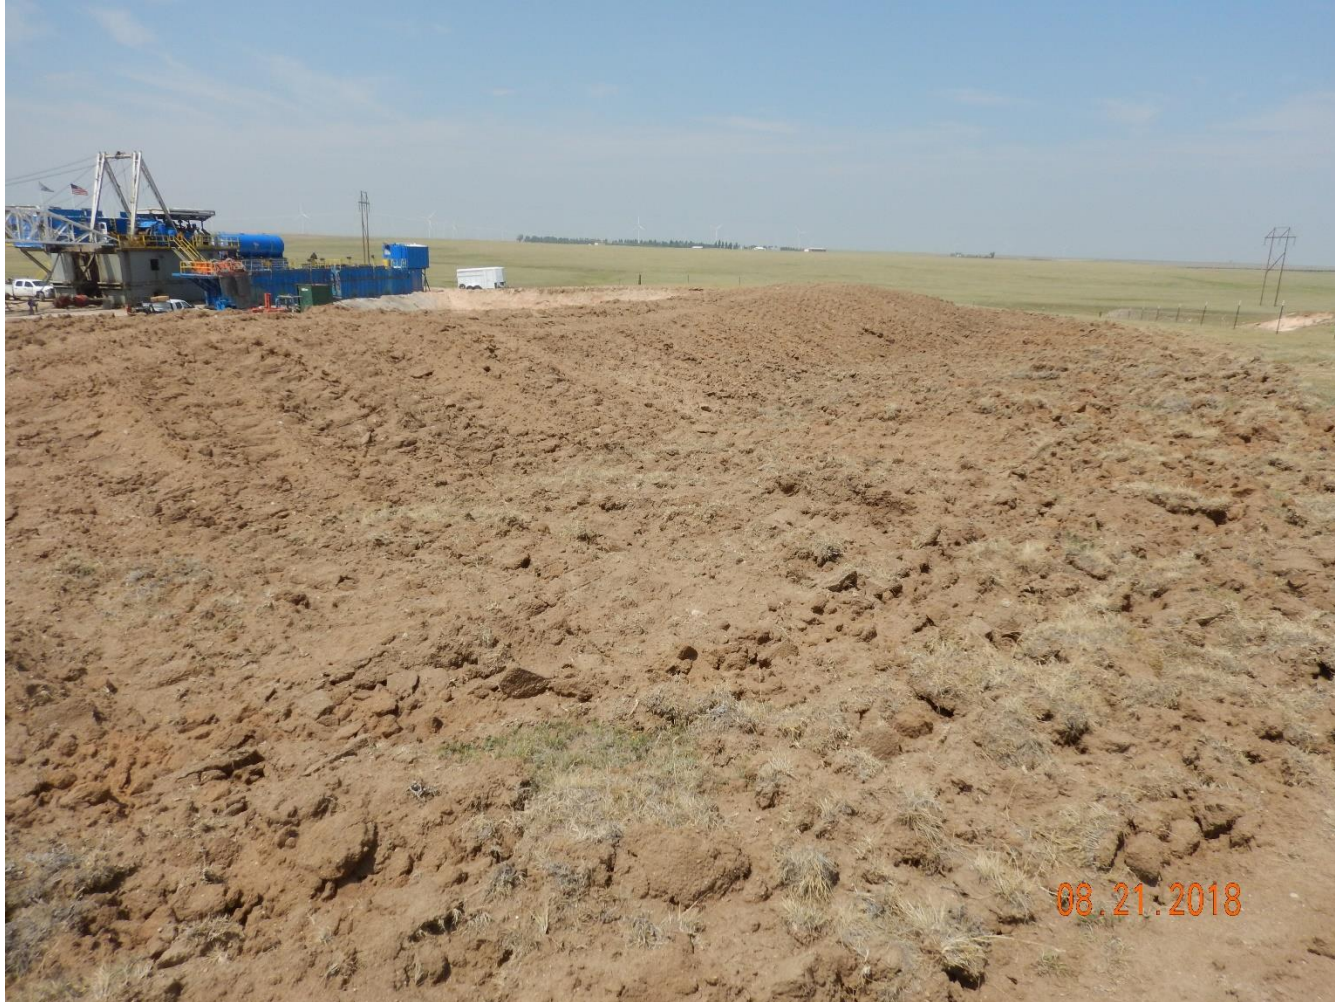
Photo 23: Photo taken from the east end of the location, facing north. Photo of topsoil stock pile.

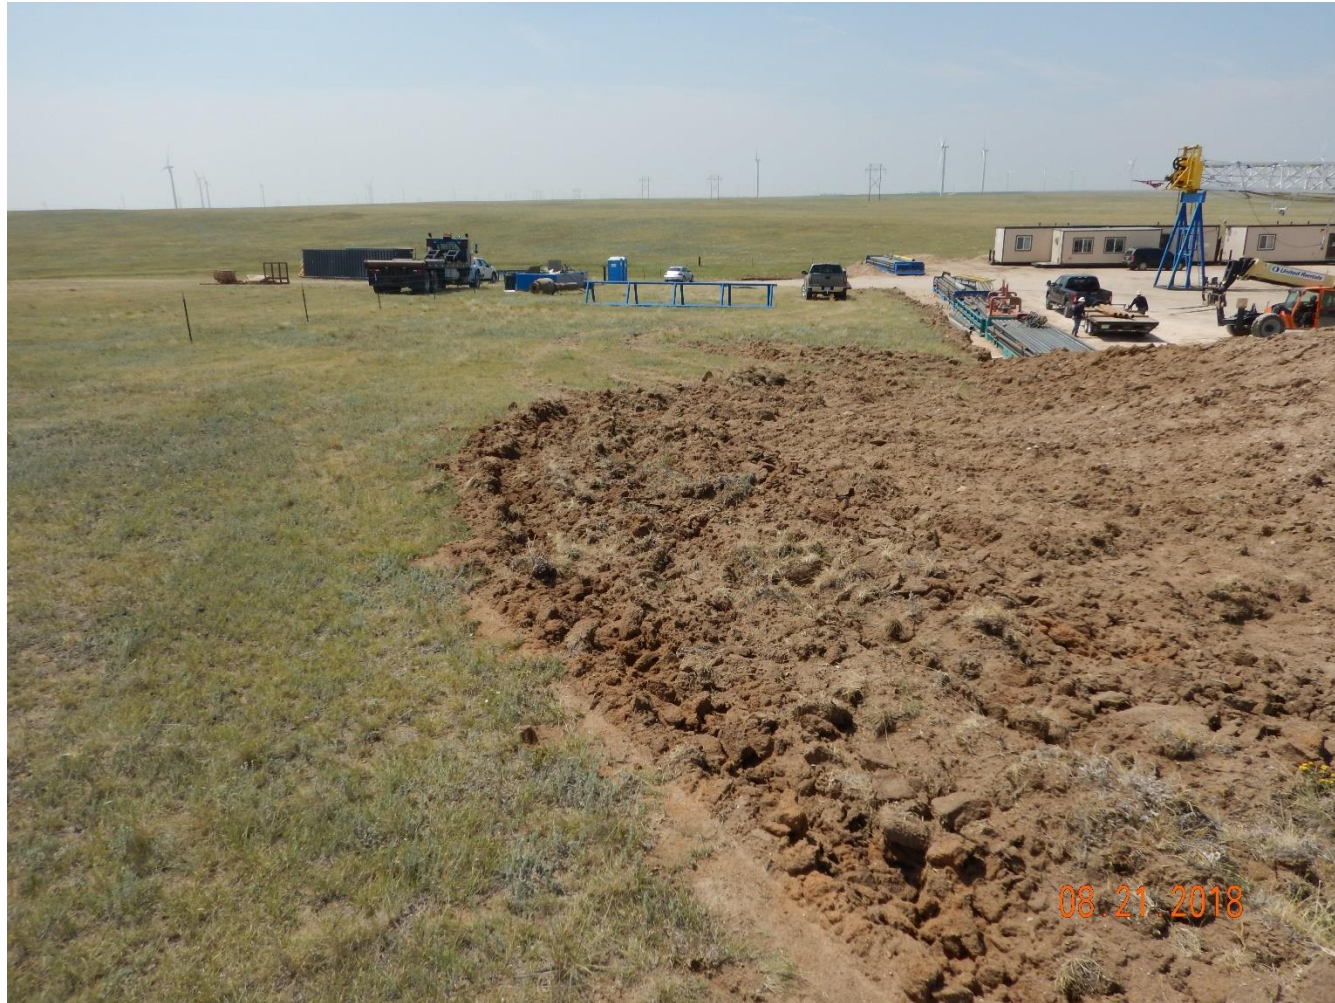
Photo 24: Photo taken from the southeast corner of the pad, facing west. Photo shows stormwater and erosion controls have only been partially installed on the south end of the location.

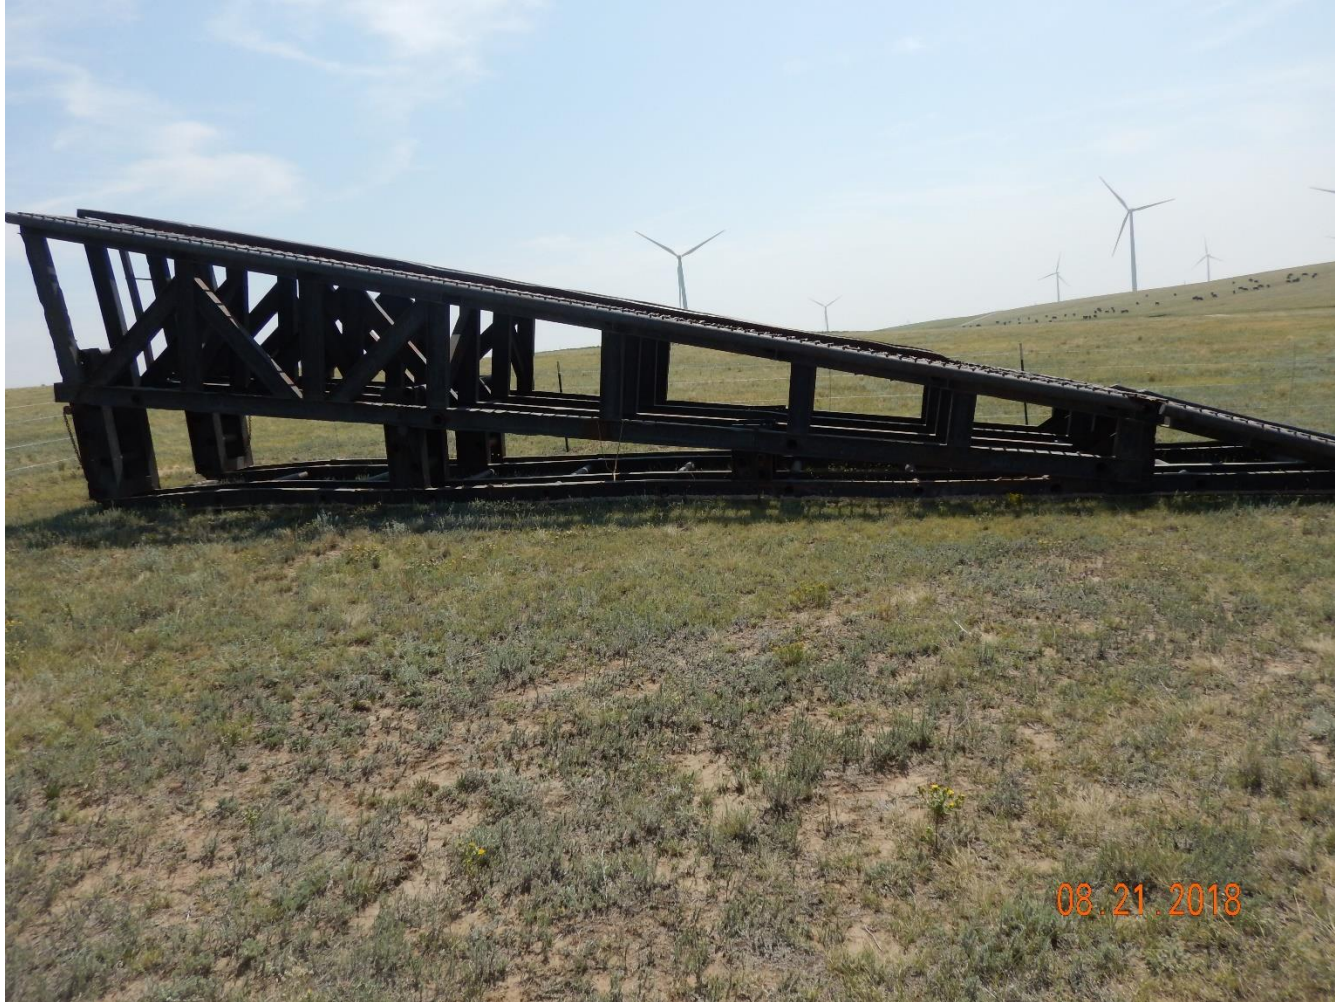
Photo 25: Photo taken from the southeast corner of the location, facing south. Photo of equipment being stored off the constructed pad.

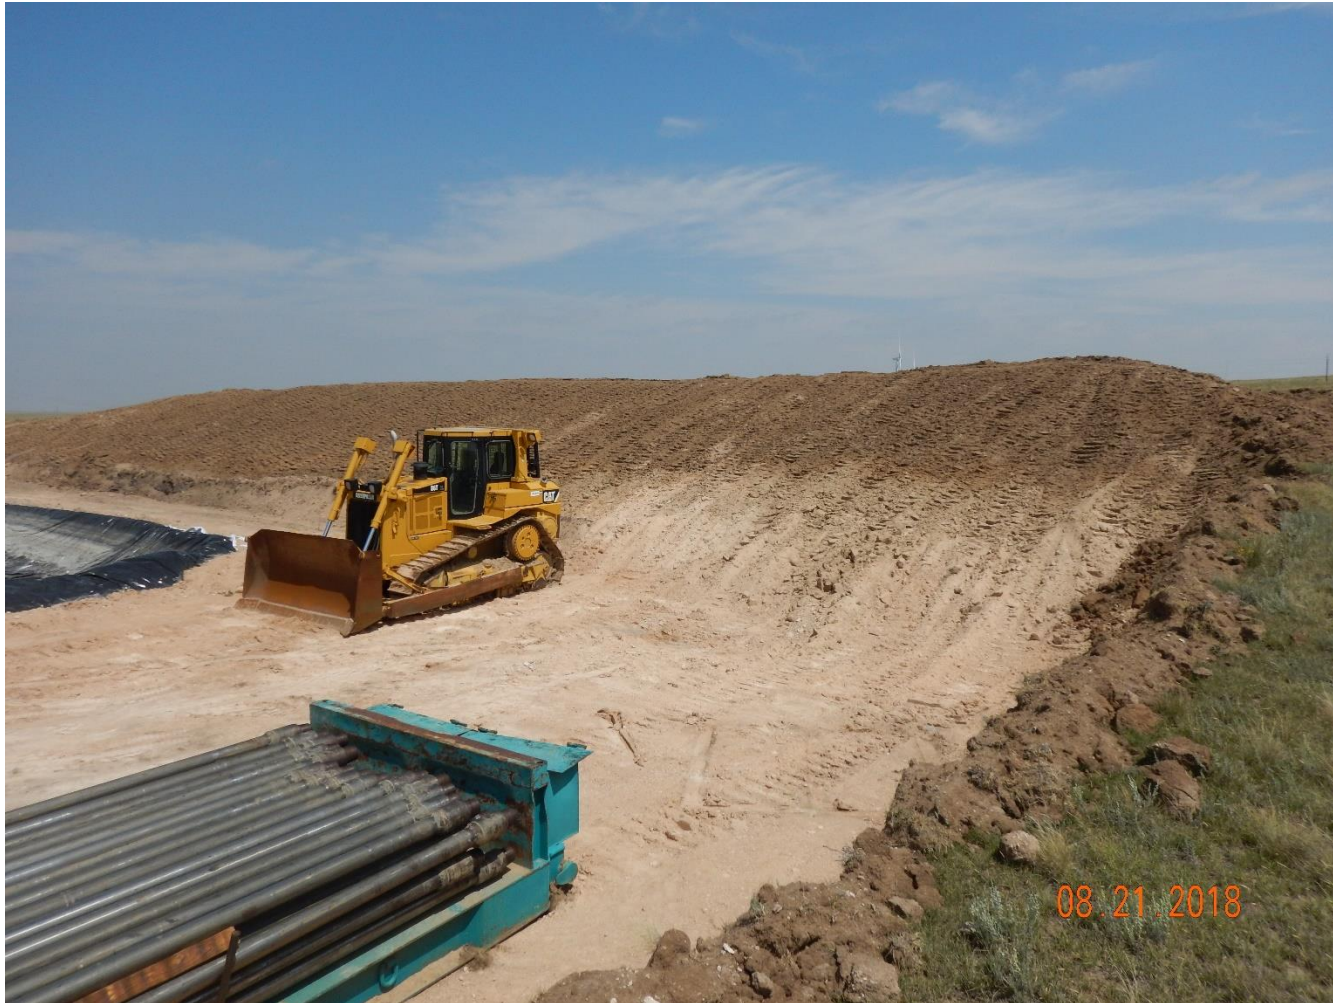
Photo 26: Photo taken from the south end of the location, facing northeast. Photo of topsoil stockpile.

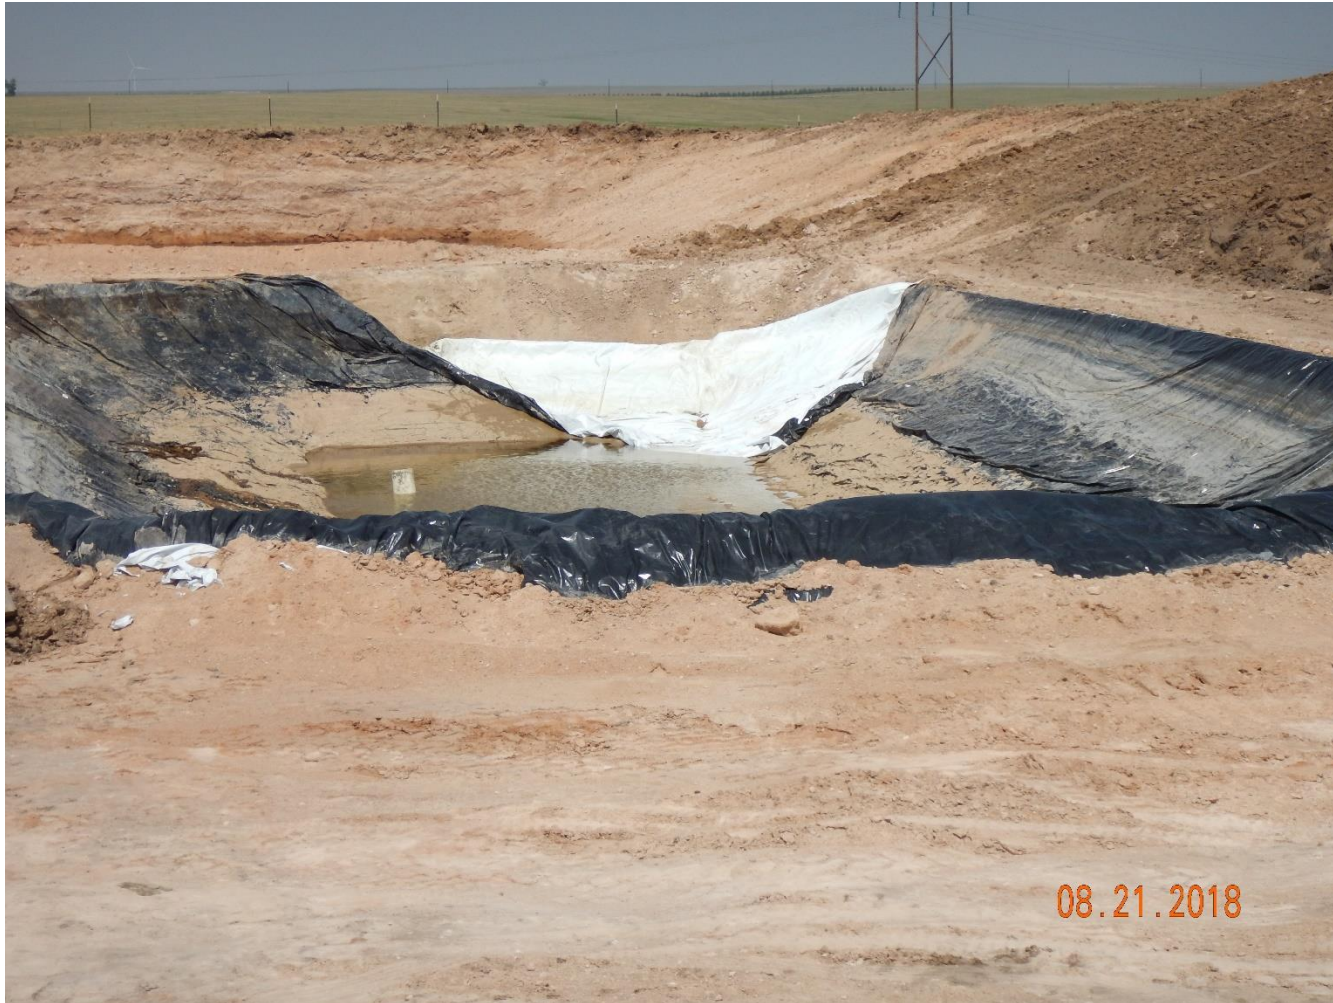
Photo 27: Photo taken from the south end of the location, facing north. Photo shows liner within pit is not in proper functioning condition.

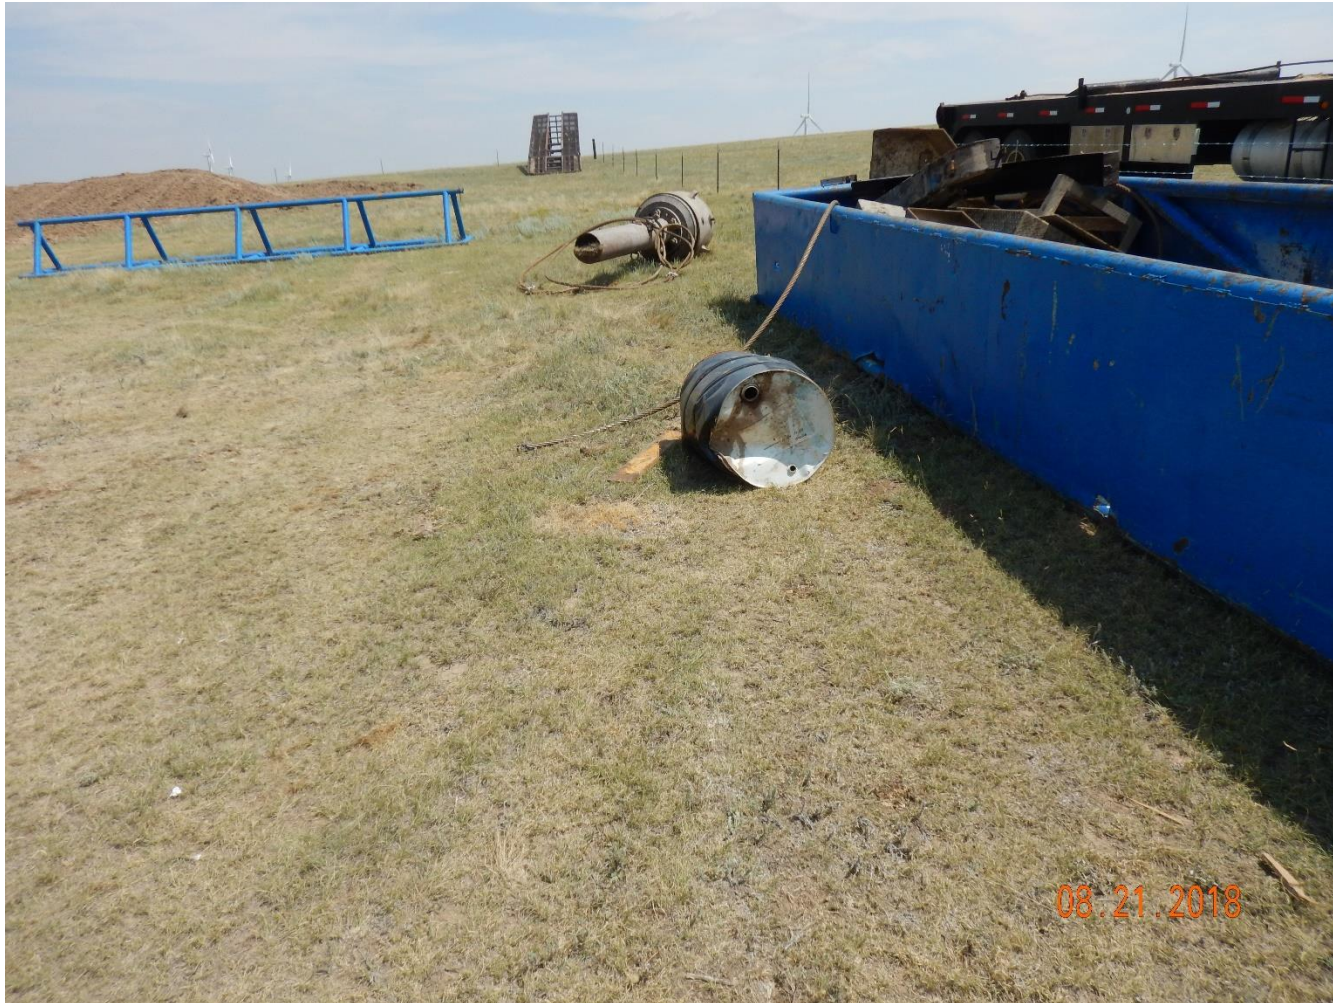
Photo 28: Photo taken from the south end of the location, facing north. Photo shows equipment being stored off the constructed pad. Photo also shows an open barrel laying on its side upon the soil surface. This is improper storage of material and material management. Barrel needs to be placed in secondary containment or removed and properly stored or disposed. Any contaminated soils will need to be cleaned/remediated or removed and properly disposed.

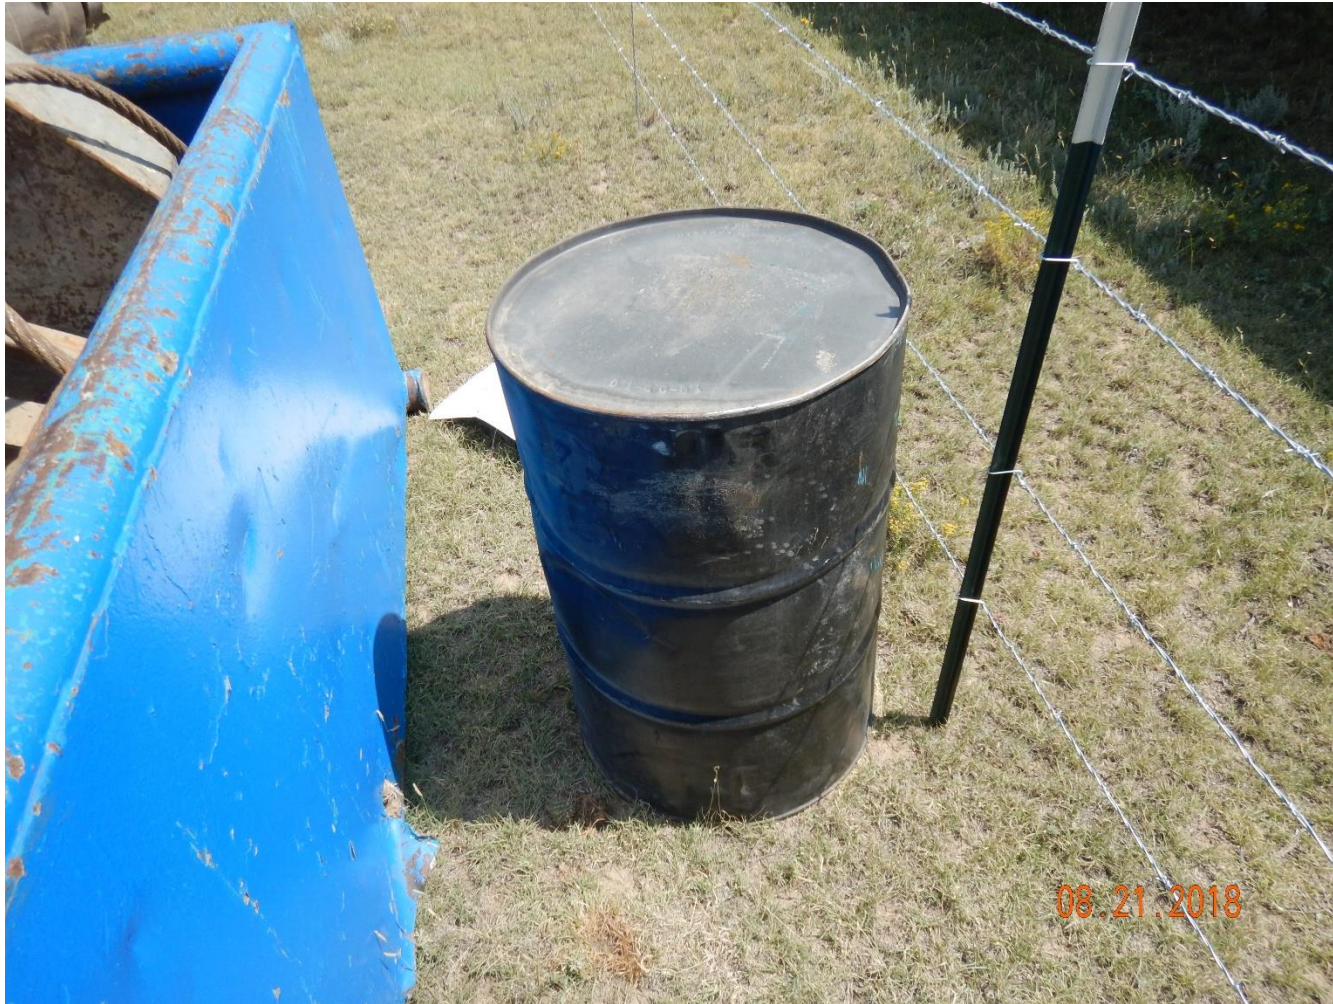
Photo 29: Photo taken from the south end of the location, on the south end of the blue metal container. Photo also shows a barrel laying with the top placed upon the surface of the soil. See comments under photo 28.

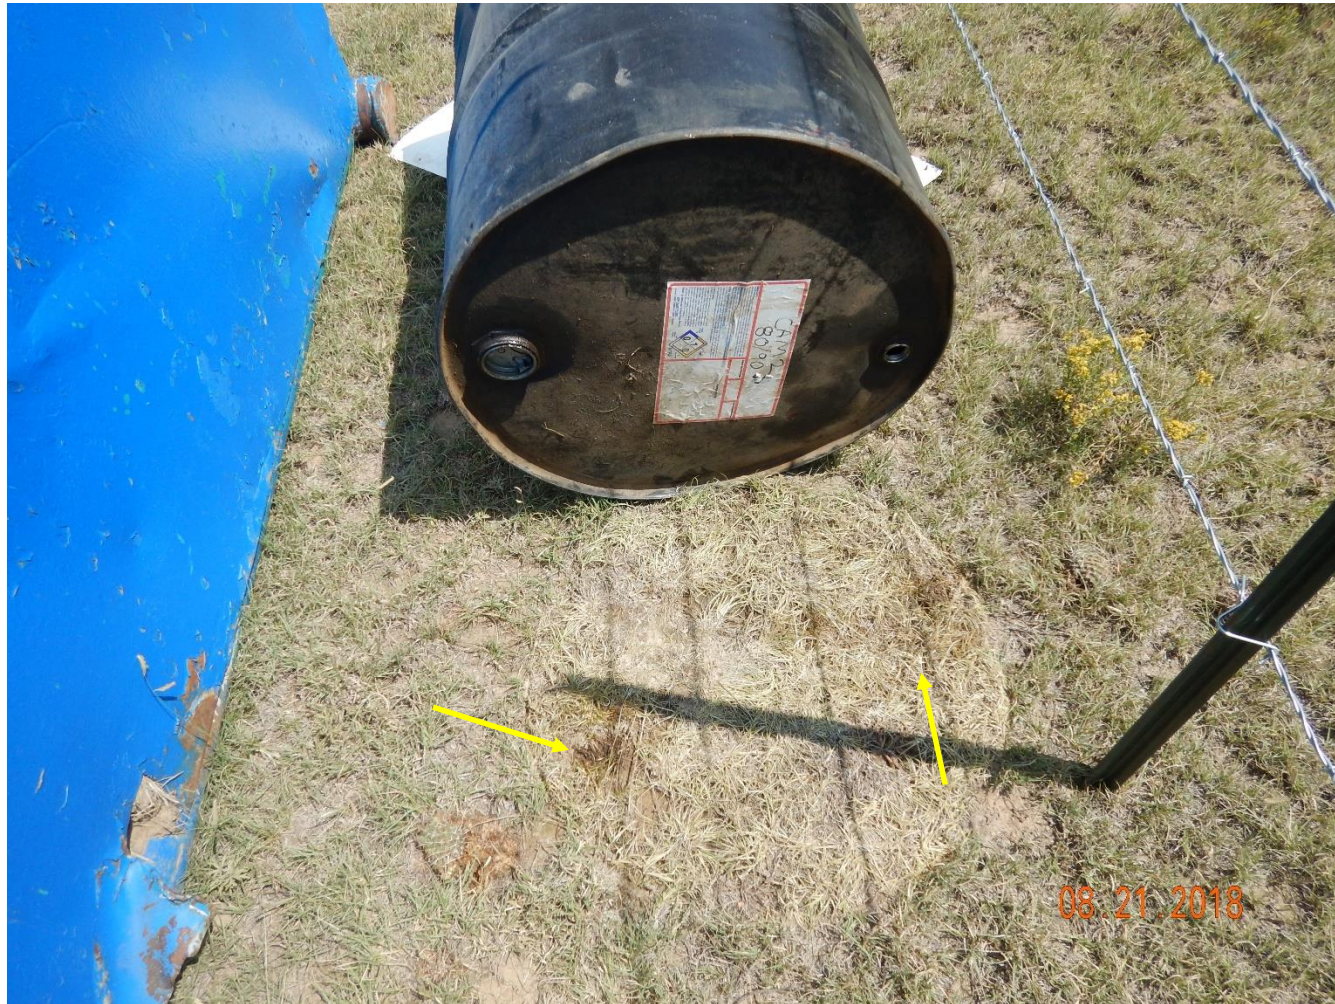
Photo 30: Continued from photo 29. Photo shows barrel was placed open on the soil surface. Photo shows contaminants on soil surface.

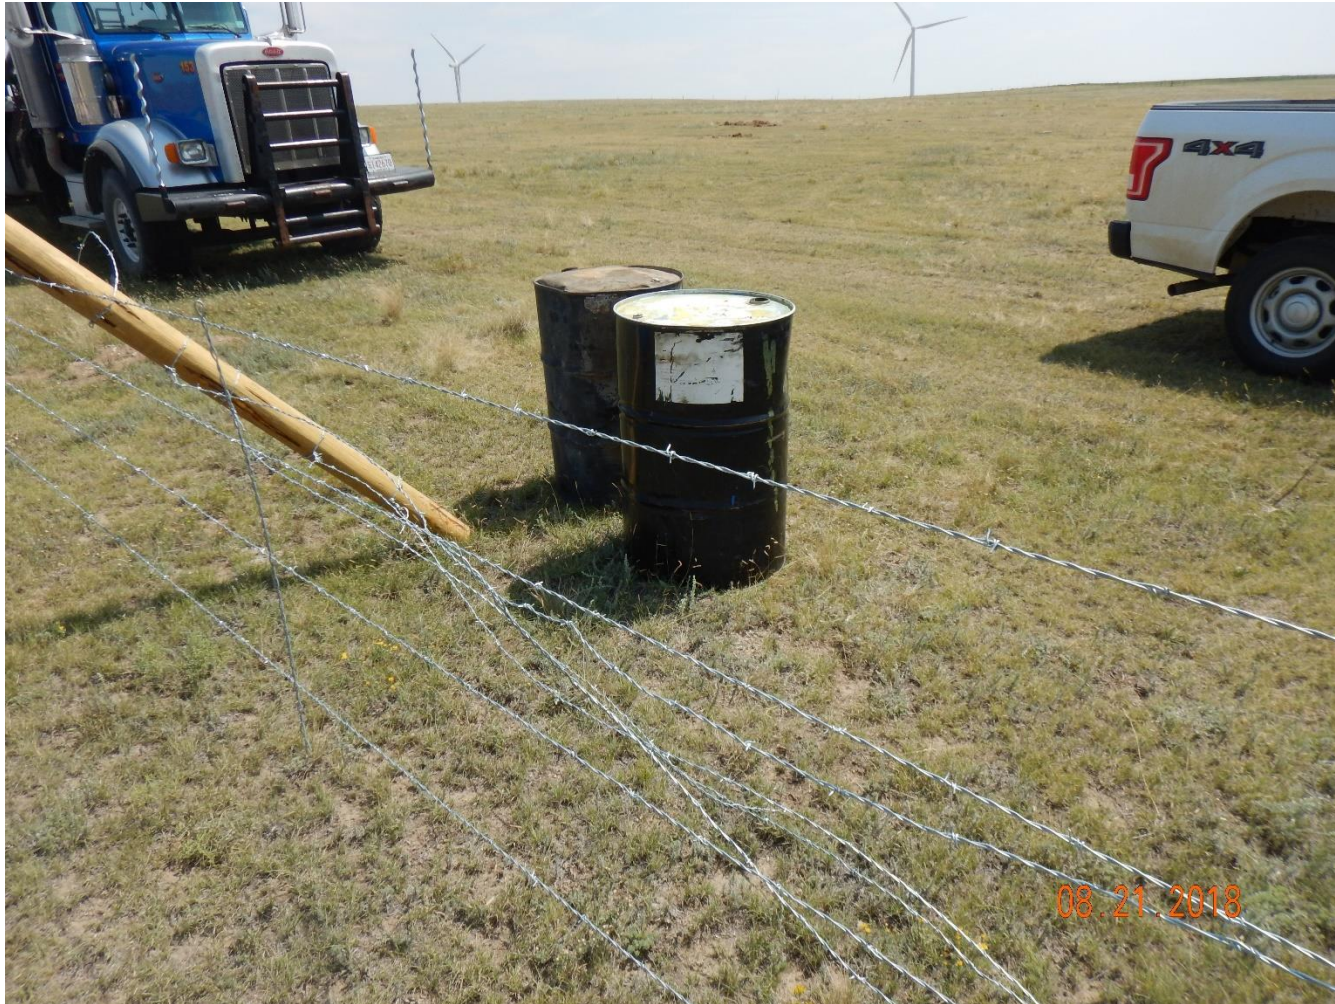
Photo 31: Photo taken from the south end of the location, facing southeast. Photos show two additional barrels. Barrels are being improperly stored off of the location. See comments under photo 28

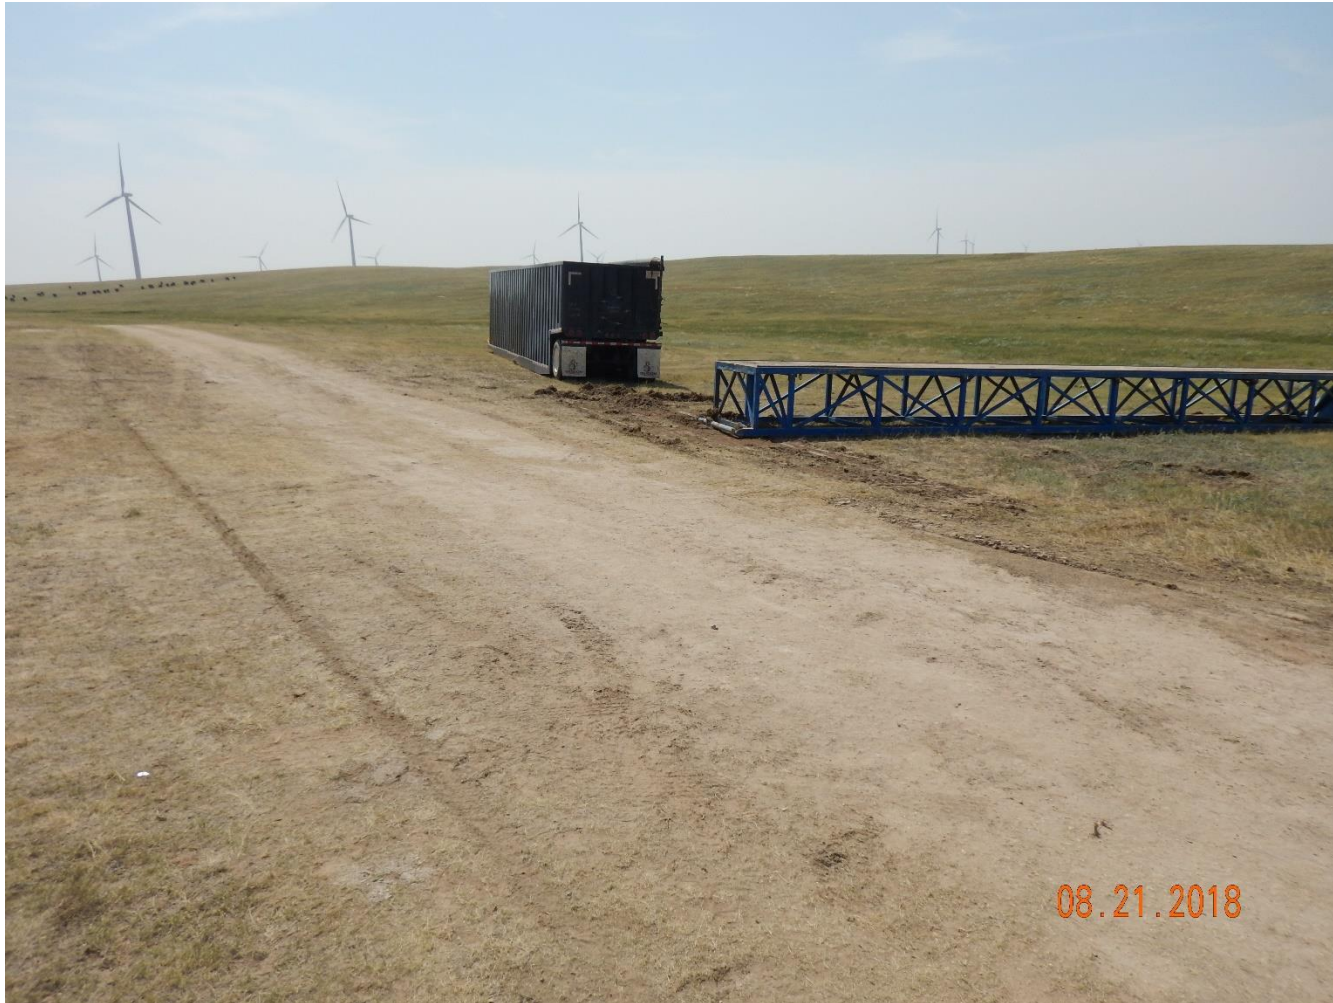
Photo 32: Photo taken from the south end of the location, facing south. Photo shows equipment being stored off of the location. Any additional disturbance will require reclamation.

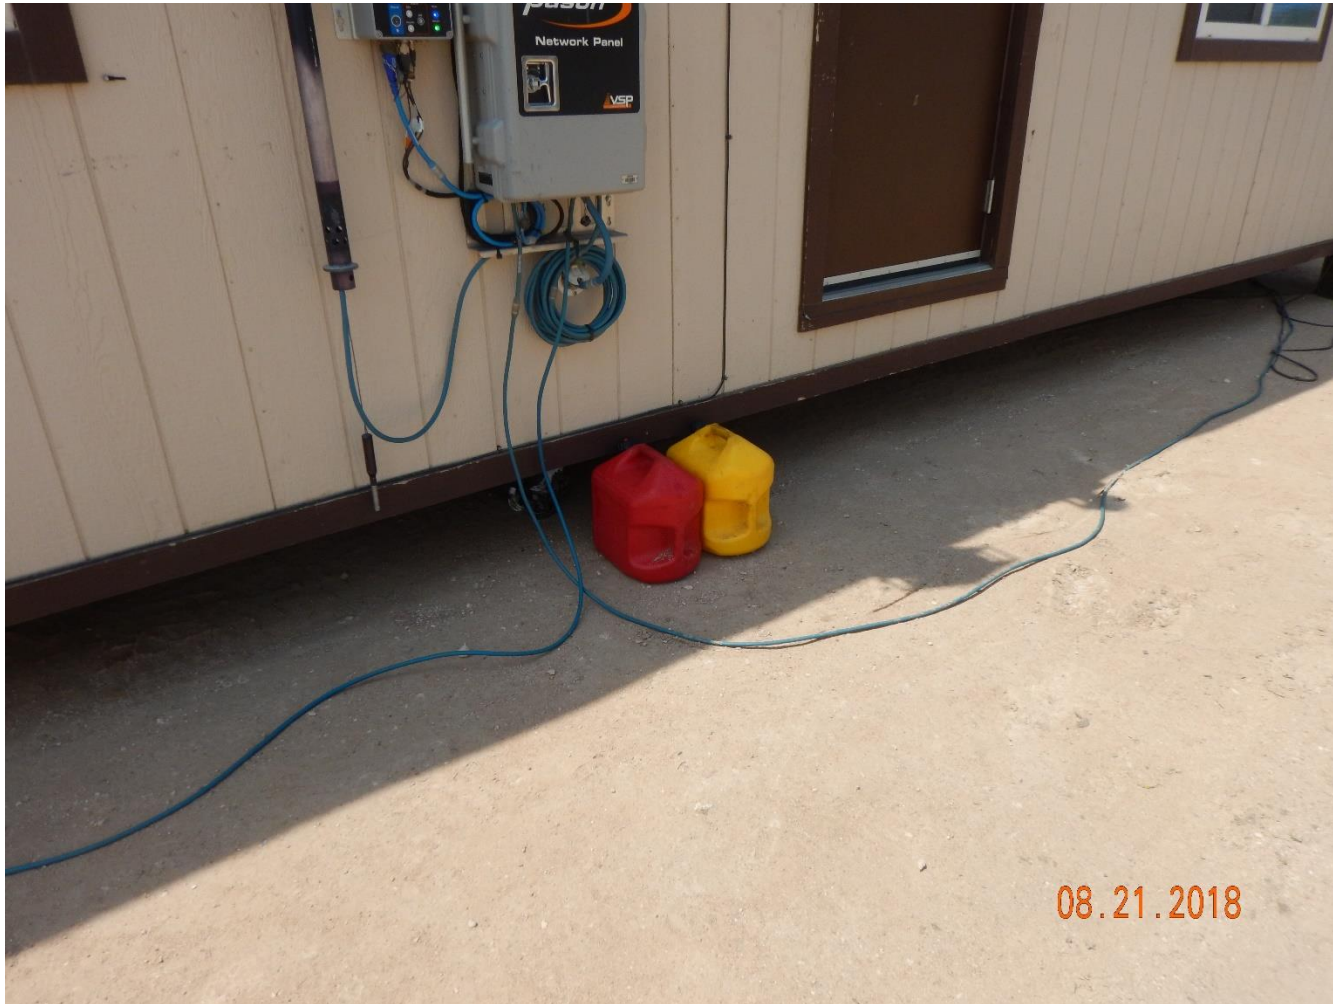
Photo 33: Photo taken from the west end of the location adjacent to the trailers on site. Photo shows gas cans improperly stored on location. See comments under photo 28.

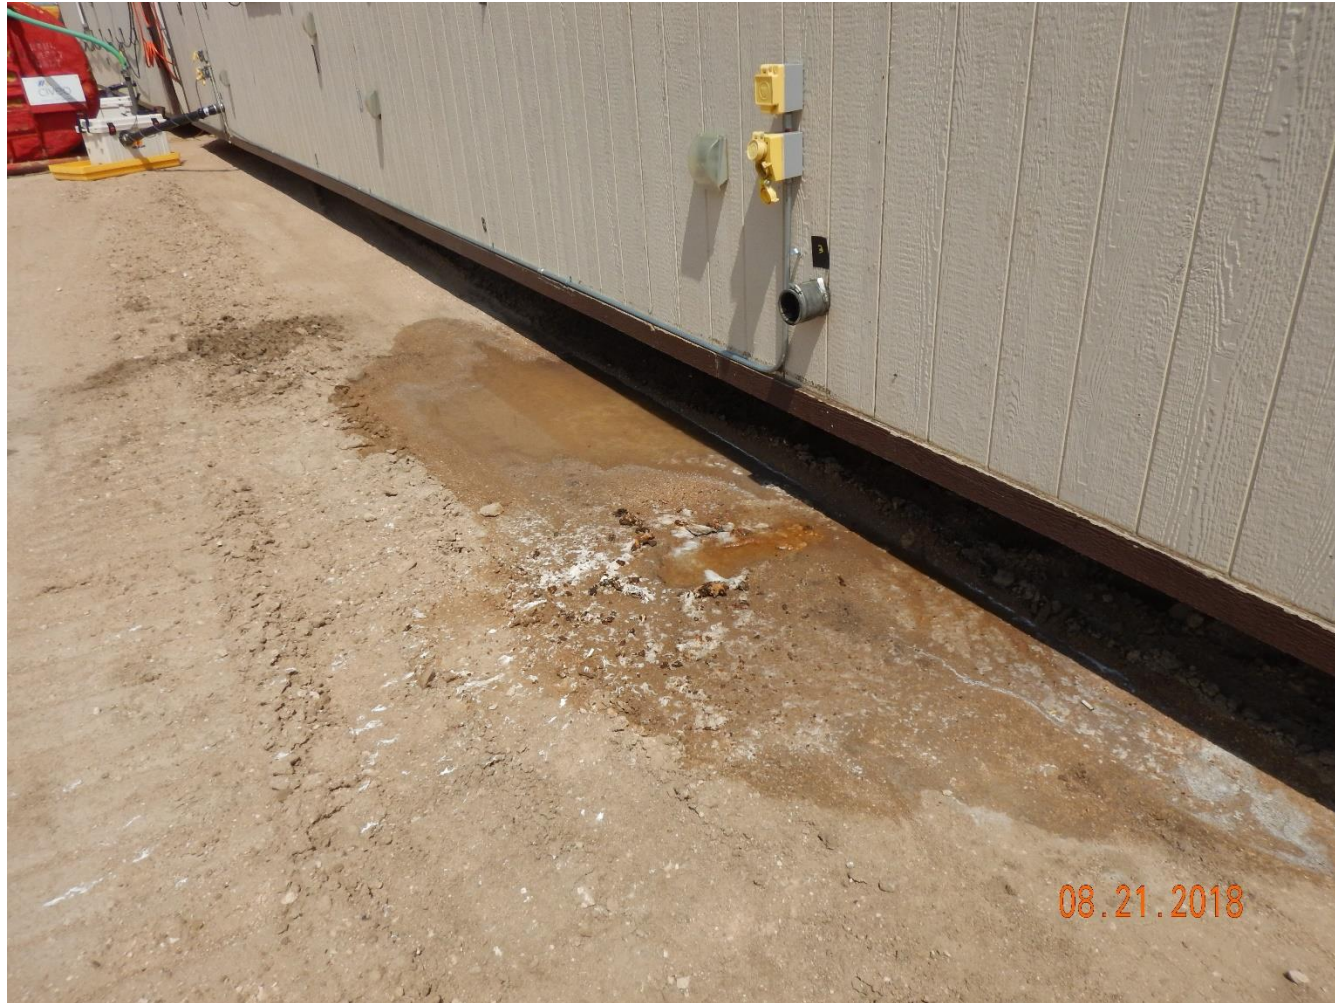
Photo 34: Photo taken from the west end of the location, on the west side of the office trailers on location, facing northeast. Photo shows what appears to be sewage discharge from the southern trailer.

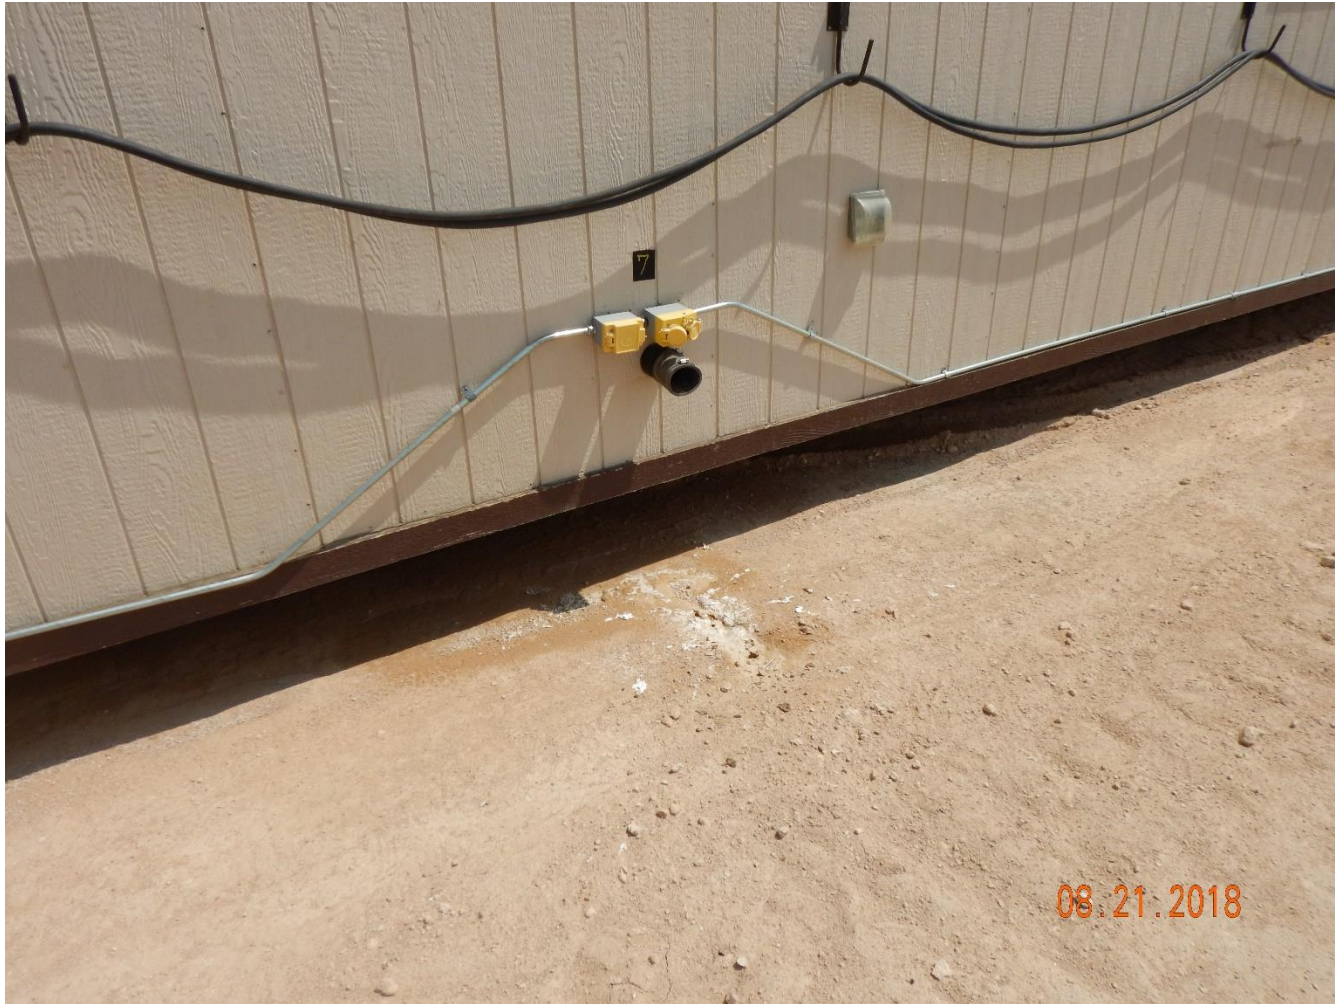
Photo 36: Photo taken from the west end of the location, on the west side of the office trailers on location, facing southeast. Photo shows what appears to be sewage discharge from the northern trailer.
