Inspection Photos

08/21/2018

Operator: GRAND MESA OPERATING CO - 35080

Location ID: 453036

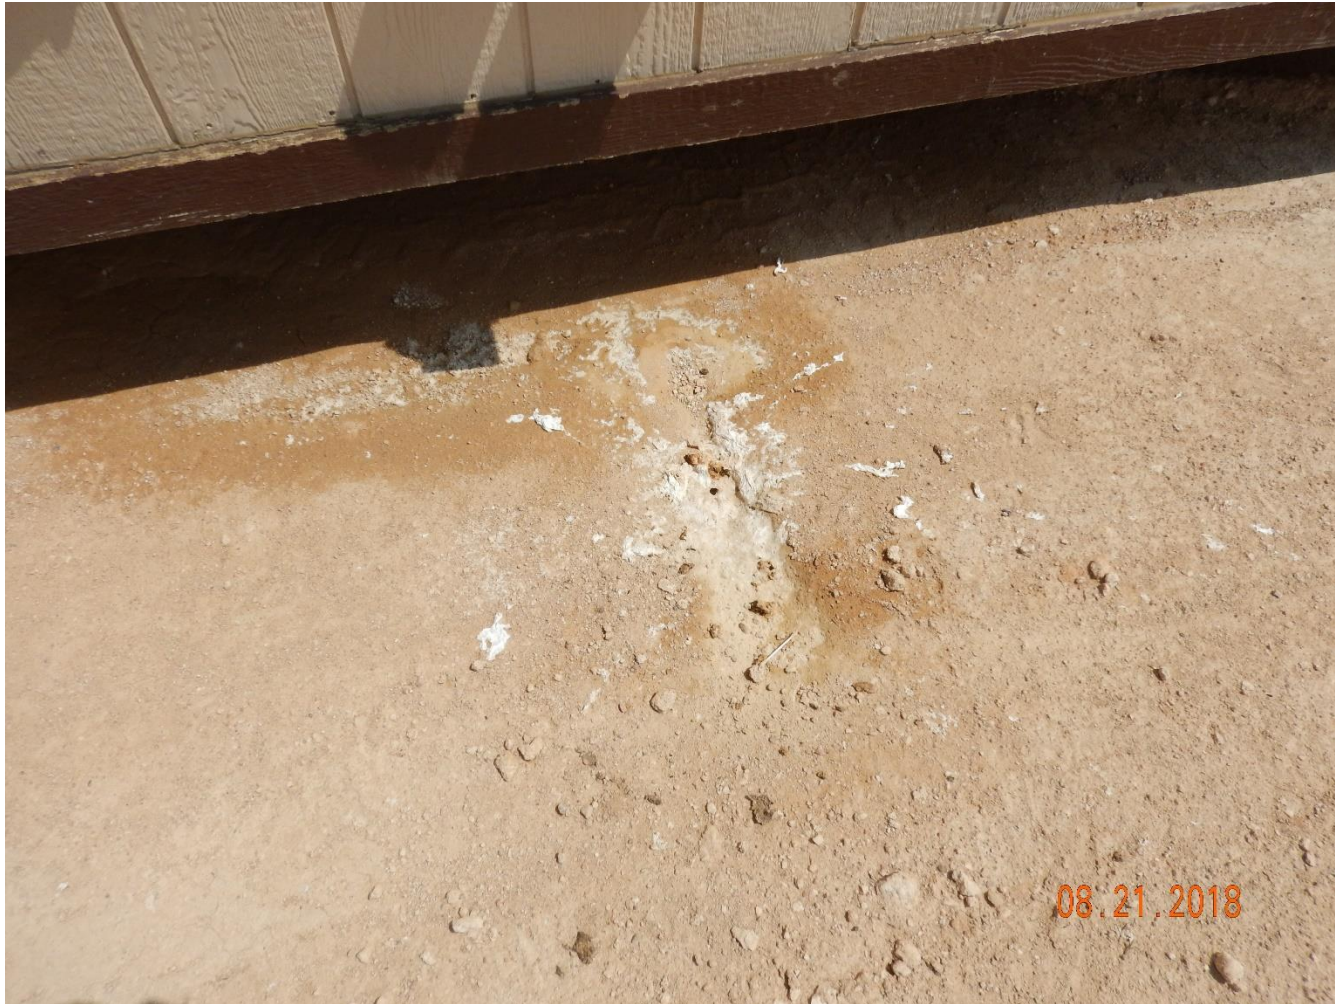
Photo 37: Continued from photo 36

Photo 36: Photo taken from the west end of the location, on the west side of the office trailers on location, facing southeast. Photo shows what appears to be sewage discharge from the northern trailer.

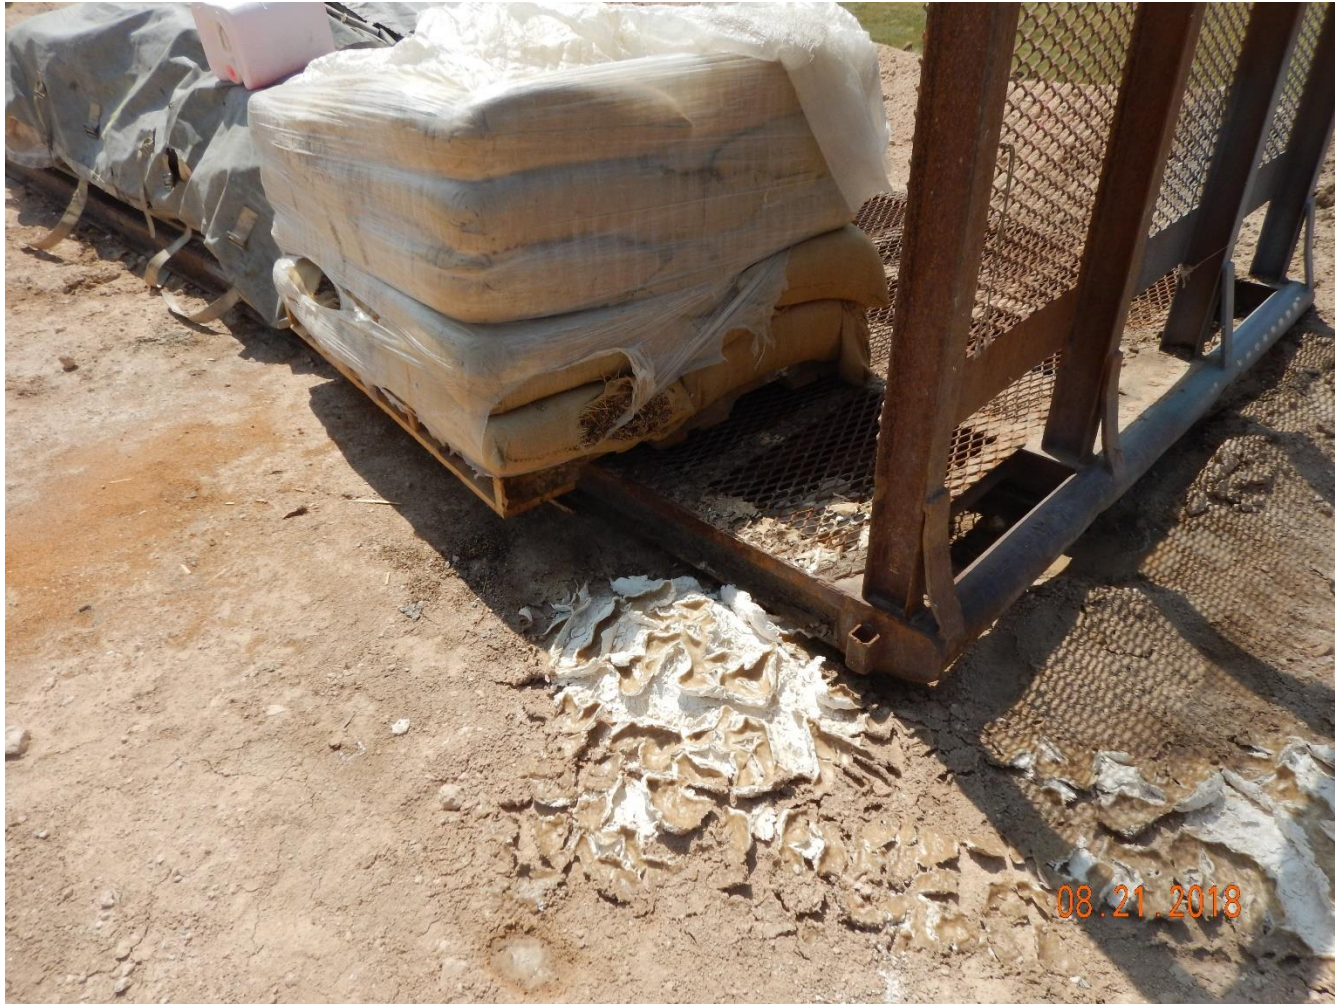
Photo 38: Photo taken from the northwest corner of the pad, facing southwest. Photo shows packaged materials appear to have been ripped, with various materials being spilt onto the location.

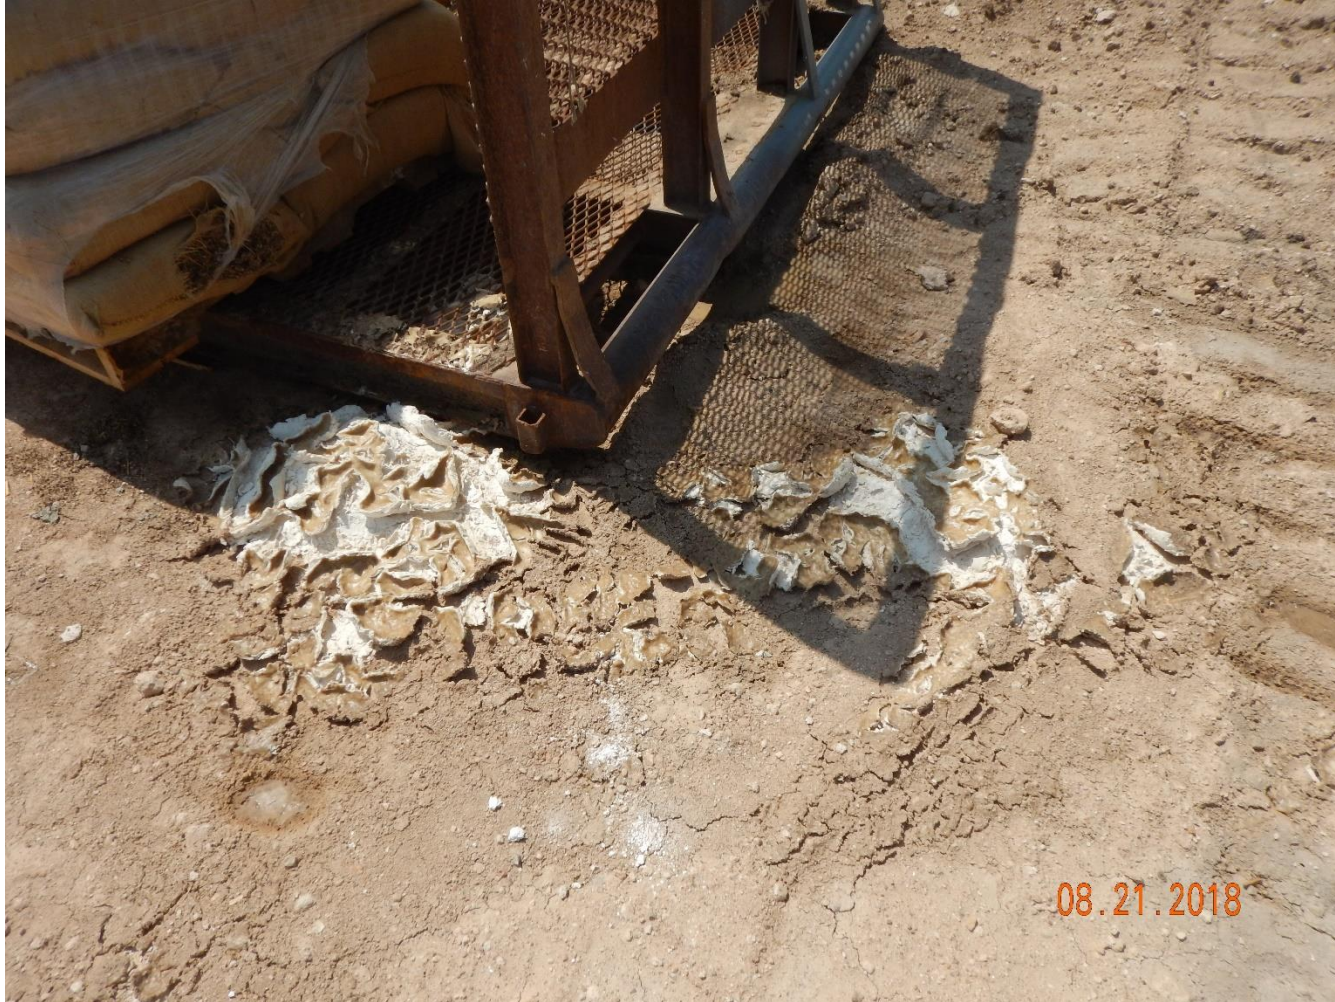
Photo 39: Photo taken from the northwest corner of the pad, facing west. Photo shows packaged materials appear to have been ripped, with various materials being spilt onto the location.

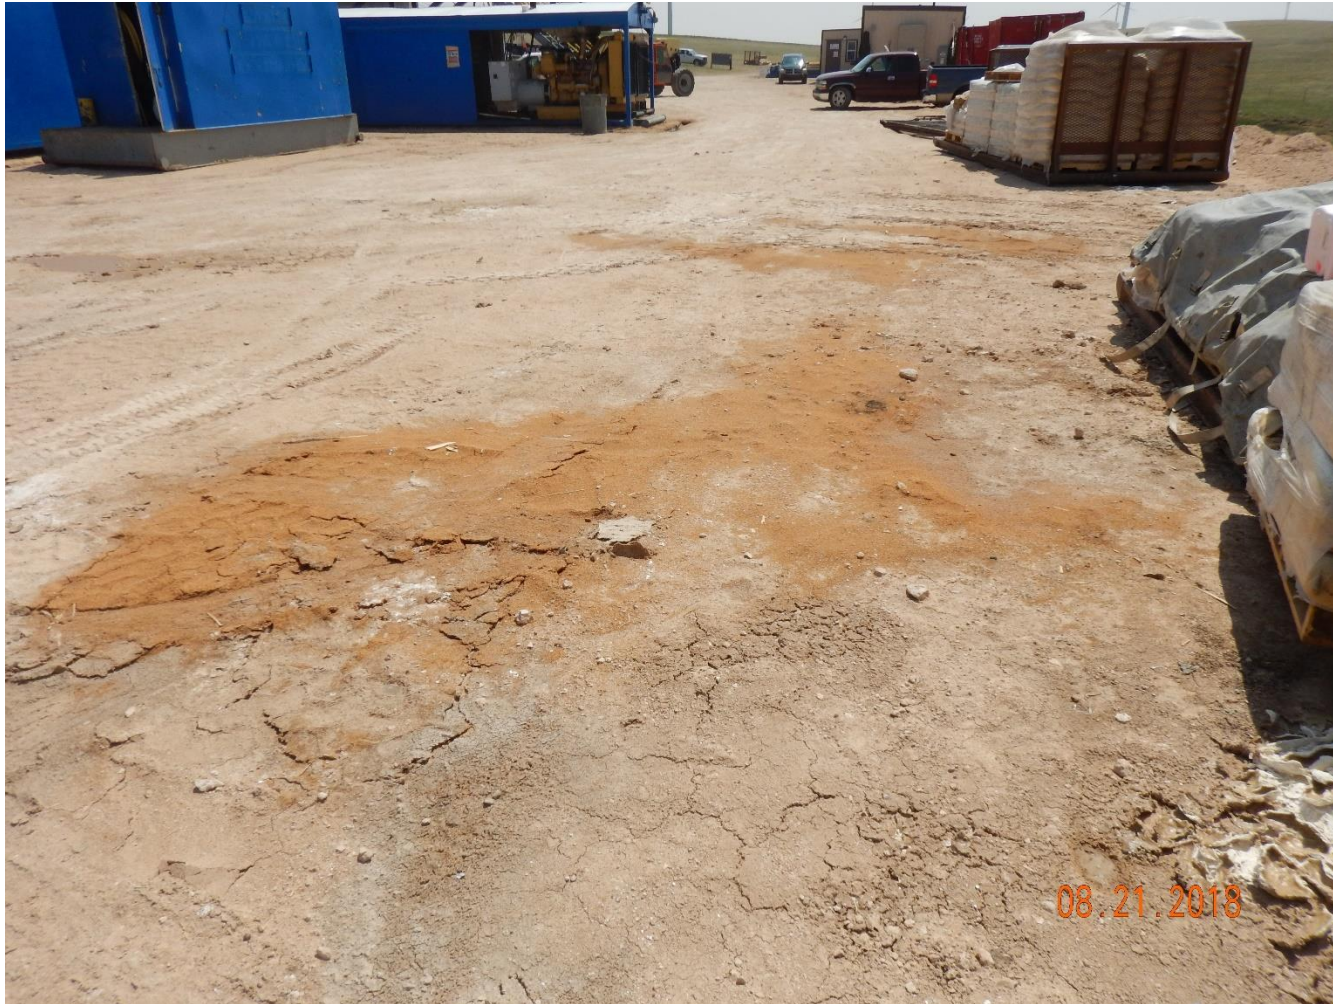
Photo 40: Photo taken from the northwest corner of the pad, facing south. Photo shows packaged materials appear to have been ripped, with various materials being spilt onto the location.

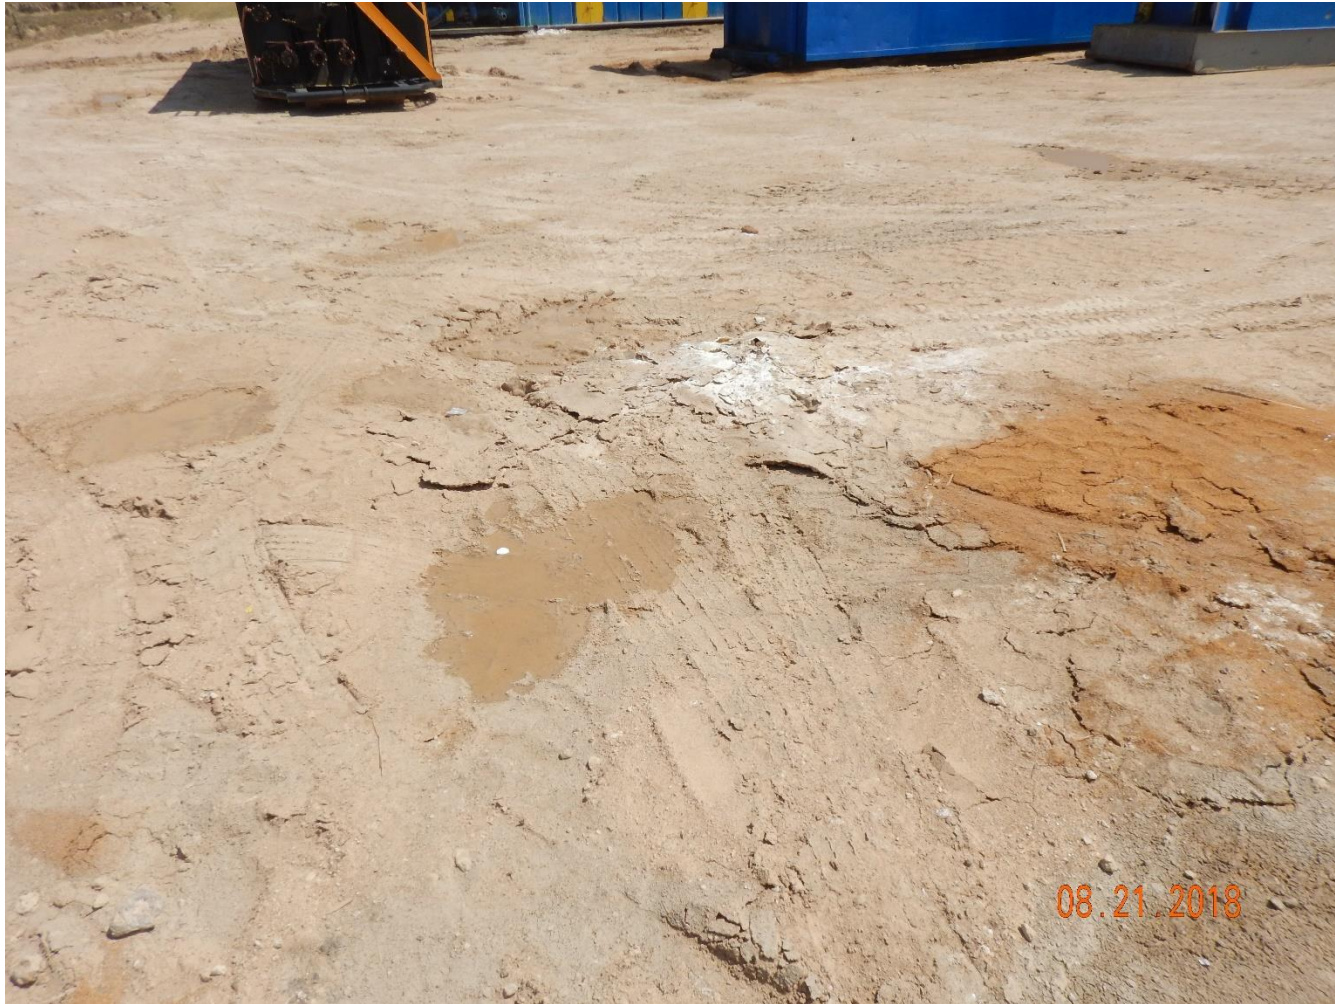
Photo 41: Photo taken from the northwest corner of the pad, facing east. Photo shows packaged materials appear to have been ripped, with various materials being spilt onto the location.

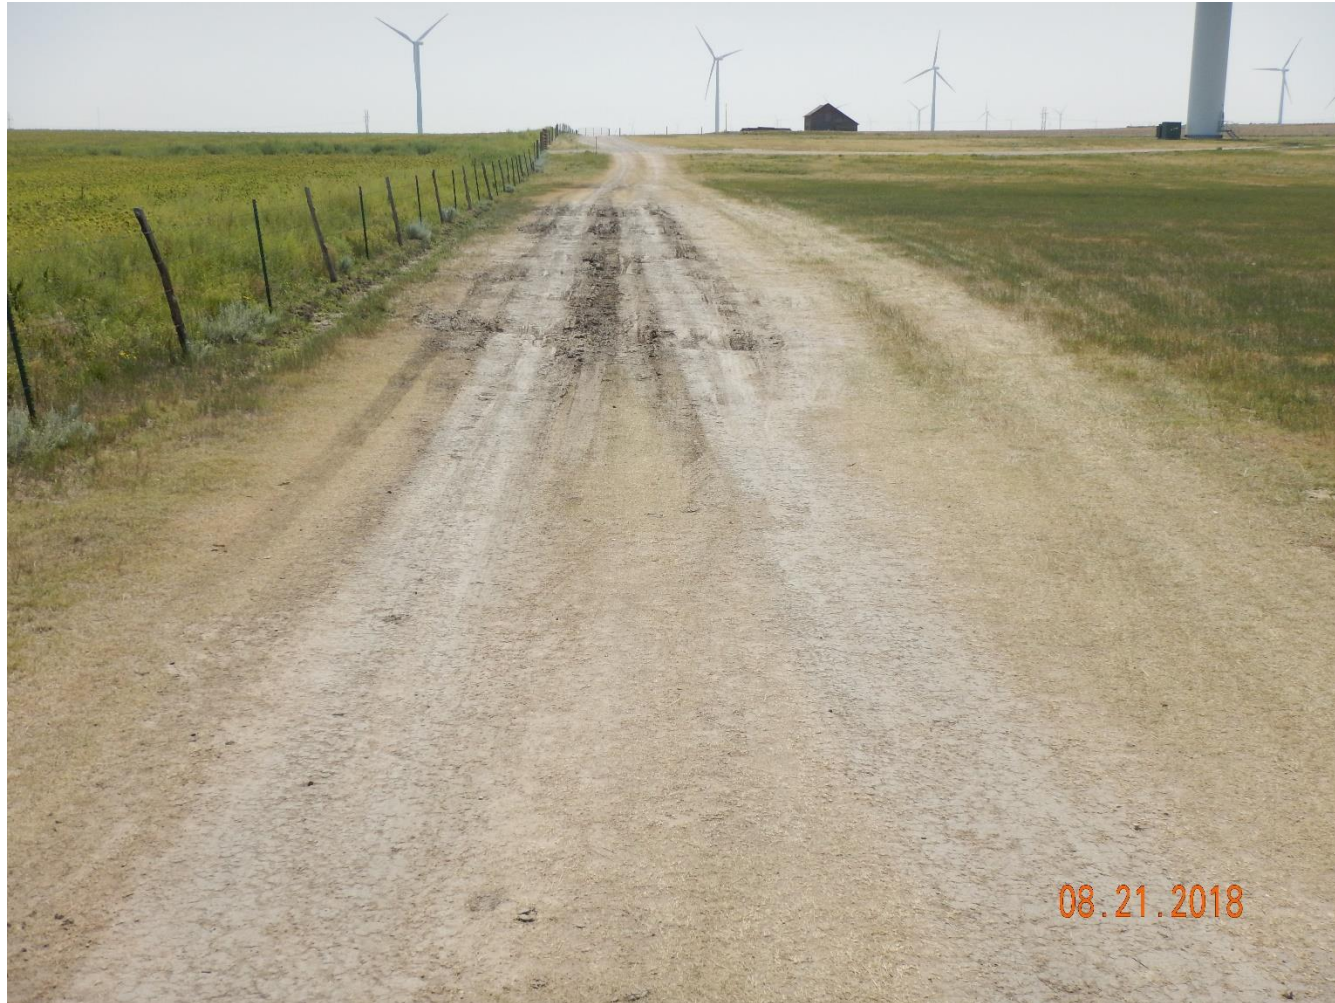
Photo 42: Photo taken from the access road, south of the location, facing south. Photo shows areas of the access road where rutting as occurred. Photo also shows evidence of vehicular travel off of the access road. Maintenance should be conducted and BMPs implemented to allow for travel along access road and minimize off-location/road disturbances in accordance to 1002.e(4)

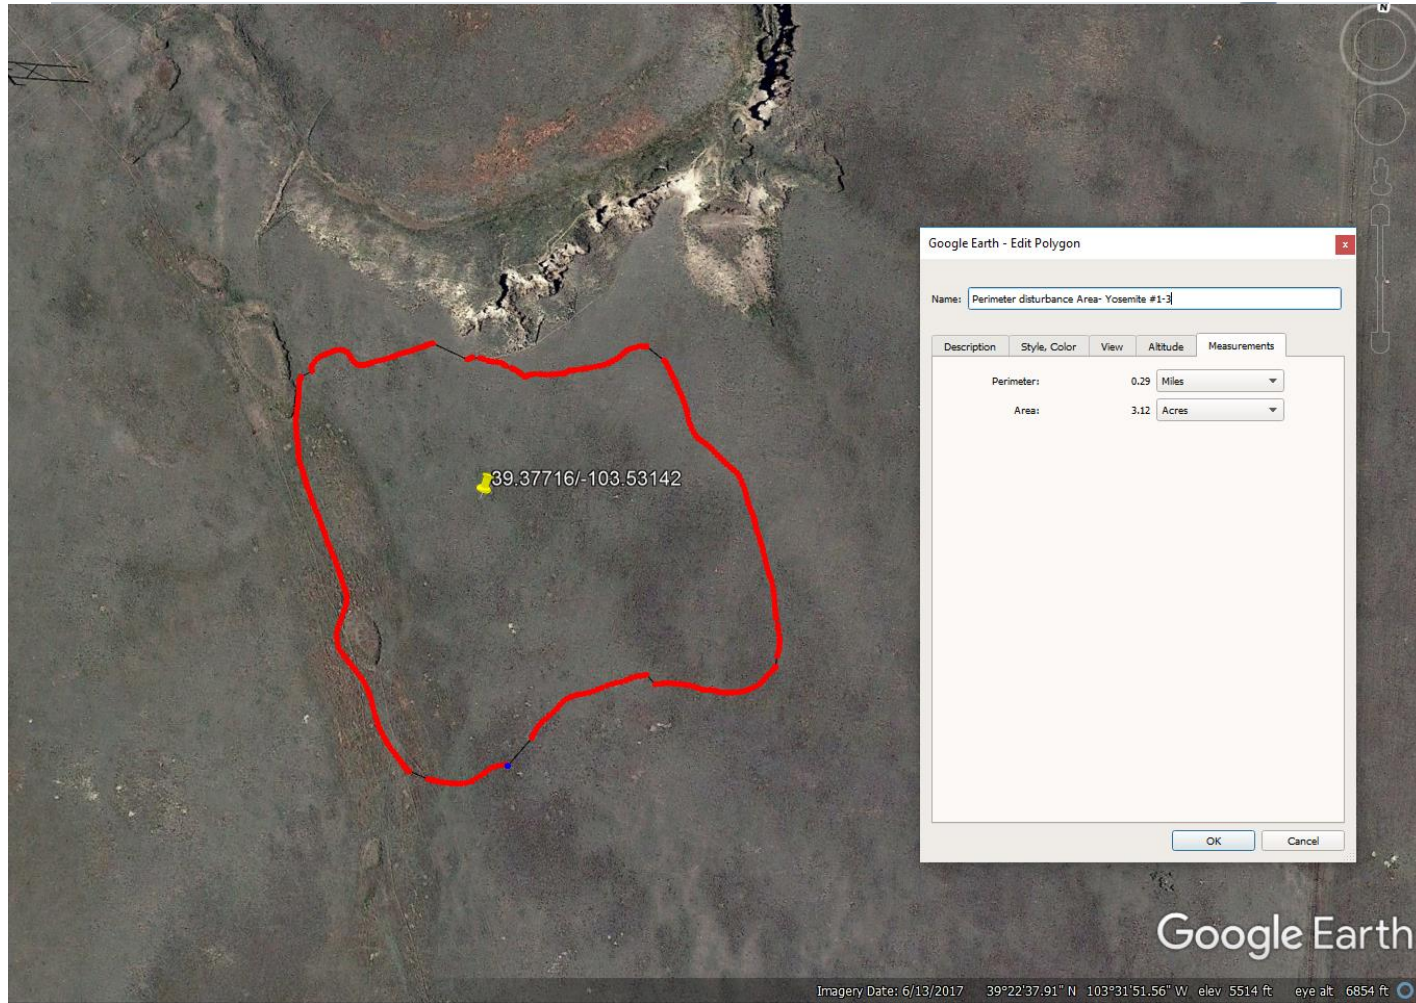
Photo 43: 2017 Google earth aerial imagery. 2A doc. #453036 states size of disturbance area during construction will be 2 acres in size. GPS measurements were conducted indicating that the disturbance area, not including the fenceline, is 3.12 acres in size.
