Reclamation Inspection

August 21, 2018

Operator: K P KAUFFMAN COMPANY INC - 46290

Location ID: 455229

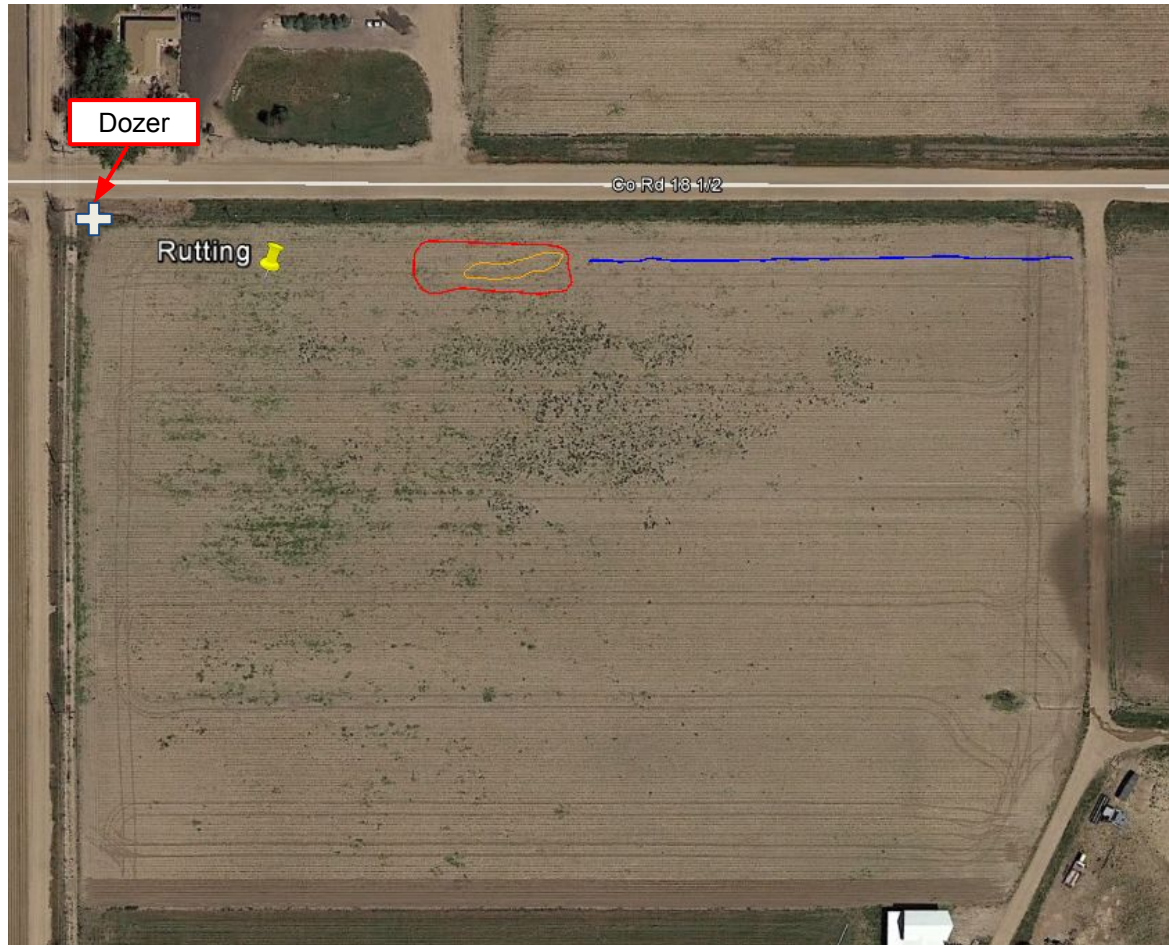
Google Earth aerial imagery illustrating field collected data from August 21, 2018. Image illustrates disturbance related to a spill/release point. Red line = ~5300 square feet excavated area; Orange line = ~1000 square feet of questionable topsoil replacement; Blue line = ~400' compacted area from equipment and vehicle traffic. Note: Operator left dozer on surface owners property and rutting was observed nearby.

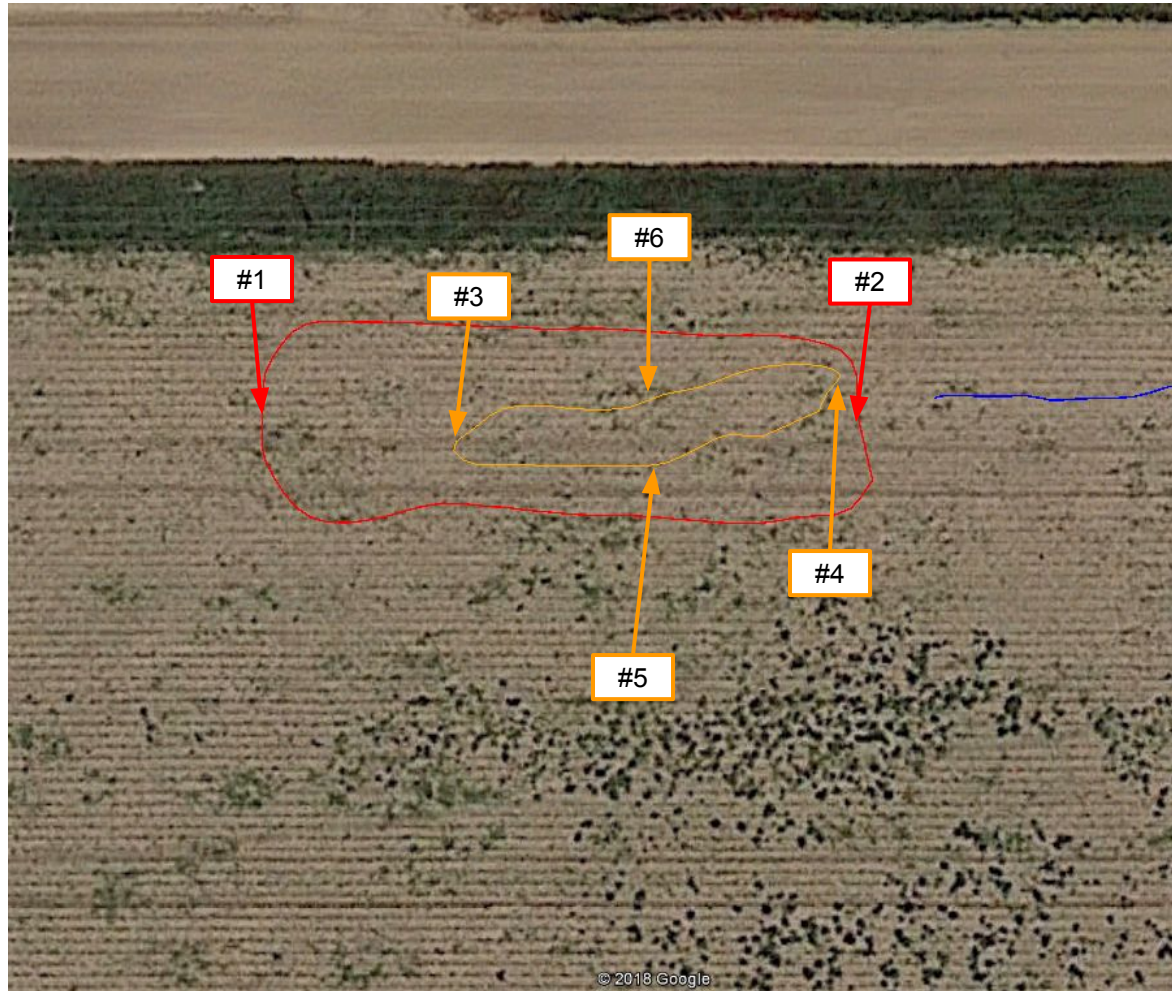
Approximate Lat/Longs to help guide the Operator for required soil samples: #1= 40.123391, -104.800045; #2= 40.123398, -104.799572; #3= 40.123379, -104.799891; #4= 40.123421, -104.799585; #5= 40.123369, -104.799732; #6= 40.123412, -104.799729

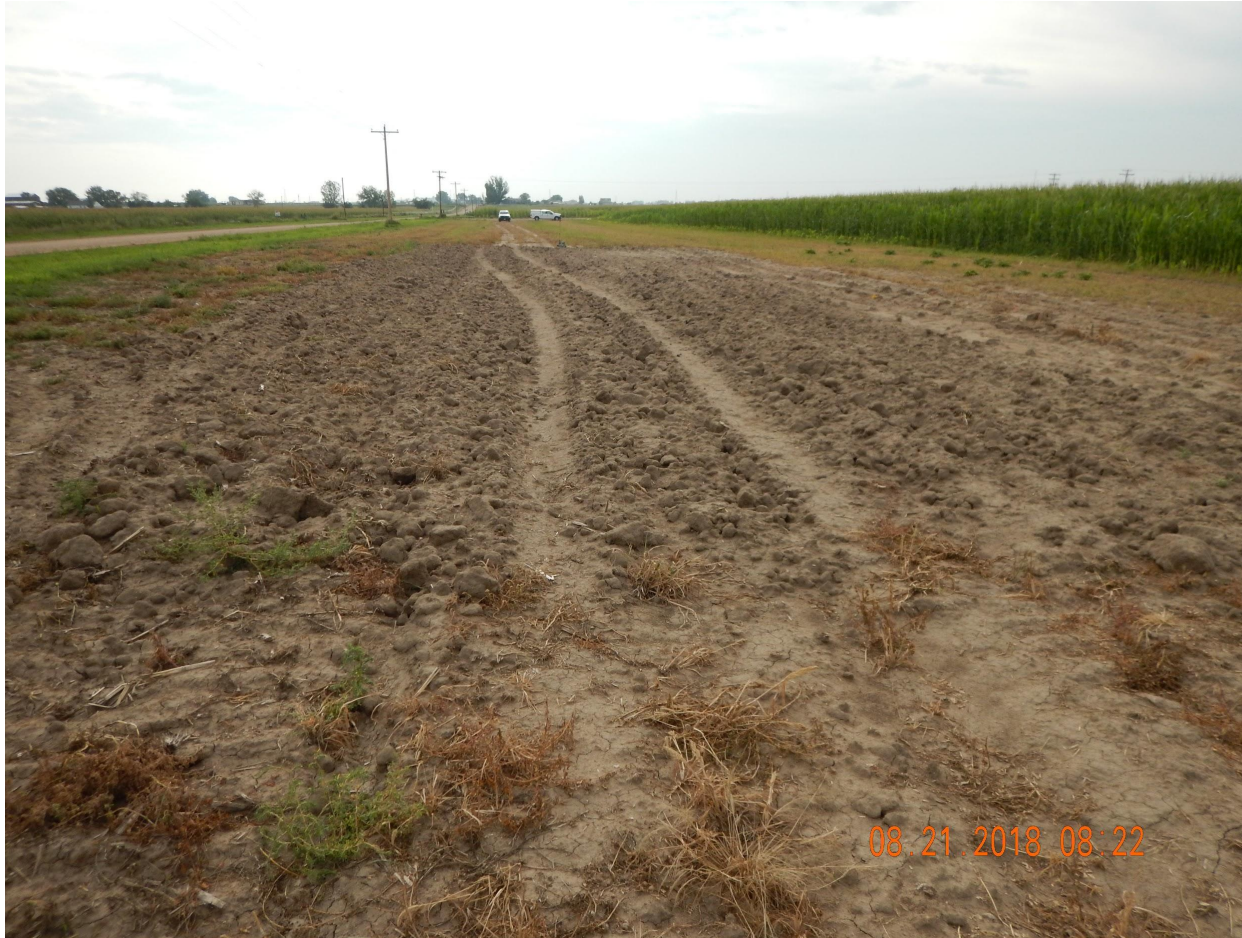
Photo 1. Photo taken west of the spill/release point, facing East. Spill/release point area has not been properly contoured to match the surrounding area or allow for flood irrigation. Once the area has been properly contoured, Operator shall ensure a firm but friable seedbed preparation has been performed. Note: Operator shall properly decompact to a depth of eighteen (18") inches on all impacted areas.

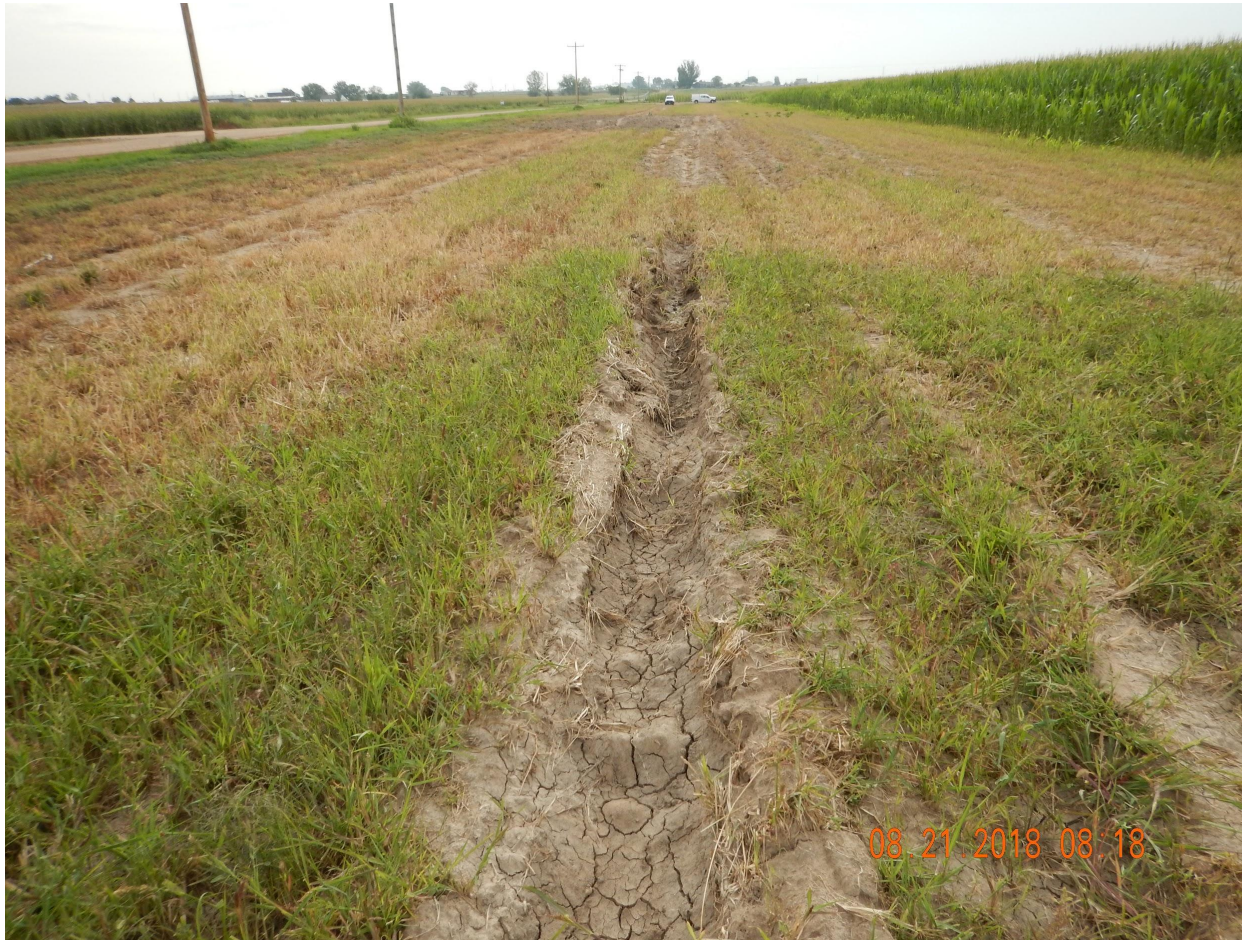
Photo 2. Photo taken west of the spill/release point, facing East. Appears rutting may have occurred. Operator shall repair all ruts.

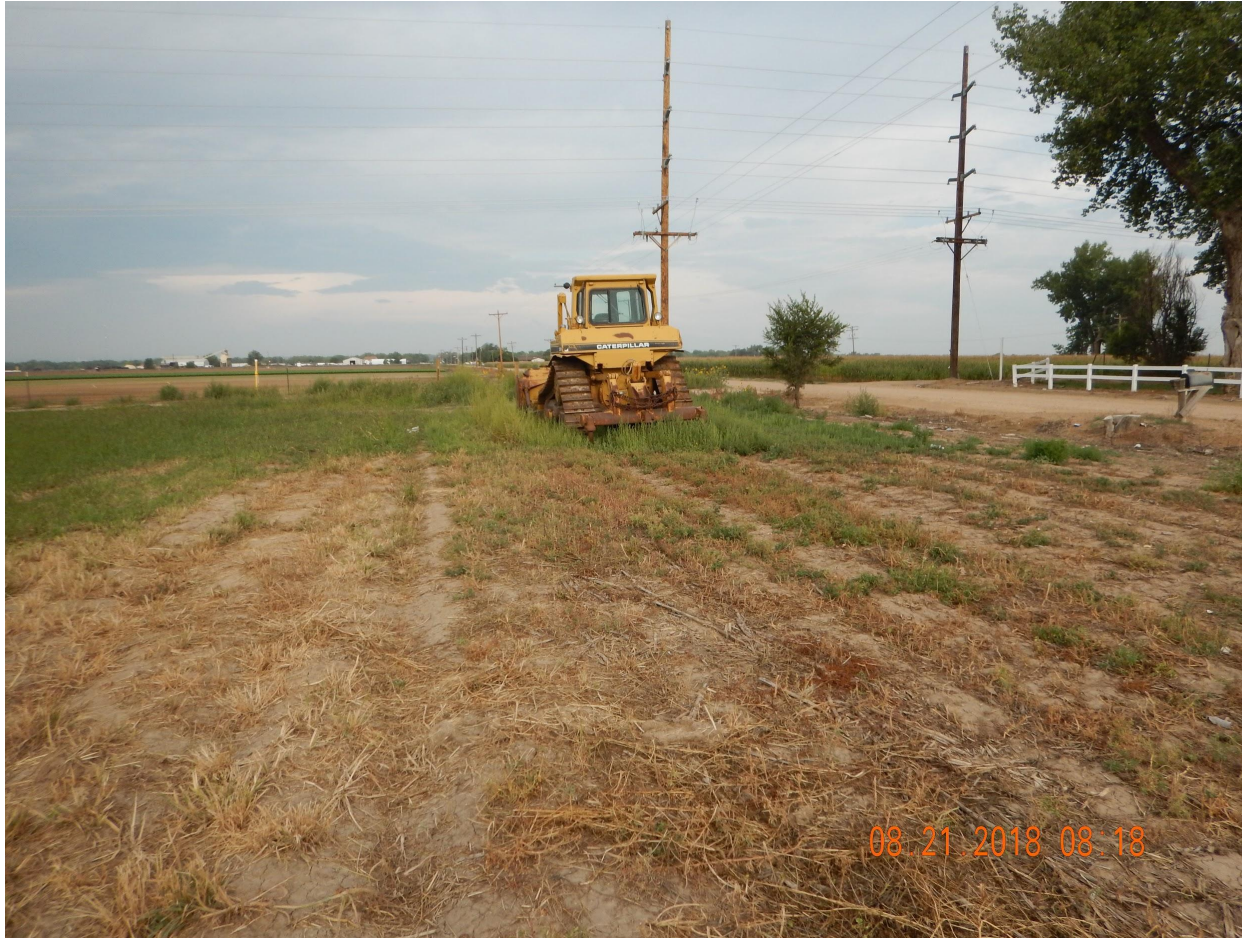
Photo 3. Photo taken west of the spill/release point, facing West. Operator has left dozer at location since work was completed in July. Note: Weed growth around the dozer. Operator shall remove unused equipment immediately.

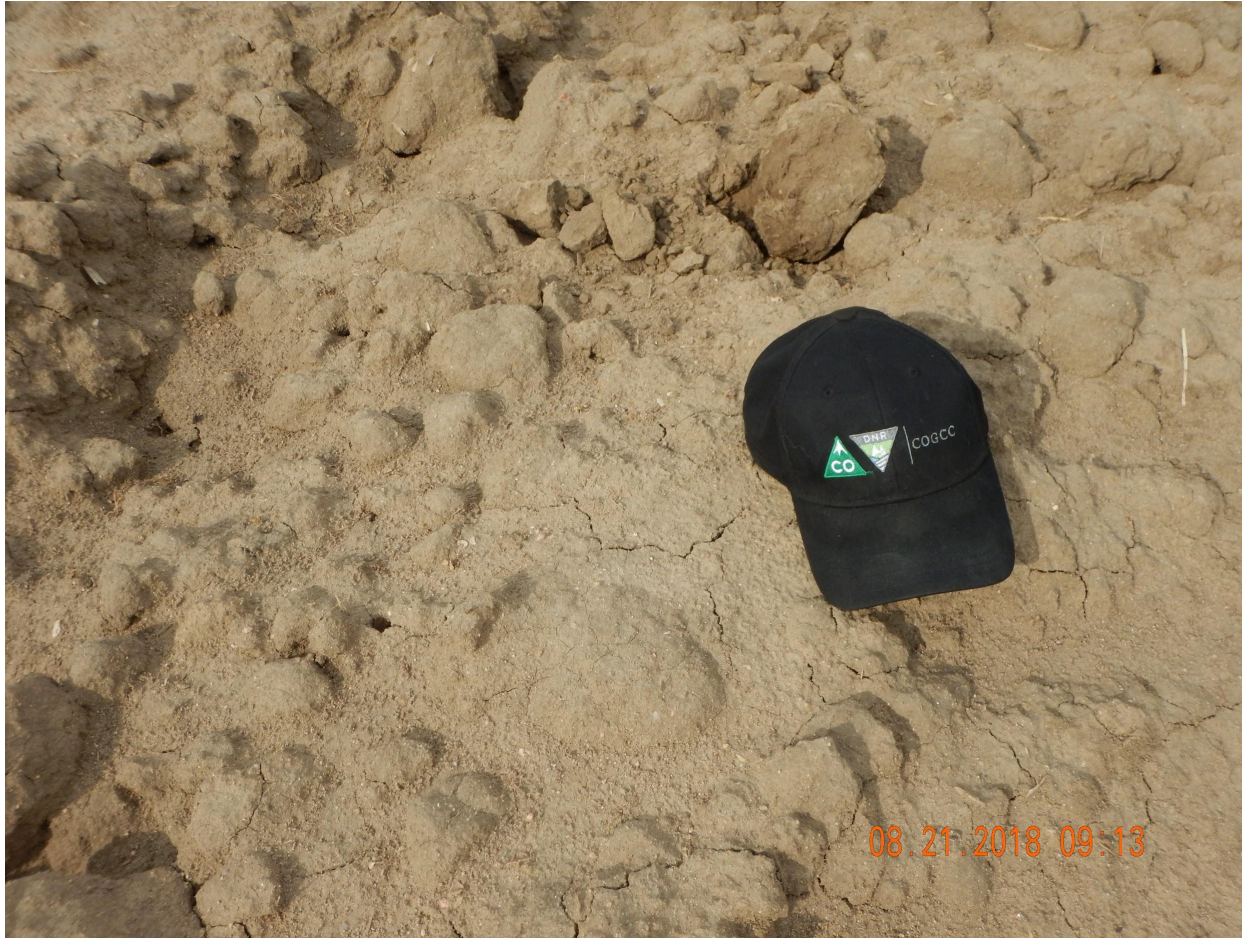
Photo 4. Photo taken from a portion of the excavated area. It is unclear whether or not this soil material is equivalent to reference area soils. Soil samples were collected for confirmation. Operator shall ensure all imported soil is the same or equivalent to that of reference area soils.

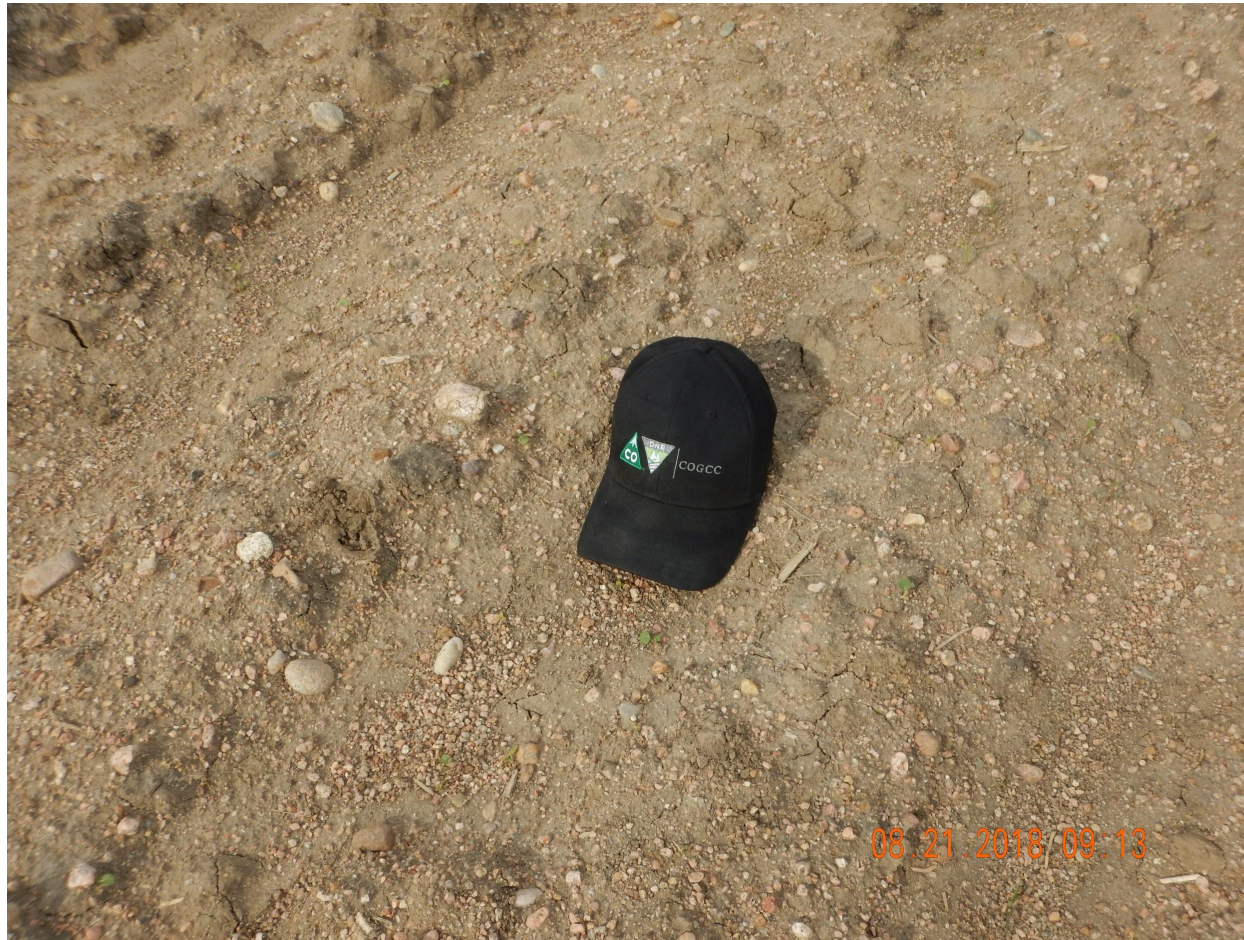
Photo 5. Photo taken from a portion of the excavated area. This area (orange line in first slide) does not appear to be soil material that is equivalent to reference area soils, as this soil material consisted of coarse rock fragments not observed in reference areas. Soil samples were collected for confirmation. Operator shall ensure all imported soil is the same or equivalent to that of reference area soils.

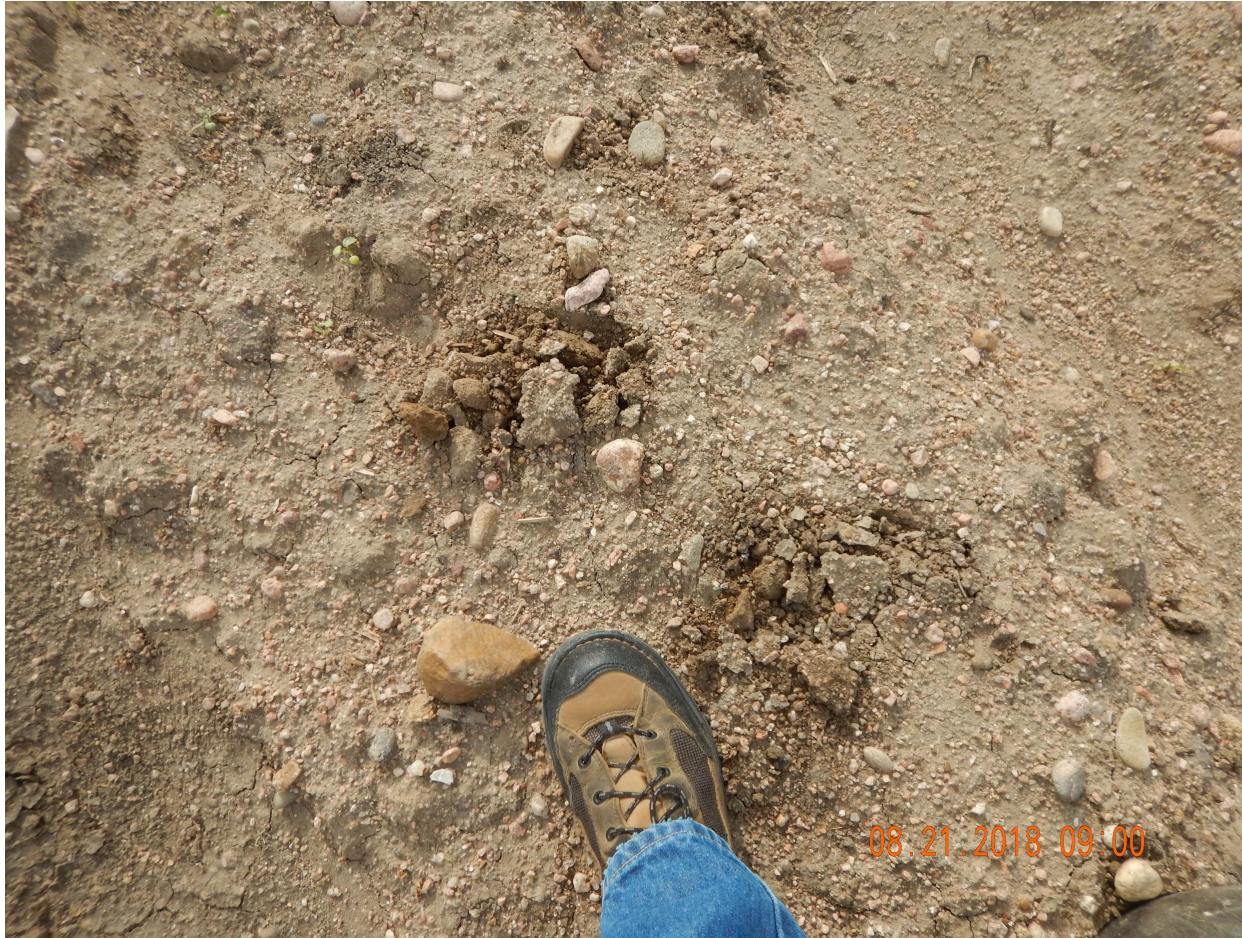
Photo 6. Photo taken from a portion of the excavated area. This area (orange line in first slide) does not appear to be soil material that is equivalent to reference area soils, as this soil material consisted of coarse rock fragments not observed in reference areas. Soil samples were collected for confirmation. Operator shall ensure all imported soil is the same or equivalent to that of reference area soils.

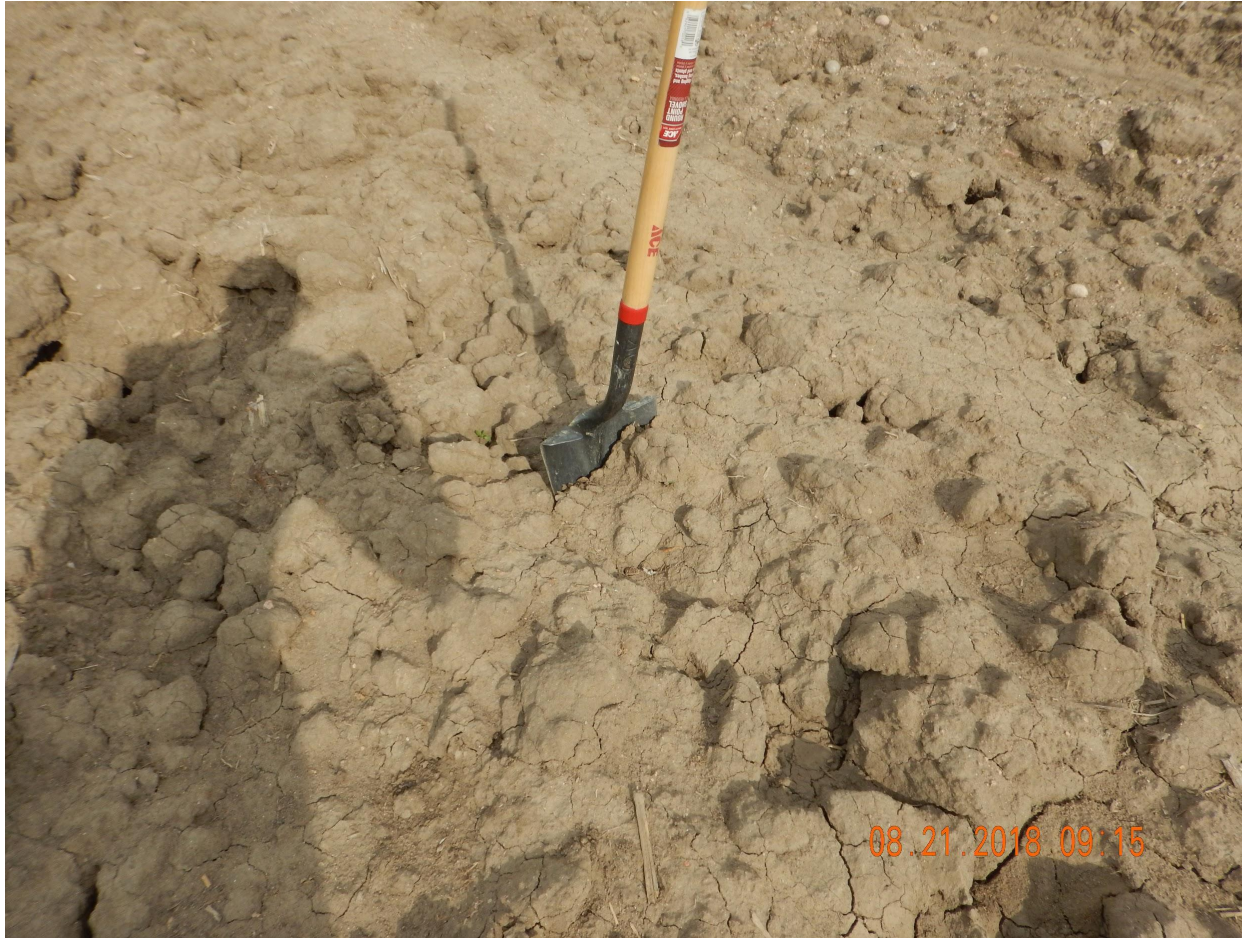
Photo 7. Photo taken from a portion of the excavated area. Photo illustrates excavated areas appear to be decompacted. COGCC Staff did not make an assessment on whether proper decompaction was performed to a depth of eighteen (18") inches per Reclamation rules. Operator shall properly decompact to a depth of eighteen (18") inches on all impacted areas.

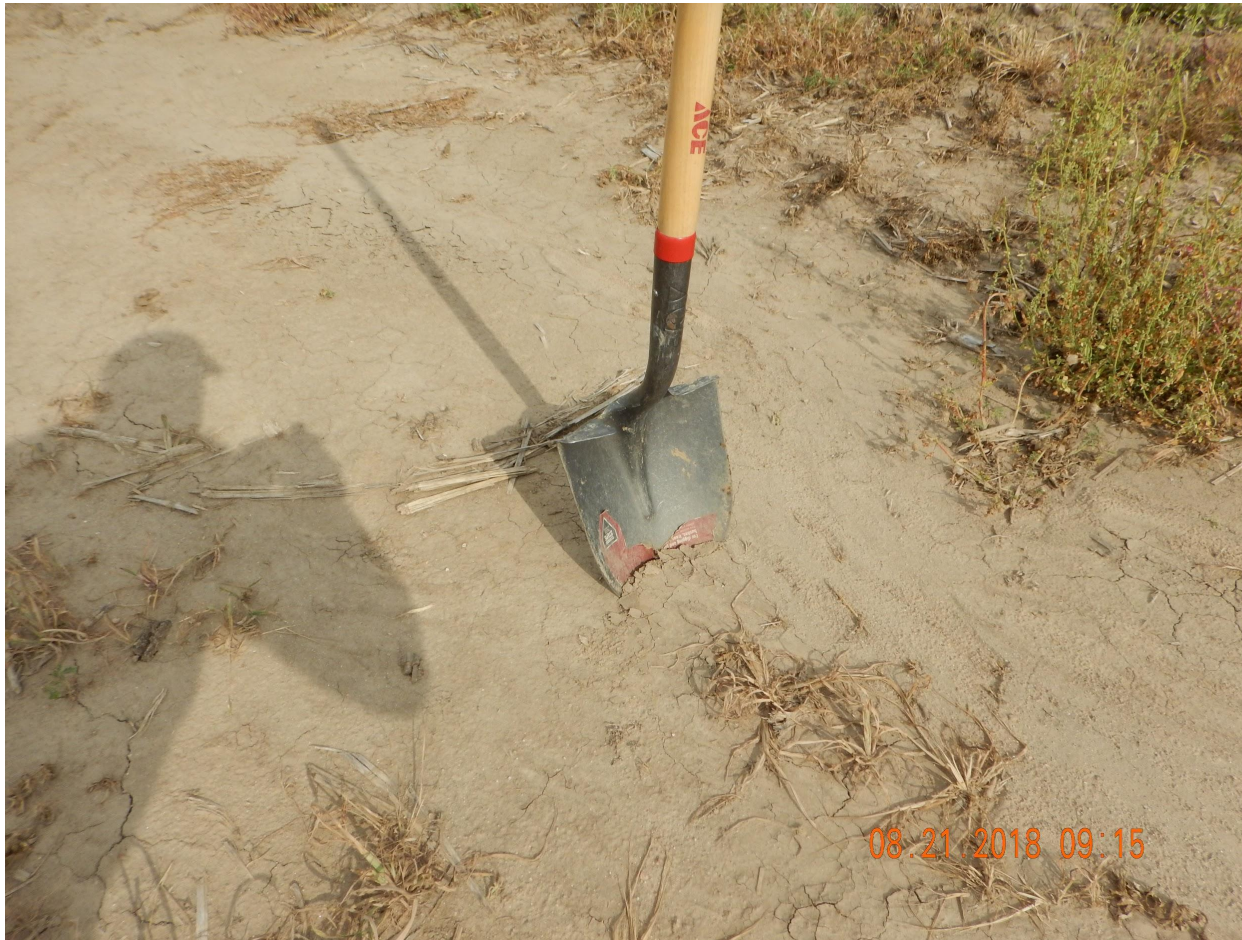
Photo 8. Photo taken from a portion of a compacted area (blue line in first slide) from equipment and vehicle traffic. Operator shall properly decompact to a depth of eighteen (18") inches on all impacted areas. Once the area has been properly decompacted, Operator shall ensure a firm but friable seedbed preparation has been performed.

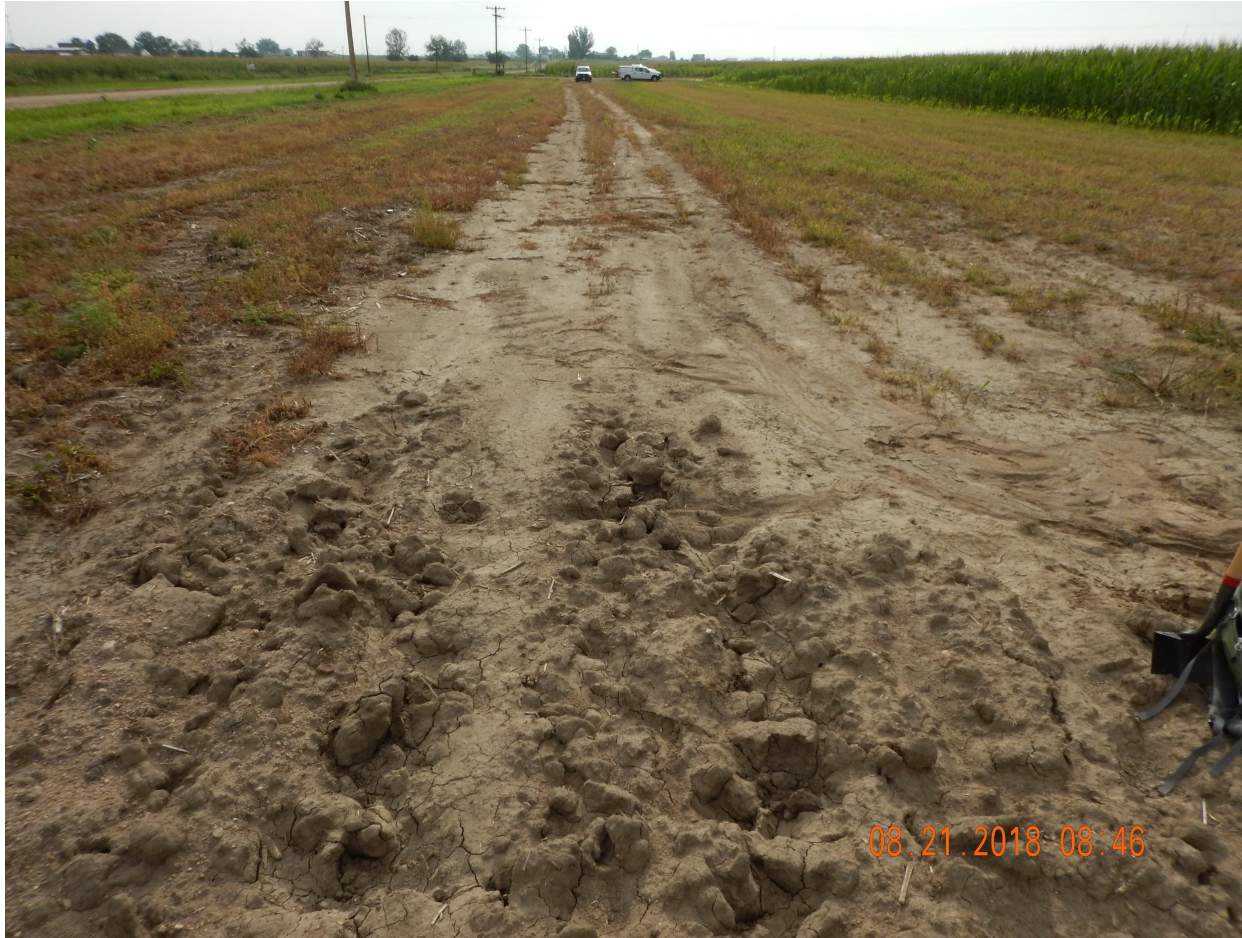
Photo 9. Photo taken from the eastern spill/release point, facing East. Photo illustrates the ~400' area of compaction. Operator shall properly decompact to a depth of eighteen (18") inches all areas impacted areas. Once the area has been properly decompacted, Operator shall ensure a firm but friable seedbed preparation has been performed.
