Inspection Photos

08/14/2018

Operator: CASCADE PETROLEUM LLC - 10414

Location ID: 439341

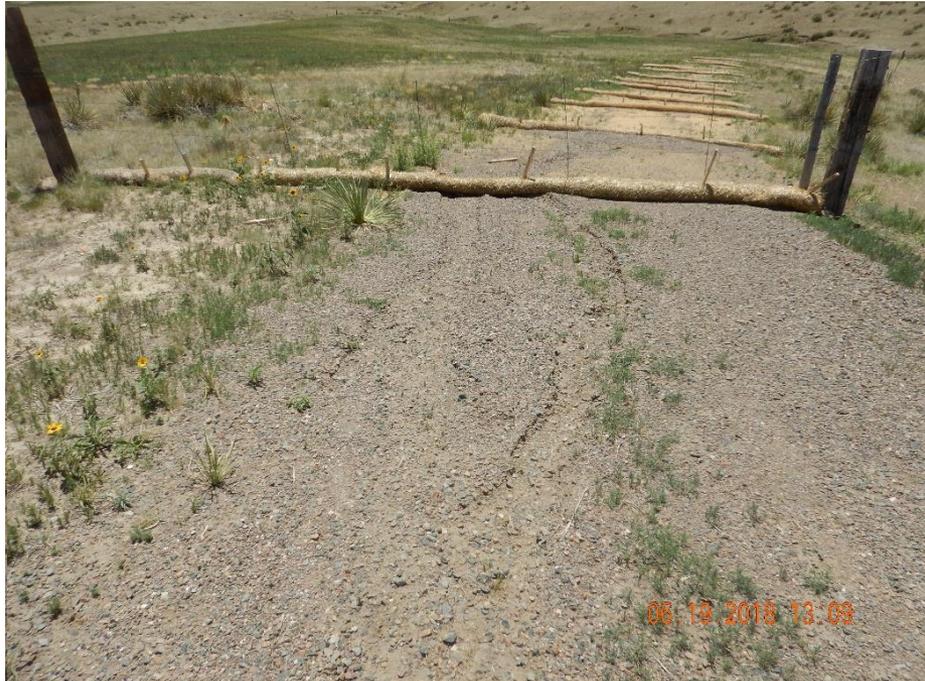
Photo 1: Photo from Inspection #682503518 dated 6/19/2018 (photo #16). Photo taken from the northwest end of the location, facing south. Previous inspection documented erosion degradation along access road and wattle/erosion log no longer in proper functioning condition as stormwater erosion was cutting underneath the wattle. Previous inspections required operator to perform stormwater management

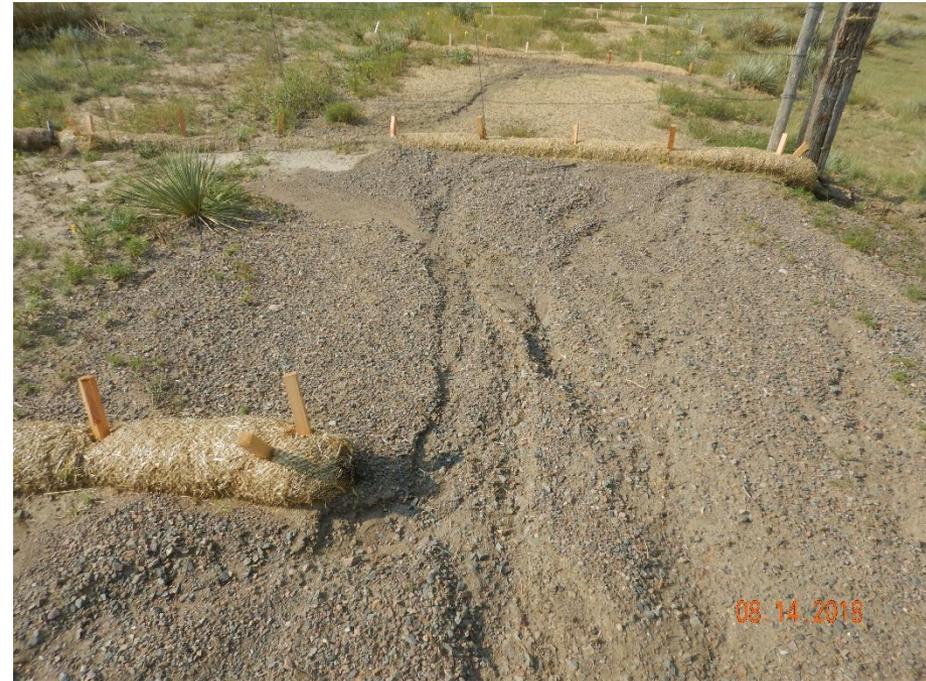
Photo 2: Photo date 8/14/2018. Photo taken from the northwest end of the location, facing south. Photo shows wattle appears to have been replaced, however, BMP has now filled with sediment and is no longer in proper functioning condition. Additionally, stormwater erosion degradation observed along access road has not been sufficiently repaired or stabilized and has been allow to continue.

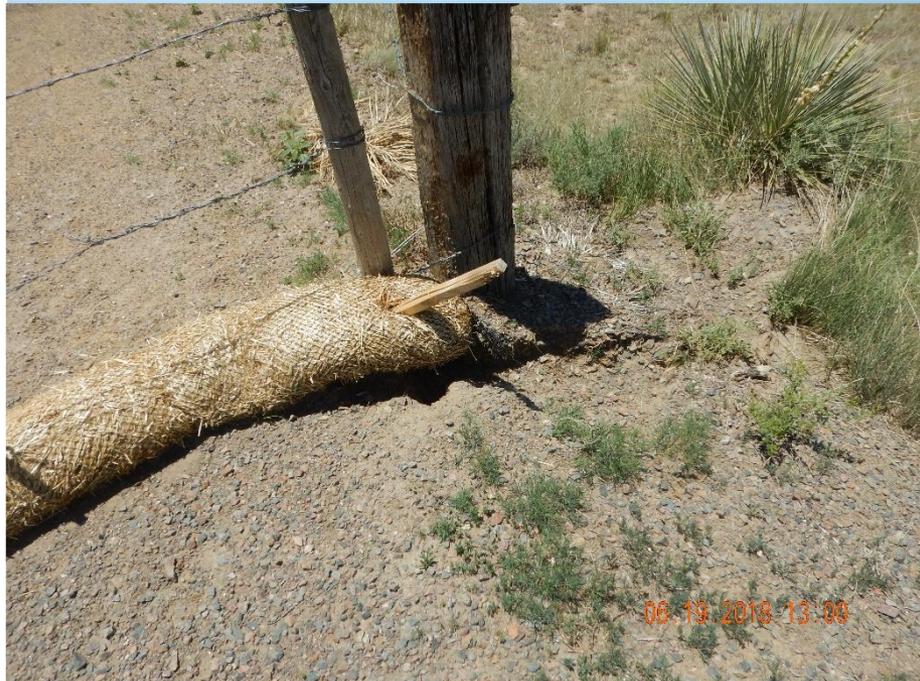
Photo 3: Photo from Inspection #682503518 dated 6/19/2018 (photo #3). Photo taken from the entrance gate of the location. Photo shows stormwater erosion occurring at the entrance with sediment deposition traveling off the location. See comments under photo 1.

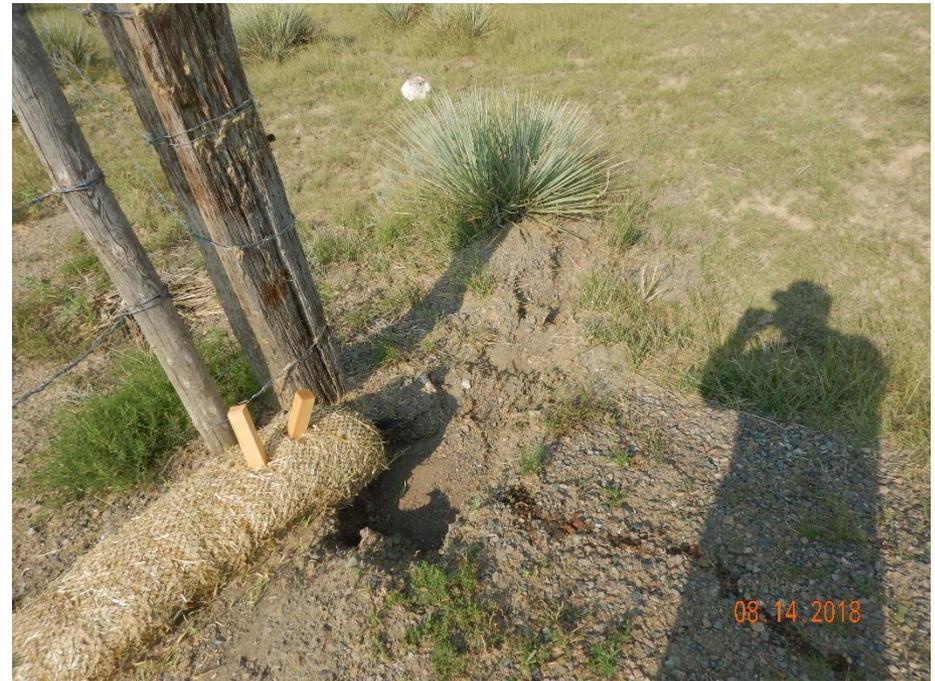
Photo 4: Photo date 8/14/2018. Photo taken from the entrance gate of the location. Photo shows stormwater erosion degradation has not been repaired or stabilized, and degradation and sediment transport off location has been allowed to continue.

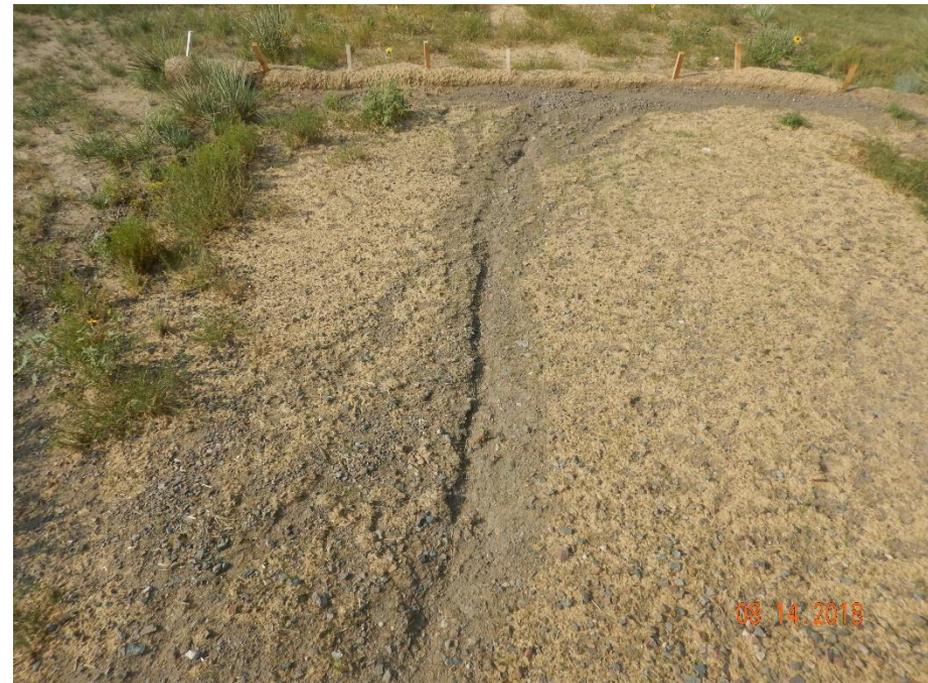
Photo 6: Photo taken from the area of the reclaimed access road on the northwest end of the location, facing south. Photo shows stormwater erosion degradation has continued. Wattle (erosion log) appears to have filled with sediment, and stormwater now appears to be diverting west around the wattle.

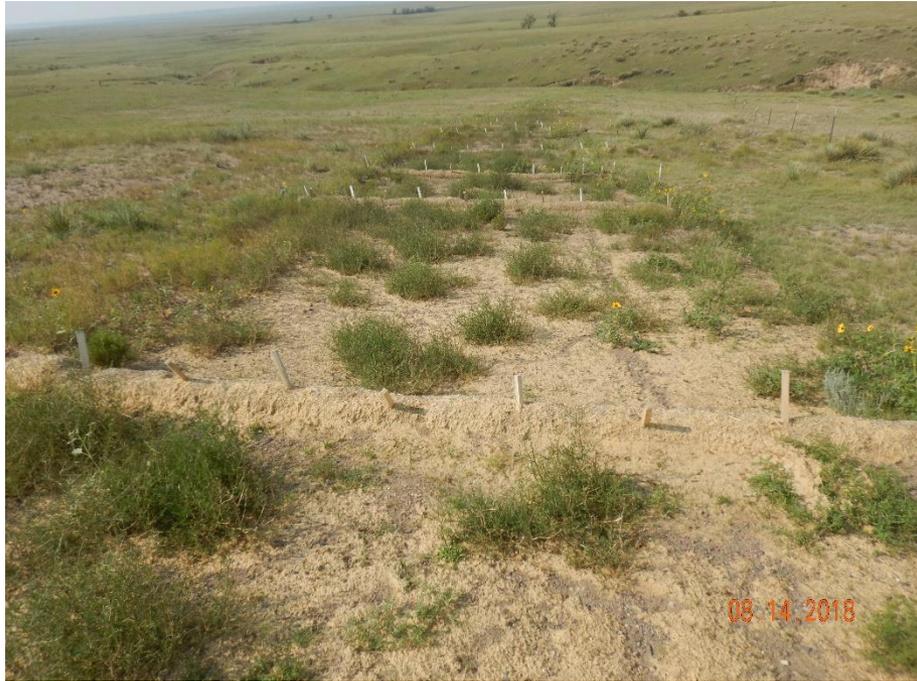
Photo 7: Photo taken from the area of the reclaimed access road on the west end of the location, facing south. Photo shows hydromulching and additional maintenance to properly install stowmater and sediment erosion controls appears to have been conducted.

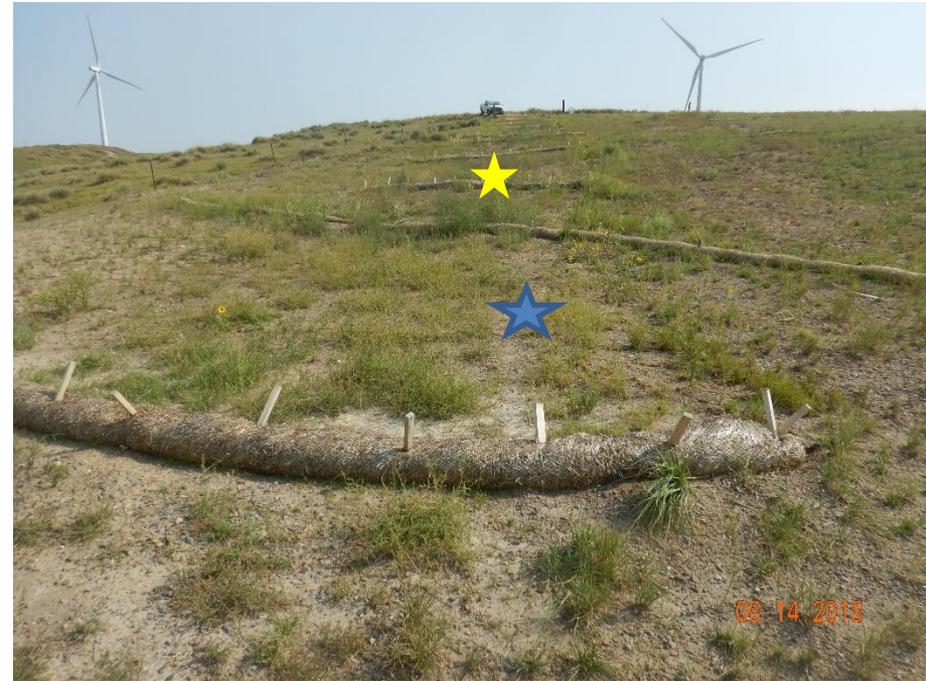
Photo 8: Photo taken from the area of the reclaimed access road on the west end of the location, where access road ended and began traveling east to the well. Photo facing north. Photo shows areas of the access road where gravel/road base has not been removed. Blue and yellow stars show areas where photos 9 and 10 was taken.

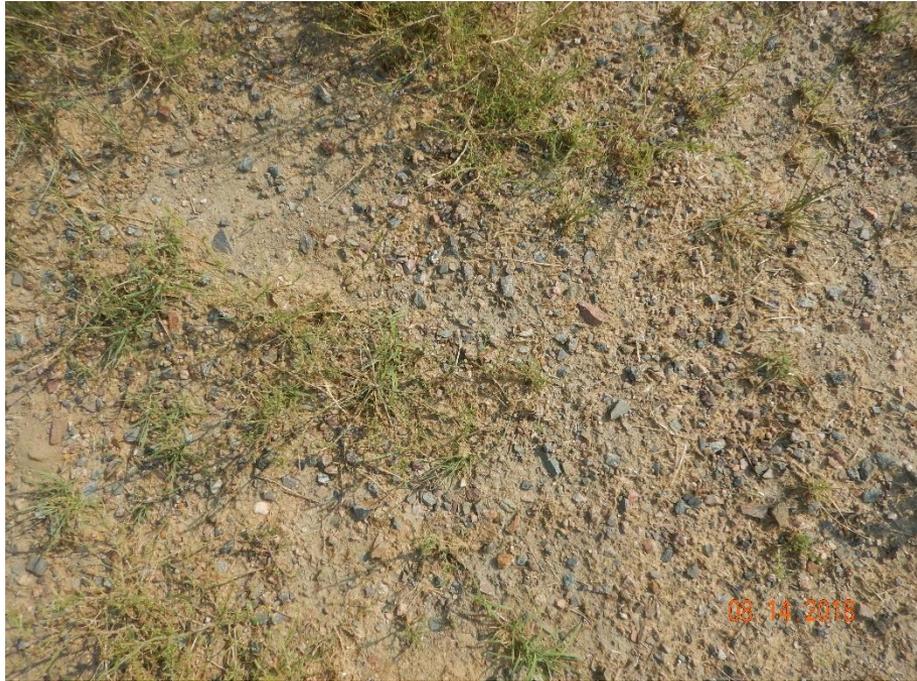
Photo 9: See comments under photo 8. Photo shows areas of the access road on location where gravel/road base remains.

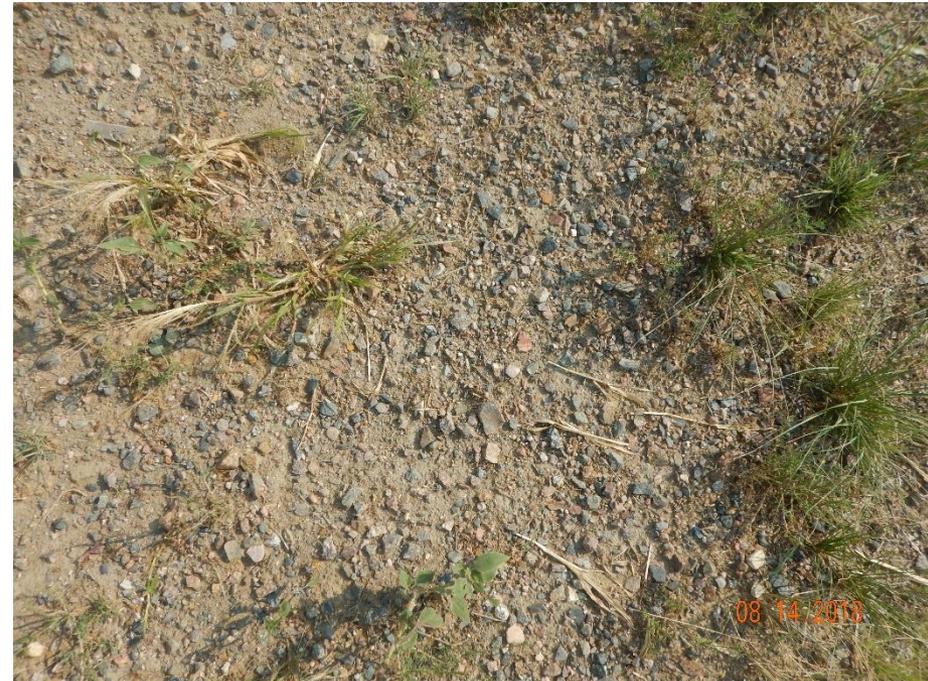
Photo 10: See comments under photo 8. Photo shows areas of the access road on location where gravel/road base remains.

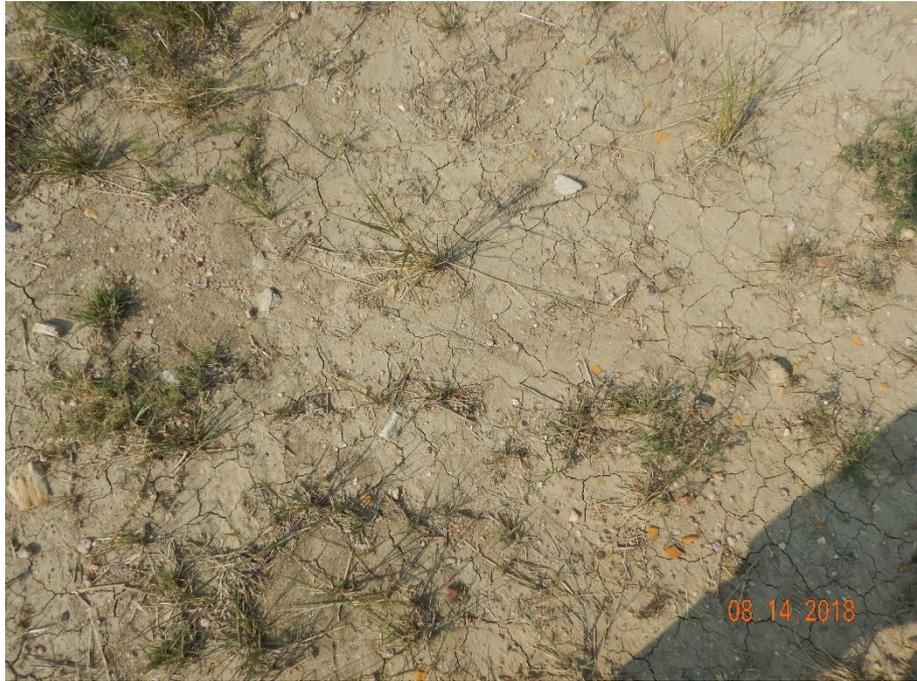
Photo 11: Photo taken from the location. Photo was taken to compare/contrast areas of the location, from areas of the access road where gravel/road base has not been removed.

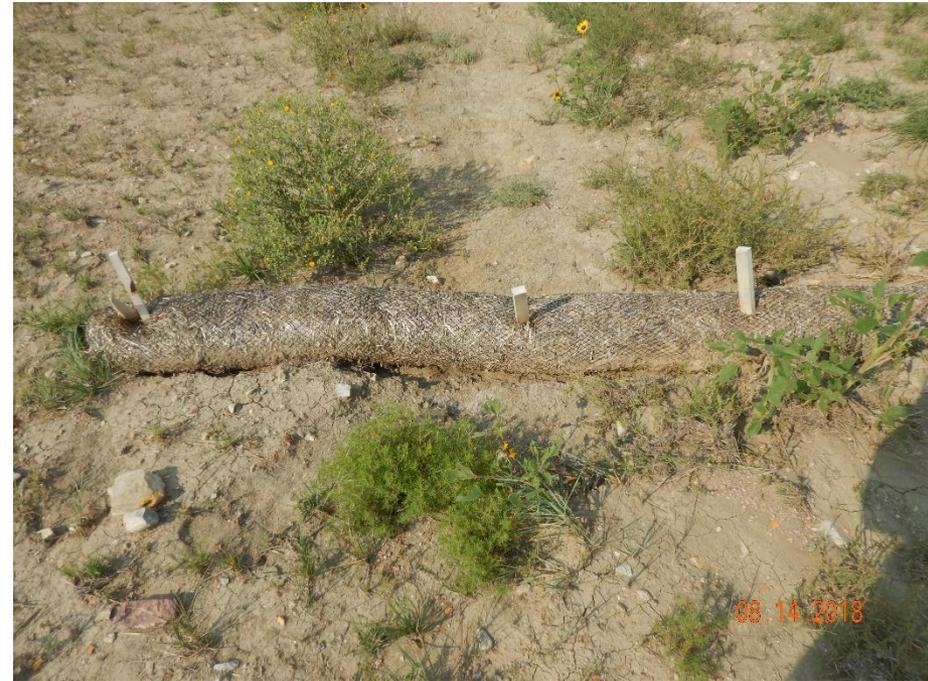
Photo 12: Photo taken from the location. Photo of wattle. Unable to find evidence that maintenance has occurred. Wattle does not appear to have been installed or maintained in accordance to good engineering practices or per corrective actions. Stormwater appears to be traveling under wattle.

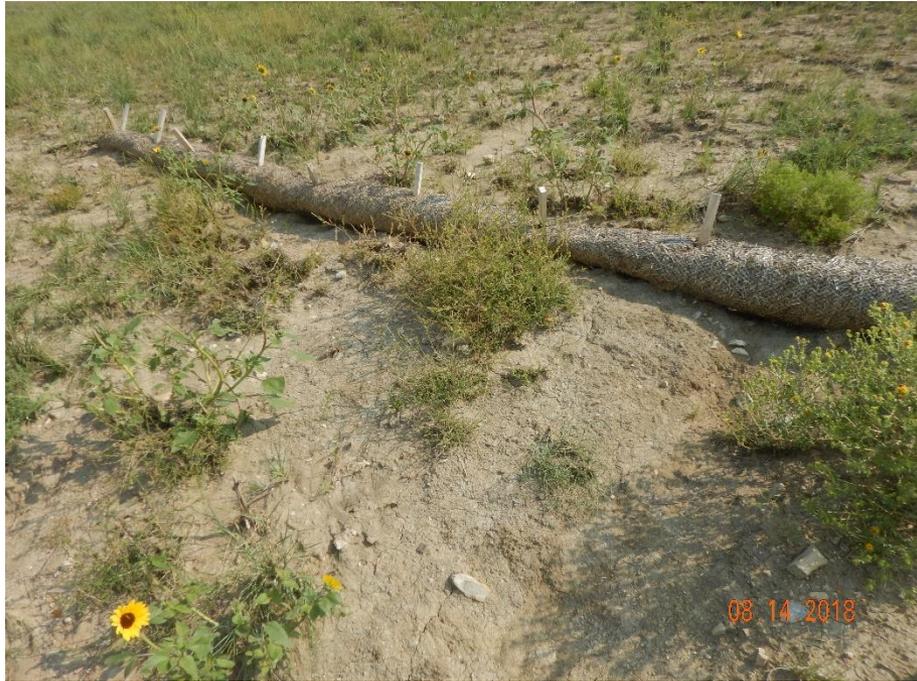
Photo 13: Photo taken from the southern end of the location, facing north. Though some maintenance has been evident on some of the controls on location, sufficient maintenance and stormwater management does not appear to have been conducted or occurring per corrective actions. Photo shows stormwater appear be continuing to cut beneath wattles and erosion degradation has continued on the location.

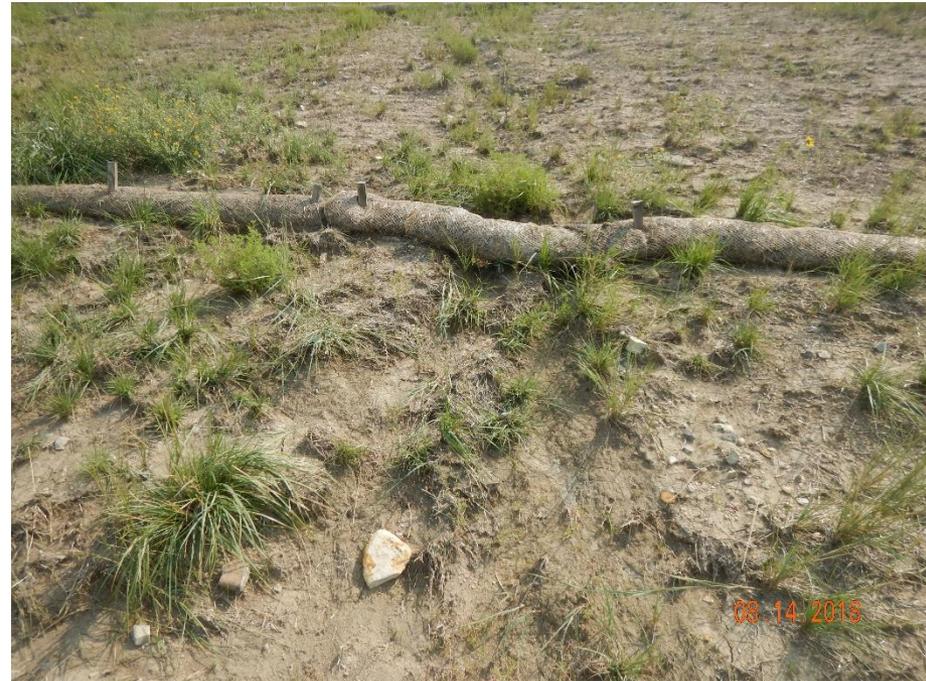
Photo 14: Photo taken from the southern end of the location, facing north. See comments under photo 13.

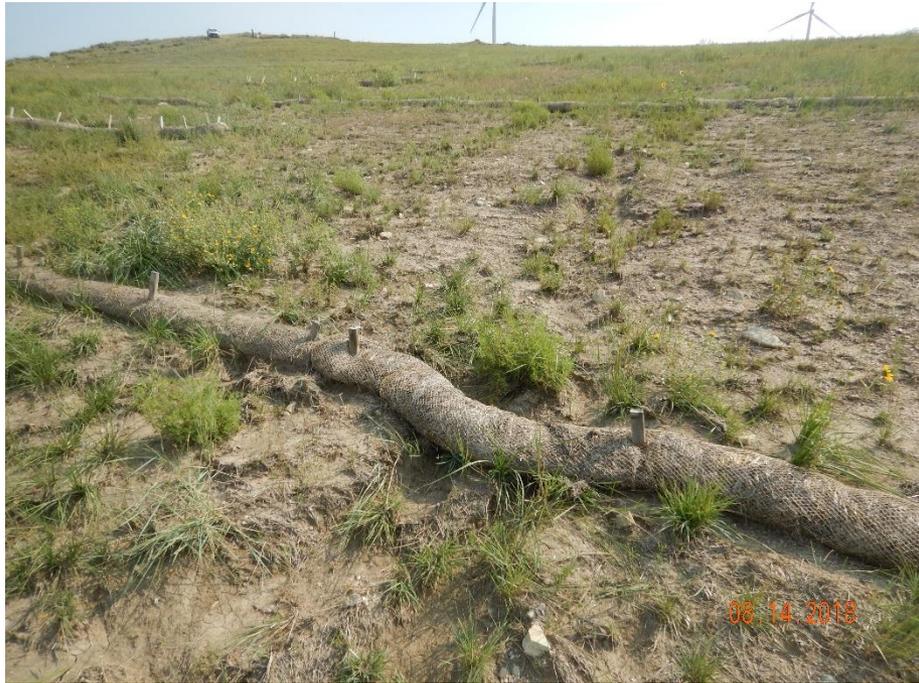
Photo 13: Photo taken from the southern end of the location, facing north. See comments under photo 13.

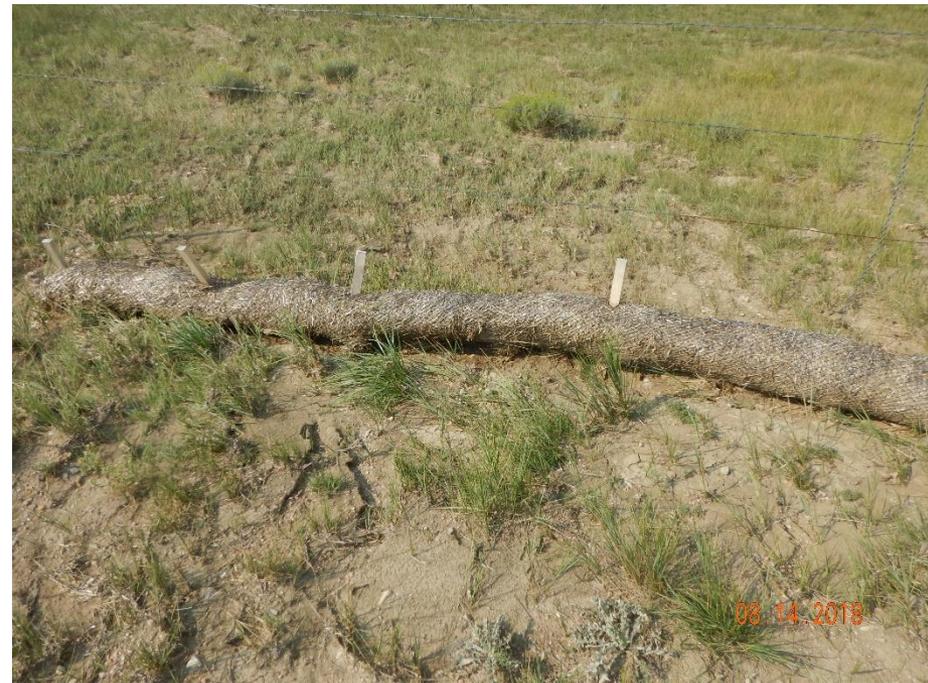
Photo 14: Photo taken from the south end of the location, facing south. See comments under photo 13.

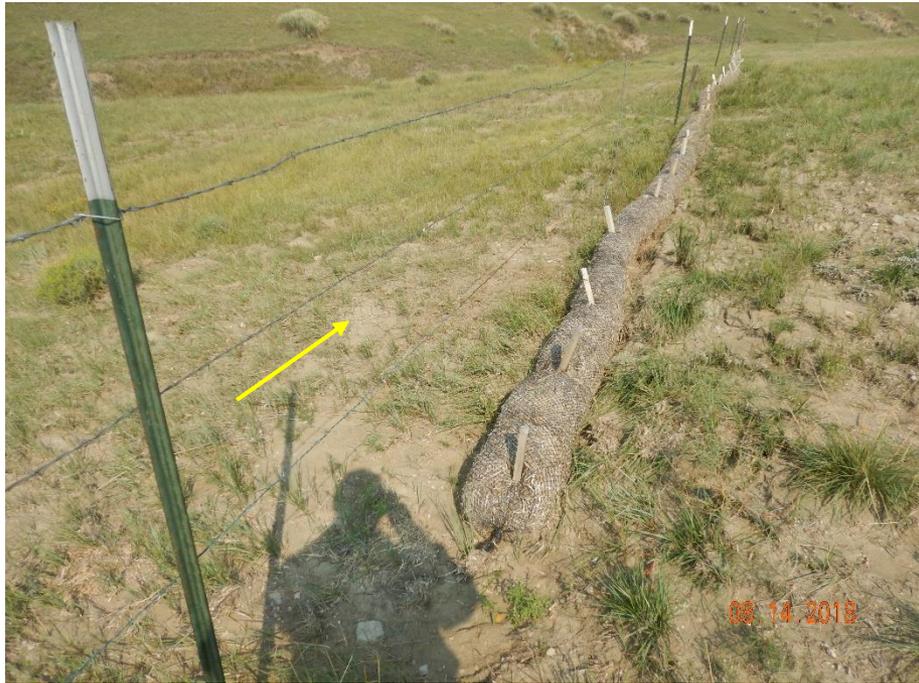
Photo 15: Continued from photo 14. Photo shows sediment from sediment laden stormwater discharge has continued to transport sediment off location..

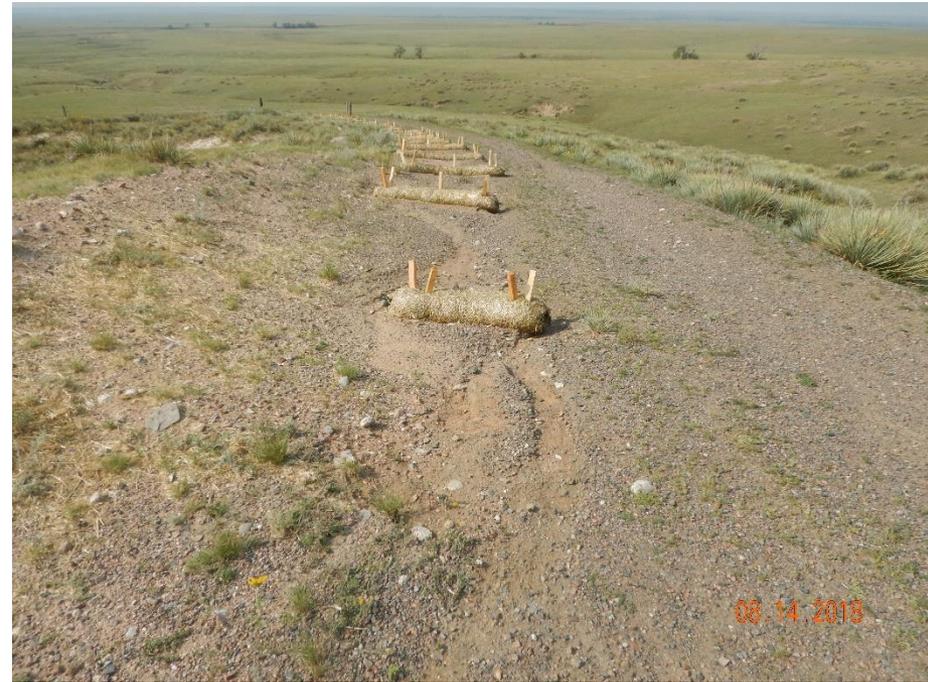
Photo 16: Photo taken from the access road gate, north of the location facing south. Photo shows additional controls have been installed along access road, however, stormwater erosion degradation does not appear to have been repaired, and controls do not appear to be sufficient to mitigate stormwater degradation. See photos 1-4 for additional stormwater concerns on/from access road.
