Inspection Photos
Location Name: Pinnacle Unit 10-30
API: 05-103-08459

COLORADO
Oil & Gas Conservation
Commission
Department of Natural Resources

Inspection Number: 689801591

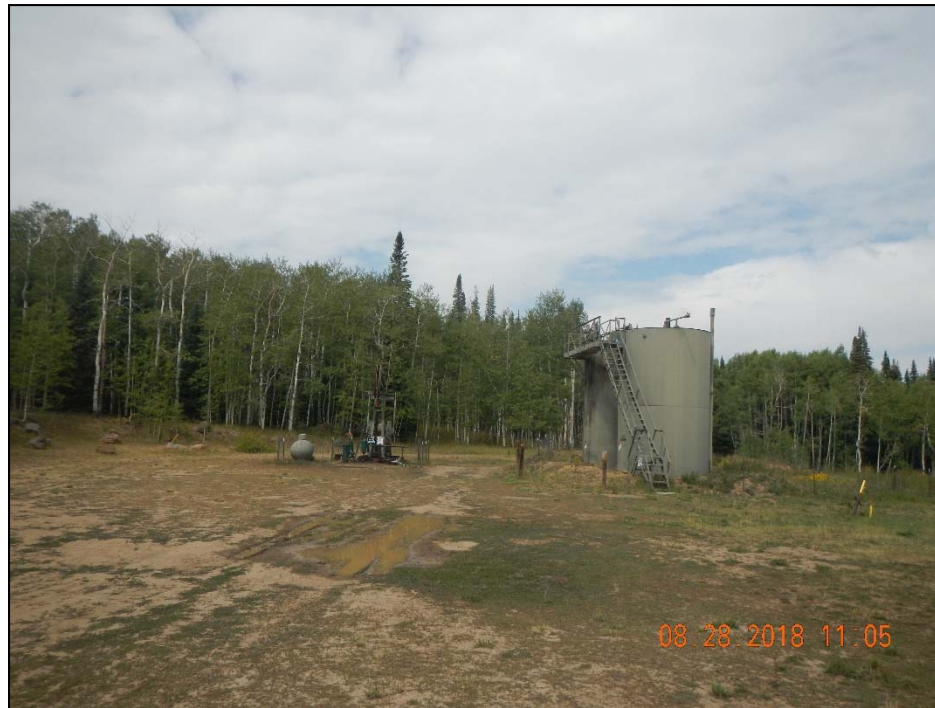
Photo 1. Overview of location taken at entrance facing southwest.

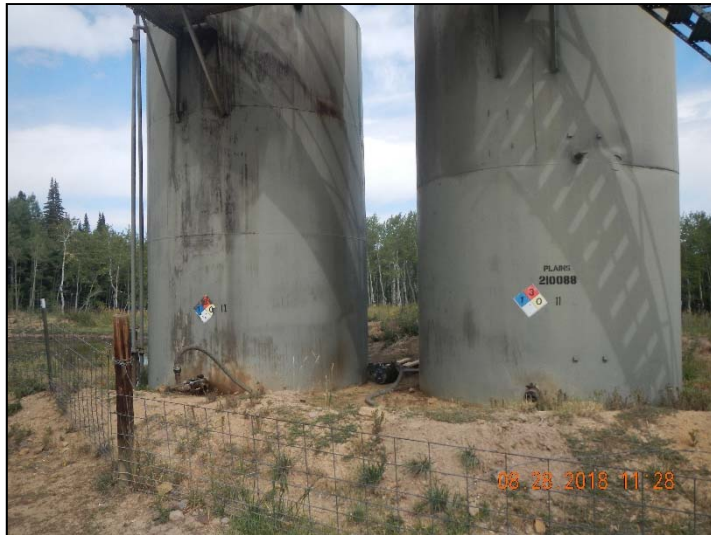
Photo 2. Incomplete tank labels.

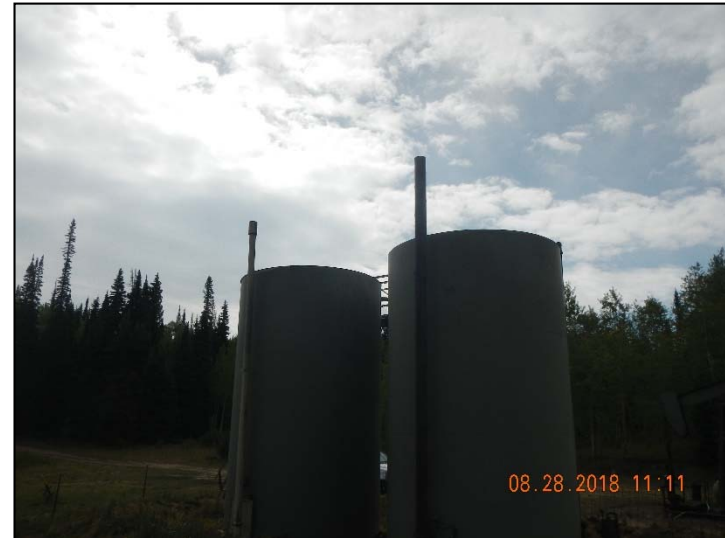
Photo 3. No wildlife protection apparent on exhaust on right hand tank.

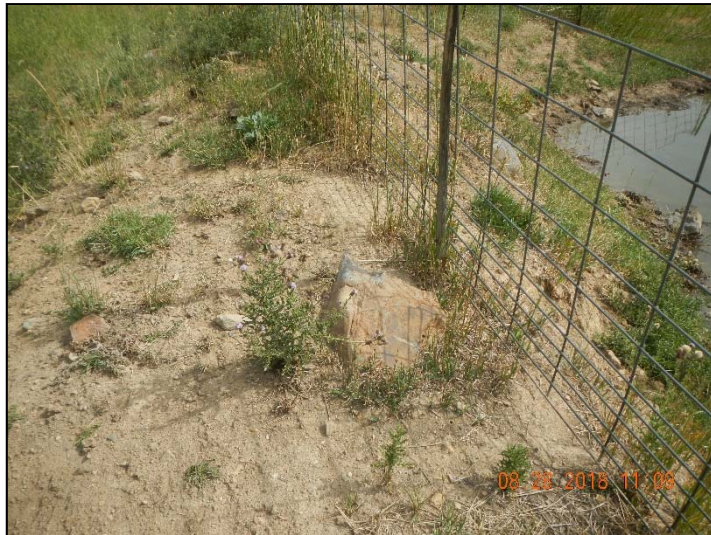
Photo 4. Example of blooming noxious weeds on location.

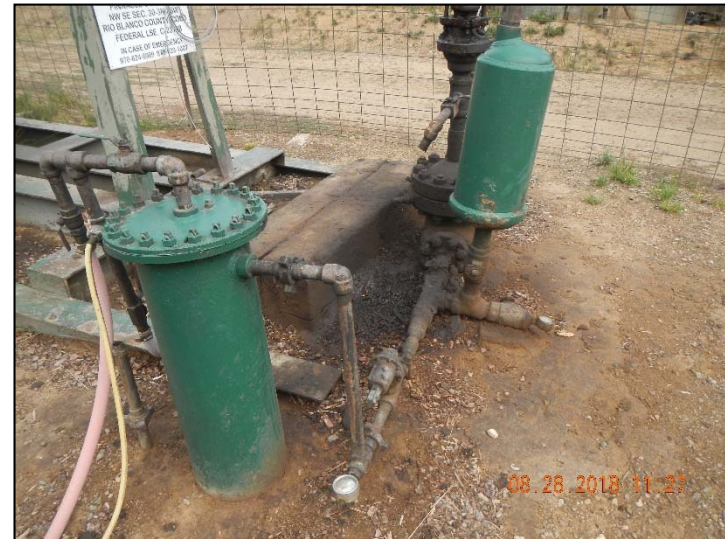
Photo 5. Stained soil at wellhead.

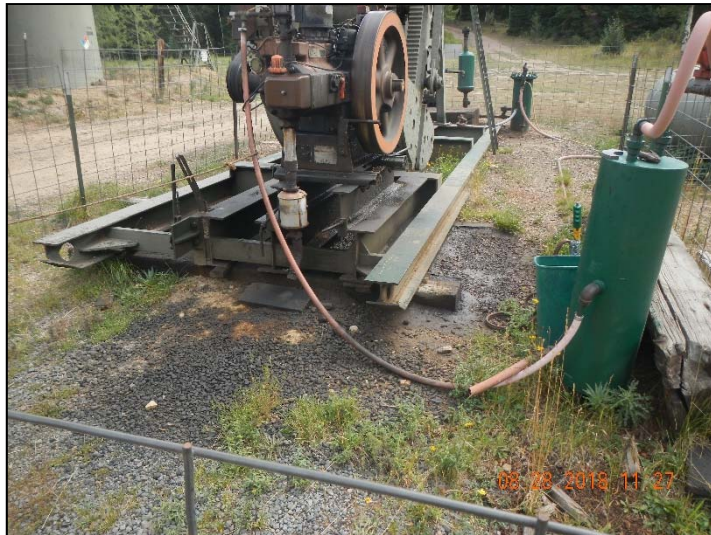
Photo 6. Stained soil at pump jack exhaust.

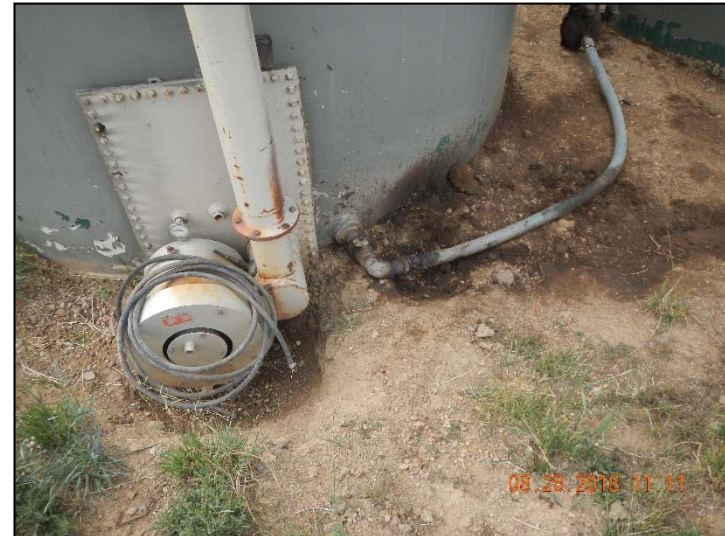
Photo 7. Stained soil at tank base.

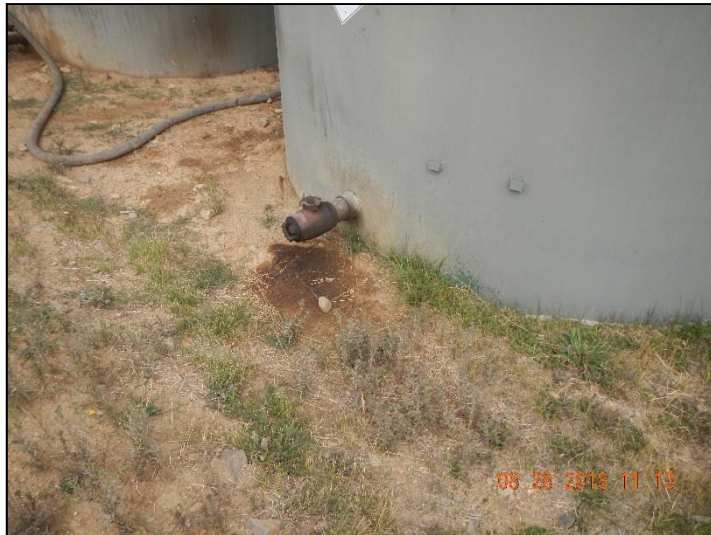
Photo 8. Stained soil at tank base.

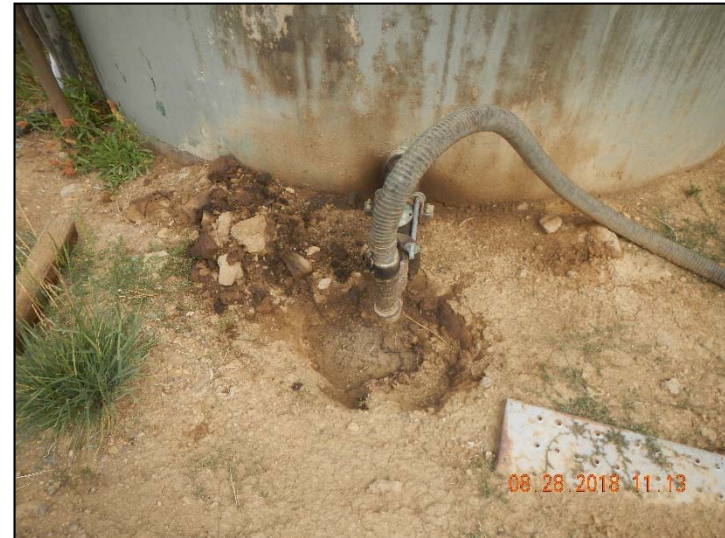
Photo 9. Stained soil at tank base.

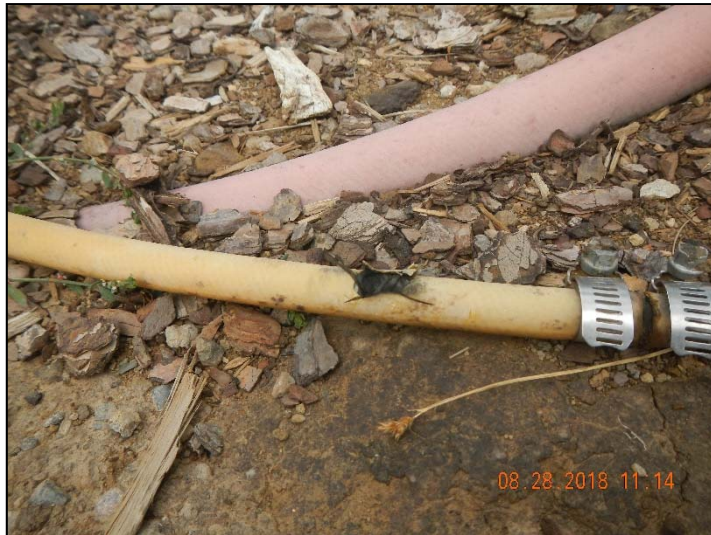
Photo 10. Photo of active leak location in line from wellhead separator.

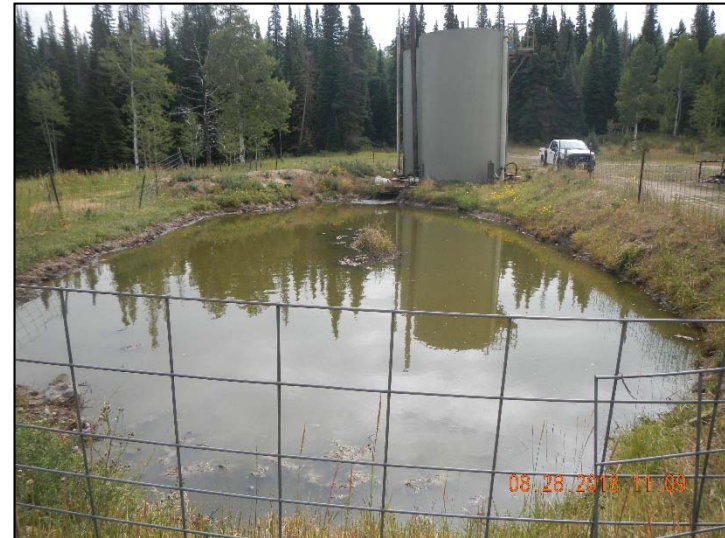
Photo 11. Pit. 2 feet of freeboard not present on left hand bank.

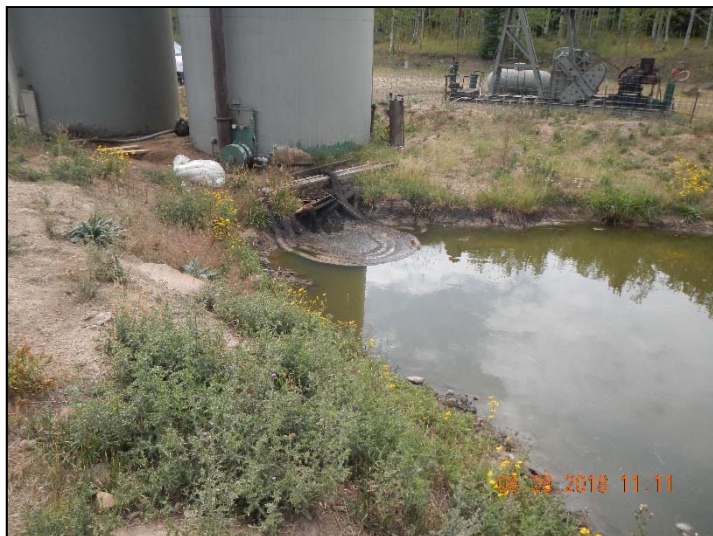
Photo 12. Oil in pit.

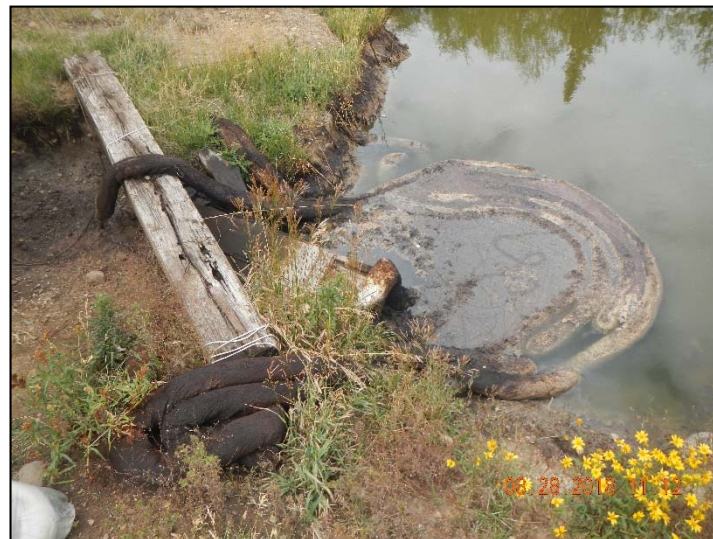
Photo 13. Oil and oil saturated absorbent pads and sheen in pit.
