Inspection Photos

08/29/2018

Operator: 8 NORTH LLC - 10575

Location ID: 456060

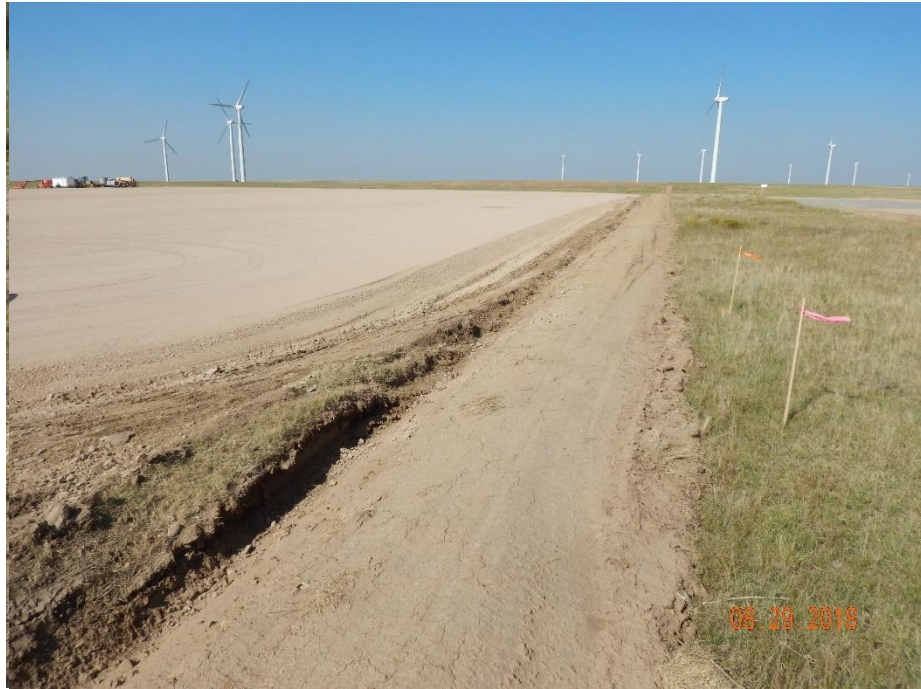
Photo 1: Photo taken from the north end of the location, facing west. Photos 1-5 provide an overview of the construction site from west, to southwest, to southeast, to east.

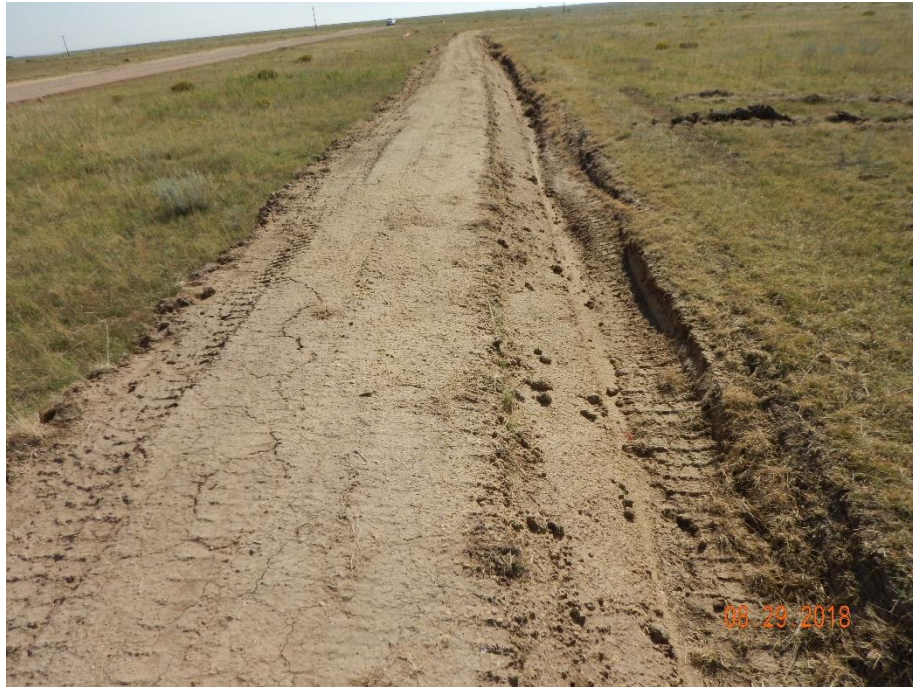
Photo 5: Photo taken from the north end of the location, facing east. Photo shows the stormwater control ditch and berm operator has installed along the perimeter of the location.

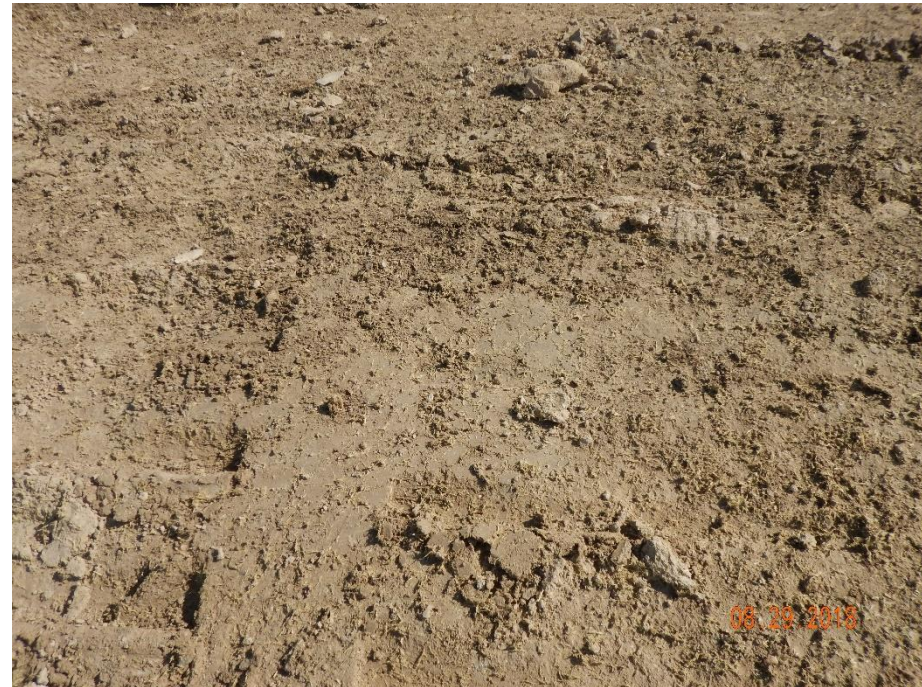
Photo 6: Continued from photo 5. Photo shows ditch/berm has been properly compacted. Additionally, operator has applied a Tackifier for additional soil stabilization.

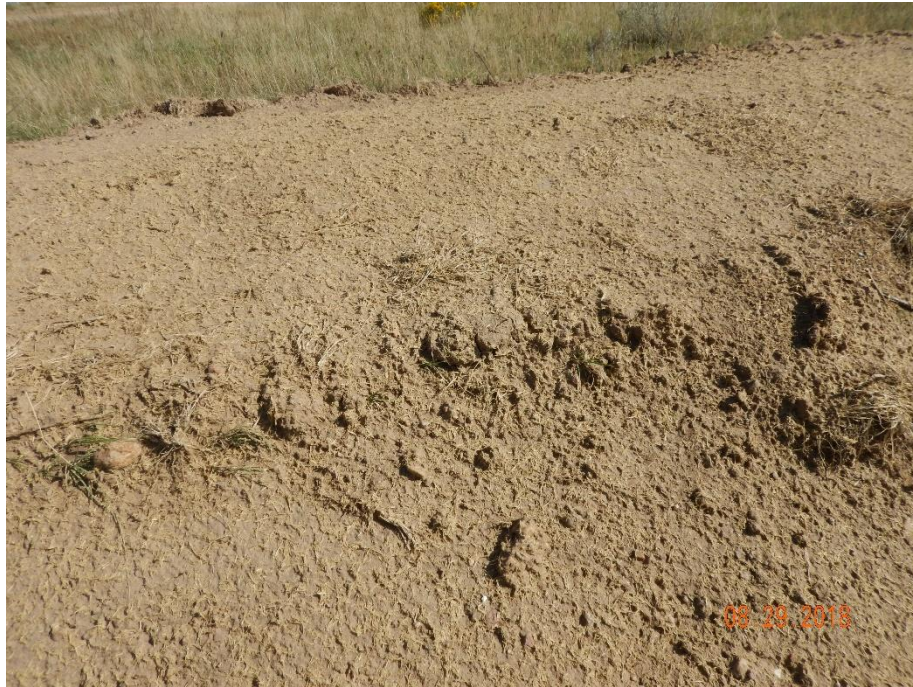
Photo 7: See comments under photo 6.

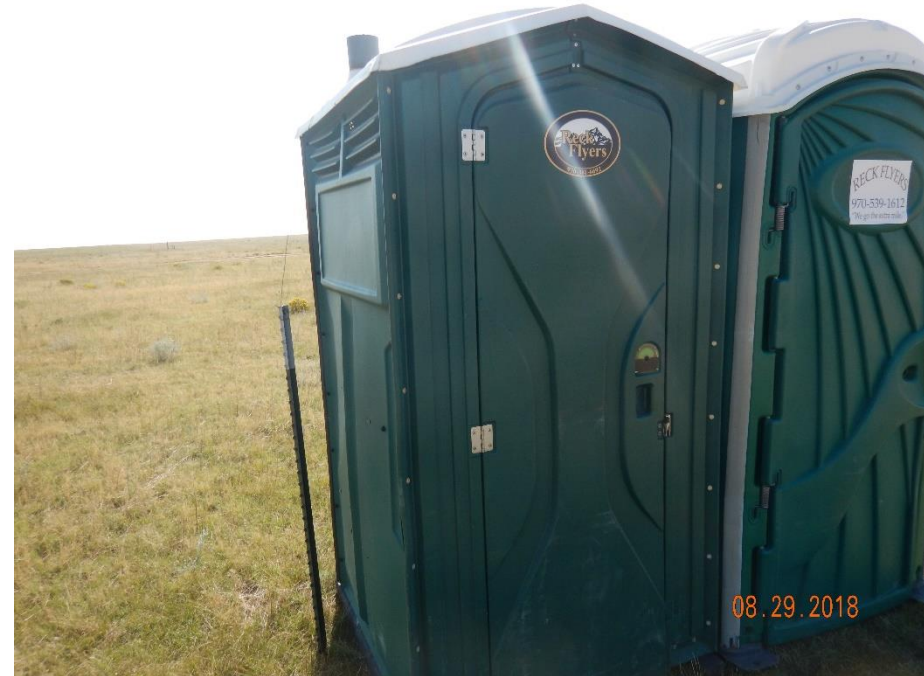
Photo 8: Photo taken from the east end of the pad, facing east. Photo shows two porta-johns that have been secured down.

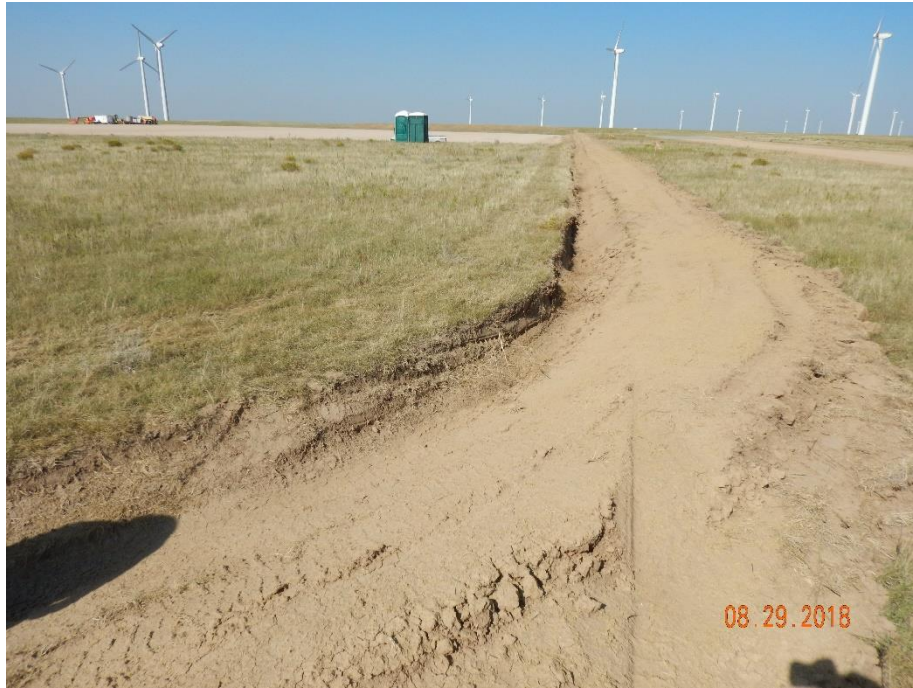
Photo 9: Photo taken from northeast end of the location, facing west. Photo shows the stormwater ditch along the perimeter of the location.

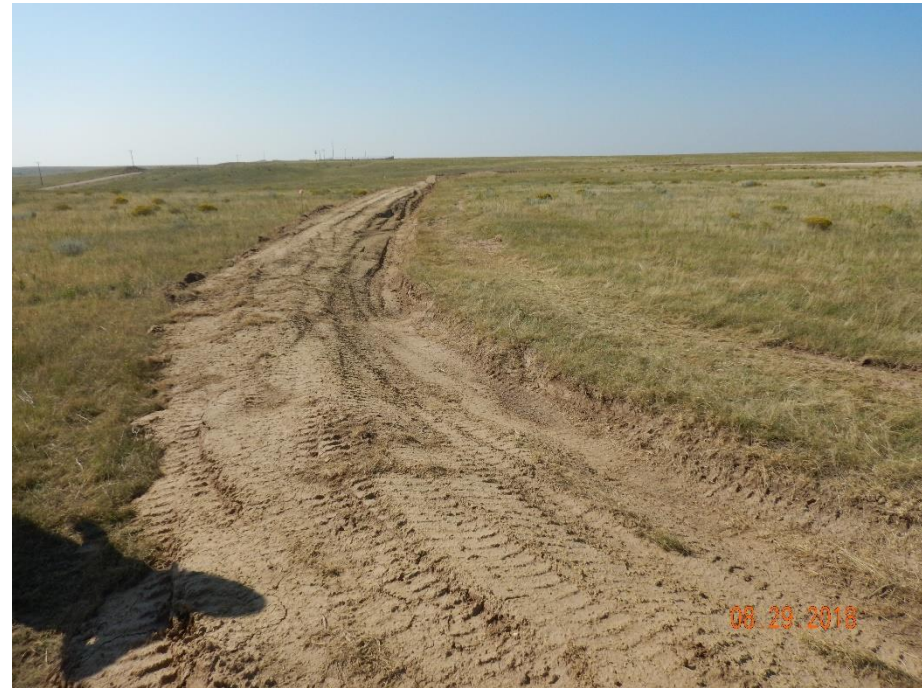
Photo 10: Photo taken from northeast end of the location, facing south. Photo shows the stormwater ditch along the perimeter of the location.

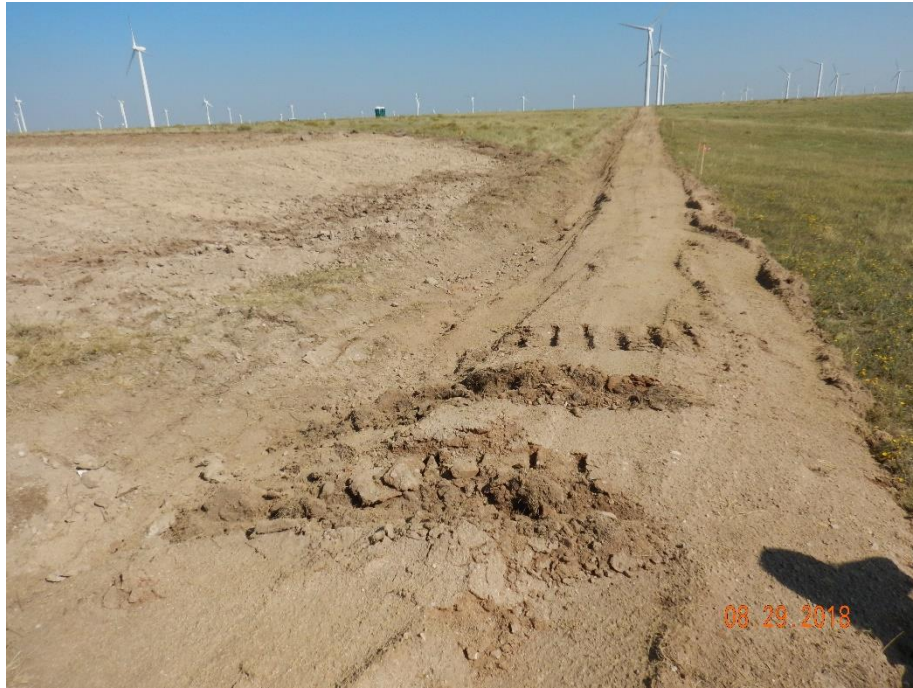
Photo 11: Photo taken from southeast end of the location, facing north. Photo shows the stormwater ditch along the perimeter of the location. Photo also shows that ditch/berm appear to have been traveled over compromising the integrity of the BMP. Advise maintenance. It is also noted that this area of the ditch appears to be the lowest point of the location. The perimeter control does not appear to have an outlet-area to allow for sediment laden-free stormwater discharge from the location.

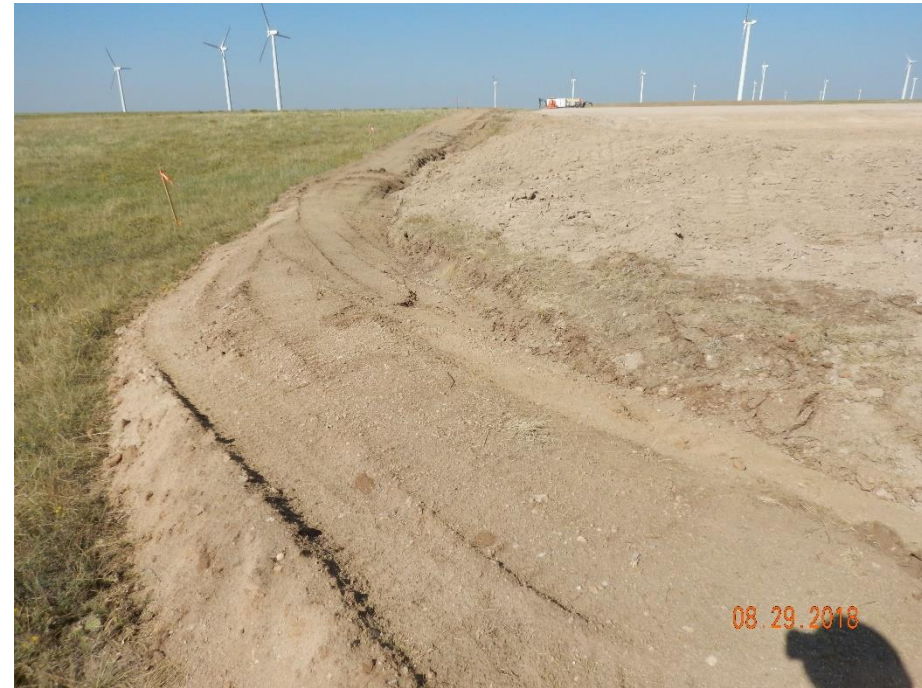
Photo 12: Photo taken from southeast end of the location, facing west. Photo shows the stormwater ditch along the perimeter of the location.

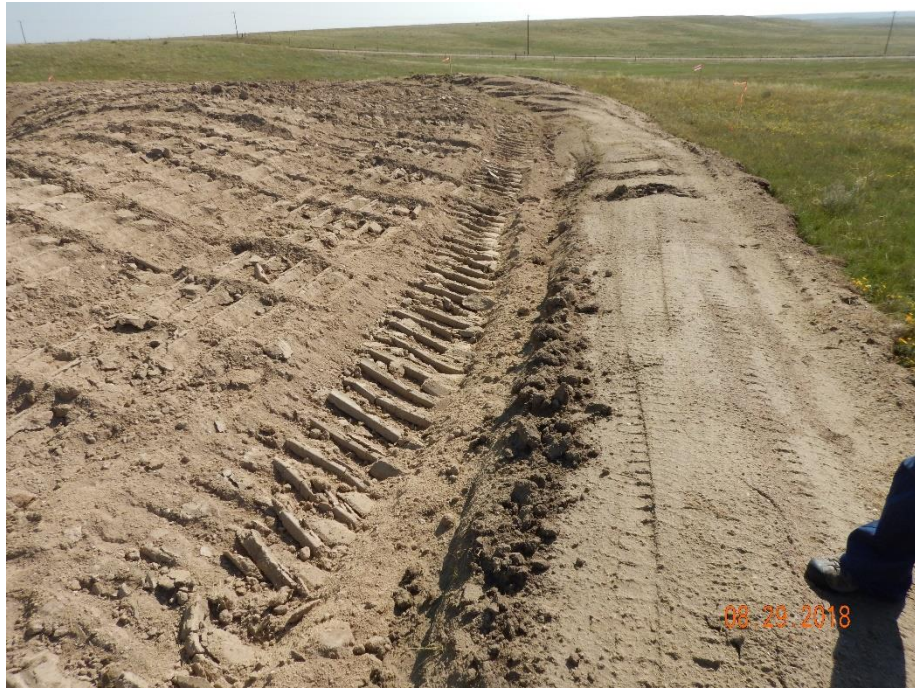
Photo 13: Photo taken from the southeast end of the location, facing east. Photo shows a portion of the sediment pond/trap on the southeast corner of the pad. BMP does appear to have been installed in conjunction with the perimeter ditch as a secondary control, however, it is noted that pond does not appear to have sufficient inlet protection, or a protected outlet to allow for sediment laden-free stormwater discharge from the location in accordance with good engineering practices.

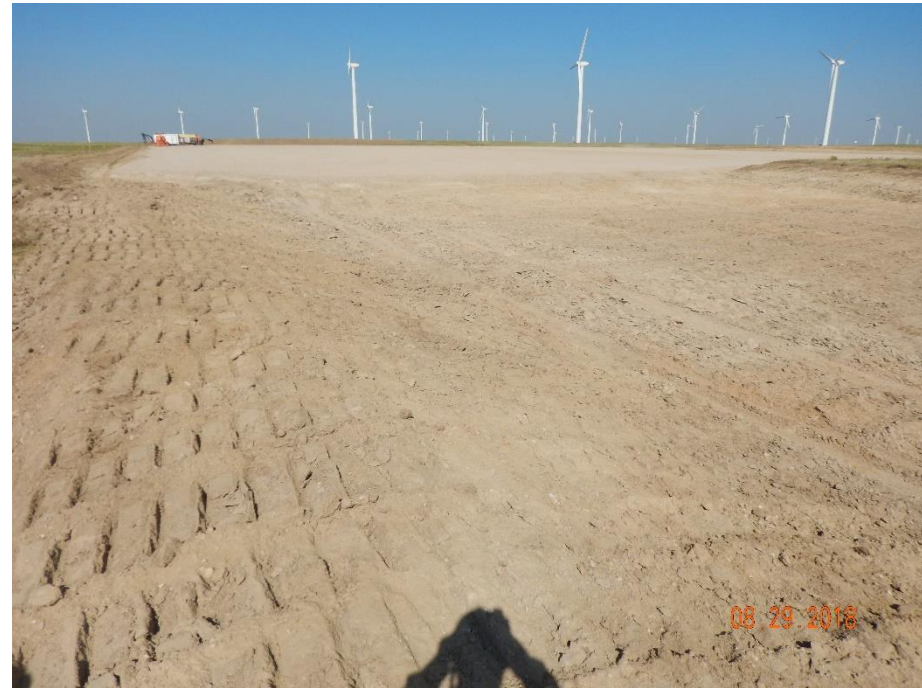
Photo 14: Photo taken from the southeast end of the location, facing west. Photo of the sediment pond/trap. See comments under photo 13.

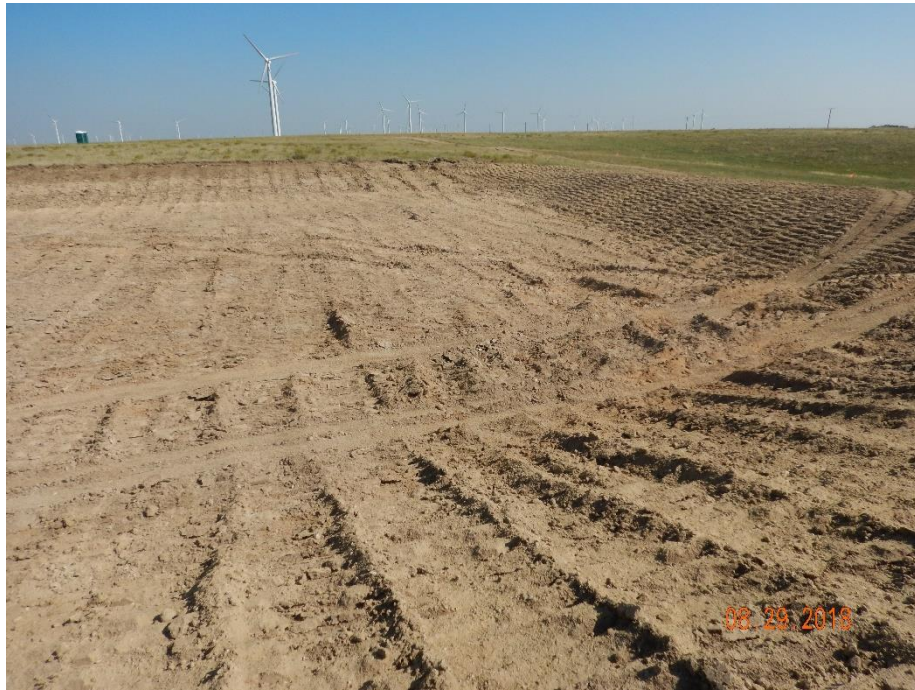
Photo 15: Photo taken from the southeast end of the location, facing west. Photo of the sediment pond/trap. See comments under photo 13.

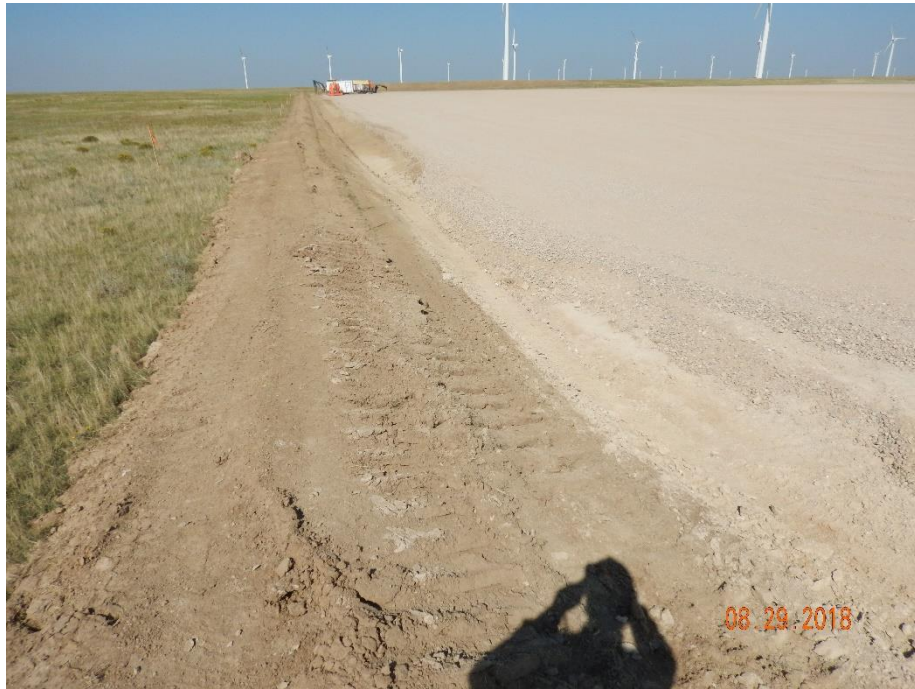
Photo 17: Photo taken from the southeast corner of the pad, facing east. Photo shows perimeter stormwater control ditch along the perimeter of the pad. Ditch appears to have been properly constructed and compacted. Operator also implemented a Tackifier on ditch/berm for additional stabilization.

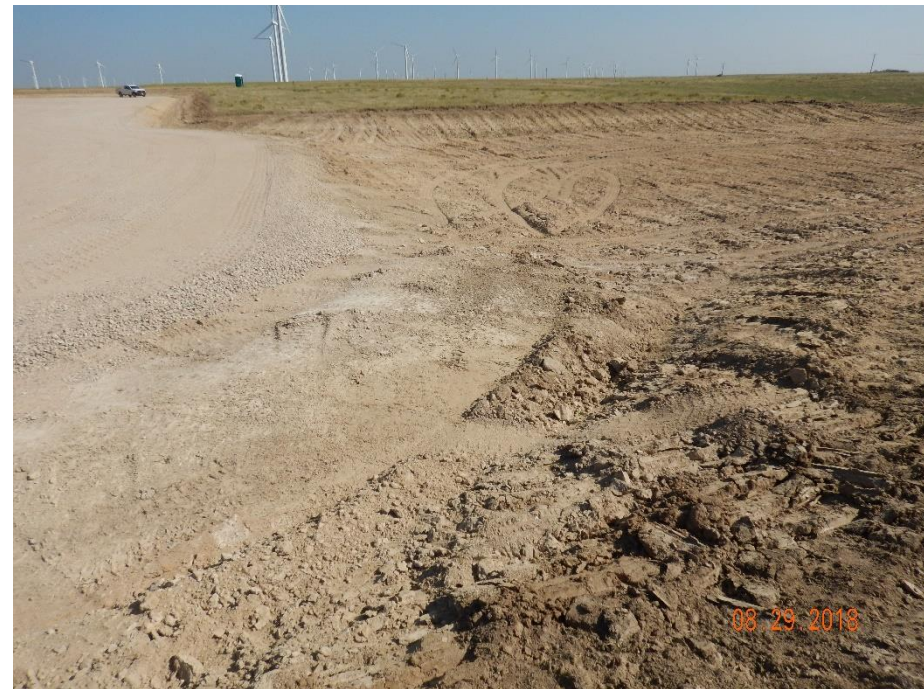
Photo 18: Photo taken from southwest corner of the sediment trap/pond. Photo shows BMP does not appear to have inlet protection in accordance with good engineering practices. See comments under photo 13.

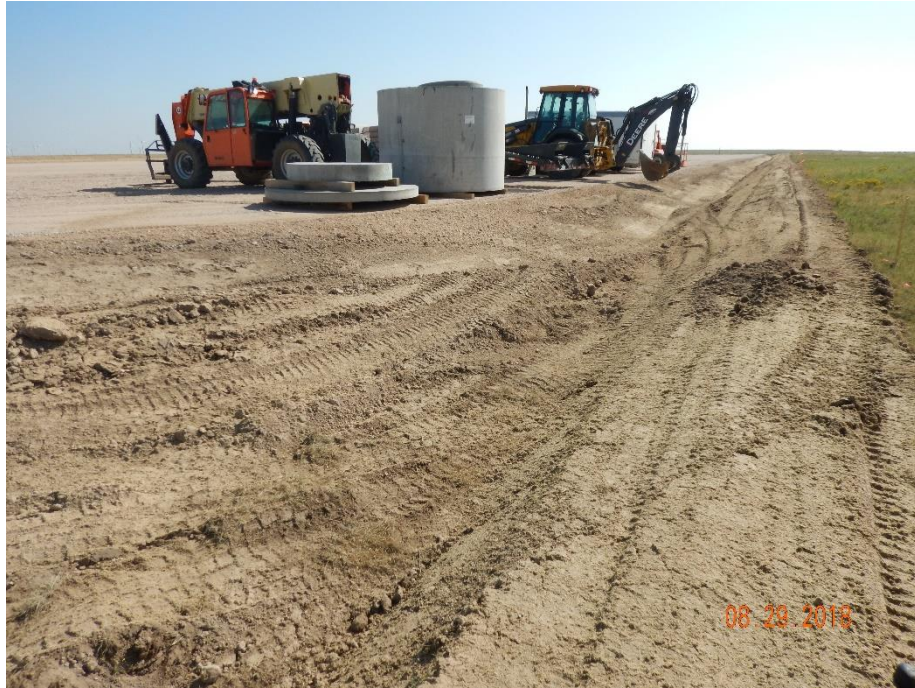
Photo 19: Photo taken from the southwest corner of the pad, facing east. Photo shows the stormwater ditch along the perimeter of the pad/location.

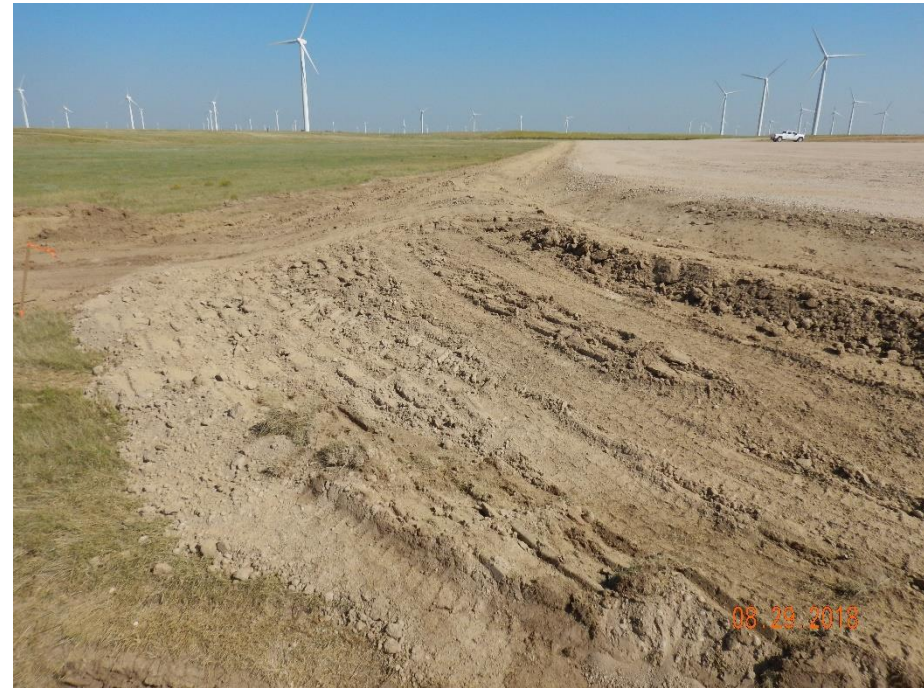
Photo 20: Photo taken from the southwest corner of the pad, facing north. Photo shows the stormwater ditch along the western perimeter of the pad

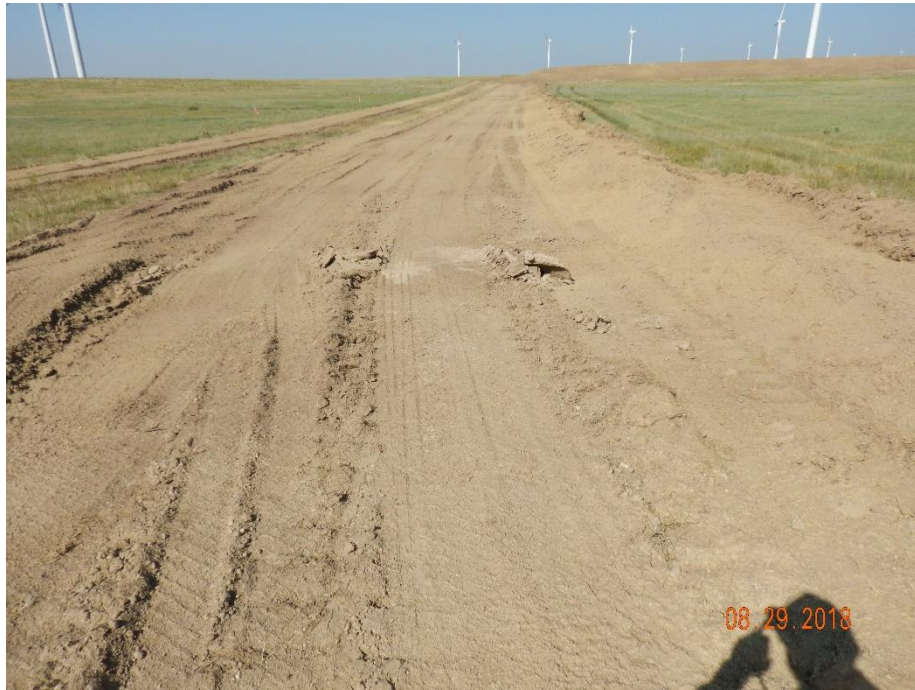
Photo 21: Photo taken from the southwest end of the pad, facing west. Photo shows area where equipment traveled from the pad to the topsoil pile on the west end of the location. Operator appears to have applied a tackifier to these areas for soil stabilization.

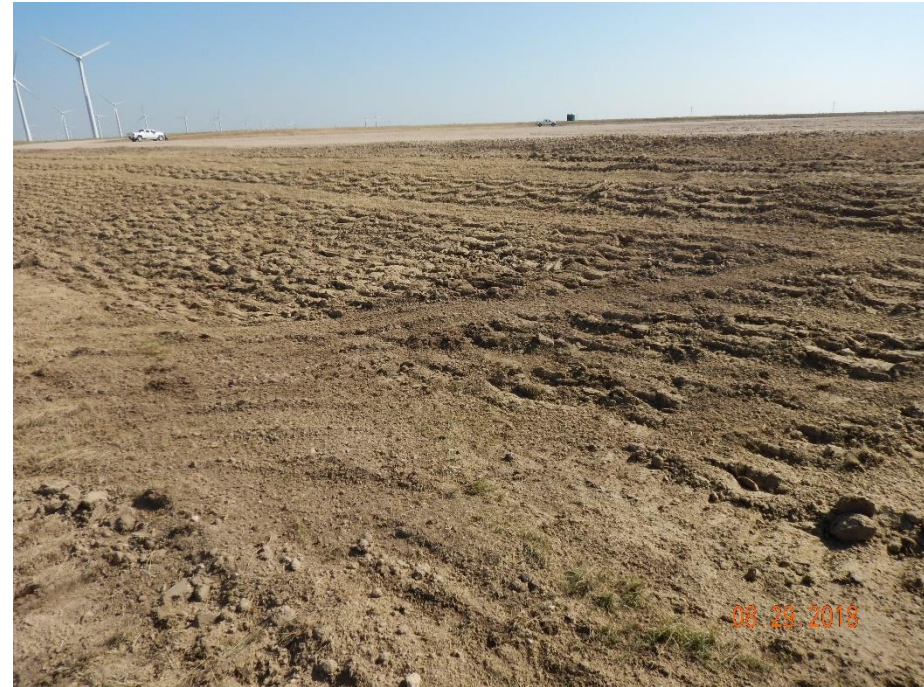
Photo 22: Photo taken from the west end of the pad, facing northeast. Photo shows slopes have been tracked and a tackifier applied for stabilization.

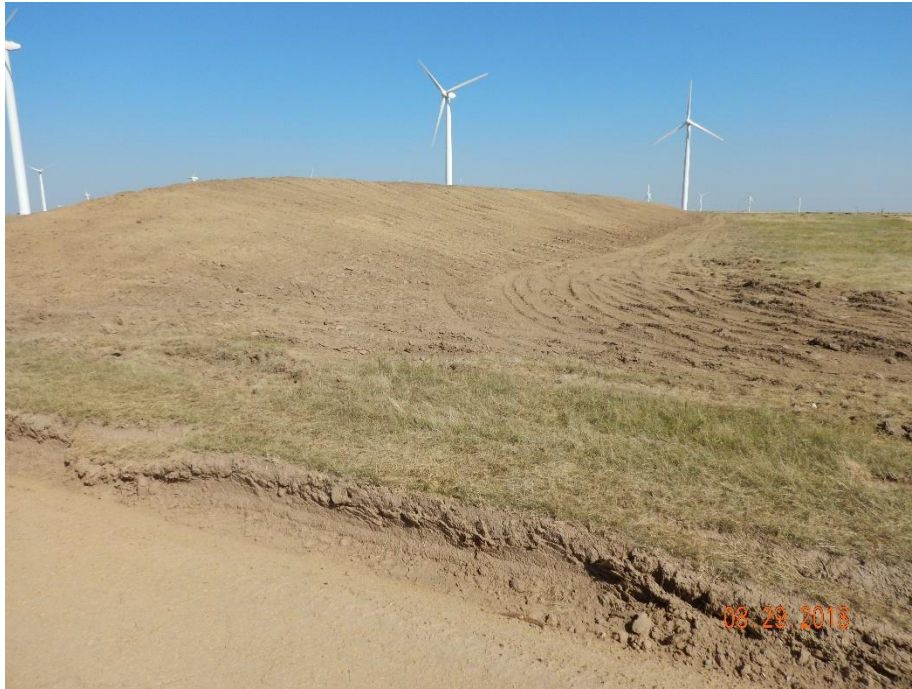
Photo 23: Photo taken from the southwest end of the location. Photo shows topsoil stockpile.

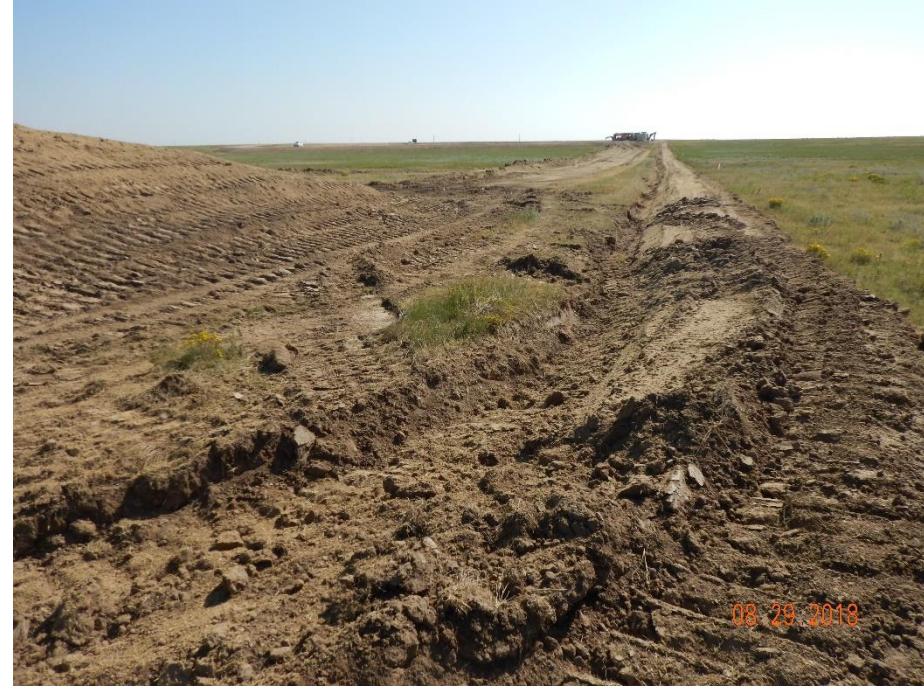
Photo 24: Photo taken from the southwest corner of the location, facing east. Photo shows the stormwater ditch along the perimeter of the location.

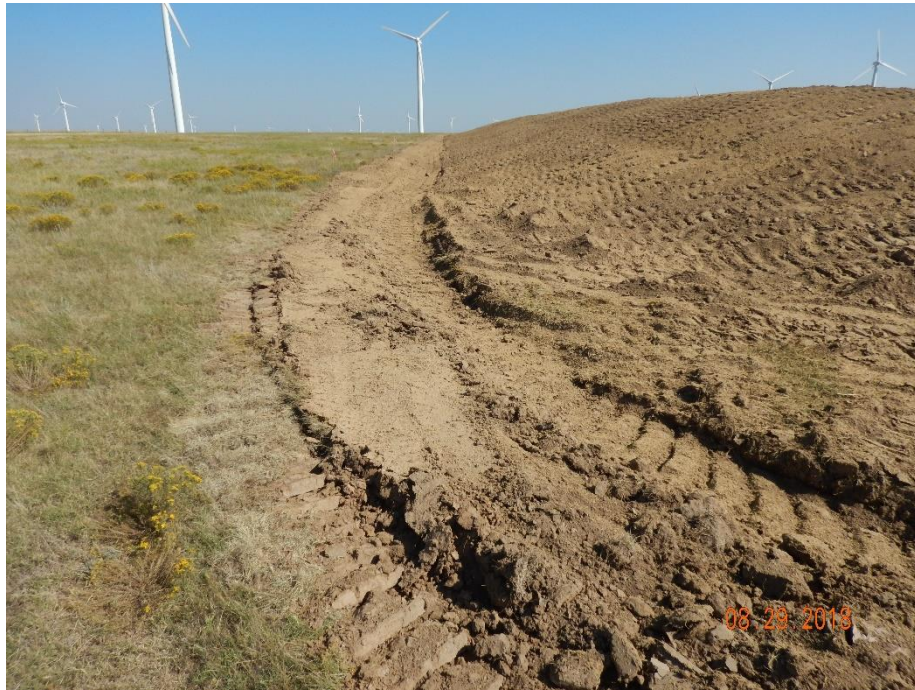
Photo 25: Photo taken from the southwest corner of the location, facing north. Photo shows the stormwater ditch along the perimeter of the location.

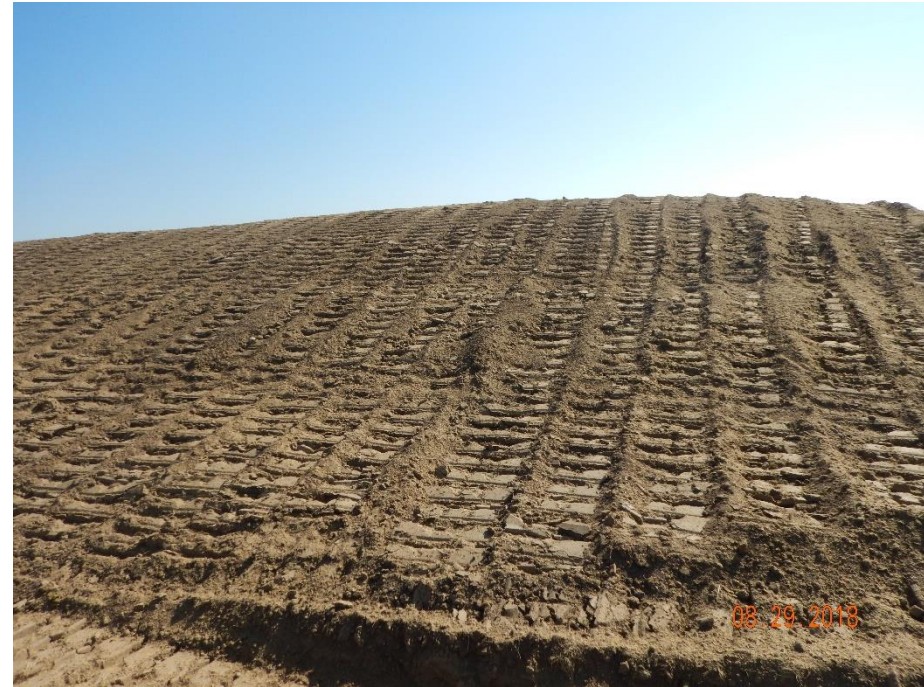
Photo 26: Photo taken from the west end of the location, facing northeast. Photo shows slopes of the topsoil stockpile have been tracked and a tackifier applied for stabilization.

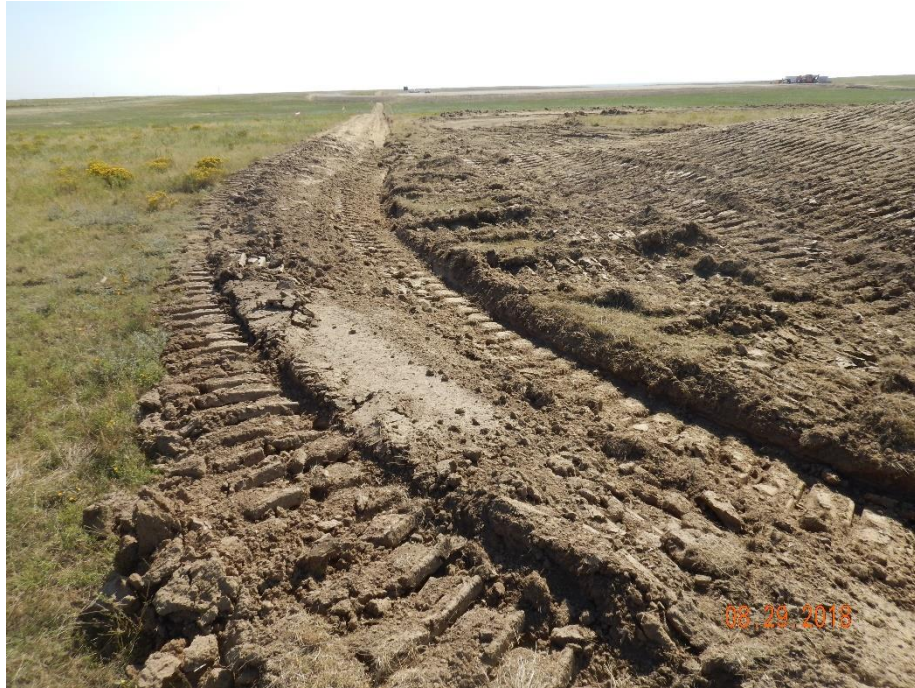
Photo 26: Photo taken from the northwest corner of the locaiton, facing east. Photo shows the stormwater ditch along the perimeter of the location.

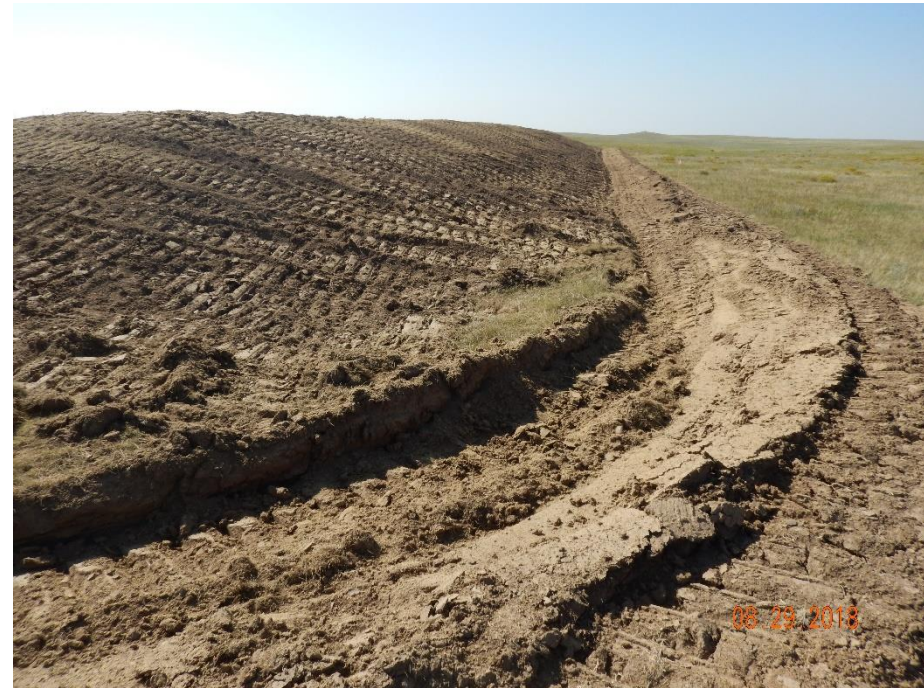
Photo 27: Photo taken from the northwest corner of the locaiton, facing south. Photo shows the stormwater ditch along the perimeter of the location.

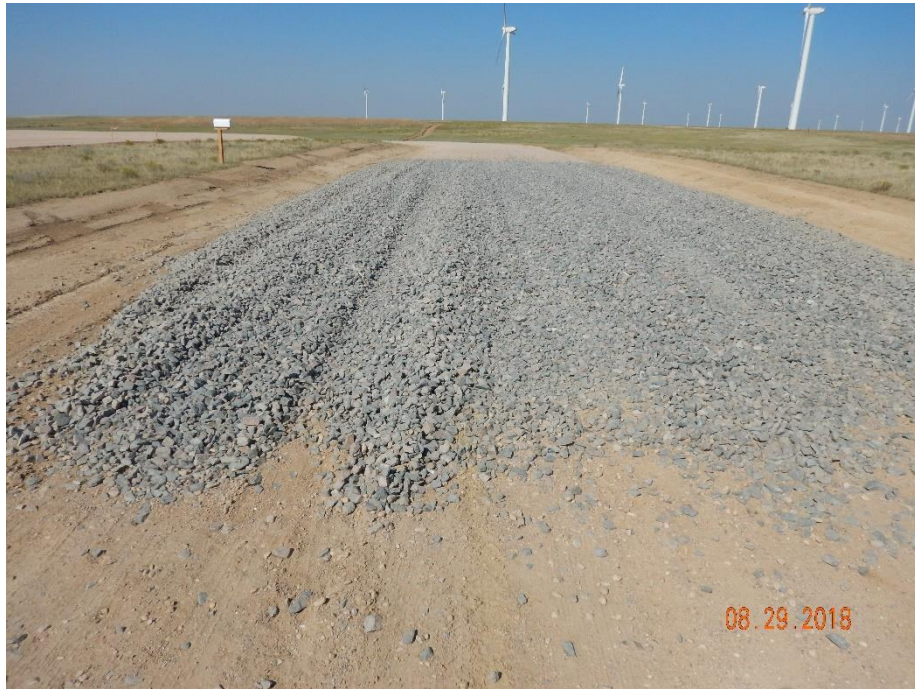
Photo 27: Photo taken from the access road, facing west. Photo shows tracking pad.

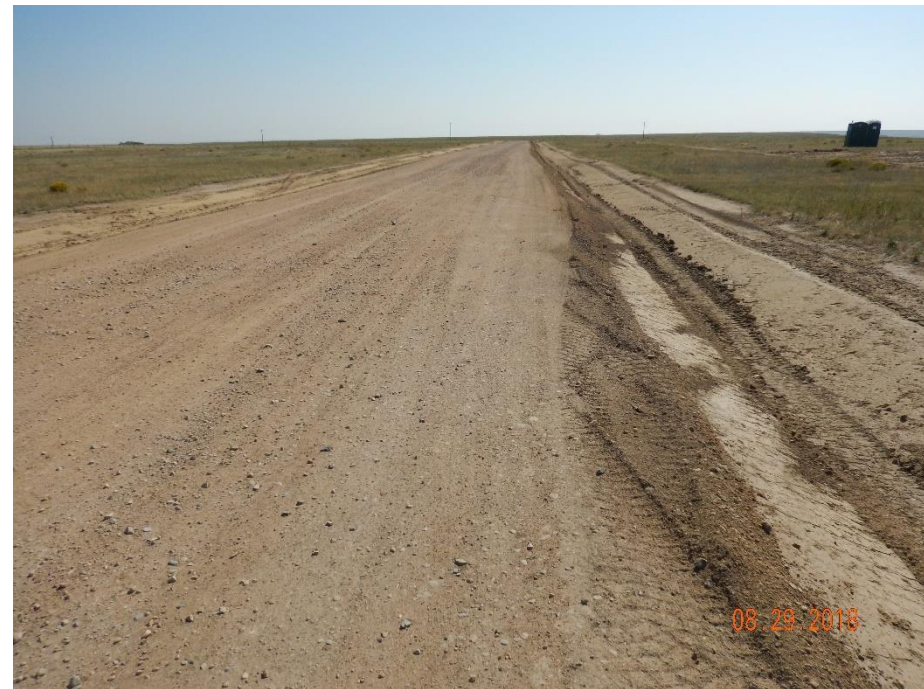
Photo 28: Photo taken from the access road, facing west. Photo shows ditches along access road.
