Inspection Photos 08/30/18
Location: KP Kauffman Fac 4A Header
Spill ID# 456892

Document Number: 401743992
Date Received: 08/24/2018
Spill report taken by: CANFIELD, CHRIS
Spill/Release Point ID: 456892

SPILL/RELEASE REPORT (INITIAL /w SUPPLEMENTAL)
This form is to be submitted by the party responsible for the oil and gas spill or release. Refer to COGCC Rule 906.b. for reporting requirements of spills or releases of ESP fluids or produced fluids. Submit a Site Investigation and Remediation Worksheet (Form 27) when requested by the Director.

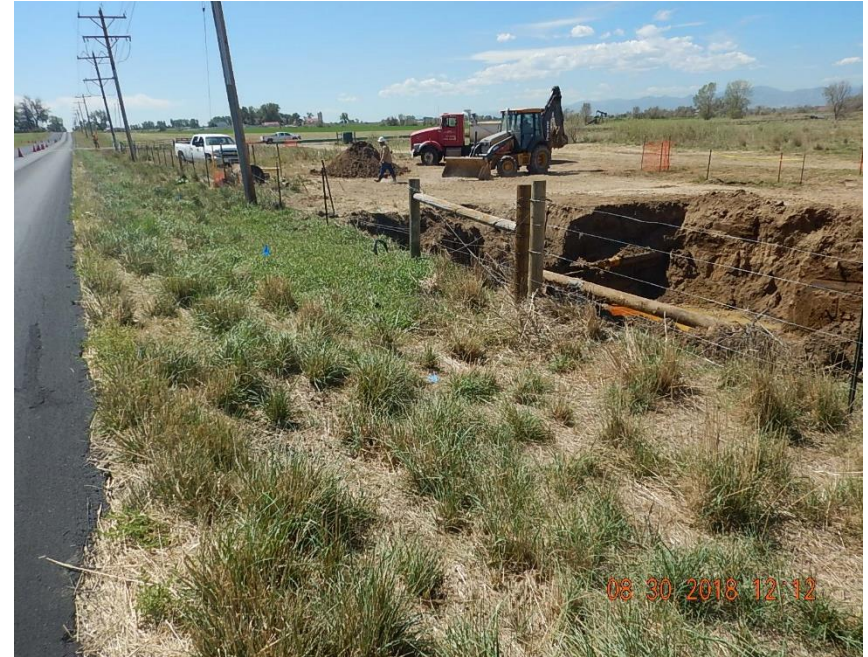
Copy of form 19 spill report filed by KPK

View of excavation/ remediation area from WCR 7 looking south.

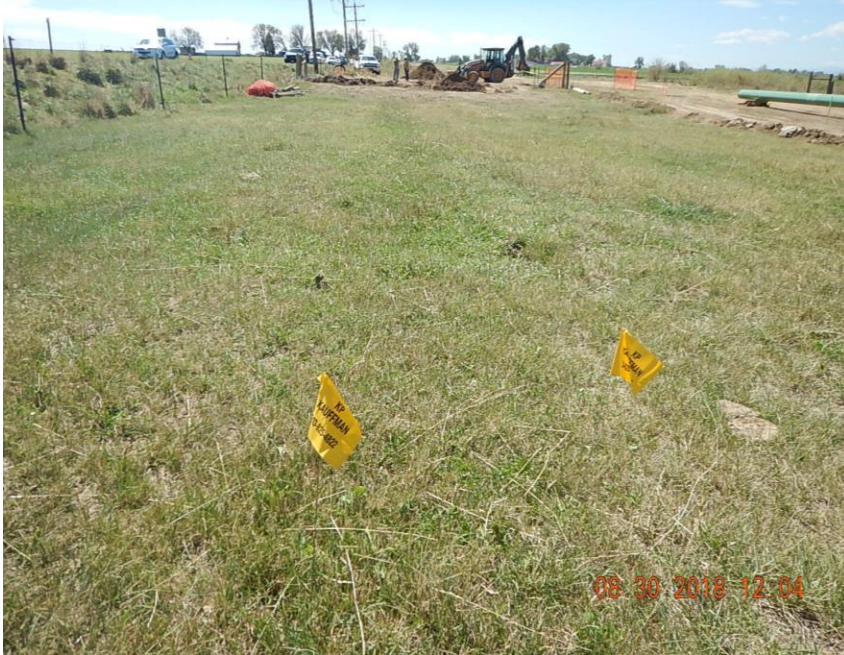
View of excavation area and line locates (pin flags) marking the KPK flowlines routed N-S to the area of release. View to South.

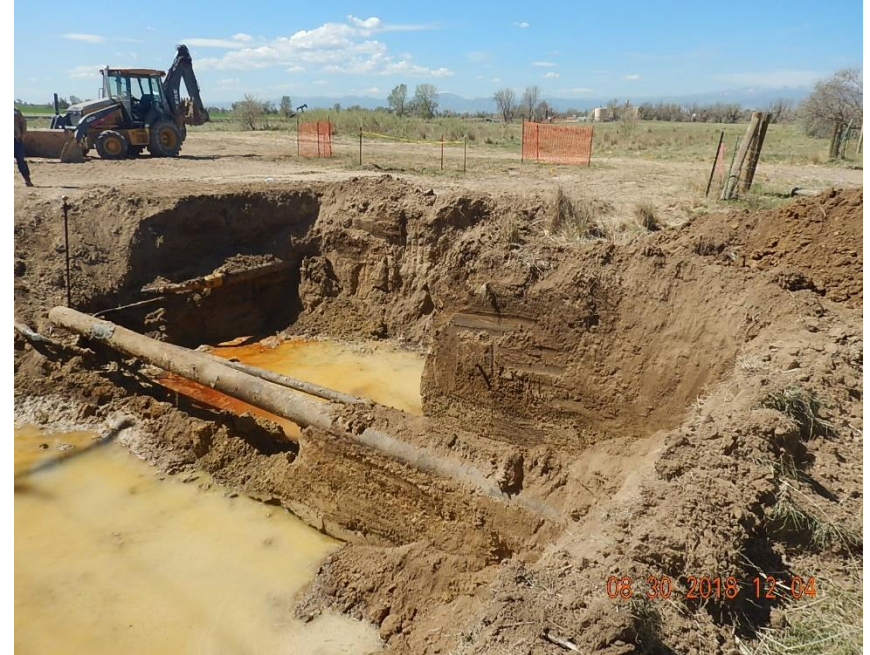
View into excavation showing flowlines exposed; Oil sheen apparent on standing groundwater in the excavation.

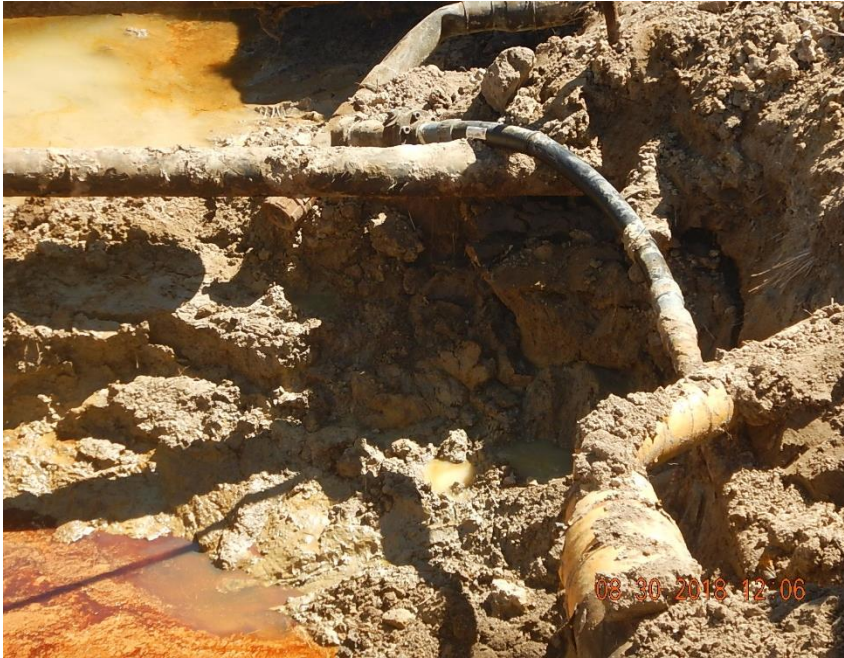
Close up view of flowlines exposed in excavation; The release appears to be a result of the kink observed on the 3" poly flowline although more than one integrity issue may exist.

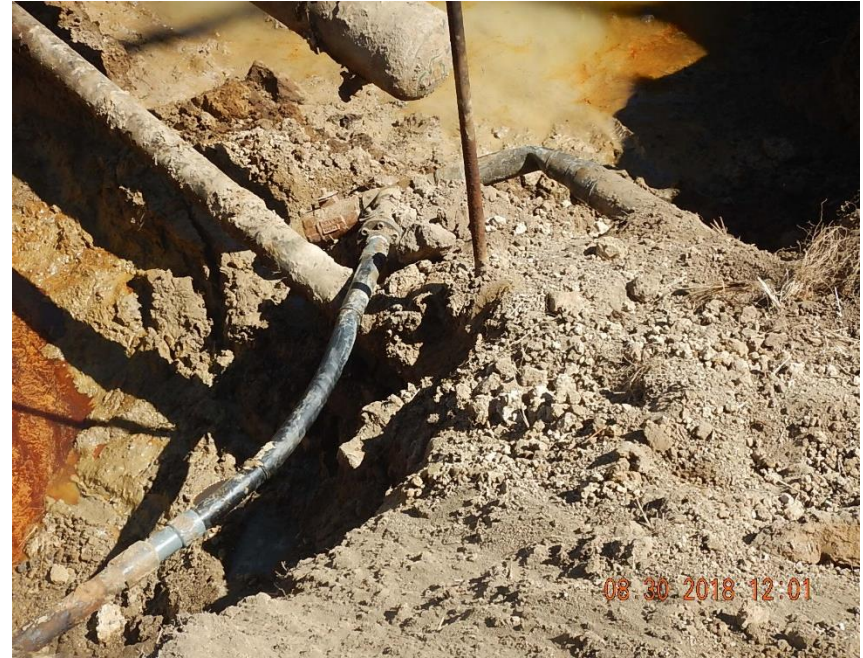
Closer view of the kink at the 2" to 4" transition of the off location poly flowline.
