Inspection Photos
Location Name: Entrada 1-28
API: 05-057-06116

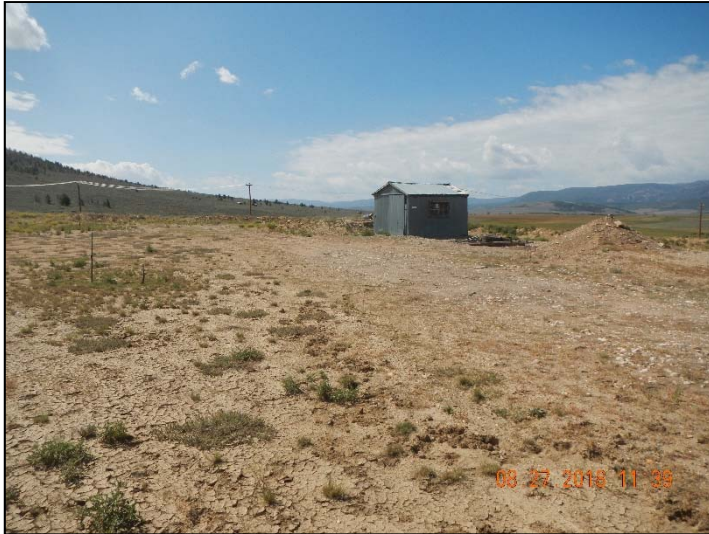
Photo 1. Overview of location taken at entrance facing southwest.

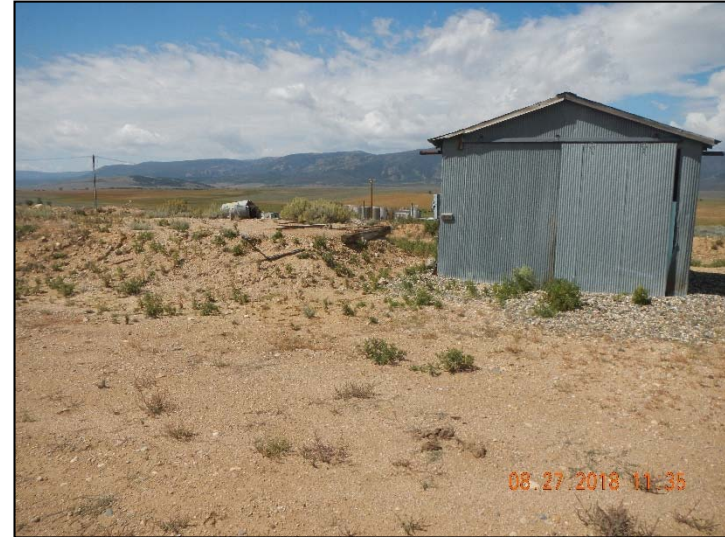
Photo 2. Noxious and annual weeds outside wellhead housing; rods, wood and other debris to the left.
