Inspection Photos

Operator: BP America

API: 05-067-07859

Date: 8/16/2018

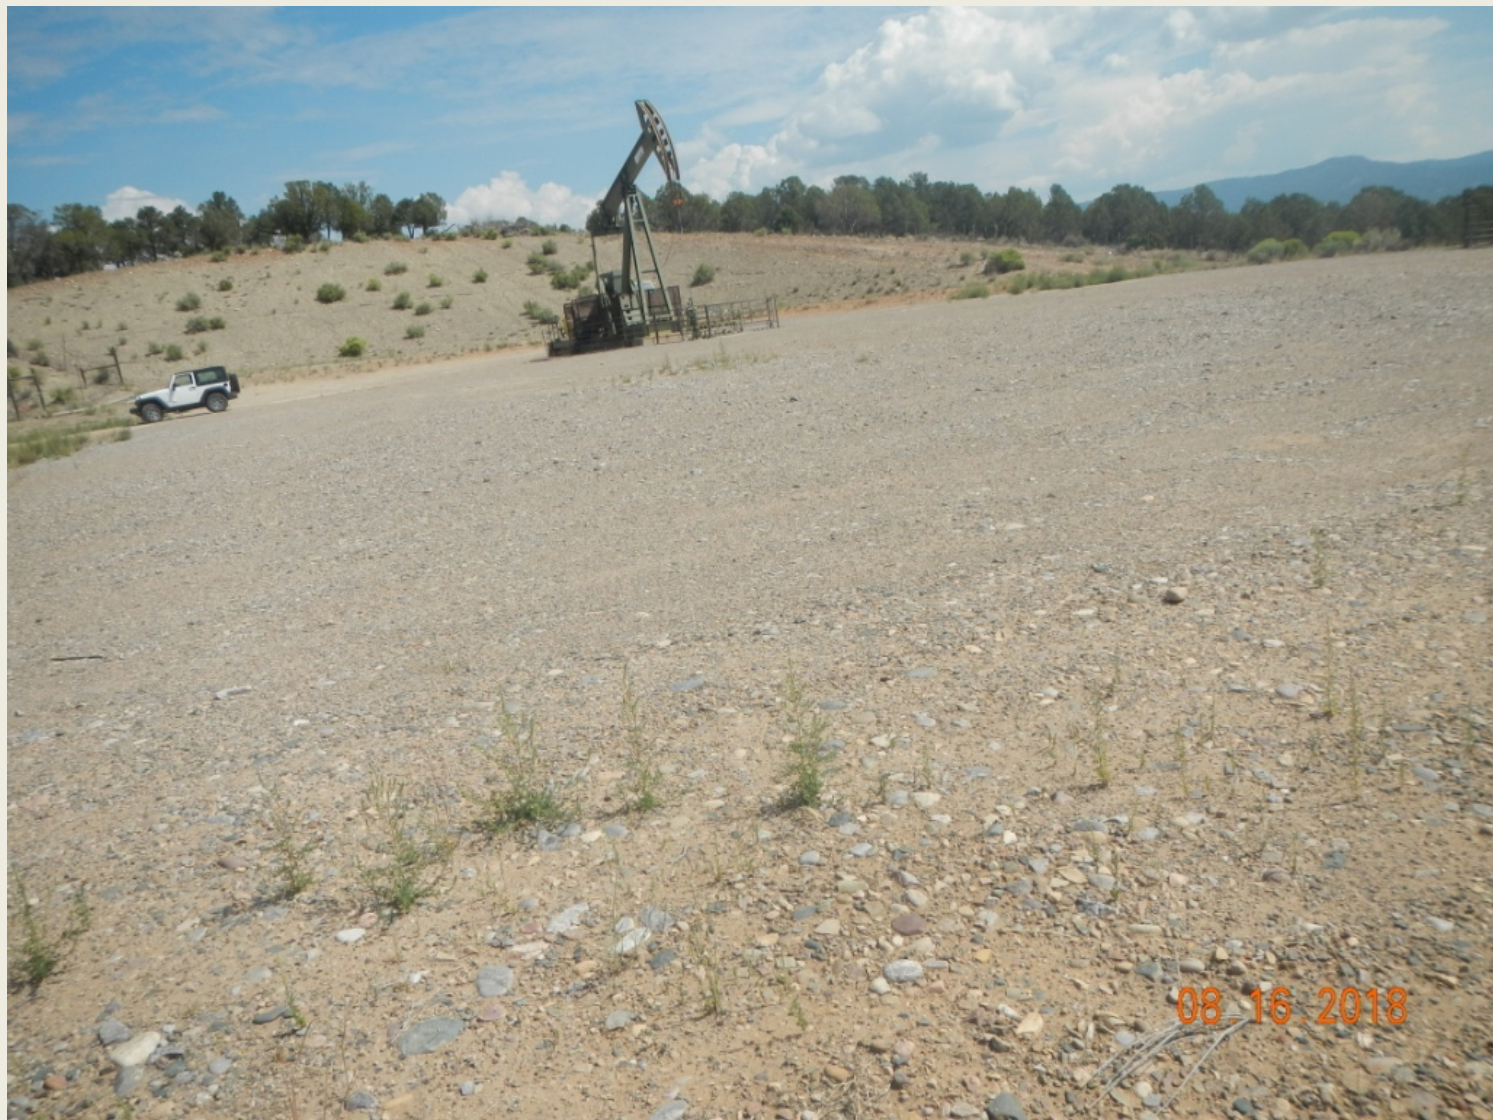
Photo 1. View of the project area from the southwestern corner facing center.

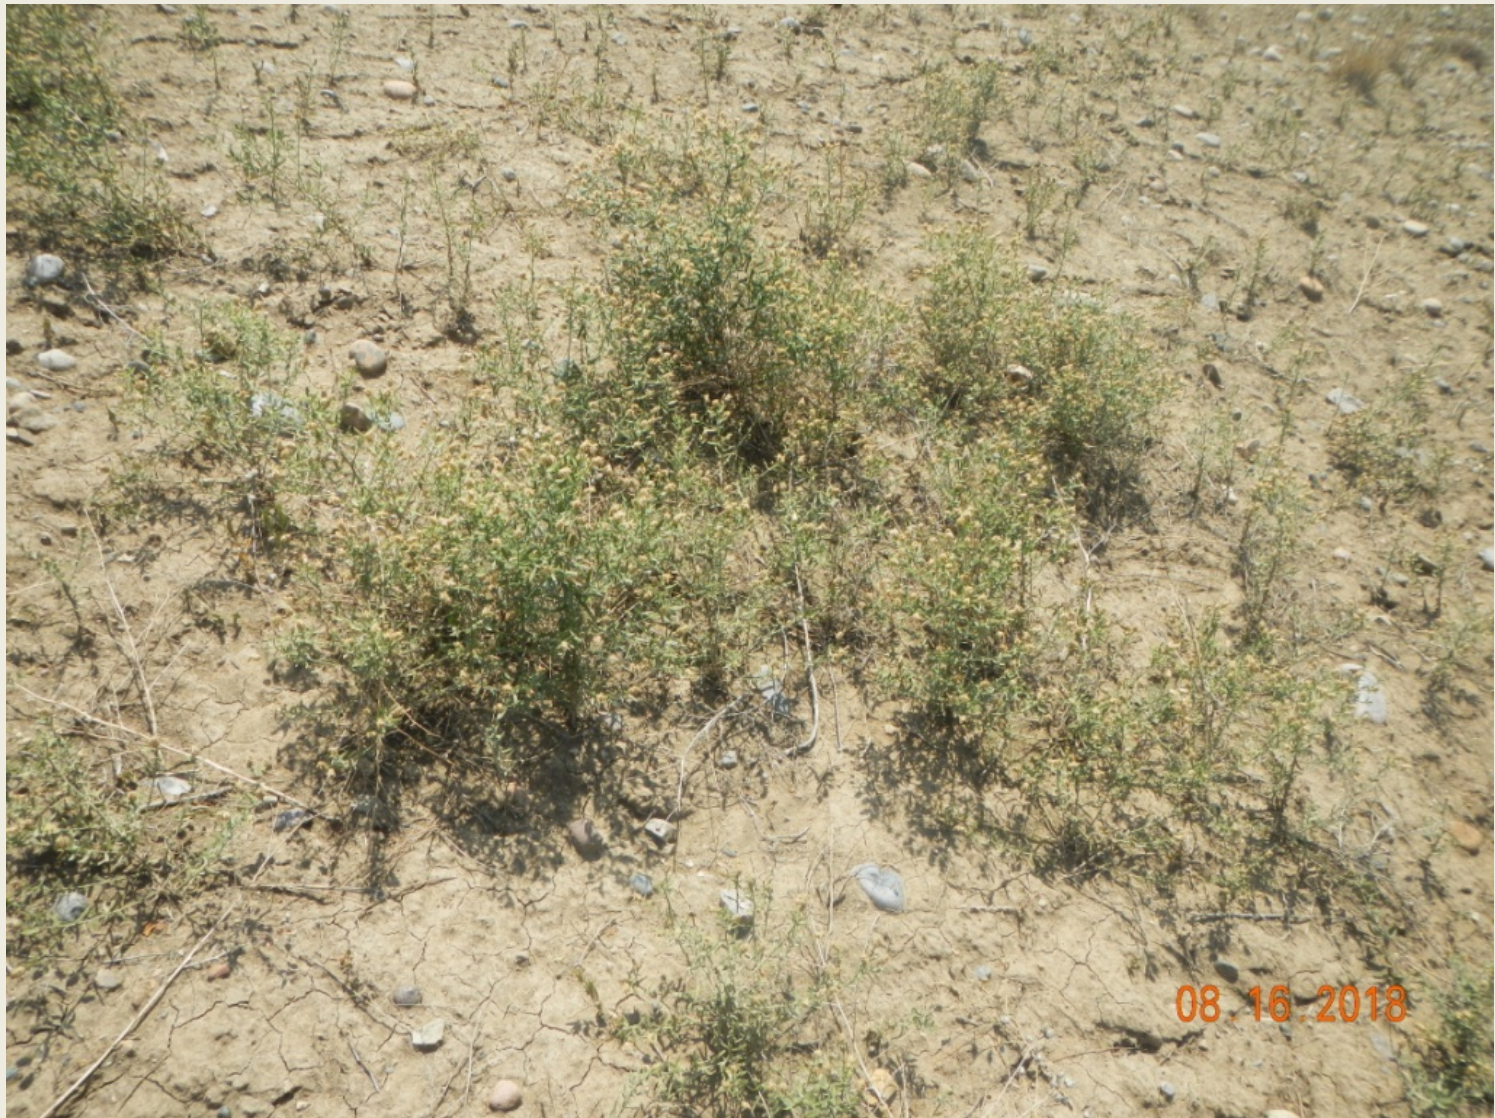
Photo 2. View of Russian knapweeds (*Acroptilon repens*) within the southern project area. Thousands of individuals are present within the interim reclamation area.

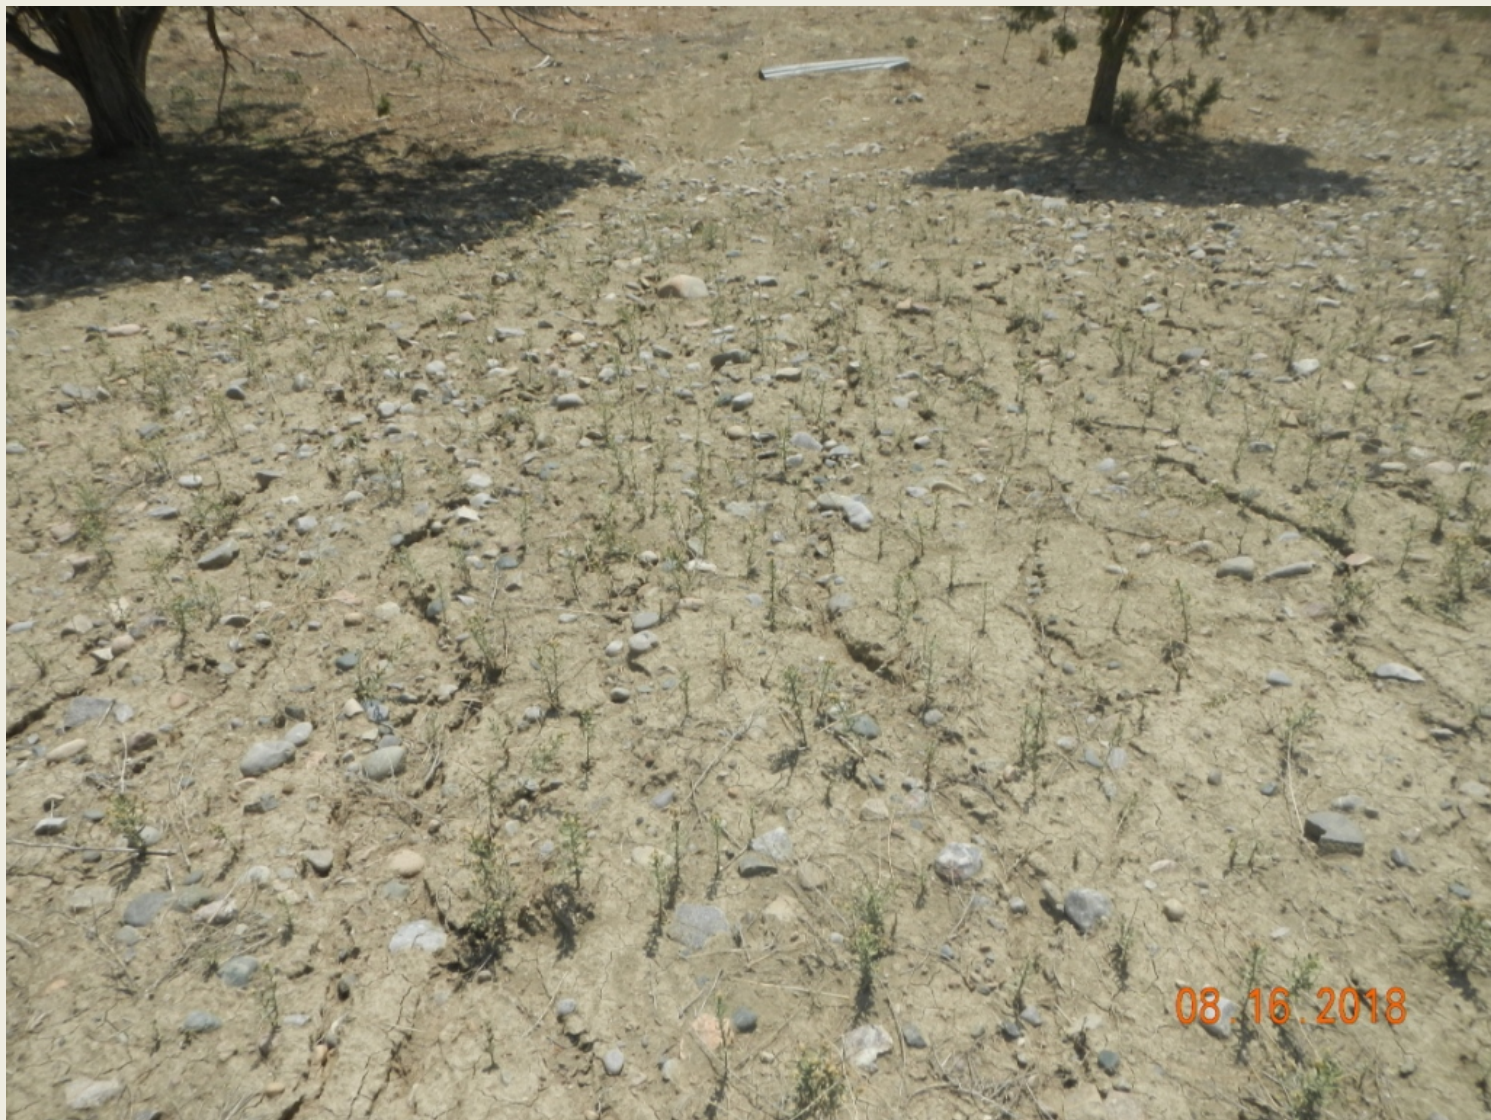
Photo 3. View of rilling in the southeastern portion of the interim reclamation area. Small plants are largely R. knapweeds.

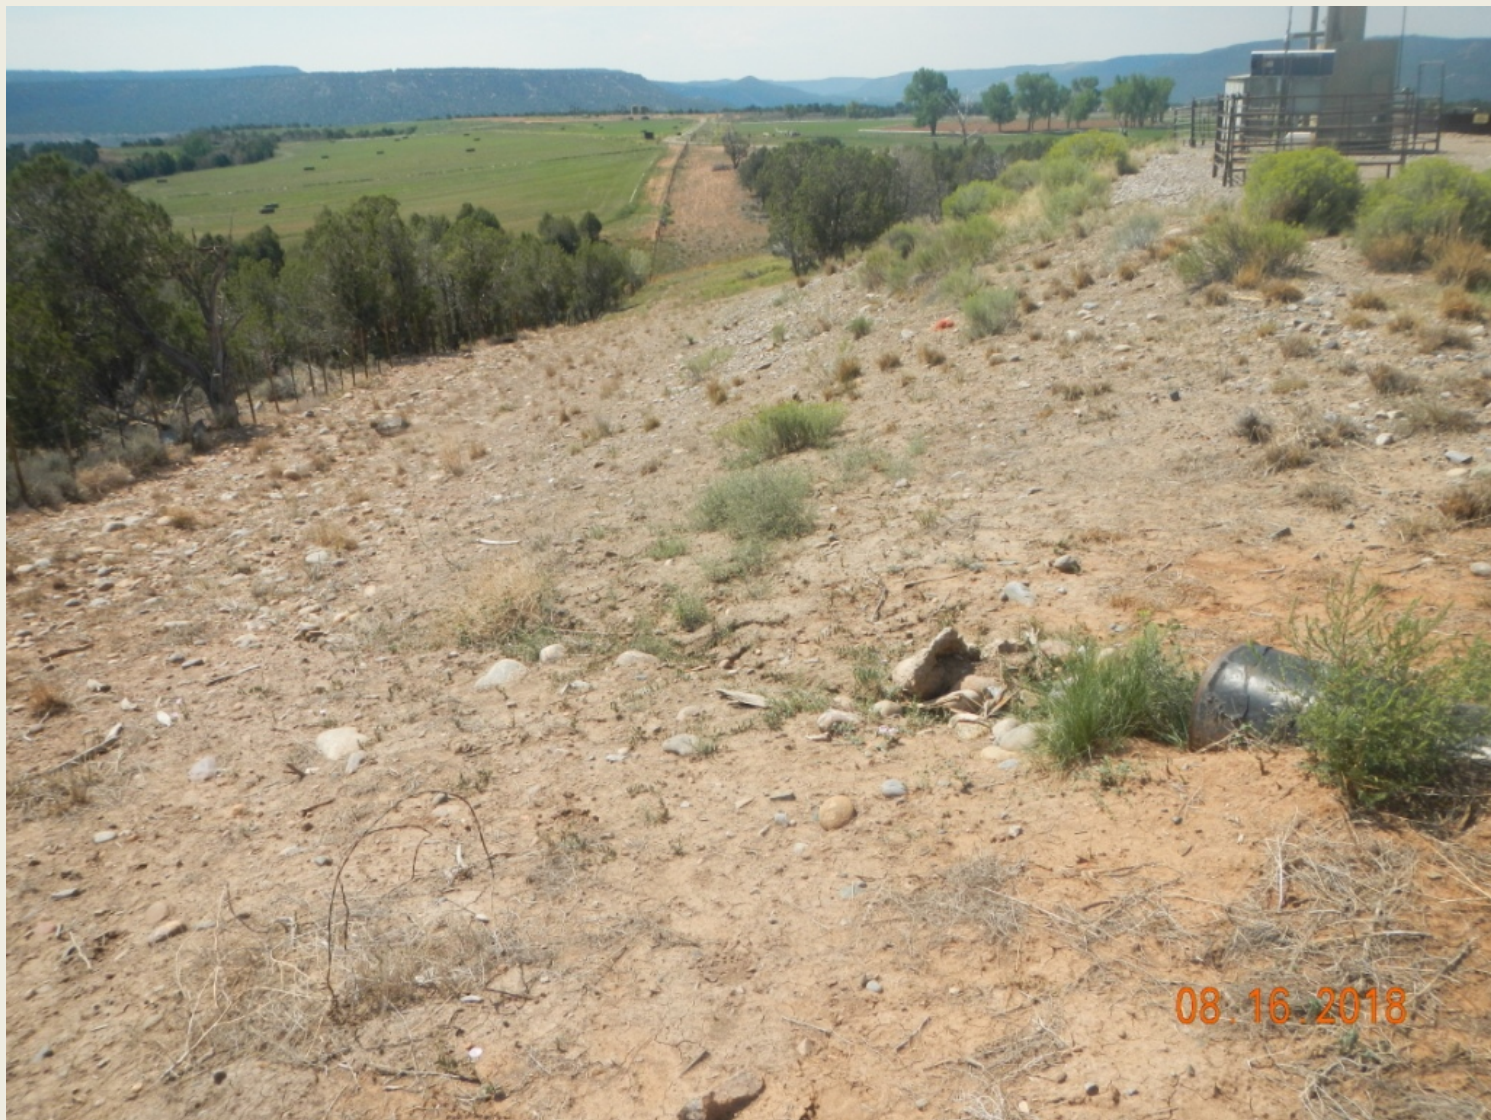
Photo 4. View of wire debris and erosional channel forming at the culvert outlet in the northeastern portion of the project area.

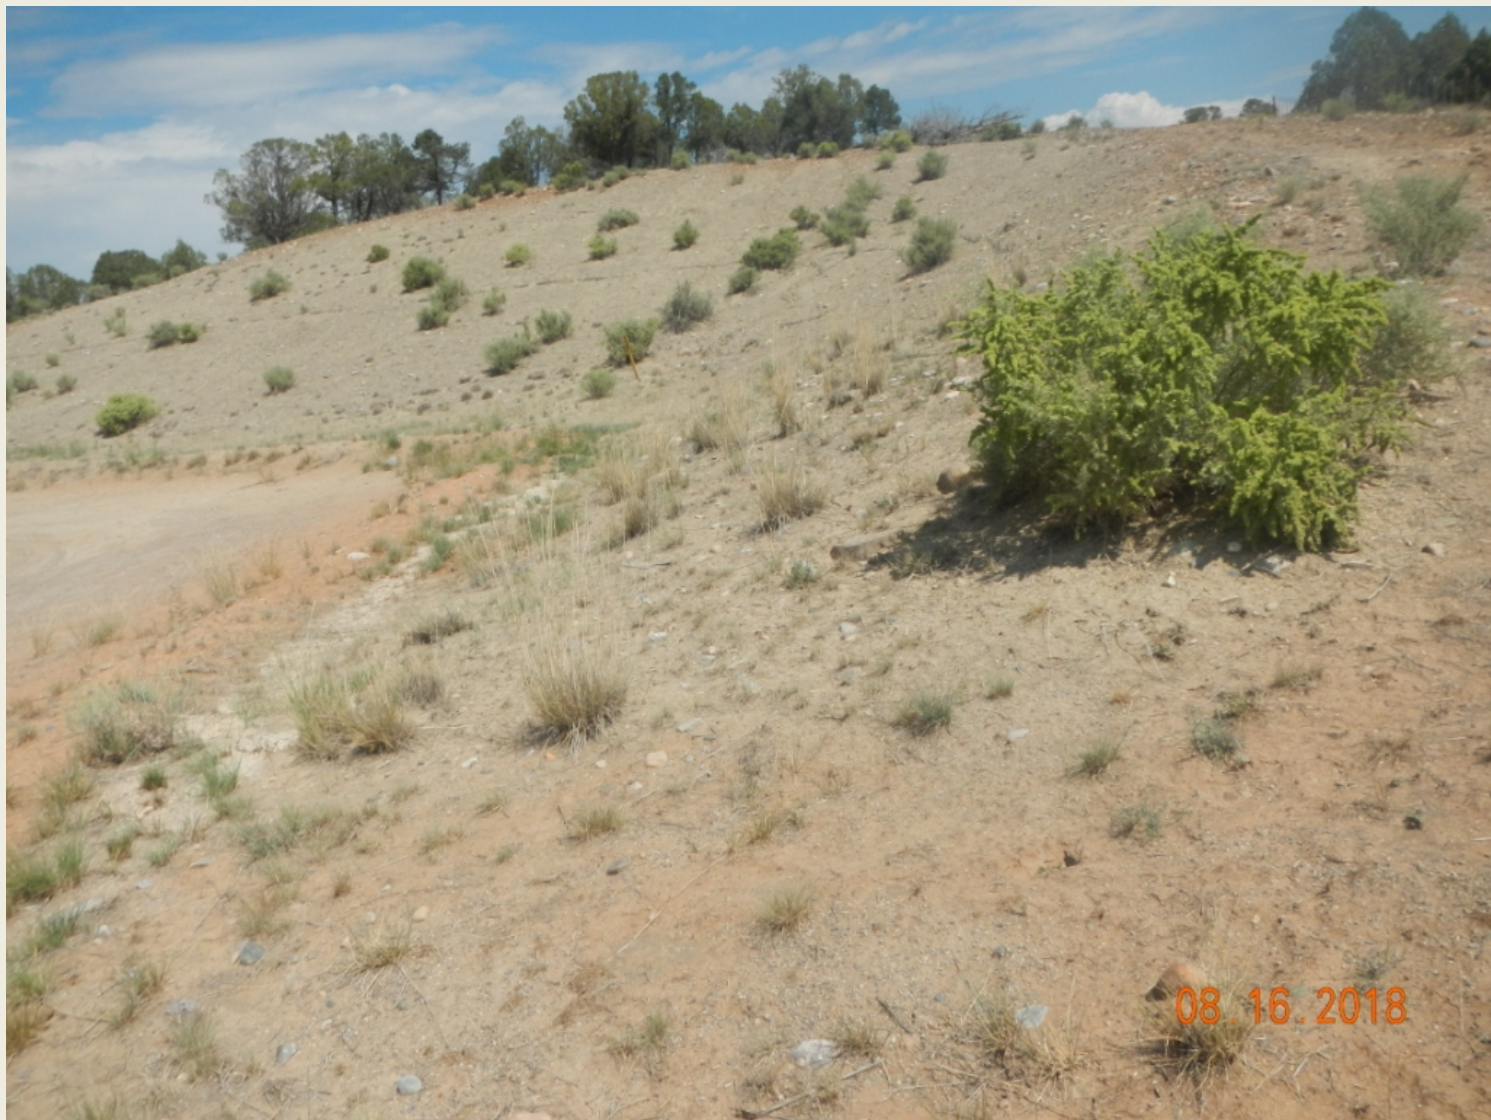
Photo 5. View of the northern and northeastern cut-slopes from the northeastern edge facing northwestward. Vegetation is sparse on the cut-slope and erosion is occurring in several areas.

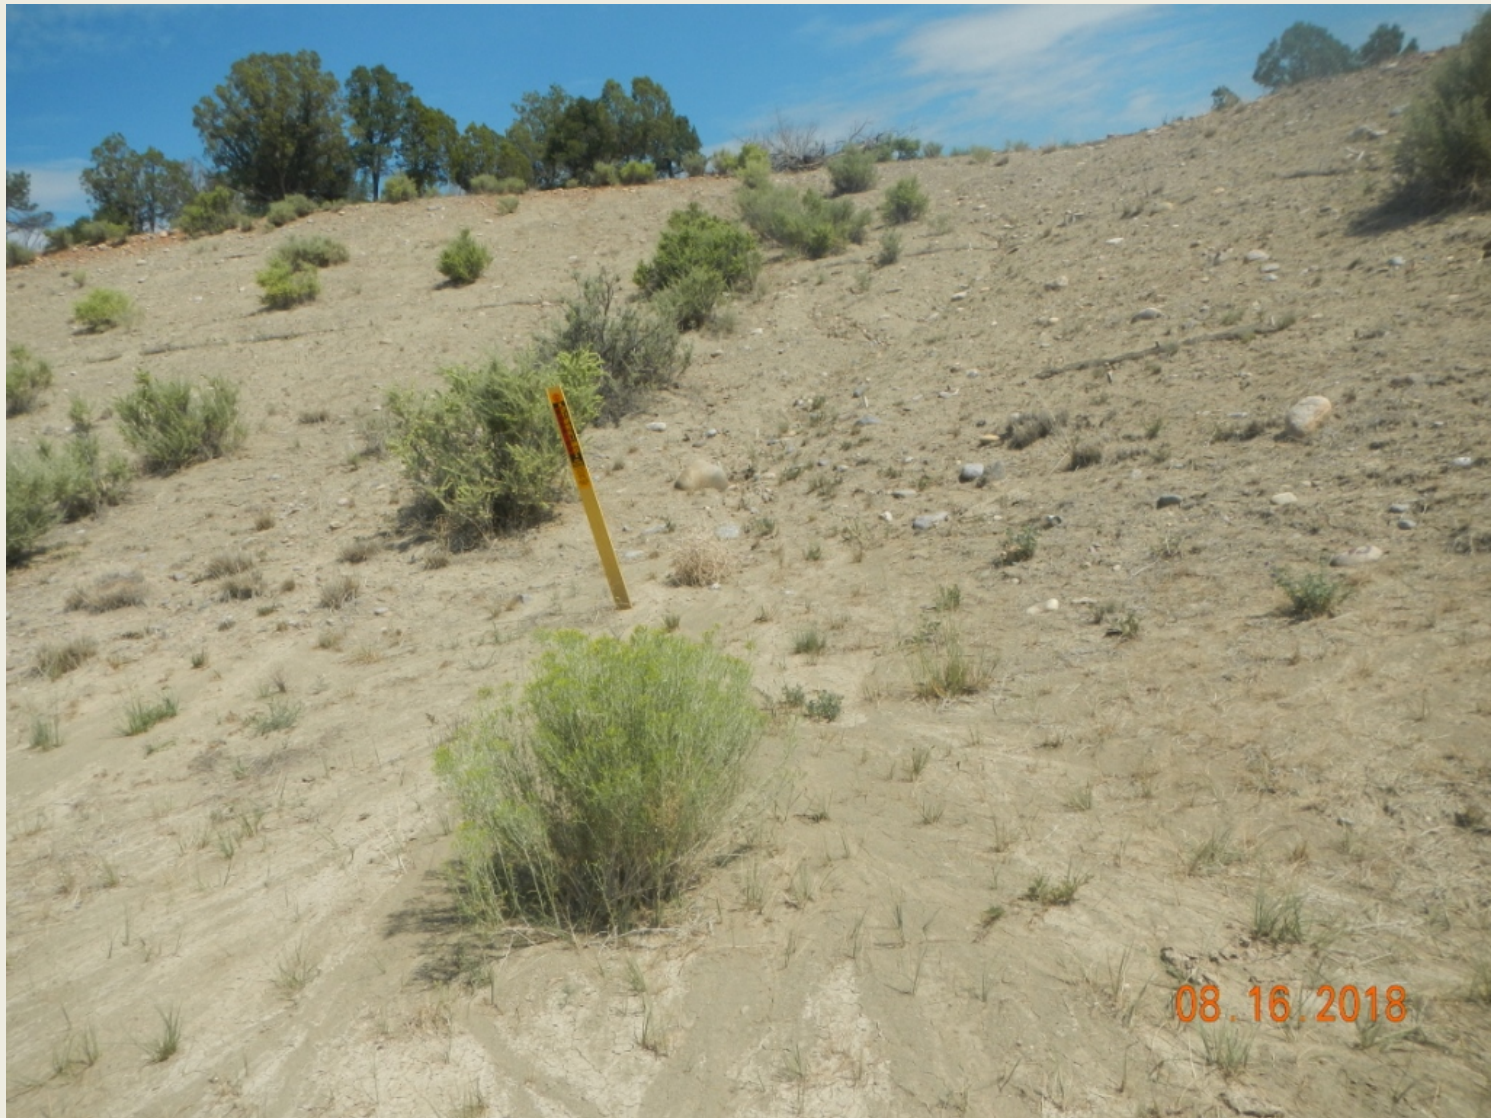
Photo 6. View of erosional channel and sediment deposition in the northeastern project area.

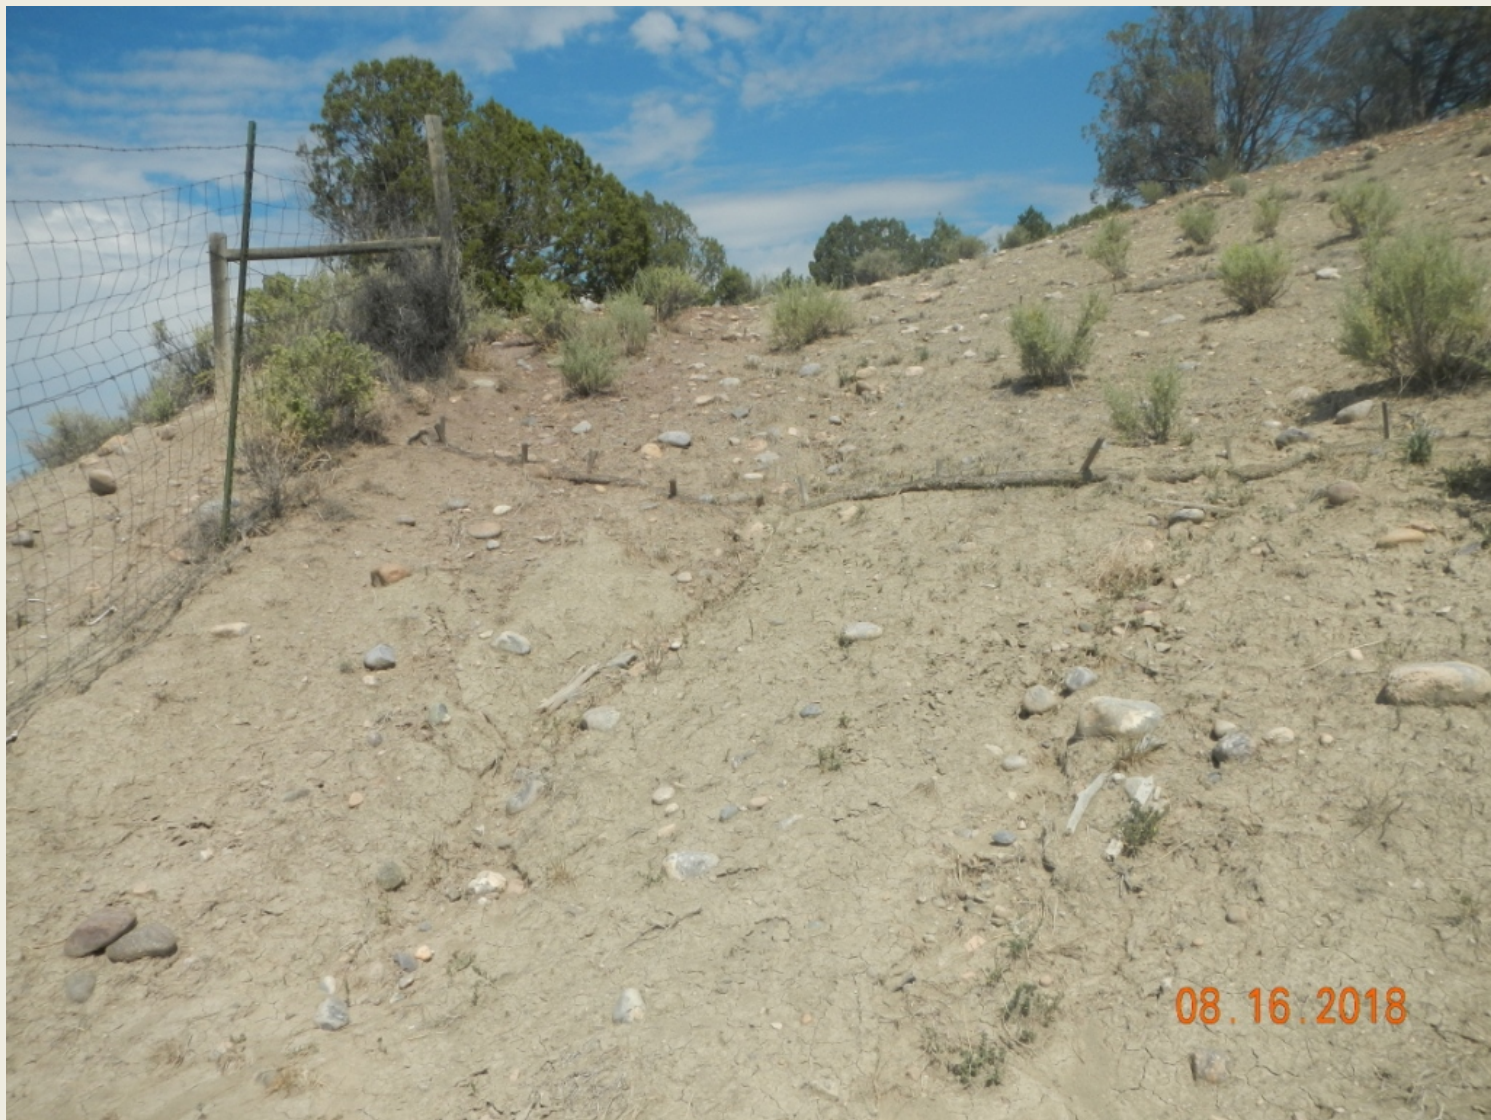
Photo 7. View of erosion occurring in the northwestern corner of the project area. Wattles do not appear to be functioning and are not sufficient stormwater controls for the slope.

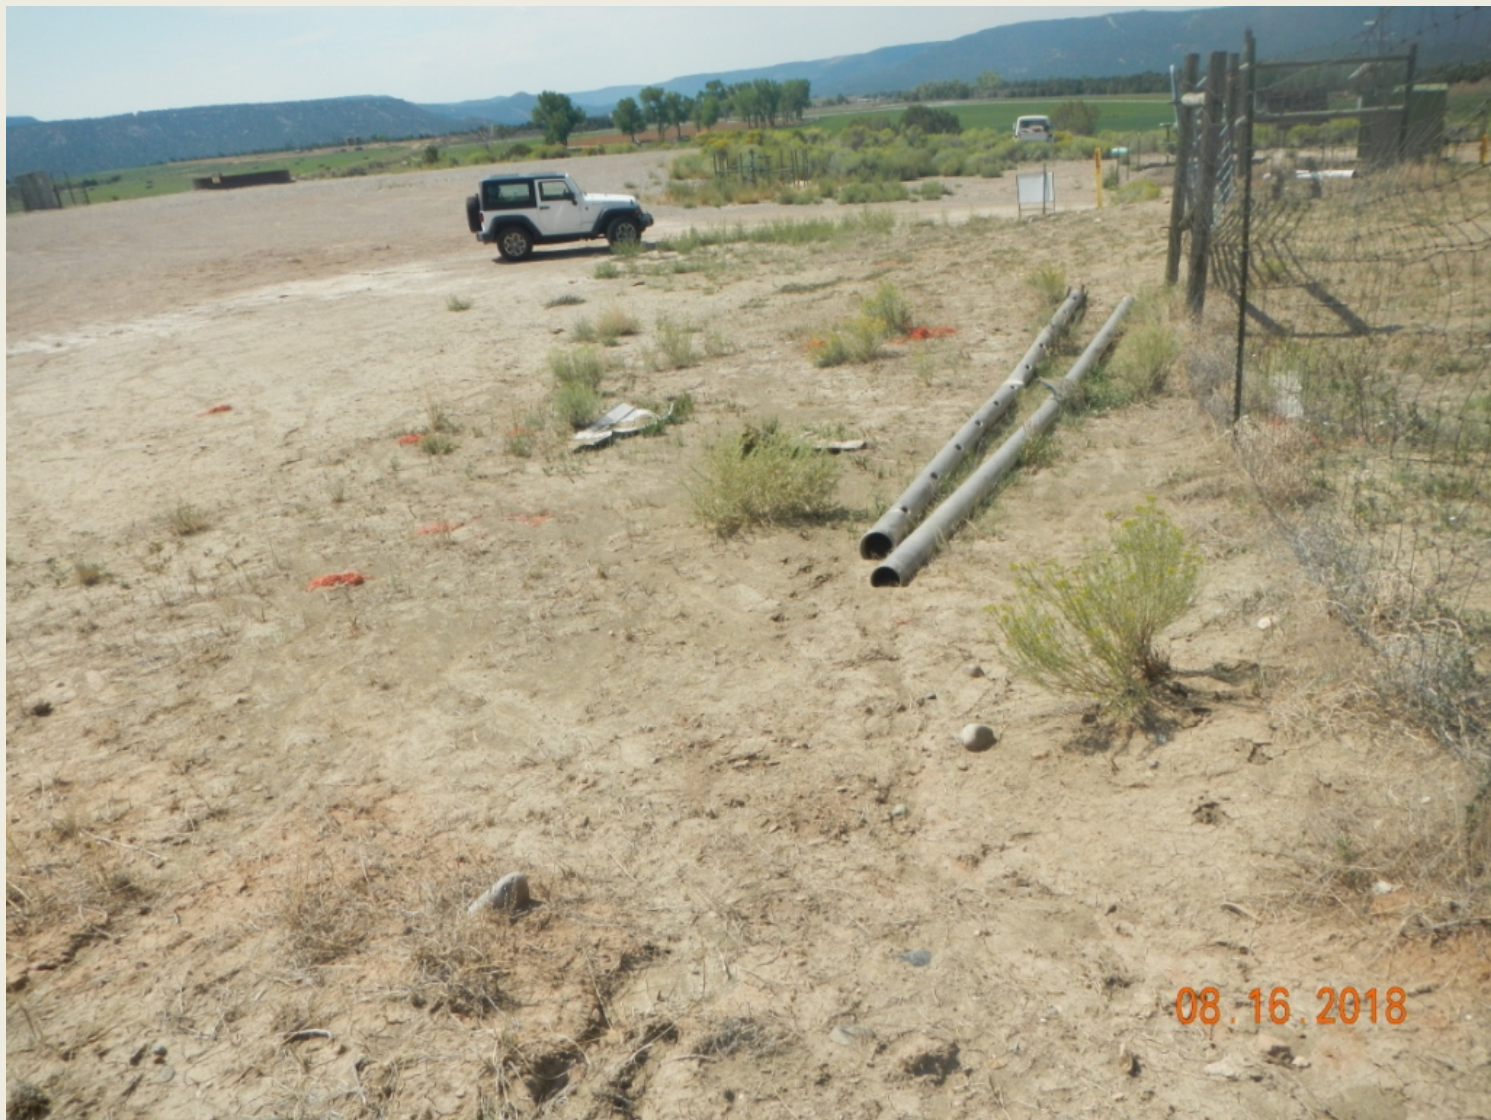
Photo 8. View of debris in the western project area.
