Inspection Photos

Operator: Logos Operating

API: 05-067-05180

Date: 8/16/2018

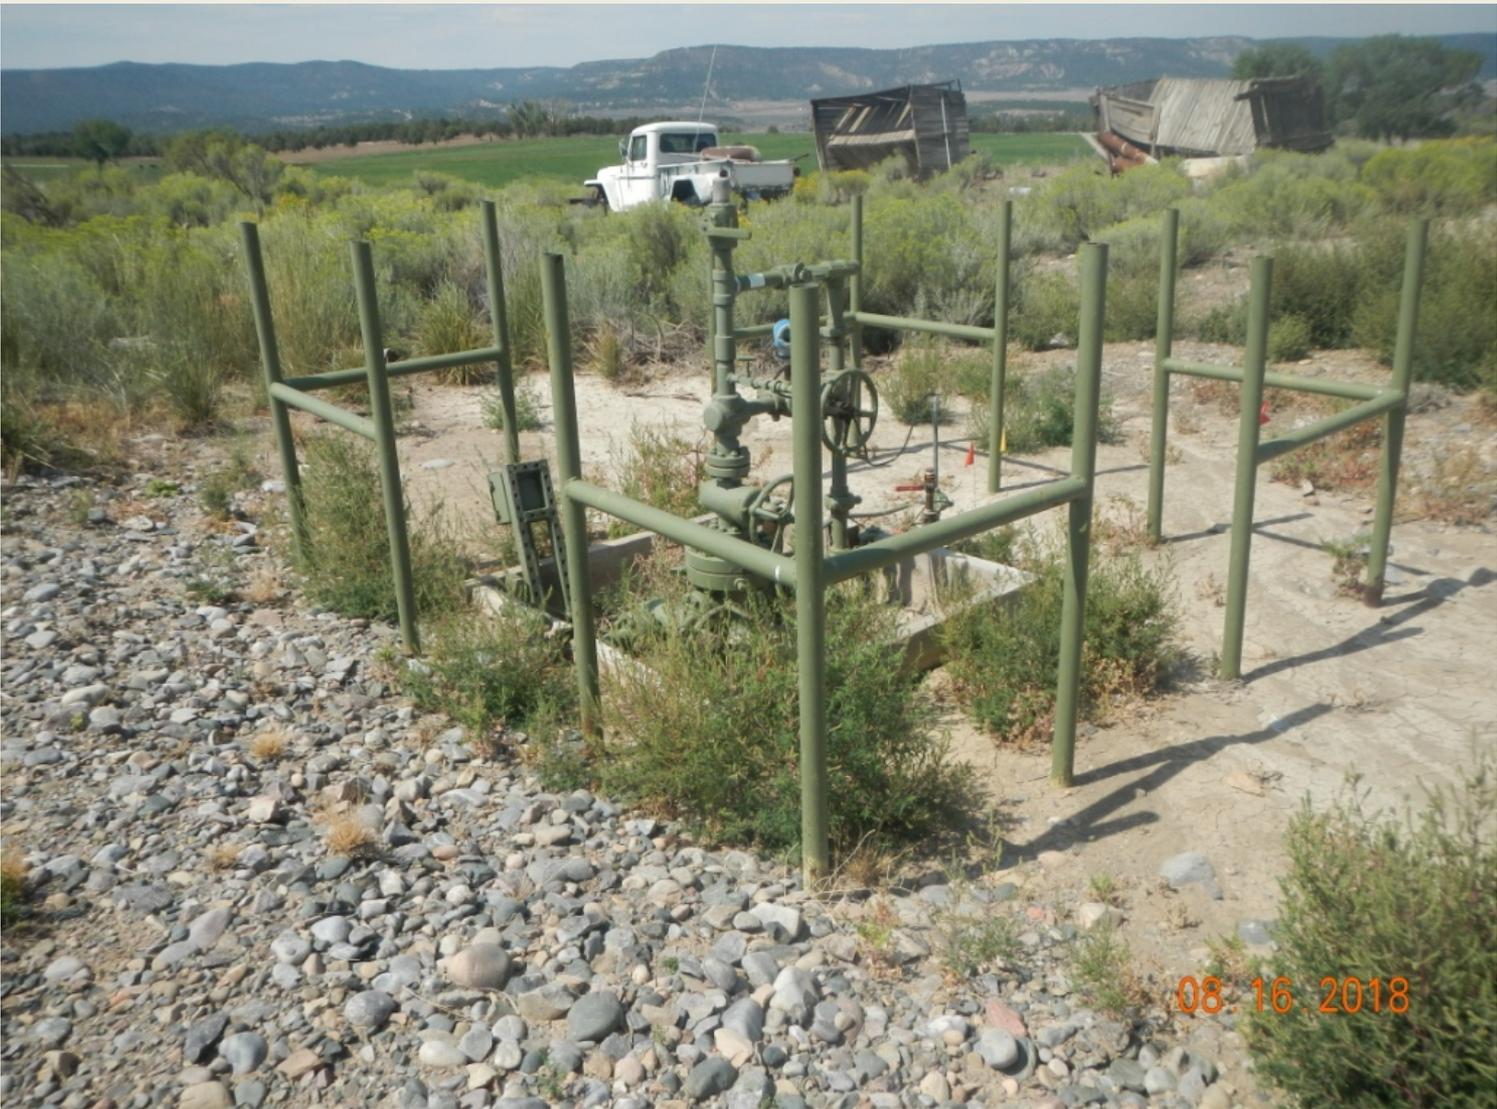
Photo 1. View of the project area from the southwestern corner facing center. What appears to be surface owner debris is stored south of facilities. If this is on well pad disturbance it needs to be removed.

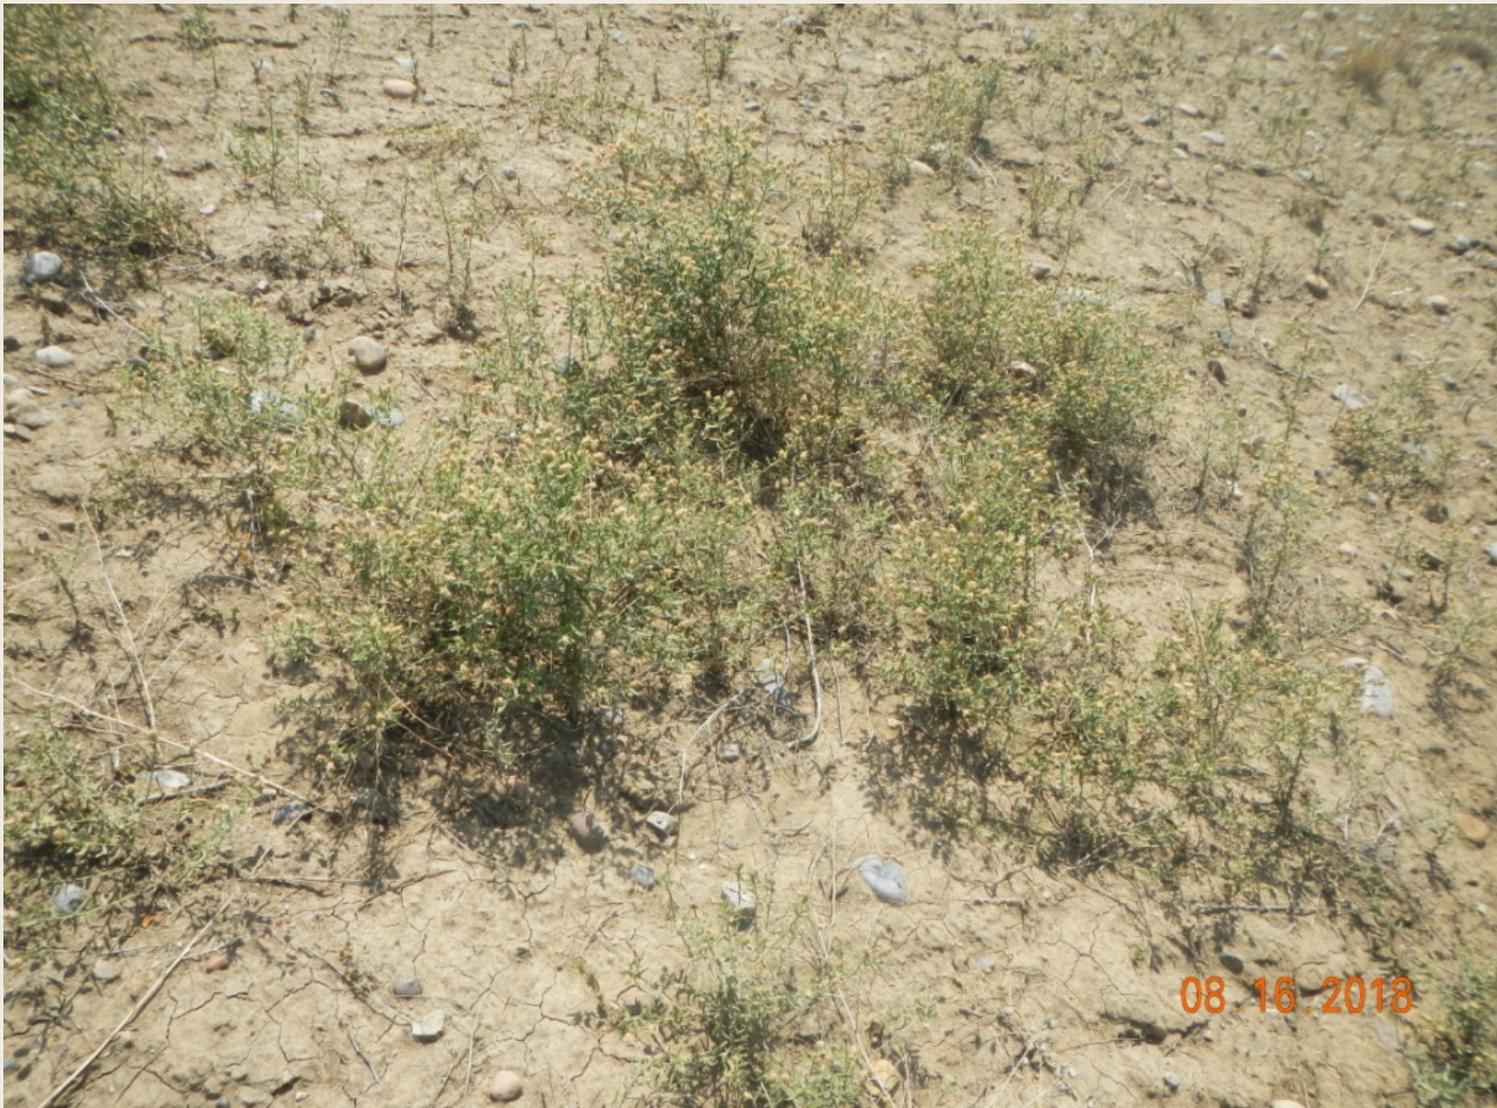
Photo 2. View of Russian knapweeds (*Acroptilon repens*) within the southern project area. Thousands of individuals are present within the interim reclamation area.

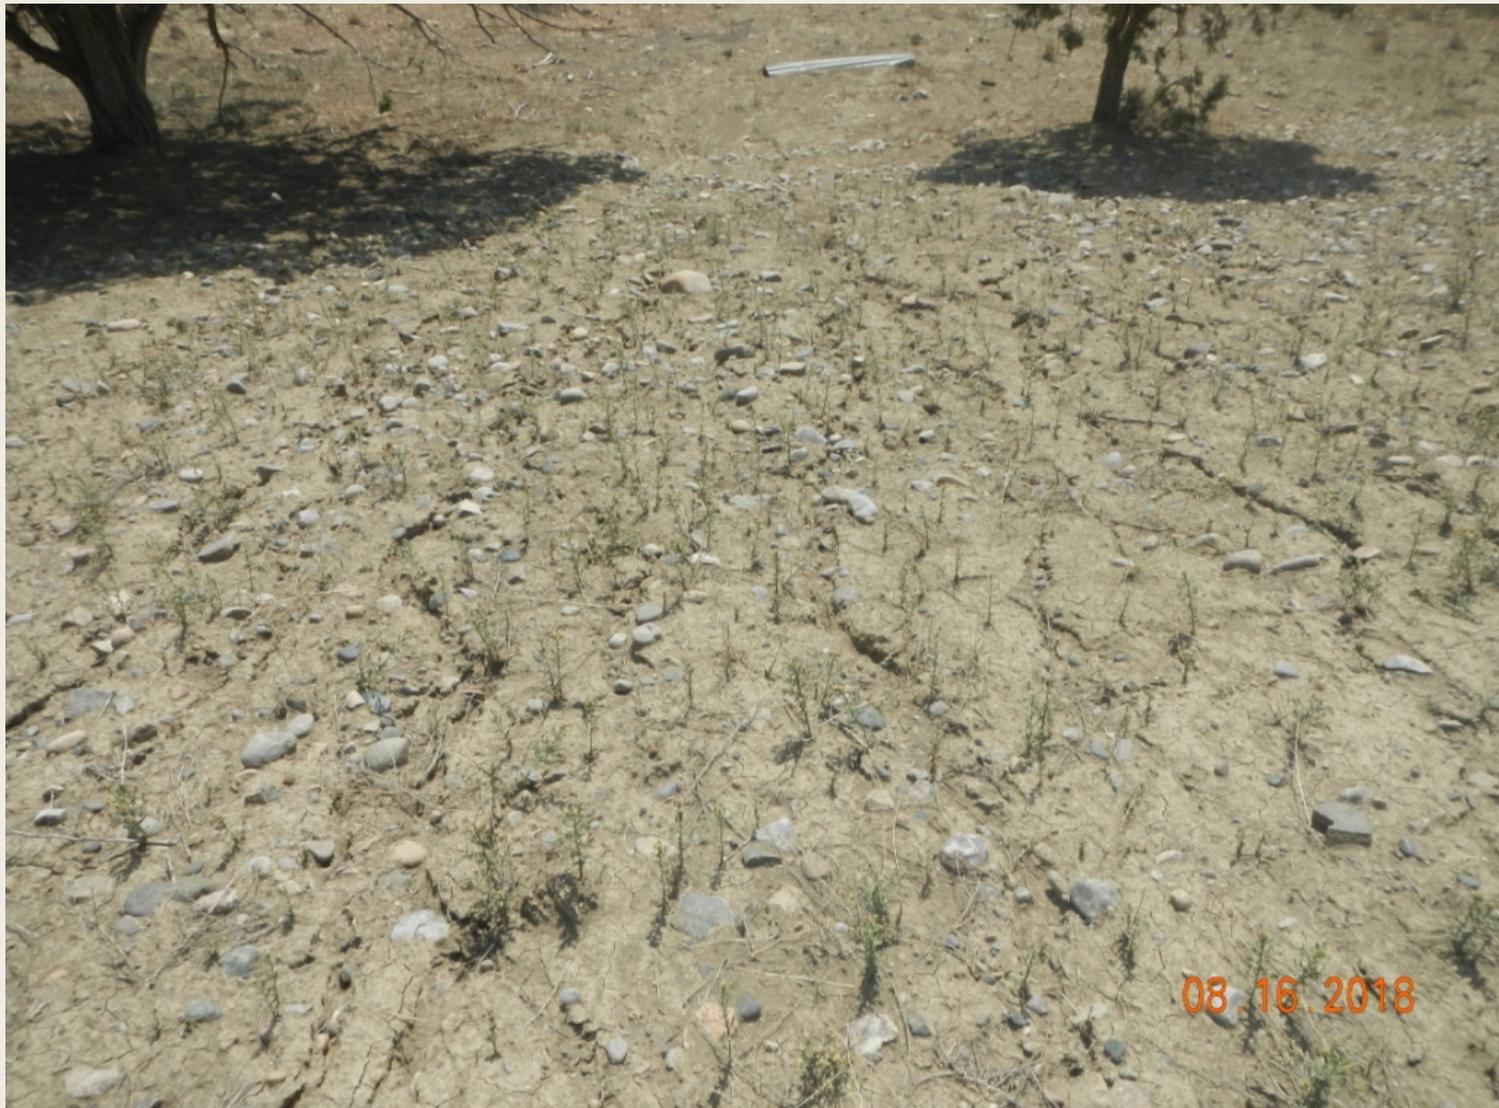
Photo 3. View of rilling in the southeastern portion of the interim reclamation area. Small plants are largely R. knapweeds.

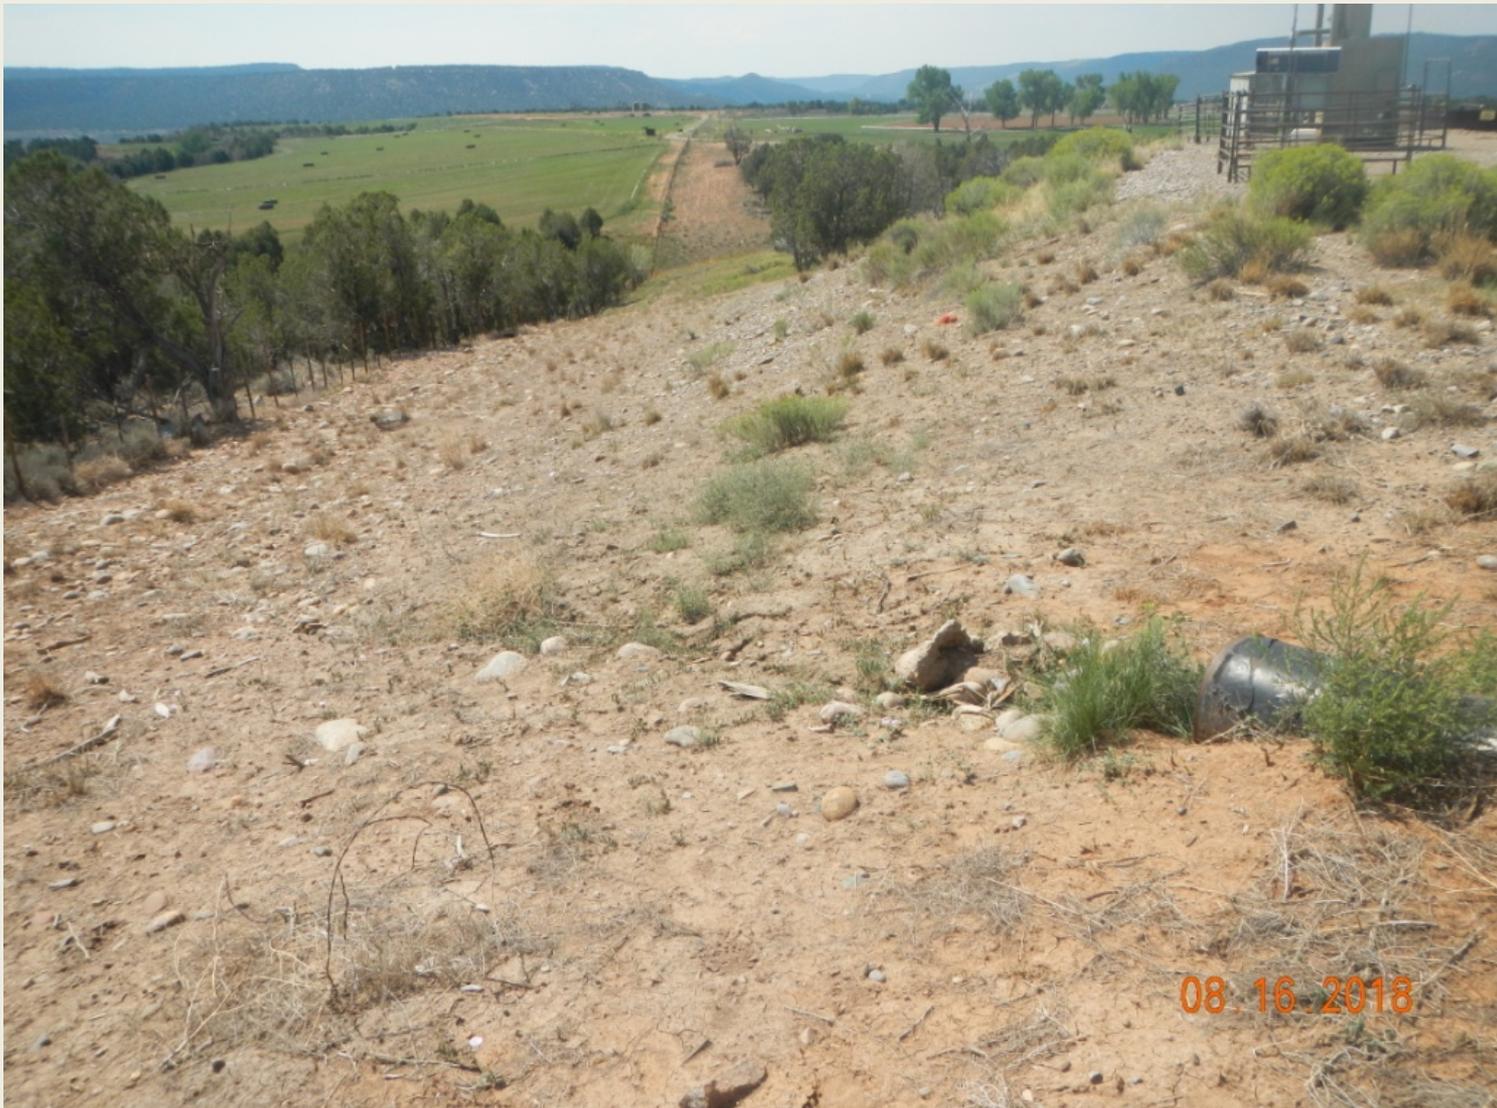
Photo 4. View of wire debris and erosional channel forming at the culvert outlet in the northeastern portion of the project area.

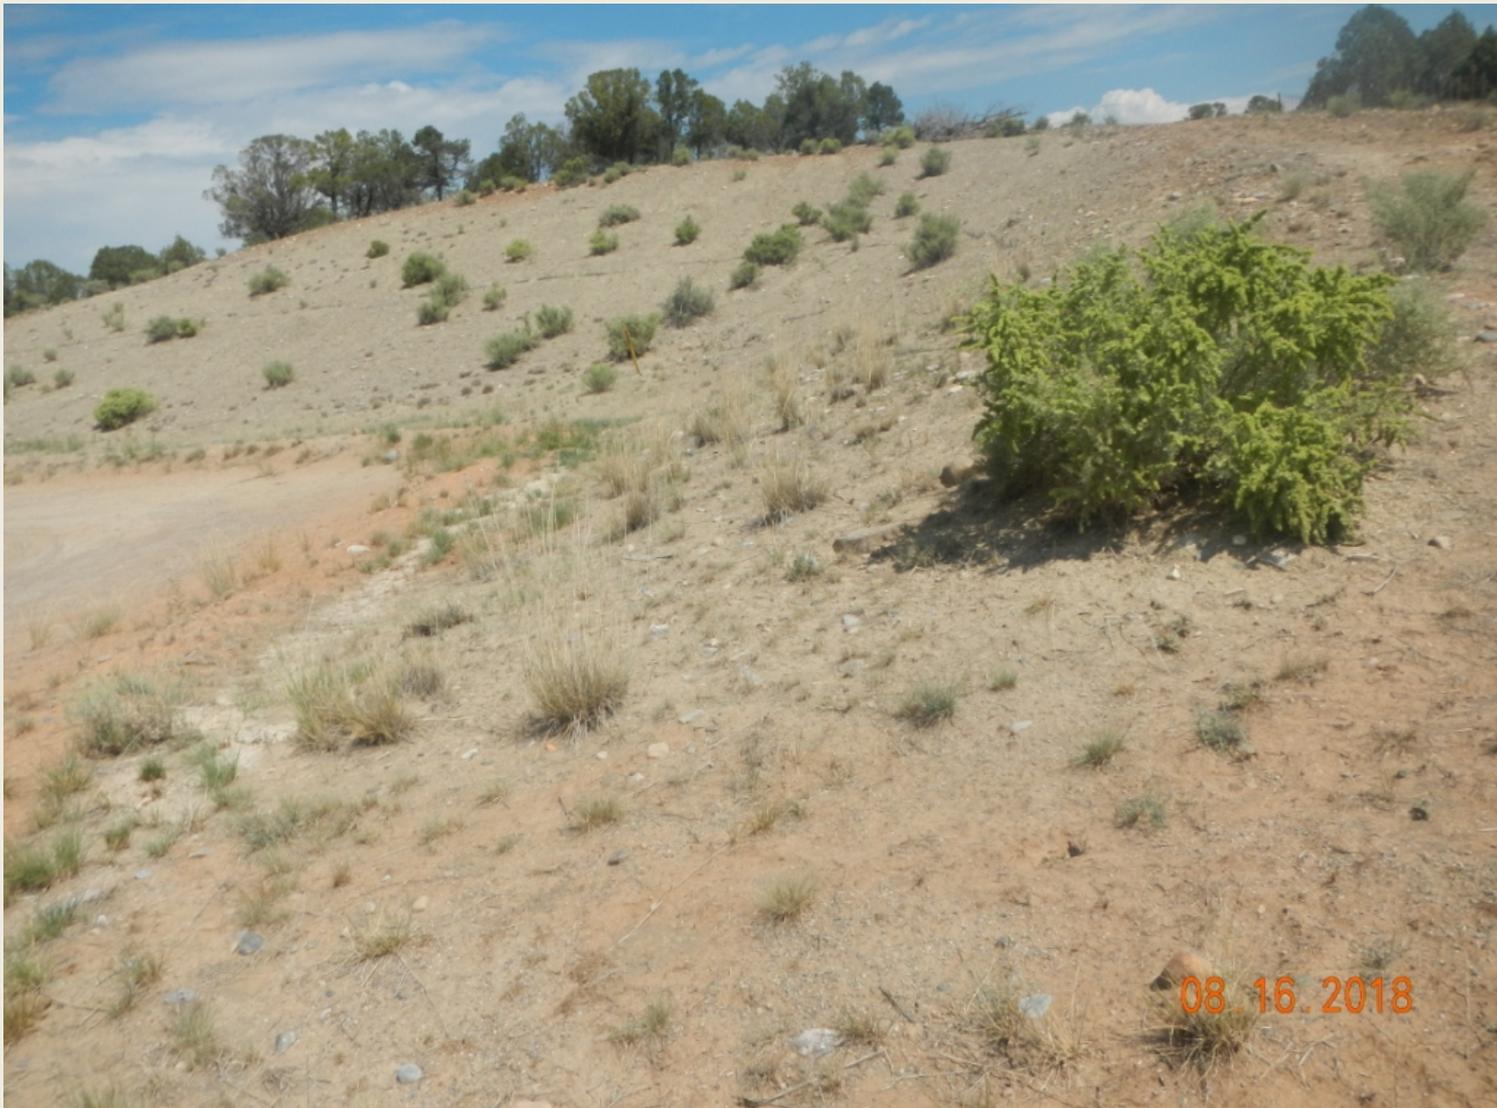
Photo 5. View of the northern and northeastern cut-slopes from the northeastern edge facing northwestward. Vegetation is sparse on the cut-slope and erosion is occurring in several areas.

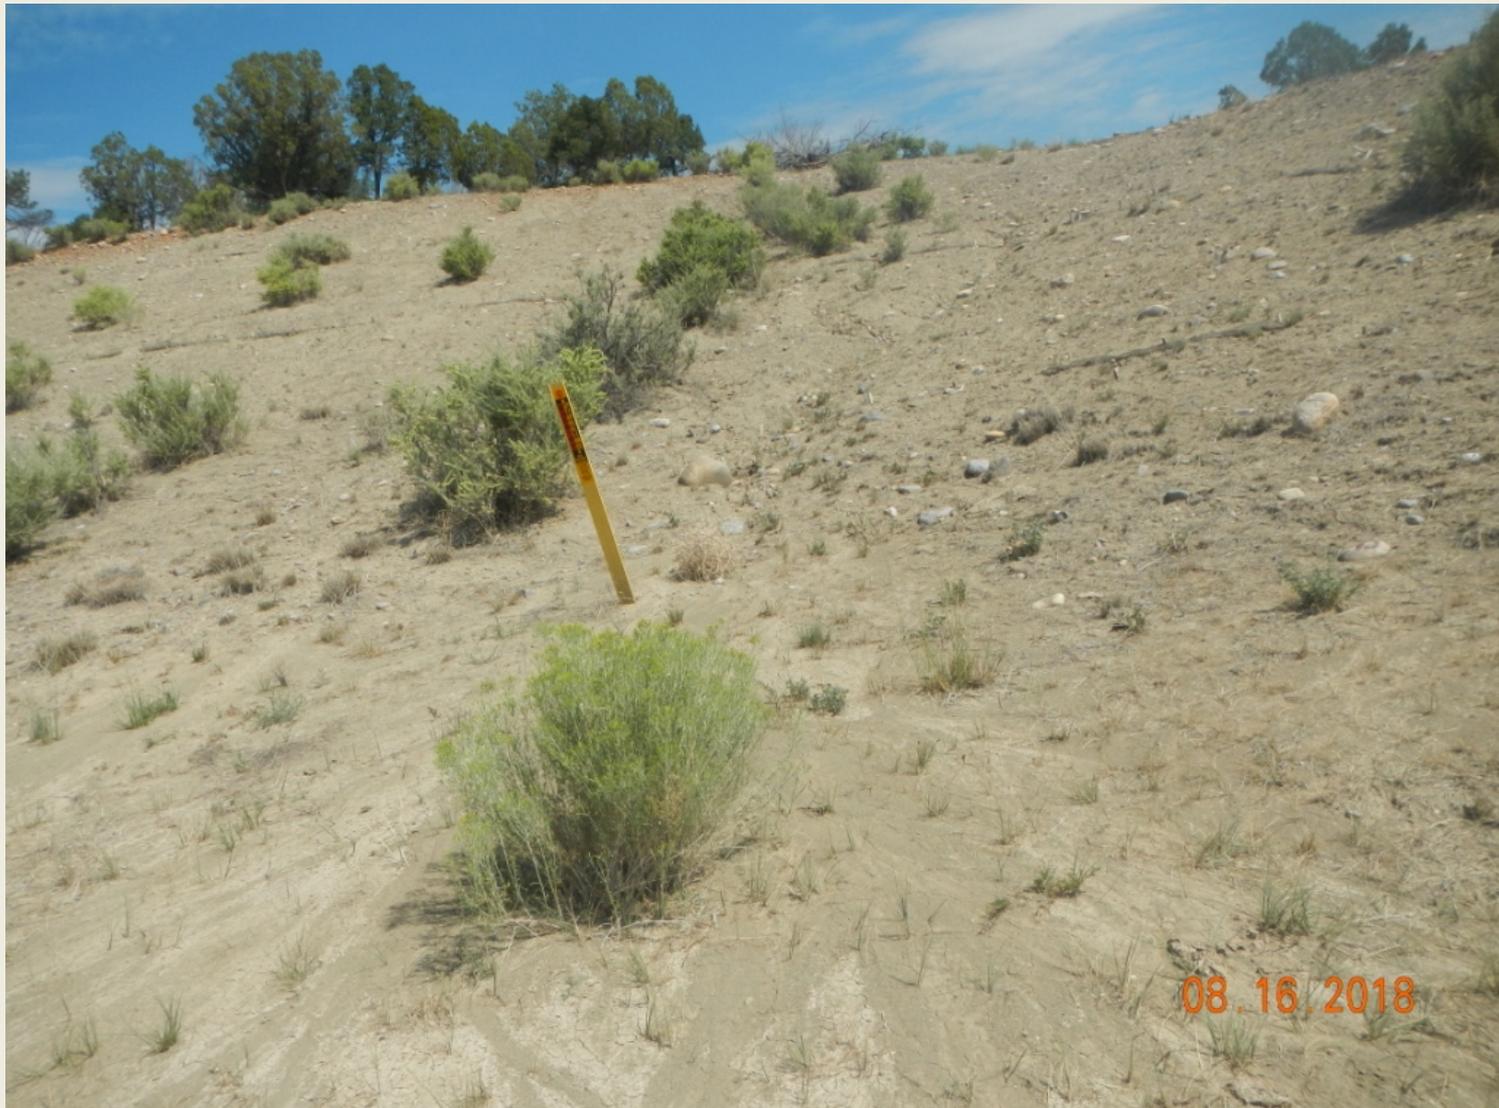
Photo 6. View of erosional channel and sediment deposition in the northeastern project area.

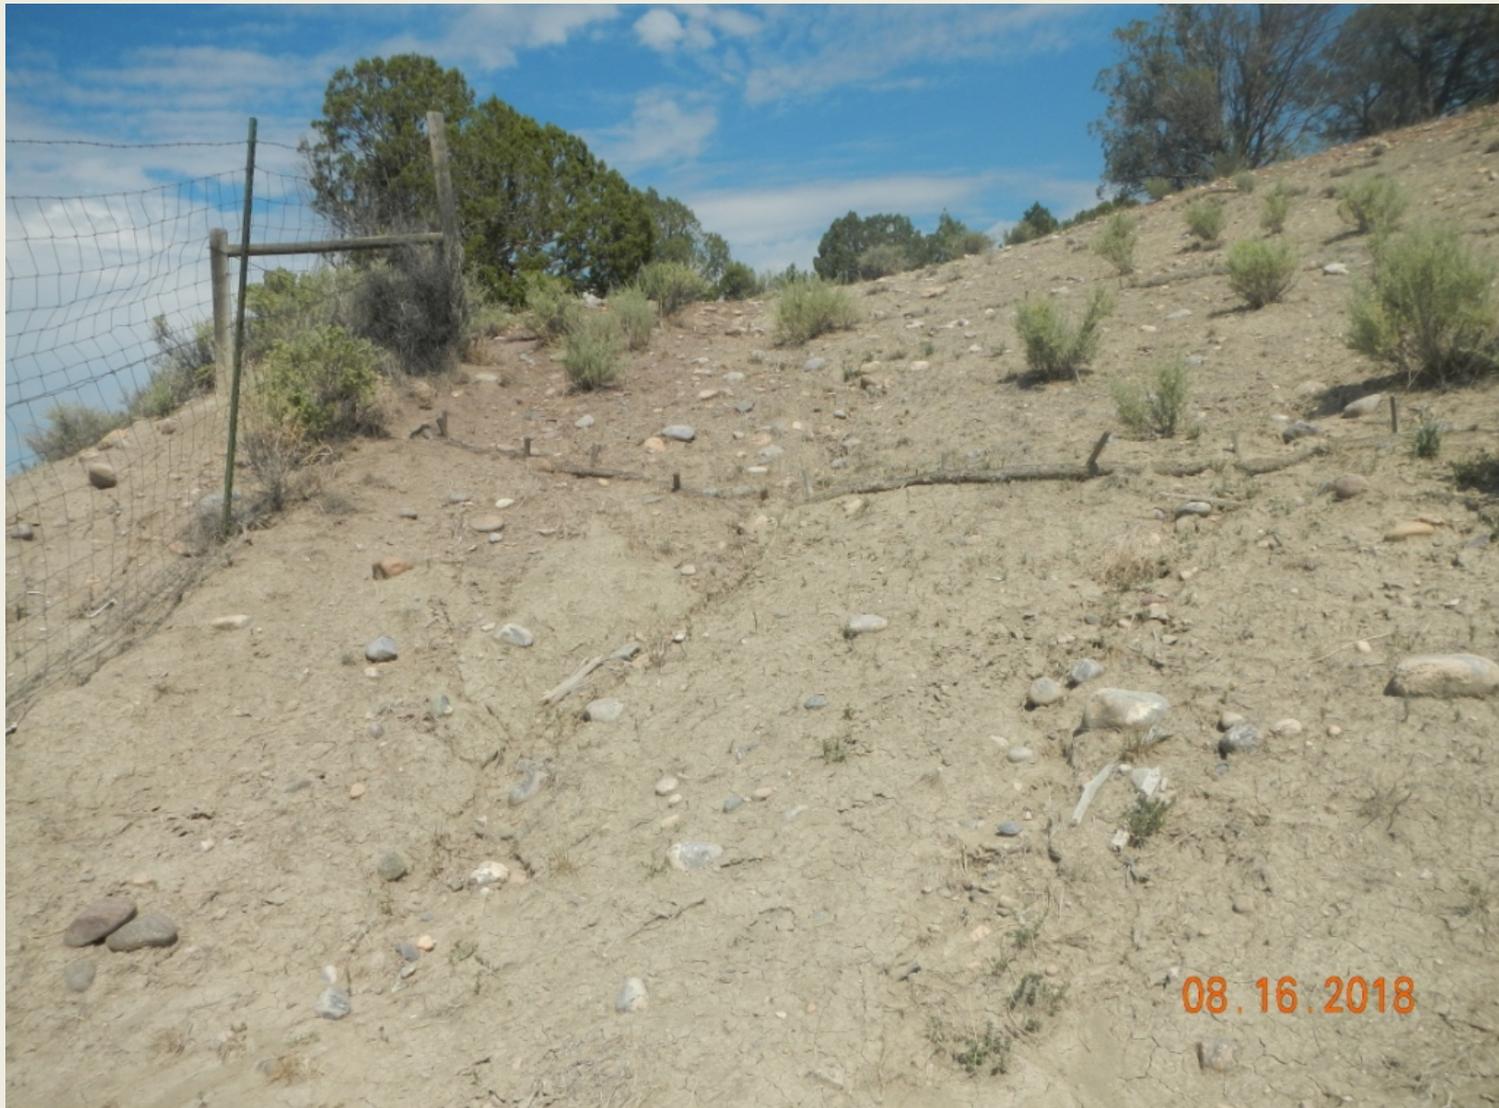
Photo 7. View of erosion occurring in the northwestern corner of the project area. Wattles do not appear to be functioning and are not sufficient stormwater controls for the slope.

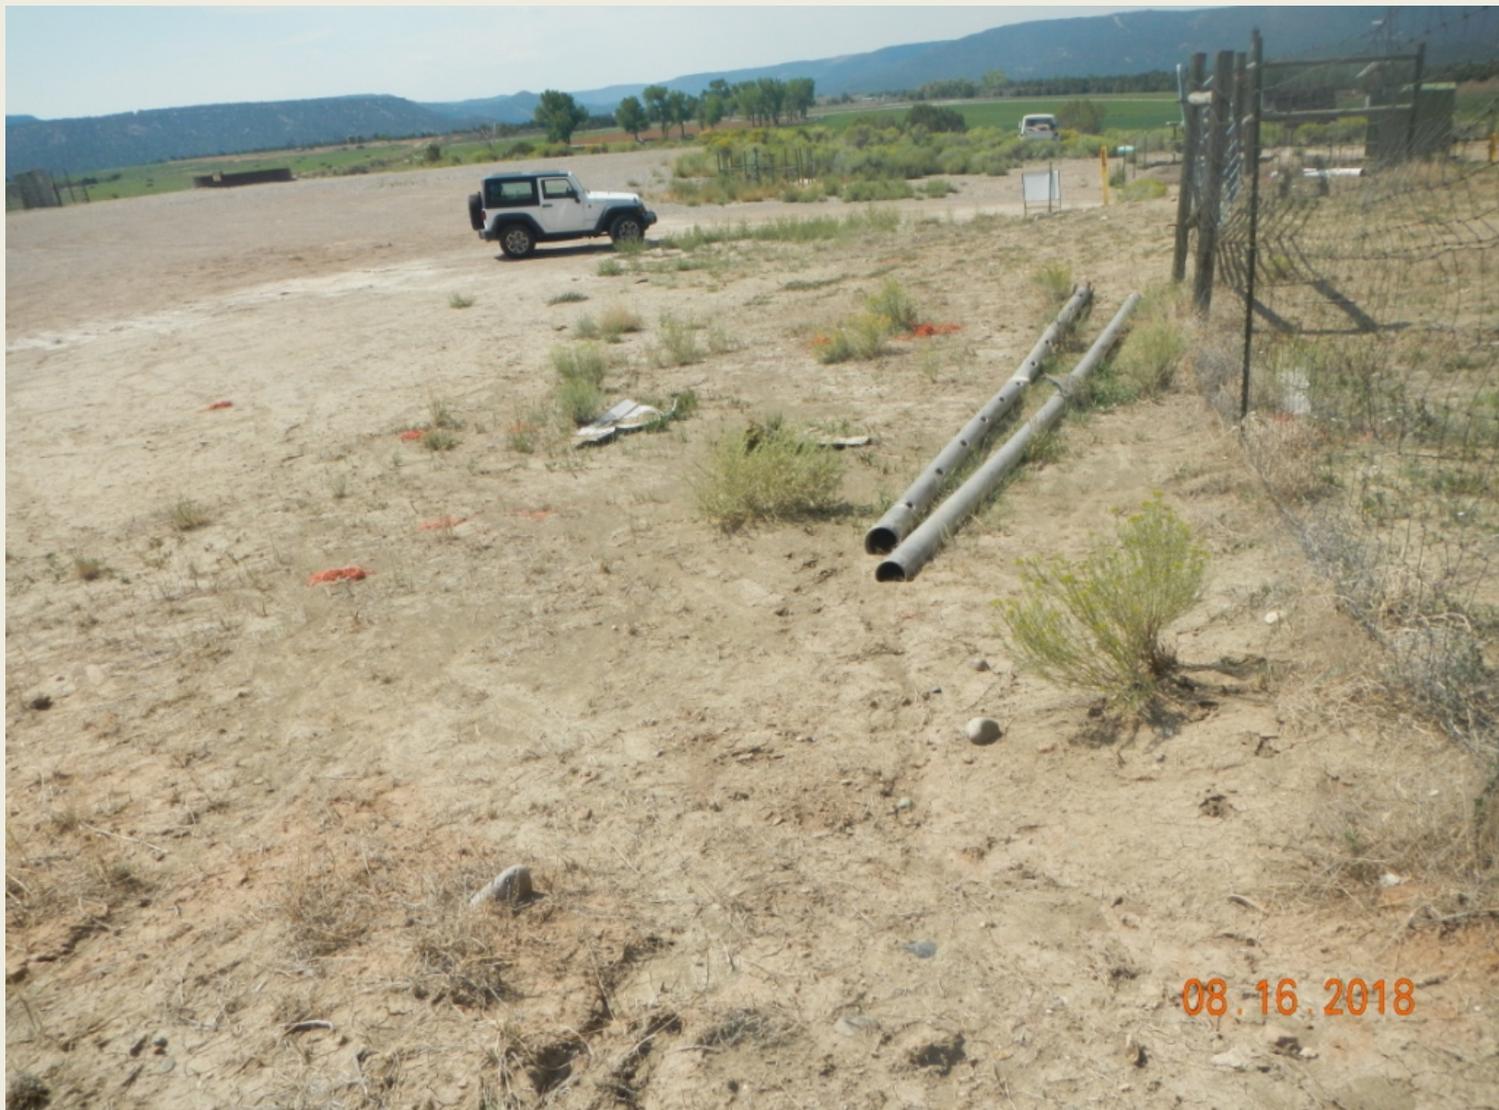
Photo 8. View of debris in the western project area.
