Inspection Photos  
Location Name: Schroeder 33-32  
API: 05-081-07131

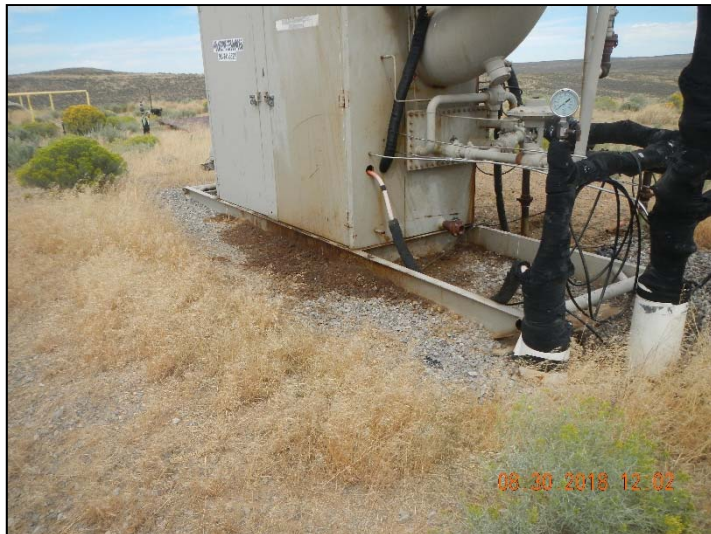
**Photo 2. Stained soil at separator.**

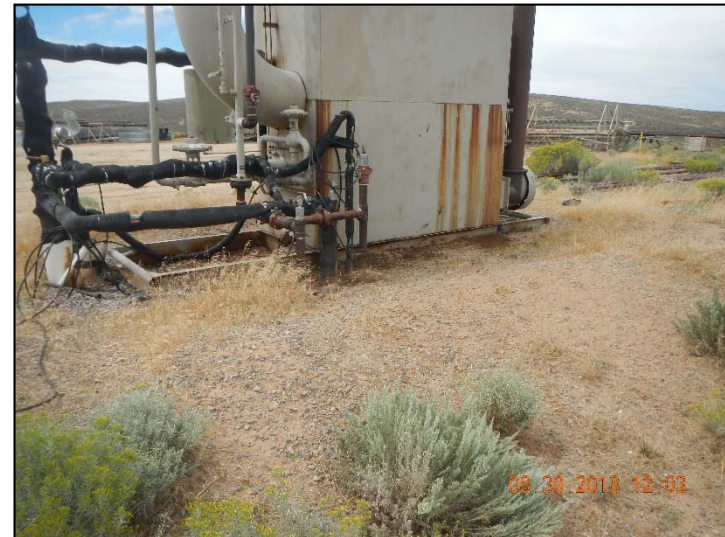
**Photo 3. Stained soil at separator.**

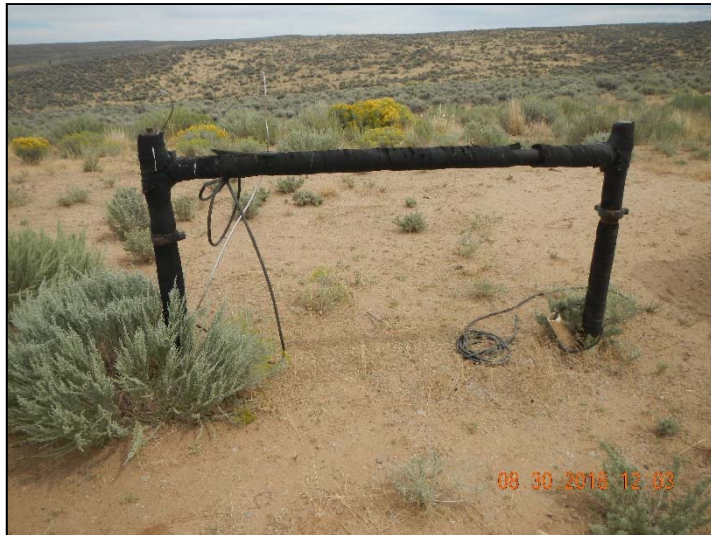
**Photo 4. Unmarked risers.**

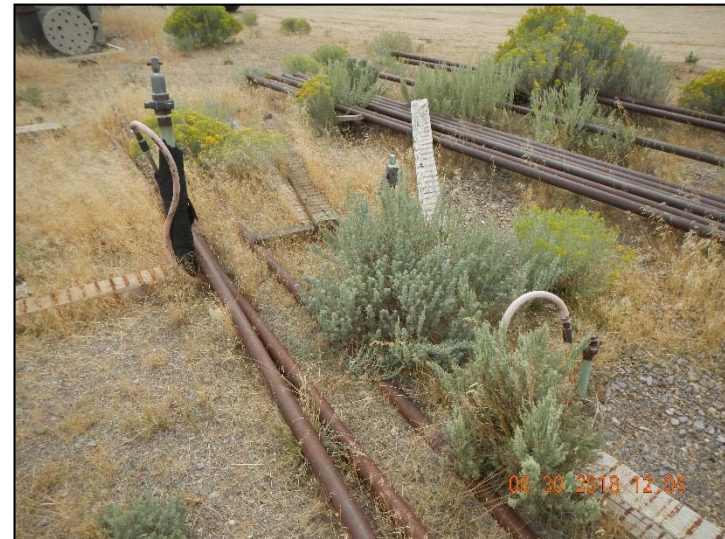
**Photo 5. Unmarked risers. Equipment stored on location.**

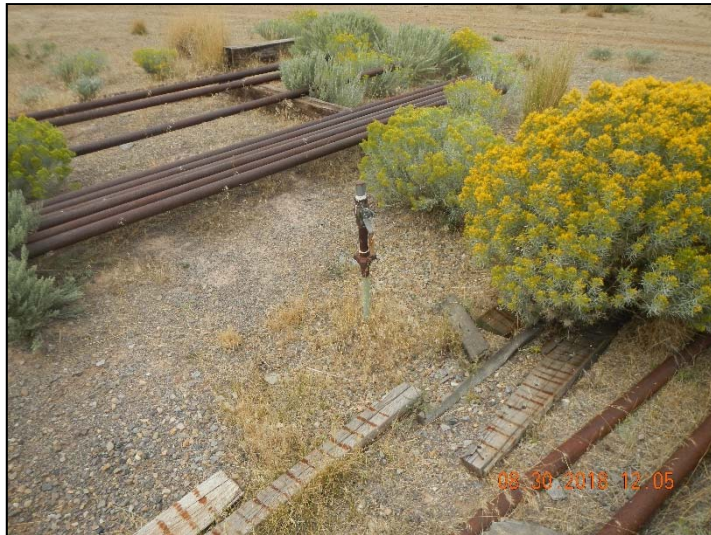
**Photo 6. Unmarked riser. Equipment stored on location.**

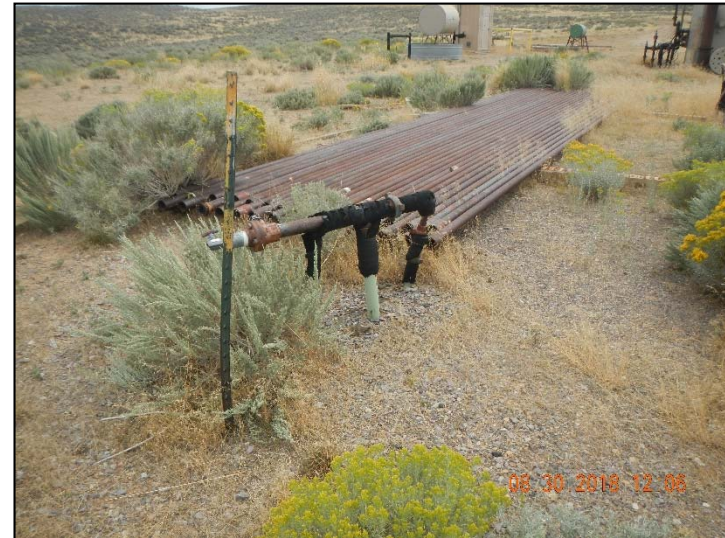
**Photo 7. Unmarked risers. Equipment stored on location.**

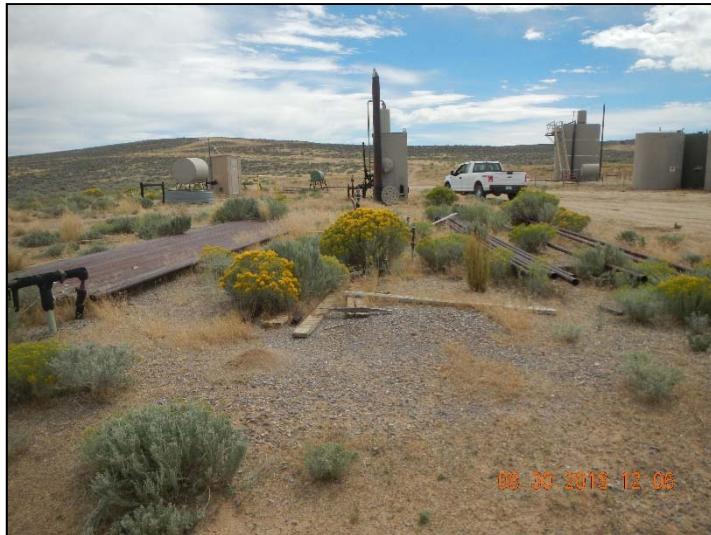
**Photo 8. Unmarked risers. Equipment stored on location.**

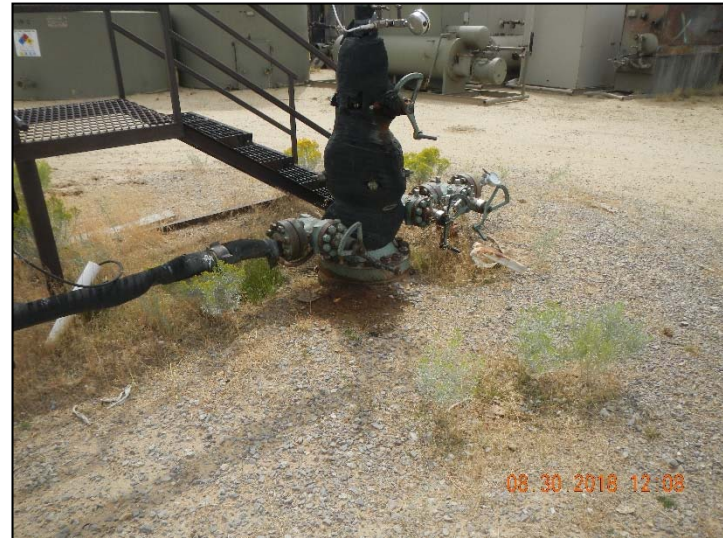
**Photo 9. Stained soil at wellhead.**

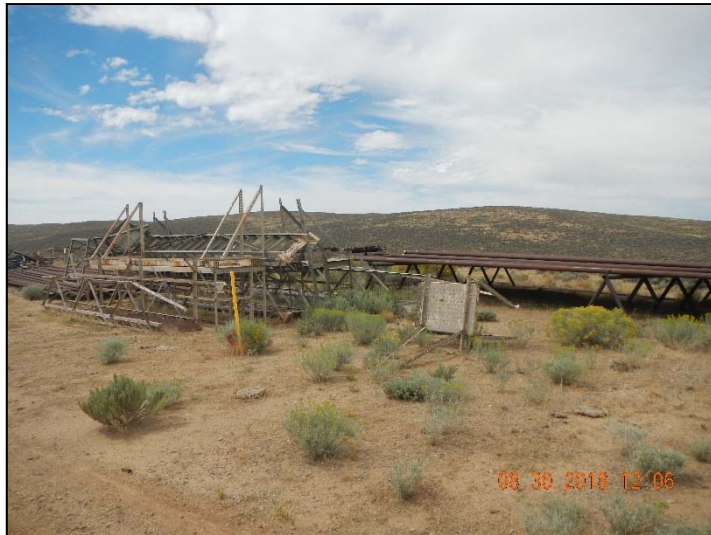
**Photo 10. Equipment stored on location.**

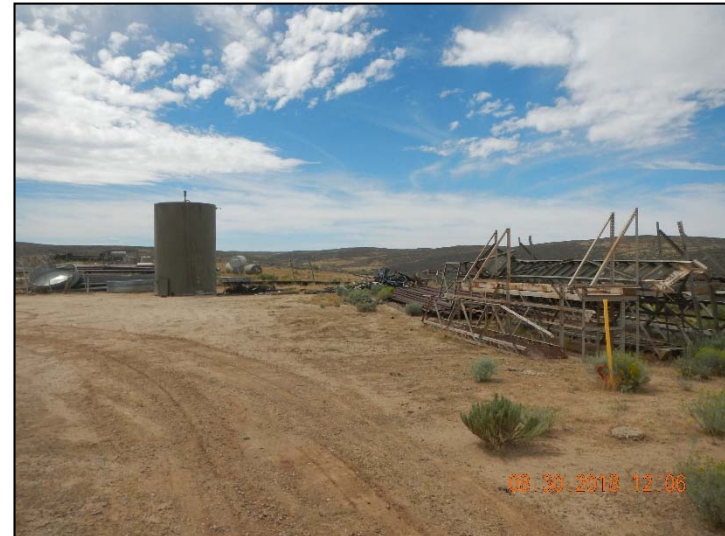
**Photo 11. Equipment stored on location.**

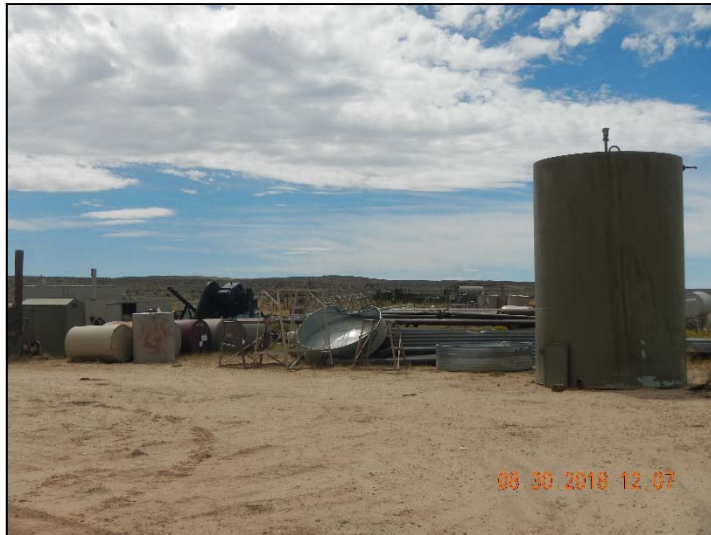
**Photo 12. Equipment stored on location.**

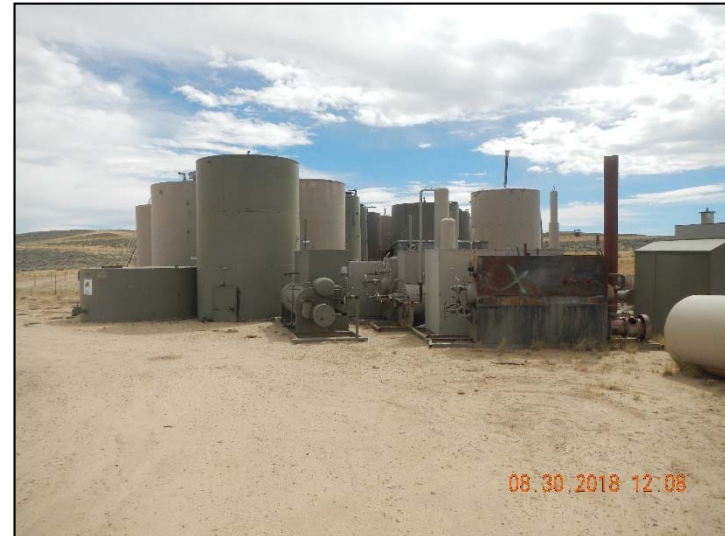
**Photo 13. Equipment stored on location.**

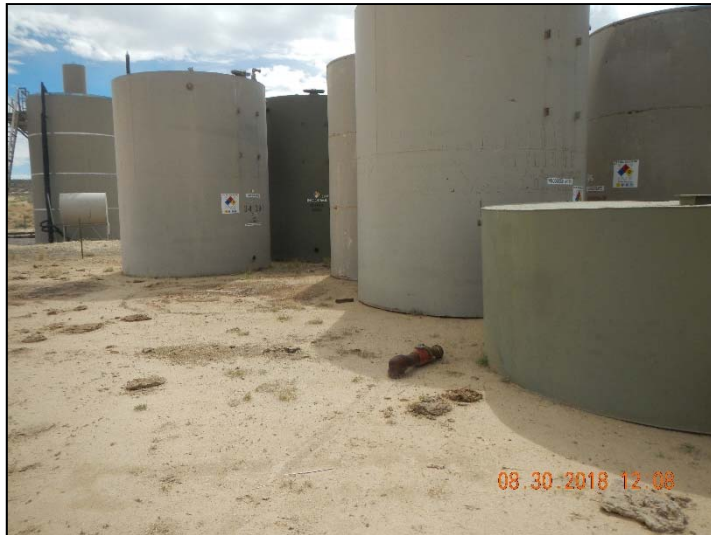
**Photo 14. Equipment stored on location.**

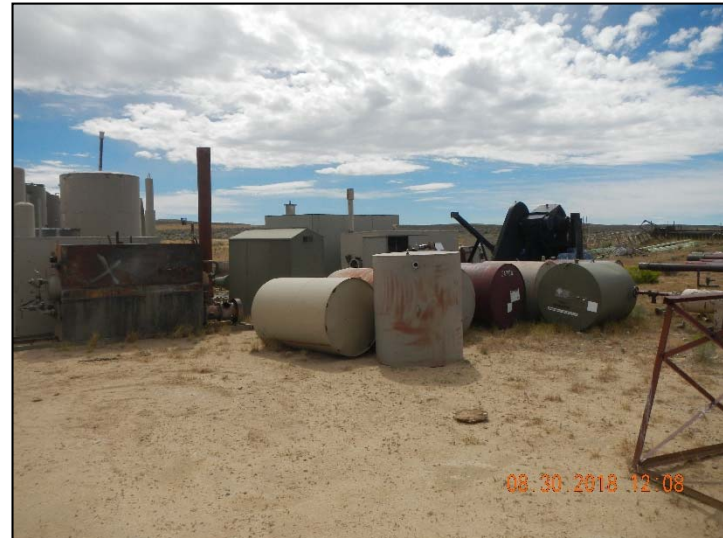
**Photo 15. Equipment stored on location.**

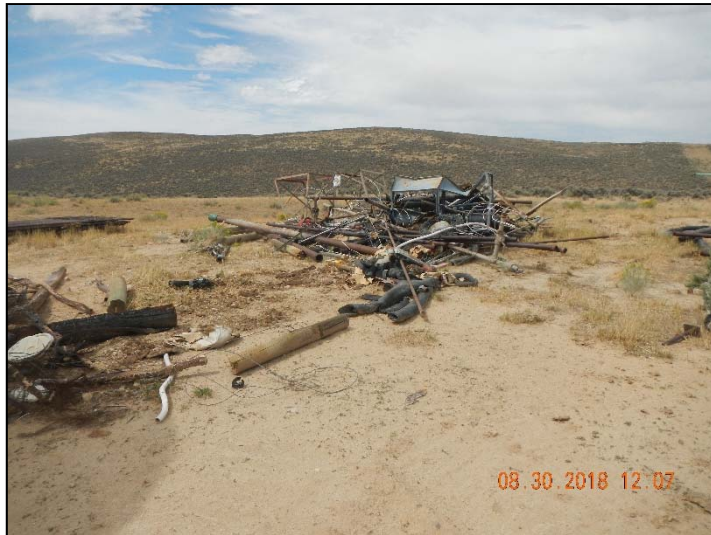
**Photo 16. Equipment stored on location.**

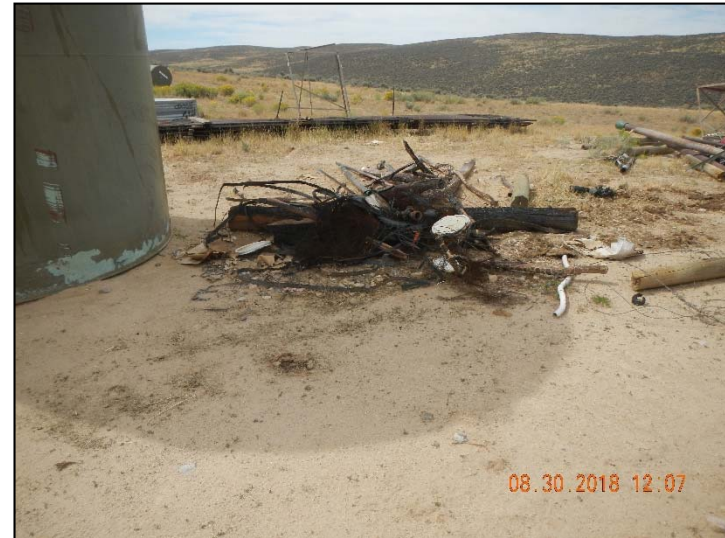
**Photo 17. Equipment stored on location.**

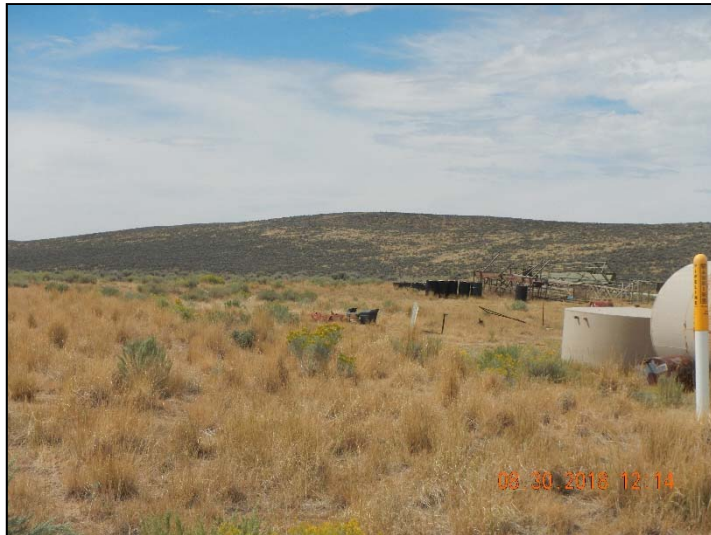
**Photo 18. Equipment stored on location.**

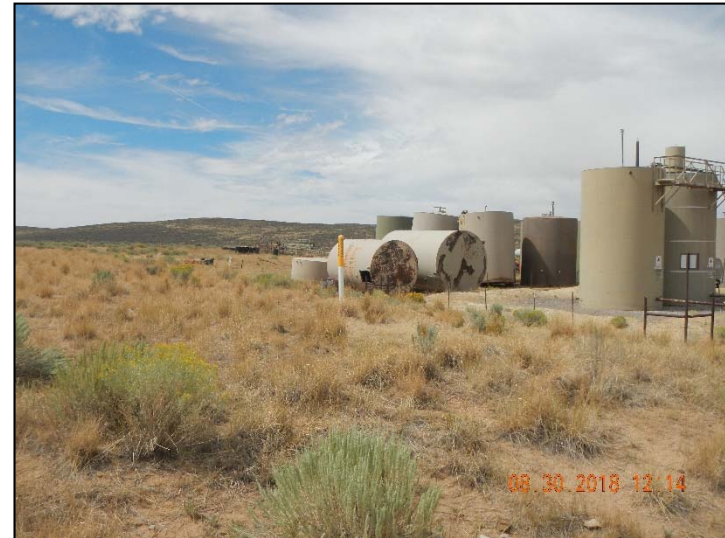
**Photo 19. Equipment stored on location.**
