Inspection Photos

Operator: BP America

API: 05-067-08808

Date: 8/16/2018

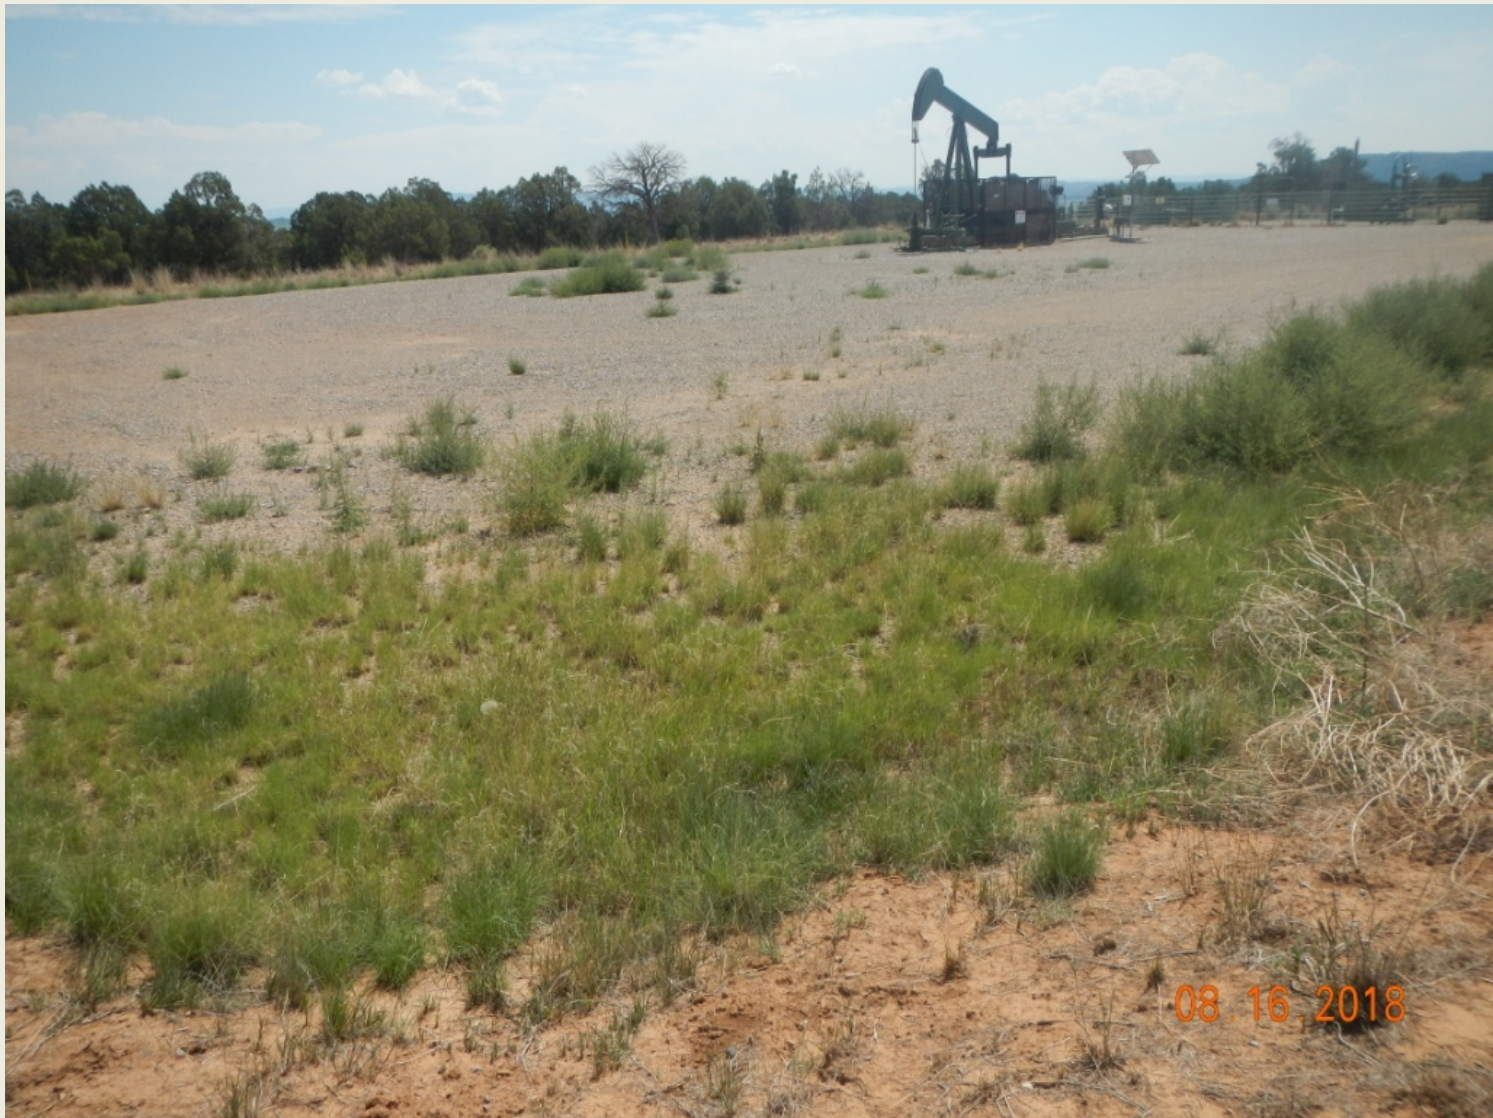
Photo 1. View of the project area from the northwestern corner facing center.

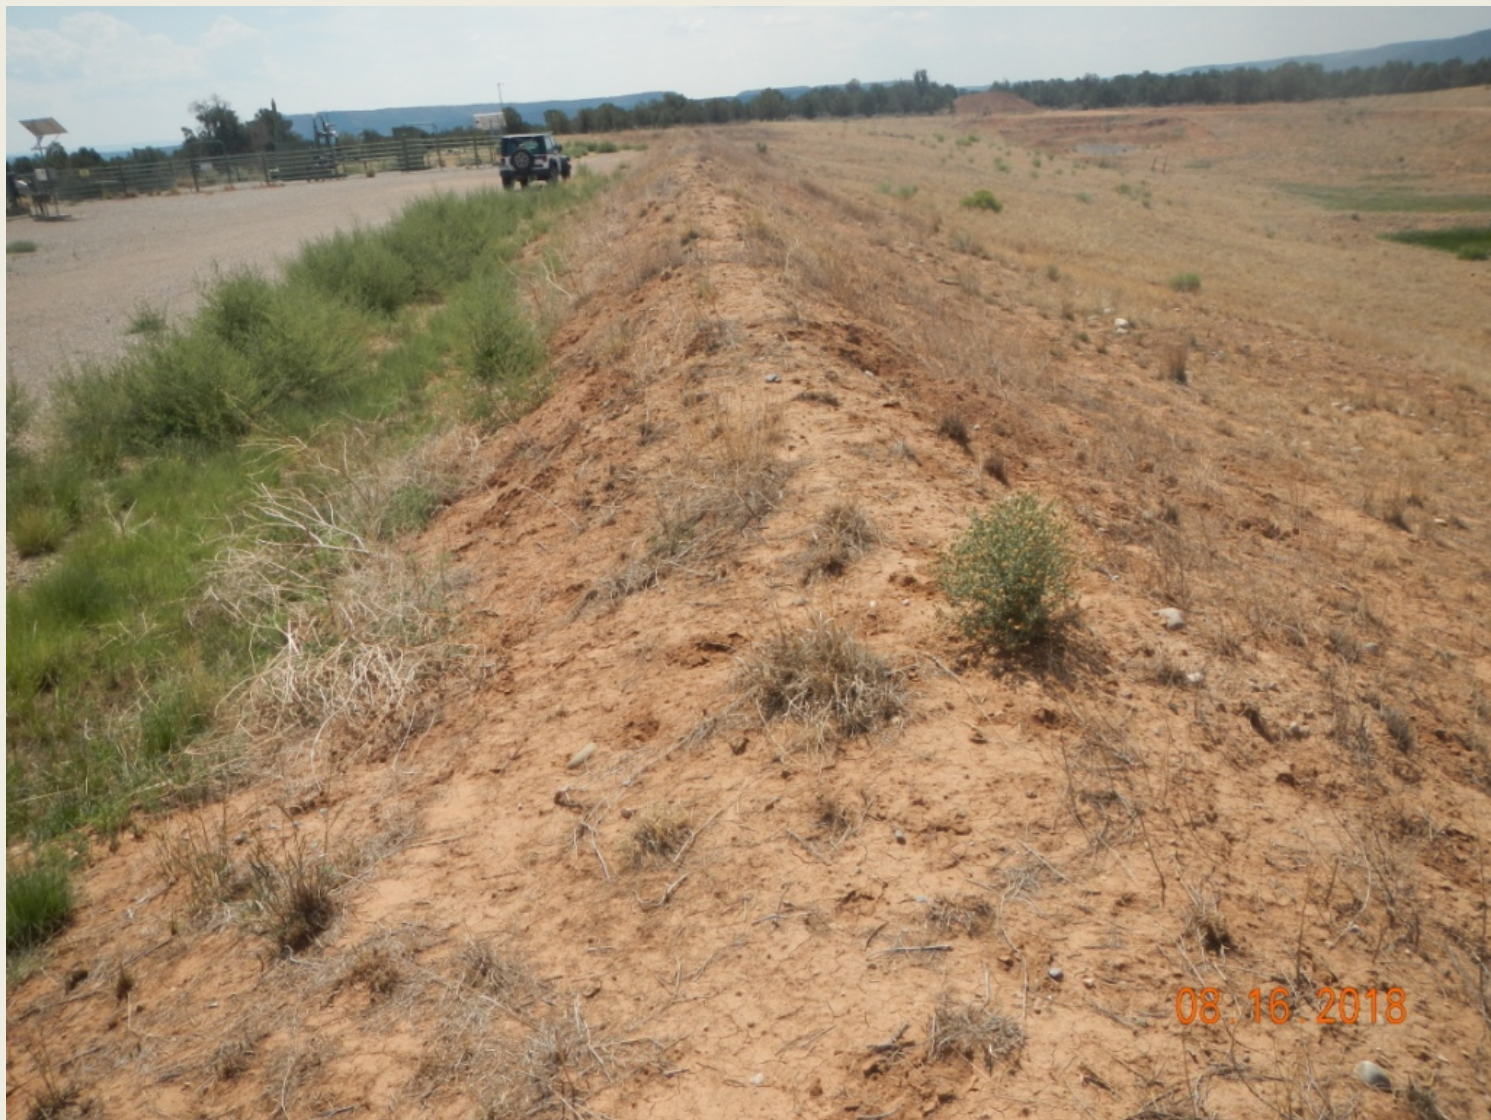
Photo 2. View of the western portion of the project area from the northwestern corner facing southward.

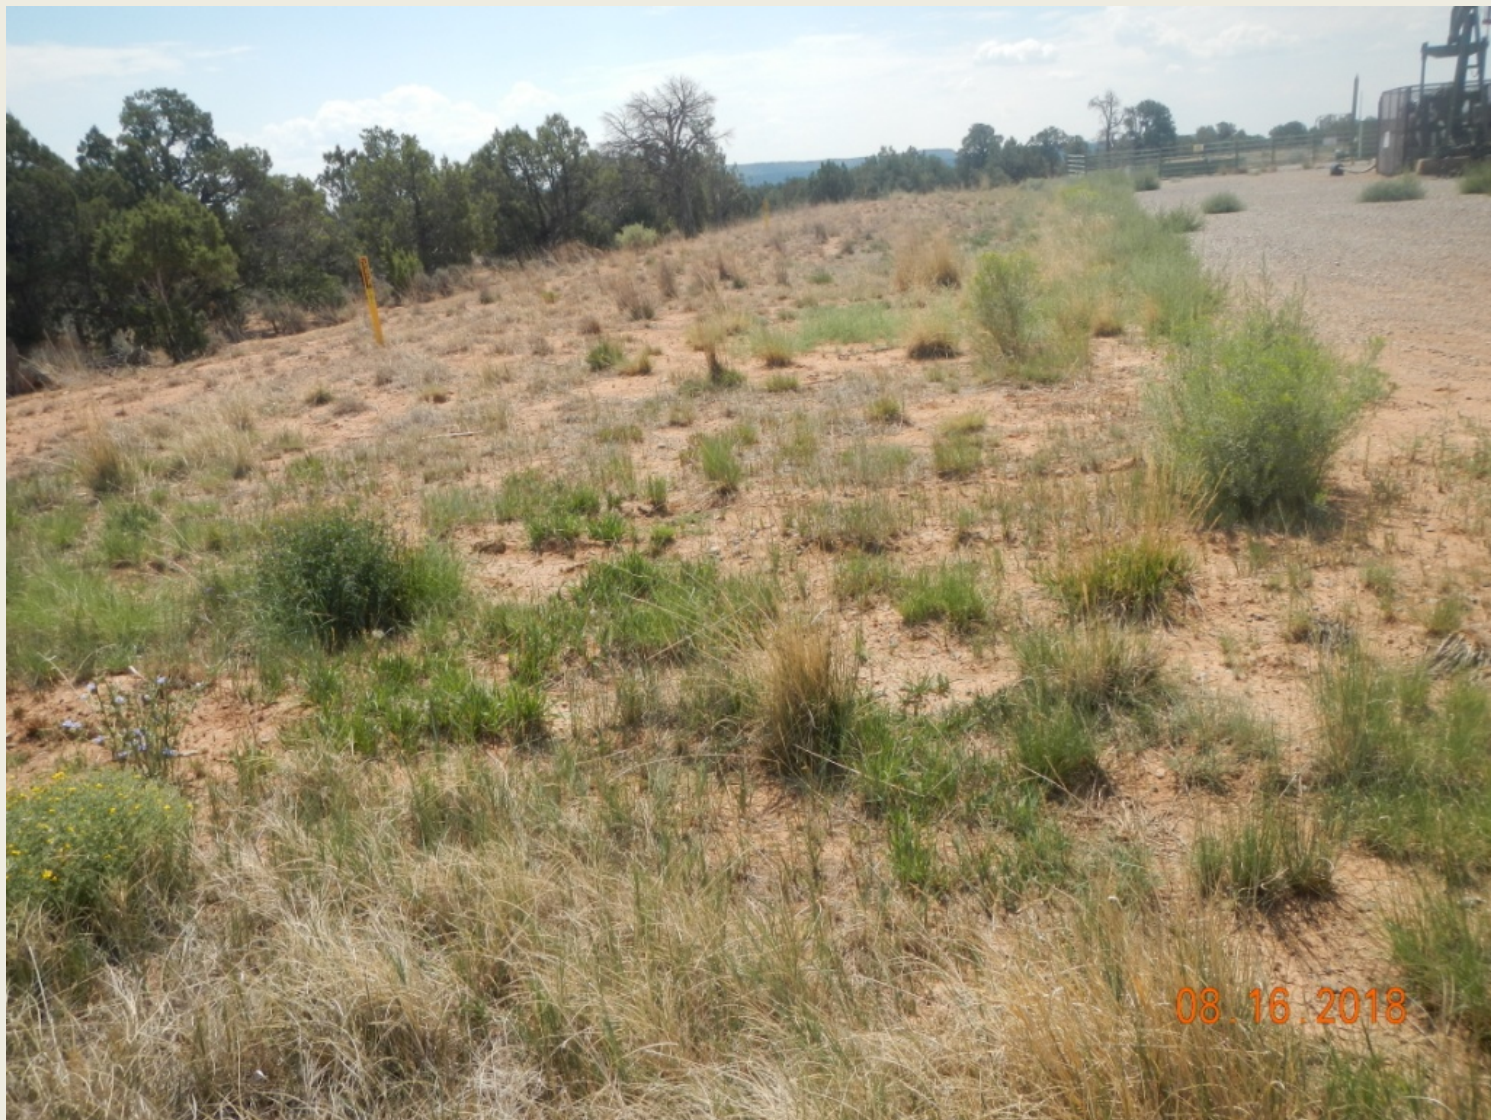
Photo 3. View of the eastern portion of the project area from the northeastern corner facing southward.

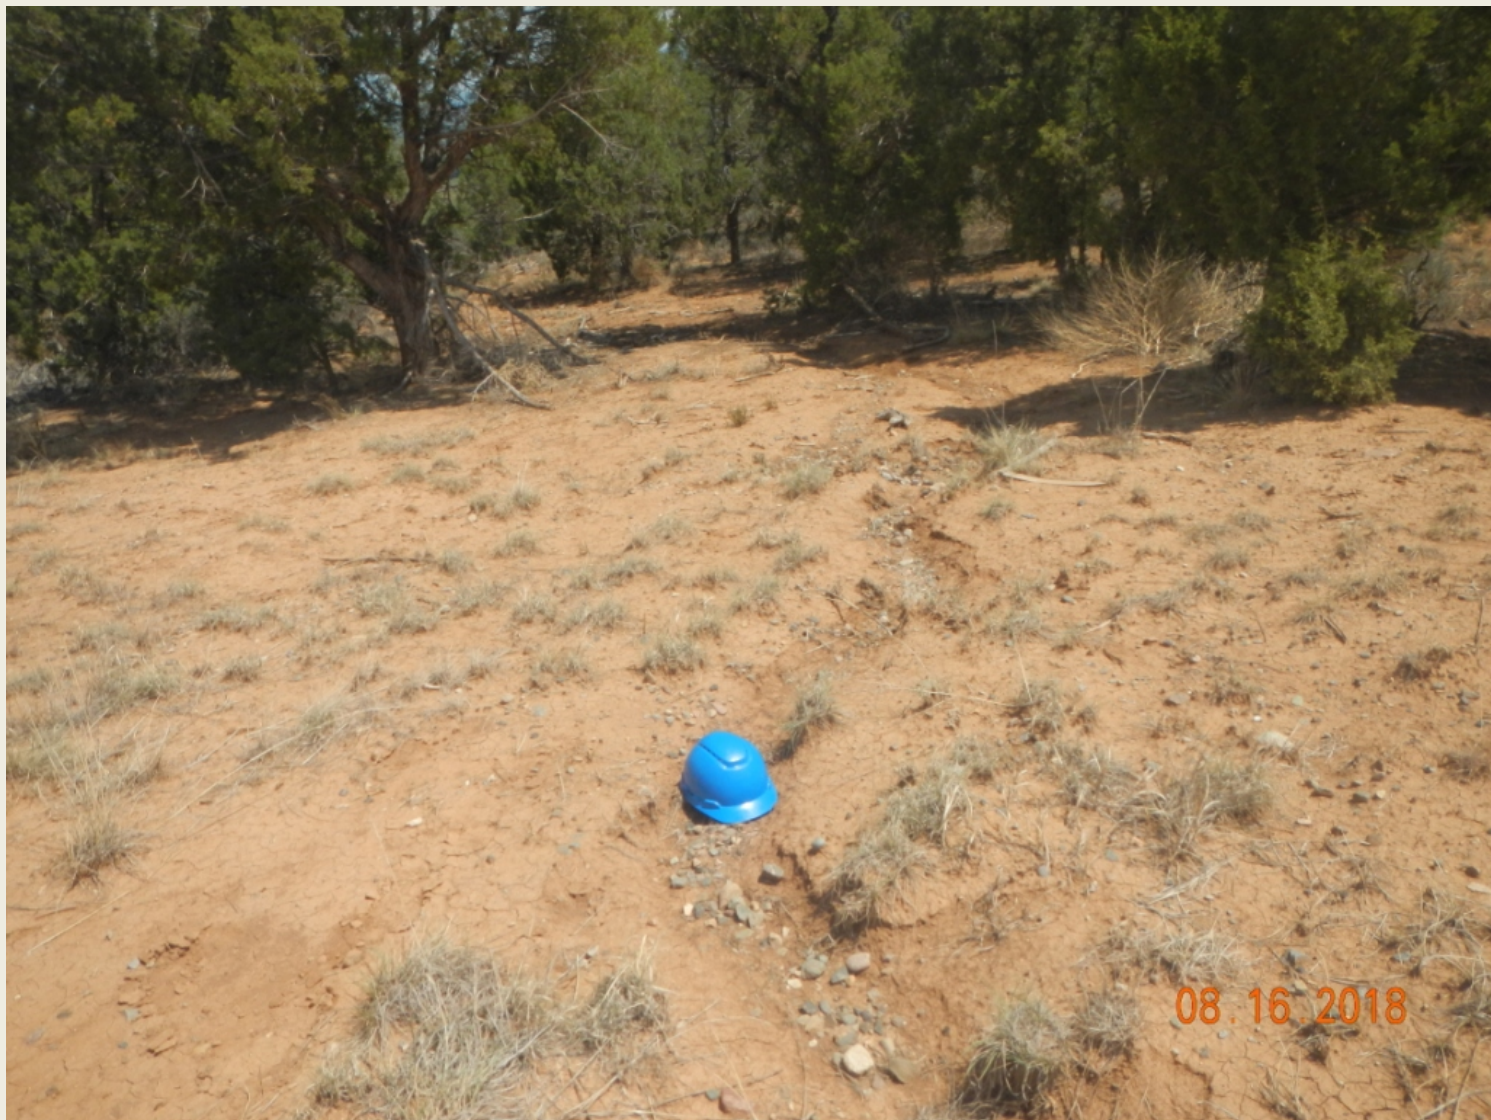
Photo 4. View of erosional channel in the northeastern project area that needs stabilization.

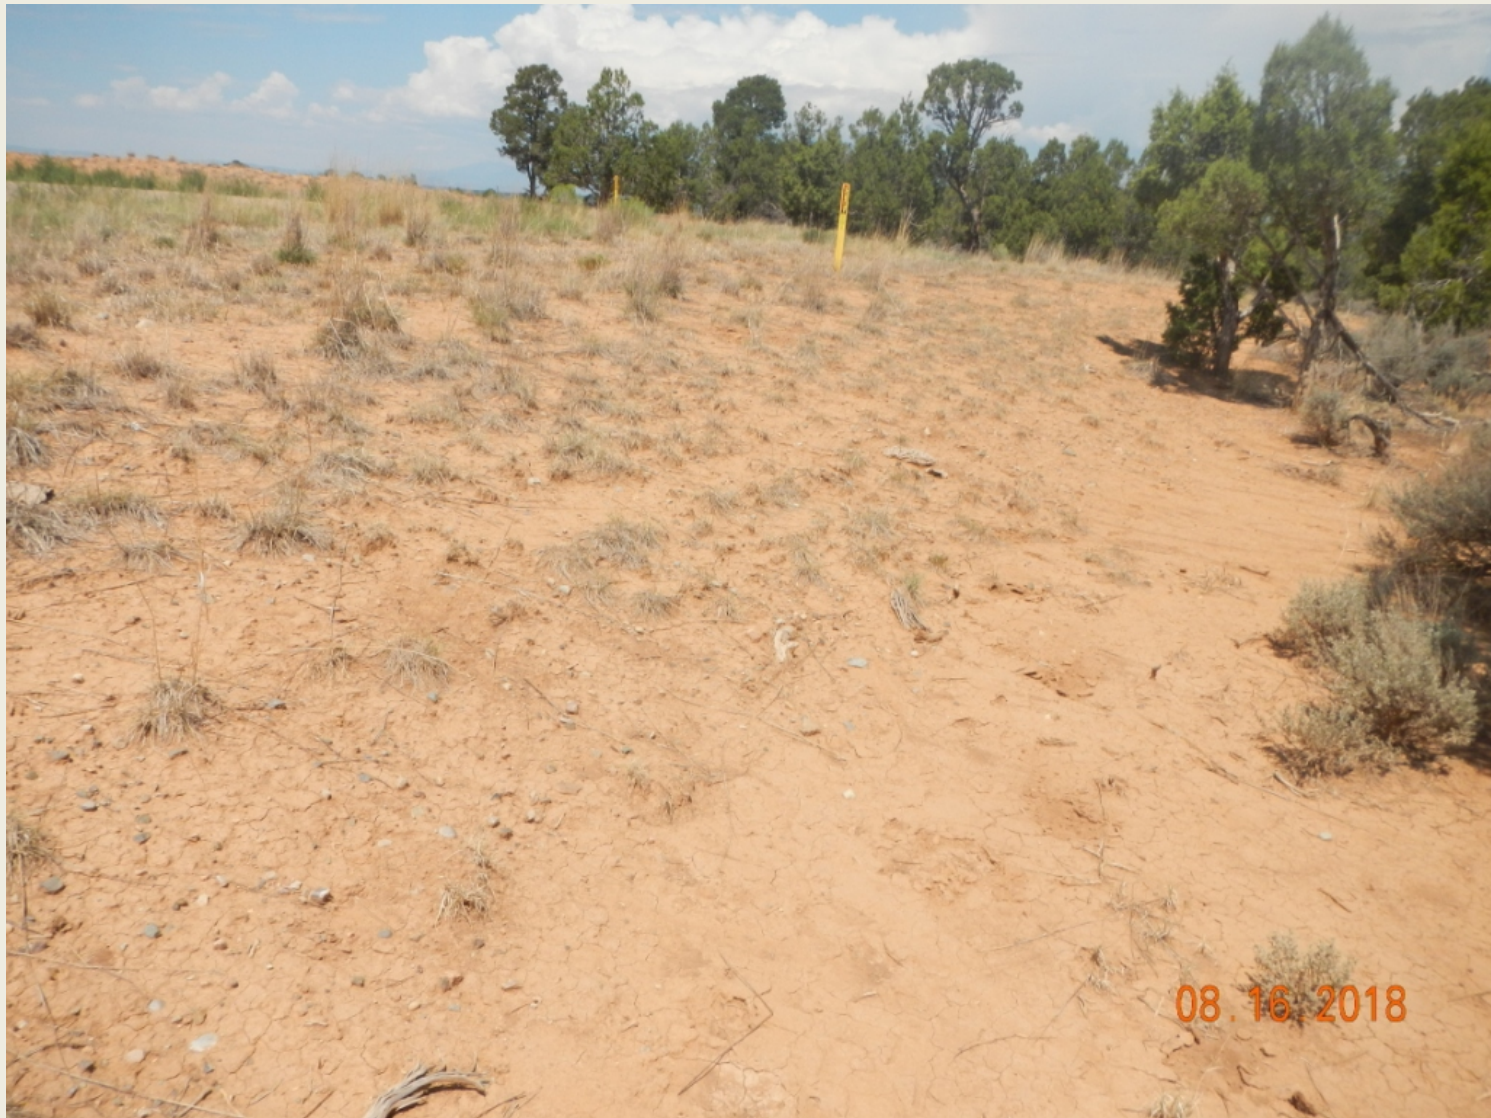
Photo 5. View of pedestaling around vegetation and sediment movement in sheet flow and rilling pattern along the eastern edge of the project area. Sediment is being deposited offsite.

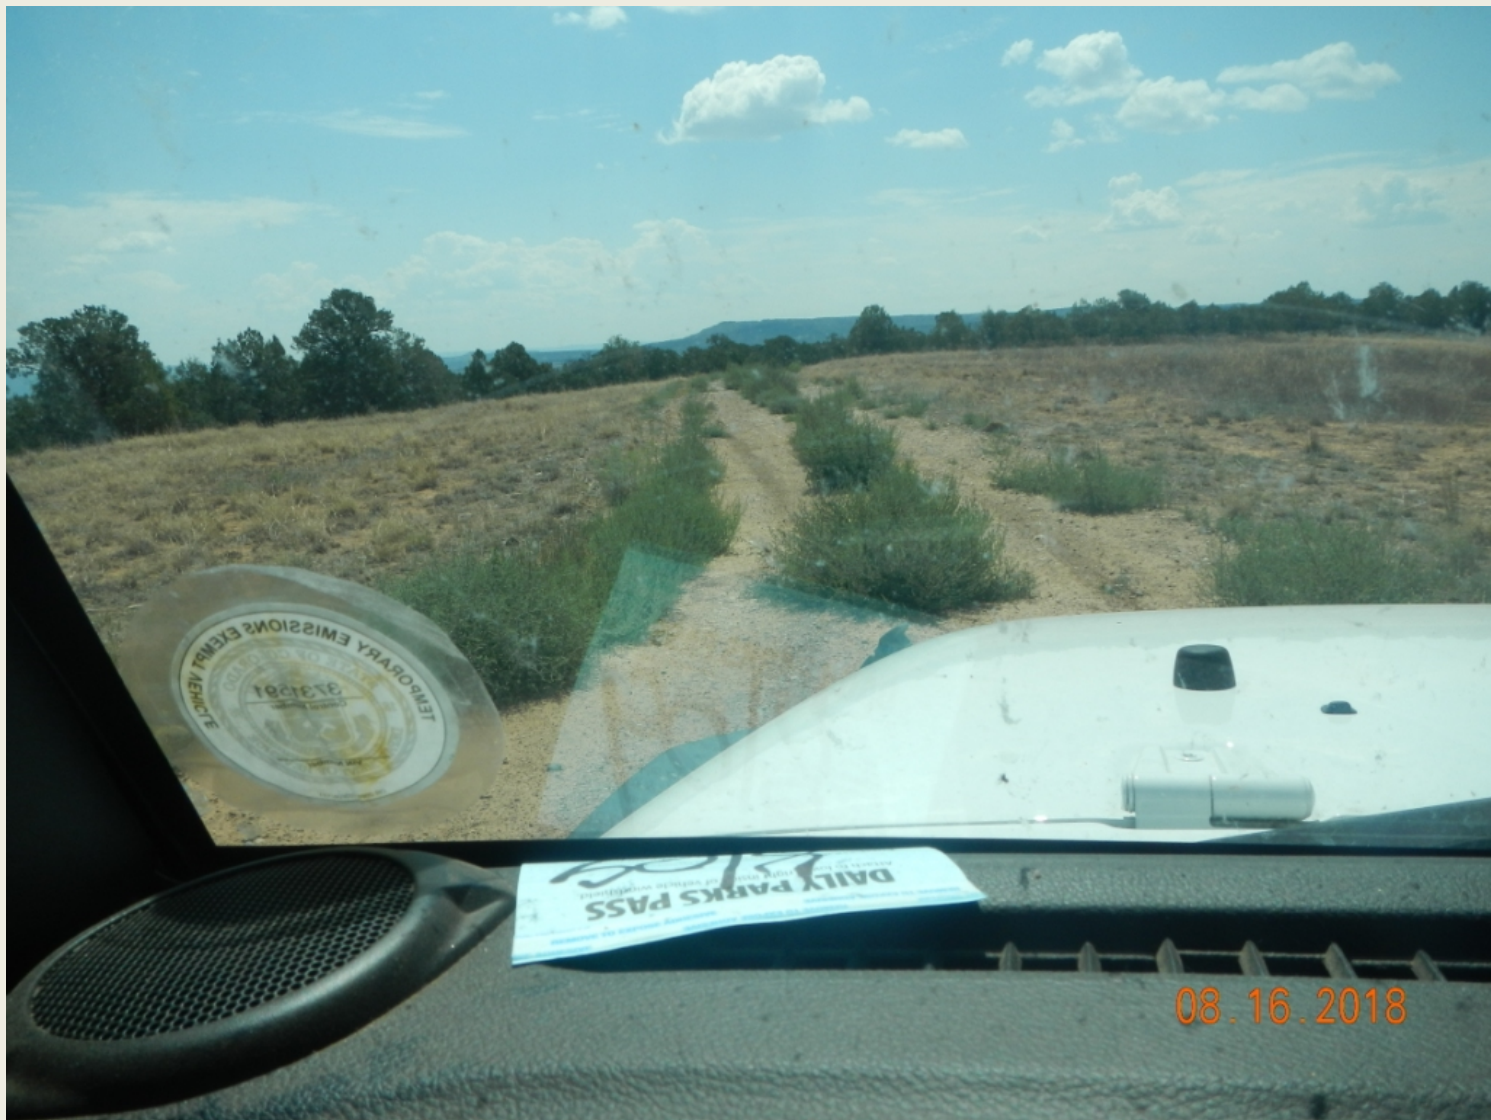
Photo 6. View of kochia (*Kochia scoparia*) that will soon dry and become debris on the access road.

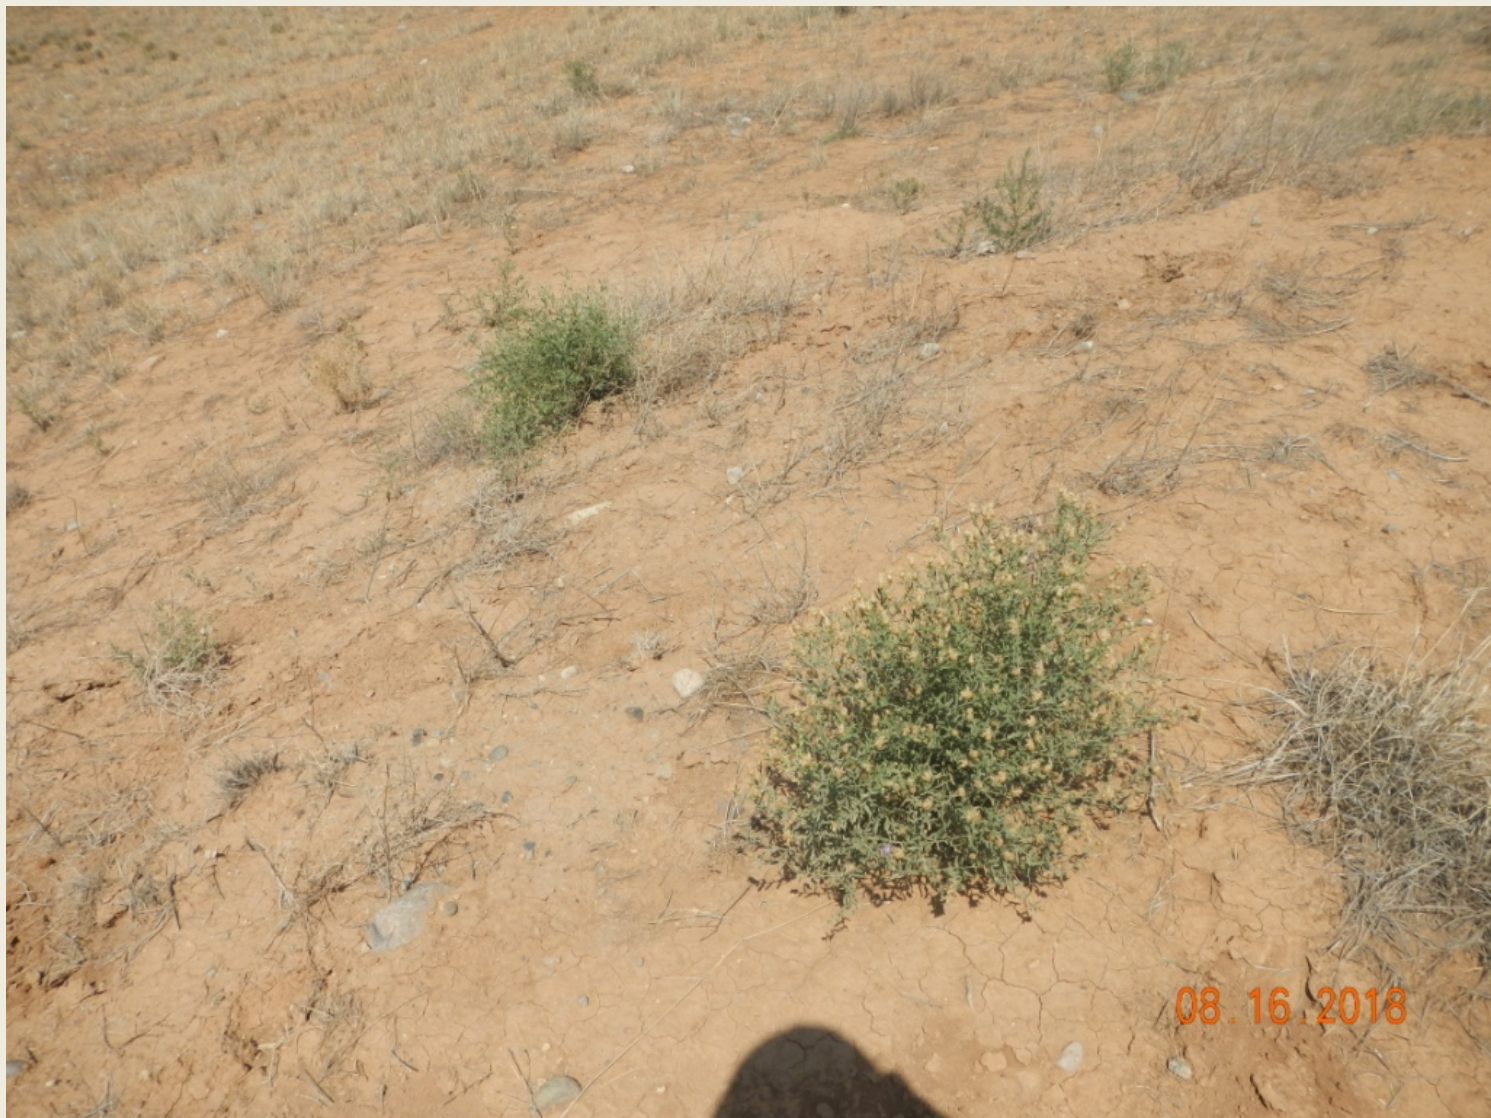
Photo 7. View of Russian knapweeds (*Rhaponticum repens*) within the northwestern portion of the project area.
