Inspection Photos

Operator: Logos Operating

API: 05-067-08097

Date: 8/16/2018

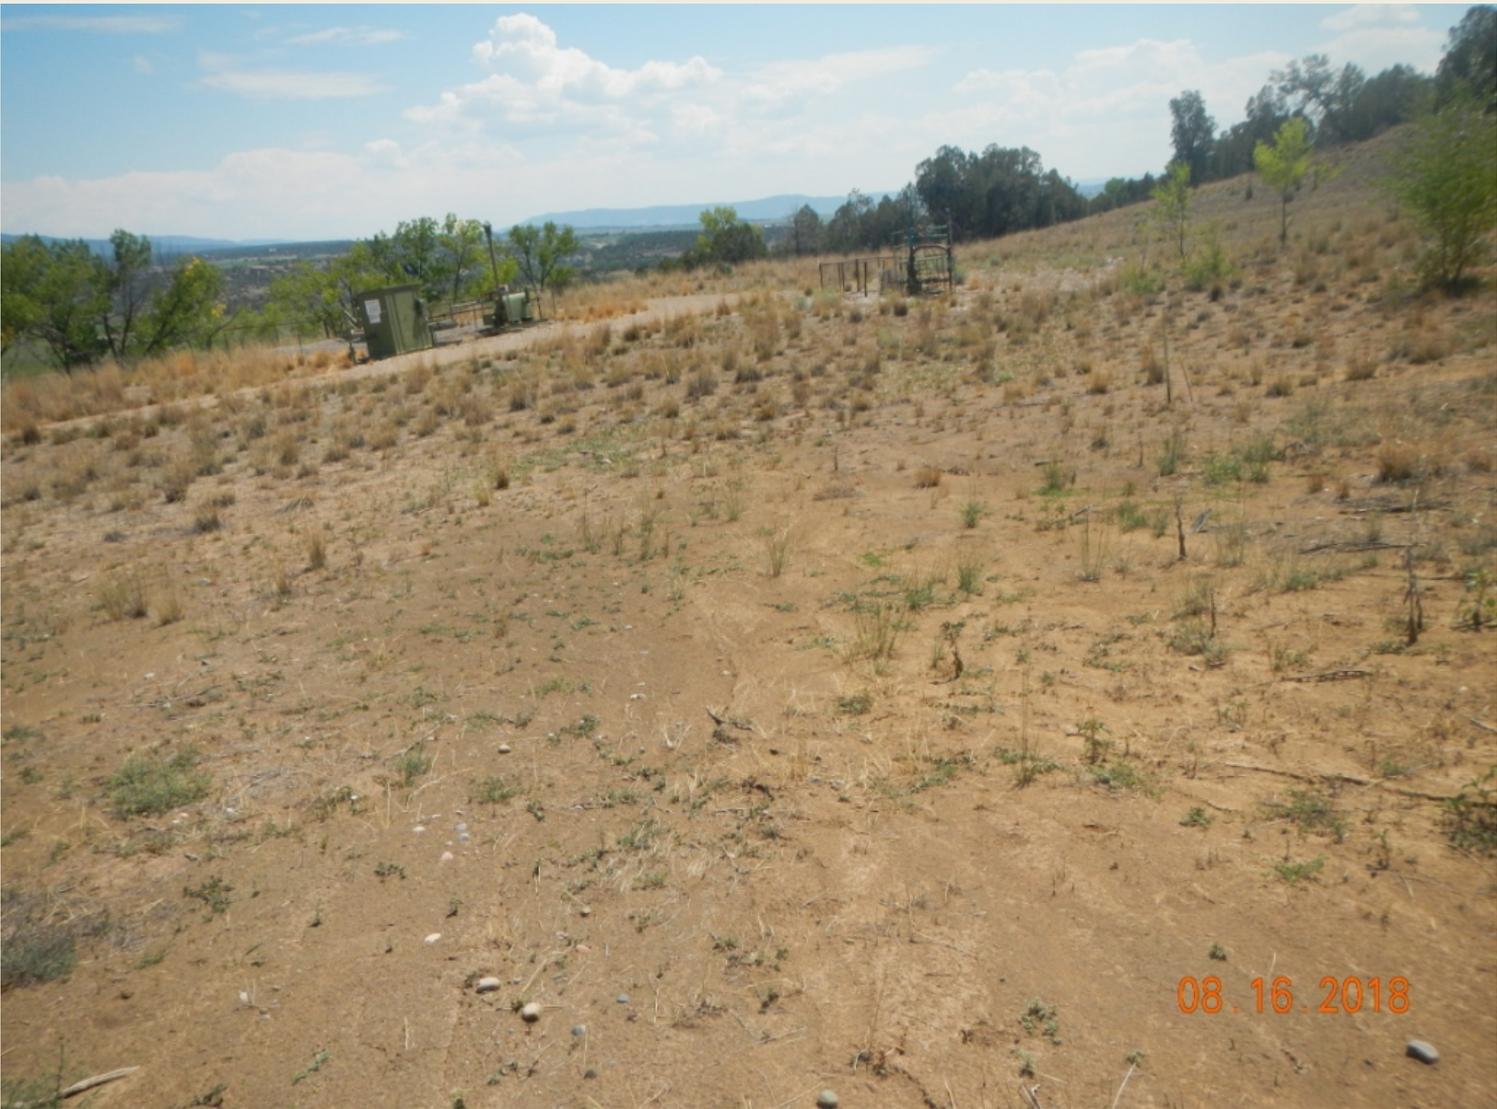
Photo 1. View of the project area from the western corner facing center.

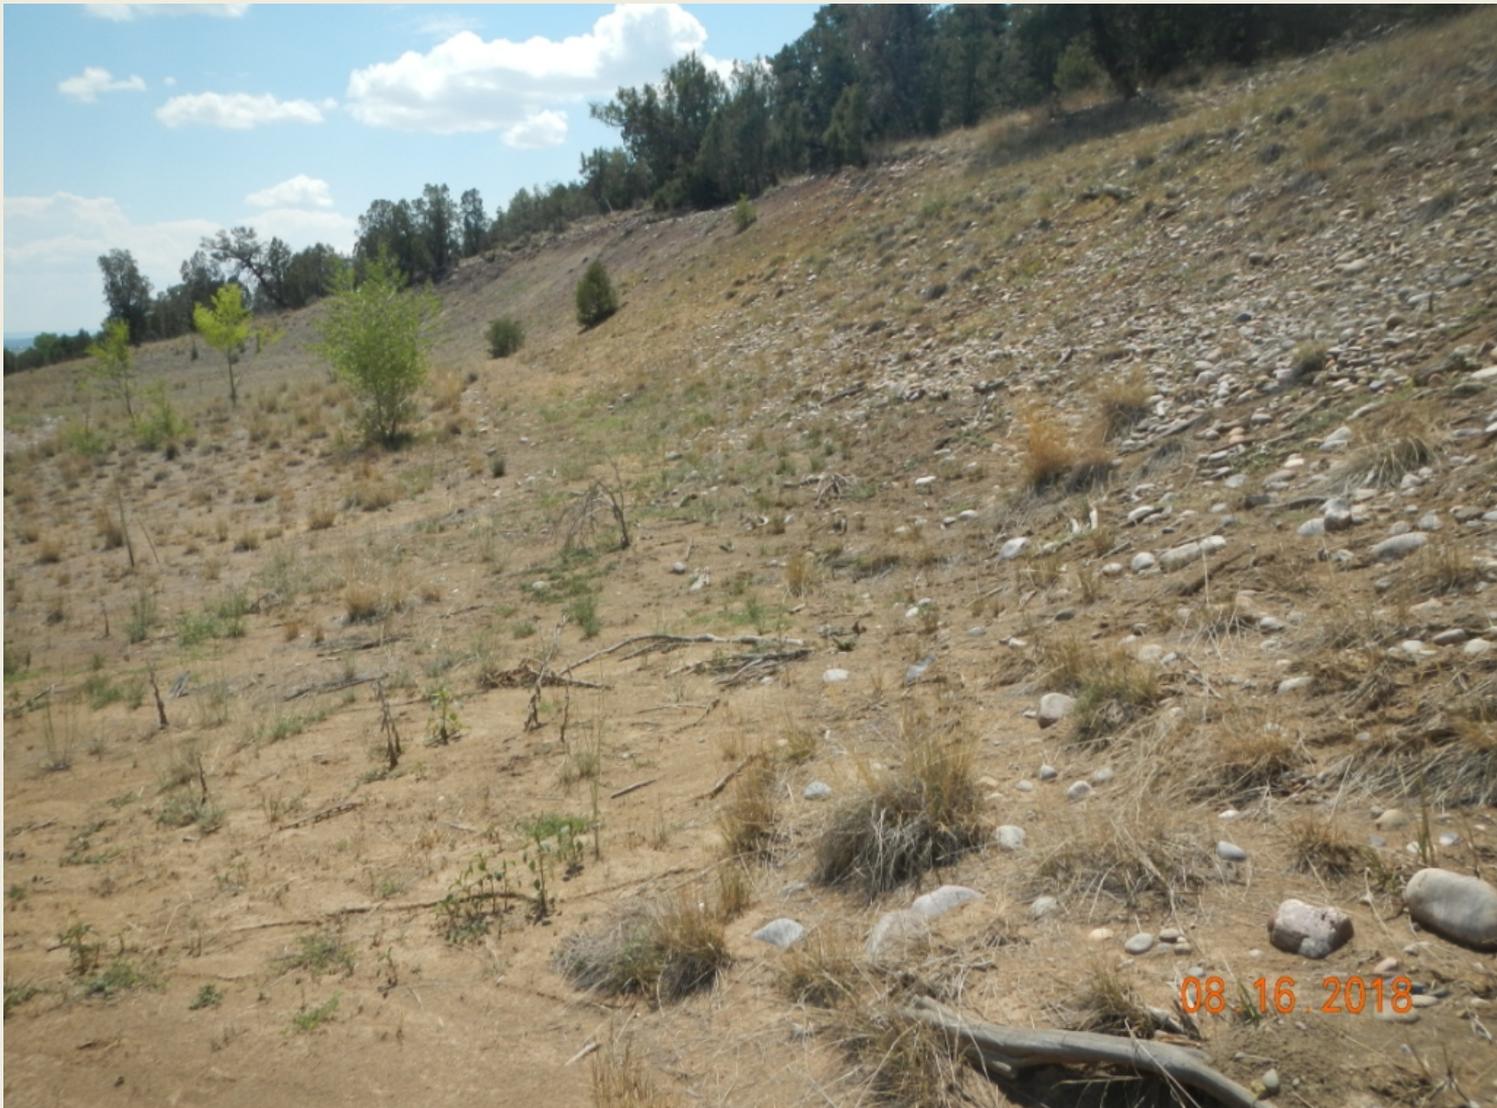
Photo 2. View of the western portion of the project area from the western corner facing southeastward.

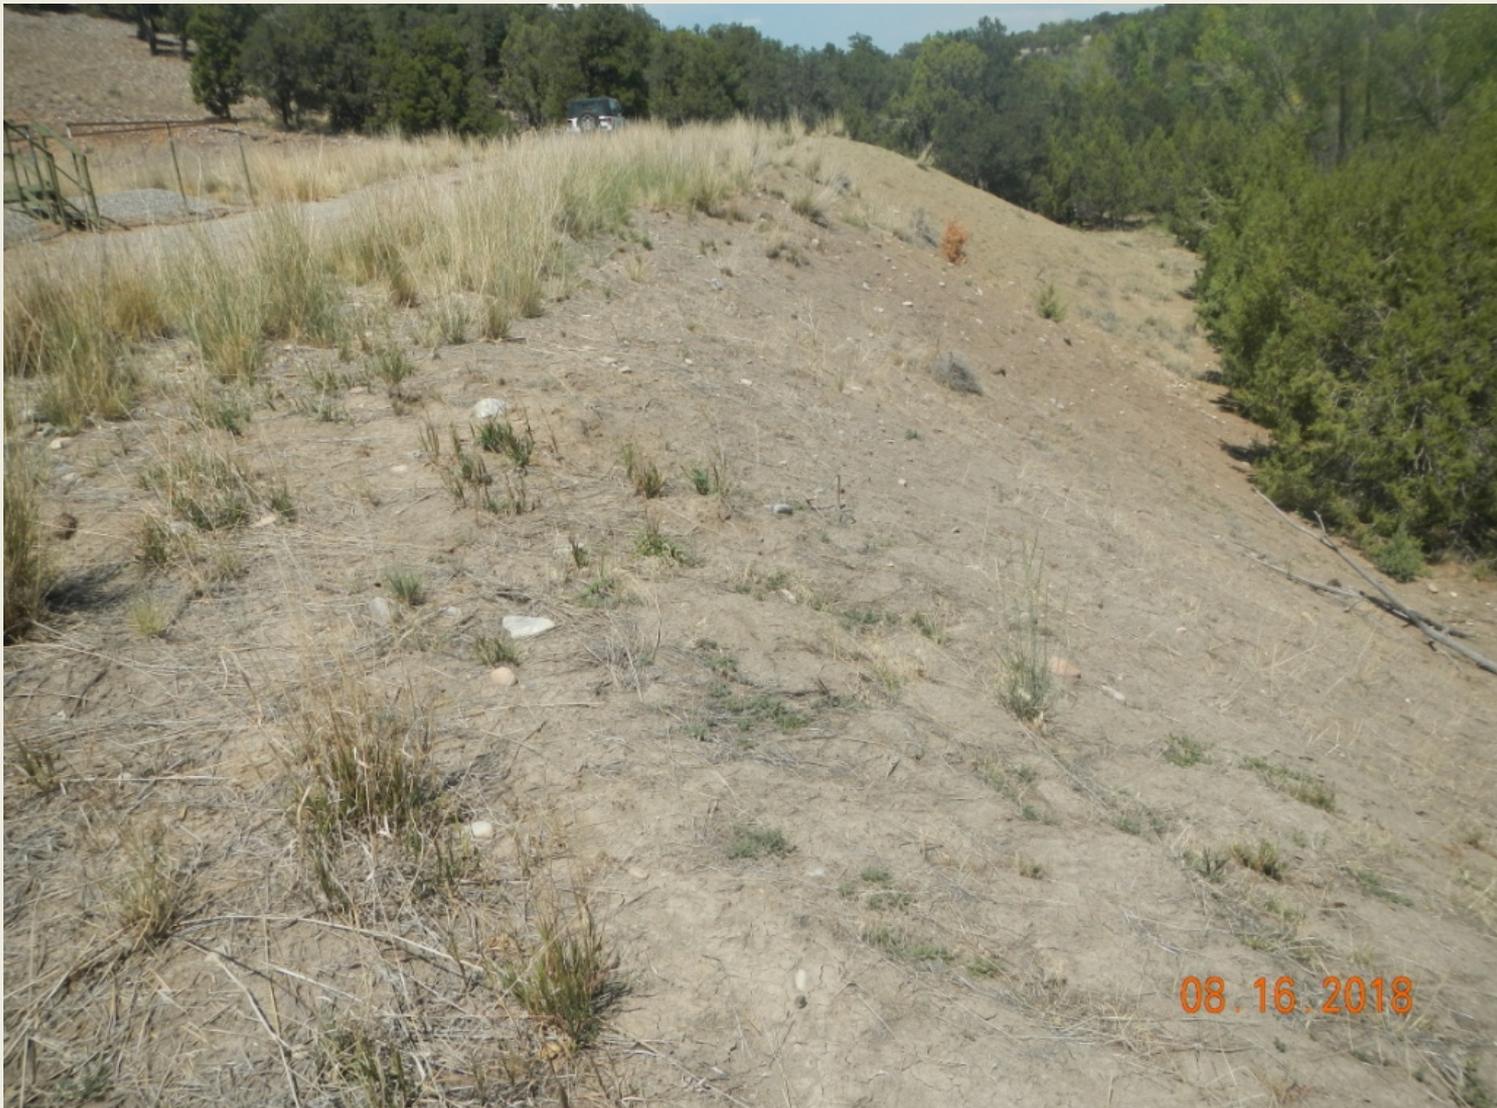
Photo 3. View of the eastern portion of the project area from the southeastern corner facing northward. Revegetation is sparse on the fill slope. Many grasses appear to be dried out.

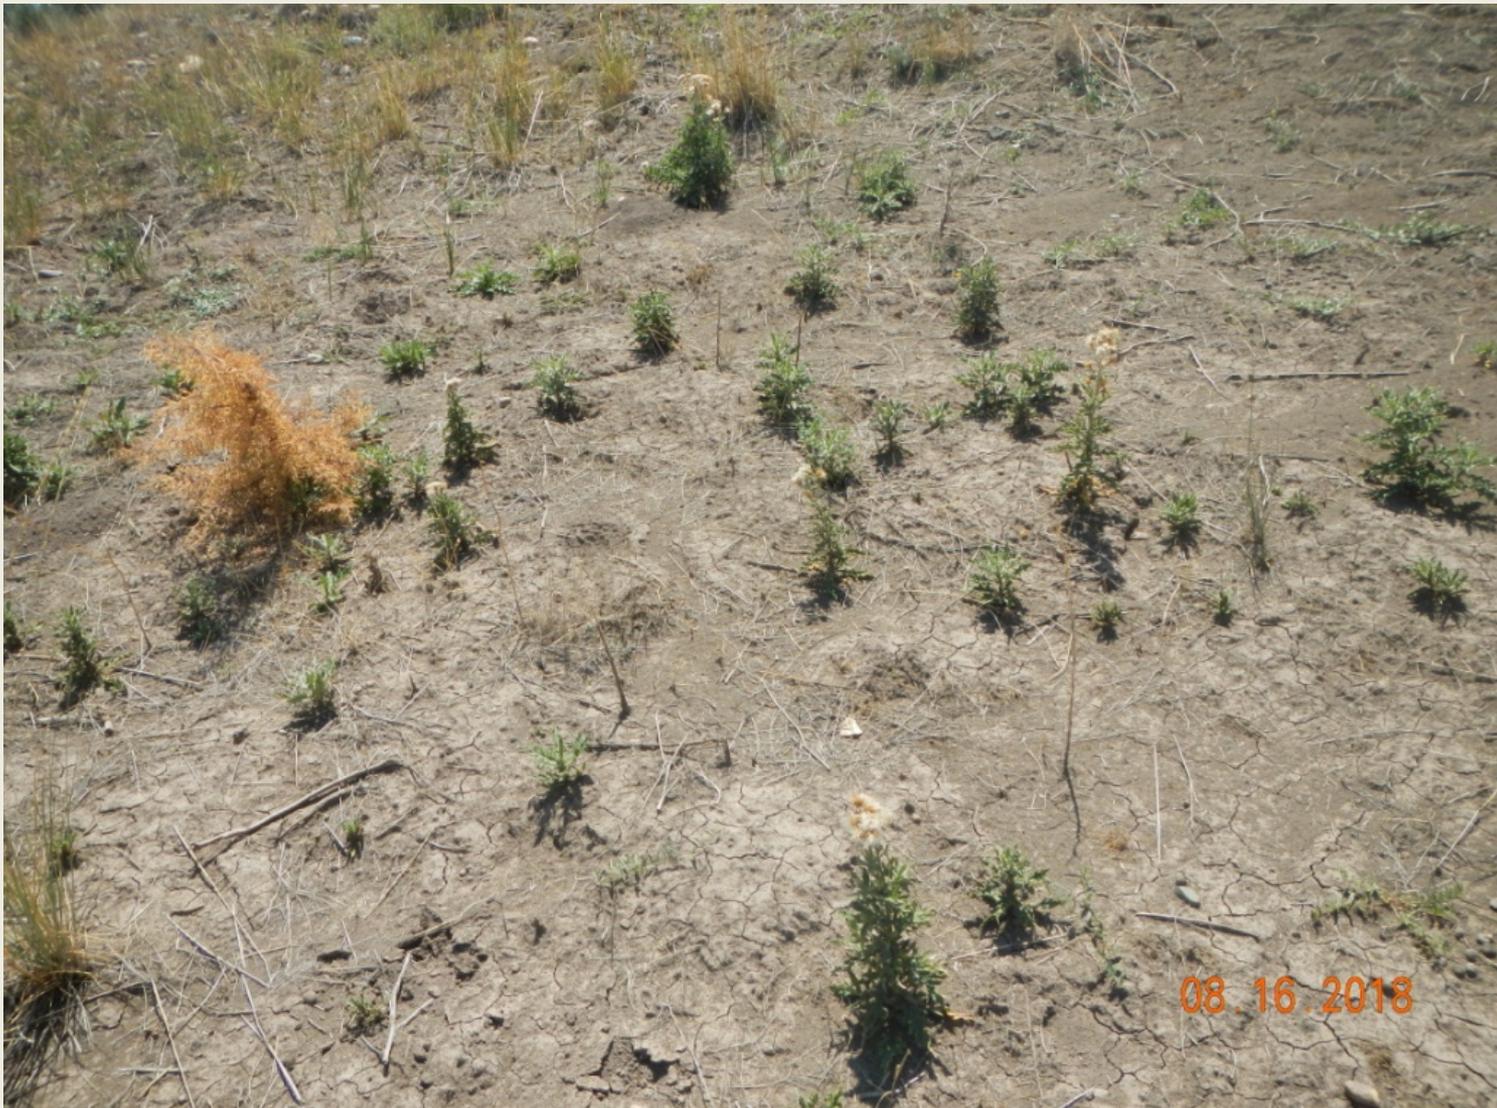
Photo 4. View of Canada thistles (*Cirsium arvense*) within the southern project area.

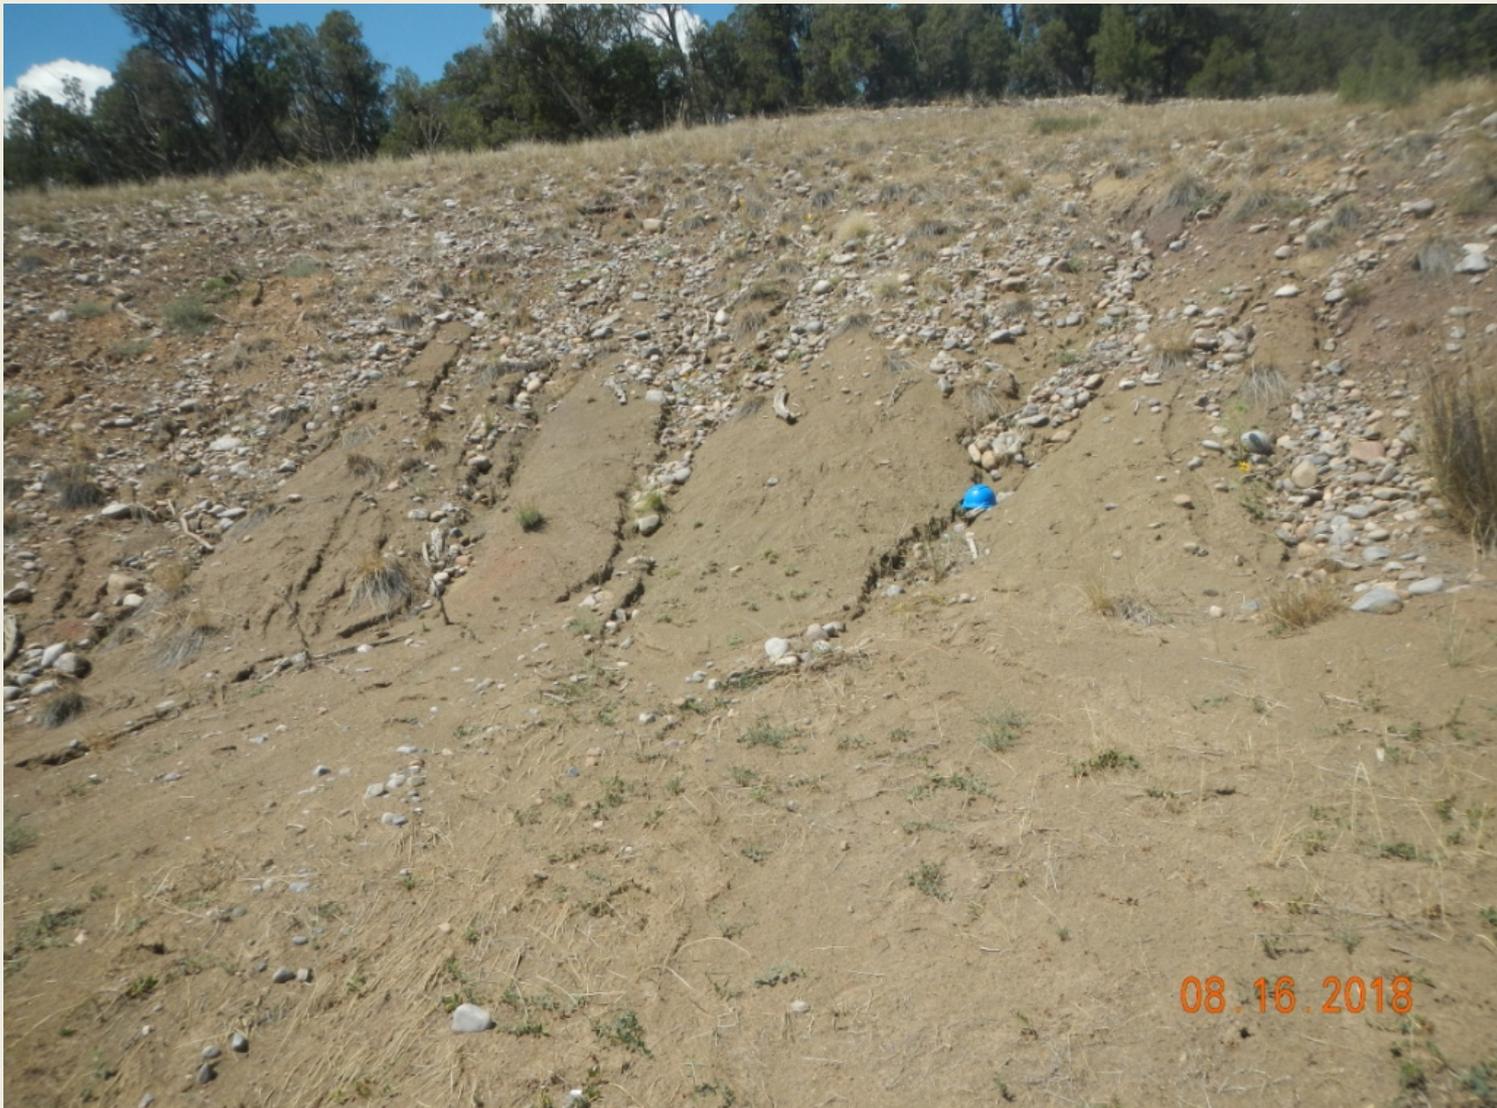
Photo 5. View of erosional channels and sediment deposition within the northwestern cut-slope.

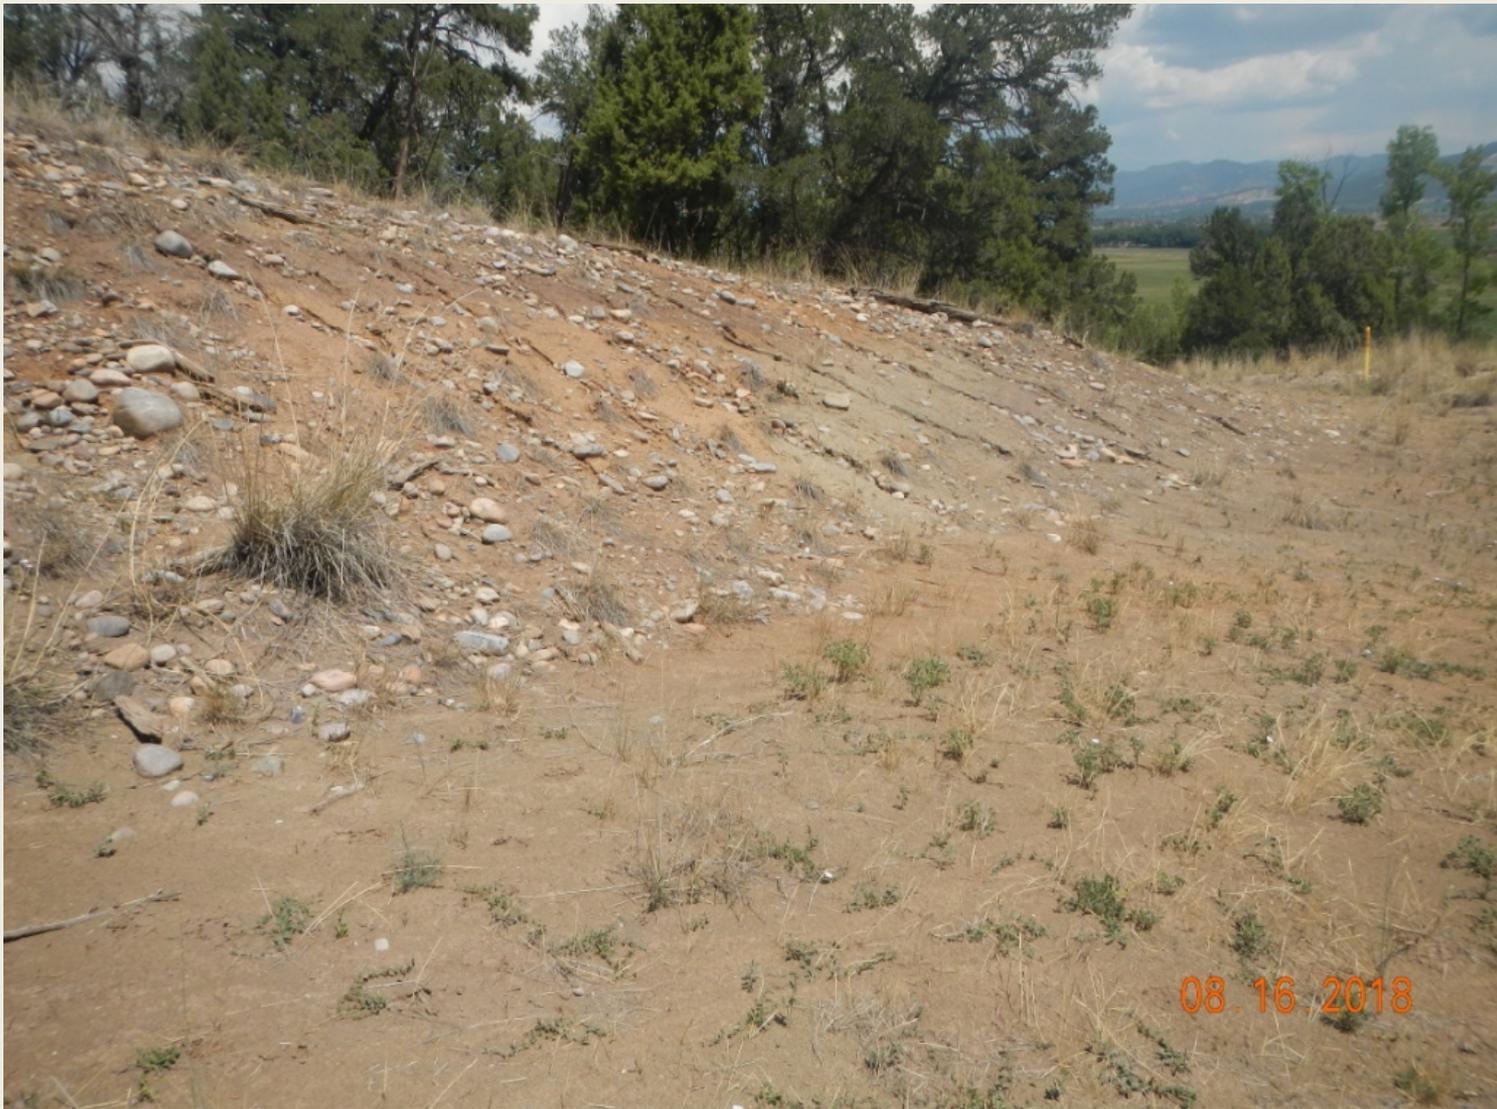
Photo 6. View of the northern portion of the project area from the northwestern corner facing eastward. Erosional channels and sediment deposition is occurring within this portion of the project area.

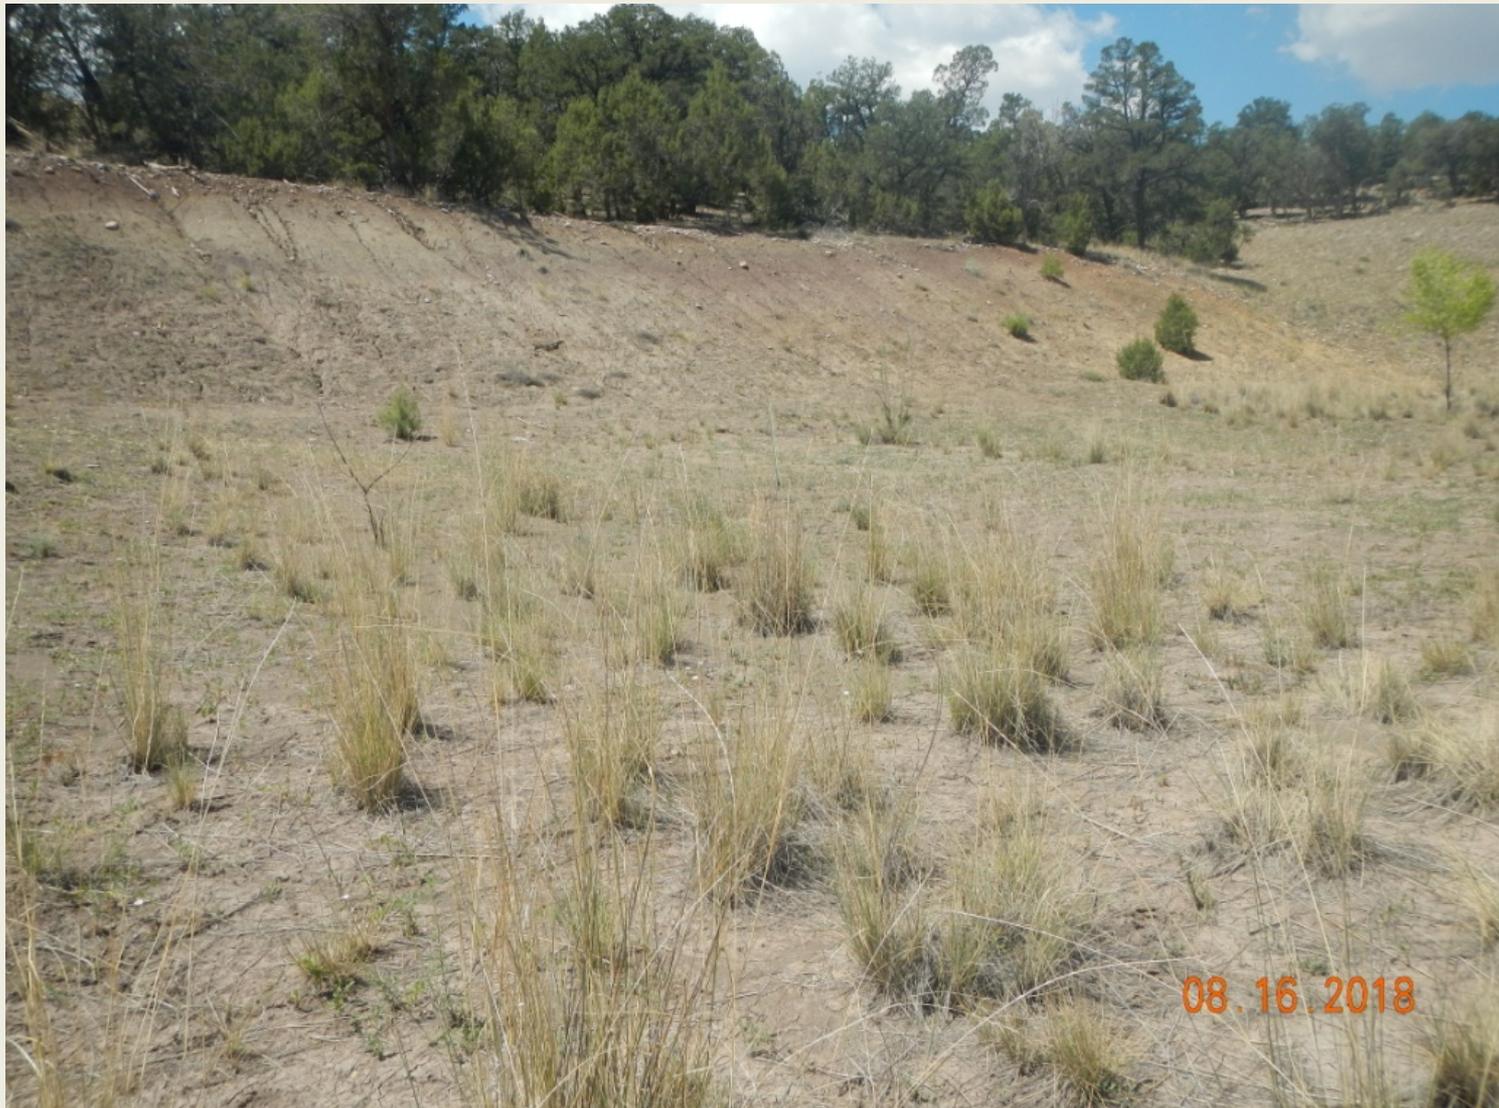
Photo 7. View of the southern and southwestern cut-slope from the southern edge facing westward. Erosion is occurring in this portion of the cut-slope near the top where vegetation is not established.
