# Inspection Photos

Operator: BP America

API: 05-067-06998

Date: 8/16/2018

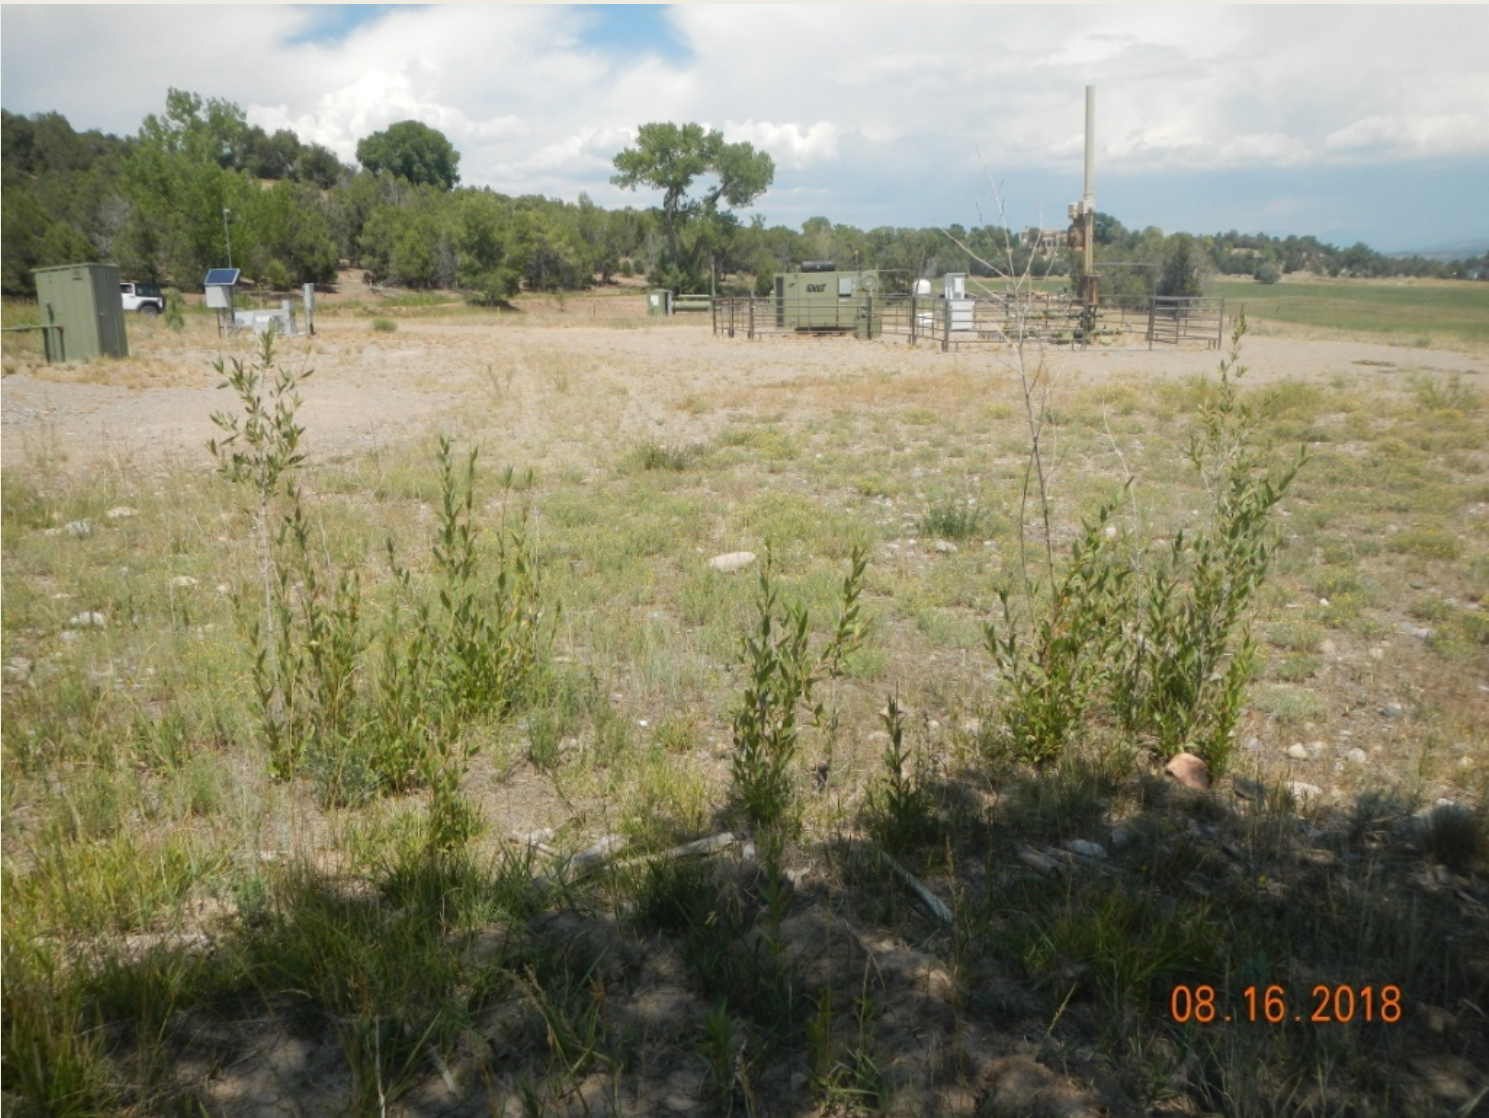
**Photo 1. View of the project area from the southern edge facing center. Revegetation is progressing within the southern project area.**

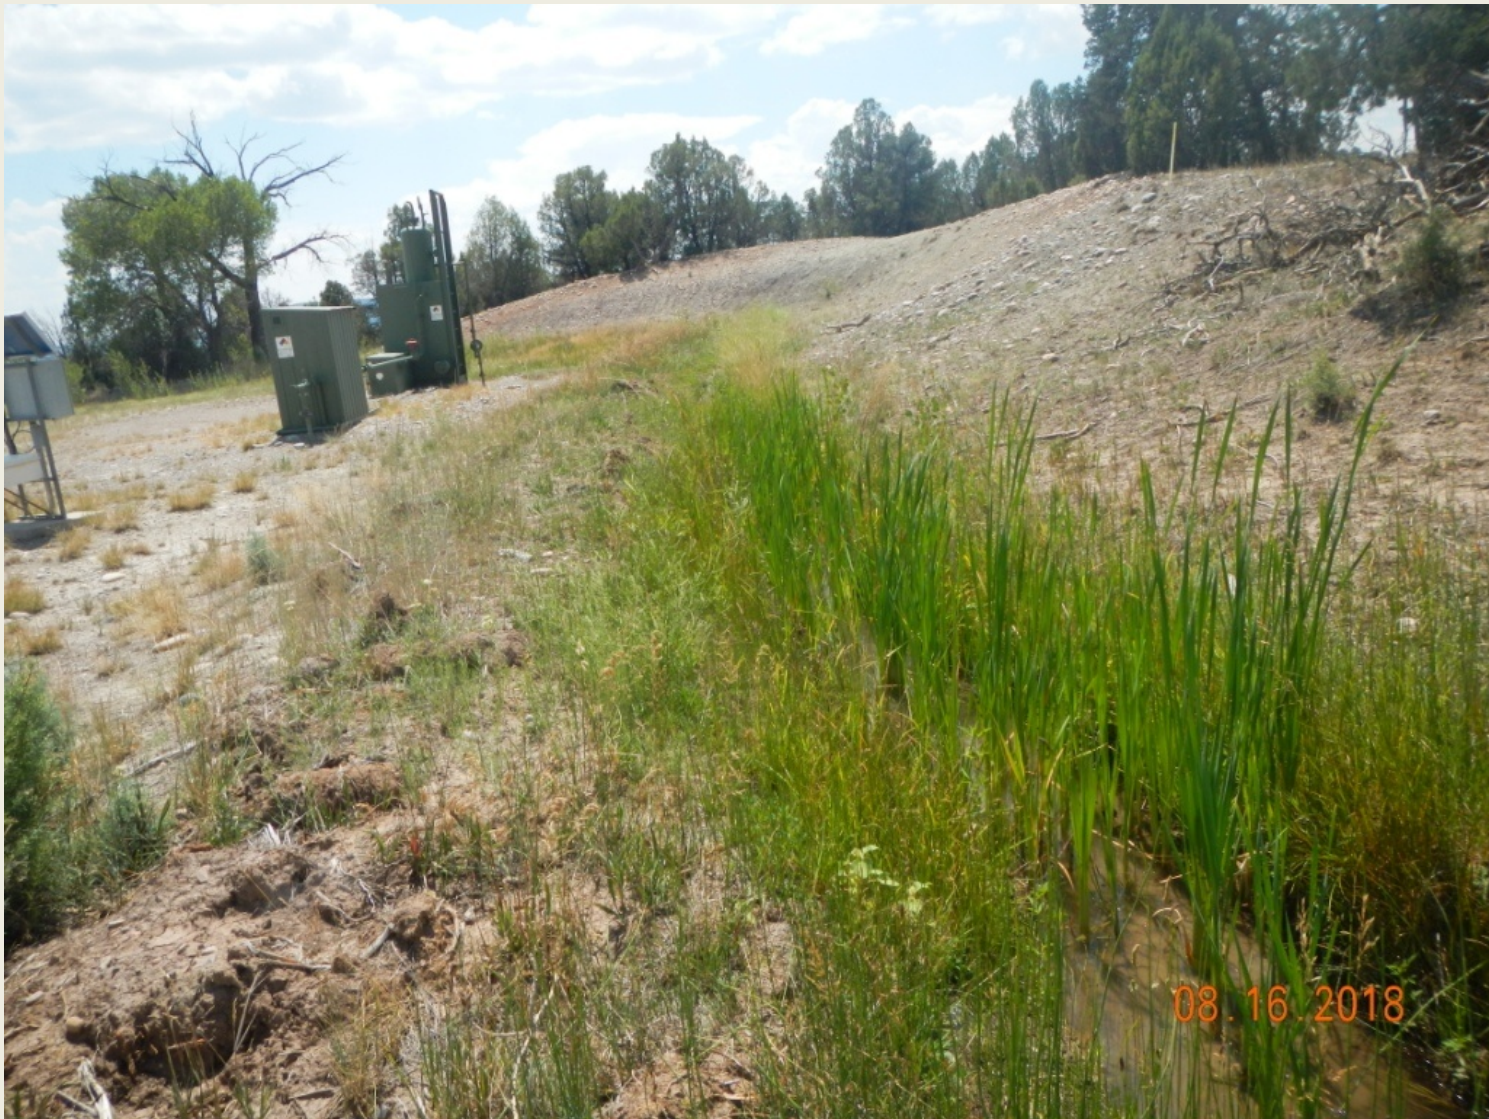
**Photo 2. View of the western corner of the project area from the northwestern corner facing southward.**

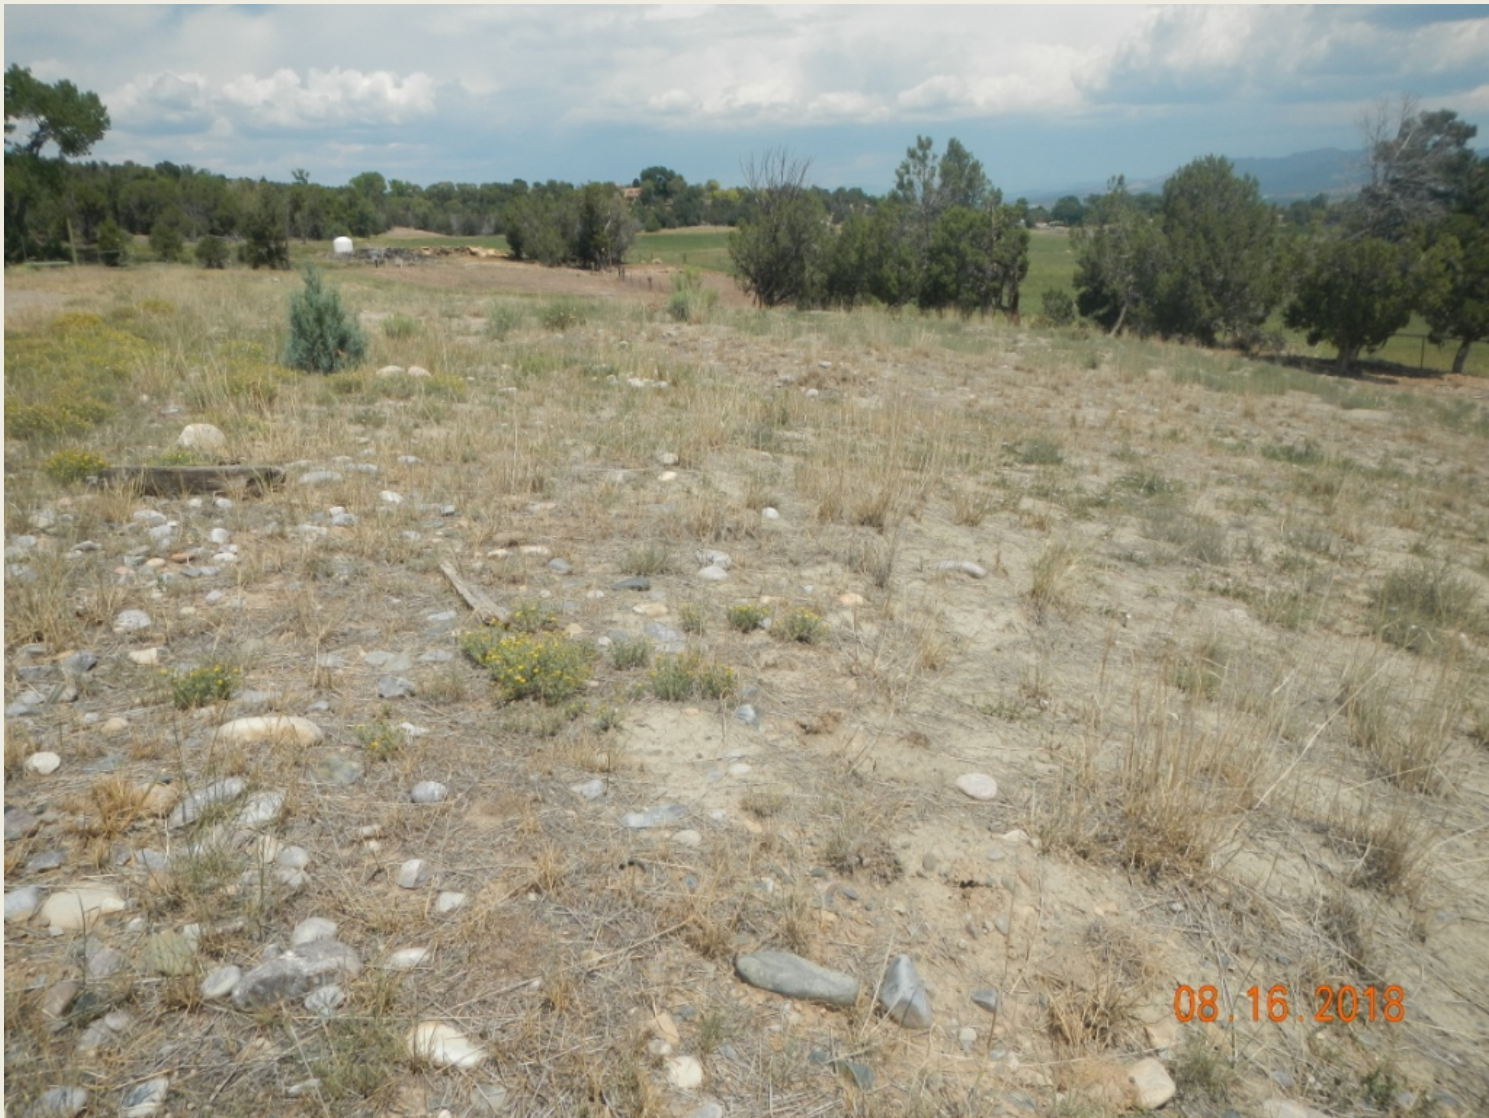
**Photo 3. View of the eastern portion of the project area from the southeastern corner facing northward.**

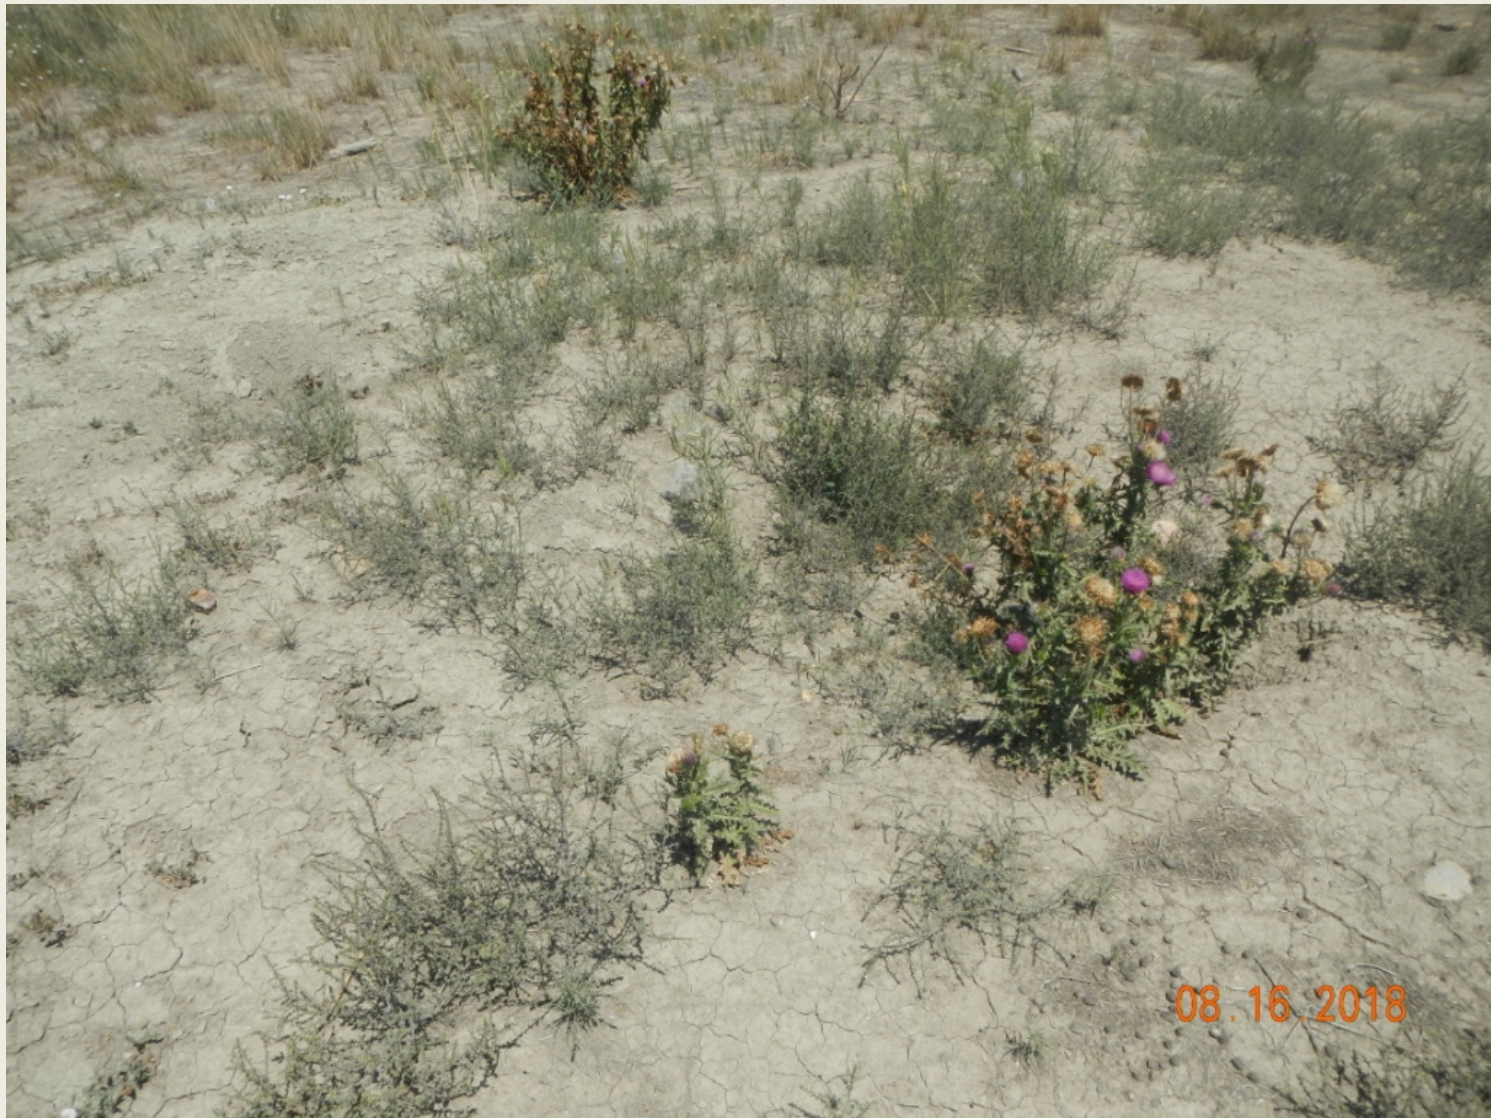
**Photo 4. View of musk thistles (*Carduus nutans*) in flower and seed condition in the eastern project area.**
