Inspection Photos
Location Name: Moyer - 612N56W / 29SESE
Location #: 317529

Oil & Gas Conservation
Commission

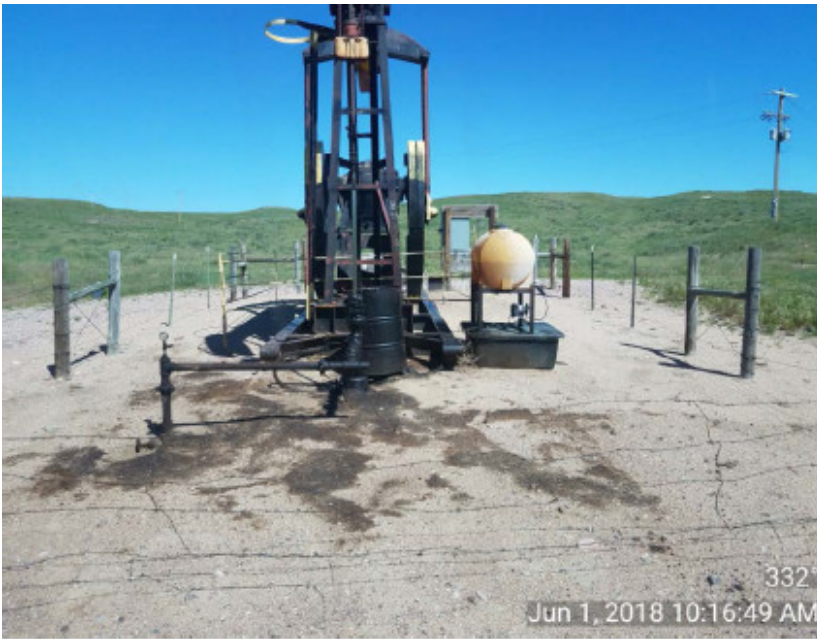
Photo #1
Moyer Unit 16-29 (API 05-123-07014) wellhead
Stained soil
From previous FIR

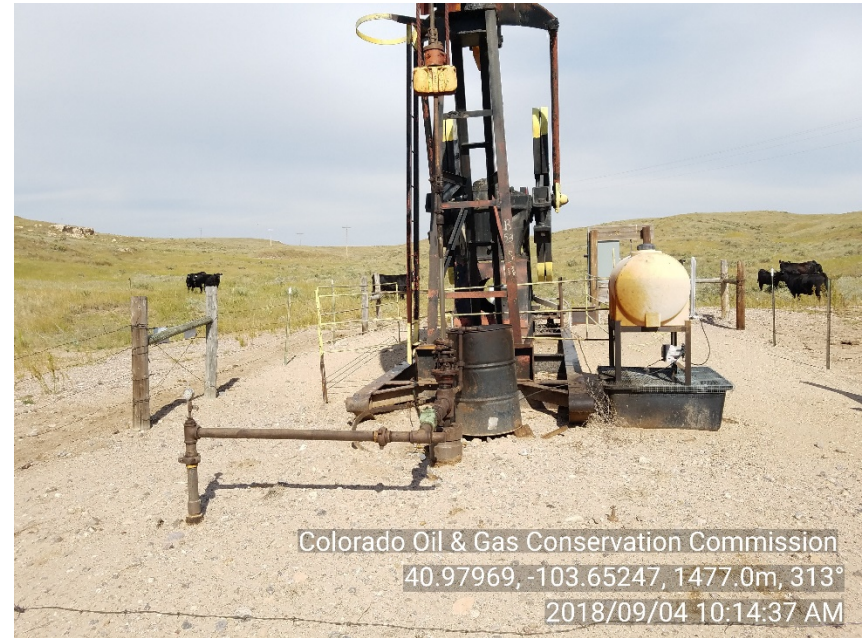
Photo #2
Moyer Unit 16-29 wellhead
Stained soil appears to be remediated
Bradenhead needs plumbed to surface

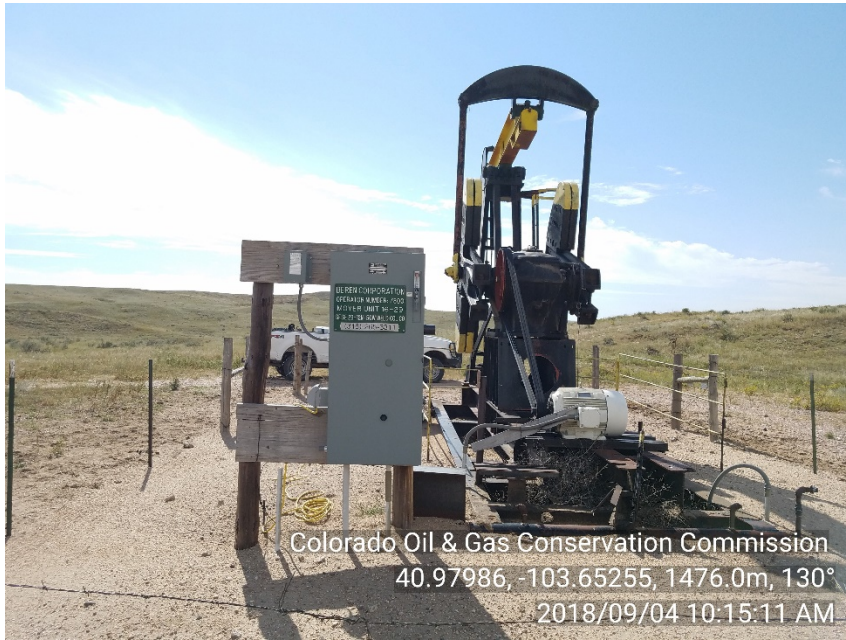
Photo #3
Moyer Unit 16-29 wellsite sign

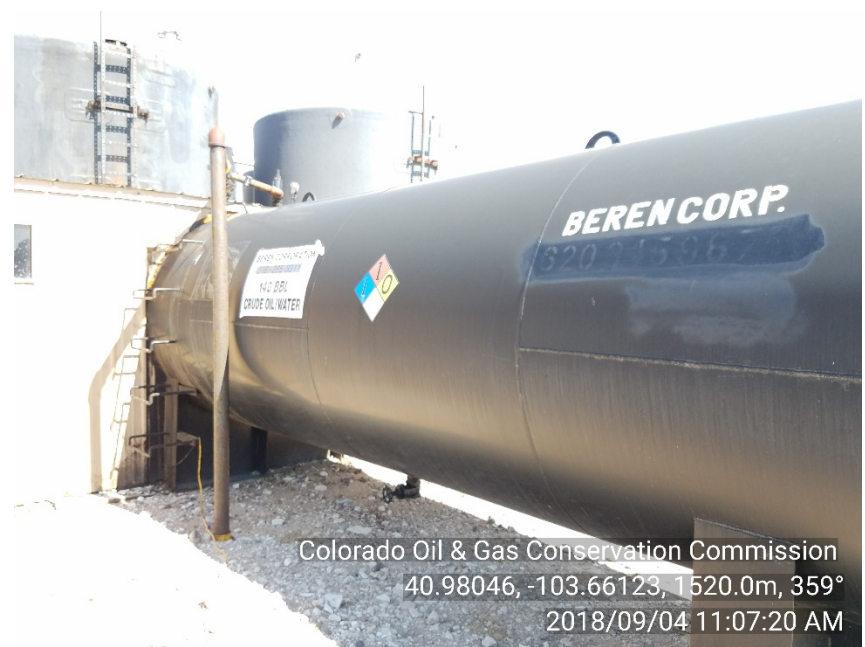
Photo #4
Moyer Unit Battery
Free Water Knockout

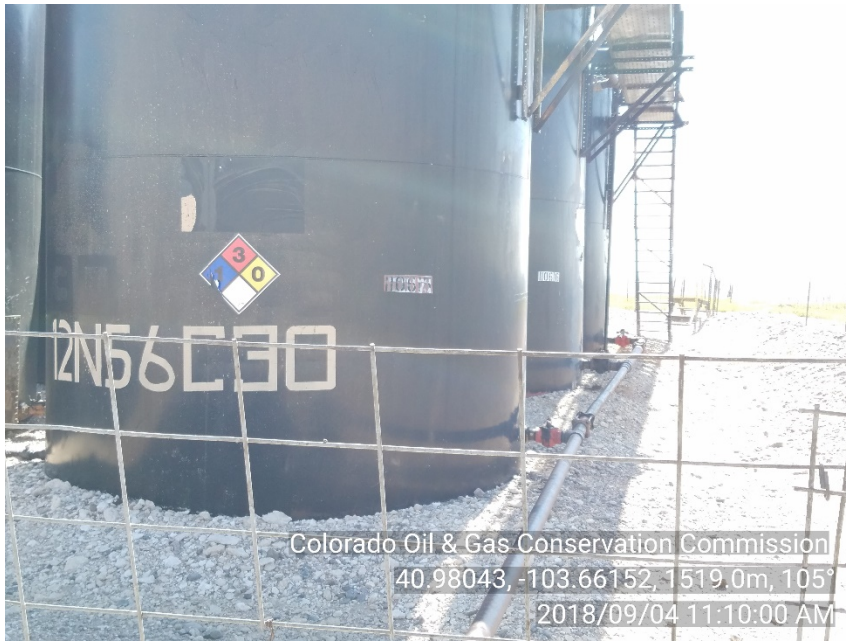
Photo #5

Moyer Unit Battery

Moyer 11-29, 13-29, 15-29, 3-32, 11-32 (UIC wells)

Moyer 10-29, 14-29, 16-29, 15-30, 16-30, 6-32

(Producing wells)

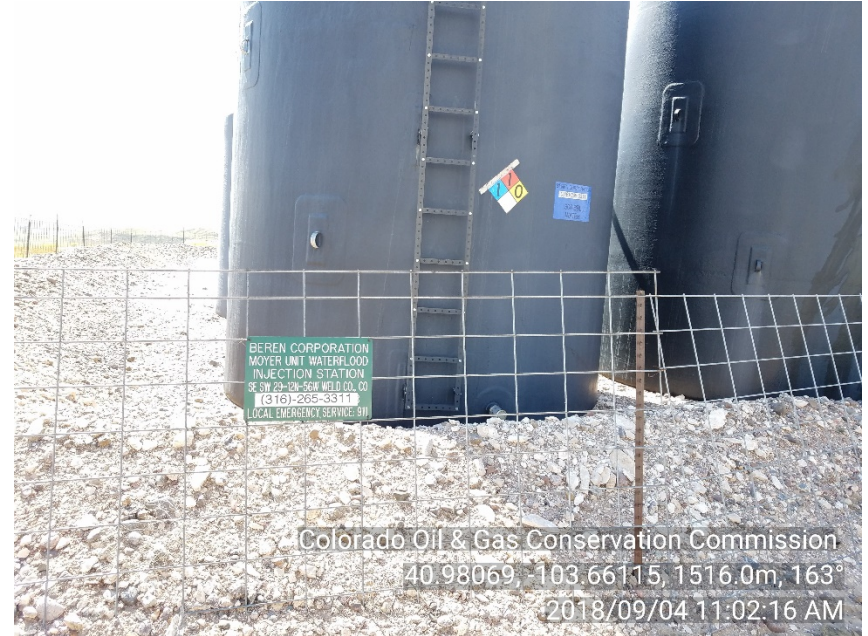
Photo #6

Moyer Unit H2O tanks
